ASBESTOS INVENTORY CONTROL

Building Name:	Archives	Inspection Date:	December 20, 2022
Building Code:	HB-19	Inspected By:	Neal Richardson
Building Address:	380 William Avenue	Construction Date:	1903

HB-19

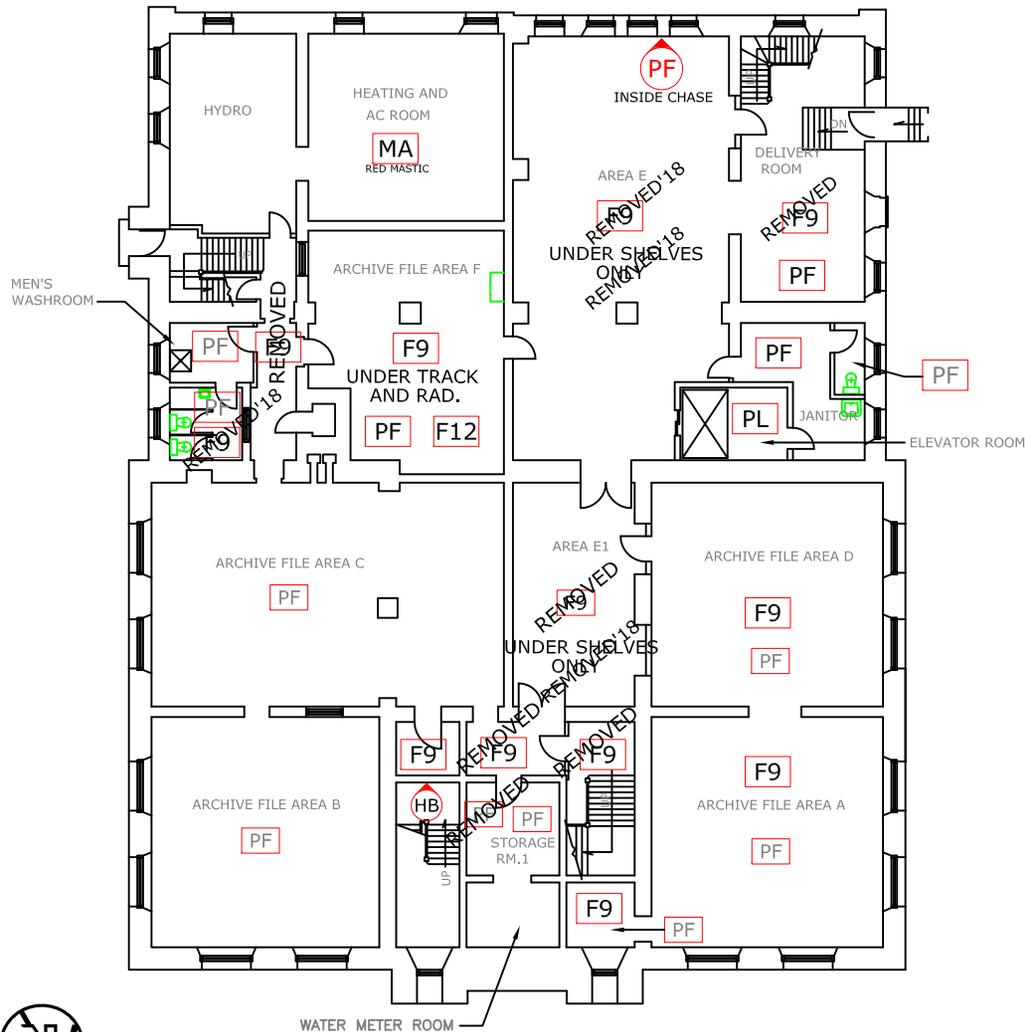
BASEMENT PLAN

Material Location	Material Description	Drawing Label	Material Condition	Testing Status	Lab Report #	Date M/Y	Test %	Est. %
	Drywall Compound Contains Asbestos							
	Red Duct Mastic Contains Asbestos							
Basement								
Delivery Room	Pipe Fitting Insulation	PF	Good					
	9x9 Floor Tile	F9	Removed'11					
Janitor's Closet	Pipe Fitting Insulation	PF	Good					
Elevator Room	Plaster - Ceiling	PL	Good					
Area A	Pipe Fitting Insulation	PF	Good					
Corner Room at Area A	Pipe Fitting Insulation	PF	Good					
	9x9 Floor Tile	F9	Good					
Area B	Pipe Fitting Insulation	PF	Good					
Area C	Pipe Fitting Insulation	PF	Good					
Area D	Pipe Fitting Insulation	PF	Good					
	9x9 Floor Tile	F9	Needs Repair					
	Concrete Floor Topping (Under Floor Tile)		Good	TESTED	123144	Feb/13	0	
Area E	Pipe Fitting Insulation			TESTED	43654	Jan/07	0	
	9x9 Floor Tile - Under Shelving only	F9	Removed'18					
	Pipe Fitting Insulation - Inside South Wall	PF	Needs Repair	TESTED	212629	Dec/18	80

Plaster - Wall	PL	Needs Repair	TESTED	212629	Dec/18	0	
Area E1	9x9 Floor Tile	F9	Removed'11

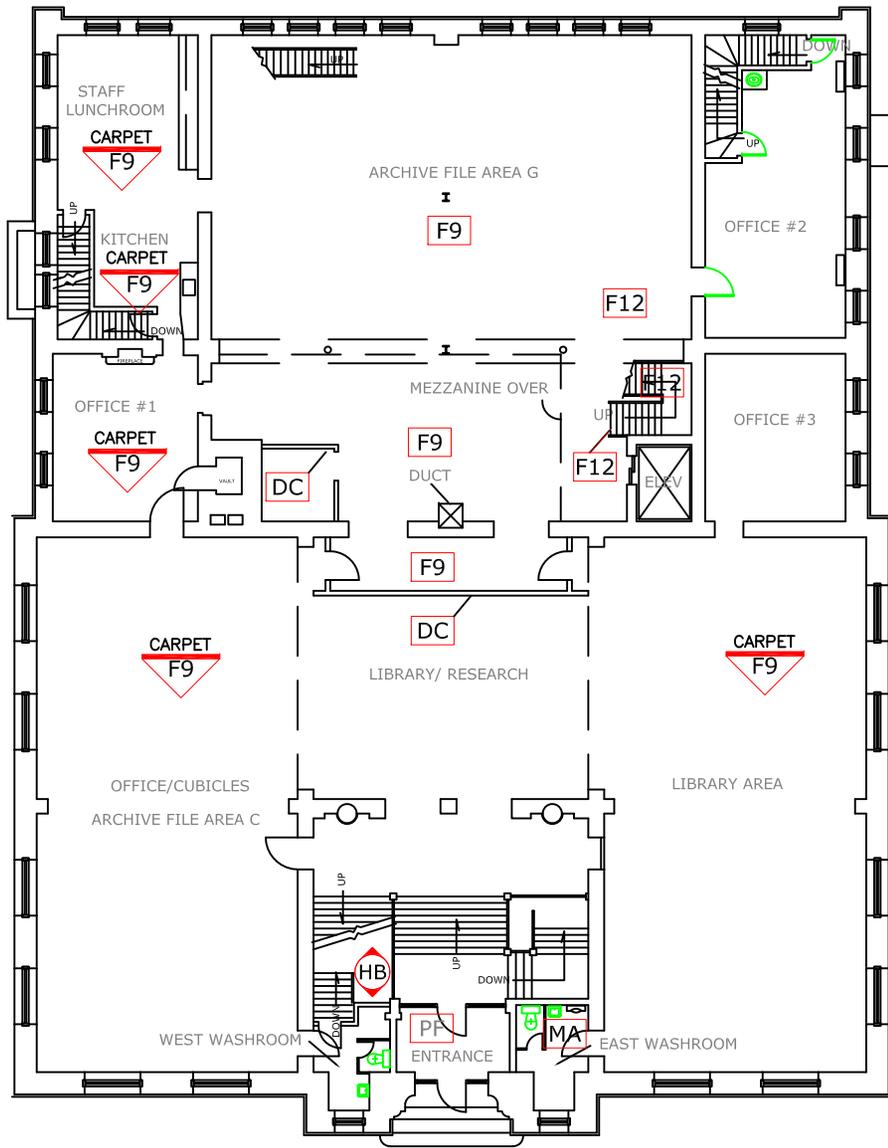
MAIN FLOOR PLAN

Material Location	Material Description	Drawing Label	Material Condition	Testing Status	Lab Report #	Date M/Y	Test %	Est. %
Plaster Column	Stucco - Walls	ST	Good	TESTED	92461	Oct/10	0	
	Plaster (2 Samples)	PL		TESTED	b222911	Dec/19	0	
	Scratch Coat (2 Samples)			TESTED	b222911	Dec/19	0	
Partition Wall	Drywall Compound (3 Samples)	DC	Good	TESTED	b222911	Dec/19	1-5	
Back Stairs - East	Steam Pipes		Removed					
Area G - Archive	Pipe Fitting Insulation		Removed/07	TESTED	43652	Apr/07	0	
	9x9 Floor Tile - Black Backing	F9	Good	TESTED	b73719	Jul/10	0	
	9x9 Floor Tiles - Black Backing (3 Samples)	F9	Needs Repair	TESTED	230025	Nov/19	0	
	Glue Tan/Red (3 Samples)			TESTED	230025	Nov/19	0	
	12x12 Floor Tile - Stair Treads	F12	Good	TESTED	84854	Apr/10	5	
	12x12 Floor Tile - Gray	F12	Good	TESTED	84854	Apr/10	3	
	12X12 Floor Tile - Green	F12	Good	TESTED	116724	Aug/12	3	
	Duct Insulation	DI	Good	TESTED	84854	Apr/10	0

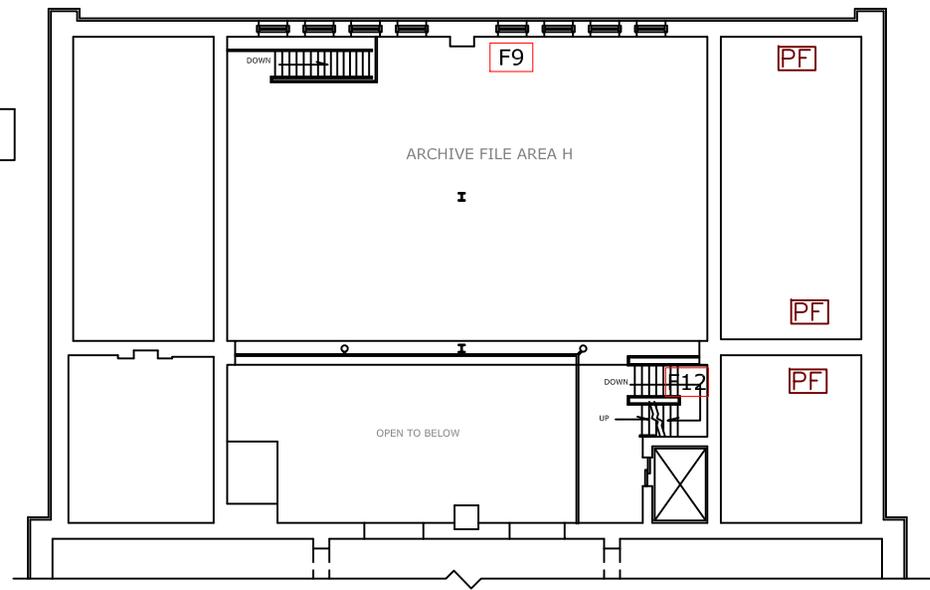
MAIN FLOOR MEZZANINE PLAN

Safe	Brick		Good	TESTED	194108	Oct/17	0	
Main Floor - Mezzanine								
Area H	Pipe Fitting Insulation	PF		TESTED	84854	Apr/10	0	
	9x9 Floor Tile - grey - Black Backing	F9	Good	TESTED	194108	Aug/12	0	
Ceiling	Plaster (1 Sample)	PL		TESTED	b222911	Dec/19	0	
	Scratch Coat (1 Sample)	PL		TESTED	b222911	Dec/19	0	
Second Floor								
North Stairwell	Terazzo		Needs Repair	TESTED	244938	Oct/'20	0	
Developing Film Room	Pipe Fitting Insulation	PF	Good

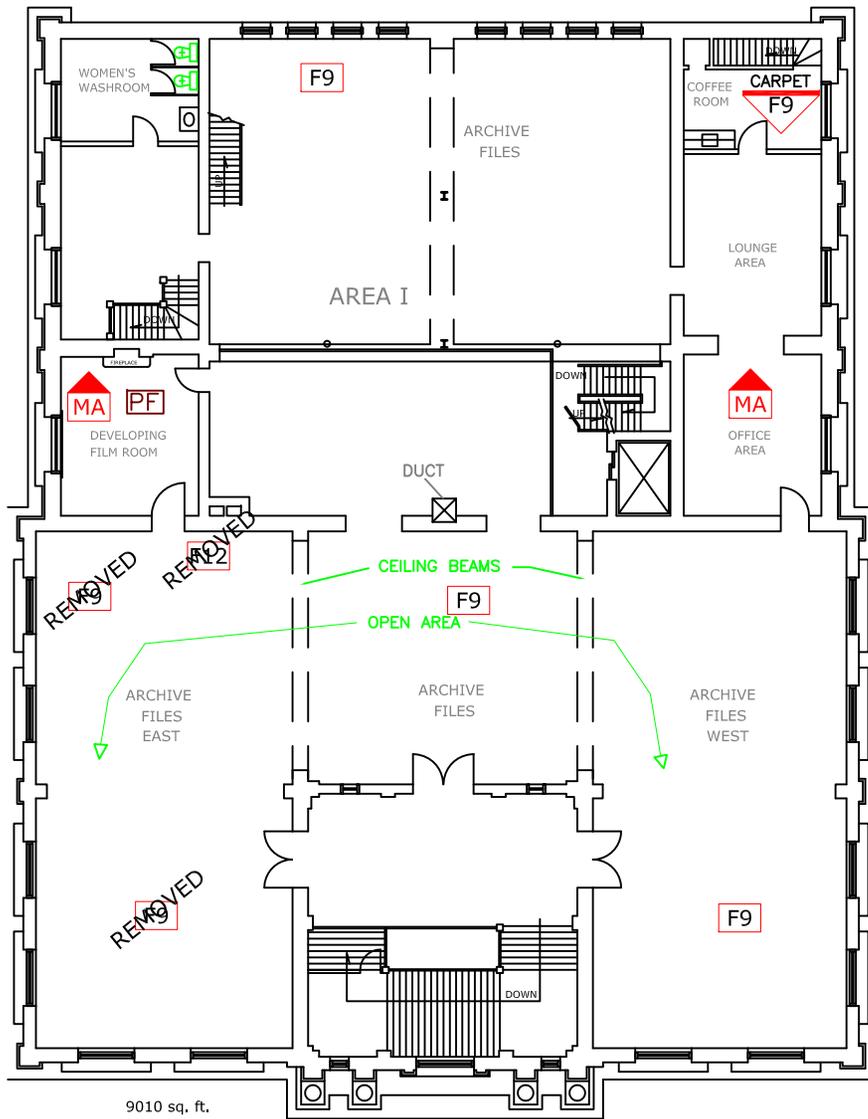
SECOND FLOOR PLAN

Sheet Flooring	FS	Good	TESTED	101846	Jul/11	0	
	Mastic - Duct - Above Ceiling (Red/ Brown)	MA	Good					
Area I	Pipe Fitting Insulation	PF						
	9x9 Floor Tile - Beige and Red Tiles	F9	Good	TESTED	84854	Apr/10	5	
	12x12 Floor Tile - Grey	F12	Good	TESTED	116724	Aug/18	3	
Wall	Plaster (1 Sample)	PL	Needs Repair	TESTED	b222911	Dec/19	0	
	Scratch Coat (1 Sample) *See Pinchin Report 234838.278*	PL	Good	TESTED	b222911	Dec/19	<0.1	0
Wall	Plaster	PL	Good	TESTED	b261750	Nov/'21	0	
Wall - Arch West	Plaster	PL	Good	TESTED	b261750	Nov/'21	0	
Column - Arch East	Plaster	PL	Good	TESTED	b261750	Nov/'21	0	
Wall - Second Flor SF	Plaster	PL	Good	TESTED	b261750	Nov/'21	0	
Wall - South	Plaster	PL	Good	TESTED	b261750	Nov/'21	0

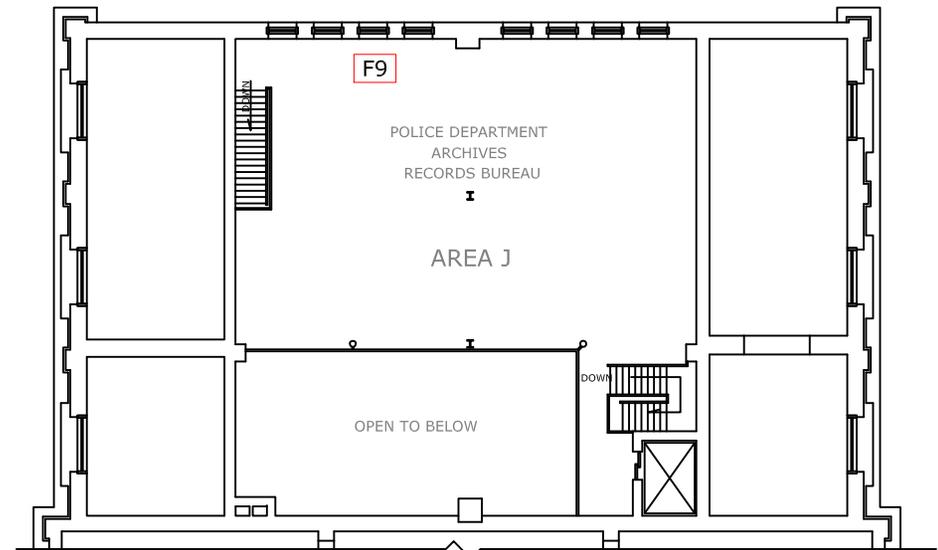
2ND FLOOR MEZZANINE PLAN

Fireplace Lining		Good	TESTED	194108	Oct/17	0	
Office @ Lounge Area	Mastic - Duct - Above Ceiling (Red/ Brown)	MA	Good					
Ceiling 2nd Floor	Plaster	PL	Good	TESTED	43653	Jan/07	0	
	Plaster	PL	Good	TESTED	64723	Feb/08	0	
Ceiling Under 2nd Flr Mezzanine	12x12 Ceiling Tile - Non-Asbestos							0
Archives Files East	Underlay		Needs Repair	TESTED	194108	Oct/'17	0	
Second Floor - Mezzanine								
Area J	Pipe Fitting Insulation	PF	Good	TESTED	101926	Aug/12	0	
	9x9 Floor Tile - Black Backing	F9	Good	TESTED		Jun/13	0	
Burried Pipe at South End of Property	Pipe Insulation	PI		TESTED		Sept/08	50-75	
Rooftop	Mortar		Good	TESTED	194108	Oct/17	0	
East Parapet Roof	Roof Mastic	MA	Good	TESTED	194108	Oct/17	15	
South Parapet Roof	Roof Mastic	MA	Good	TESTED	194108	Oct/17	10
