EKW - PHOTO 1: ENTRANCE TO ELMWOOD KILDONAN POOL

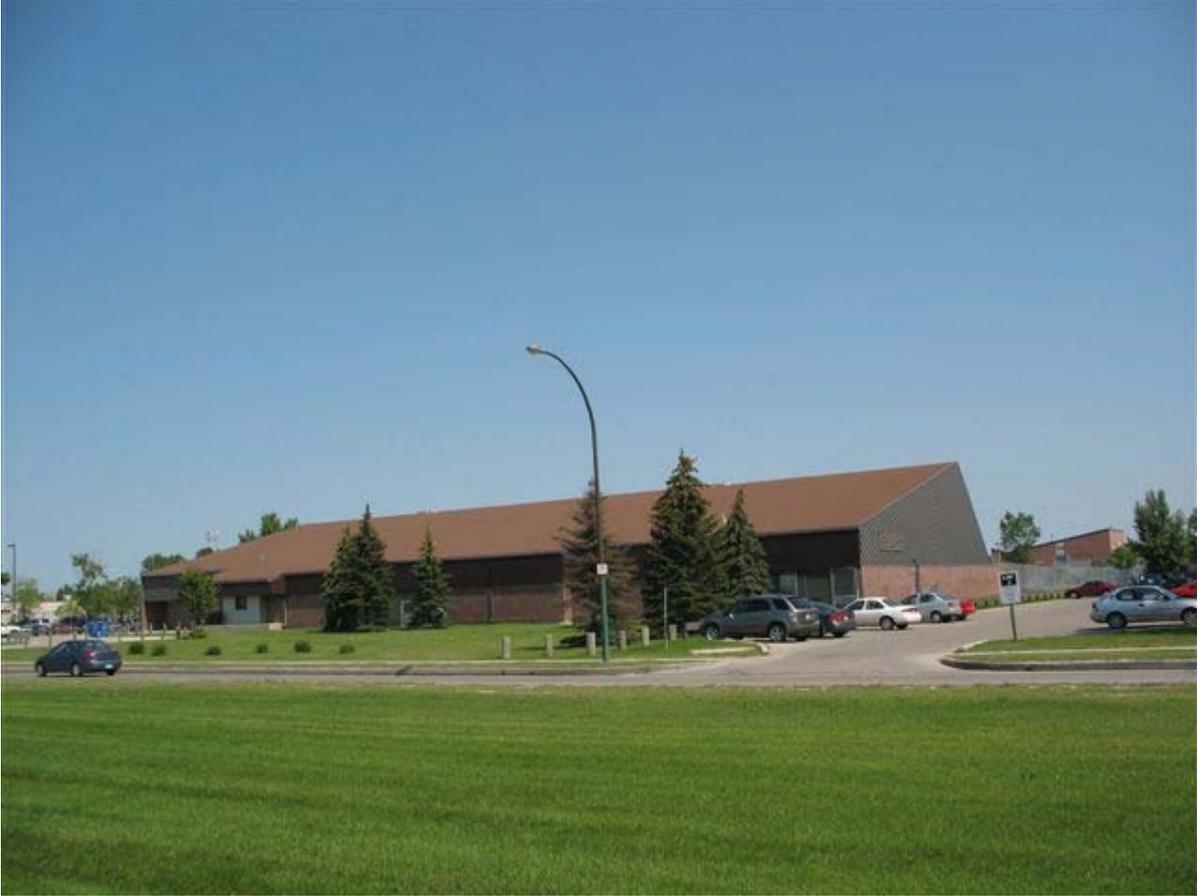
EKW- PHOTO 2: ELMWOOD KILDONAN POOL SEEN FROM CONCORDIA AVENUE. SOUTH ELEVATION

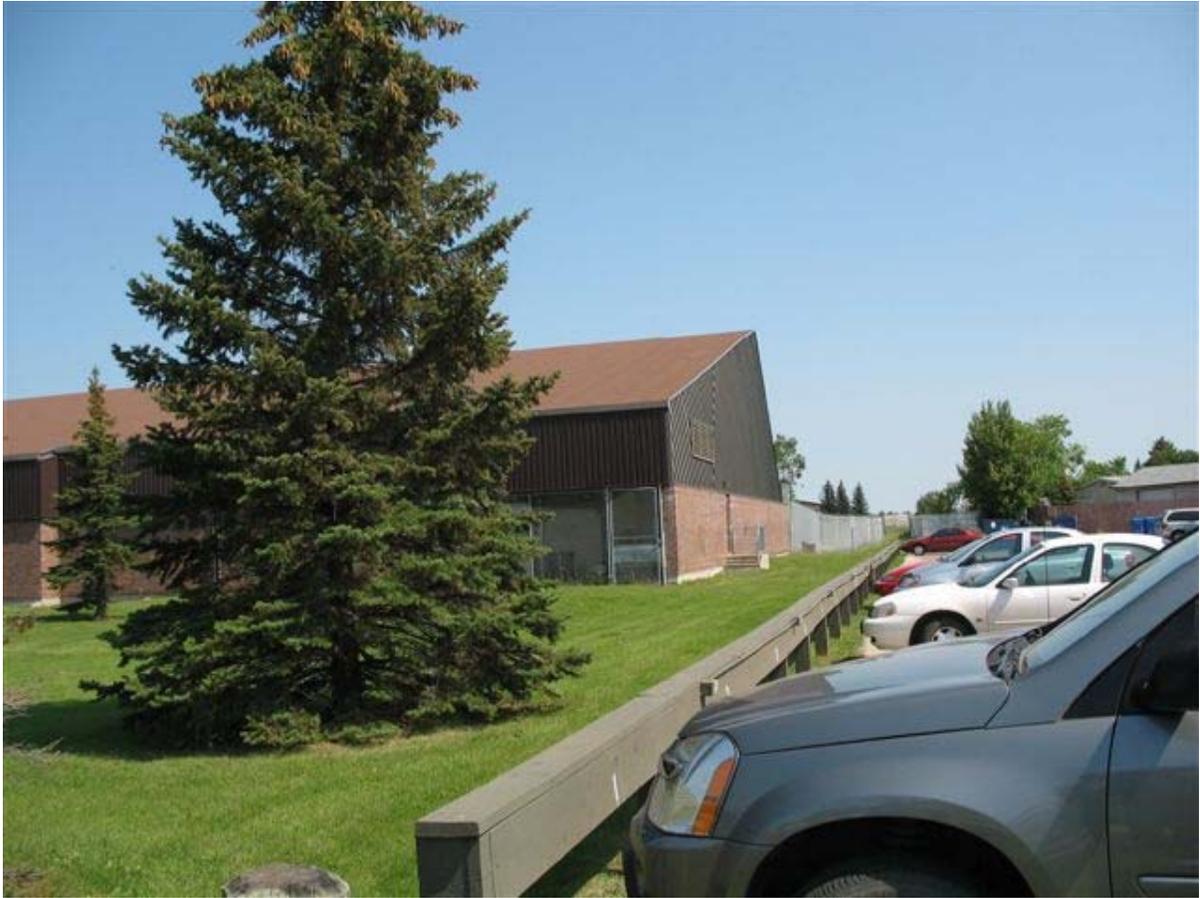
EKW- PHOTO 3: ELMWOOD KILDONAN POOL, SOUTH EAST CORNER. NOTE THE EAST WALL FACING THE ROW OF PARKING IS ADJACENT TO THE LOCATION OF THE WATERSLIDE INSIDE THE POOL BUILDING

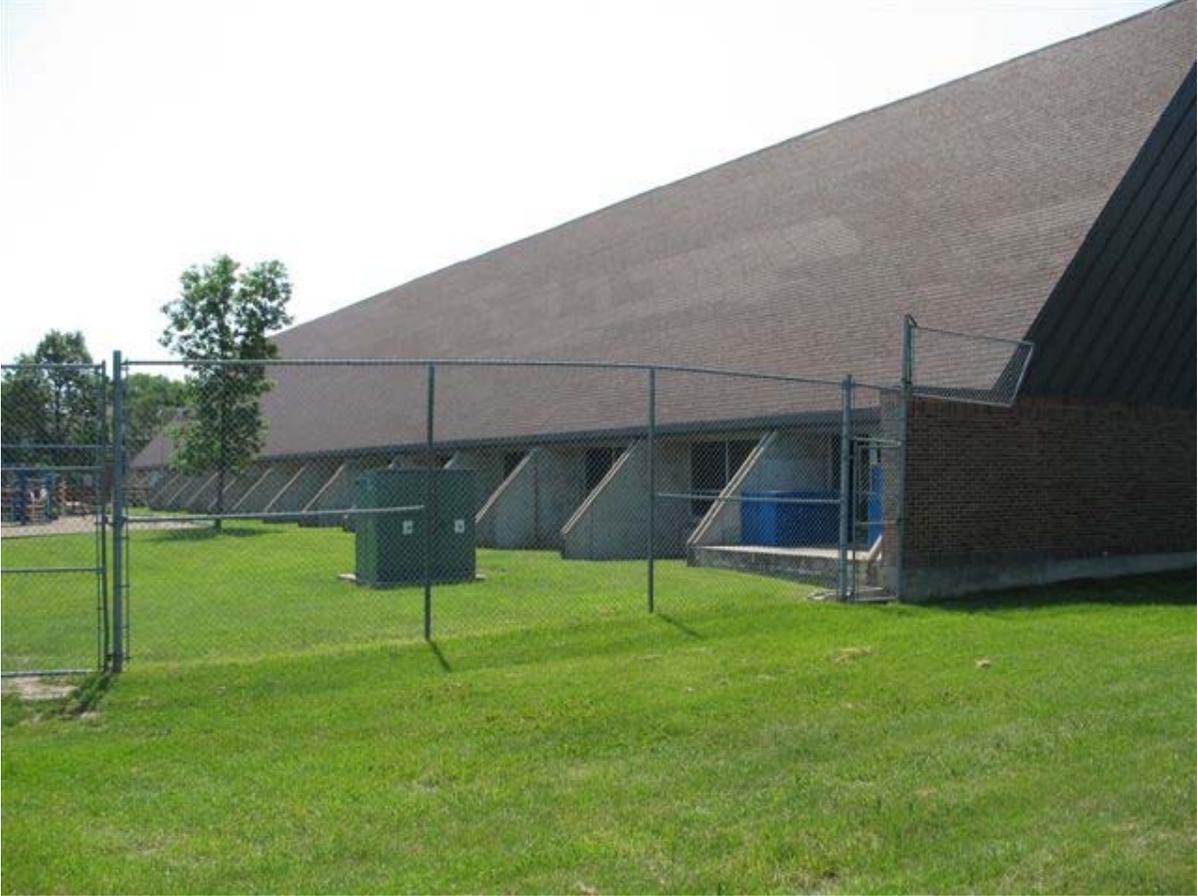
EKW- PHOTO 4: ELMWOOD KILDONAN POOL, NORTH WALL FACING THE PLAYGROUND AREA. NOTE: THE CONCRETE BUTTRESSES ARE IN LINE WITH THE INTERIOR WOOD BEAM FRAMING.

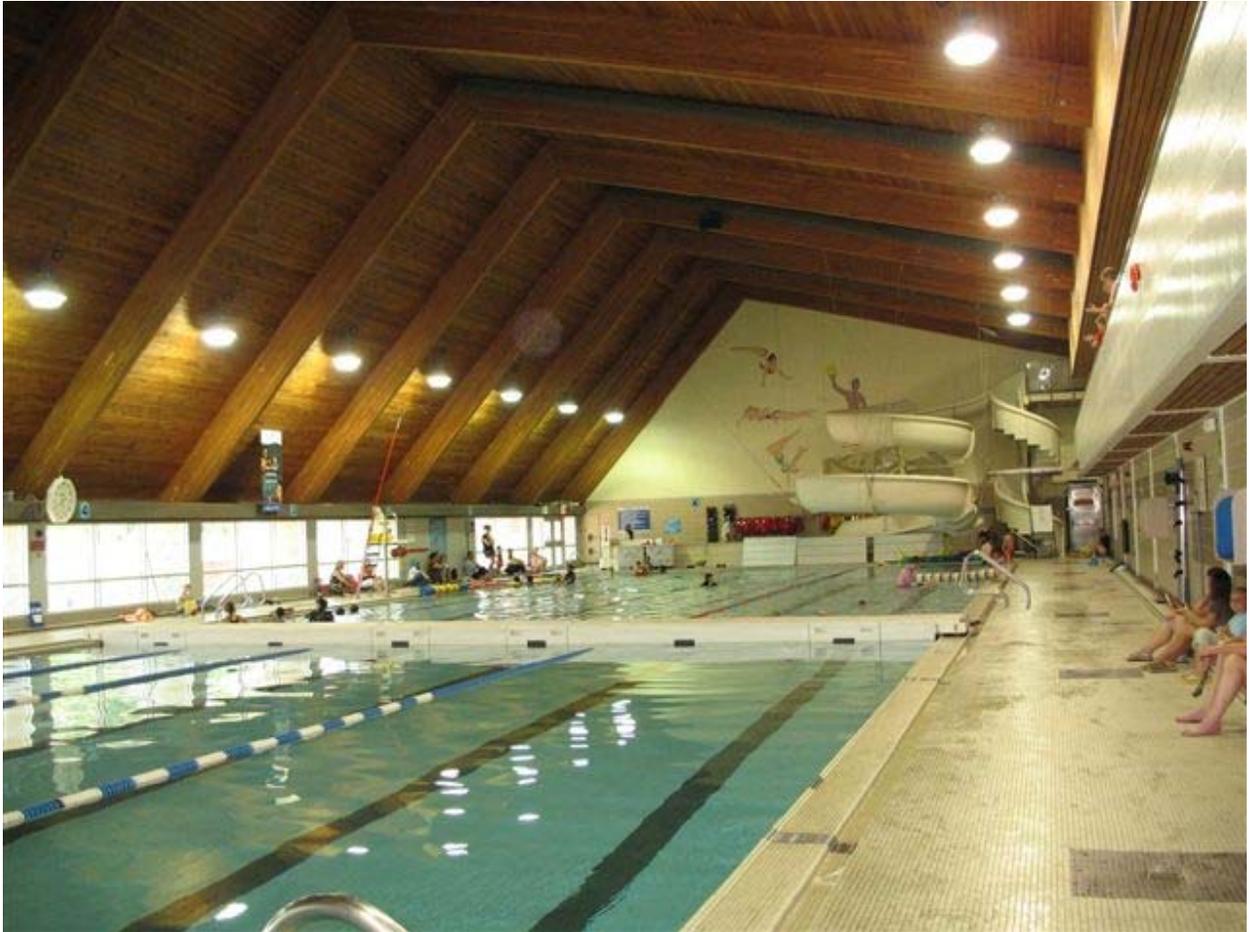
EKW- PHOTO 5: ELMWOOD KILDONAN POOL INTERIOR, LOOKING EAST. THE EXISTING WATERSLIDE IS LOCATED AGAINST THE EAST WALL, AT THE SHALLOW END OF THE POOL. THE NEW STRUCTURE IS ALSO TO BE LOCATED ALONG THE EAST WALL.

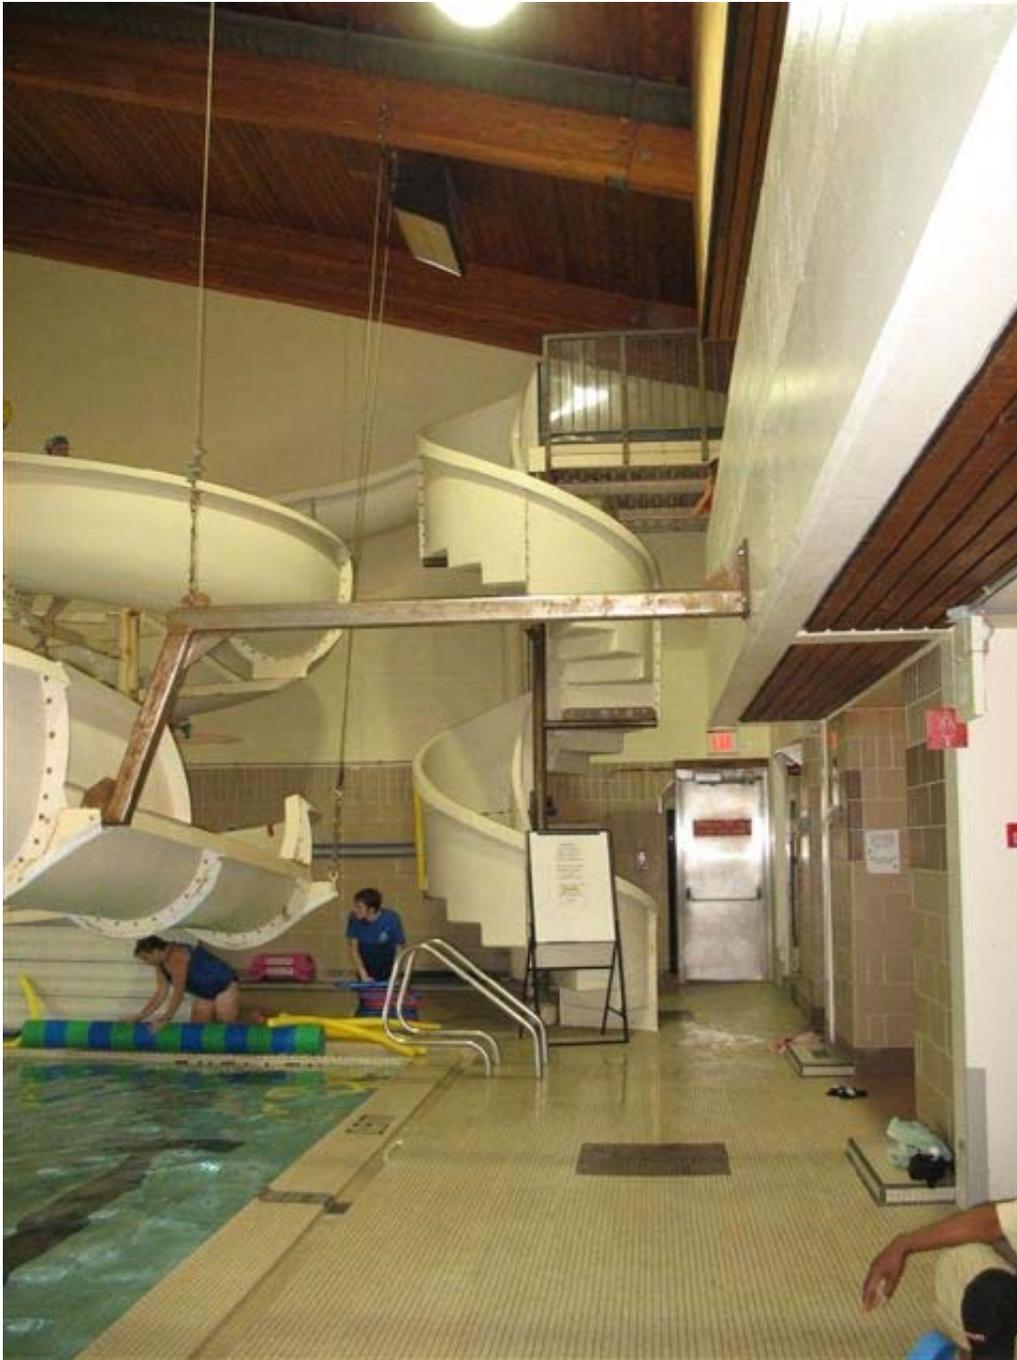
EKW- PHOTO 6: ELMWOOD KILDONAN POOL VIEW OF THE EXISTING WATERSLIDE SPIRAL STAIR ACCESS TO PLATFORM AT NOMINAL 17 FT HEIGHT. THE WATERSLIDE CABLE SUSPENSIONS, SPIRAL STAIR AND STEEL SUPPORTS IN THE FOREGROUND ARE ALL TO BE REMOVED UNDER THIS CONTRACT.

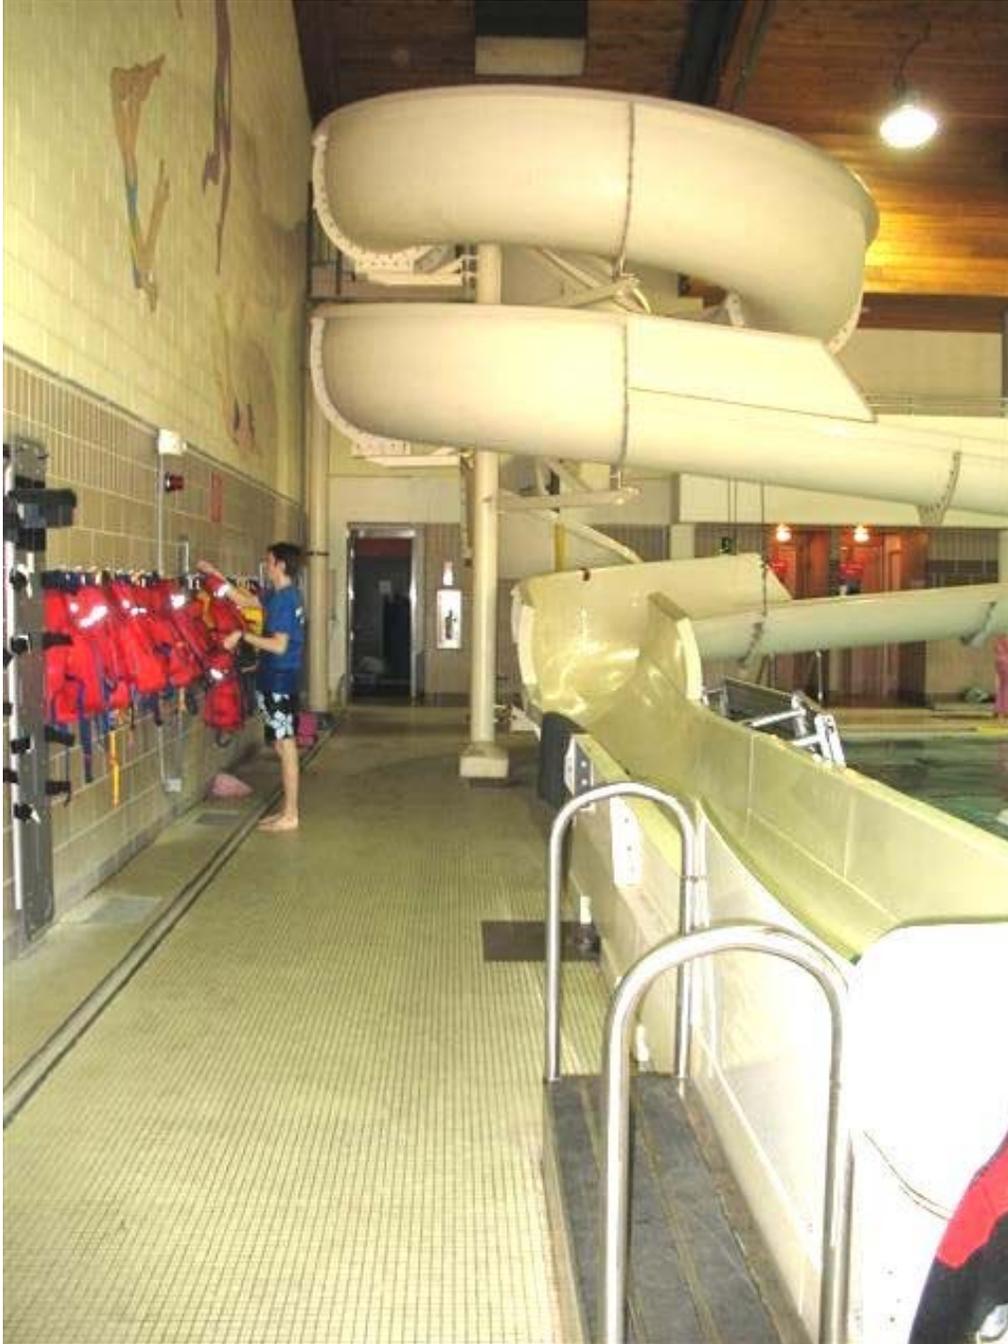
EKW- PHOTO 7: EXISTING WATERSLIDE TO BE DEMOLISHED, LOOKING SOUTH ALONG THE EAST APRON OF THE POOL. NOTE THE TERMINATION OF THE WATERSLIDE RUNS ALONG THE APRON ADJACENT TO THE POOL. THE TERMINATION OF THE NEW WATERSLIDE IS TO BE IN GENERALLY THE SAME LOCATION.

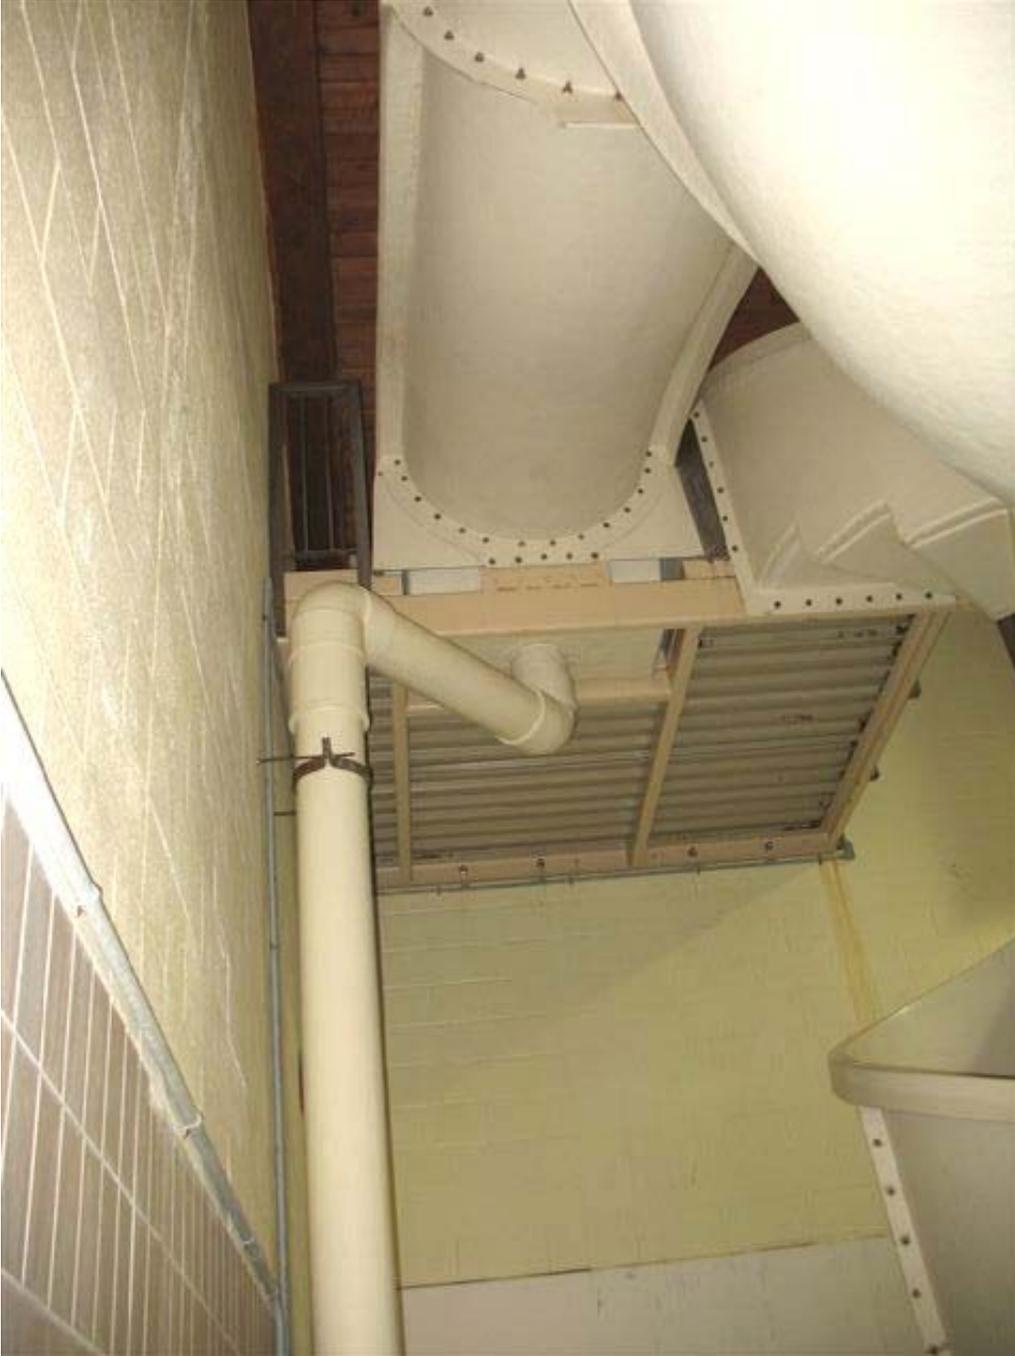
EKW- PHOTO 8: VIEW FROM UNDERSIDE OF THE EXISTING ACCESS PLATFORM. THIS PLATFORM IS TO BE DEMOLISHED AND REMOVED UNDER THIS CONTRACT. NOTE THE PRESENT LOCATION FOR THE WATER SUPPLY PIPING.

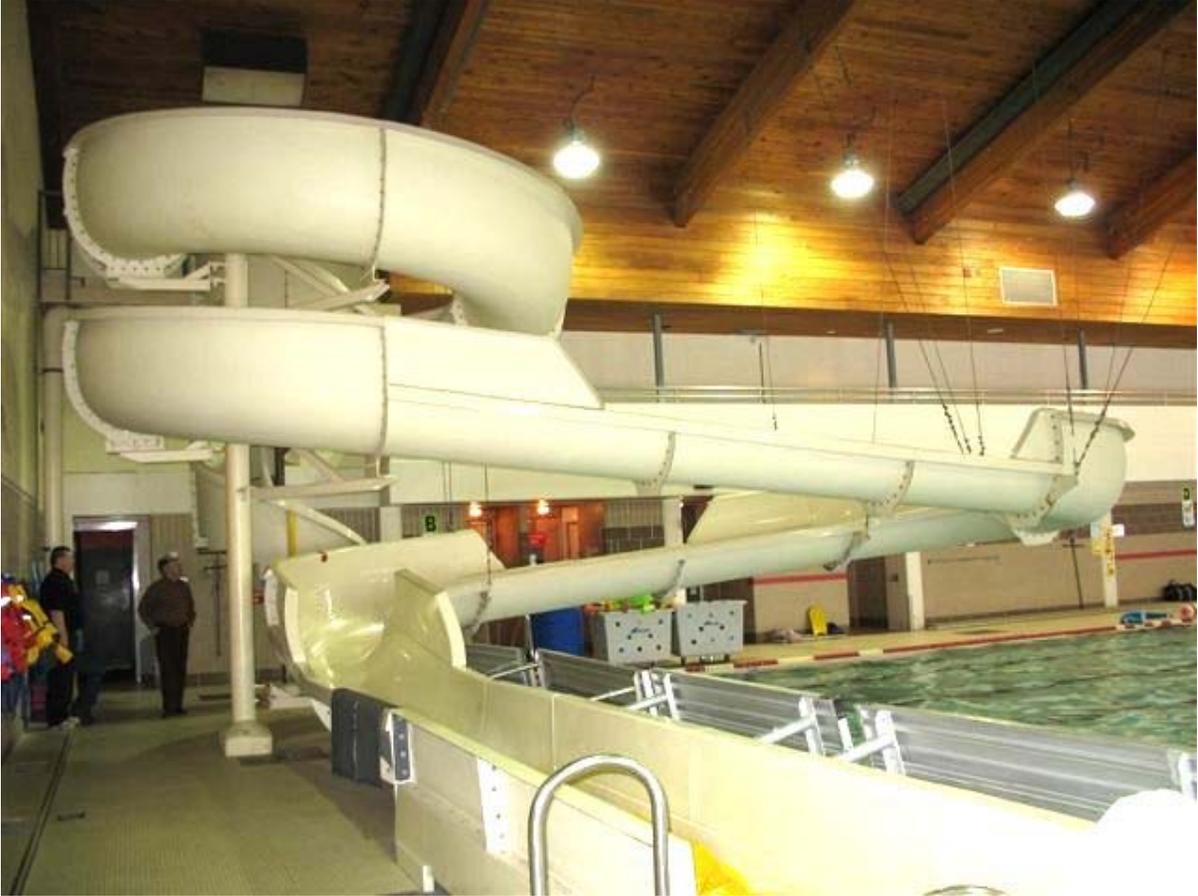
EKW- PHOTO 9: EXISTING WATERSLIDE SEEN LOOKING SOUTH. THE WATERSLIDE INCLUDING THE MAST AND SUPPORT STRUCTURES ARE TO BE DEMOLISHED AND REMOVED UNDER THIS CONTRACT.

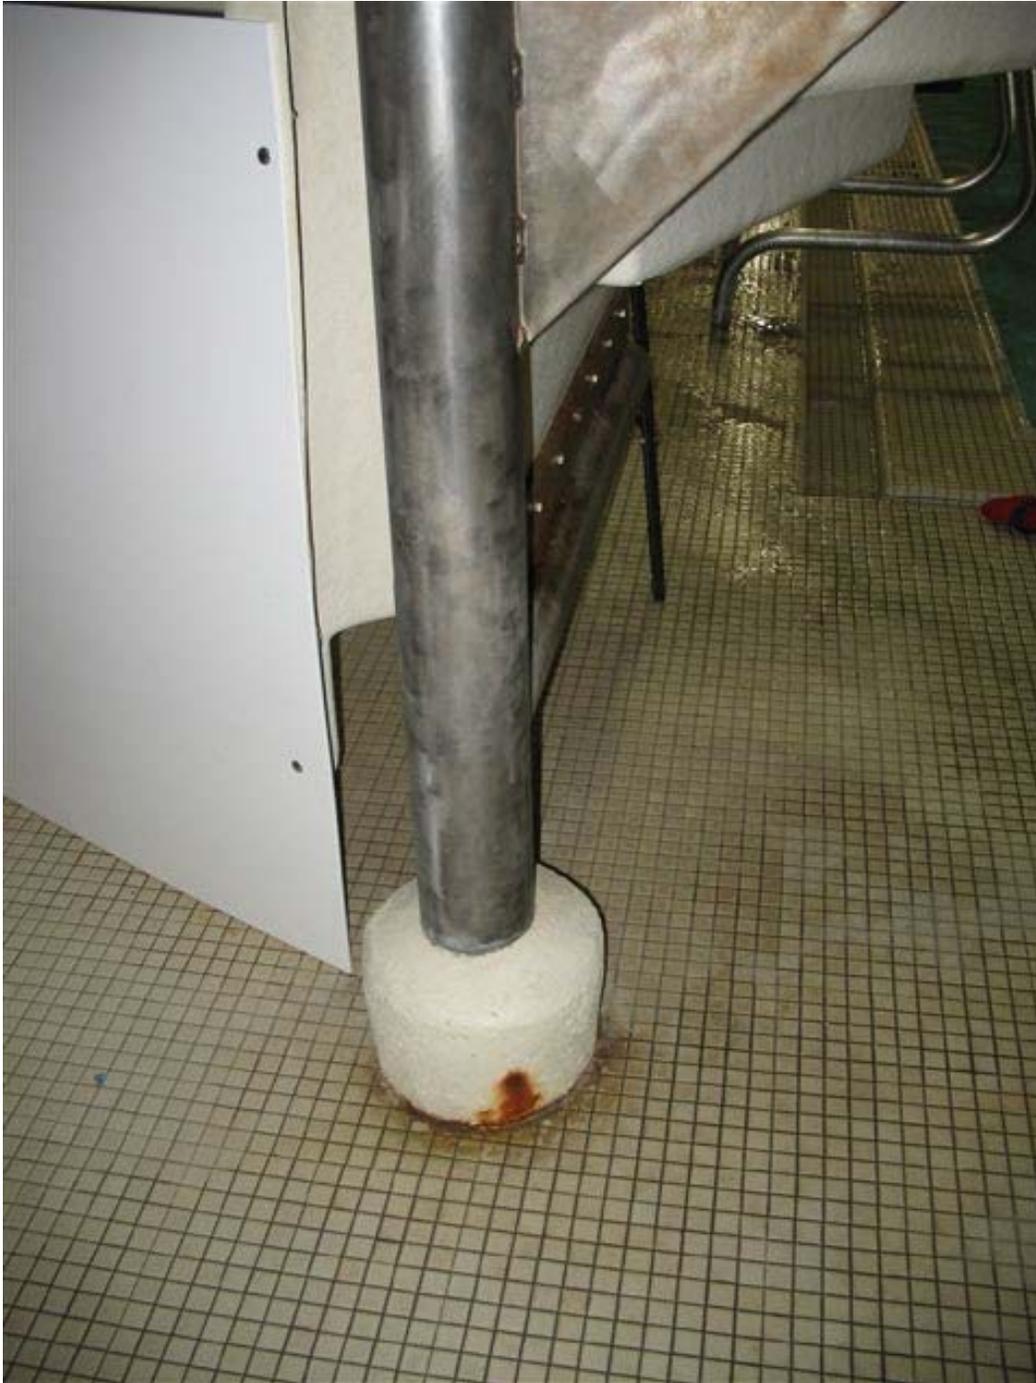
EKW- PHOTO 10: SUPPORT MAST FOR EXISTING SPIRAL STAIR TO BE DEMOLISHED AND REMOVED UNDER THIS CONTRACT. POOL DECK FINISHES TO BE RESTORED.

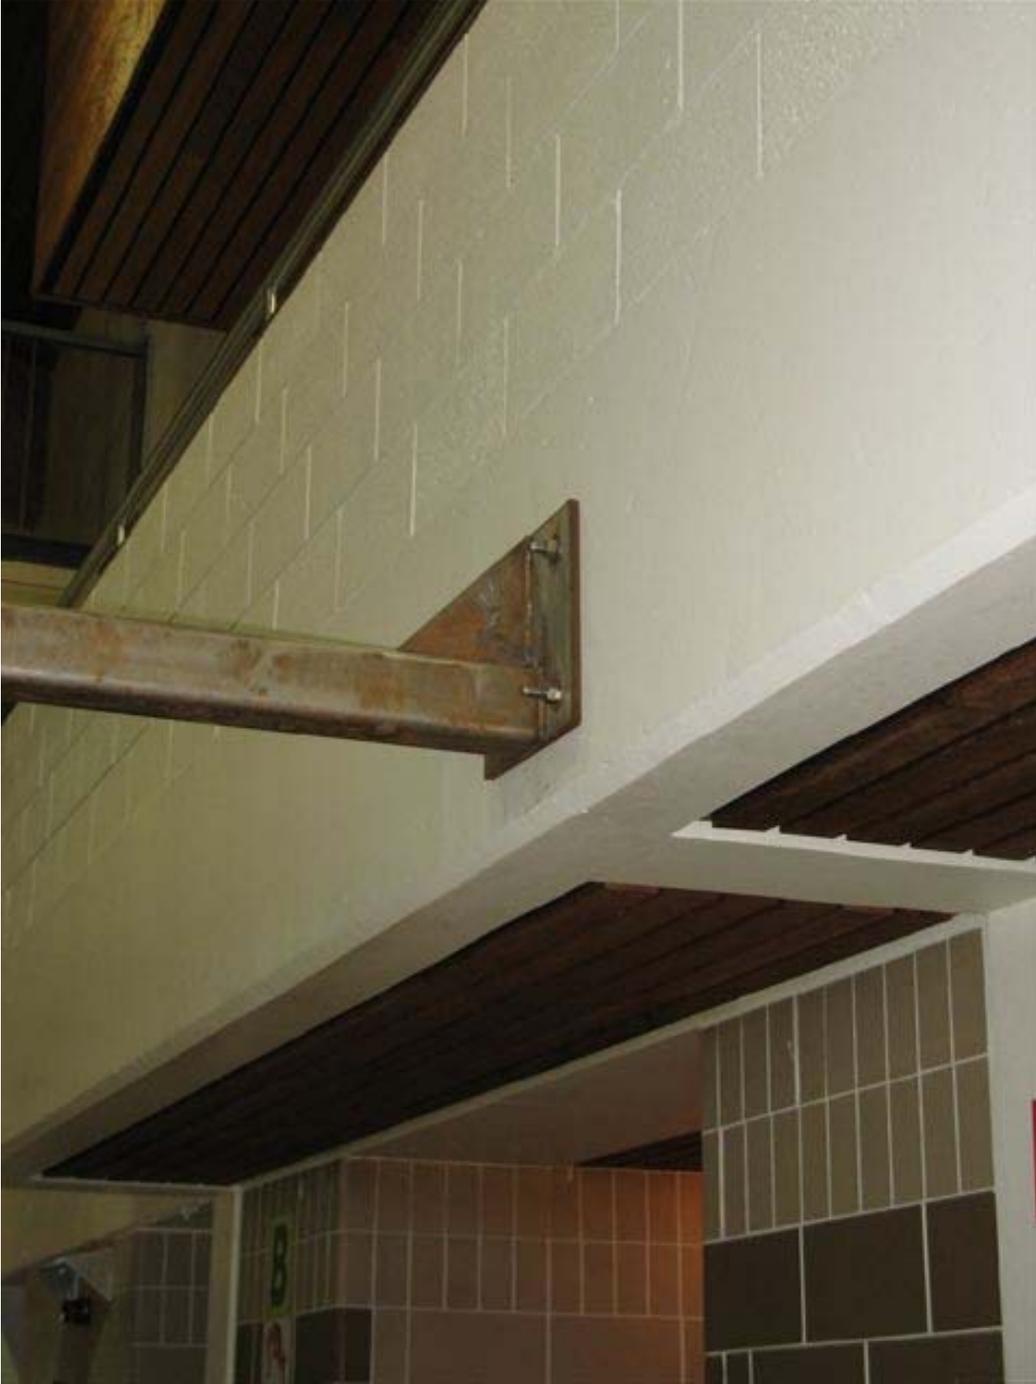
EKW- PHOTO 11: ANCHOR POINT FOR EXISTING HANGER SUPPORTING SECTION OF WATERSLIDE. THE HANGER IS TO BE REMOVED UNDER THIS CONTRACT AND THE WALL FINISH RESTORED.

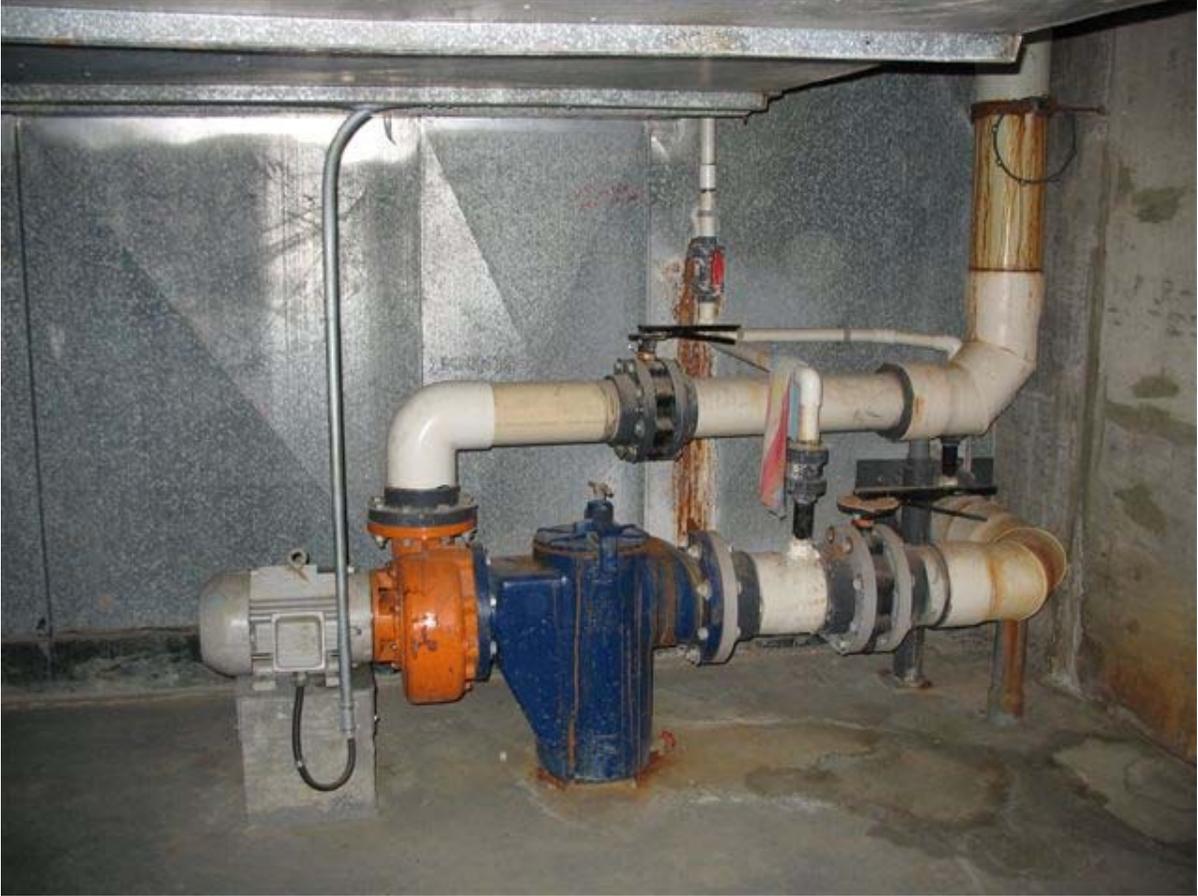
**EKW- PHOTO 12: EXISTING PUMP AND FILTER. NOTE:
EQUIPMENT TO BE REPLACED UNDER THIS CONTRACT.**

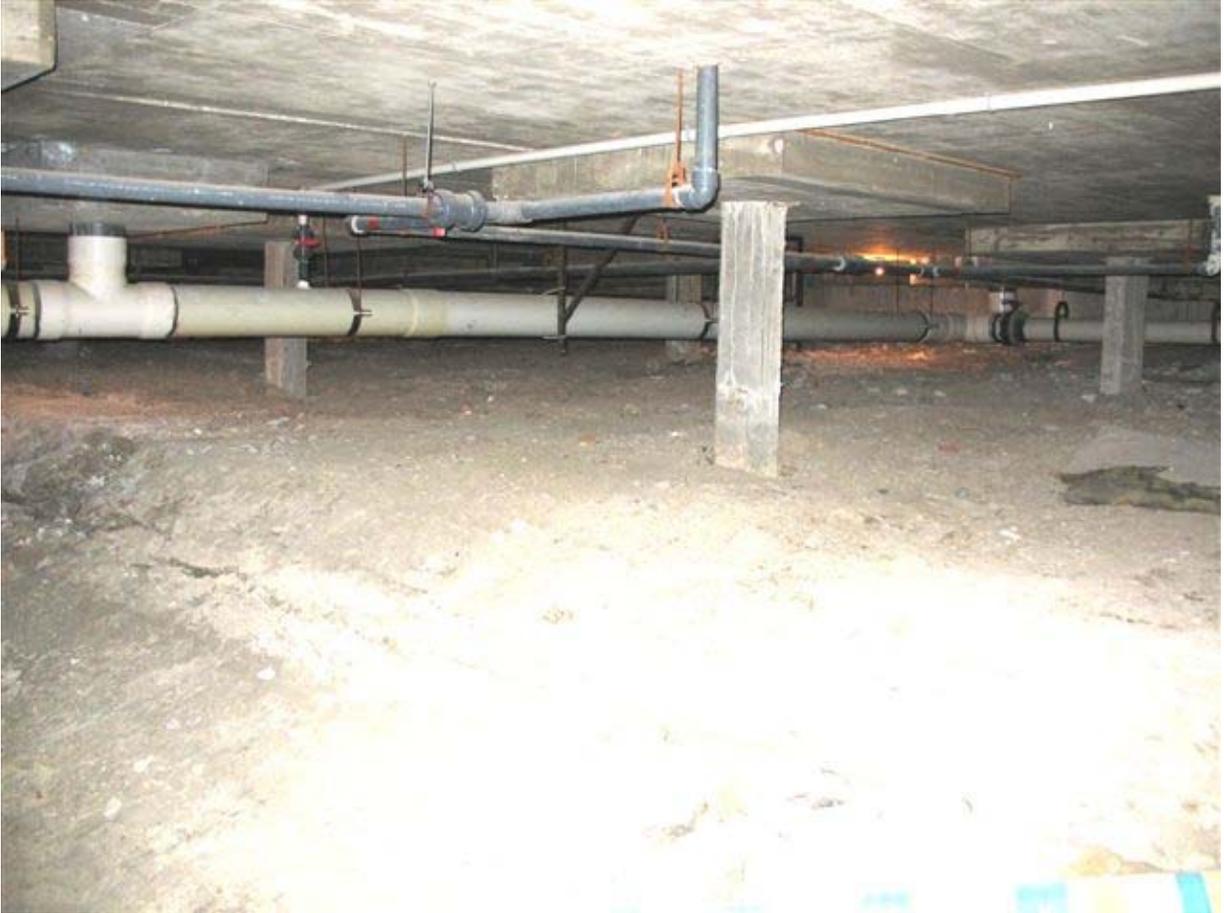
EKW- PHOTO 13: EXISTING MAKE UP WATER FROM UNDERSIDE OF POOL. NOTE: EXISTING SCH 40 PVC PIPING TO BE REPLACED WITH NEW SCH 80 PVC PIPING UNDER THIS CONTRACT.

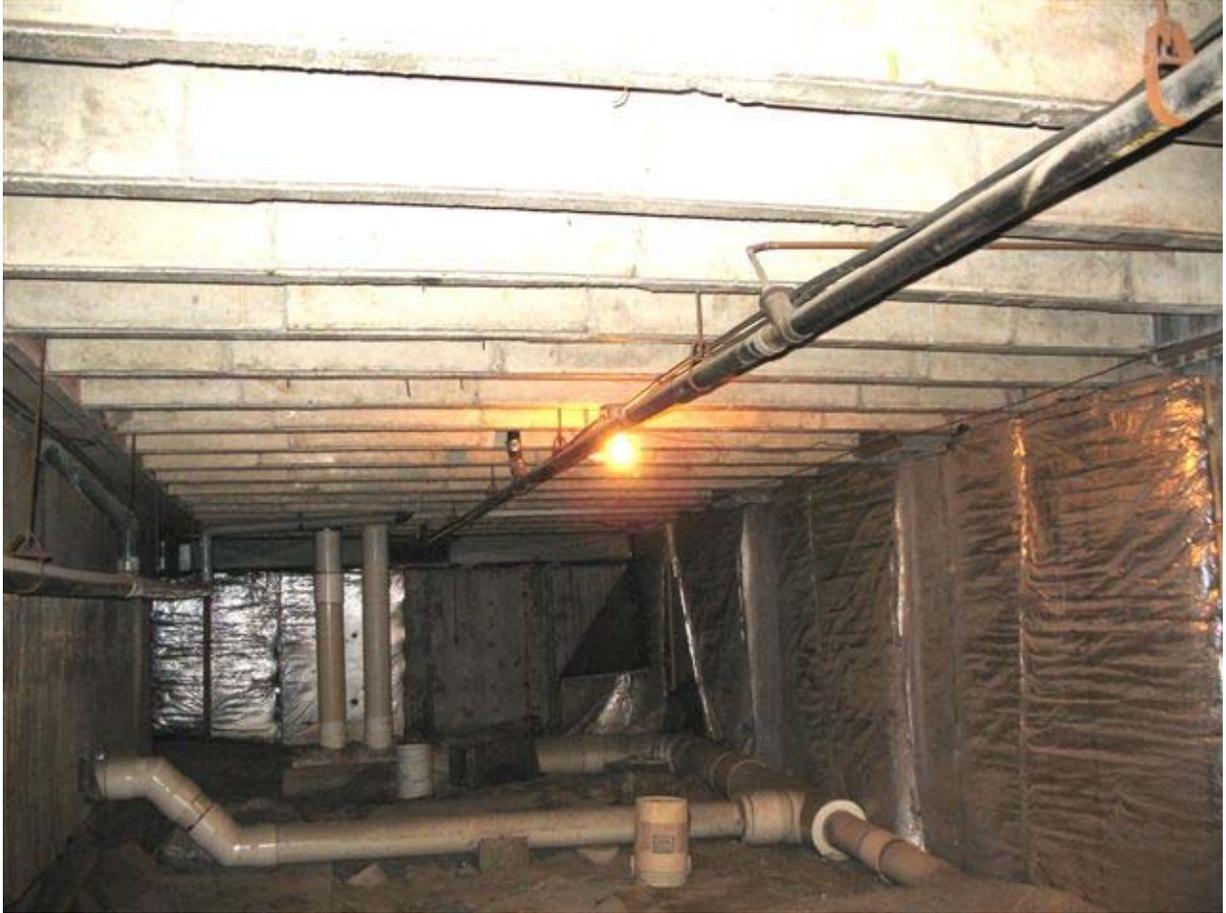
EKW- PHOTO 14: EXISTING RETURN WATER FROM SLIDE CONNECTING TO MAKE UP WATER FROM POOL RUNS TO PUMP INLET. NOTE: EXISTING SCH 40 PVC PIPING TO BE REPLACED WITH NEW SCH 80 PVC PIPING UNDER THIS CONTRACT.

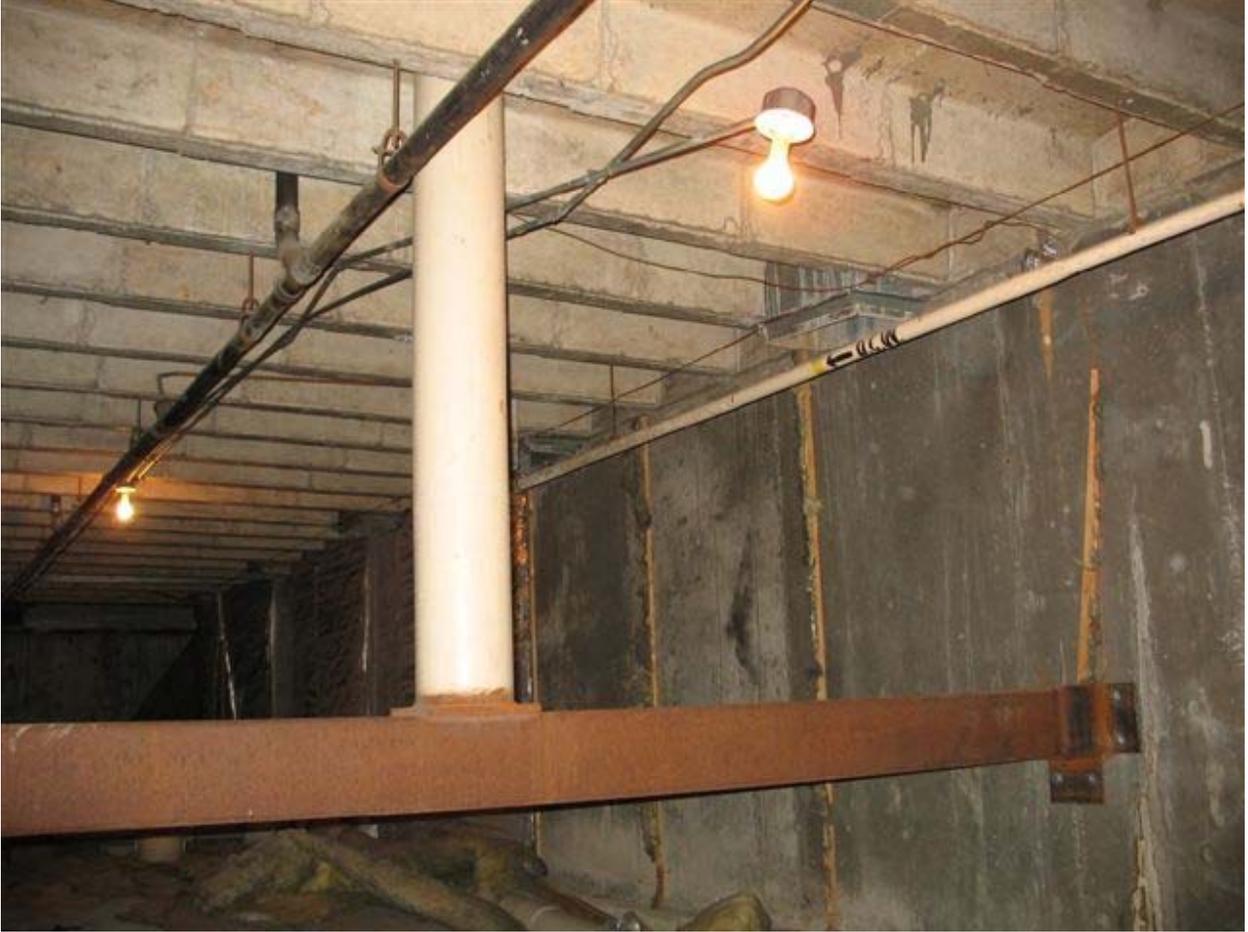
EKW- PHOTO 15: STRUCTURAL STEEL SUPPORT FOR EXISTING MAST SPANNING TUNNEL AREA OF BASEMENT BELOW THE EXISTING WATERSLIDE. NOTE: MAST TO BE REMOVED, STRUCTURAL SUPPORT MAY BE RETAINED IF SUITABLE.
