**THE CITY OF WINNIPEG**  
Winnipeg WATER AND WASTE DEPARTMENT

SHOAL LAKE AQUEDUCT  
DRAINAGE SIPHON REPAIRS  
MILES 50.31, 53.75 & 55.23  
DRAINAGE SIPHON 53.75  
(SITE 2)  
PLANS & SECTIONS

SHEET 4 OF 7  
CITY DRAWING NUMBER  
**D-11545**  
REV

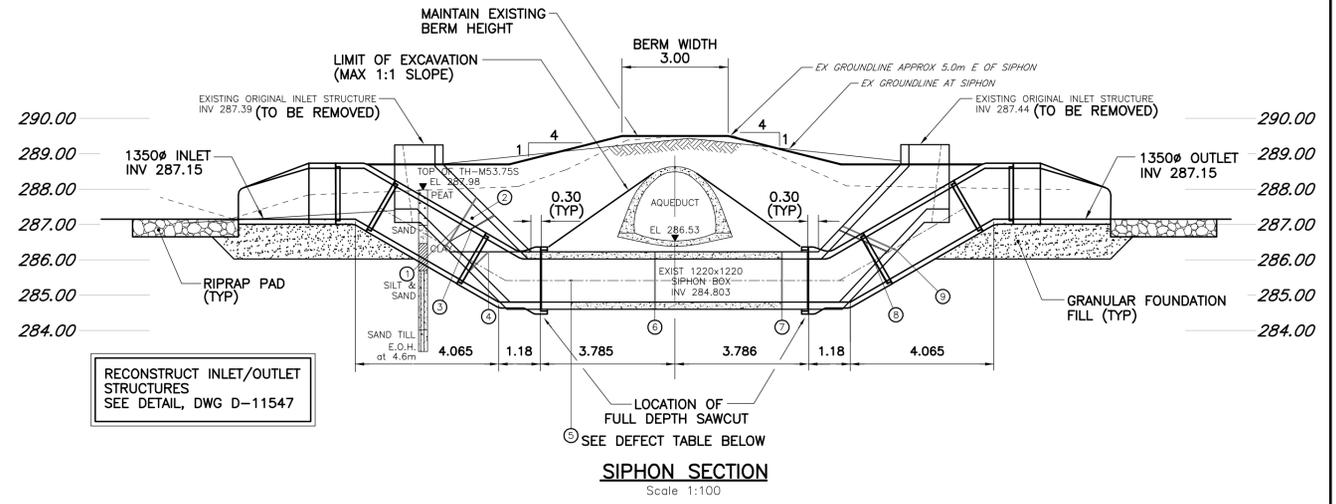
SIPHON SECTION  
Scale 1:100

DEFECT	DESCRIPTION	REMEDIAL ACTION
1	COMPLETE TRANSVERSE CRACK IN THROAT 1.5m FROM HEADWALL AND 1.3m FROM INLET INVERT. CRACK OPEN 1mm.	
2	WEST WALL BROKEN TO 300mm WIDE BETWEEN DEFECTS 1 & 3.	
3	COMPLETE TRANSVERSE CRACK IN THROAT 2.1m FROM HEADWALL AND 1.3m FROM INLET INVERT. CRACK OPEN >25mm (NO OFFSET). CONCRETE DELAMINATED & SPALLED AT CEILING; REINFORCING EXPOSED.	
4	HORIZ CONSTRUCTION JOINT OPEN 10mm FROM SIPHON BOX TO 0.9m FROM BOX, WHERE 5mm CRACK IN WALLS STARTS AND RUNS TO INLET INVERT (<5mm). CONSTRUCTION JOINT SOUTH OF CRACK IS TIGHT.	
5	50' CORE HOLE IN EAST AND WEST WALLS, 1.2m FROM CEILING OF BOX. LOCATION OF CORE HOLES FROM CEILING NOT RECORDED.	POLYURETHANE INJECTION
6	TRANSVERSE CRACK 3.6m FROM S END OF BOX. OPEN 1mm. NO INFILTRATION.	POLYURETHANE INJECTION
7	TRANSVERSE CRACK 7.2m FROM S END OF BOX. OPEN <1mm. NO INFILTRATION.	POLYURETHANE INJECTION
8	COMPLETE TRANSVERSE CRACK IN THROAT 1.0m FROM CEILING OF BOX, RUNNING TO HORIZ CONSTRUCTION JOINT AT THROAT FLOOR. CRACK OPEN >25mm. CONC SPALLED FROM WEST WALL AT FLOOR. REINFORCING EXPOSED.

9	TRANSVERSE CRACK IN EAST WALL AND CEILING OF THROAT, ABOVE DEFECT 7. CRACK OPEN <1mm.

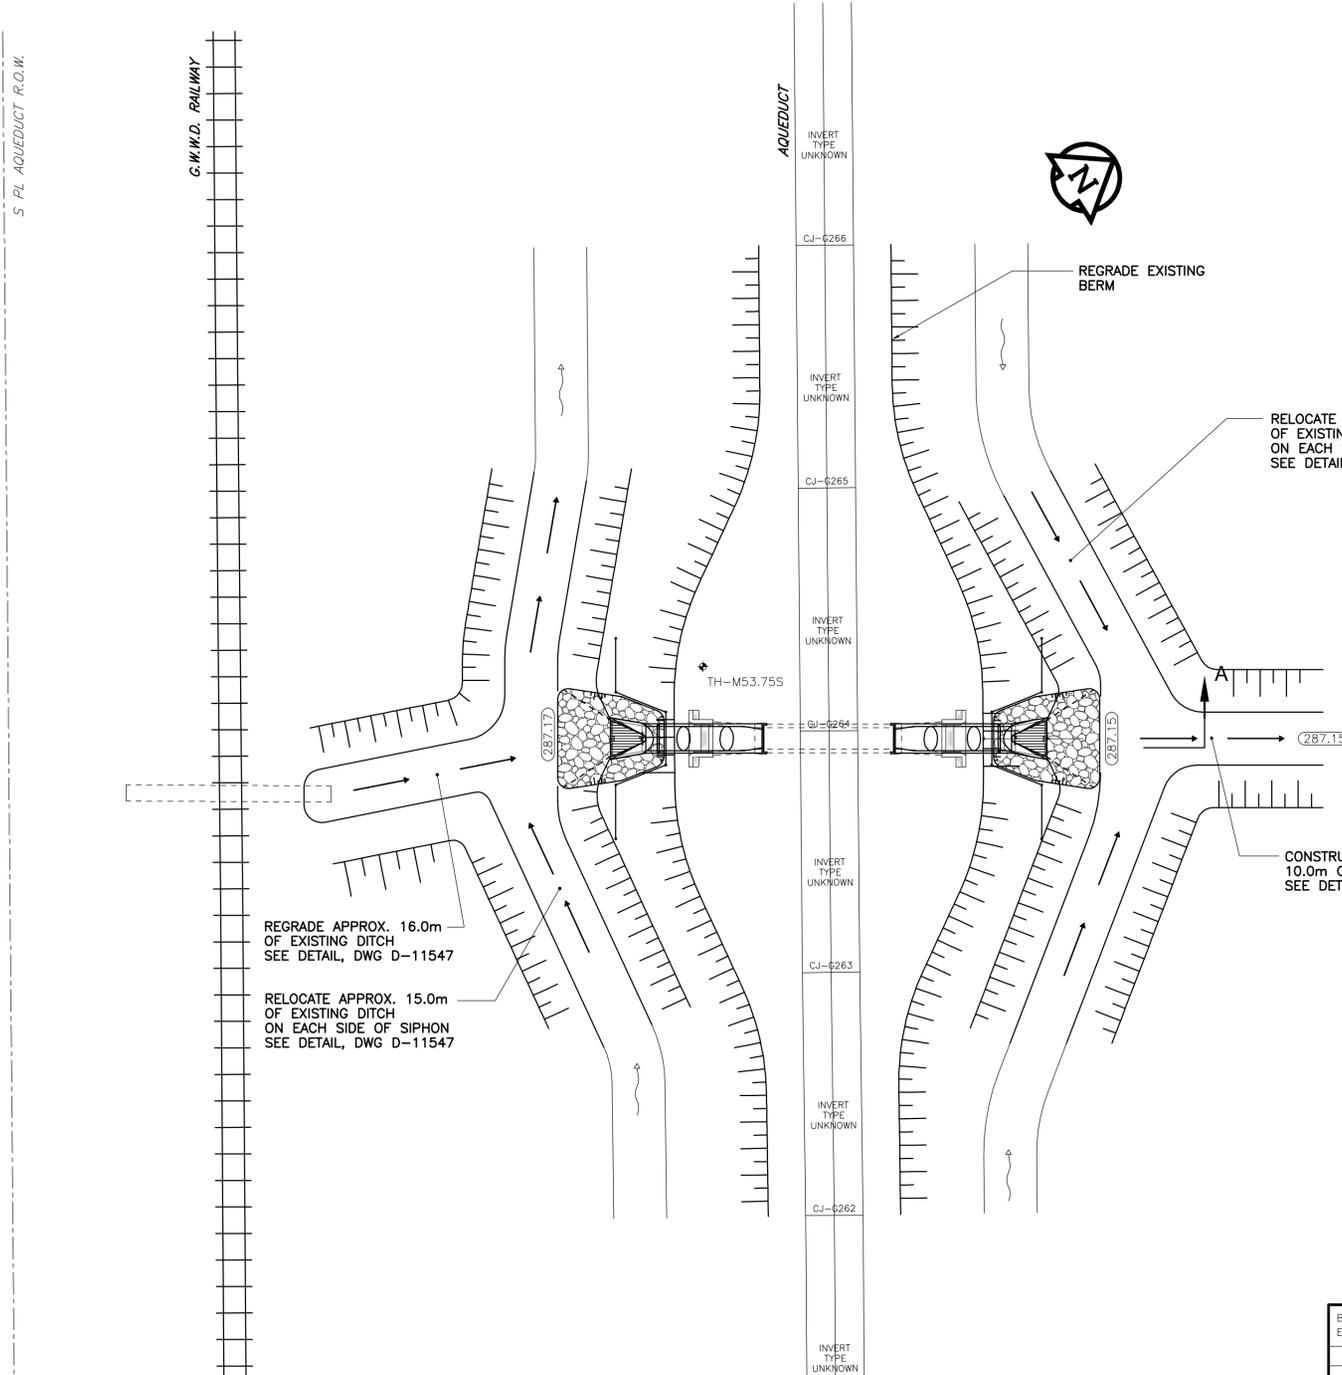
SITE PLAN  
Scale 1:200

HEADWALL	DESCRIPTION
SOUTH SIDE	- ORIGINAL HEADWALL, CONCRETE GOOD CONDITION - MINOR SPALLING AT TOP OF WALLS - MULTIPLE CRACKING ON LOWER EAST SIDE AND WING WALLS. CRACKS OPEN <1mm; NO INFILTRATION. - NO WARNING SIGN - NO INLET PROTECTION
NORTH SIDE	- ORIGINAL HEADWALL TILTED SLIGHTLY TO EAST - CONCRETE GOOD CONDITION - NO VISIBLE CRACKS - NO WARNING SIGN - NO INLET PROTECTION
