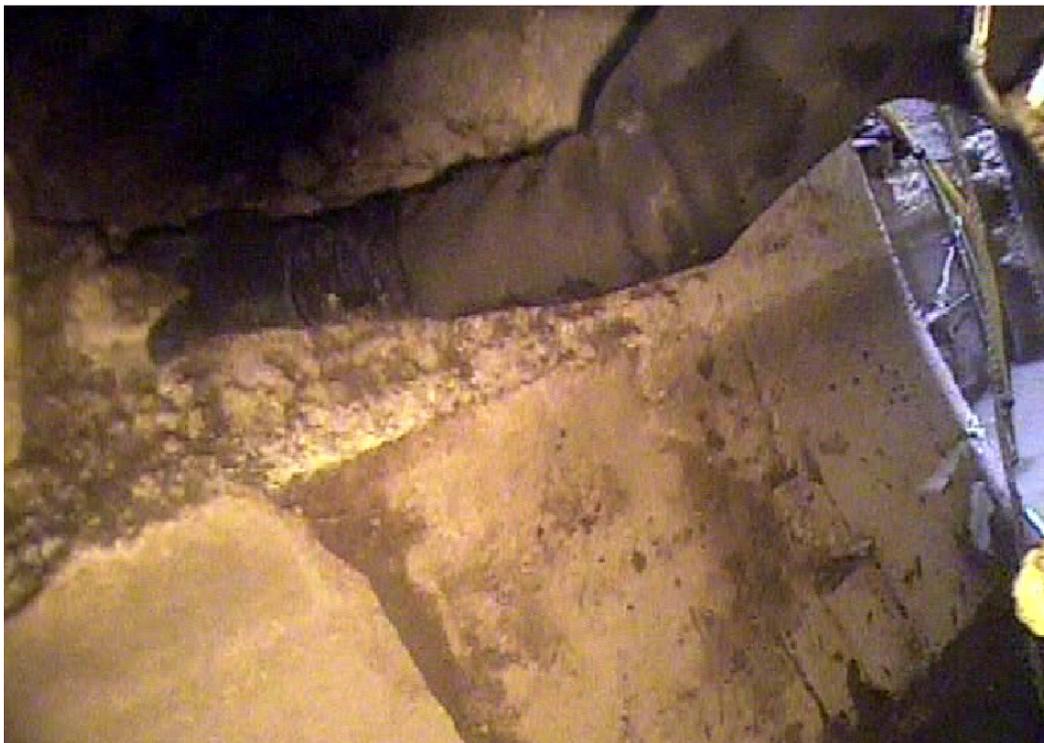
Spalling and past concrete surface repairs

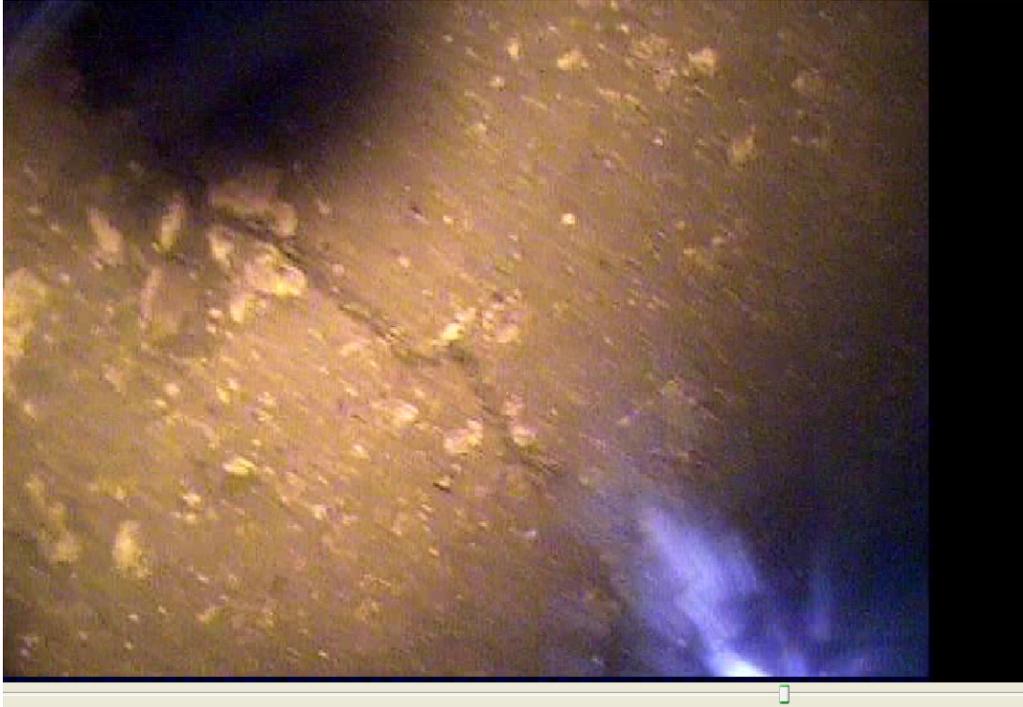
Longitudinal crack along pipe at 12:00 running throughout length of concrete section

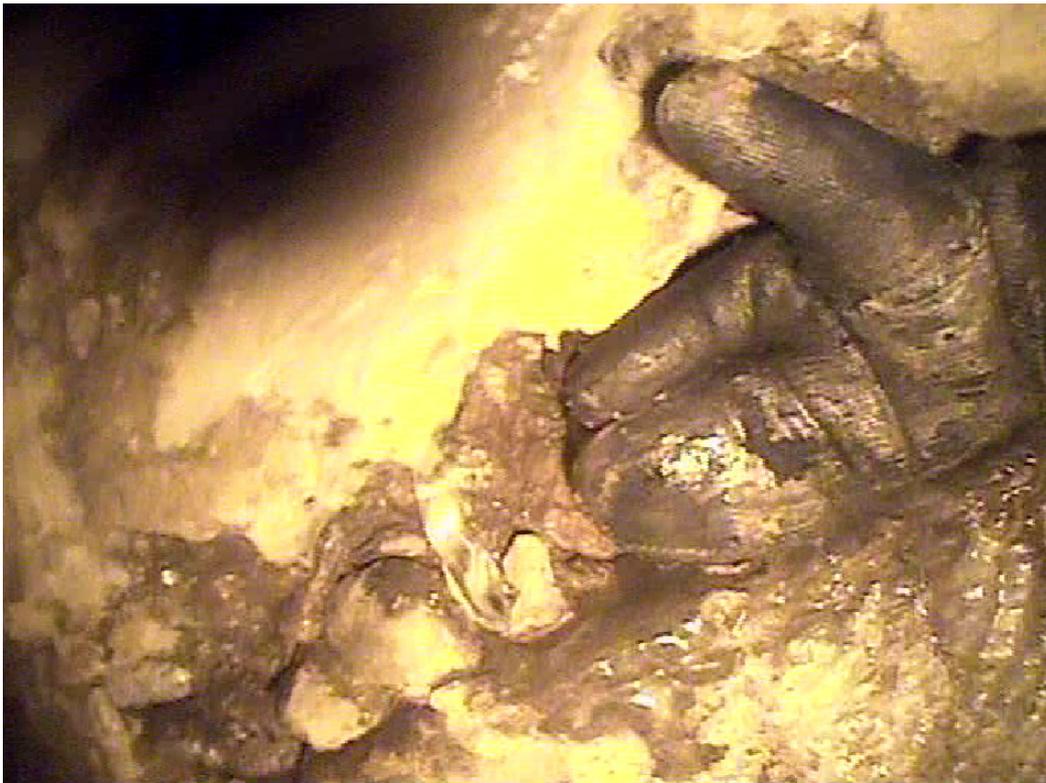
More spalling

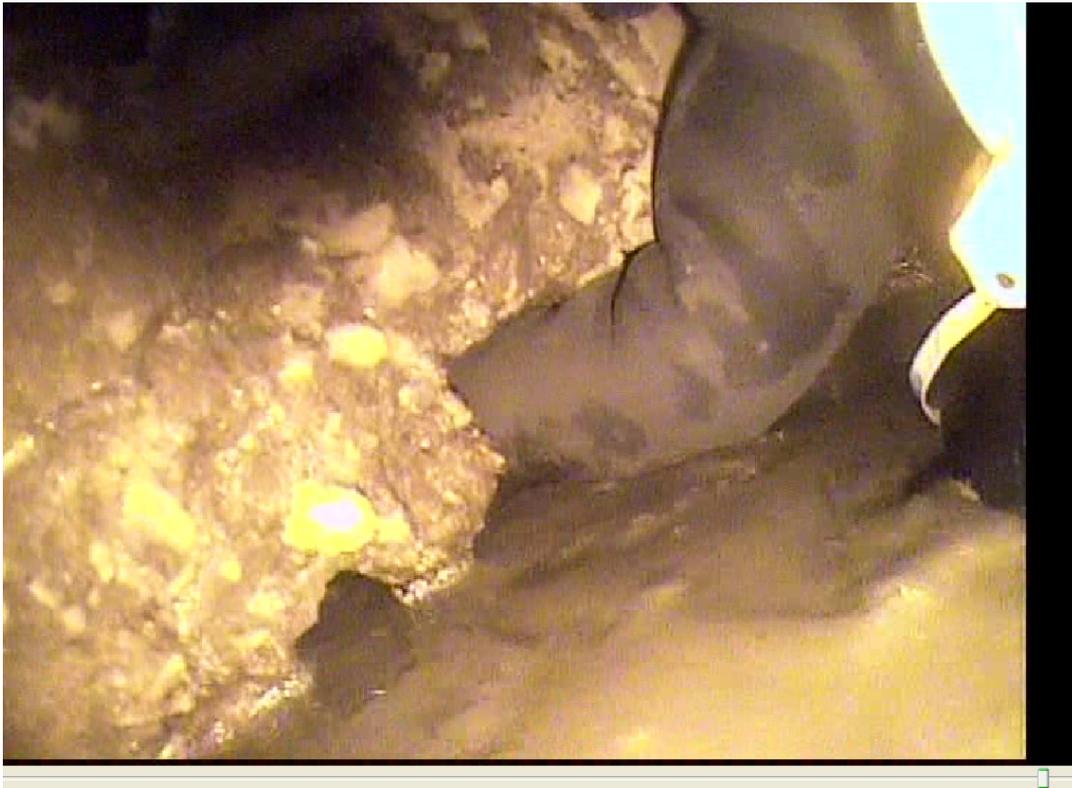
Hole in pipe 11.5 m d/s from chamber at 4:30

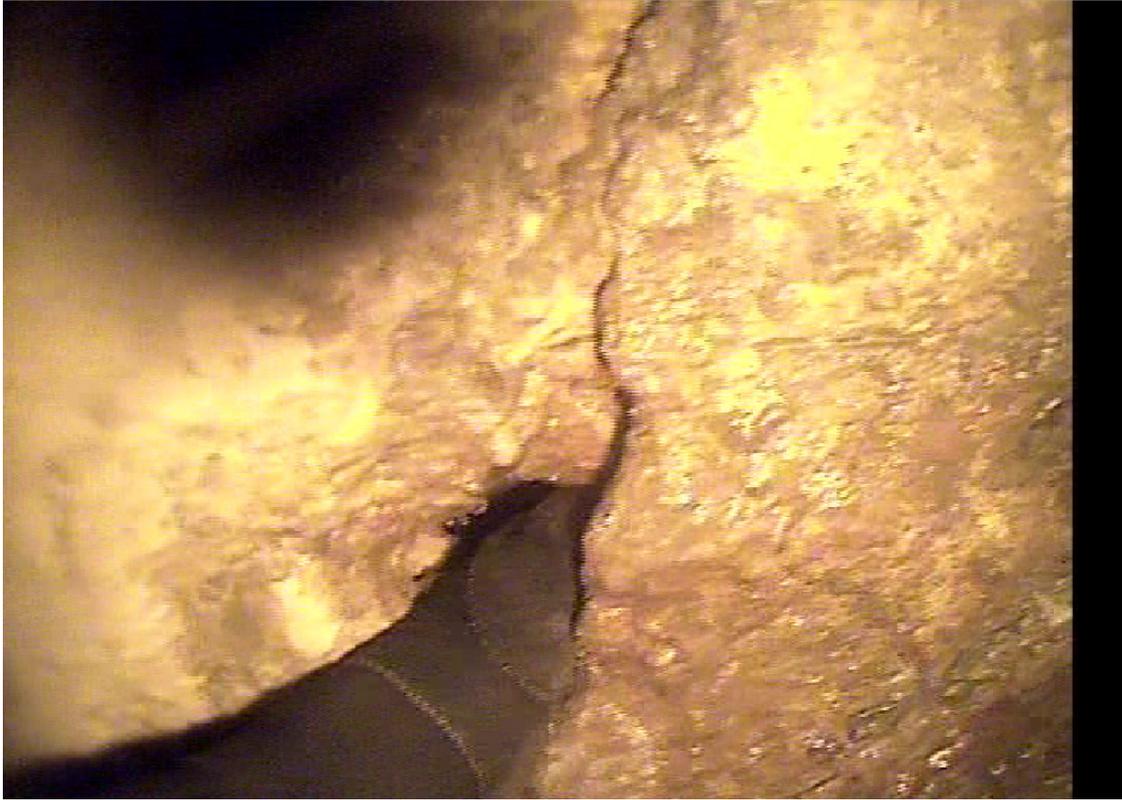
Hole in wall at 11.5m @9:00

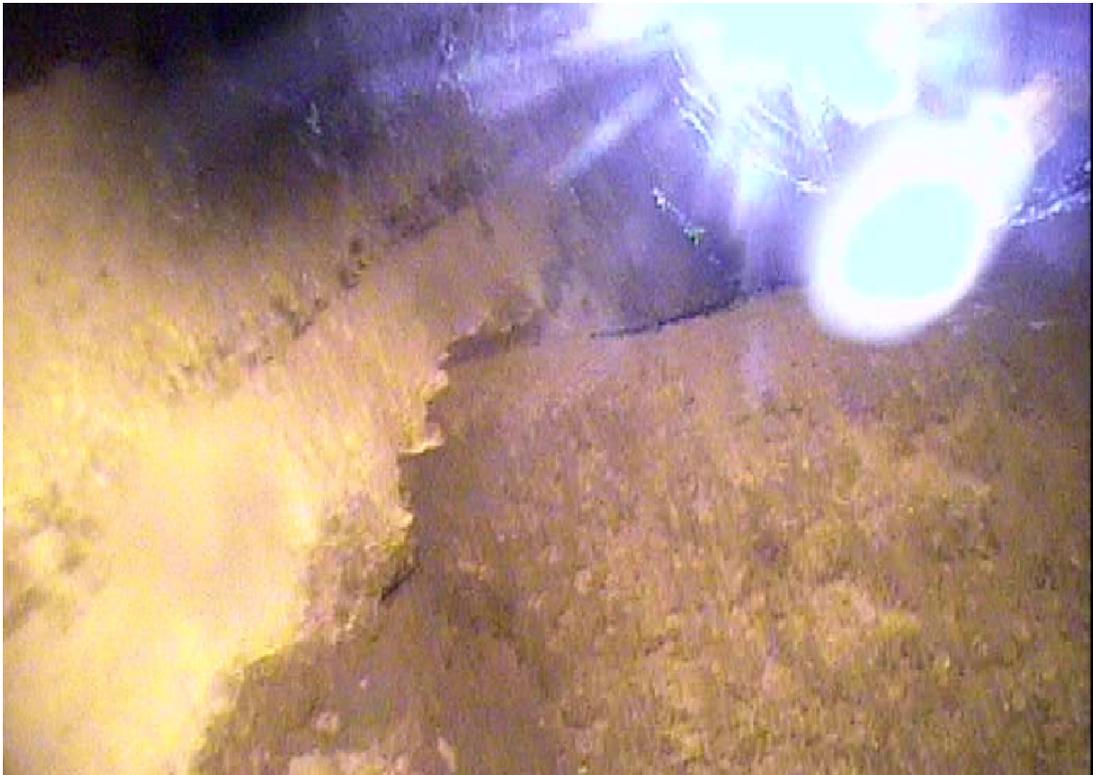
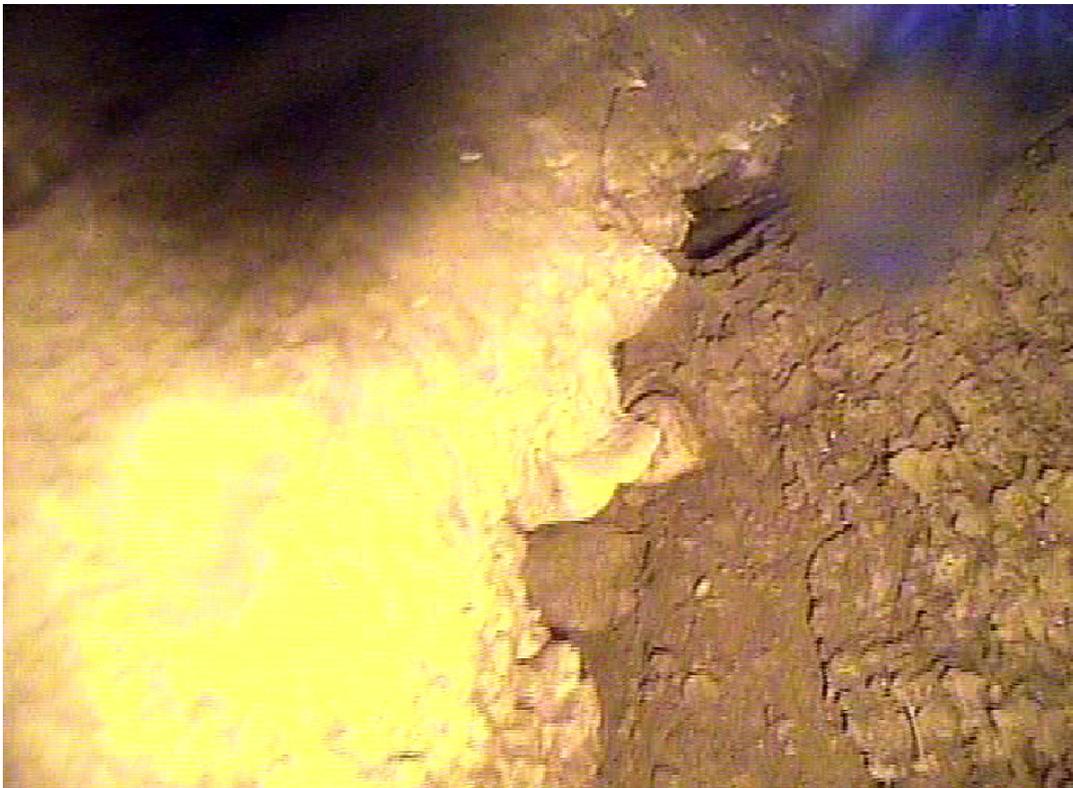
Pile of Soil below sinkhole – Shot 1

Pile of Soil below sinkhole – Shot 2

Pile of Soil below sinkhole – Shot 3

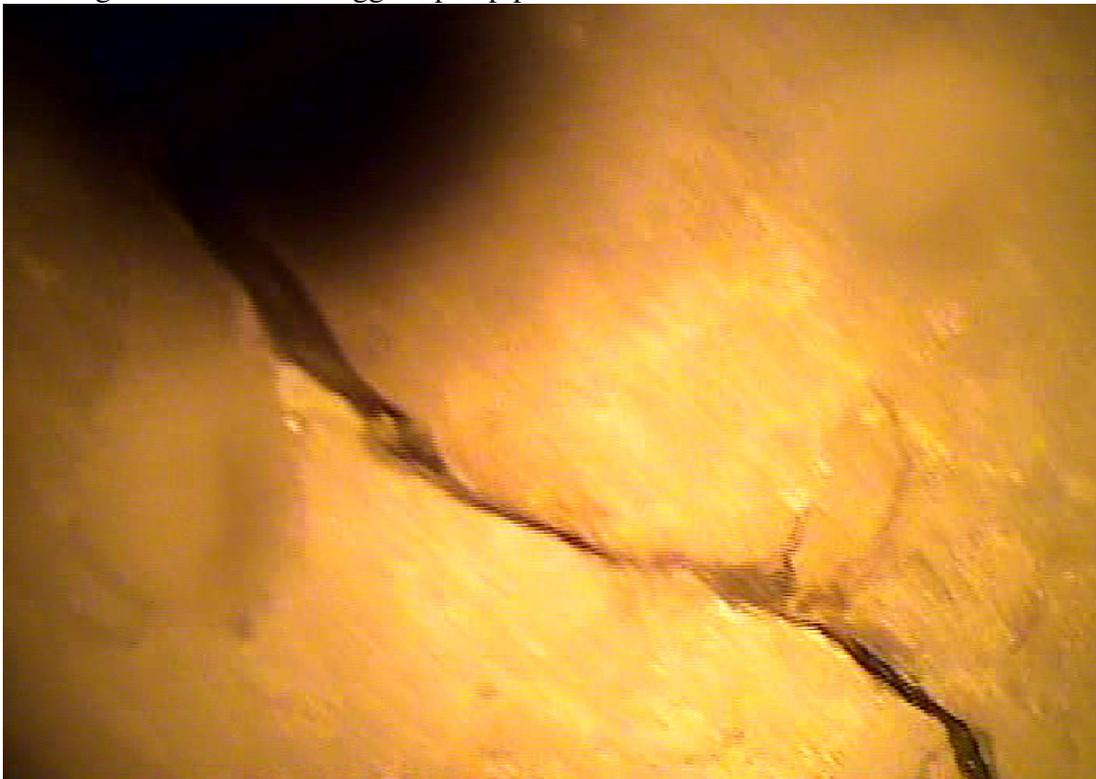
Circumferential cracking

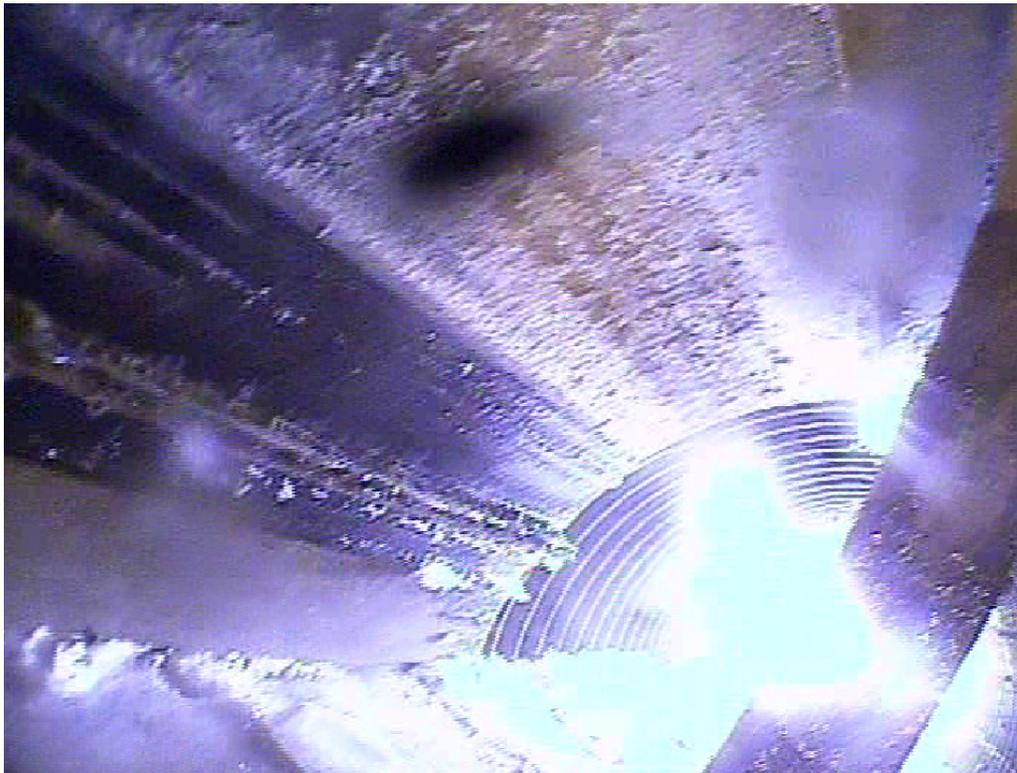
CMP Pipe with timber beam and vertical timbers. This shot shows the internal slip joint.
