**Rehabilitation of the Portage Avenue
Twin Bridges over Sturgeon Creek**

Preliminary Engineering Study

Report No. 1 07 1234.AB

April 2013

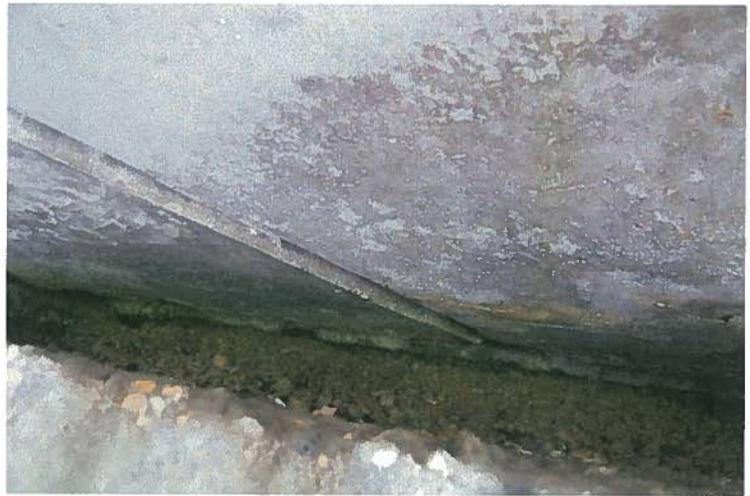
Substructure: The abutment and wingwalls are in good condition. The abutment ballast walls are inaccessible for inspection. However, based on the presence of gravel and soil on the seat of west abutment, north structure, it is suspected that the concrete in the ballast wall and/or girder ends have spalled and deteriorated. The pier shafts are in good condition.

Photo 2 – west abutment gravelly material on seat

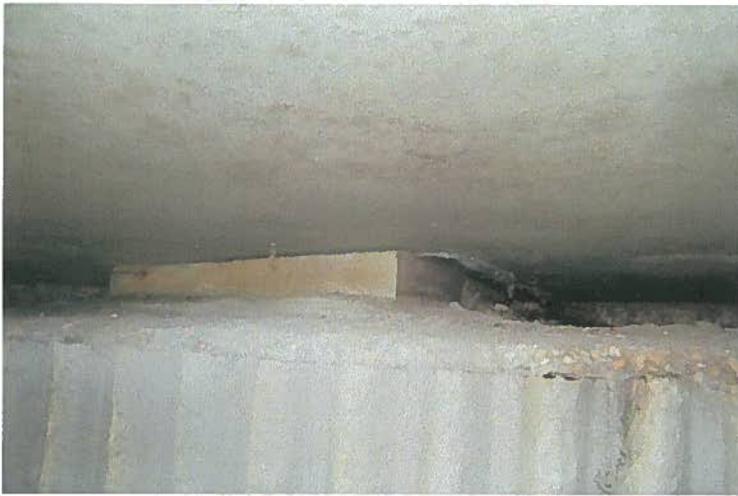
The abutment bearings are in good condition except for a few bearings in the north structure. Bearing 15 from north on the west abutment has rotated in north-south direction and four bearings from north on east abutment have cracks and rust stains. The pier bearings are in good condition with a few hairline cracks.

Photo 3 – east abutment bearing 4 from north

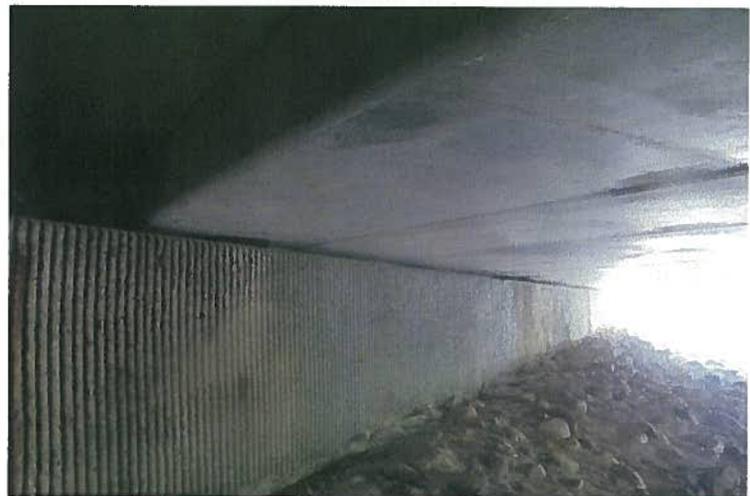
Photo 4 – west span girder 15 from north rotated

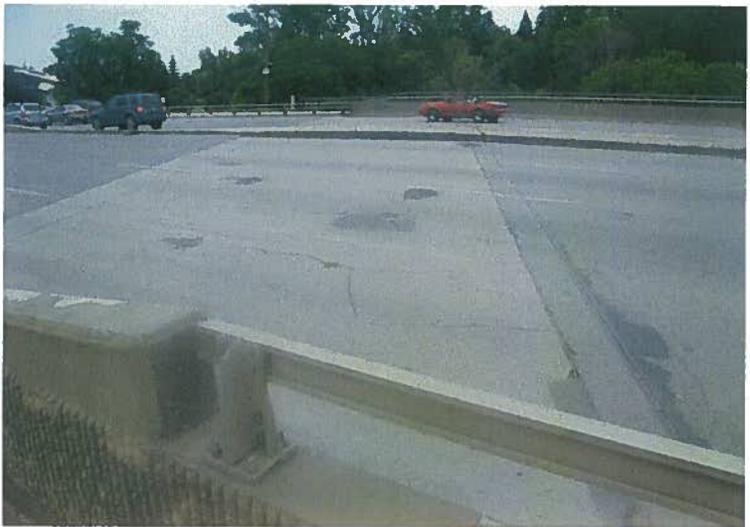
Approaches: The approach slabs have settled at the ends and have cracks and delaminations at the ballast wall ends. The approach slabs have wheel line rutting and pot holes. The south structure east approach sidewalk has settled and is a tripping hazard. The concrete in west approach sidewalk has delaminated at the expansion joint.

Photo 6 – east approach looking south

Recommended Work:							
<ul style="list-style-type: none"> • Replace approach slabs. 							
None > 10 Yrs <input type="checkbox"/> 6-10 Yrs <input type="checkbox"/> 1-5 Yrs <input checked="" type="checkbox"/> Now < 1 Year <input type="checkbox"/> Urgent <input type="checkbox"/>

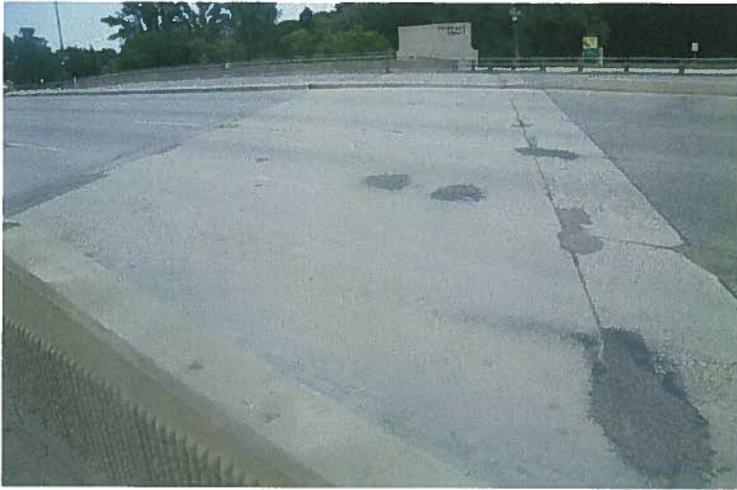
Photo 7 – west approach looking south

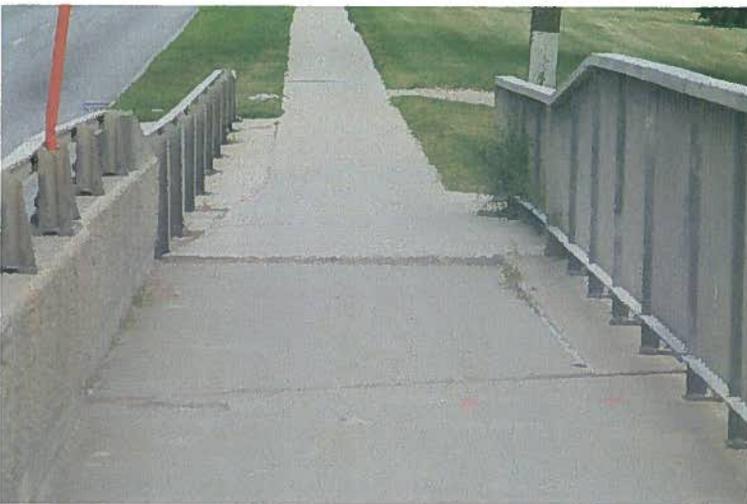
Photo 9 – south sidewalk east end trip hazard

Element Group:	Approaches					Length:	6.4m
Element Name:	Sidewalk					Width:	1.98m
Location:	East & West Abutments					Height:	0
Description:	Pedestrian Sidewalk					Count:	4
Material:	Concrete					Total Quantity:	50 sq.m.
Element type:	Cast-in-Place Reinforced					Not Inspected:	<input type="checkbox"/>
Environment:	Benign <input type="checkbox"/> Moderate <input type="checkbox"/> Severe <input checked="" type="checkbox"/>					Perform. Deficiencies	Maint. Needs
Condition Data:	Units	Exc.	Good	Fair	Poor		
	Sq.m.		48	1	1		
Comments:	<ul style="list-style-type: none"> • South Structure – West Slab delaminated near expansion joint. • South Structure – East corner settled, tripping concern. • Refer to Photos 8 & 9. 						
Performance Deficiencies:							
<ul style="list-style-type: none"> • Excessive settlement and delaminations. 							
Recommended Work:							
<ul style="list-style-type: none"> • Replace sidewalk approach slab. • Urgently repair tripping concern.

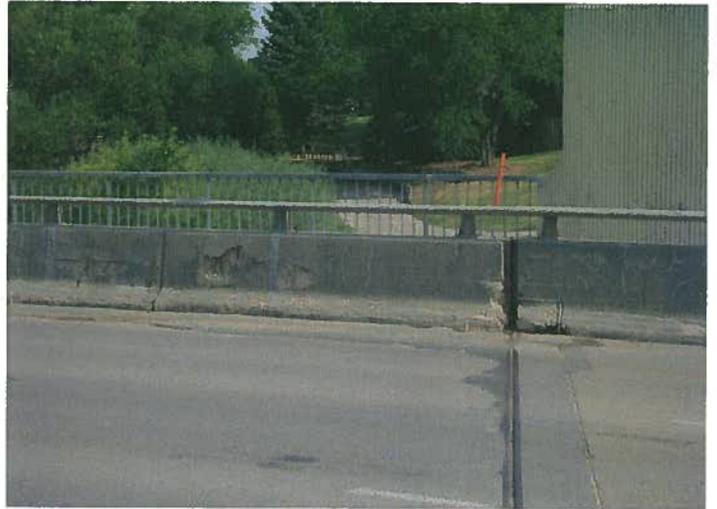
The sidewalk concrete has hairline cracks and delaminations. The sidewalk expansion joint at west abutment, north structure, has settled. The median has spalled concrete at expansion and construction joints. The traffic side face of concrete barrier in north structure has spalled and exposed re-bars at a few locations.

Photo 10 – north barrier

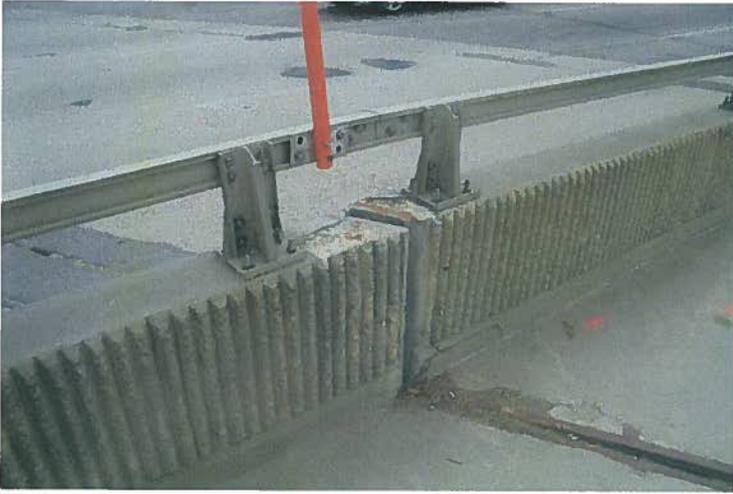
The deck expansion joint at west abutment, north structure, has settled by 15 mm on the bridge deck side. This relative settlement is likely a result of the abutment repairs undertaken in 2008. The strip seal also appears to be leaking.

Photo 13 – north traffic back wall at west expansion joint

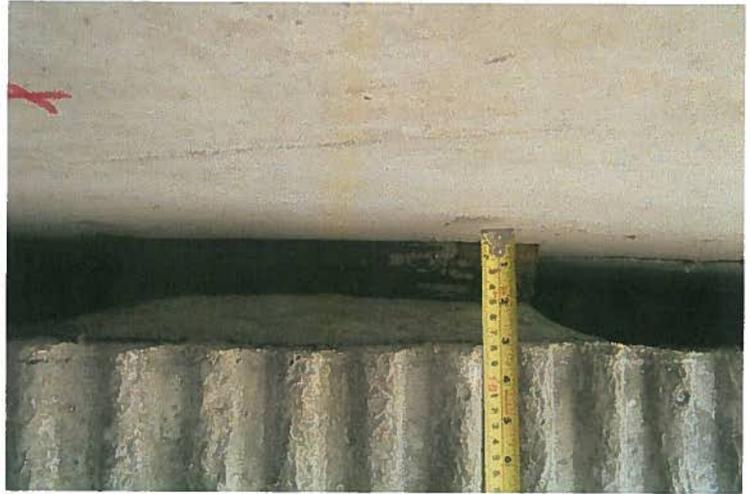
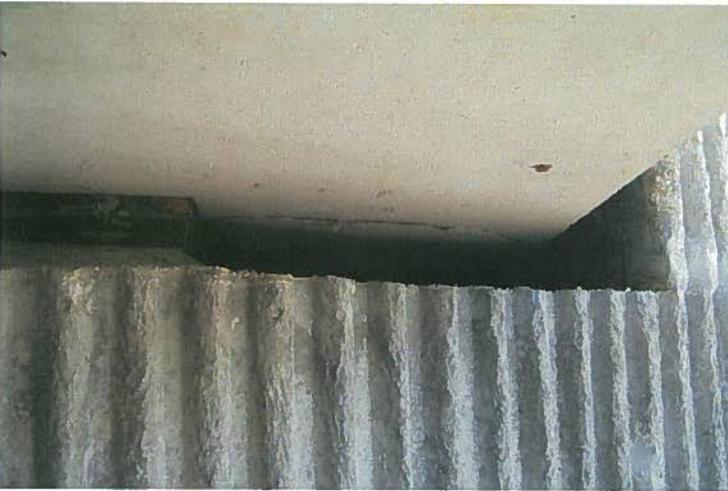
Superstructure: The cells in the box cell girders are inaccessible; therefore, the visible exteriors of the girders were inspected. The concrete in the bottom of a few girders in the north structure at abutment ends have delaminated. The spalled concrete on west abutment seat may be from the deteriorated cast-in-place concrete at girder end caps. Girder 15 from north has rotated south. The median soffit which carries encased conduits has spalled at west pier and has a wide crack at the midspan.

Photo 14 – NW bearing and delamination at bottom of girder

Photo 15 – NW bearing and delamination at bottom of girder

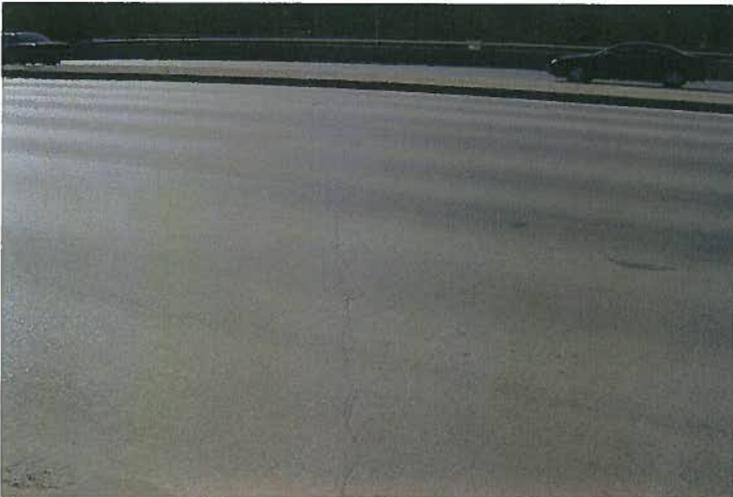
The high density concrete deck overlay has medium cracks over the piers in both structures. There are other minor longitudinal cracks in the overlay. The corrosion potential survey consisted of exposing the top layer of re-bar along the bridge deck by concrete coring. A visual inspection of the condition of the epoxy-coating and re-bar was made at each core hole location. The epoxy-coating and re-bar were all found to be in excellent condition with no sign of coating deterioration or corrosion.

Photo 17 – deck cracking

- Remove remaining epoxy overlay, prepare surface and treat concrete bridge deck surface/cracks using Methacrylate (MMA) Technology.
- Construct roadway expansion joint.

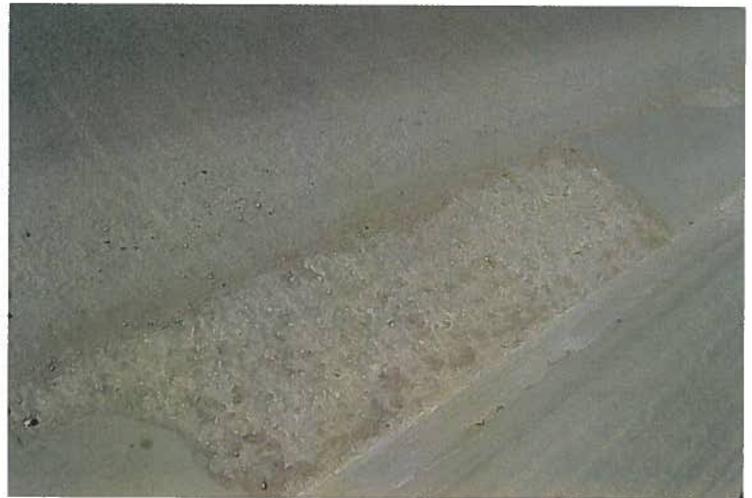
Photo 18 – deck scaling

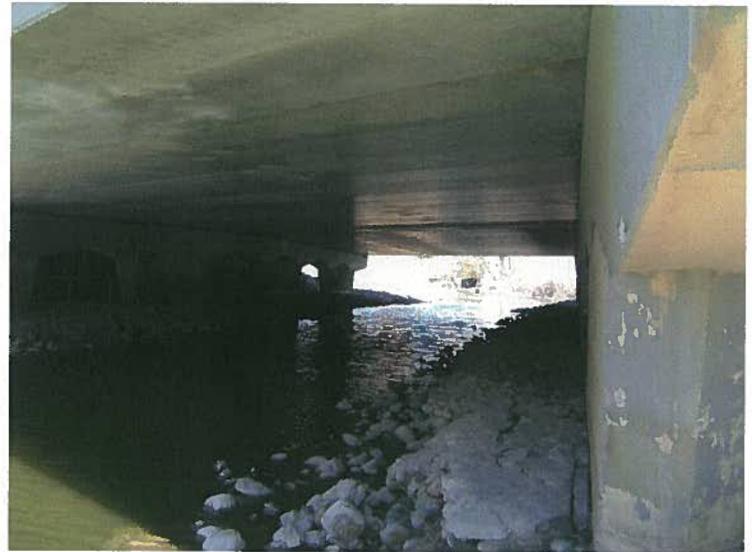
A relatively small section of grouted rip rap on the east creek bank is missing.

Photo 22 – creek riprap

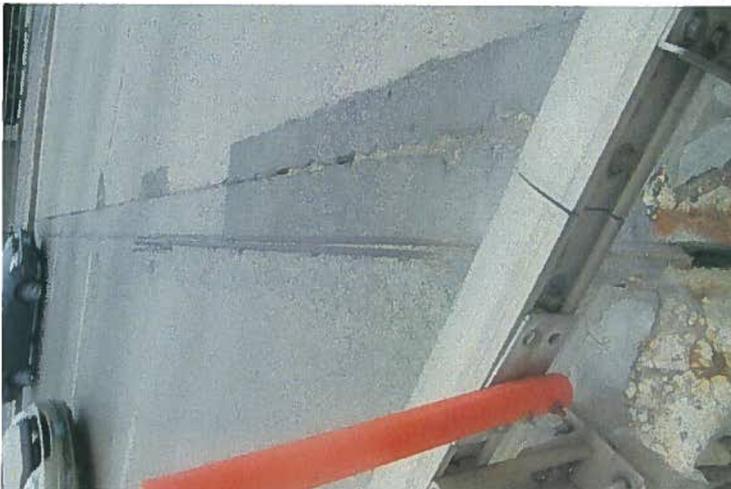
Photo 23 – west expansion joint looking south

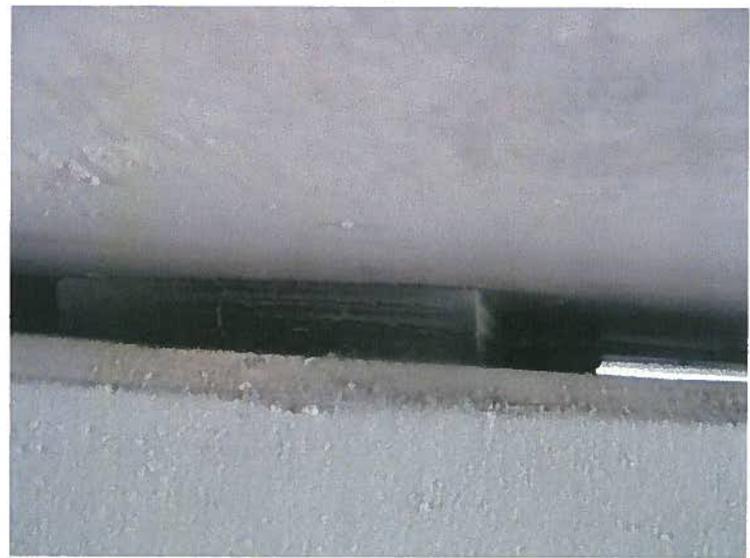
Photo 26 – east pier, east bearing 16 from north crack

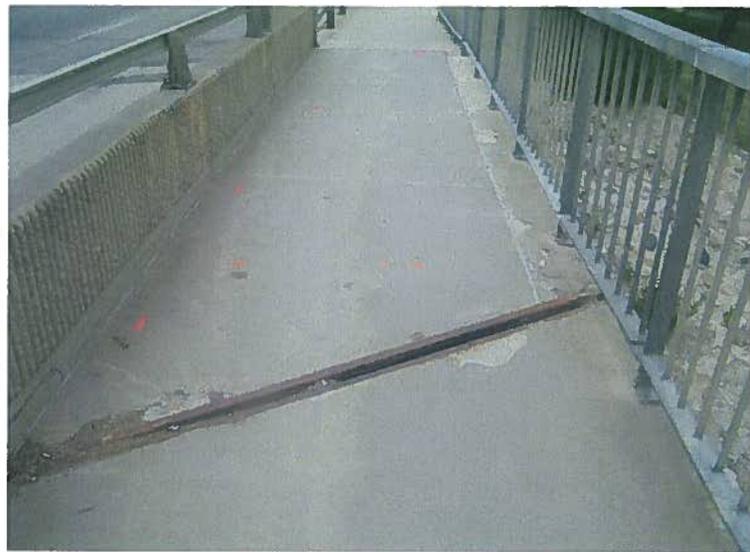
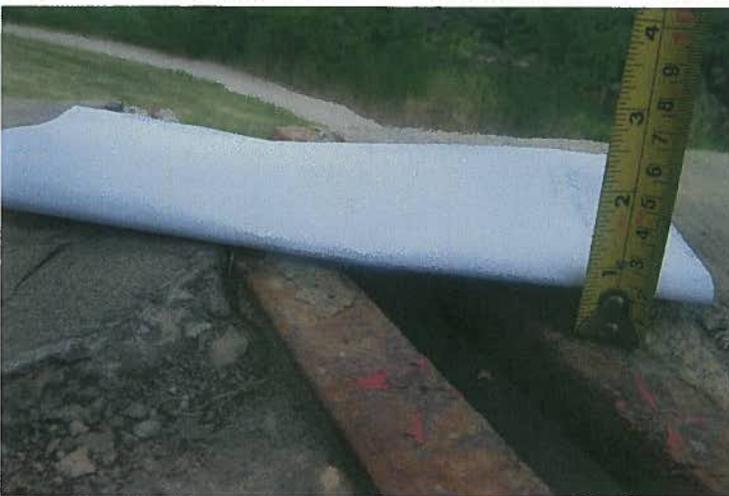
Photo 28 – north sidewalk west end minor settlement

Photo 29 – north sidewalk west end minor settlement

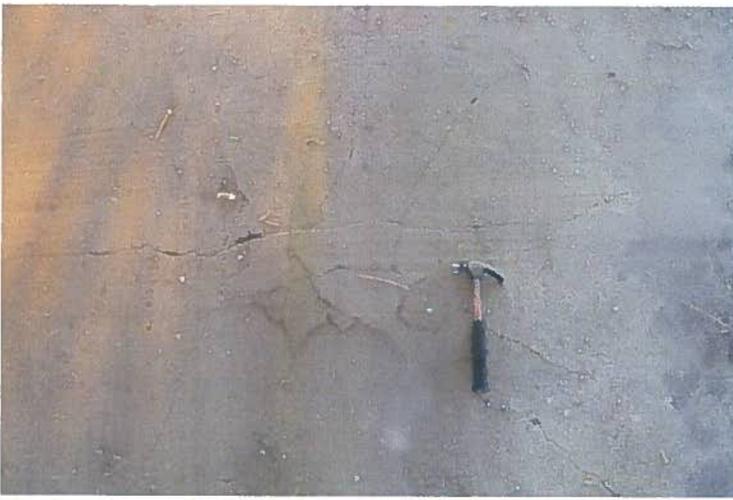
Photo 31 – under-bridge sidewalk delamination

- Modify utility conduit as required.
- Apply silane sealer to surface of traffic barriers, median, bridge sidewalk, end-posts and approach slabs.
- Miscellaneous works including, but not limited to; under-bridge lighting repair, rip rap repair, under-bridge sidewalk repair, etc.

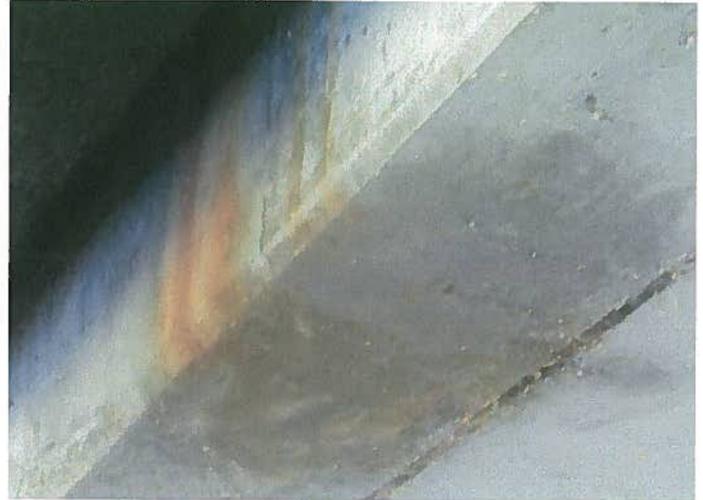
Photo 34 – midspan crack
