RE Pavement Structure Investigation Report for 2013 Regional and Local Street Renewals – Portage Ave Package

## 2013 City of Winnipeg Regional and Local Street Renewals PW File #: 13-C-03

## **Pavement Structure Investigation**

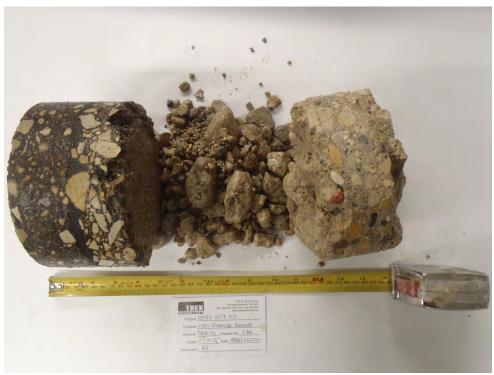
Photo 41: Asphalt and Concrete Core Sample from Test Hole TH13-34B

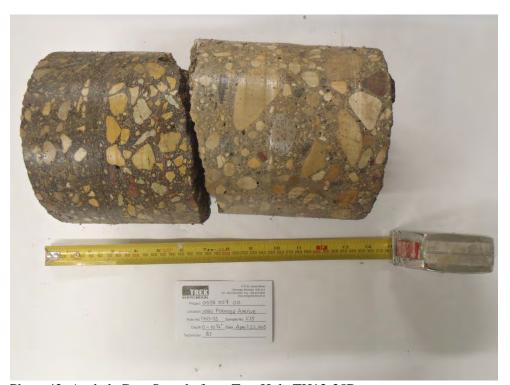
Photo 42: Asphalt Core Sample from Test Hole TH13-35B

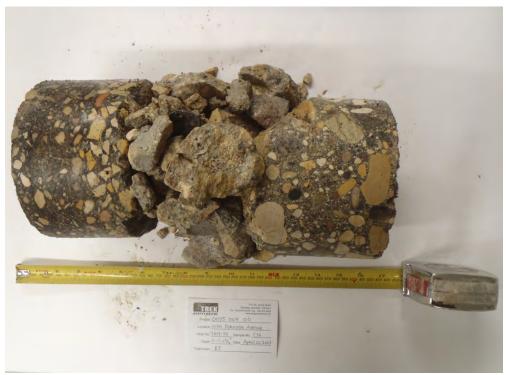
Photo 43: Asphalt and Concrete Core Sample from Test Hole TH13-36B

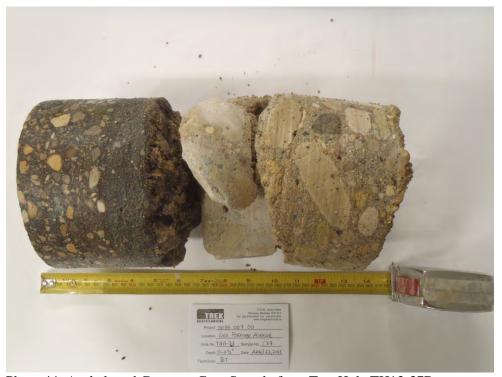
Photo 44: Asphalt and Concrete Core Sample from Test Hole TH13-37B

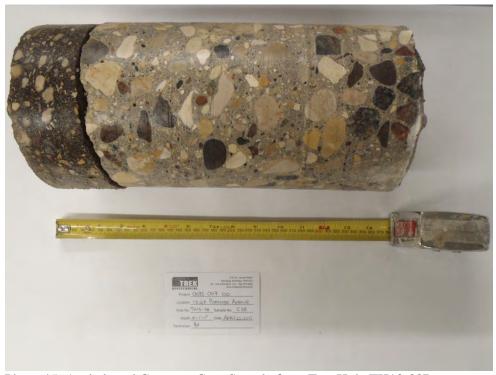
Photo 45: Asphalt and Concrete Core Sample from Test Hole TH13-38B

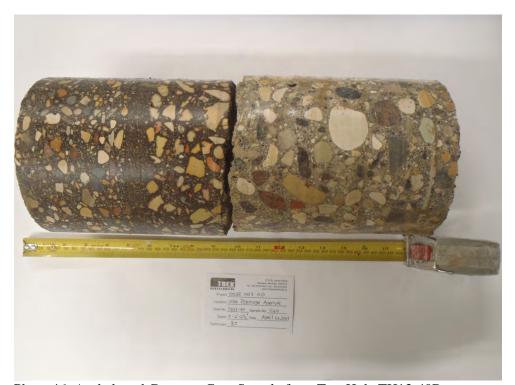
Photo 46: Asphalt and Concrete Core Sample from Test Hole TH13-40B
