ASBESTOS INVENTORY CONTROL

Building Name:	Pan Am Pool - Building	Inspection Date:	February 22, 2013
Building Code:	PI-13	Inspected By:	Ryan Matthews & Nic DeMelo
Building Address:	25 Poseidon Bay	Construction Date:	1967

PI-13

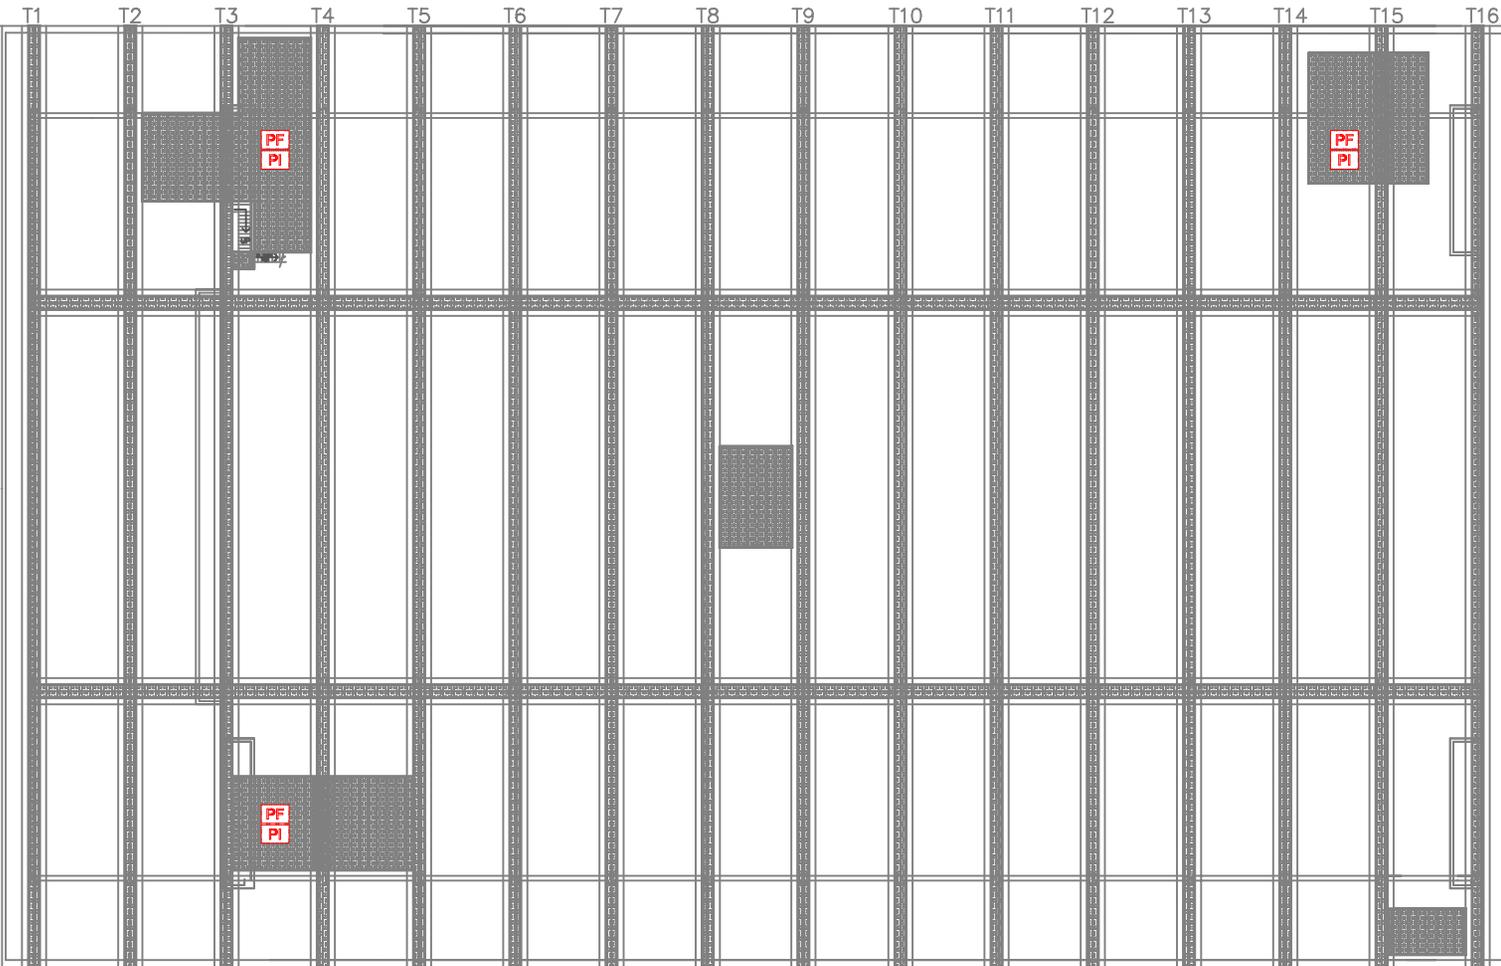
ROOF CATWALK PLAN

Remark:
- Asbestos containing pipe fittings are through out catwalk area in various locations.

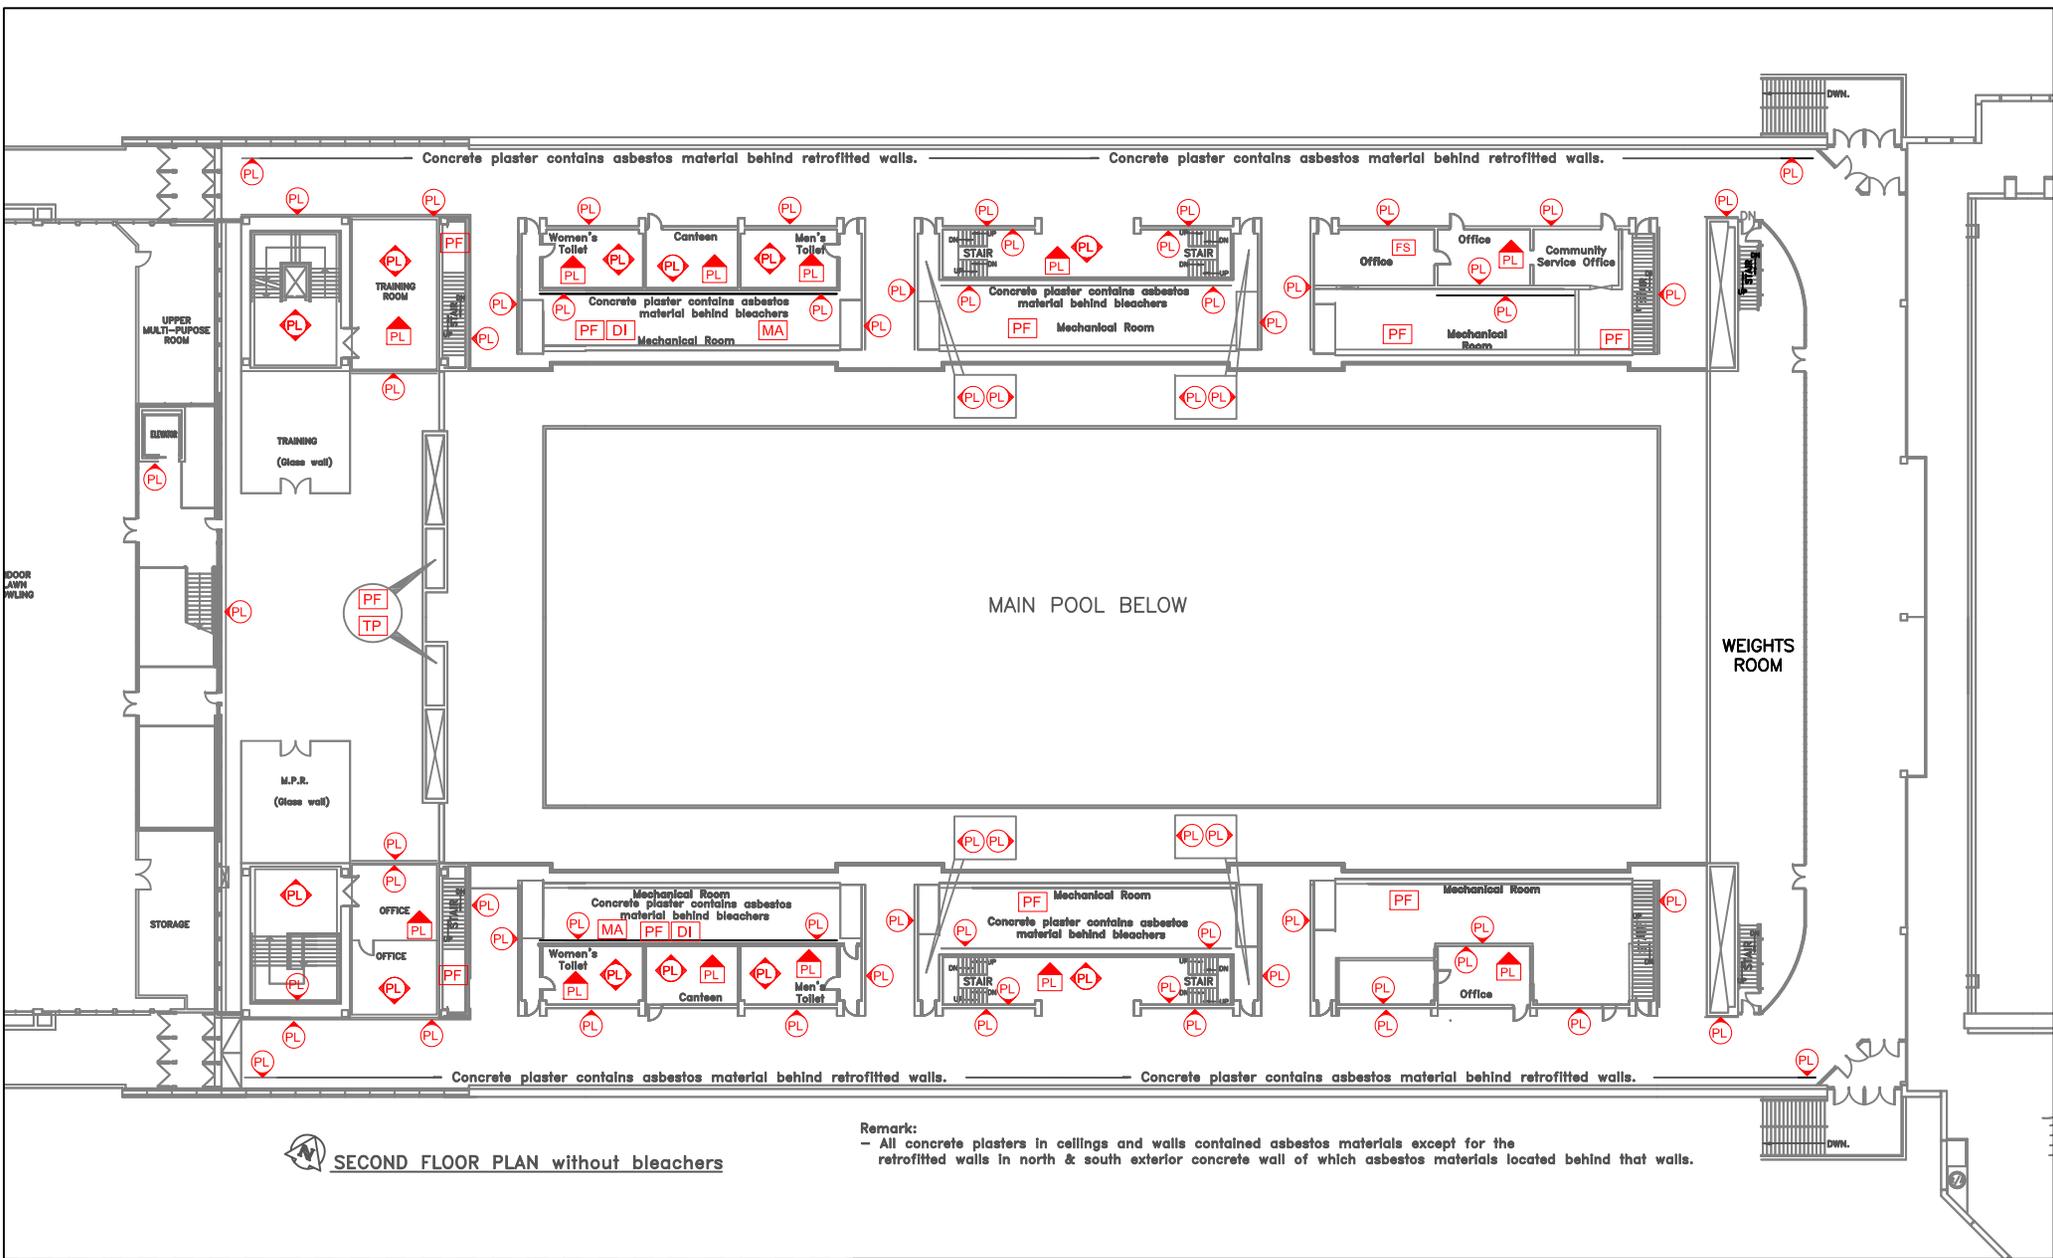
SECOND FLOOR PLAN without bleachers

Remark:
 - All concrete plasters in ceilings and walls contained asbestos materials except for the retrofitted walls in north & south exterior concrete wall of which asbestos materials located behind that walls.

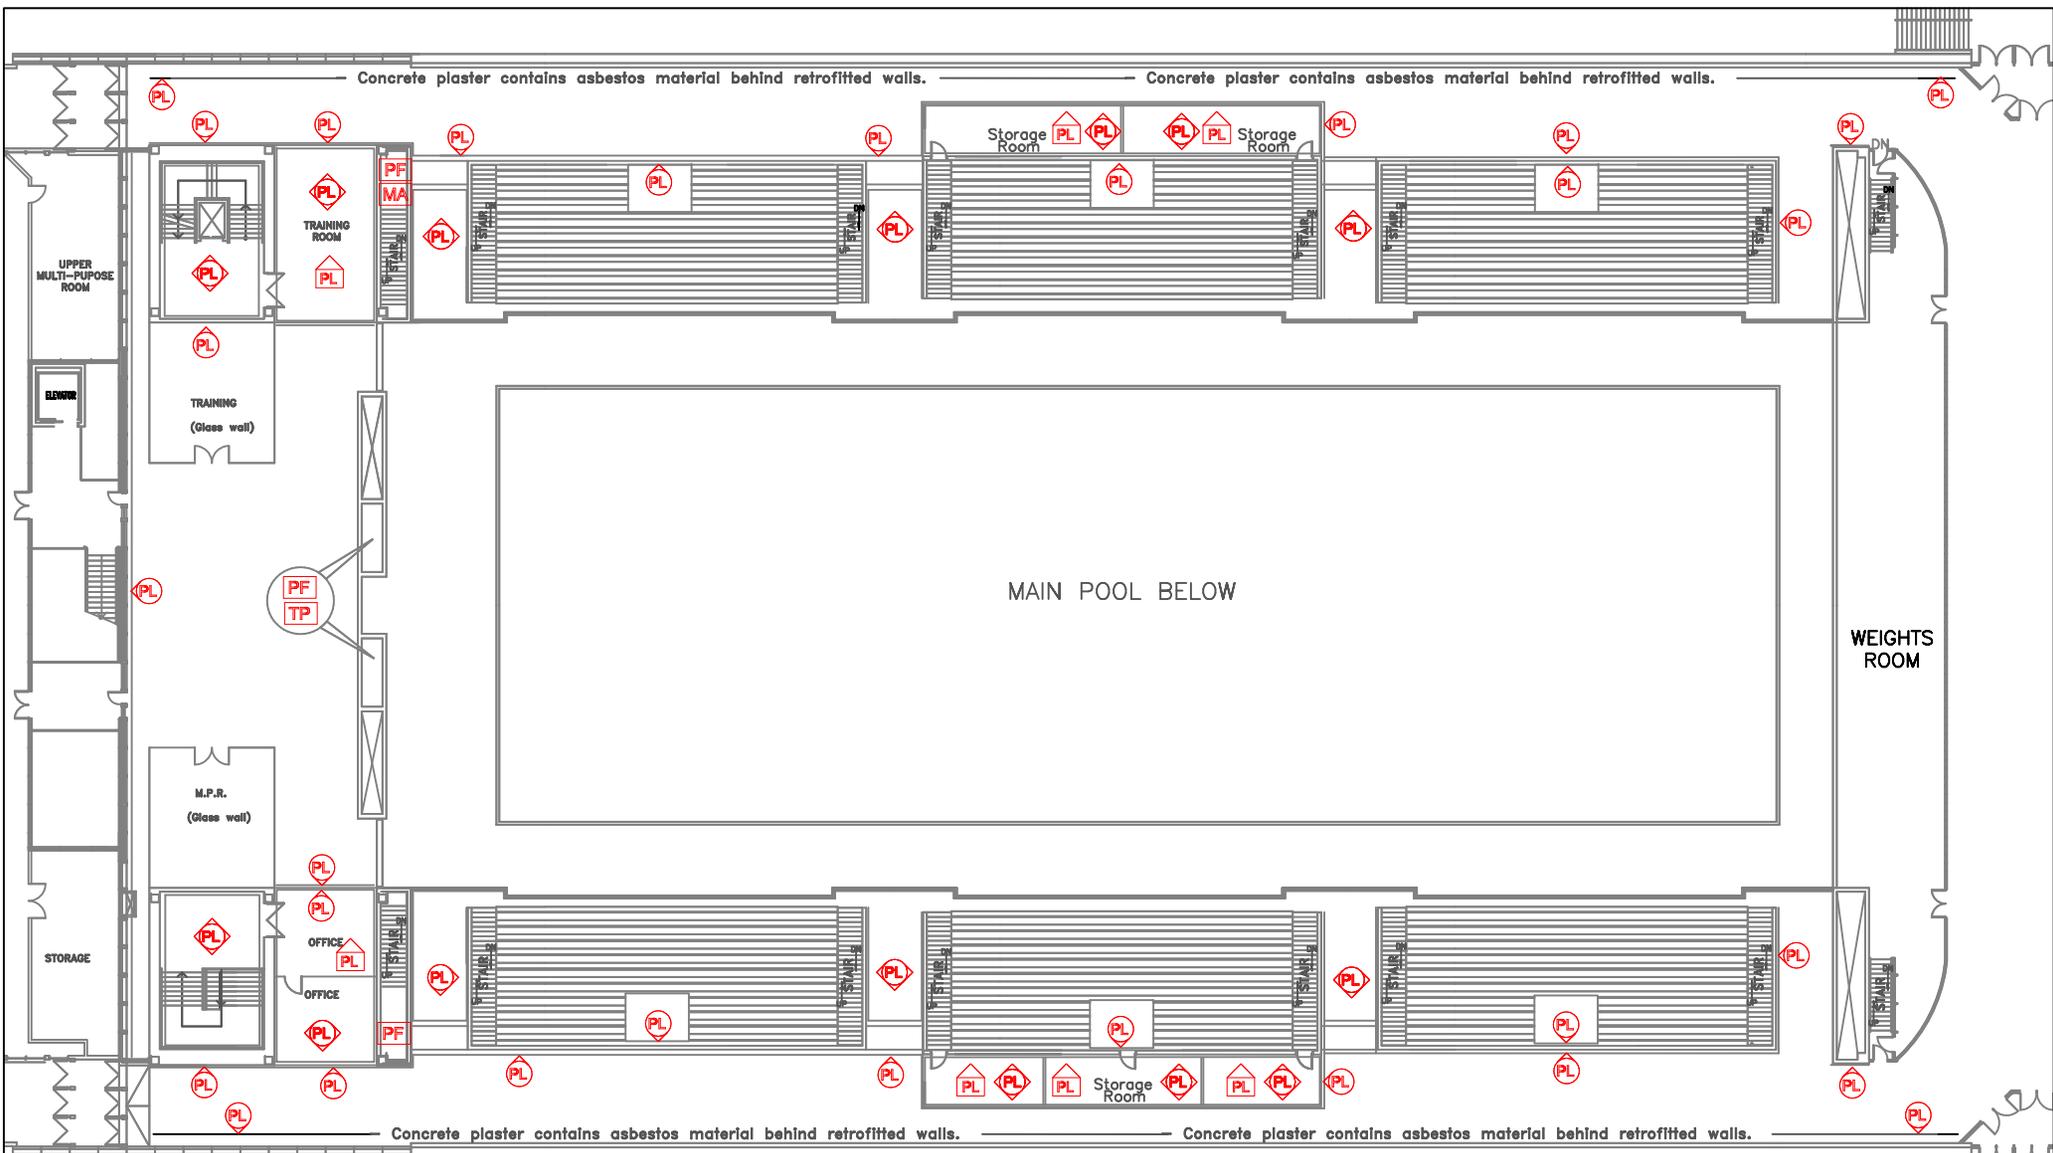
SECOND FLOOR PLAN - Mezzanine level

Remark:
 - All concrete plasters in ceilings and walls contained asbestos materials except for the retrofitted walls in north & south exterior concrete wall of which asbestos materials located behind that walls.

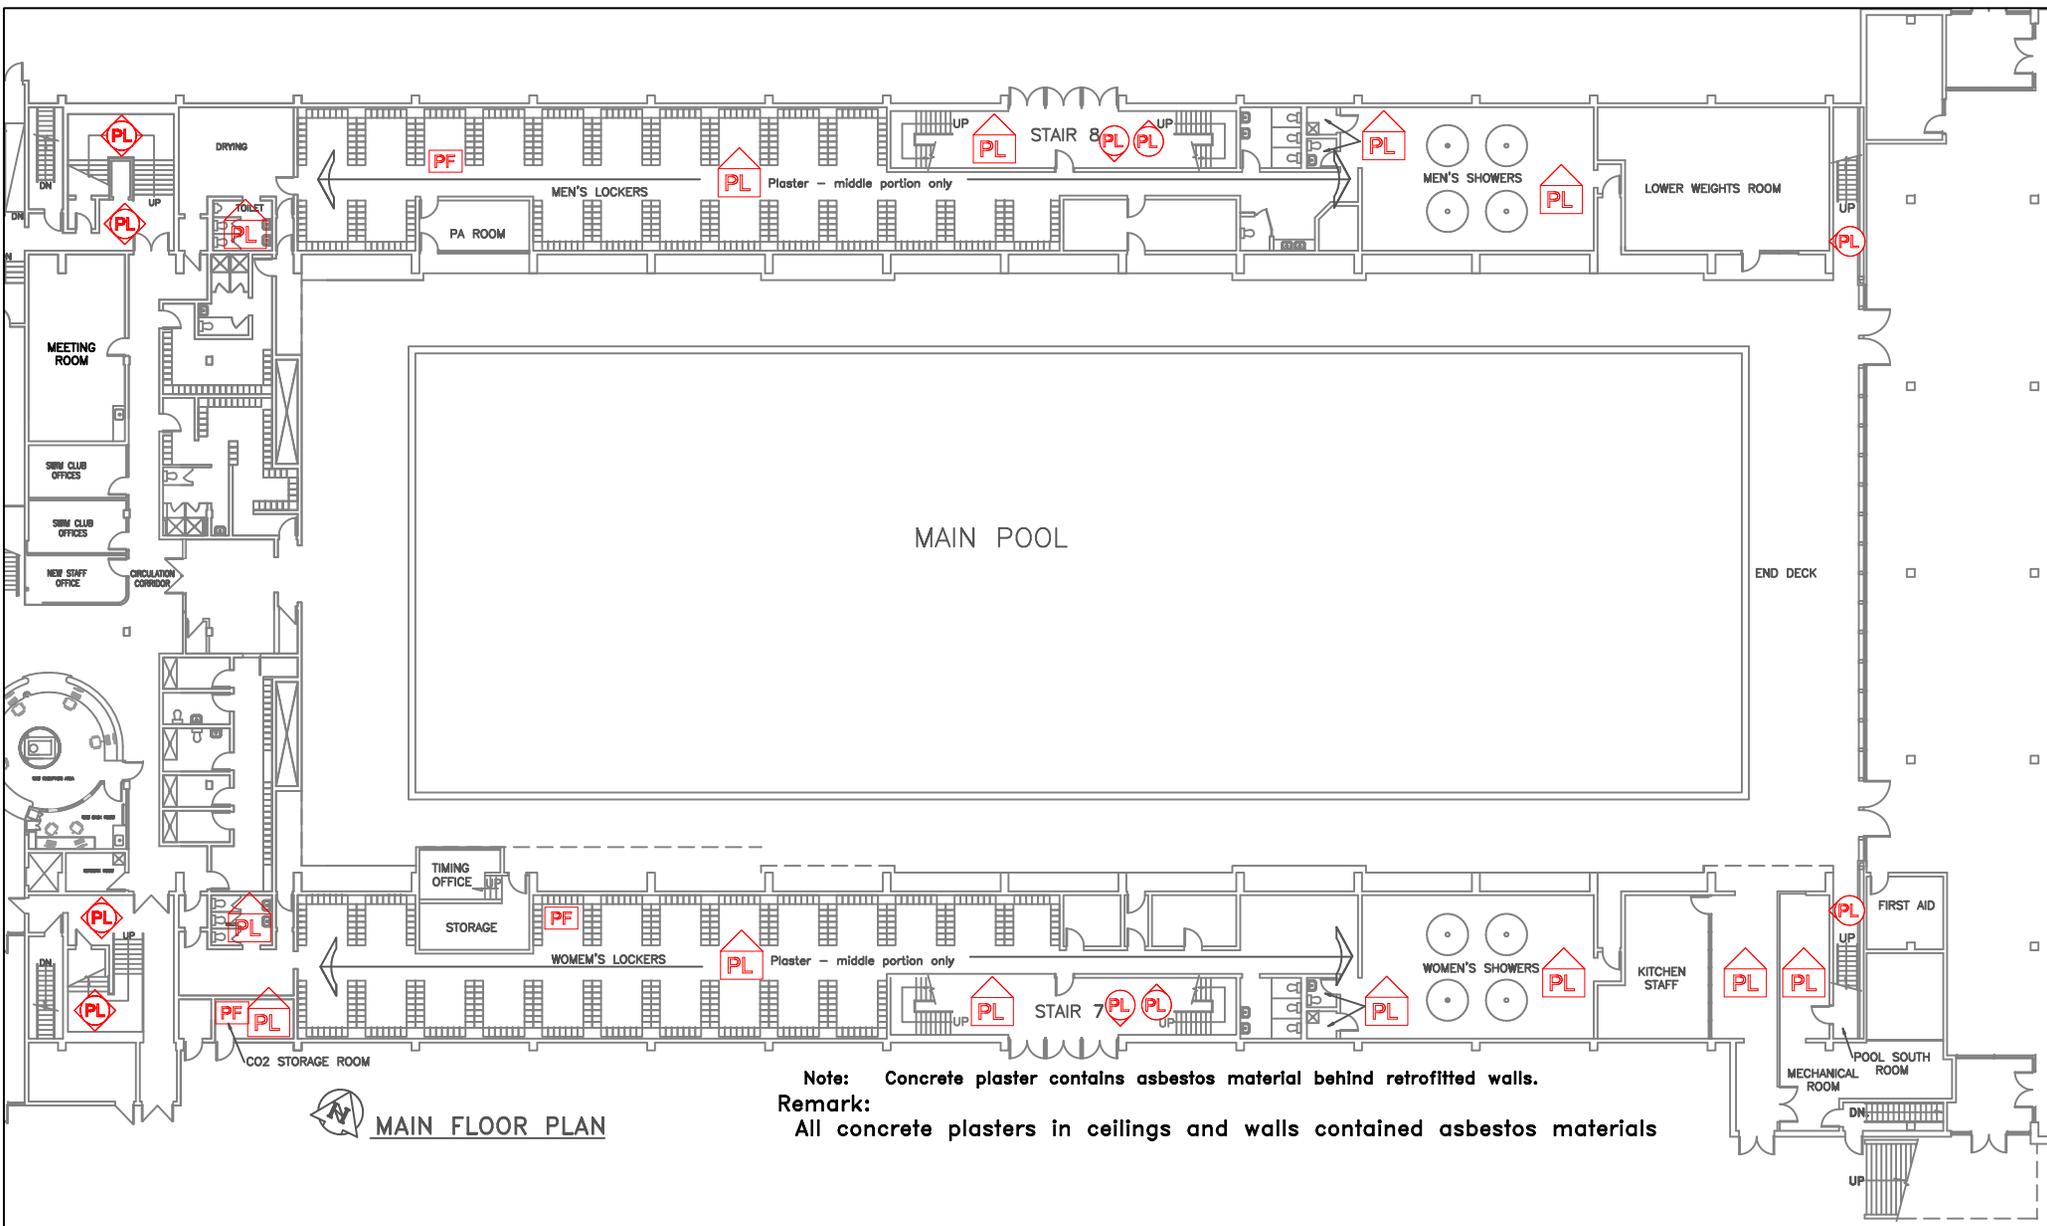
MAIN FLOOR PLAN

Note: Concrete plaster contains asbestos material behind retrofitted walls.
Remark: All concrete plasters in ceilings and walls contained asbestos materials
