ASBESTOS INVENTORY CONTROL

Building Name:	Pan Am Pool - Building	Inspection Date:	February 28, 2014
Building Code:	PI-13	Inspected By:	Ryan Matthews & Matt Kanabe
Building Address:	25 Poseidon Bay	Construction Date:	1967

PI-13

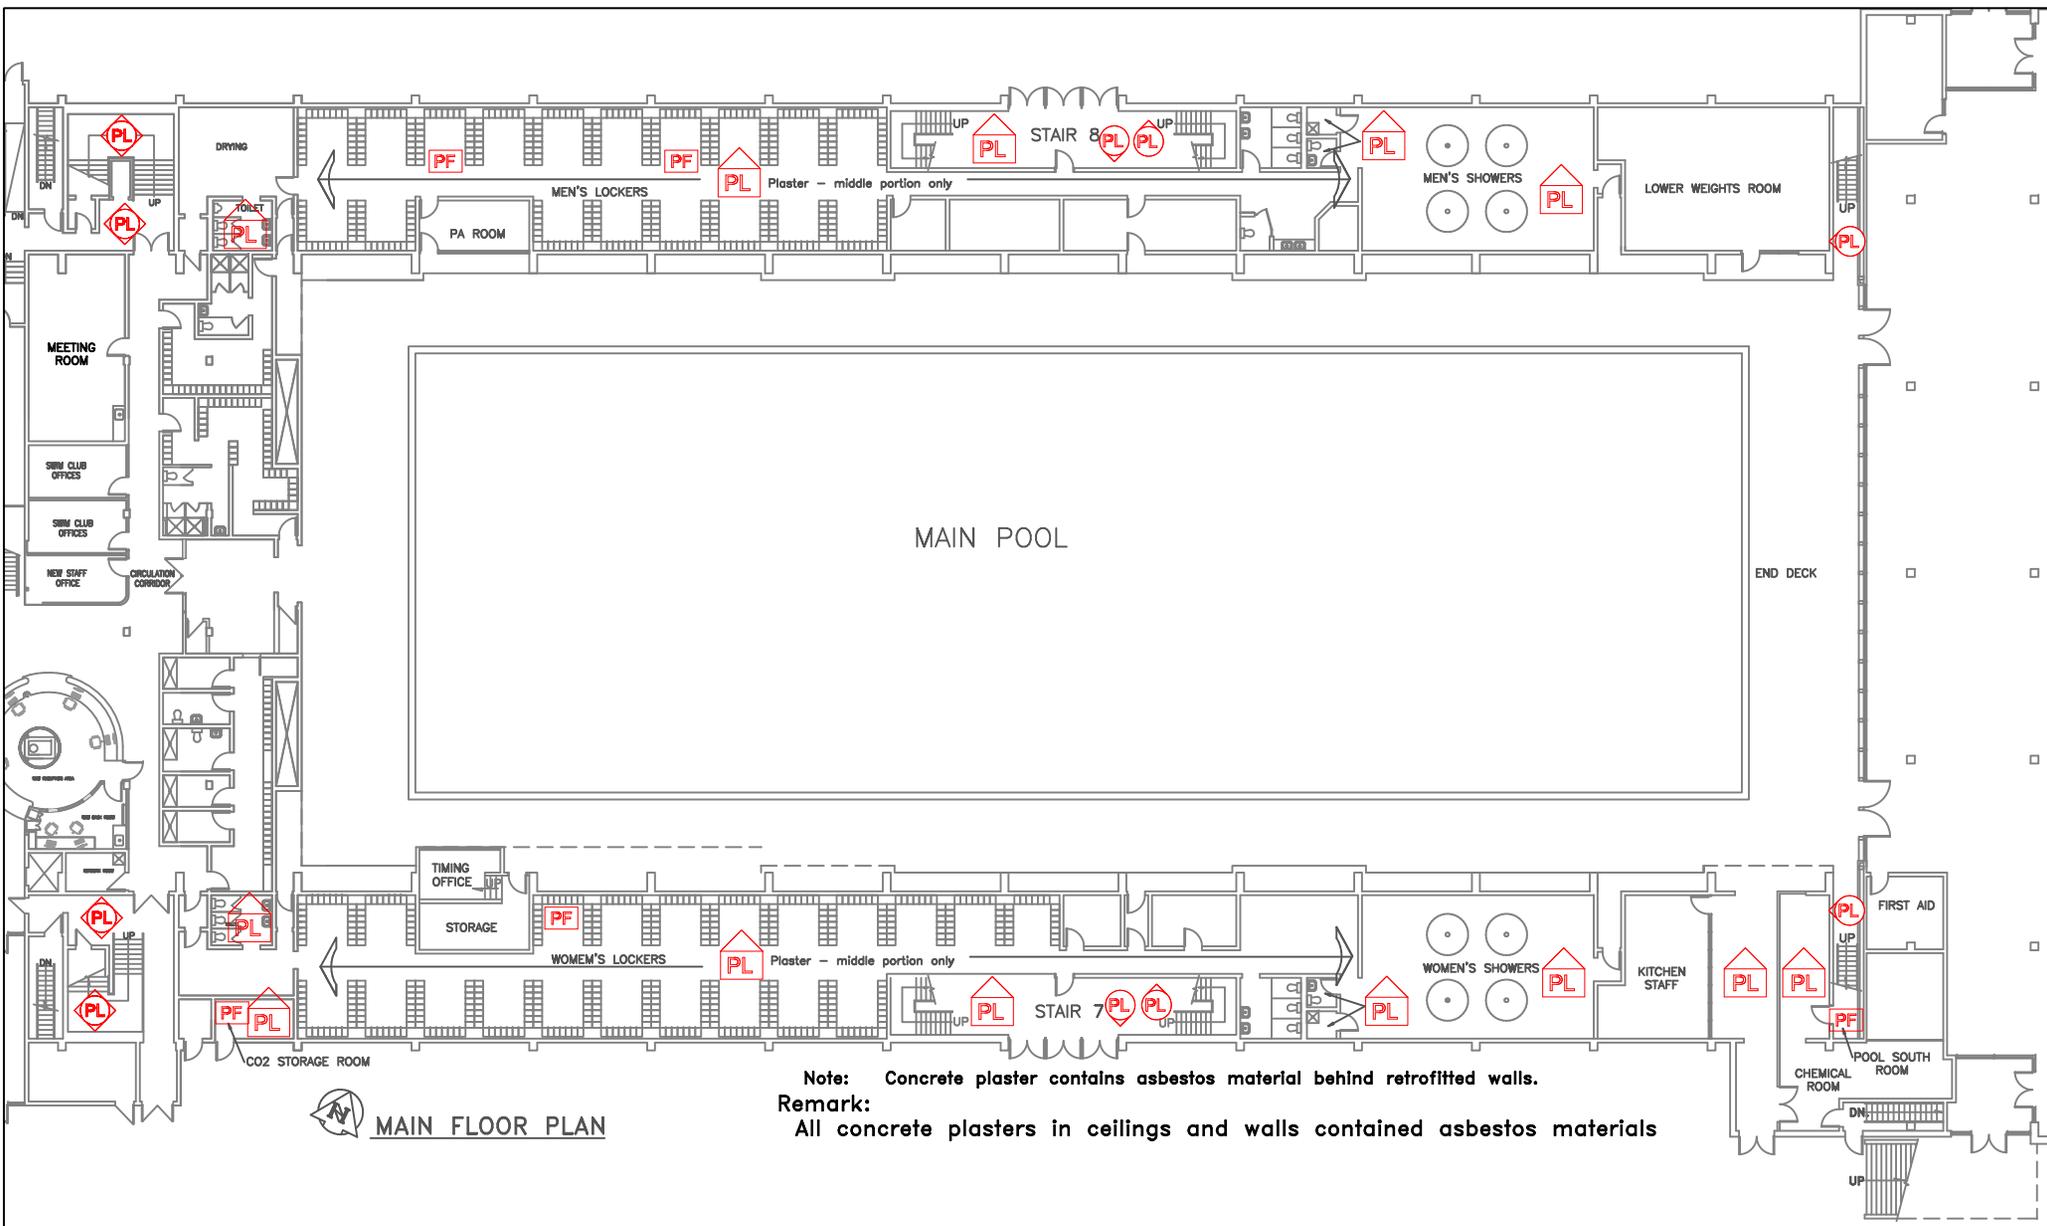
MAIN FLOOR PLAN

Note: Concrete plaster contains asbestos material behind retrofitted walls.
Remark: All concrete plasters in ceilings and walls contained asbestos materials

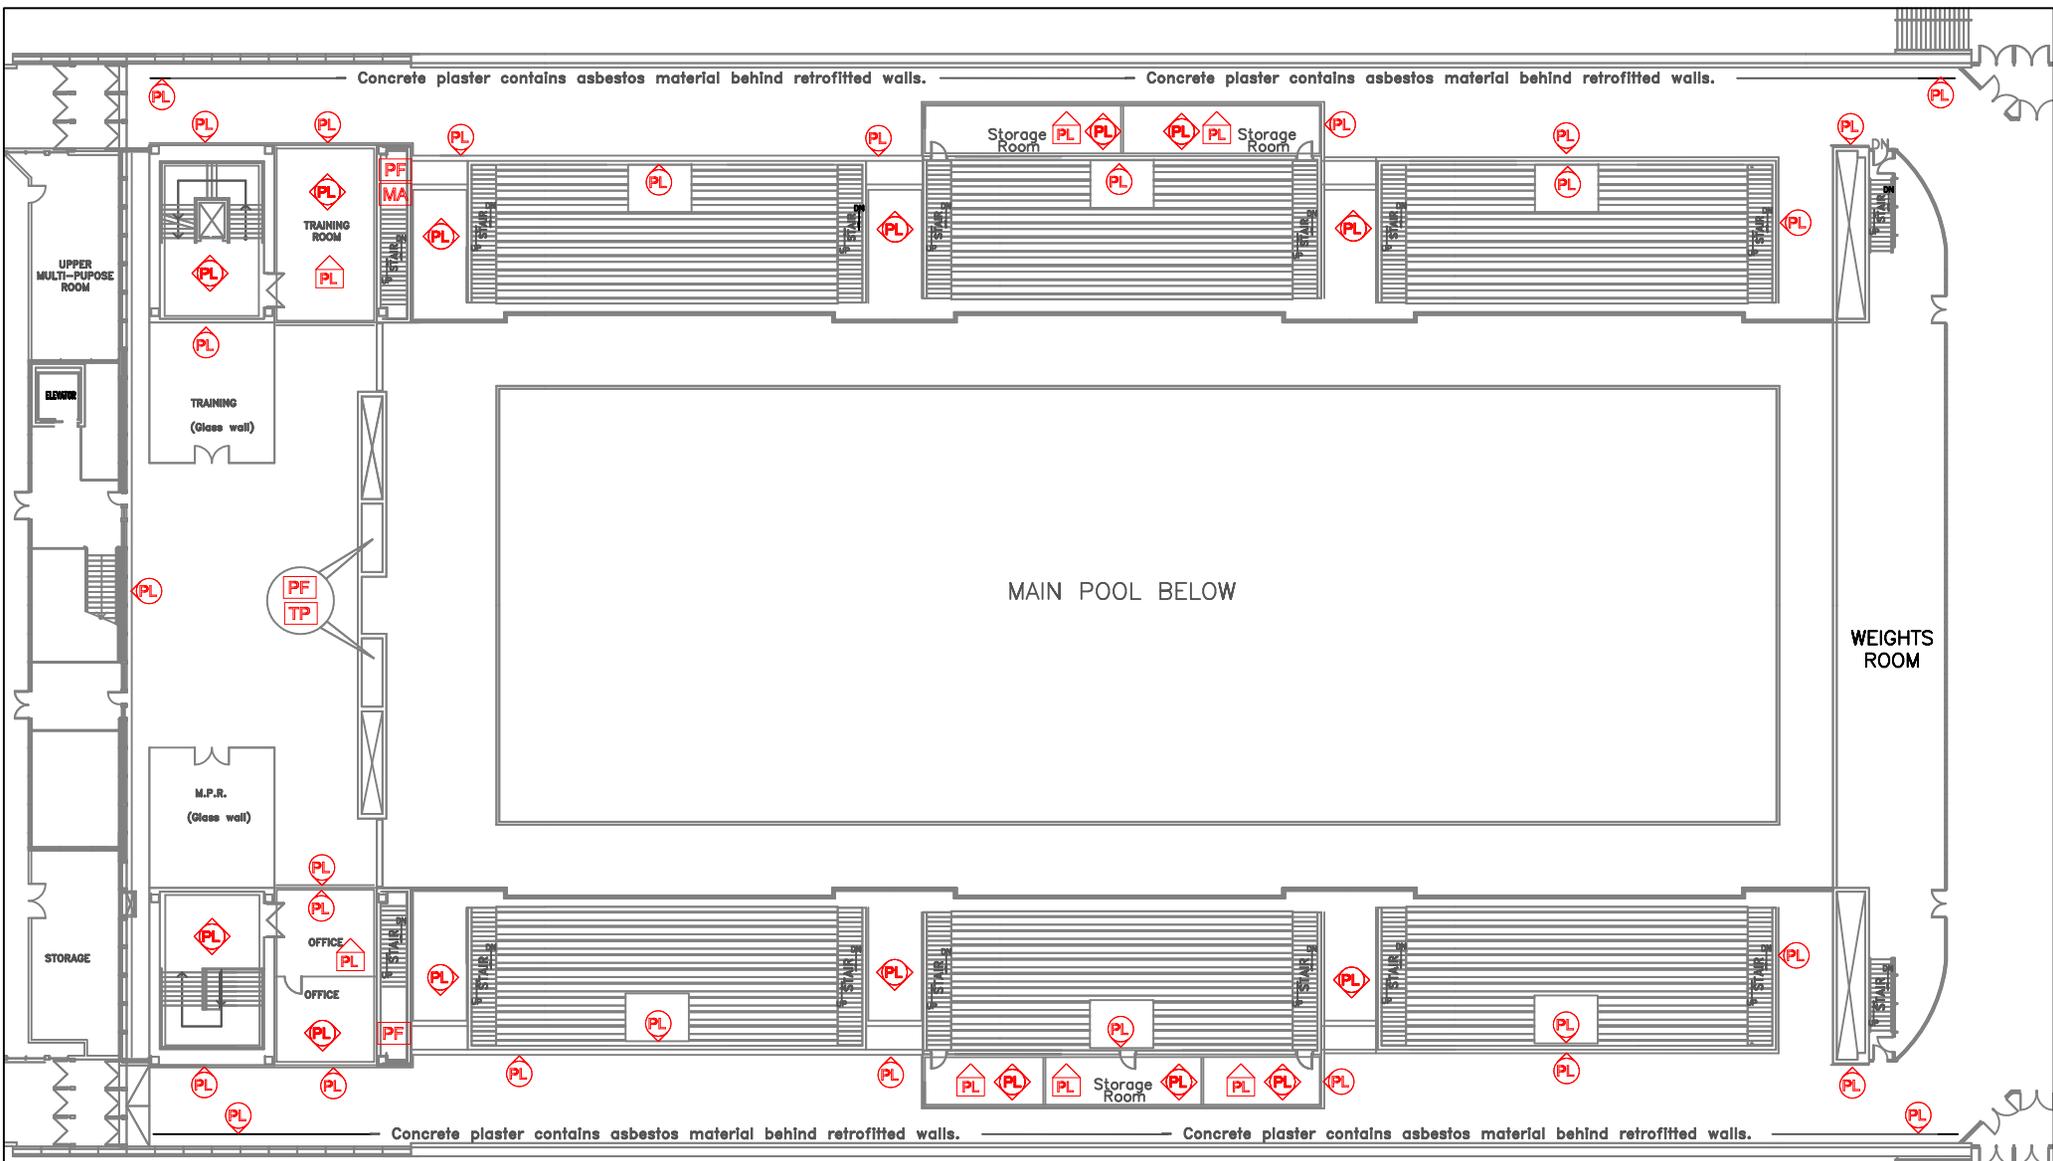
SECOND FLOOR PLAN - Mezzanine level

- All concrete plasters in ceilings and walls contained asbestos materials except for the retrofitted walls in north & south exterior concrete wall of which asbestos materials located behind that walls.

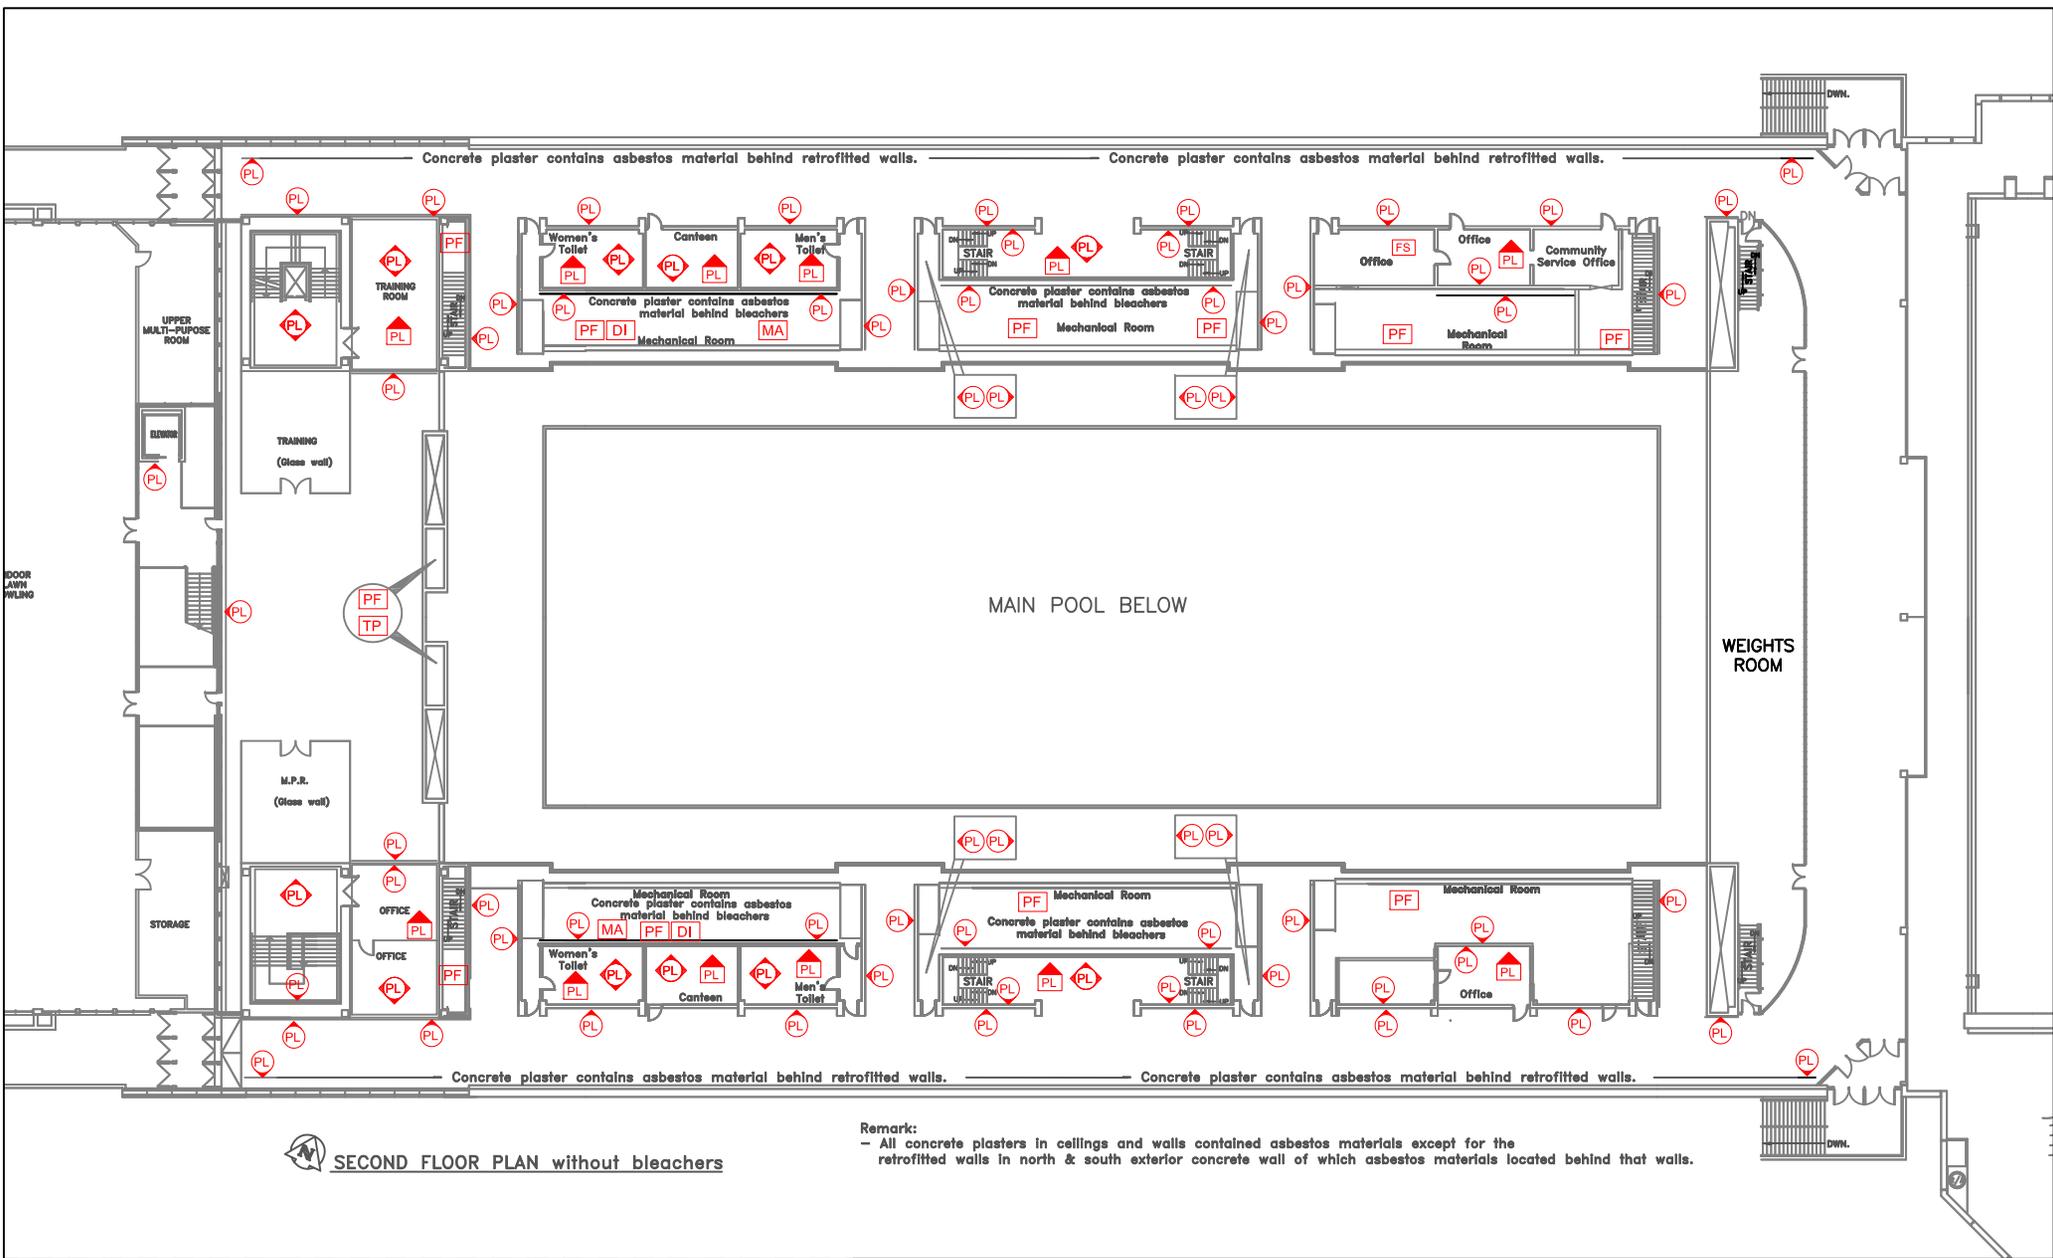
SECOND FLOOR PLAN without bleachers

Remark:
 - All concrete plasters in ceilings and walls contained asbestos materials except for the retrofitted walls in north & south exterior concrete wall of which asbestos materials located behind that walls.

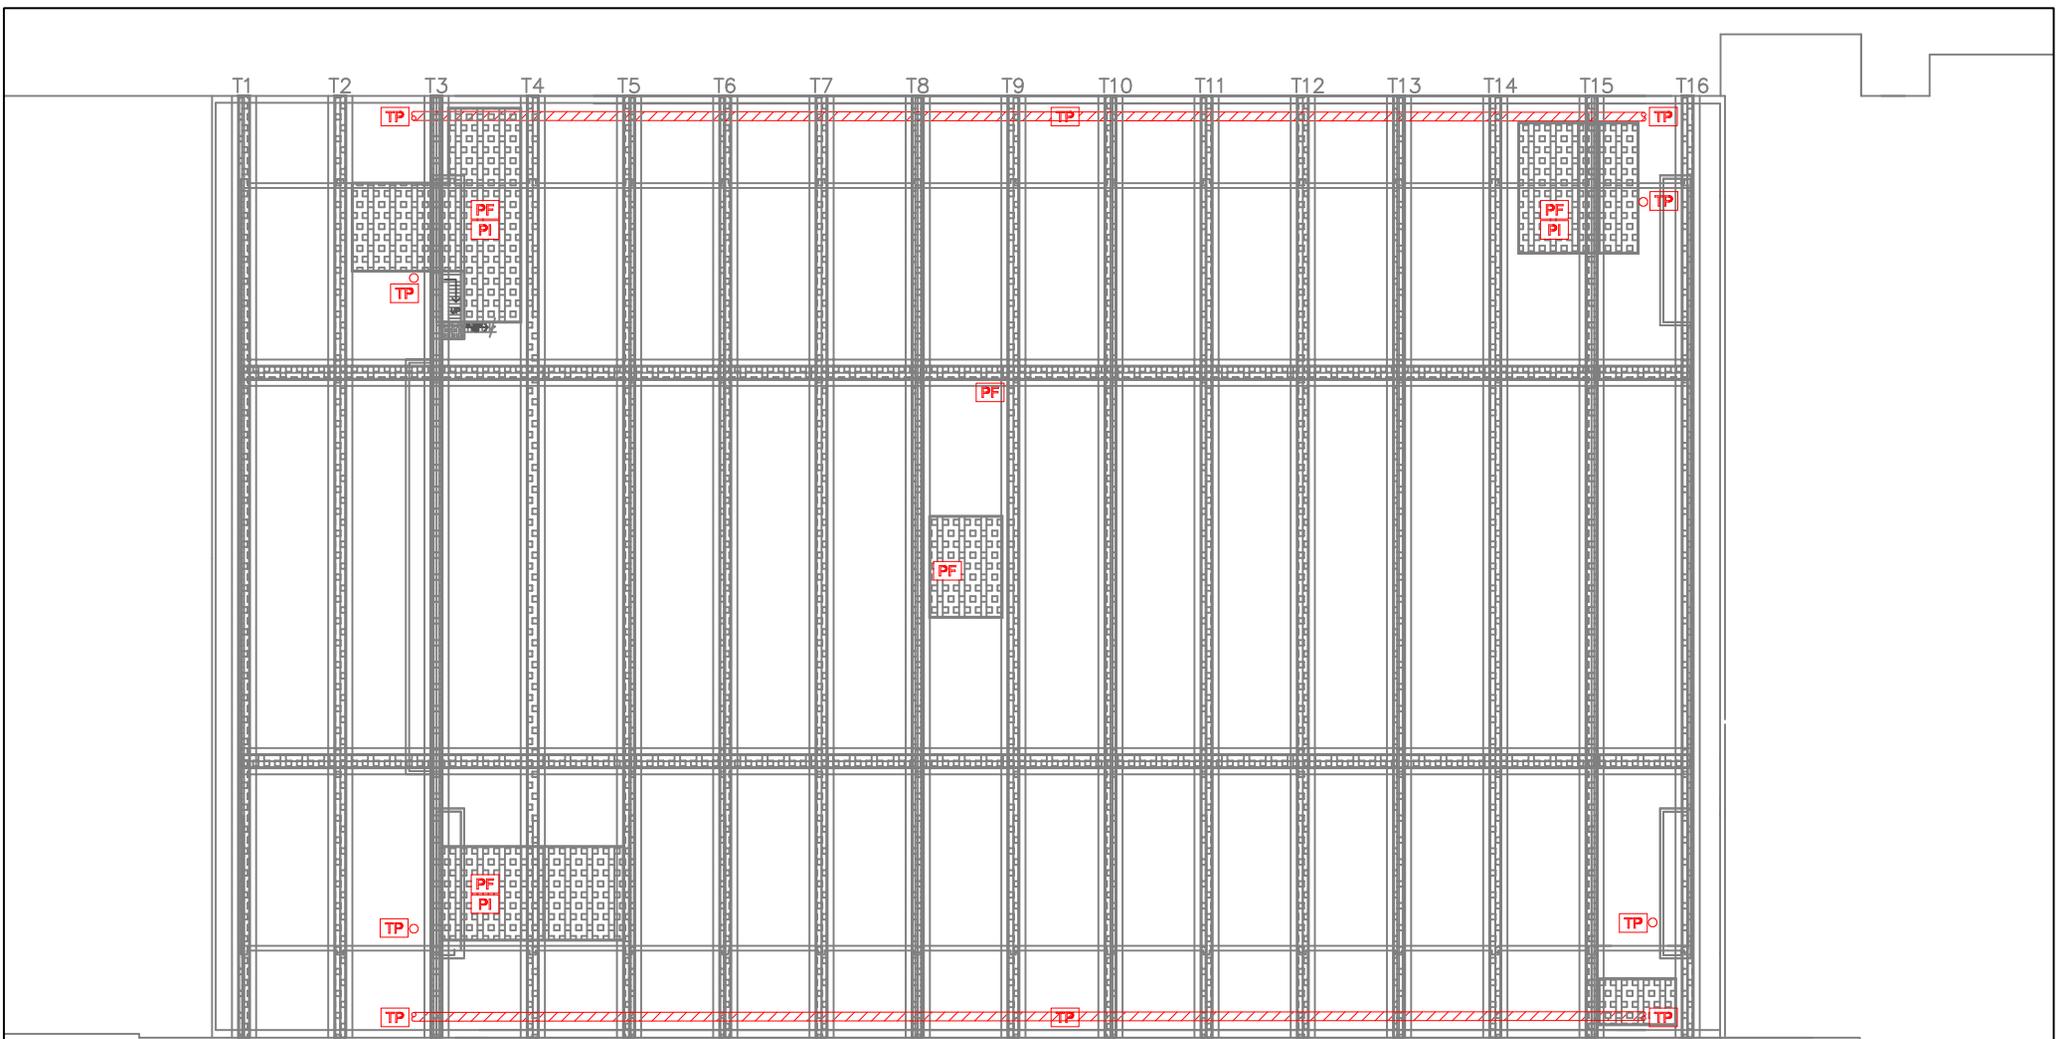
**ROOF CATWALK PLAN**

Remark:
- Asbestos containing pipe fittings are through out catwalk area in various locations.
