# **GEOTECHNICAL REPORT**

# **Riverbank Greenways Program Bunn's Creek Pathway Refurbishment Geotechnical Investigation Report**

60321375 (403)

November 2014

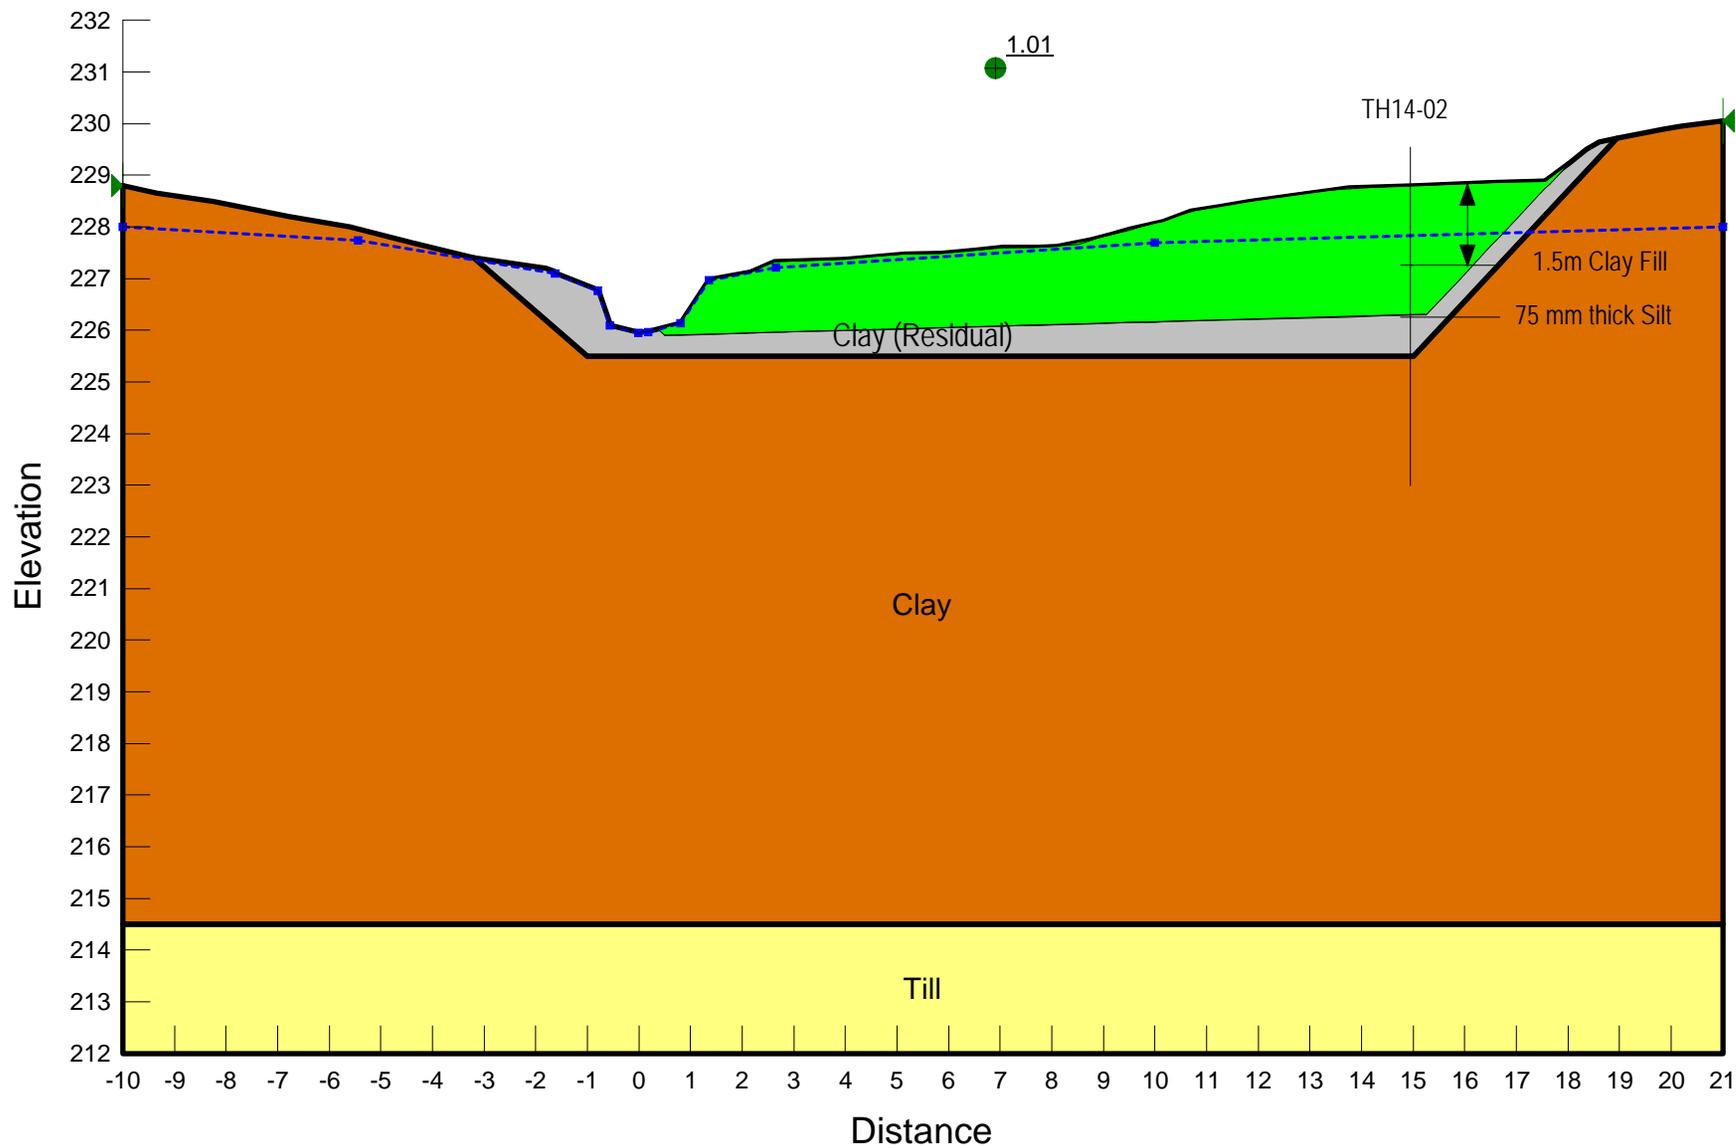
Stability Figure 01  
Bunn's Creek Pathway  
Site B  
Back Analysis

It is common practice in stability assessment of failed slopes to assign residual or reduced strength parameters to reflect the weak conditions developed at the slip surface(s) and within the displaced mass. Observations from site inspection (e.g. scarp, cracks, toe bulge, etc.), information from geotechnical drilling (e.g., slickenside, extremely wet zone, very soft zone, remolded zone, etc.) and instrumentation monitoring, if available, would provide guidance to infer and identify these zones, within the soil model, to assign the degraded strength parameters. Residual shear strength parameters for soils in the Winnipeg area are well examined in the literature and are generally accepted in the local engineering community to be in the range of Cohesion ( $c$ ) = 0 to 2 kPa and Friction Angle ( $\phi$ ) = 8 to 12 degrees.

Back analysis, for fully specified slip surface, was completed for each representative section assuming the design conditions discussed above to obtain an estimate of the operating strength parameters. The slip surface was approximately defined based on the observations from visual inspection and drilling information. The factor of safety was assumed to be close to unity. The estimated soil strength parameters for each section from back analysis are presented in Table 01 and the related analysis results are graphically presented on Stability Figures 01 to 03 in Appendix C. Soil strength parameters for intact clay, till and granular fill, based on published data and knowledge of local conditions, are also presented in Table 01.
