# Building Condition Assessment & Facility Feasibility Study

## St. Vital Library 6 Fermor Avenue

December 4, 2014

Project No. 2196

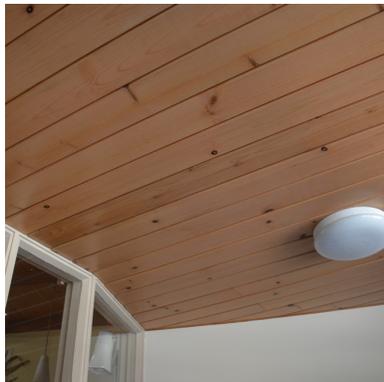
Combustible wood ceiling finish

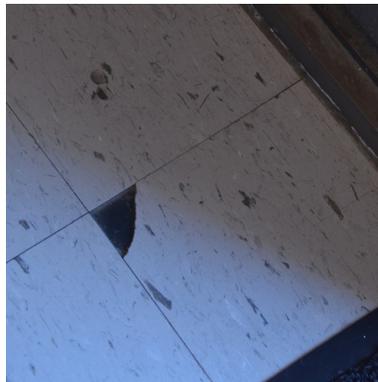
- Vinyl composite tile and rubber base. Condition appears fair with visible signs of wear and tear. Minor damage visible in select areas. Replacement recommended with product more suitable to a vestibule / entrance area subject to seasonal conditions.

Damage to floor tile

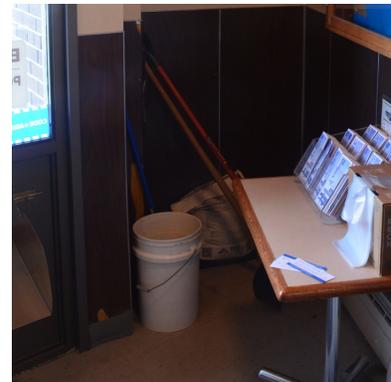
- Painted gypsum wall board on upper half of wall. Condition appears good with visible signs of wearing typical of daily public use. Patching and new paint finish recommended.
- Plastic laminate panelling on lower half of wall. Condition appears good, however, major damage to material to the right of the exterior door. Replacement recommended.

Damage to laminate material

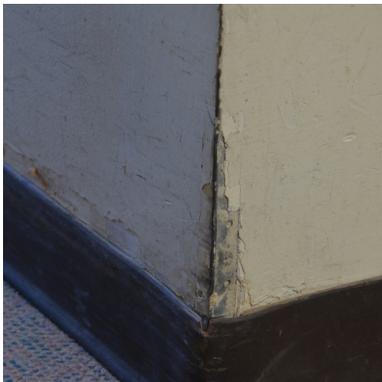
Damage to GWB at base of wall

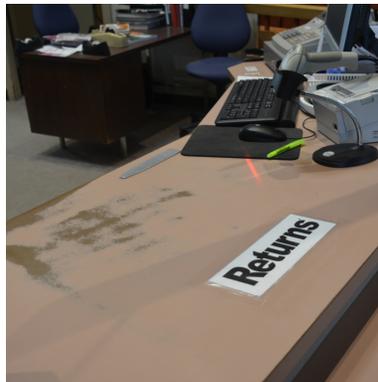
- Reception desk appears to be in poor condition with visible signs of heavy use and wear on counter surface. Replacement recommended.

Wear on reception counter

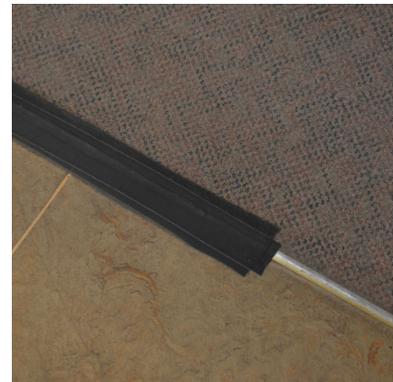
- Roll carpet and rubber base. Condition appears to be poor with visible signs of heavy wearing. Replacement recommended.
- Sheet vinyl at front of reception desk leading from main entry vestibule. Condition appears fair with visible signs of wearing. Transition edging between sheet vinyl and carpet held in place with tape. Replacement recommended.

Tape securing threshold at carpet

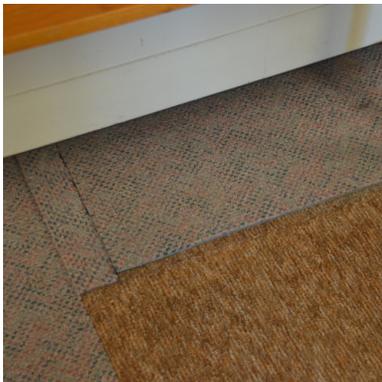
- Roll carpet and rubber base. Condition appears to be poor with visible signs of heavy wearing and various patching throughout. Replacement recommended.

Carpet Patching

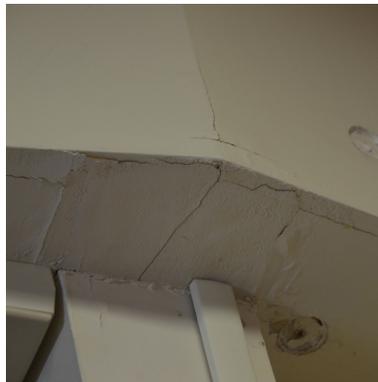
Damage to GWB bulkhead and un-patched plugs

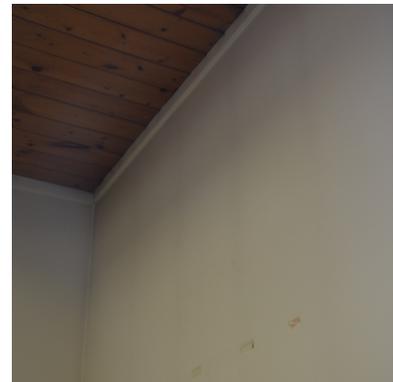
Stud shadowing along north wall

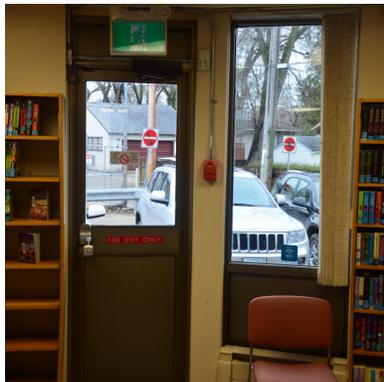
- The exterior emergency exit door does not comply with the requirements of todays building code. The door width falls below the minimum requirements for an exit and the door release (panic) hardware is an outdated model. As increasing the overall width of the exit door is a major undertaking, at minimum, replacement of door release hardware is required.

Non-code compliant exit door

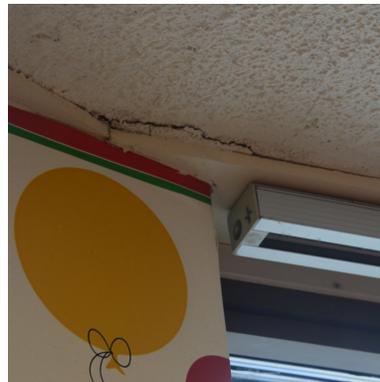
Damage to stucco ceiling

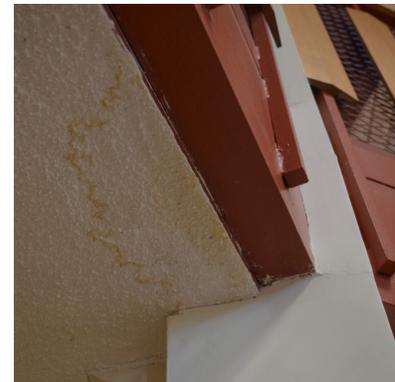
Water staining at underside of mezzanine structure

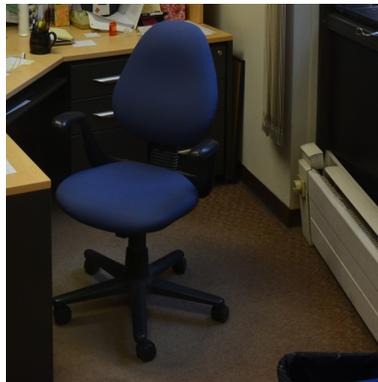
Wear on carpet flooring

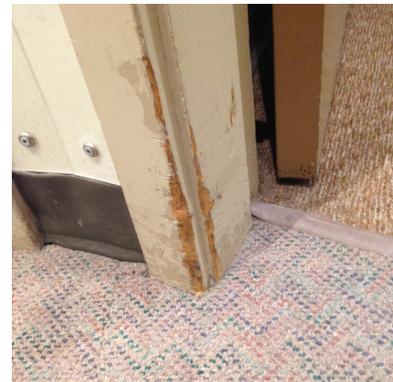
- Painted hollow core wood doors and frames. Condition appears poor with heavy signs of use and damage at base of door frames. Replacement recommended.

Damage to wood door frame

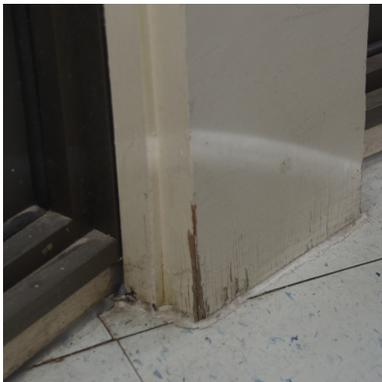
Damage at base of wall between windows

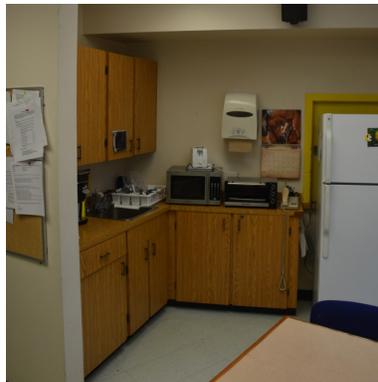
- Kitchen cabinets. Condition appears poor with visible signs of wearing and damage typical of daily use. Appearance is dated. Replacement recommended.

View of kitchen cabinets

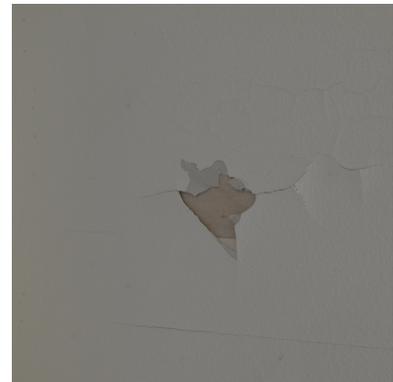
Damage to GWB wall finish

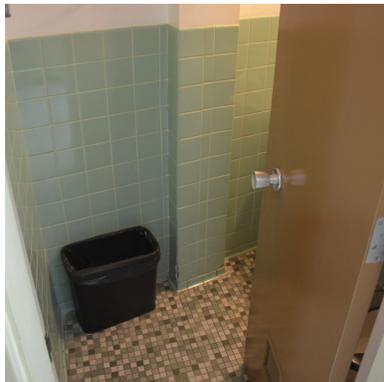
Dated ceramic tile wall and floor finish

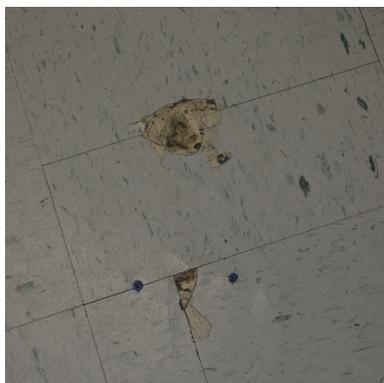
Damage to floor tile

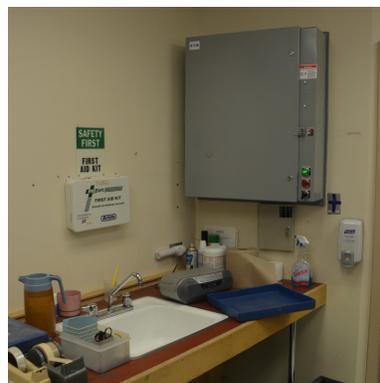
- Large electrical panel located adjacent to sink. Potential hazard due to proximity to wet area. Recommend relocating sink area to far end of counter.

Large electrical panel in close proximity to sink fixture

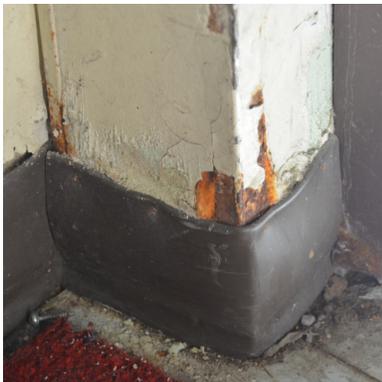
Damage at base of wall adjacent to exterior door

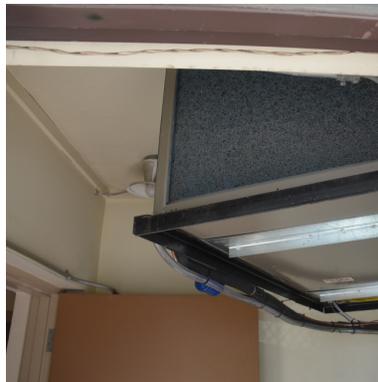
Overhead air-condition unit reduces headroom clearance

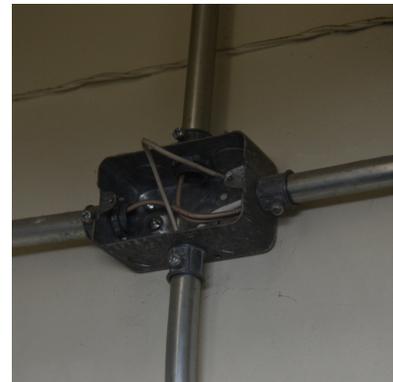
Exposed electrical box

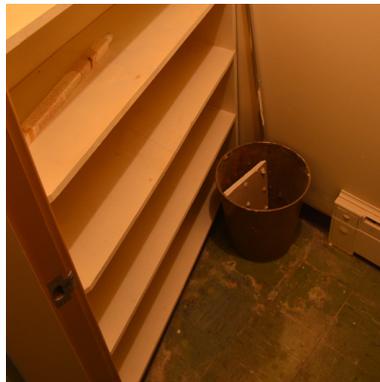
Floor tile in poor condition

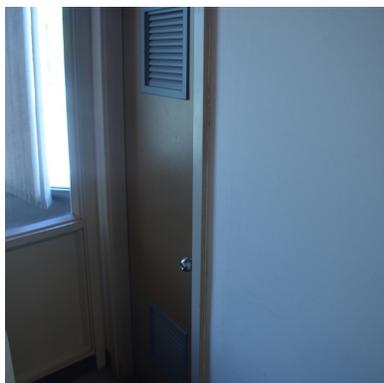
- Janitor room used for storage of chemicals is required to have a fire separation with a fire resistance rating around it. It is assumed that the existing wall construction with gypsum and stud framing meets the fire rating, however, the door and frame are not fire rated. Replacement of door and frame with fire rated product required.

Non-fire rated door c/w grilles

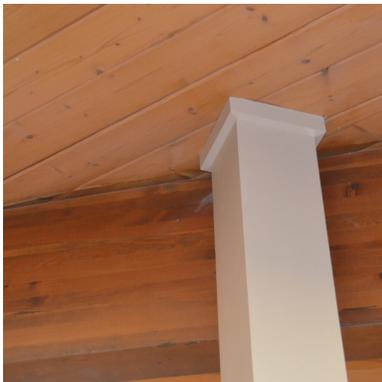
Roof decking separated from beam

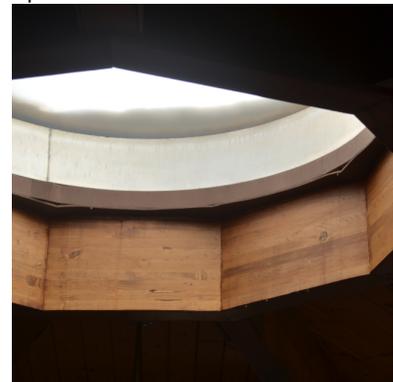
Water staining around skylight

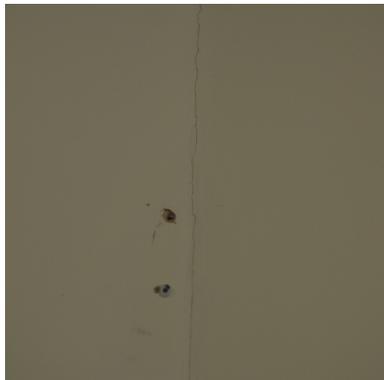
Damage and cracking in GWB

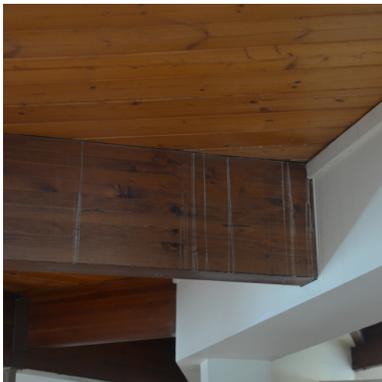
Water staining on roof structure

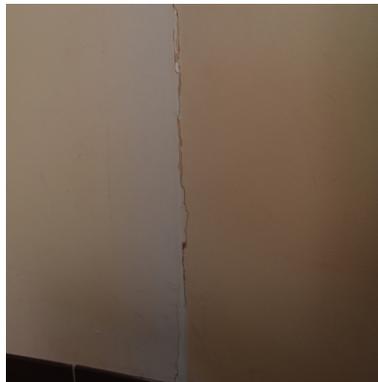
Cracking in GWB along exterior wall

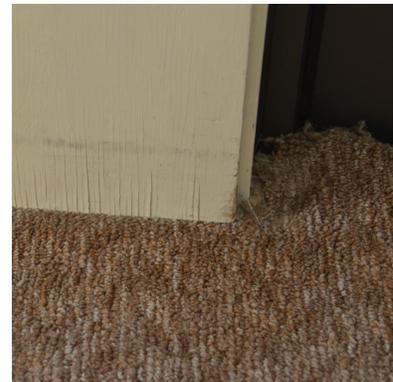
Damage at base of column due to water

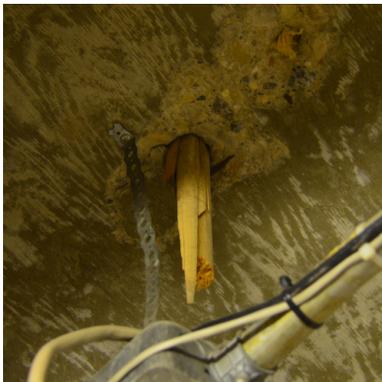
Ceiling penetration infilled with wood

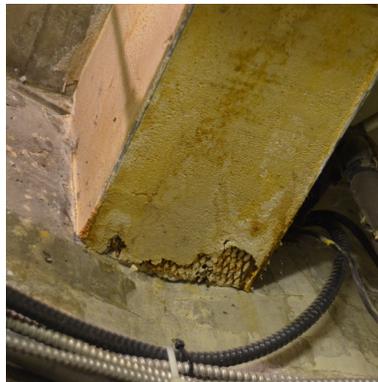
Damage on underside of GWB

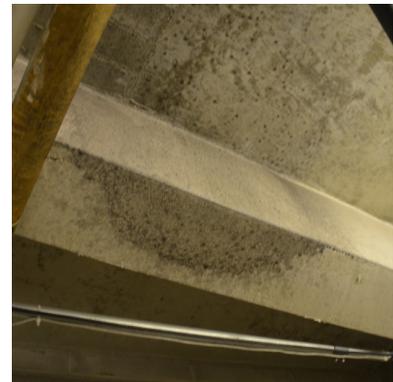
Unconfirmed growth on GWB and concrete structure

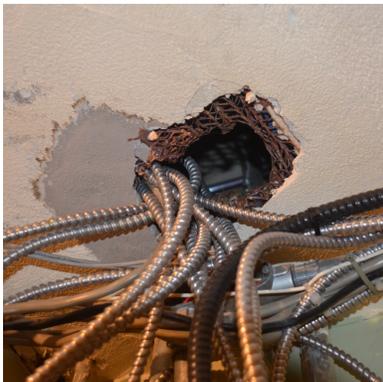
Damage to ceiling for electrical

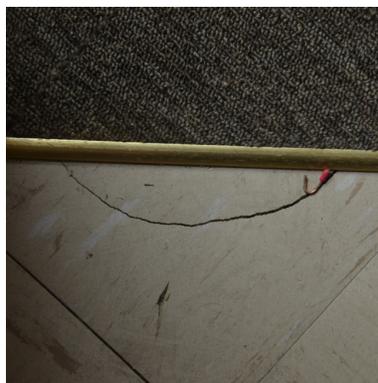
Damaged to floor tile

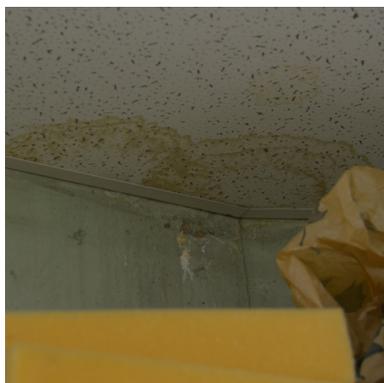
Water staining on acoustic ceiling

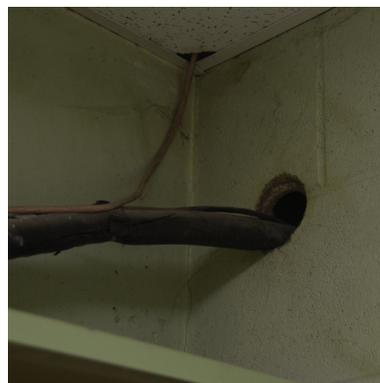
- Penetrations through West wall into adjacent Boiler room are required to be fire-stopped to maintain the fire resistance rating required around the Boiler room. Patch and firestop all penetrations into Boiler room recommended.

Penetrations into adjacent boiler room required to fire stopped

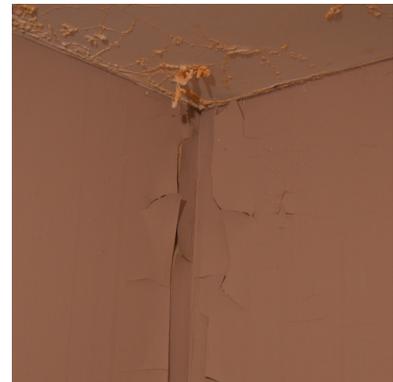
Damage to GWB and ceiling

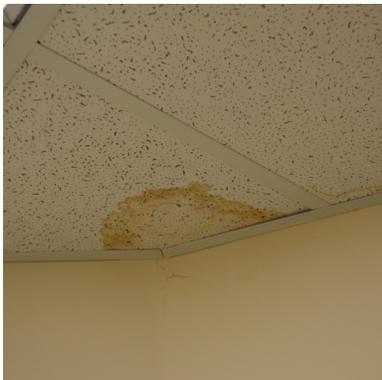
Water staining on acoustic ceiling

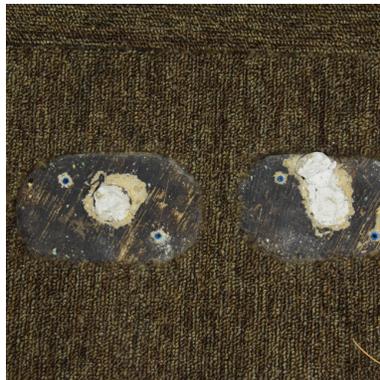
Damage to carpet finish

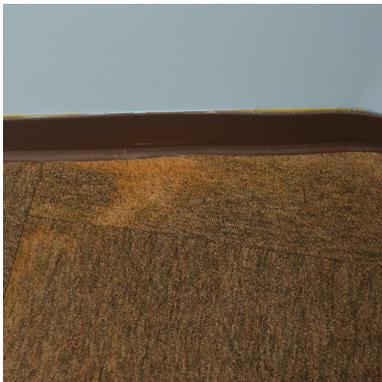
Damage to carpet floor finish

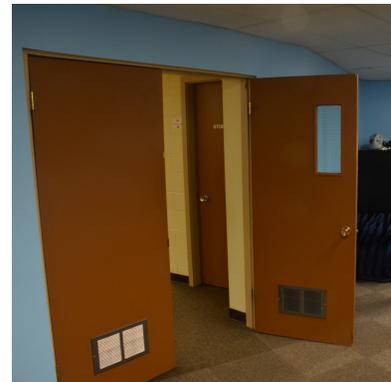
- Double doors swing into the room which is not permitted by code for a space containing an occupancy greater than 60. Doors are required to swing in the direction of travel. The room has a posting outside the entrance door limiting occupancy to 90. Recommend posting sign limiting occupancy within the room to less than 60.
- Code requires two means of egress from rooms having an intended occupancy greater than 60. Two access to exits have been provided, however, neither of them are code compliant. Recommend posting sign limiting occupancy within the room to less than 60 and reconstructing the exterior exit to meet the requirements of todays code.

Double doors accessing room

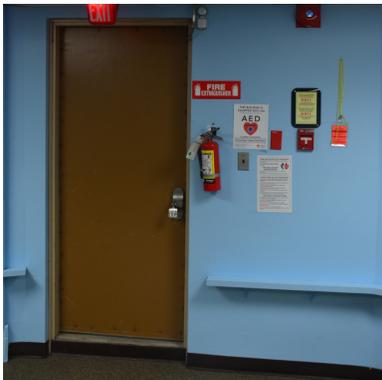
- Existing exit stair enclosure does not meet the Manitoba Building Code requirements of today. The enclosure is partially constructed out of combustible materials, door release hardware on basement level door is outdated, door sill at basement level is set up above the floor approximately 5" which creates a step or tripping hazard and only a partial handrail has been installed on one side of the stair. Replacement recommended with new code compliant construction.

Step up and non-compliant door release hardware on door

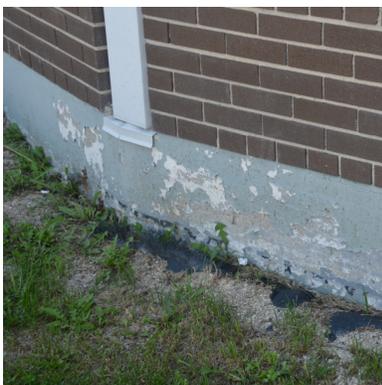
Paint finish peeling off concrete foundation

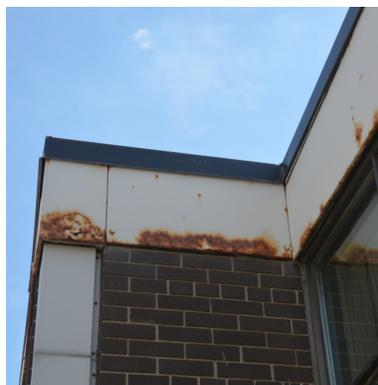
Rust on metal cladding

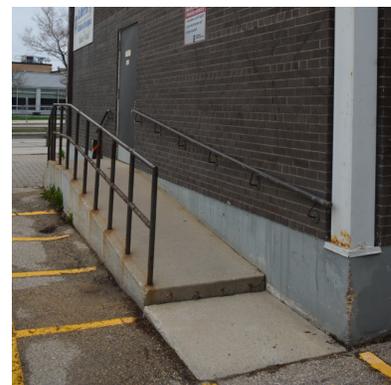
- Concrete ramp and stair construction at West exit is not code compliant. Handrails are required to extend past the last riser at both top and bottom of stairs and ramp; detectable warning surfaces are required at top and bottom landings as well as each stair tread; landing at base of ramp has fallen approximately 6" below ramp level rendering the ramp inaccessible; adequate clearance has not been provided between the door and railing system. Replacement recommended.

Concrete base at ramp fallen away

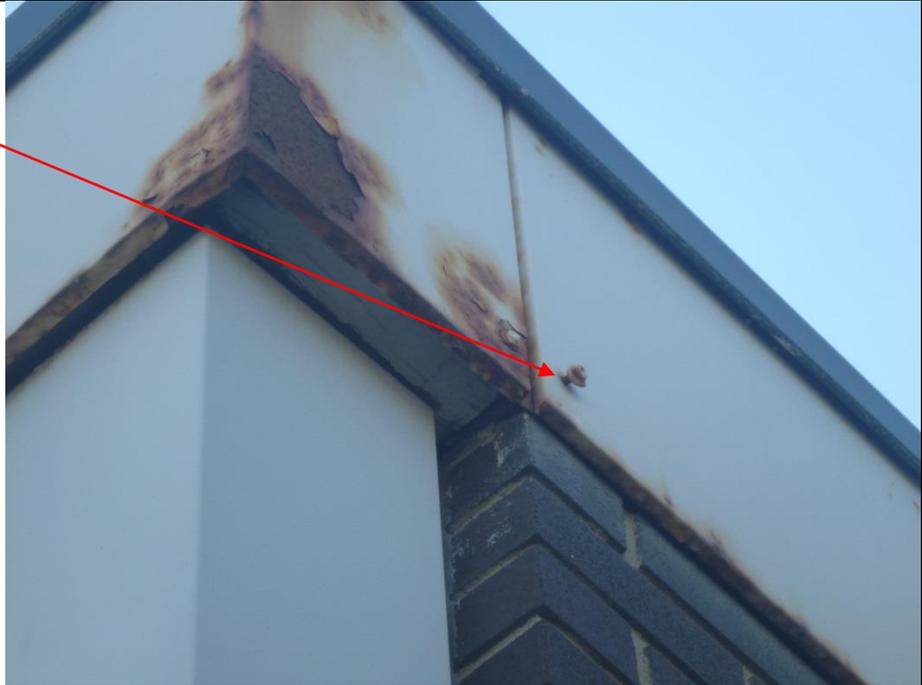
Photograph #1:  
Minor corrosion on metal  
fascia panel. Note also  
displaced screw fastener.

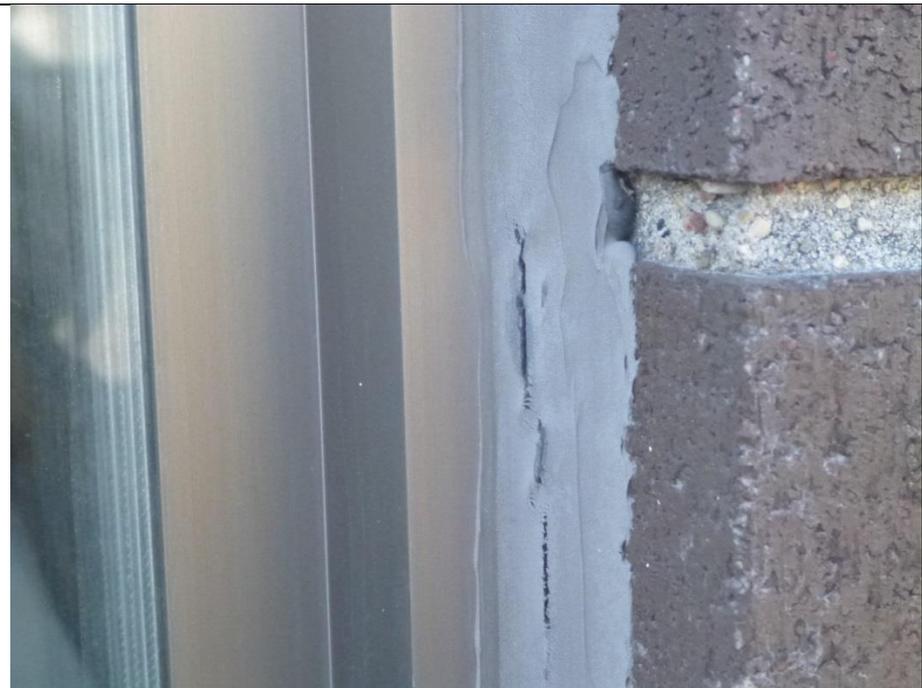
Photograph #2:  
Failed caulking at window  
jamb.

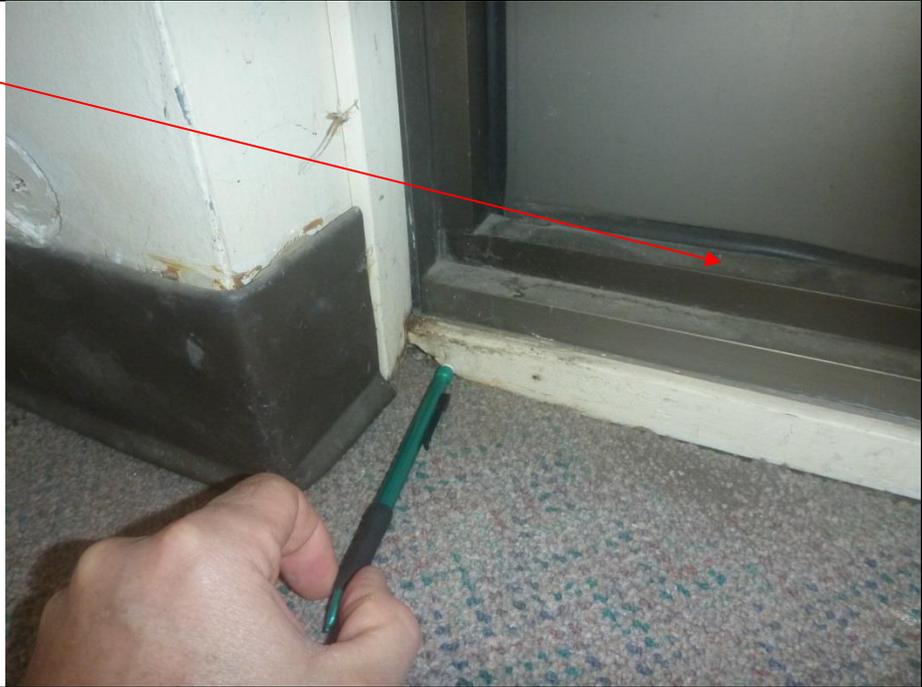
Photograph #3:  
Deteriorated sill and  
evidence of dried water  
stains. Note also displaced  
gasket.

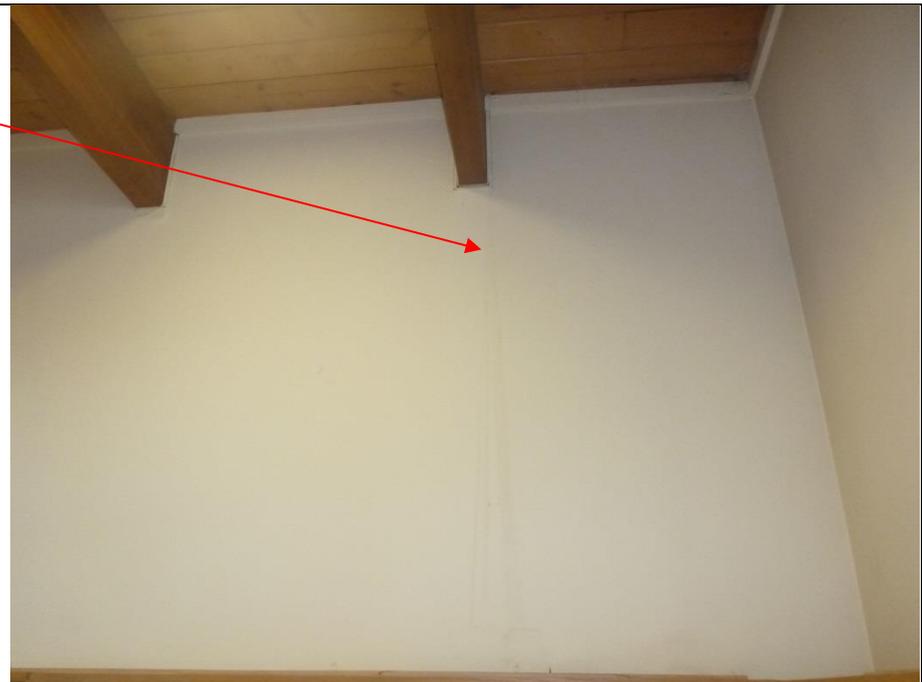
Photograph #4:  
Water staining from glulam  
projection at exterior wall.

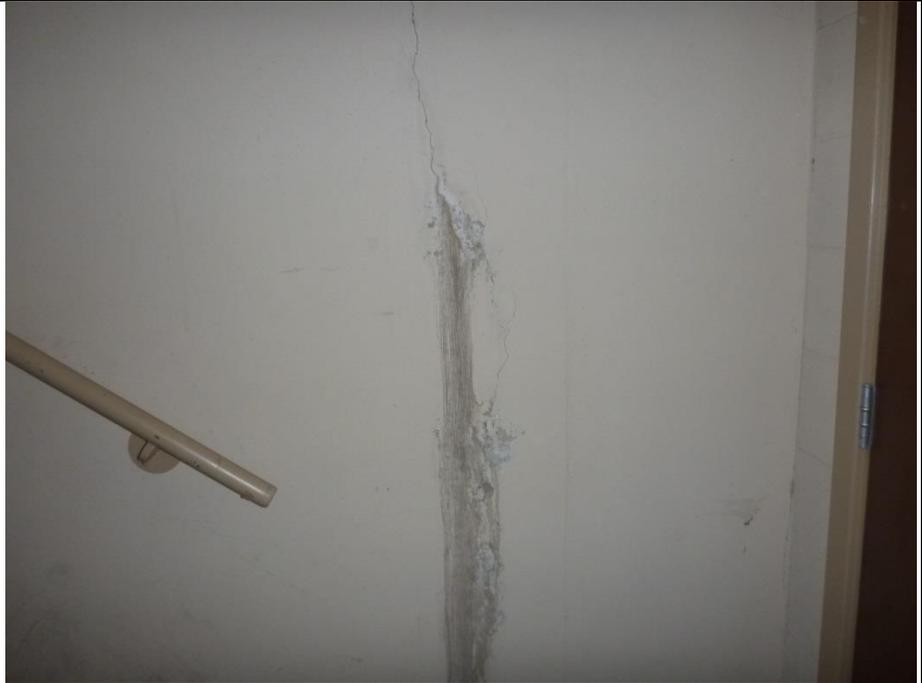
Photograph #5:  
Water penetration in rear  
stairwell of foundation wall  
(south-west).

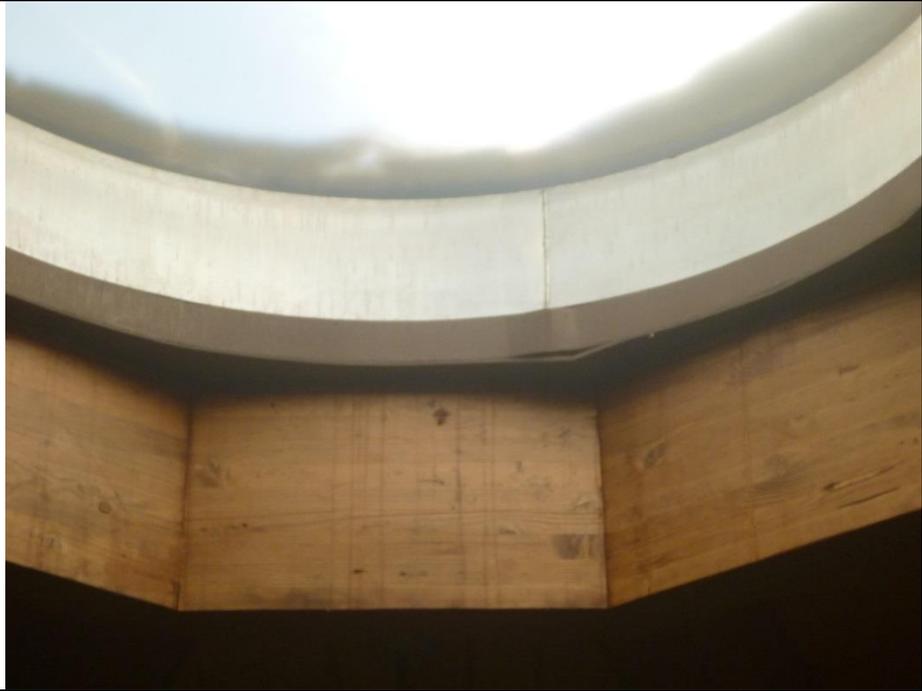
Photograph #7:  
Water staining along  
framing below skylight.

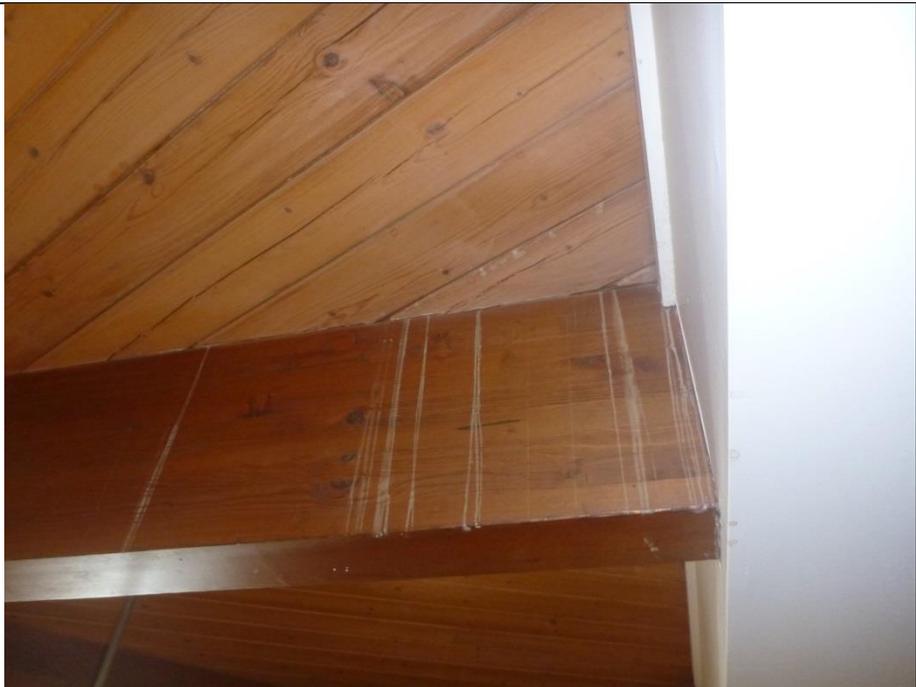
Photograph #8:  
Water staining in glulam  
beam supporting east roof.

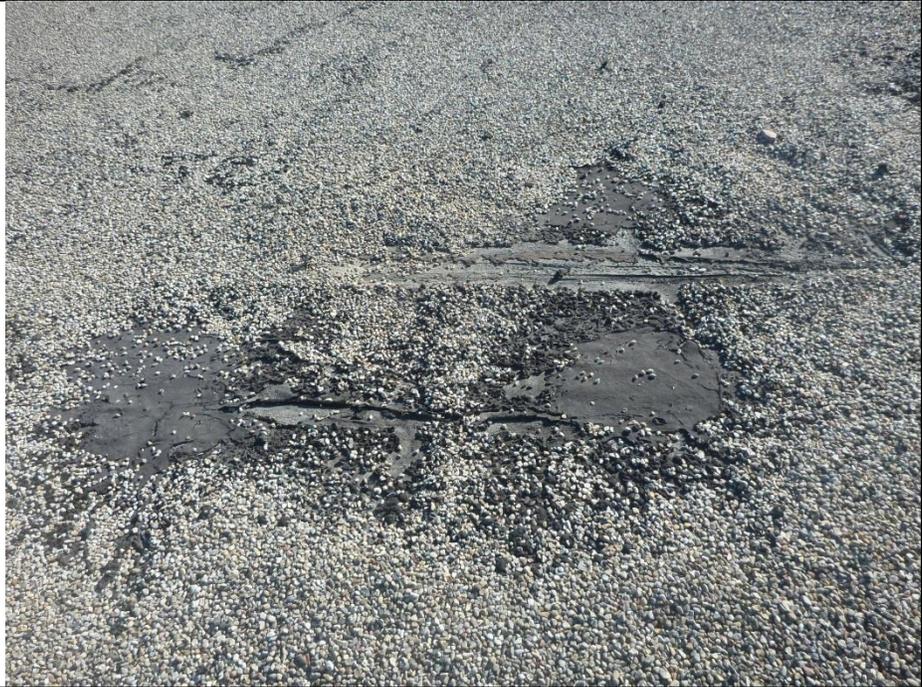
Photograph #9:  
Example of exposed,  
deteriorated felts.
