## Architectural Evaluation Report

VA Project No.: 11-14

Project Name: City of Winnipeg Machray Park Redevelopment

Re: Machray Park Redevelopment  
Architectural Evaluation of existing Wading Pool change room, washroom and mechanical building.

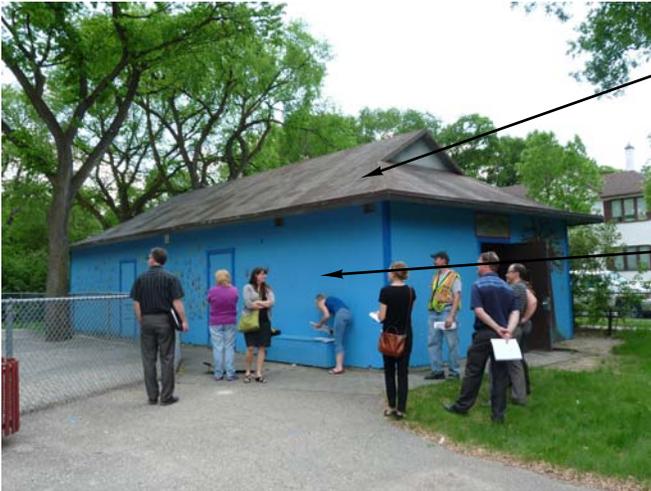
NORTH WEST BUILDING CORNER

### ROOF:

- 2x4 roof truss construction with no insulation.
- ADD: Blow-in insulation (Above Mechanical Room), vents, eaves troughs, and down spouts.

### EXTERIOR WALLS:

- 2x4 wall construction with ranch wall wood siding but no insulation
- ADD: Roxul insulation (Mech Room)
- REPAIRS: Repaint (including graffiti protection coating)
- RECLAD: Install Hardie Board on lower 3' portion around buliding and on walls surrounding mechanical room

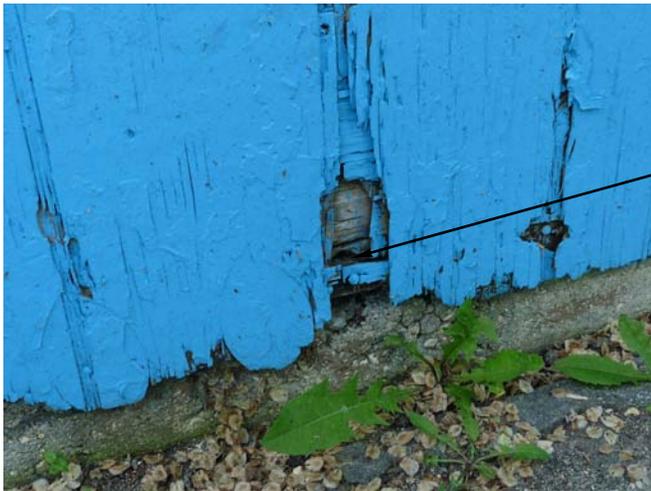
BASE OF EXTERIOR WALL

The building's exterior walls show signs of vandalism and graffiti, which is common in the neighborhood. Any new exterior finishing materials used should be durable and allow for easy graffiti removal, cleaning or repainting. The exterior ranch wall wood siding and base plates show signs of rot, particularly on the northeast face of building which faces the wading pool. Recommended repairs would include, insulating the walls and ceiling of the mechanical room which would require removing all the interior and exterior cladding around the mechanical room, cutting and removing the lower +/-3' portion of the wood siding around the entire building to address the rot, performing localized repairs to the base plates, and then re-clad the lower 3' and mechanical portions of the building

### EXAMPLE OF ROTTEN SECTION OF EXTERIOR WALL:

with Hardie Board. Upon removal of the existing wall cladding, any rotten plates or studs should be replaced. The full extent of rotting of the base plates cannot be determined at this time.

- Remove lower +/- 3' of exterior cladding
- Replace rotten sections of bottom plate and wall studs
- Install new Hardi Board cladding

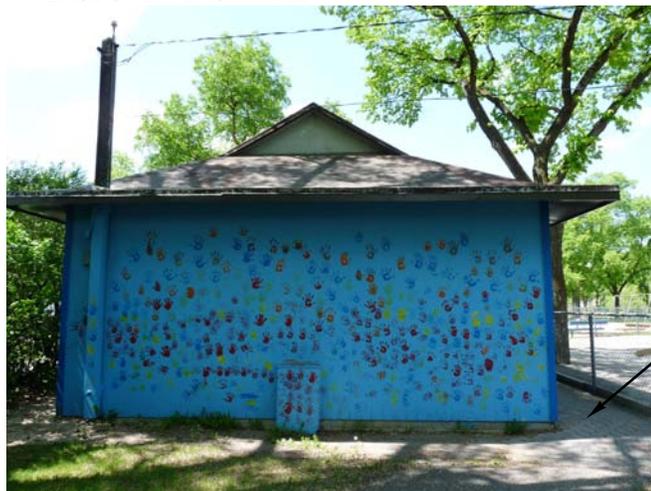
EAST BUILDING FACE

Rotting of exterior wood cladding alludes to potential drainage issues around the building. An investigation should be carried out to verify whether or not positive drainage away from building exists. While the building roof appears to be in acceptable condition, it does not feature eaves troughs and downspouts, which should be added to minimize water accumulation at the base of the building.

### DRAINAGE:

- Ensure positive drainage away from building, min 2%.

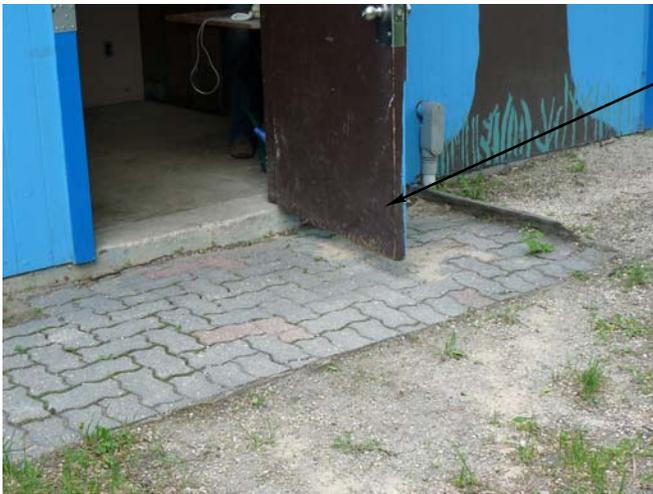
**MECHANICAL ROOM DOOR**

**MECHANICAL ROOM DOOR:**

- Existing 36" door.

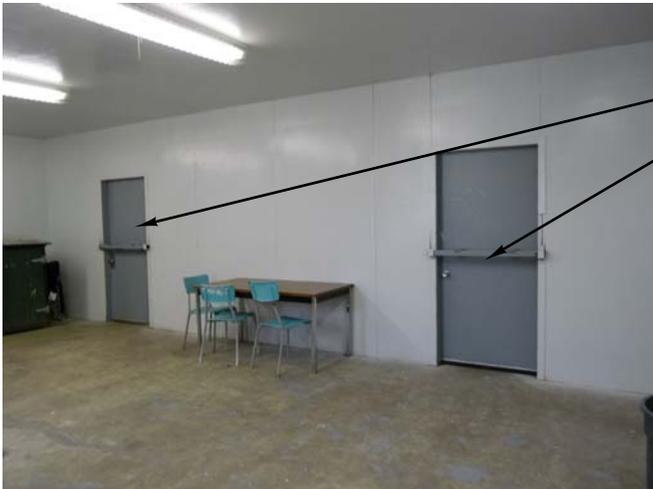
**PUBLIC ENTRY DOORS (INTERIOR)**

The existing building features three 36" entry doors, two of them on the wading pool side of the building serve the large open change area and the third serves the mechanical room. The existing door hardware found on the doors are of the twist knob style and is not barrier free accessible. The 2010 City of Winnipeg Accessibility Design Standards recommends 39" (1000 mm) doors to allow for a 36" (915 mm) clear opening for newly constructed buildings while 36" (915 mm) doors are permitted only in retrofit situations where it is not technically feasible. Given the amount of wall space available and the age of the door and hardware, new doors should be 39" wide and feature hardware that conforms to barrier free accessibility design standards including power door operators.

**DOOR HARDWARE:**

- Upgrade door hardware with power operator to be barrier free compliant.

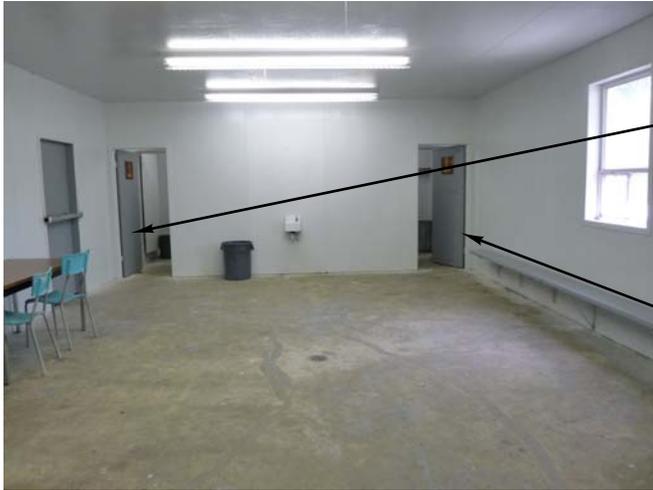
OPEN CHANGE ROOM AREA

**MULTI-STALL MEN'S WASHROOM:**

- Upgrade existing 32" door to 39" door
- Power door operator required if washroom remains multi-stall

**MULTI-STALL WOMEN'S WASHROOM:**

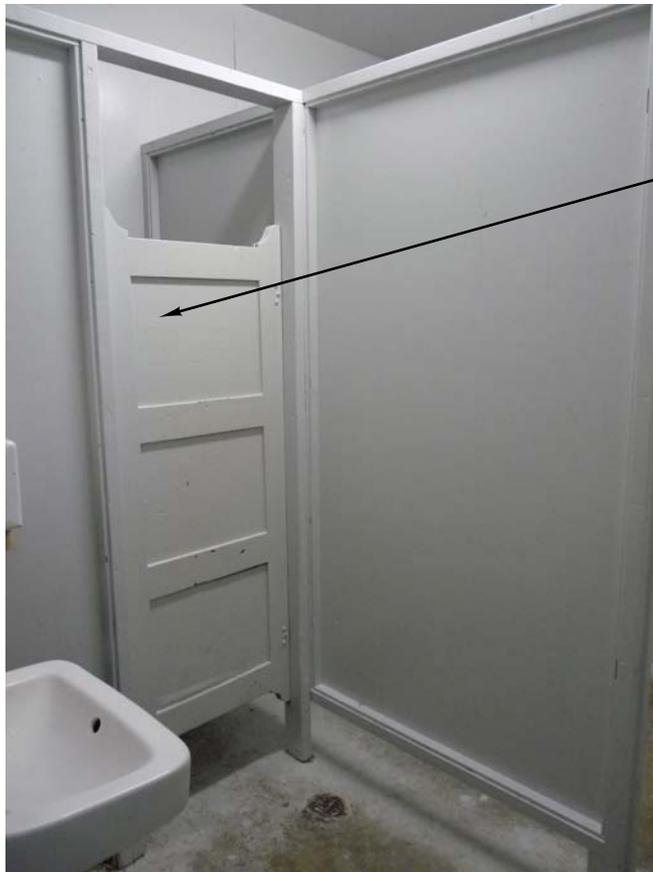
WASHROOM INTERIOR

The existing washroom facilities are accessed through the large open change area. Existing washroom doors measure only 32" wide and are not power operated. The men's washroom features two urinals, one large water closet stall and one lavatory. The women's washroom features two water closet stalls (one large and one small) and one lavatory. The current washroom facilities do not meet accessibility standards as set out in the 2010 City of Winnipeg Accessibility Design Standards (ADS). Plumbing fixtures are dated and likely do not meet today's barrier free accessibility standards, and therefore, should be replaced. The men's washroom is short one lavatory because by the Manitoba Building Code requires one lavatory for every two water closets and urinals. Both washrooms also do not feature the appropriate grab bars. Existing toilet partitions are painted wood and should be replaced with new solid plastic partitions.

**TOILET PARTITIONS:**

- Replace wood toilet partitions with solid plastic toilet partitions

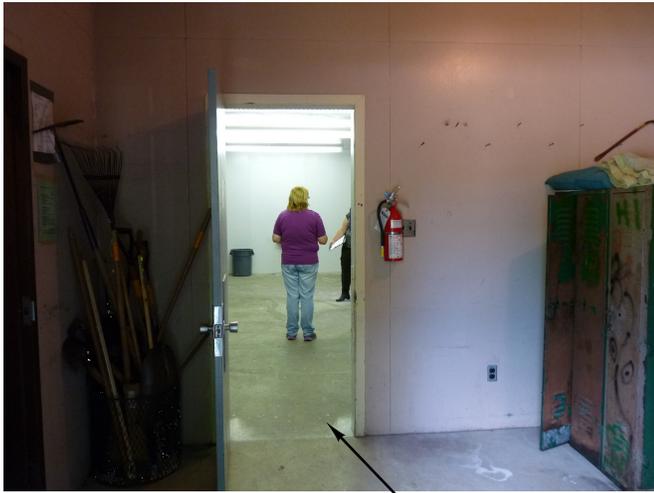
EXISTING STORAGE/STAFF ROOM

EXISTING 32"  
DOOR

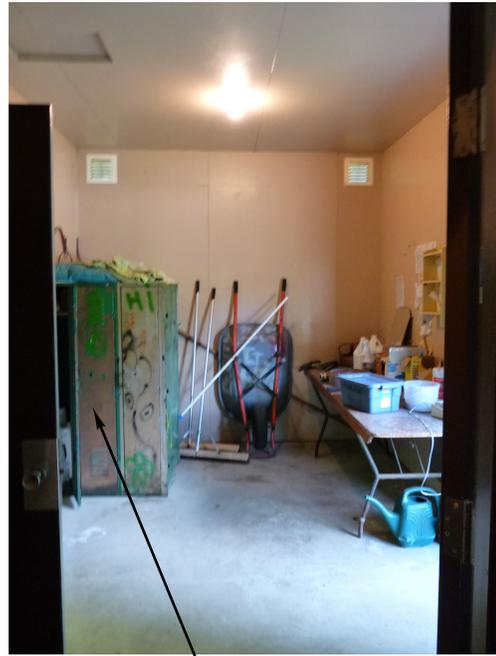
STAFF LOCKERS:  
- Replace existing lockers

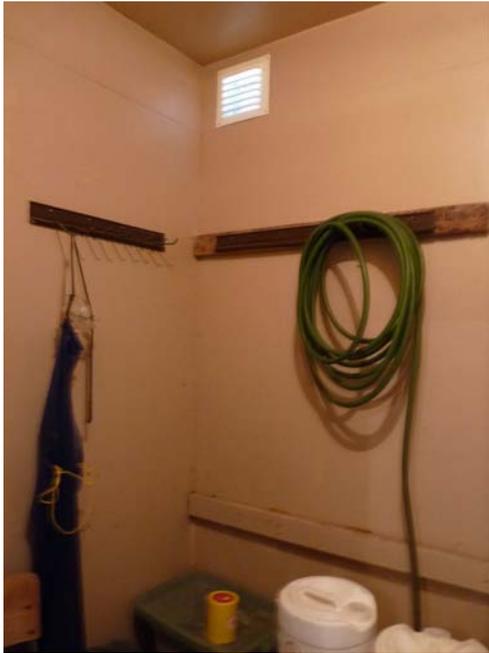
EXISTING WADING POOL MECHANICAL ROOM

The existing mechanical room is too small to accommodate the additional equipment for the spray pads. Based on a similar spray pad project recently completed in Sturgeon Heights, the footprint of the mechanical building was approximately 6 meters x 8 meters (48 square meters) to house the equipment. In order to accommodate the additional mechanical equipment, the existing mechanical room could be expanded into the existing change room open area. Due to the installation and servicing requirements of the mechanical equipment, access via a set of double doors with an 1800 mm opening may be required.
