# ASBESTOS INVENTORY CONTROL

<b>Building Name:</b>	Administration Bldg Civic Centre Complex	<b>Inspection Date:</b>	February 6, 2015
<b>Building Code:</b>	CB-01 Sub Basement	<b>Inspected By:</b>	A Brodbeck & W Dawson
<b>Building Address:</b>	510 Main St	<b>Construction Date:</b>	1964

<b>ASBESTOS LOCATIONS</b>			
BUILDING: CB-01		Administration Building Civic Centre Complex	
		510 Main Street	
		WINNIPEG, MANITOBA	
REVISED BY: AB	DATE: February 6, 2015	SCALE: N.T.S.	SHEET #: 1/10

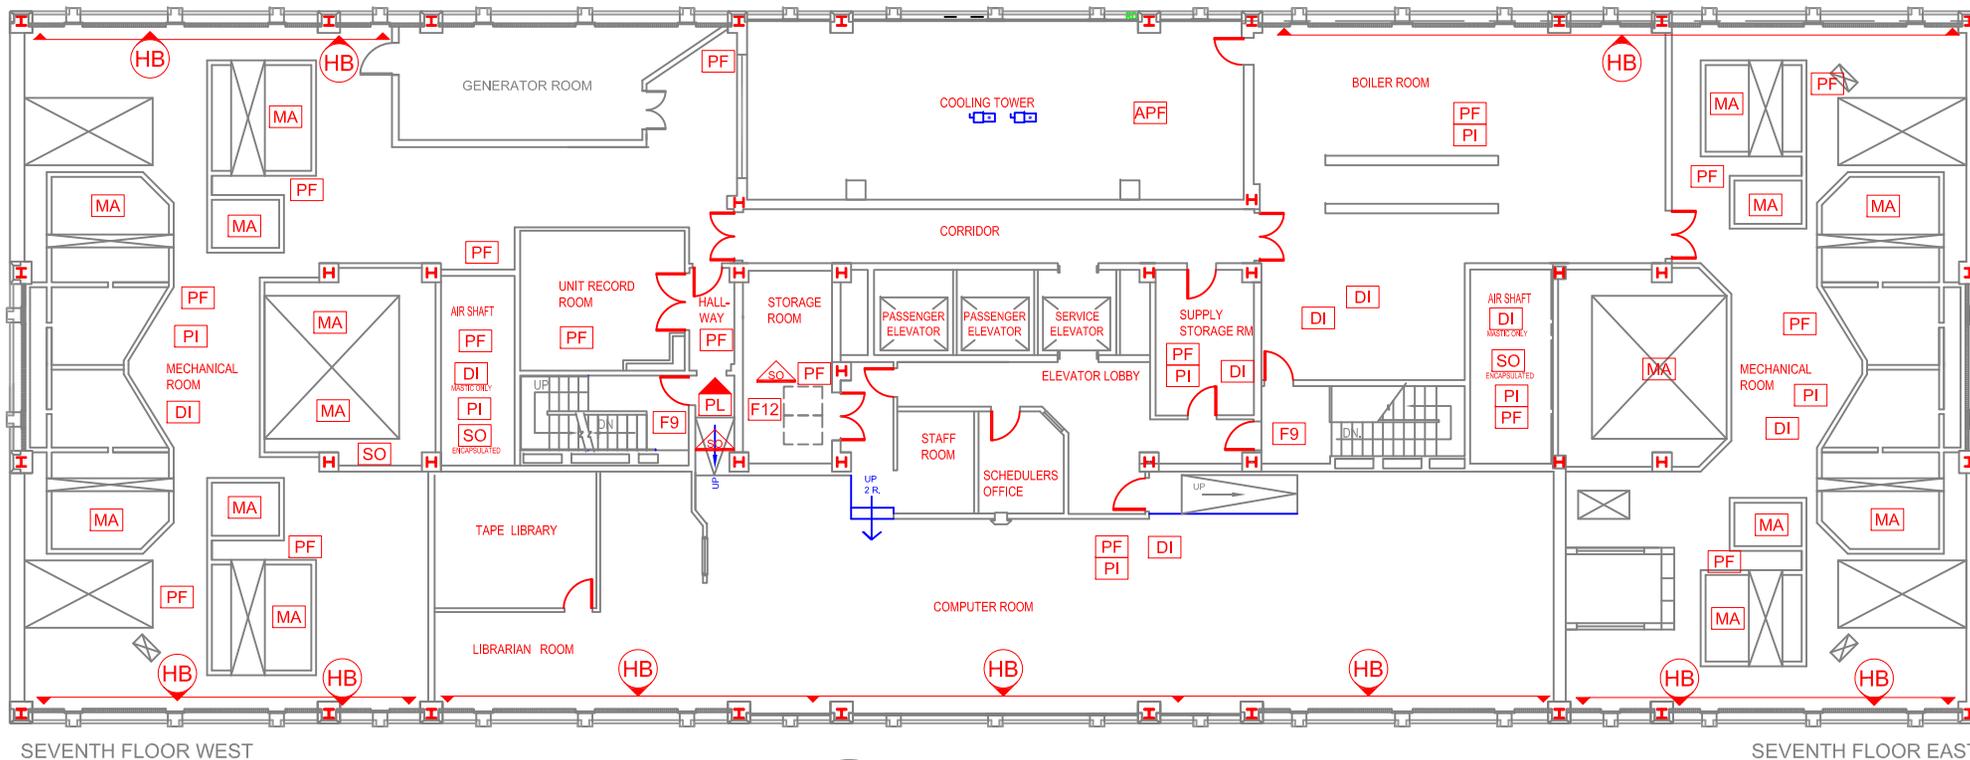
## SEVENTH FLOOR PLAN

Note:  
Spray on insulation in both air shafts were encapsulated and vacuum-2011.

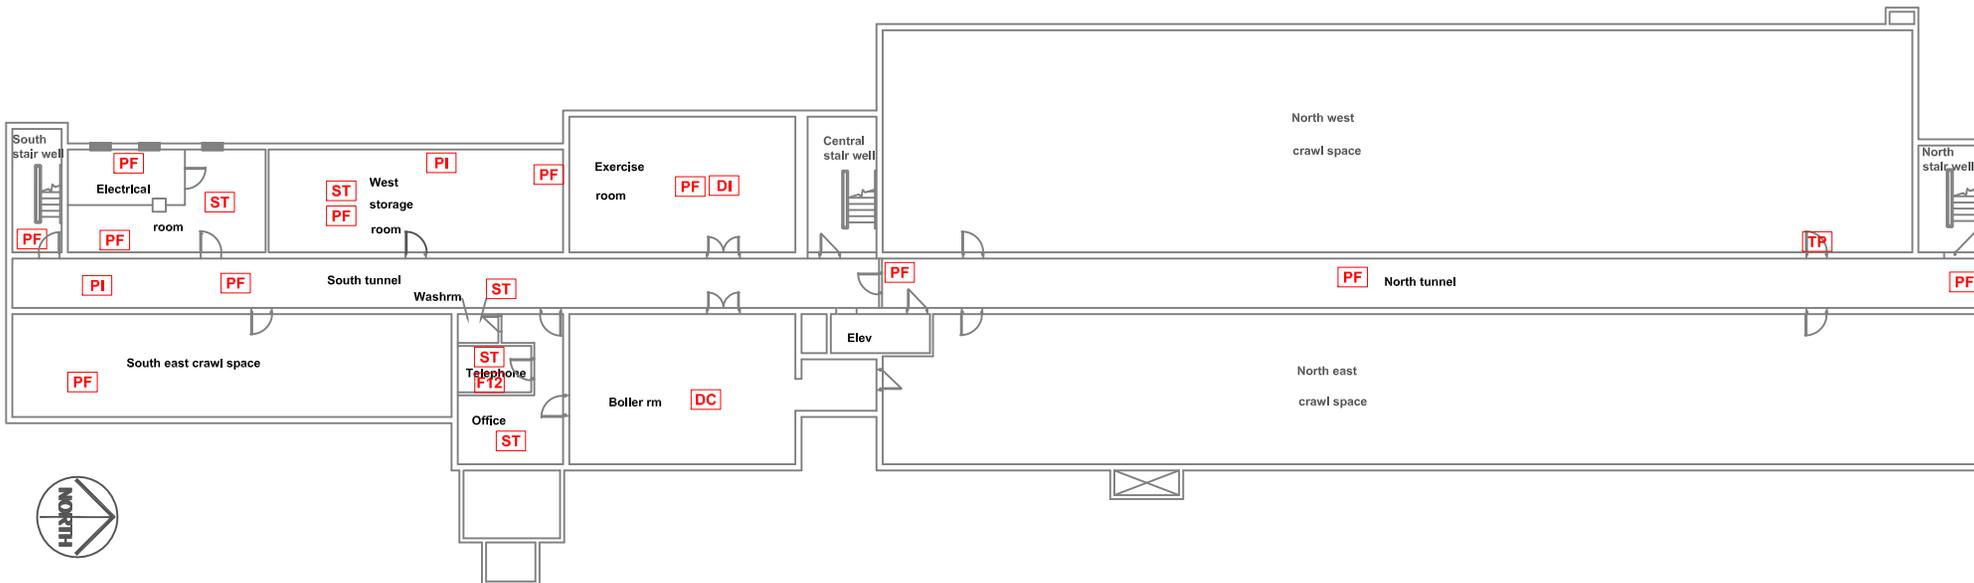
## Basement

All Drywall Compound (DC) throughout building contains asbestos.

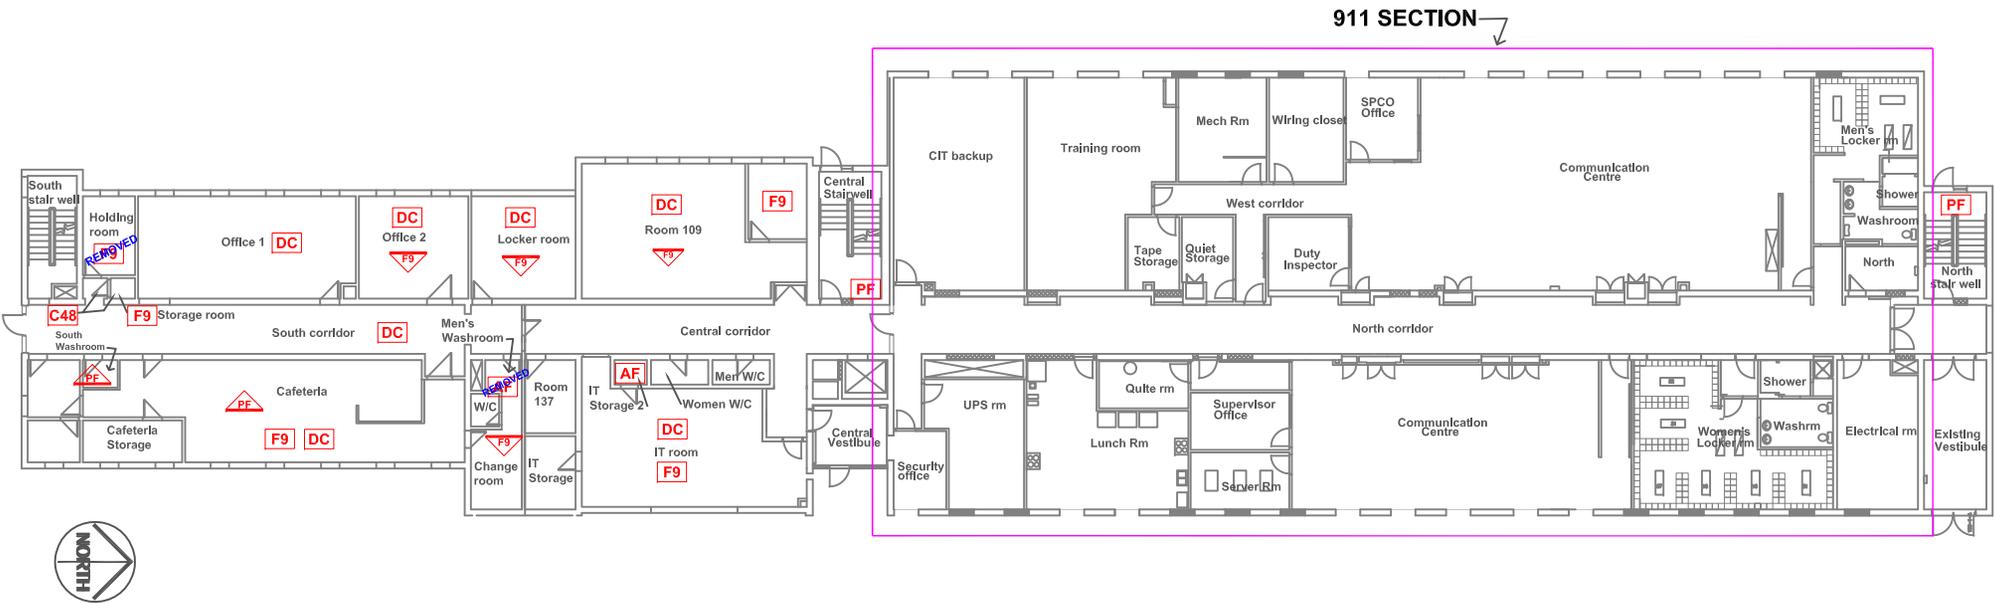
### Main floor

All Drywall Compound (DC) throughout building contains asbestos except for the 911 section.  
Possible asbestos 9x9 or 12x12 floor tile under all carpet throughout building.

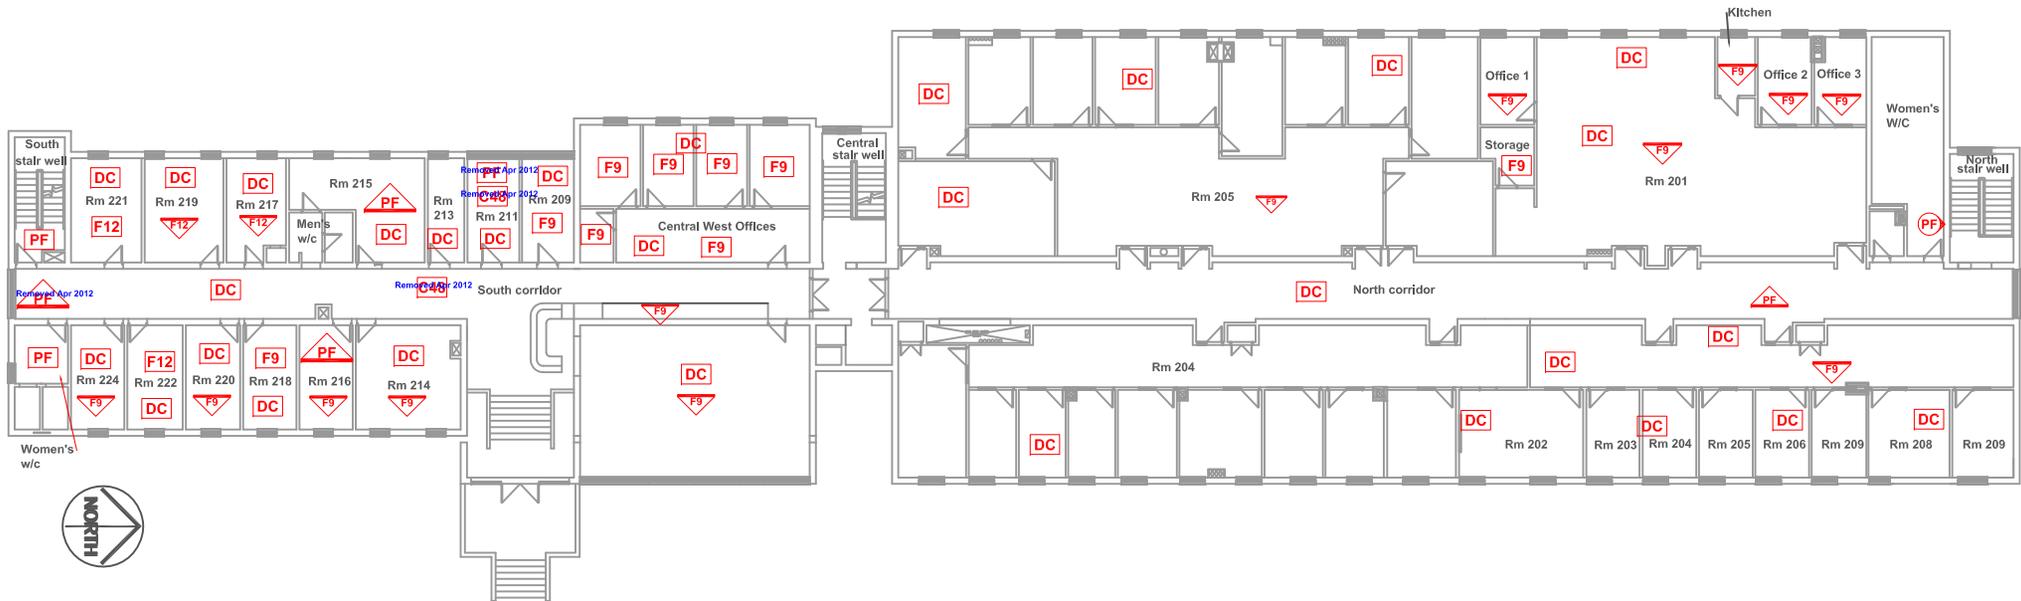
## Second floor

All Drywall Compound (DC) throughout building contains asbestos.

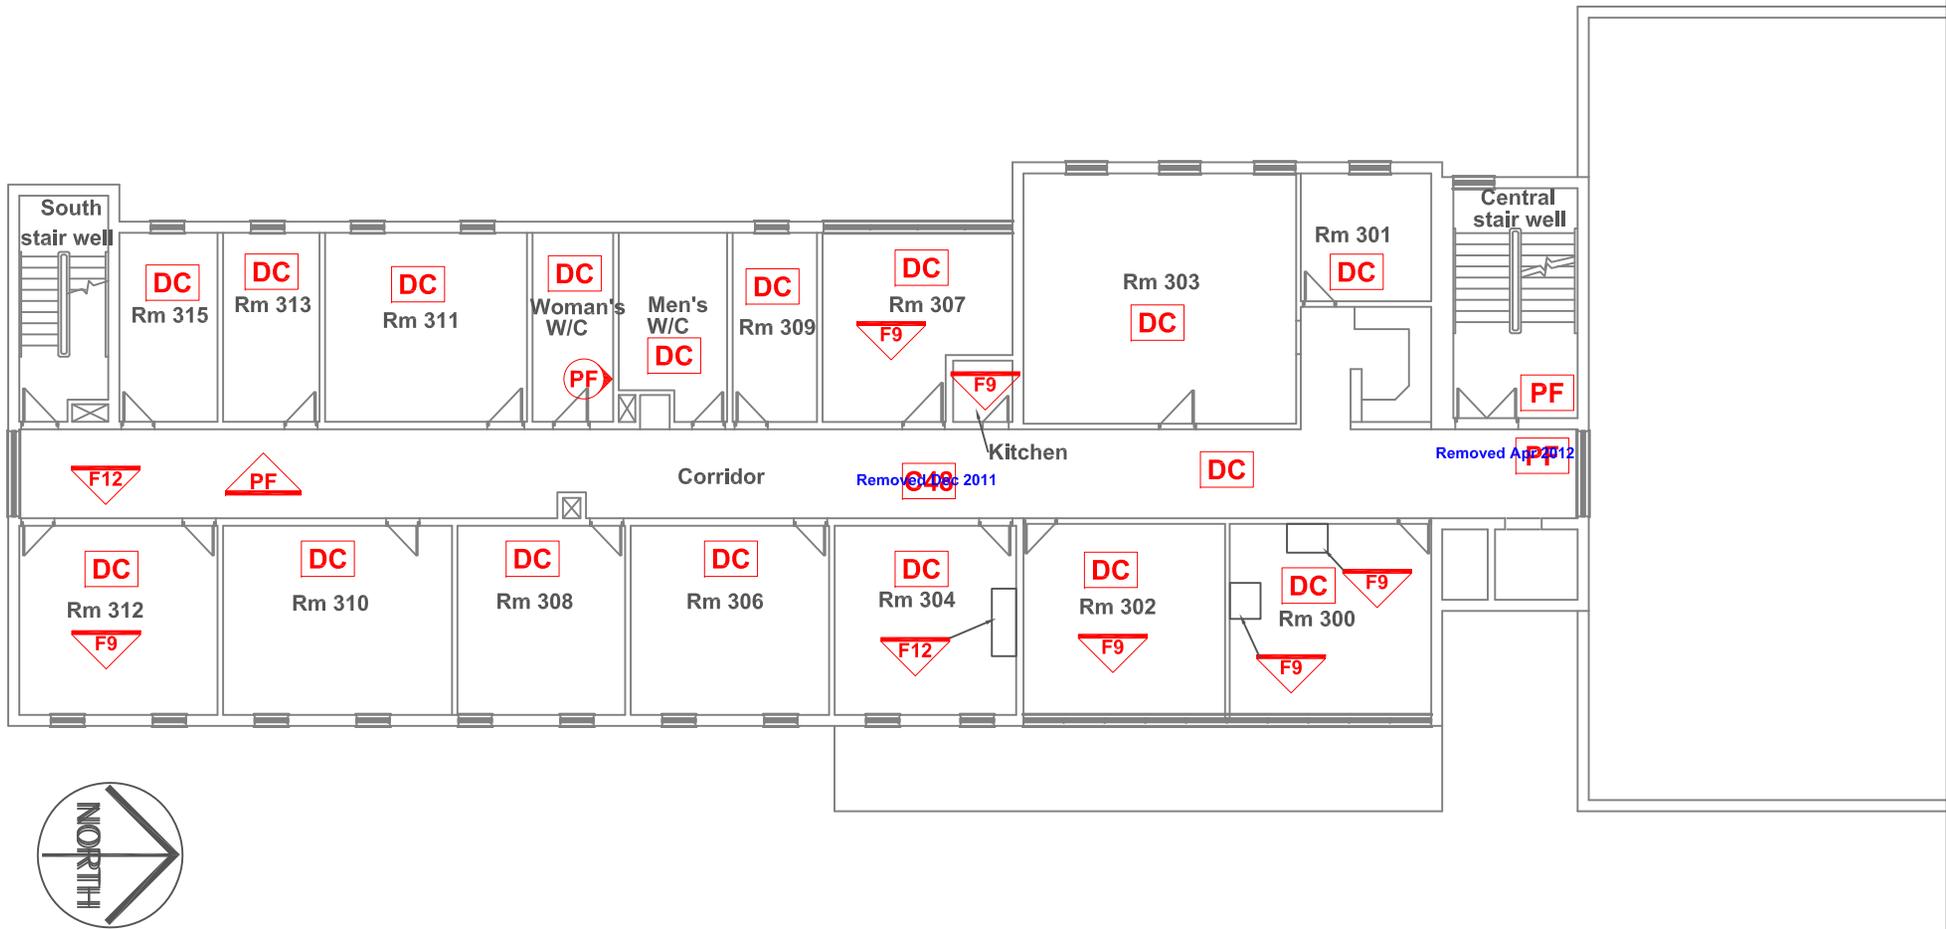
### Third floor

All Drywall Compound (DC) throughout building contains asbestos.  
Possible asbestos 9x9 or 12x12 floor tile under all carpet throughout building.
