ASBESTOS INVENTORY CONTROL

Building Name:	Eric Coy Indoor Arena	Inspection Date:	November 27, 2014
Building Code:	AR-04	Inspected By:	J Neufeld & R. Matthews
Building Address:	535 Oakdale Avenue	Construction Date:	1971

ASBESTOS LOCATIONS

BUILDING:	AR-04 Eric Coy Indoor Arena 535 Oakdale Avenue Winnipeg, Manitoba		
REVISED BY:	DATE:	SCALE:	SHEET #:
A.B.	November 1, 2012	N.T.S.	1/1

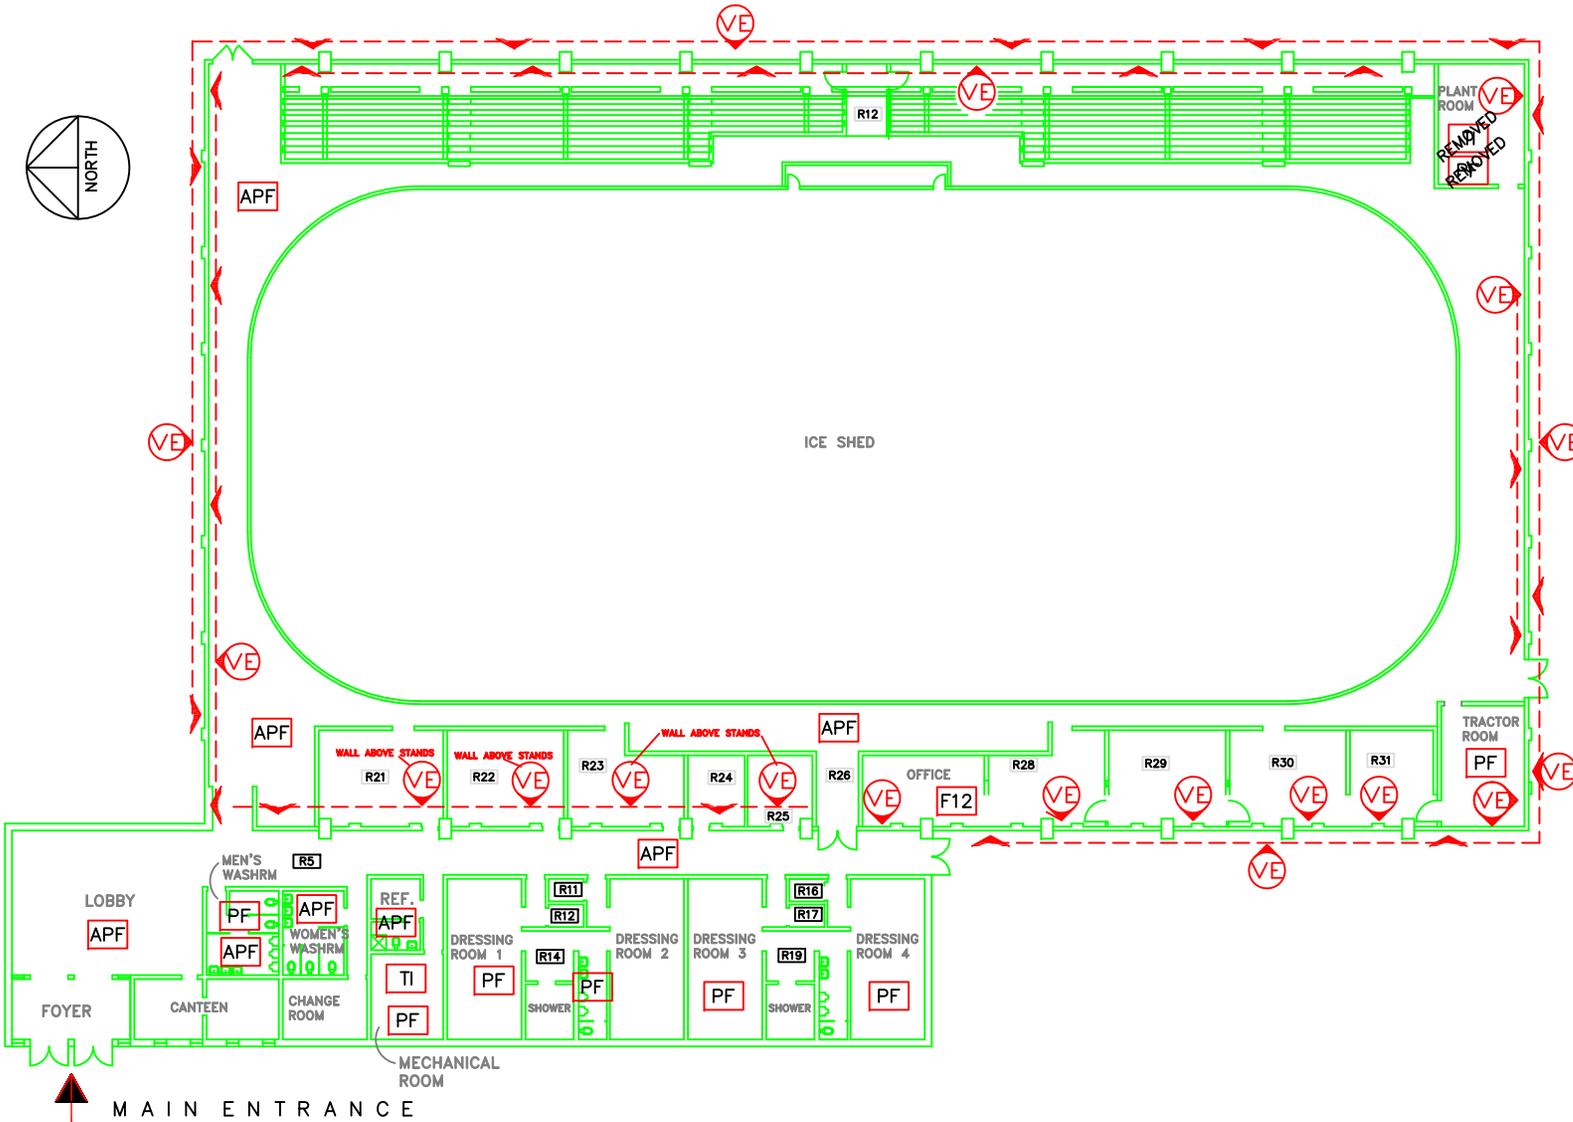
Material Location	Material Description	Drawing Label	Material Condition	Testing Status	Date M/Y	Test %	Est. %
Exterior Block Walls of Dressing Room Lobby Area	Randomly Inspected & Appear To Be Empty (Do Not Contain Vermiculite Insulation)						
Hallway/ Lobby	Asphalt Plank Flooring	APF	Good	TESTED	Oct/'12	3	
Canteen	24x48 Ceiling Tile	C48		TESTED	Oct/'09	0	
Men's Washroom	Asphalt Plank Flooring	APF	Good				3
	Pipe Fitting Insulation	PF	Good				30
Women's Washroom	Asphalt Plank Flooring	APF	Good				3
Dressing Room #4	Pipe Fitting Insulation	PF	Good	TESTED	Oct/'12	30	
	Pipe Insulation	PI	Good				0
	Asphalt Plank Flooring	APF	Good				
Shower Room #3 & #4	Pipe Fitting Insulation	PF	Good				0
	Pipe Insulation	PI					0
	Asphalt Plank Flooring	APF		TESTED	Oct/'12		0
Dressing Room #3	Pipe Fitting Insulation	PF	Good	TESTED	Oct/'12	30	
	Pipe Insulation	PI		TESTED	Oct/'12	0	
	Asphalt Plank Flooring	APF					
Dressing Room #1	Asphalt Plank Flooring	APF

Pipe Fitting Insulation	PF					
Dressing Room # 2	Asphalt Plank Flooring	APF		TESTED	Nov/'12	0	
Dressing Room #1 & #2 Shower/Washroom	Pipe Fitting Insulation	PF	Good				30
	Pipe Insulation	PI					0
	Asphalt Plank Flooring	APF					0
Mechanical Room	Pipe Fitting Insulation	PF	Good				30
	Pipe Insulation	PI	Good				
	Tank Insulation	TI	Good				
	Duct Insulation	DI	Good	TESTED	Oct/'12	0

Material Location	Material Description	Drawing Label	Material Condition	Testing Status	Date M/Y	Test %	Est. %
Ice Shed							
Office	12x12 Floor Tile (under bleachers)	F12	Good				
Plant Room	Pipe Fitting Insulation	PF	Removed				
	Tank Insulation	TI	Removed				
Tractor Room	Pipe Fitting Insulation	PF	Good				30
Corridors	Asphalt Plank Flooring	APF	Good	TESTED	Oct/'12	2	
Exterior Block Walls of Ice Shed	Contain Vermiculite Insulation (Which May Contain Asbestos)	VE	Good	N/A
