The City of Winnipeg

**Preliminary Engineering Study for Lyndale Drive
Retaining Wall – Monck Avenue to Gauvin Street
Geotechnical Assessment Report**

0015 014 00

February 23, 2016

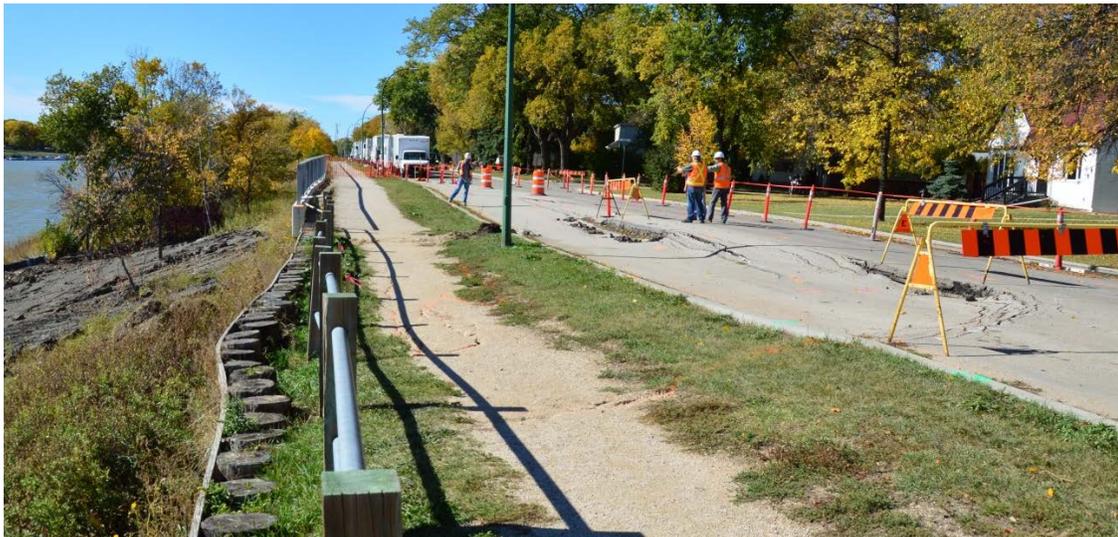
Movements of the retaining wall towards the river were observed in April of 2013; about 300 mm of horizontal movement of the top of the wall and 100 mm settlement of the asphalt pavement in the east bound lane of Lyndale Drive were observed. Crack patterns in the pavement indicated the movement had extended north to about the middle of the road and as a result, the east bound lane was closed to traffic. The movements occurred along the downstream end of the 1976 retaining wall, including the 18 m wall section fitted with the concrete pile cap. Emergency riverbank stabilization works consisting of 48 rockfill columns were implemented in the fall of 2013 to address the ongoing movements. Wall deflections and pavement settlement continued as the stabilization works were constructed, however slowed significantly upon completion of the works. The pavement distress and deflected wall are shown in Photo 01. Vibrating-wire piezometers and slope inclinometers were installed in TH13-01 and 13-02 at the locations shown in Figure 01.

Photo 01 View Downstream at Retaining Wall Movement and Pavement Subsidence
