NESS & ALCOTT FLAP GATE REPLACEMENT

- C1 - DRAWING OF EXISTING GATE CHAMBER MANHOLE (LD-209)
- C2 - SHOP DRAWING OF EXISTING FLAP GATE
- C3 - FLAP GATE INSPECTION REPORT (8 PAGES)
- C4 - SKETCH SHOWING PROPOSED MANHOLE CONFIGURATION

January 28, 2015 Inspection of Flap Gate near Sturgeon Creek at Ness
Inspection by Kyle Sanders, Service Technician, Power & Mine Supply Service Group

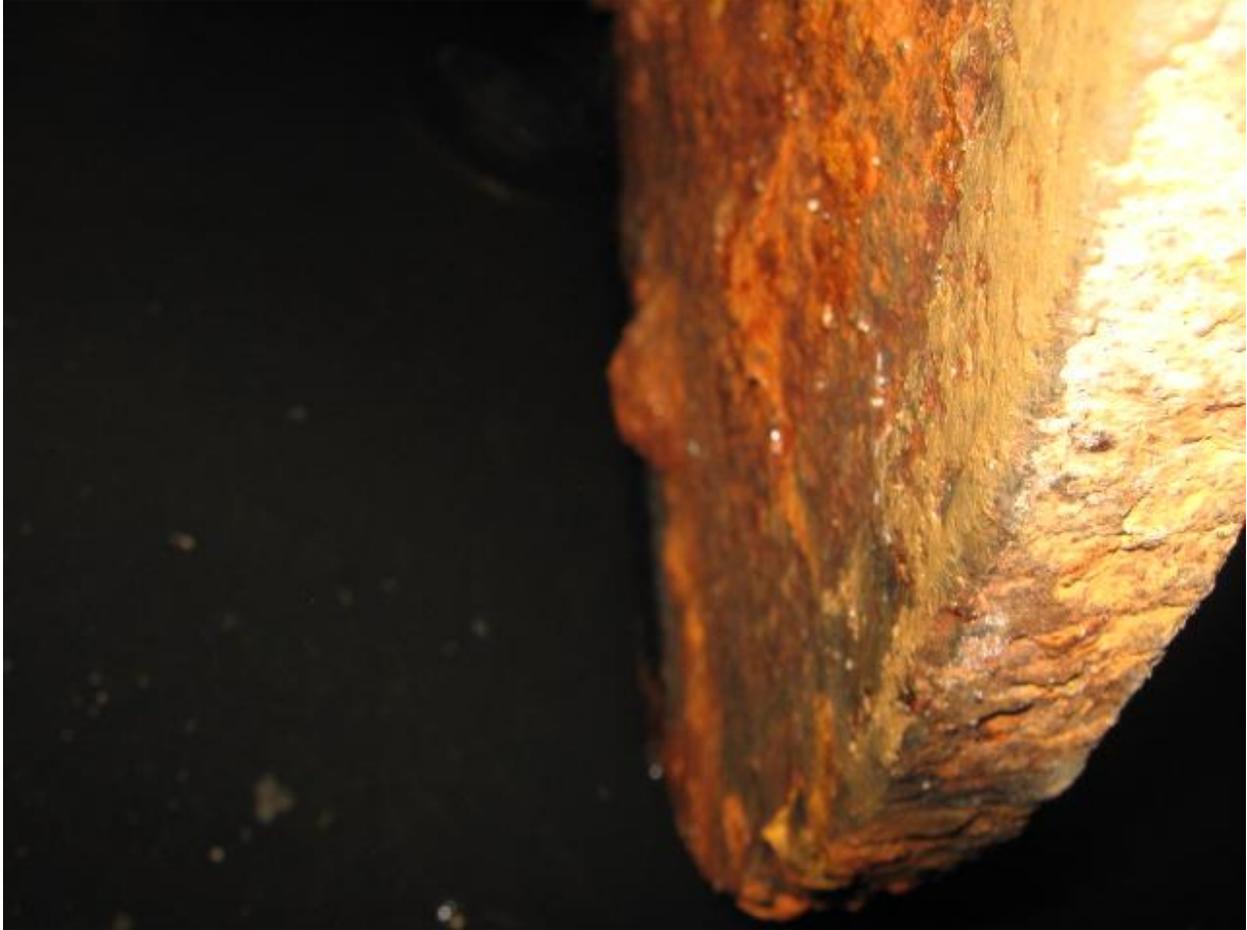
Figure 1 – Close up of the seating face on the back side of the gate disc

This Flap Gate appears to have excessive corrosion on the seating faces. Both the gate frame's seat face and the gate disc's seat face appear to be cast iron. In our experience, the City of Winnipeg prefers that all seating faces of cast iron flap gates are to be constructed of a bronze or brass material that is corrosion resistant to river water. Figure 1 and Figure 2 show the excessive corrosion evident on the seating faces. The corrosion is such that the faces are unable to seat together with a tolerance that is tight enough to provide an acceptable leakage rate. Figure 2 shows that some of the corrosion bumps are between 2 and 5 mm which cause large spaces between the seating faces and will easily allow water to pass. With this corrosion, the flap gate will definitely leak excessively. In addition, small debris and sticks collect on the seating face corrosion as shown in Figures 3 and 4 further increasing leak paths.

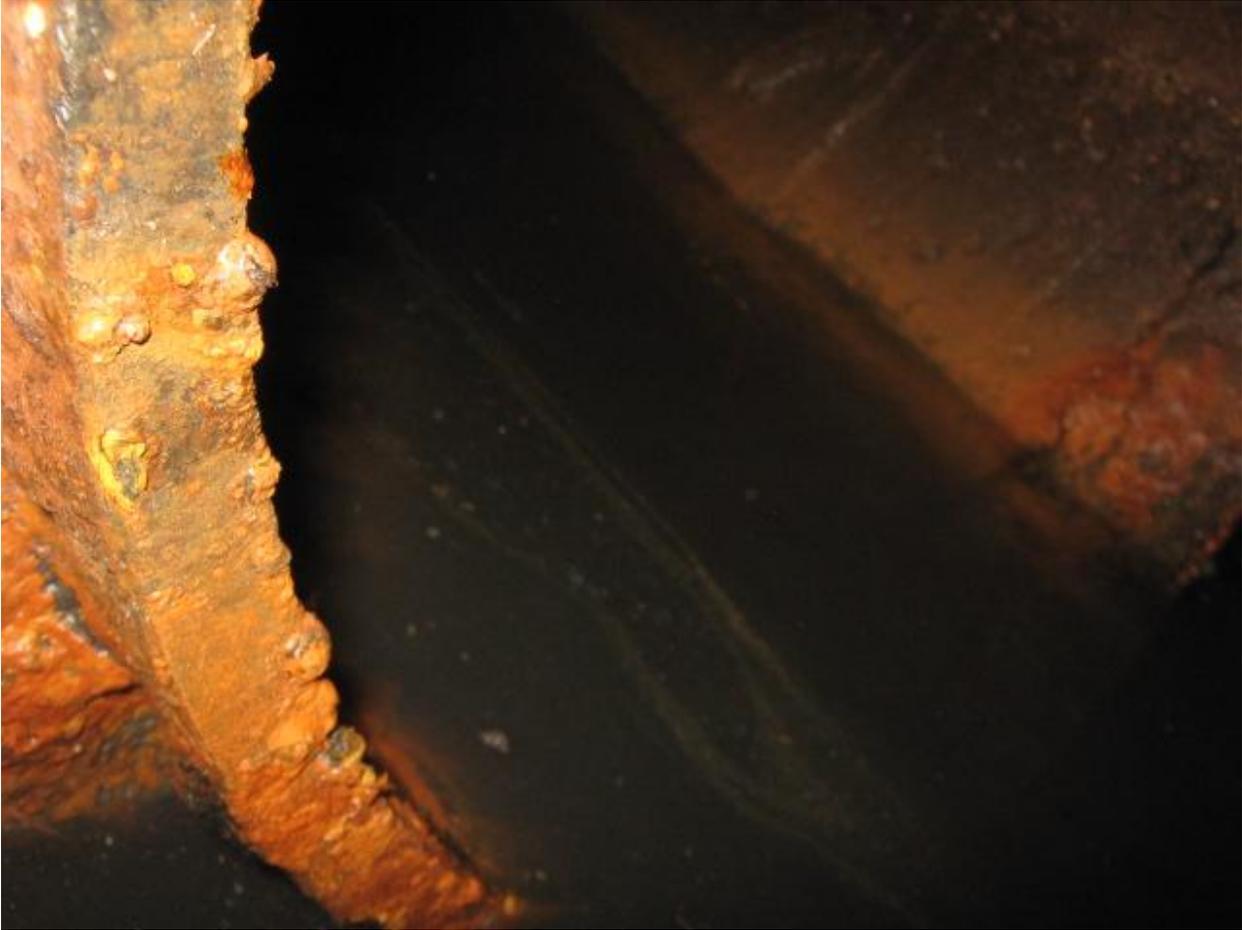
Figure 2 – seating face of gate frame

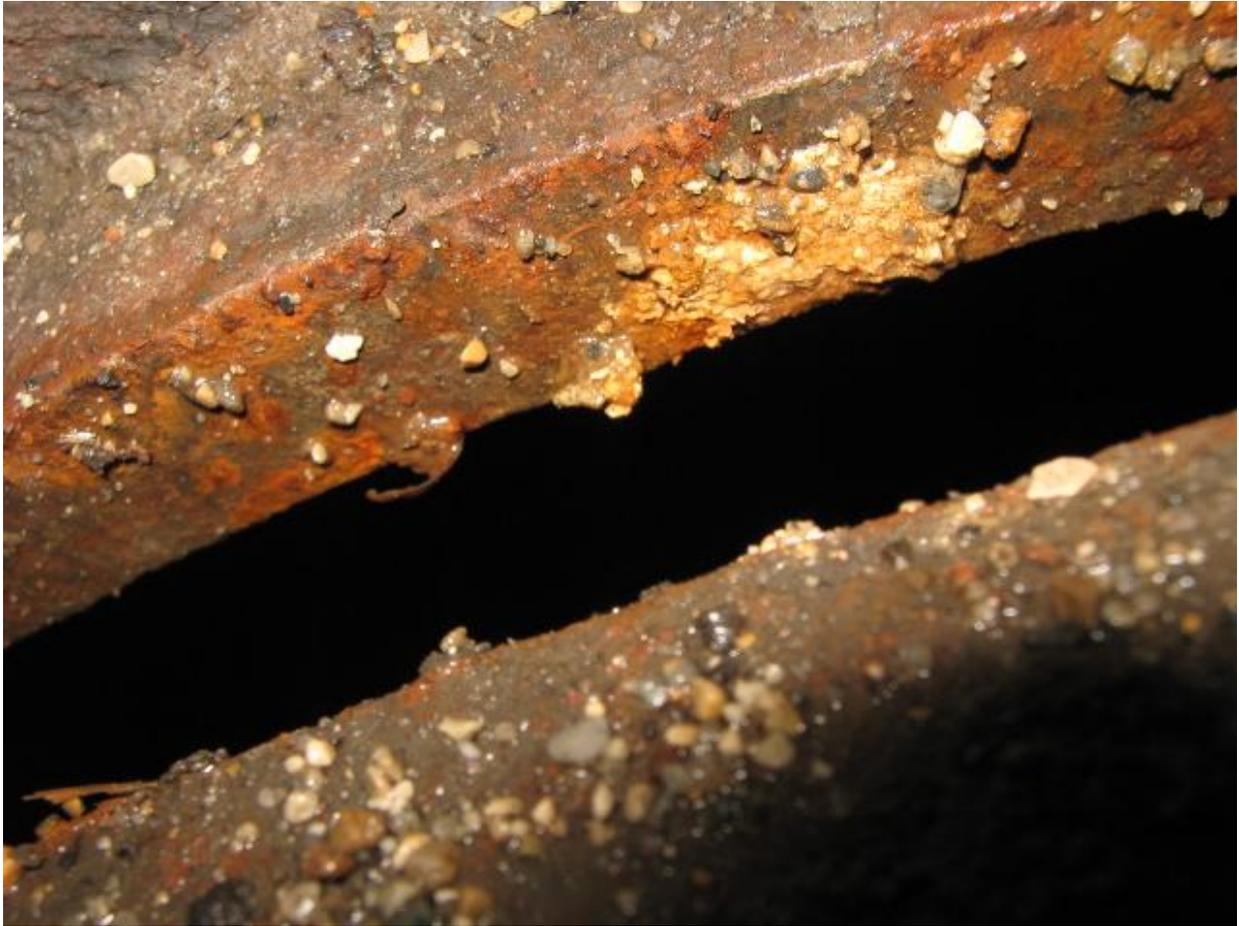
Figure 3 – Small debris stuck on gate frame seating face

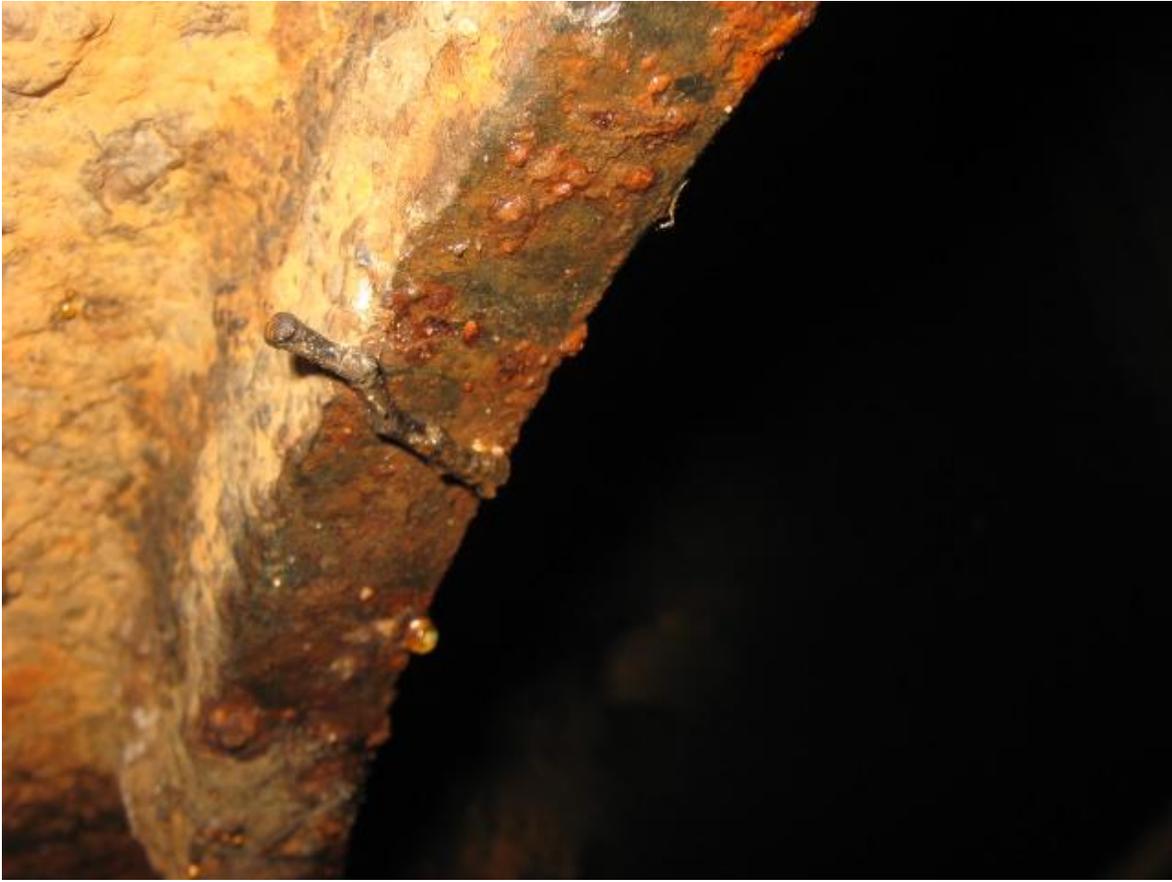
Figure 4 – Small stick stuck to corrosion on gate frame seating face

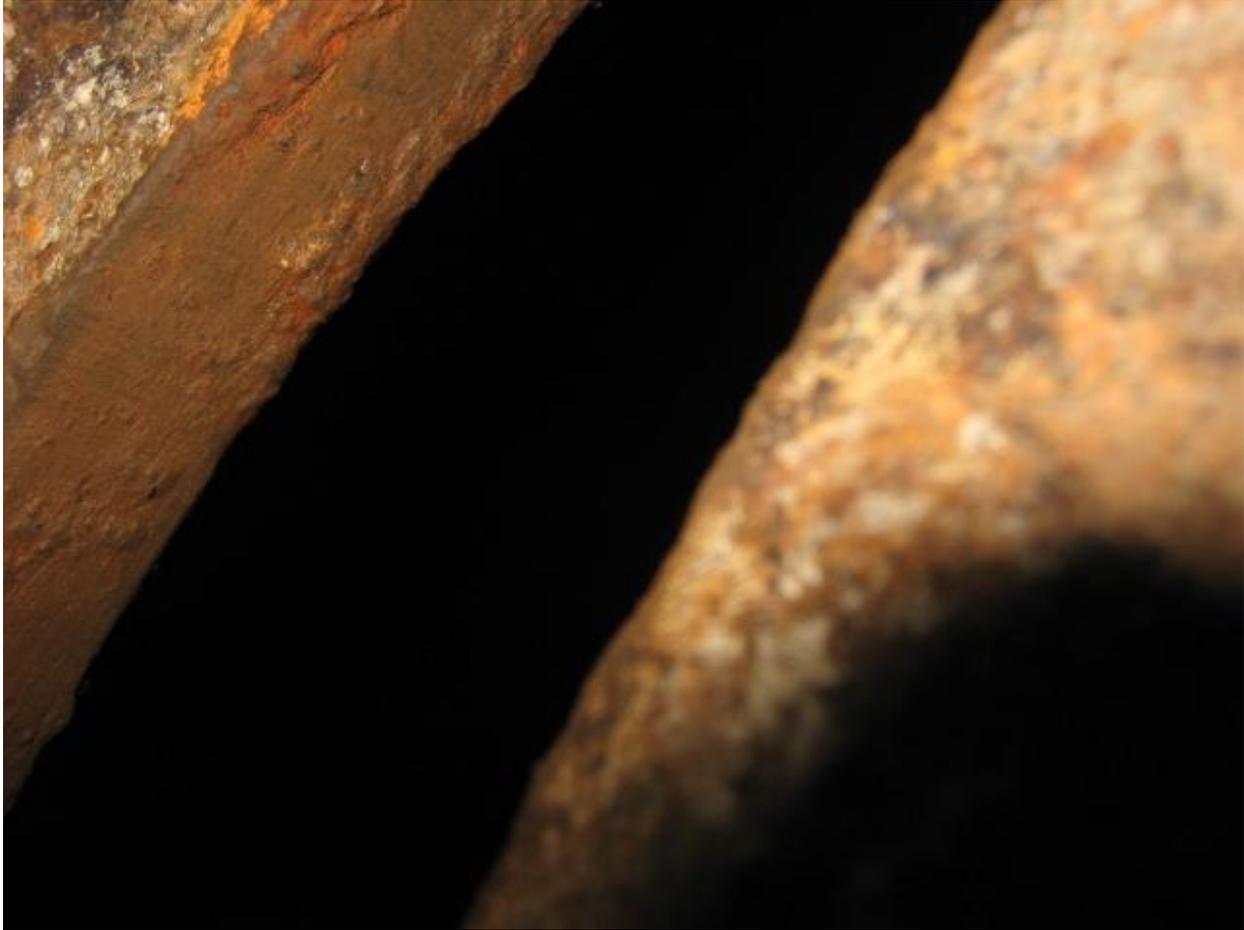
Figure 5 – Gate frame seating face after being wiped down with a work glove

Figures 5 and 6 show that the seating faces still exhibit unacceptable amounts of corrosion even after being wiped down by hand with a work glove.

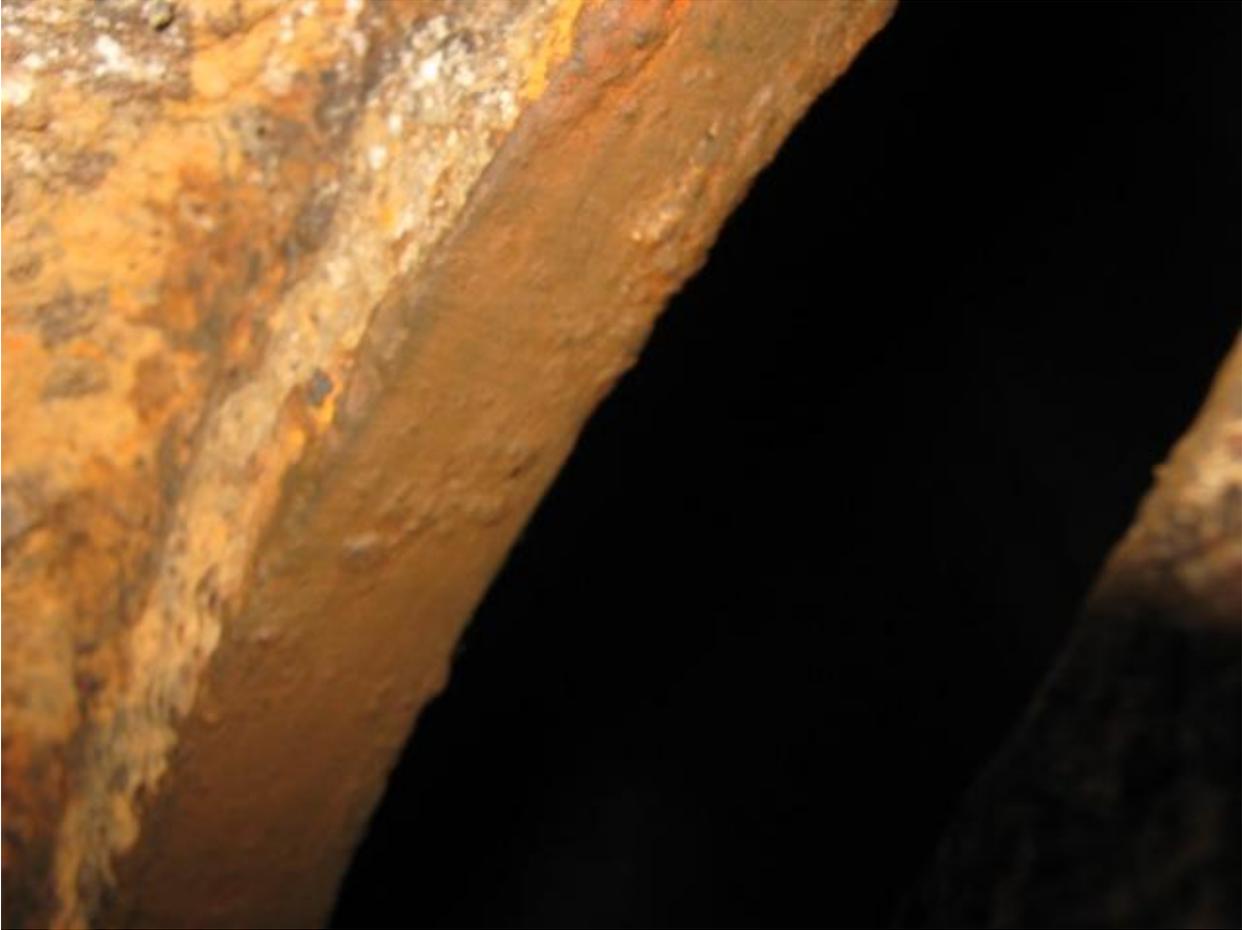
Figure 6 – Gate frame seating face after being wiped down with a work glove

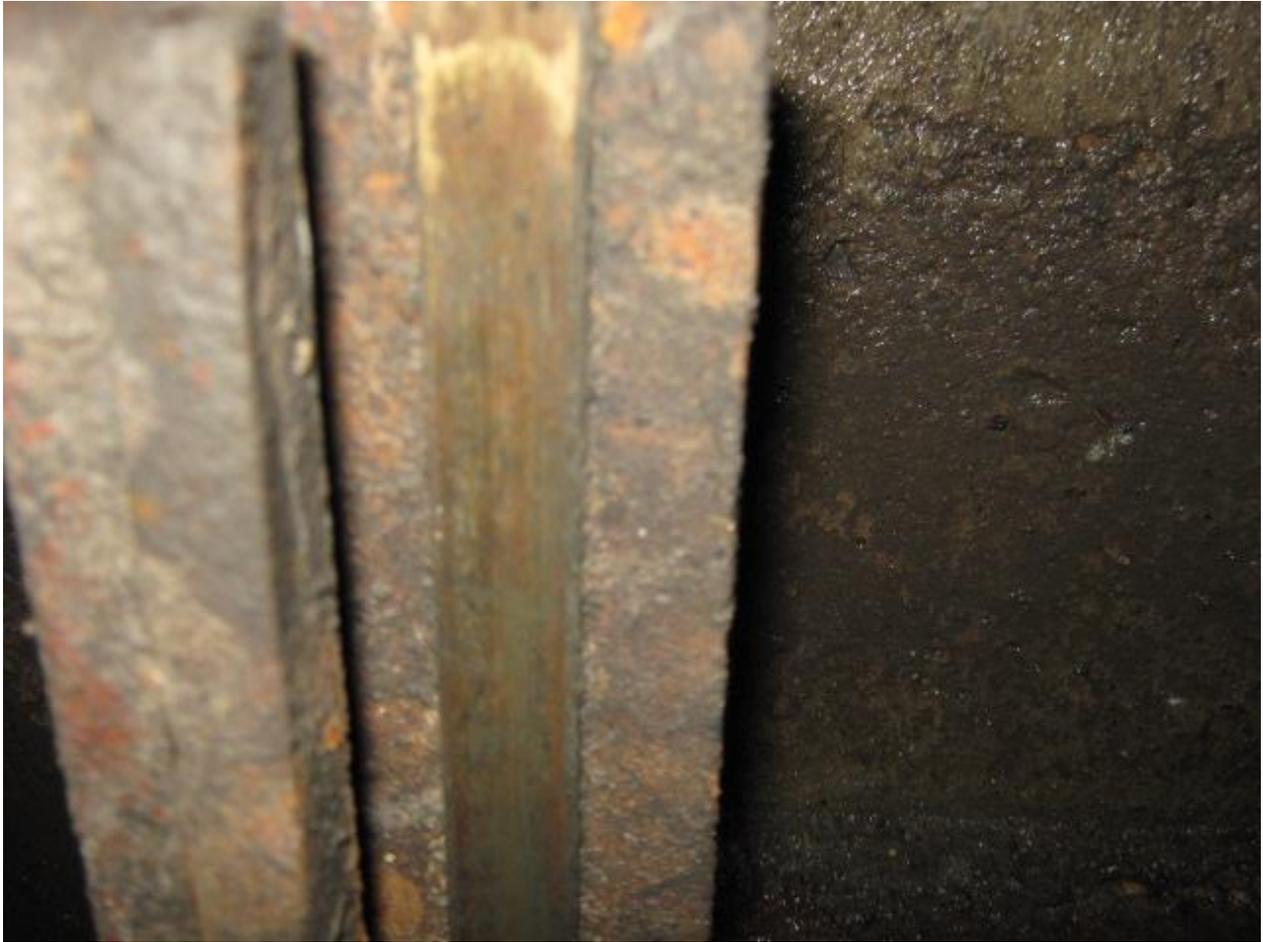
Figure 7 – Seating face on the frame of the sluice gate that is in the same chamber

For comparison, the seating faces on the sluice gate that is in the same chamber as shown in Figure 7 appear to be constructed of brass or bronze and exhibit very little corrosion. These seat faces have remained much smoother than the cast iron seating faces found on the flap gate. This suggests that if the flap gate had brass or bronze seating faces, the corrosion would be similarly low and not interfere with the mating of the seating faces thereby providing acceptable leakage rates.
