Hazardous Building Materials Assessment

20 Westgate Street, Winnipeg,
Manitoba

February 10, 2017

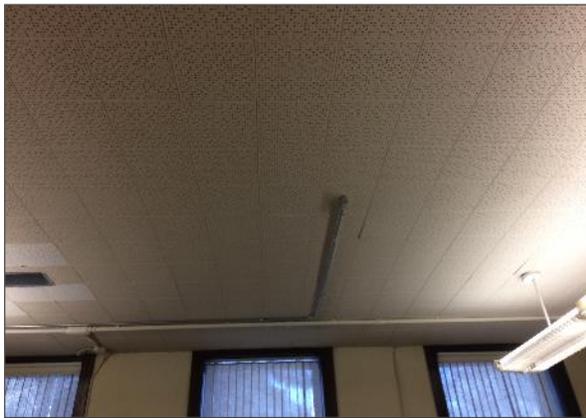
Non-asbestos acoustic ceiling tiles are present within the basement children's reading room. The ceiling tiles were determined to be non-asbestos based on the composition of the ceiling tiles (wood cellulose).

Photo #1: Non-asbestos acoustic ceiling tiles within the basement washrooms and meeting room.

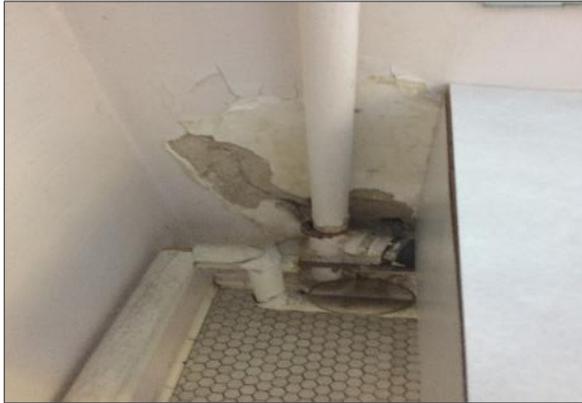
Plaster wall and ceiling finishes throughout the basement were determined to be asbestos-containing by analysis of samples 0004A-C & 0005A-C. Plaster is non-friable while in place but can generate friable dust upon removal. Plaster throughout the basement was observed painted and generally in good condition with the exception of the following damage:

- 6 SF observed in fair condition within the basement women's washroom.

Photo #2: 6 SF of damaged plaster wall finish within the basement women's washroom.

- Repair 6 SF of plaster finish in fair condition within the women's washroom.

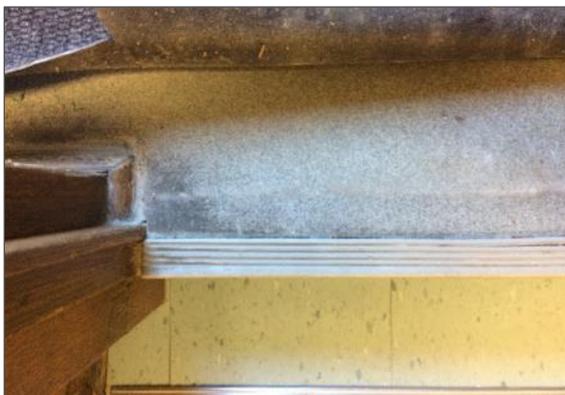
Photo #3: Non-asbestos vinyl sheet flooring with rubber backing within bathrooms.

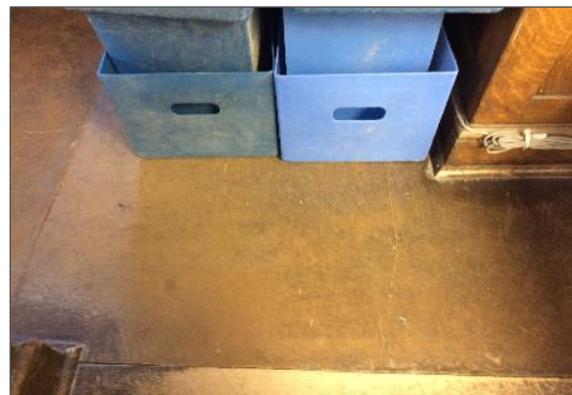
Photo #4: Non-asbestos battleship flooring within the storage mezzanine.

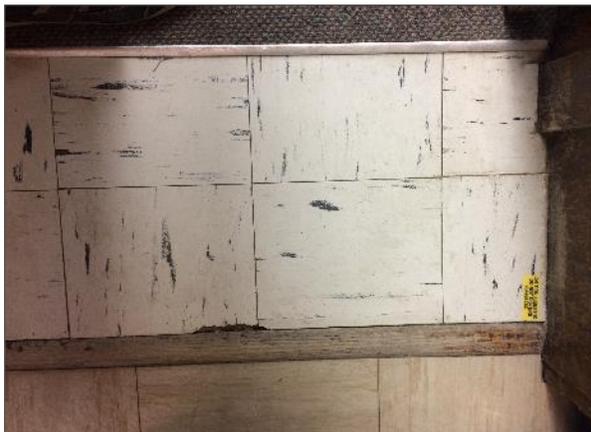
The vinyl floor tiles and mastic are non-friable and in good condition.

Photo #5: Asbestos-containing green and white floor tiles under carpet within the main floor library.

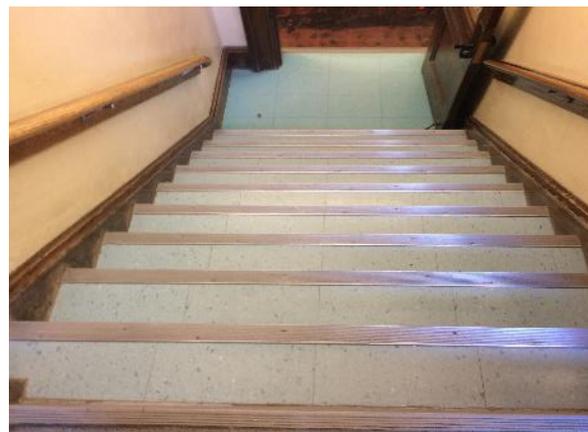
Photo #6: Non-asbestos floor tiles installed after 2000 within the stairwell.

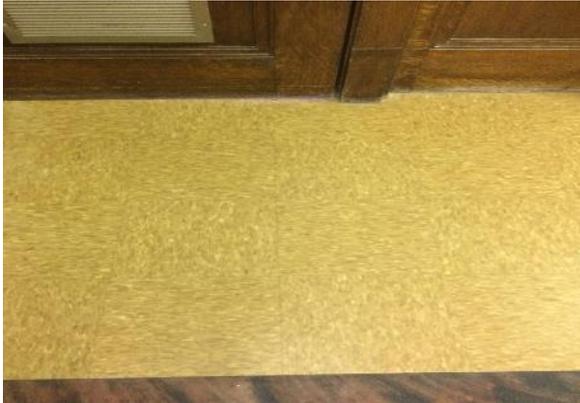
Photo #7: Non-asbestos replacement tiles installed after 2000.

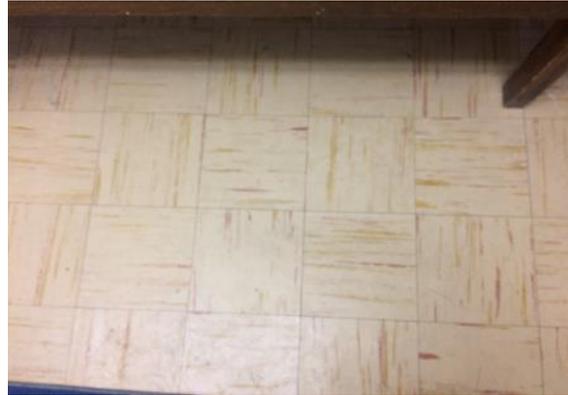
Photo #8: Asbestos-containing floor tiles within the staff room and children's reading room.

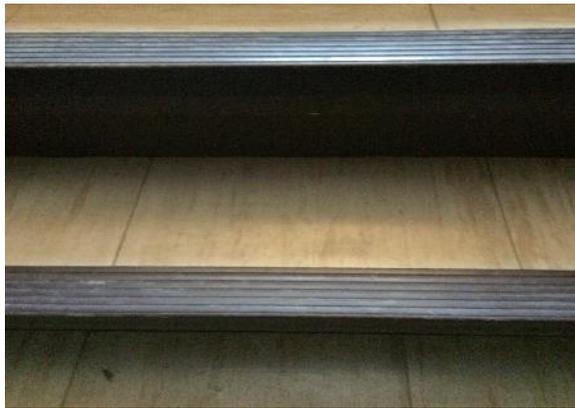
Photo #9: Asbestos-containing vinyl floor tiles within the back stairwell.
