# **GEOTECHNICAL REPORT**

## Geotechnical Report for Ellice Avenue Reconstruction

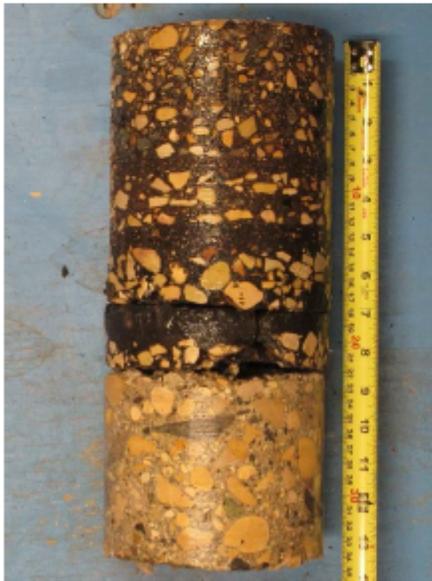
Photo 19 - Testhole 1

TESTHOLE LOCATION: 14.0 m West of Southwest corner of Ellice Avenue and Garfield Street North, 5.5 m North of South curb.  • The soil was frozen to a depth of 1.5 m. • No groundwater seepage or soil sloughing was observed during or upon completion of drilling. • Testhole terminated at a depth of 2.1 m.								10
Sample Type: GS - Grab Sample    SS - Split Spoon    RC - Rock Core ST - Shelby Tube    PT - Piston Tube    VT - Shear Vane Test Piezometer Backfill Type: <input type="checkbox"/> Bentonite <input type="checkbox"/> Drill Cuttings <input type="checkbox"/> Sand <input type="checkbox"/> Slough				Logged by: Sothea Bun Reviewed by: German Leal		<b>Stantec</b>

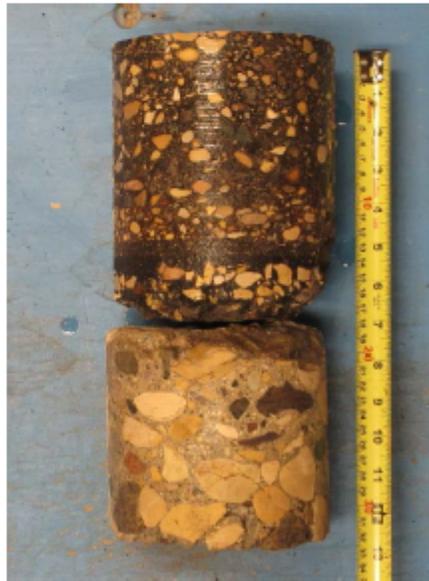
Photo 20 - Testhole 2

CL ML			GS	25						
	CL ML			GS	22						6
2	CH		Stiff brown fat CLAY (CH)	GS	27						6
			TESTHOLE LOCATION: 9.0 m West of Southwest corner of Ellice Avenue and Sherburn Street, 5.5 m North of South curb.  • The soil was frozen to a depth of 1.5 m. • No groundwater seepage or soil sloughing was observed during or upon completion of drilling. • Testhole terminated to a depth of 2.1 m.								8
3											10

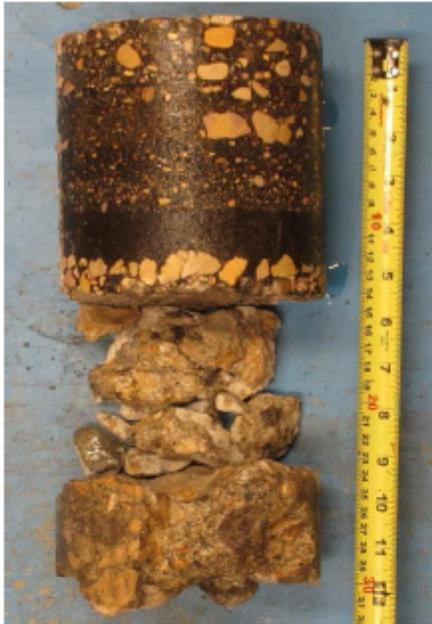
Photo 21 - Testhole 3

GS	31						
1	CL ML	Firm brown SILTY CLAY (CL-ML) - trace fine to medium sand	GS	24						4
			GS	26						
	CH	Stiff brown fat CLAY (CH)	GS	35						6
2			GS	38						
		TESTHOLE LOCATION: 11.5 m West of Southwest corner of Ellice Avenue and Ingersoll Street, 5.5 m North of South curb.  • The soil was frozen to a depth of 1.5 m. • No groundwater seepage or soil sloughing was observed during or upon completion of drilling. • Testhole terminated at a depth of 2.1 m.								8
3										10

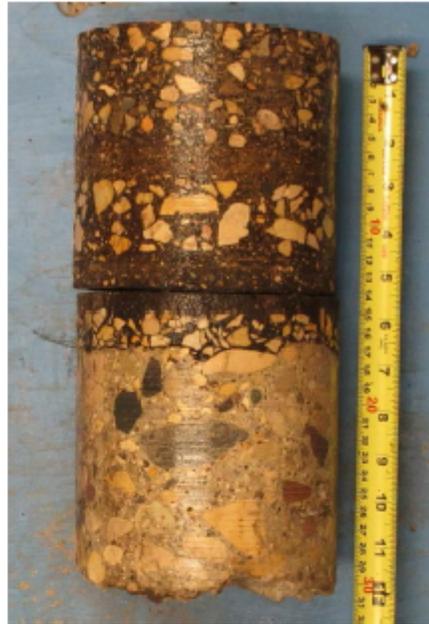
Photo 22 - Testhole 4

GS	38						8
				GS	39						10
			TESTHOLE LOCATION: 17.5 m West of Southwest corner of Ellice Avenue and Lipton Street, 5.5 m North of South curb.								
			<ul style="list-style-type: none"> <li>The soil was frozen to a depth of 1.5 m.</li> <li>No groundwater seepage or soil sloughing was observed during or upon completion of drilling.</li> <li>Testhole terminated at a depth of 2.1 m.</li> </ul>								
Sample Type: GS - Grab Sample    SS - Split Spoon    RC - Rock Core ST - Shelby Tube    PT - Piston Tube    VT - Shear Vane Test				Logged by: Sothea Bun							
Piezometer Backfill Type:  Bentonite     Drill Cuttings     Sand     Slough				Reviewed by: German Leal

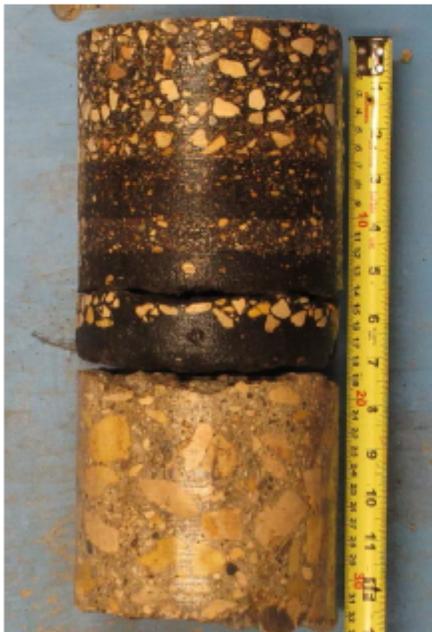
Photo 23 - Testhole 5

GS	36						8
				GS	43						10
			TESTHOLE LOCATION: 11.0 m West of Northwest corner of Ellice Avenue and Banning Street, 5.5 m South of North curb.								
			<ul style="list-style-type: none"> <li>The soil was frozen to a depth of 1.5m.</li> <li>No groundwater seepage or soil sloughing was observed during or upon completion of drilling.</li> <li>Testhole terminated at a depth of 2.1 m.</li> </ul>								
Sample Type: GS - Grab Sample    SS - Split Spoon    RC - Rock Core ST - Shelby Tube    PT - Piston Tube    VT - Shear Vane Test Piezometer Backfill Type:  Bentonite     Drill Cuttings     Sand     Slough				Logged by: Sothea Bun Reviewed by: German Leal

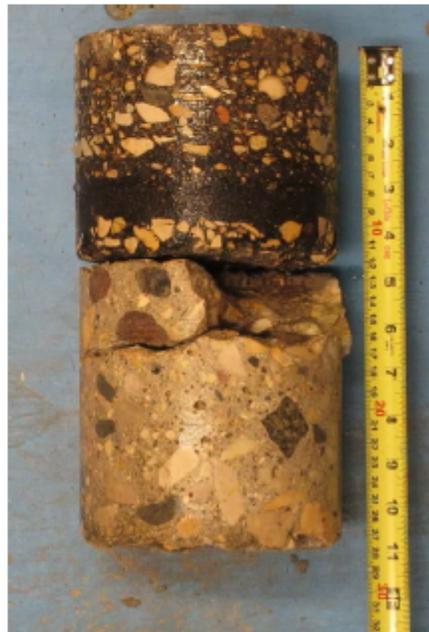
Photo 24 - Testhole 6

GS	32									4
1				GS	32									4
				GS	33									6
				GS	36									6
			- stiff brown below 1.5 m - trace silt	GS	43							6		
2												8		
			TESTHOLE LOCATION: 34.5 m West of Southwest corner of Ellice Avenue and Burnell Street, 5.5 m North of South curb.  • The soil was frozen to a depth of 1.5 m. • No groundwater seepage or soil sloughing was observed during or upon completion of drilling. • Testhole terminated at a depth of 2.1 m.									8		
3												10

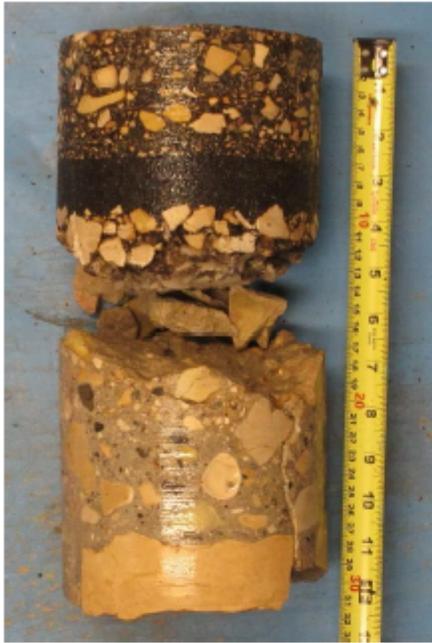
Photo 25 - Testhole 7

CH		Stiff brown fat CLAY (CH)	GS	32						4
				GS	35						5
				GS	40						6
				GS	45						7
3	TESTHOLE LOCATION: 46.0 m West of Northwest corner of Ellice Avenue and Arlington Street, 5.5 m South of North curb.  • The soil was frozen to a depth of 1.4 m. • No groundwater seepage or soil sloughing was observed during or upon completion of drilling. • Testhole terminated at a depth of 2.1 m.										8
											10
