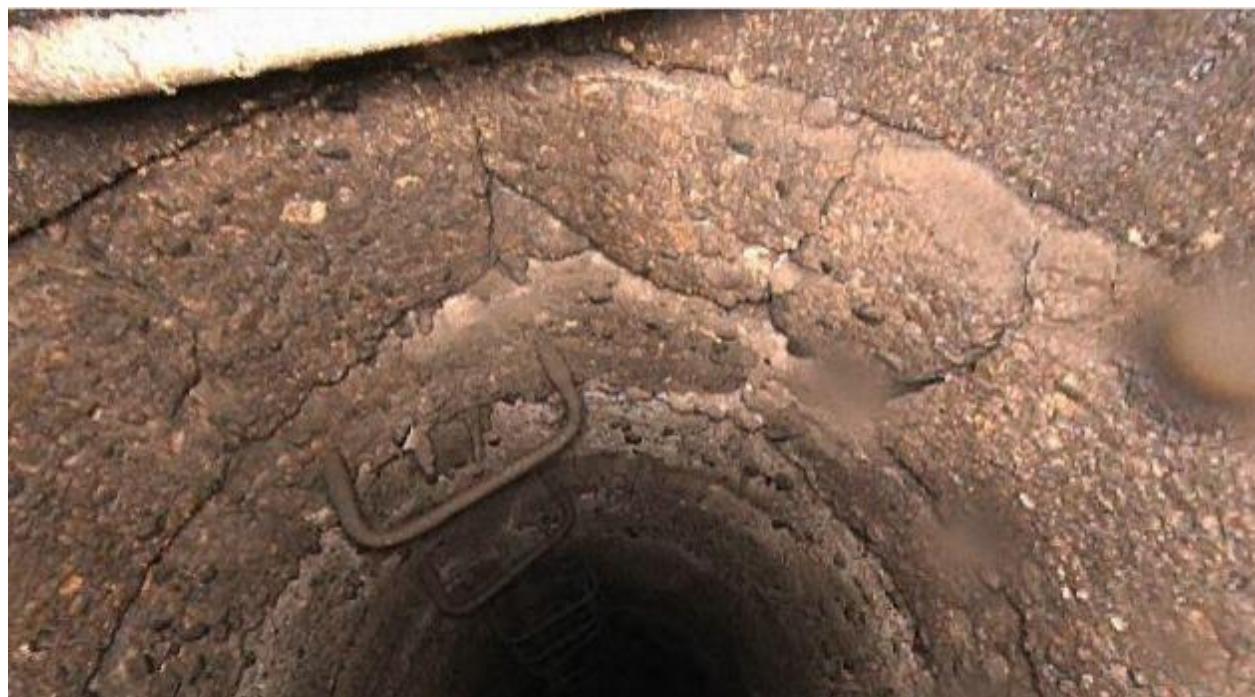
Figure 2 - MH50008490 (Dawson Rd) - Riser Condition Requiring Stabilization

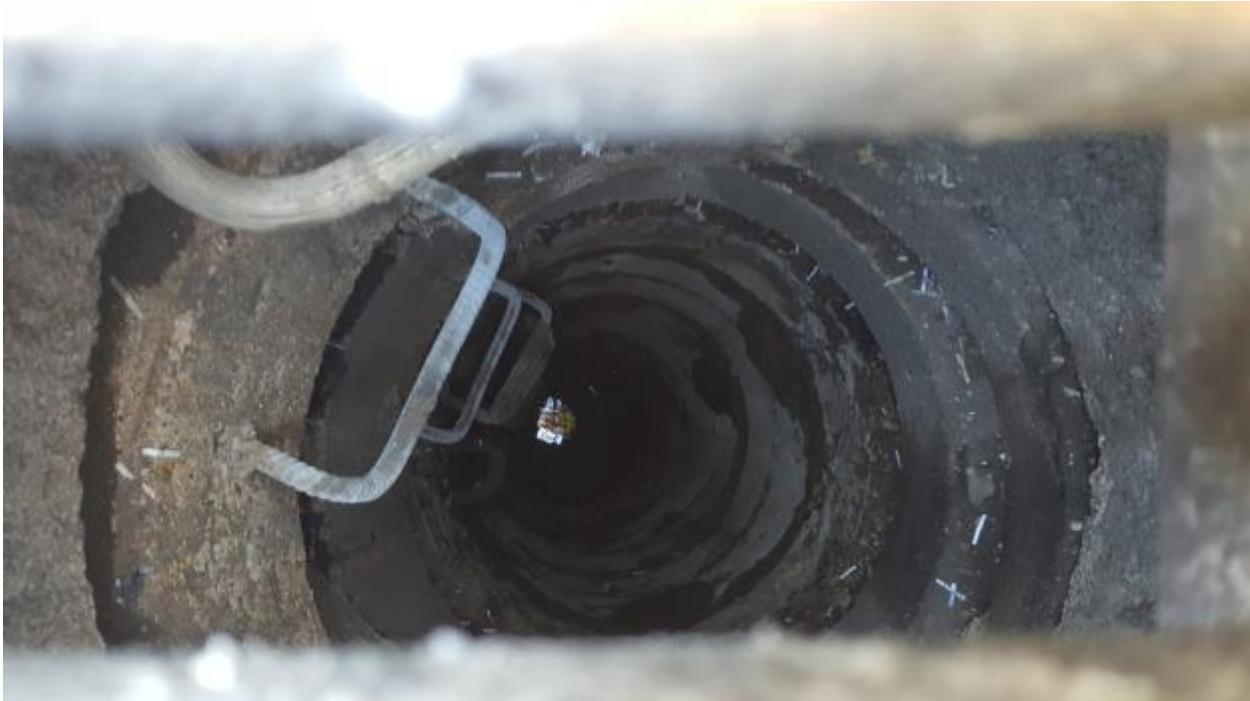
Figure 8 - MH20017744 (Higgins Av) - Riser Condition Requiring Stabilization

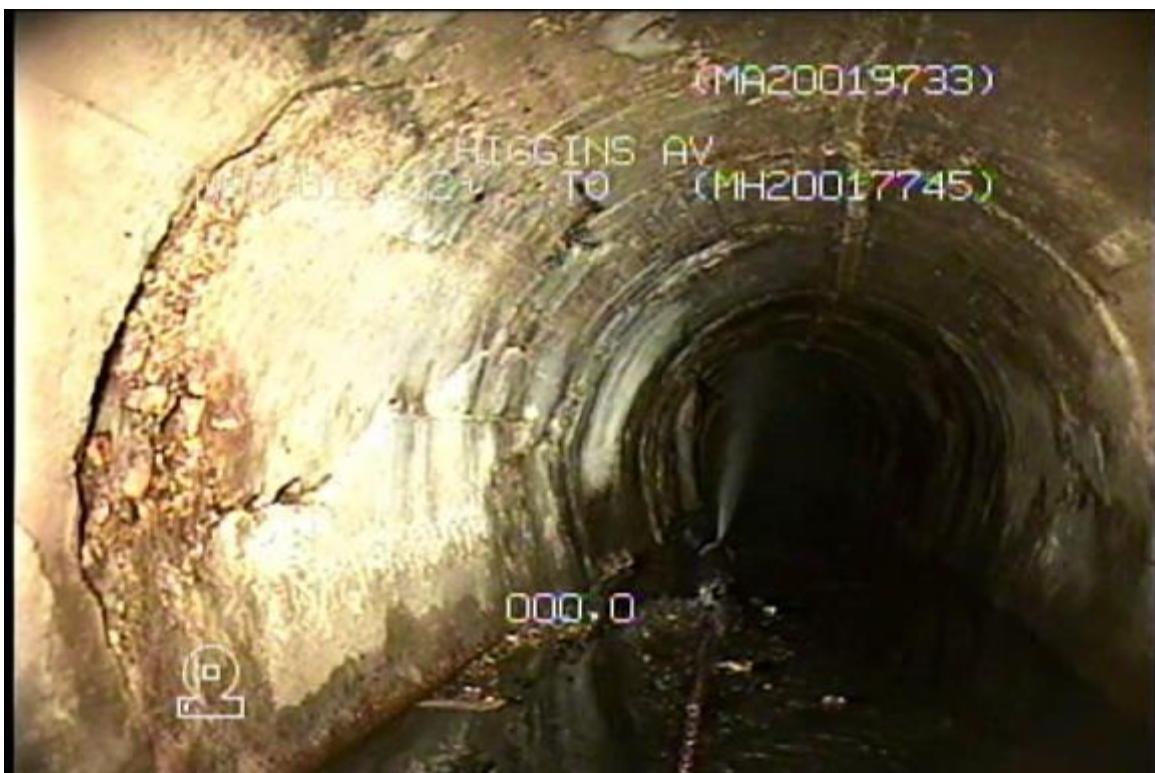
Figure 9 - S-MA20019733 (Higgins Av) - General Condition w/ Spalling

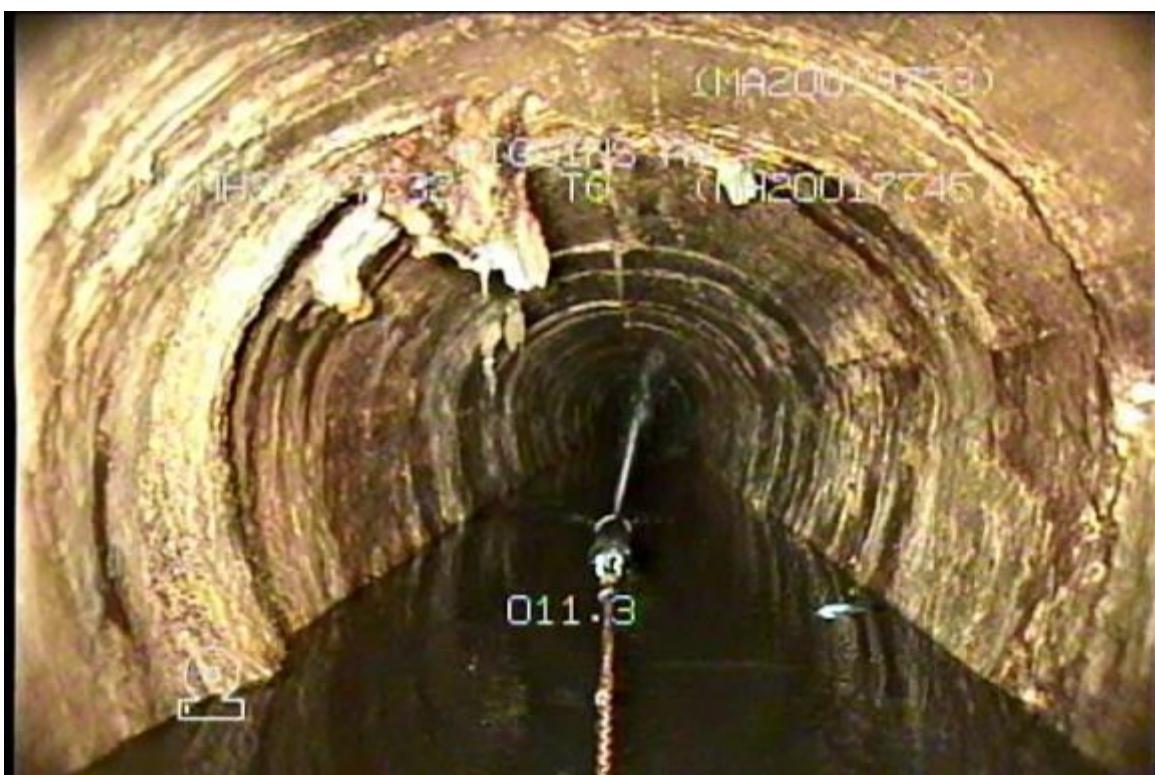
Figure 10 - S-MA20019733 (Higgins Av) - General Condition w/ Encrusted Service Connection

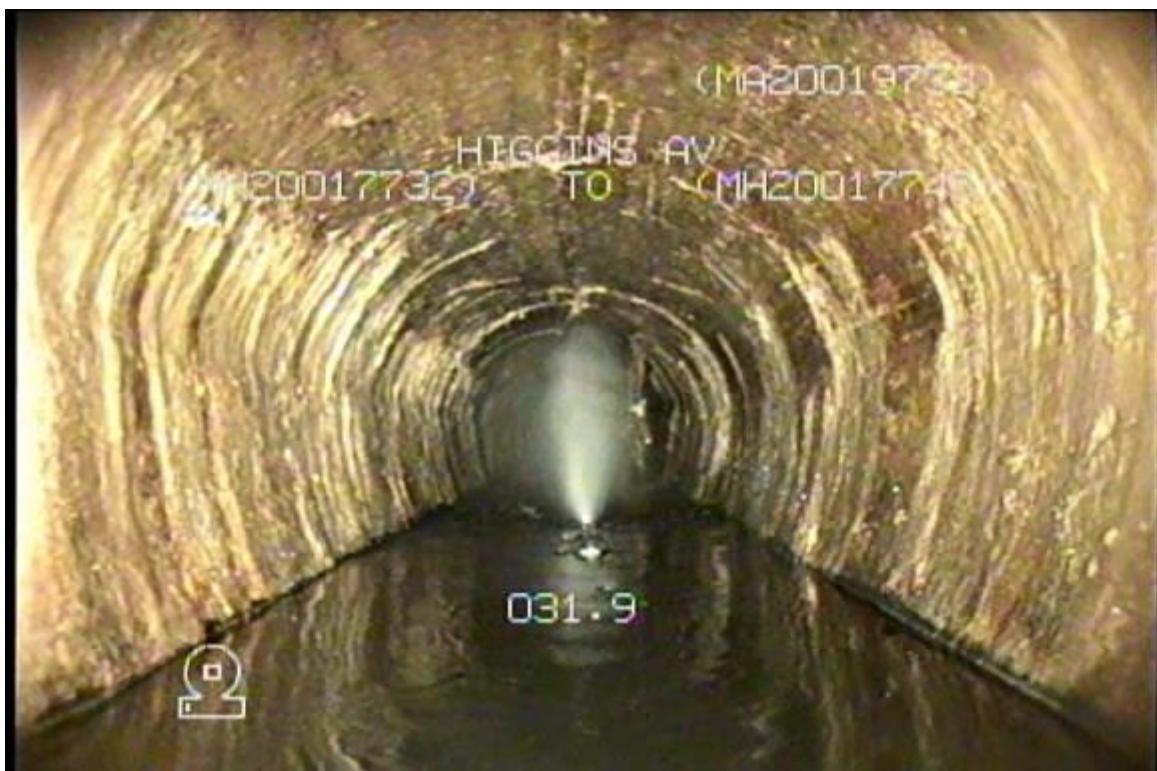
Figure 11 - S-MA20019733 (Higgins Av) - General Condition

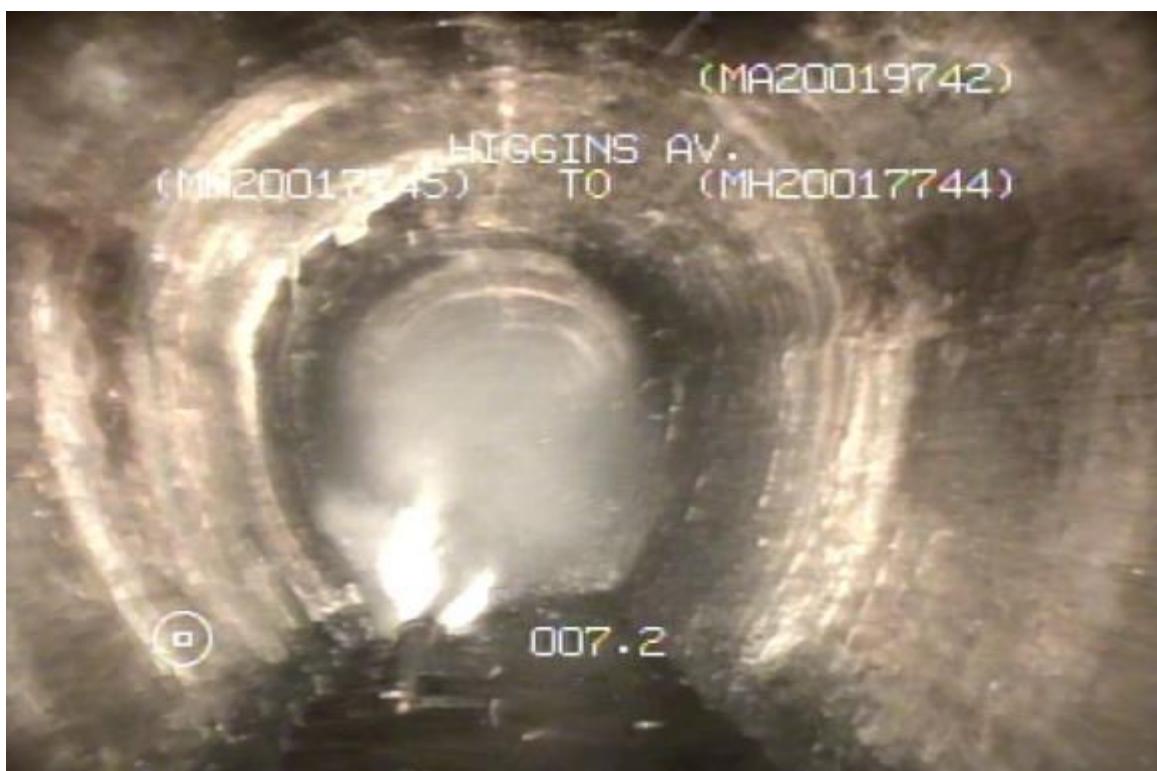
Figure 12 - S-MA20019742 (Higgins Av) - General Condition

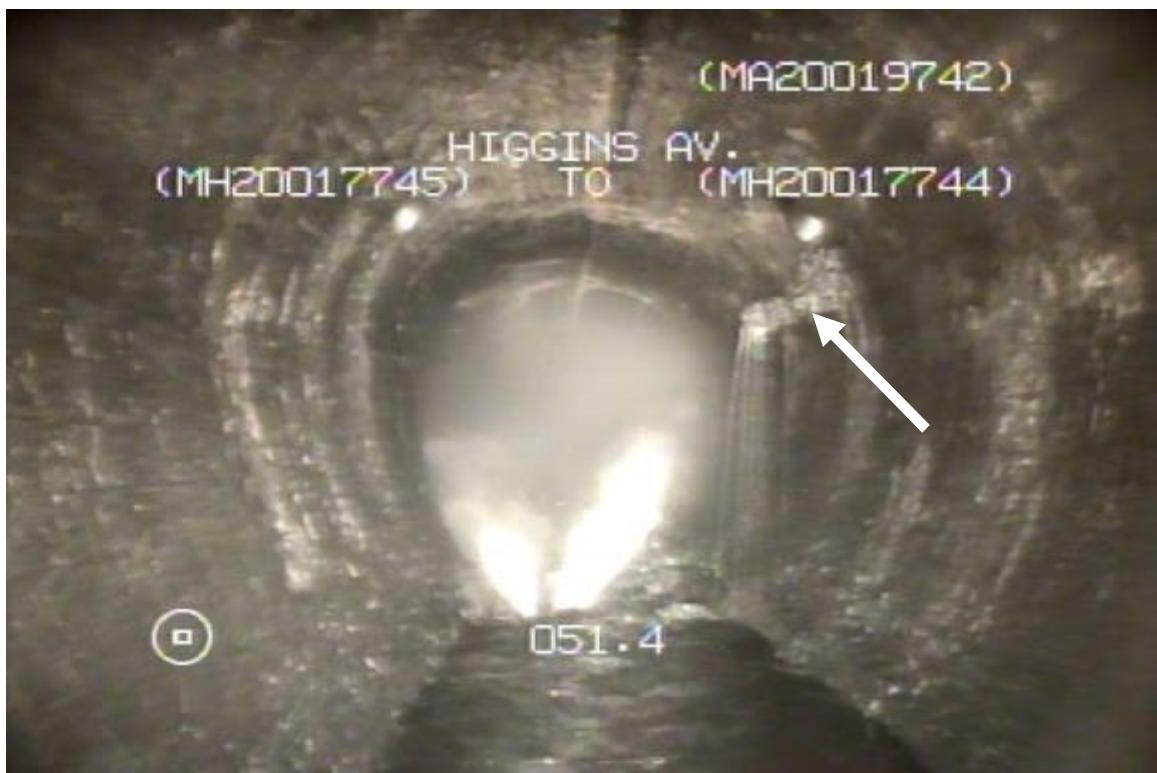
Figure 13 - S-MA20019742 (Higgins Av) - General Condition w/ Encrusted Service Connection

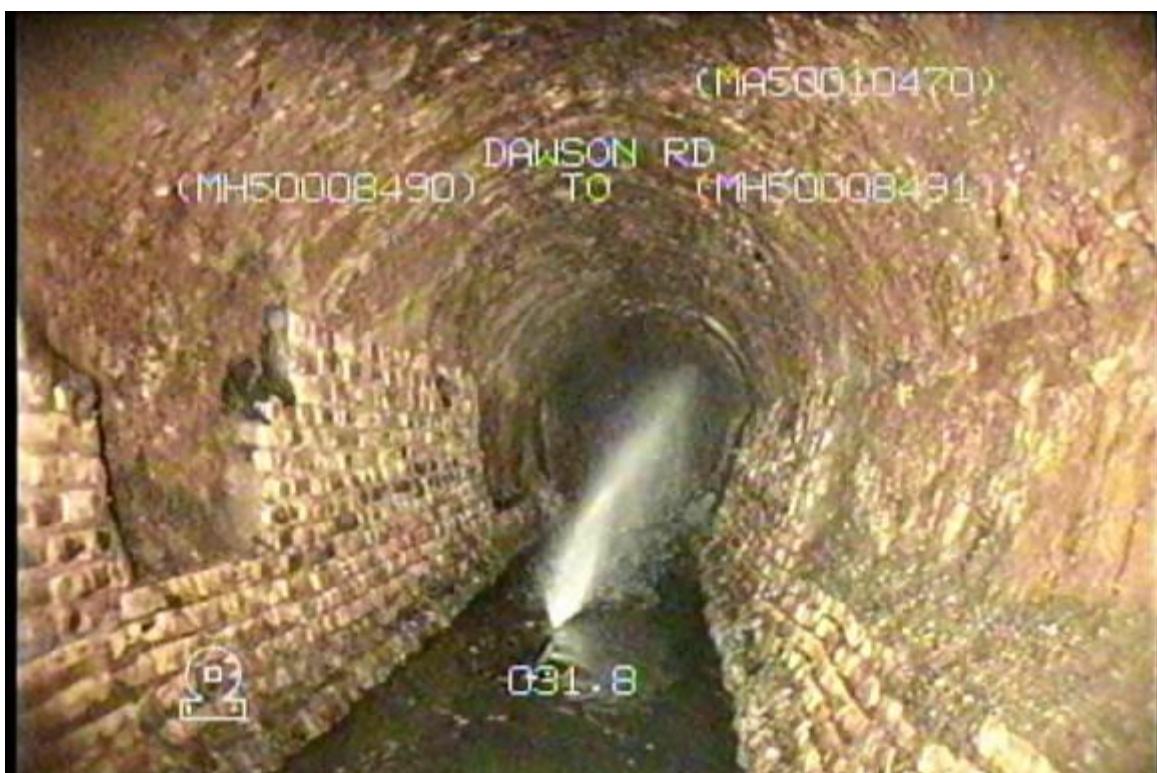
Figure 14 - S-MA50010470 (Dawson Rd) - General Condition

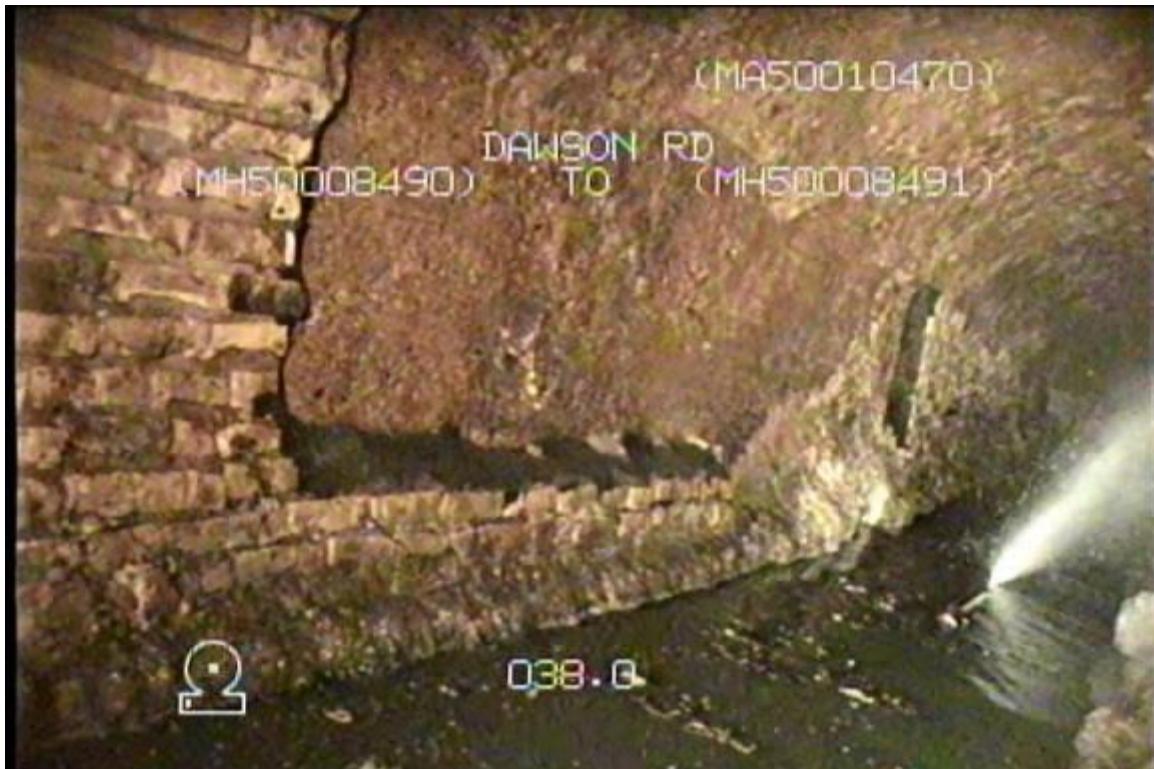
Figure 15 - S-MA50010470 (Dawson Rd) – Missing Section of Existing Brick Invert Liner

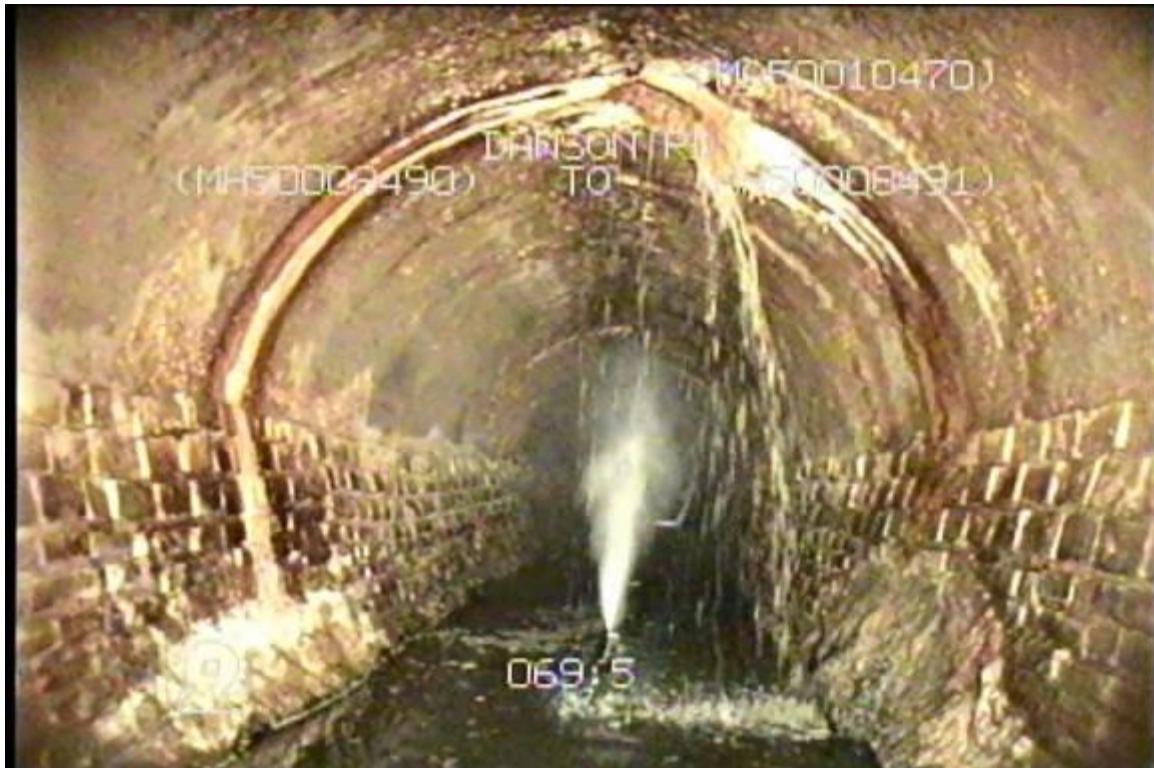
Figure 16 - S-MA50010470 (Dawson Rd) - General Condition w/ Encrusted Service Connection
