**APPENDIX D - ASBESTOS INVENTORY CONTROL – 25 POSEIDON BAY, THE CITY OF WINNIPEG,
OCTOBER 6, 2016**

ASBESTOS INVENTORY CONTROL

Building Name:	Pan Am Pool - Building	Inspection Date:	October 6, 2016
Building Code:	PI-13	Inspected By:	Ryan Matthews
Building Address:	25 Poseidon Bay	Construction Date:	1967

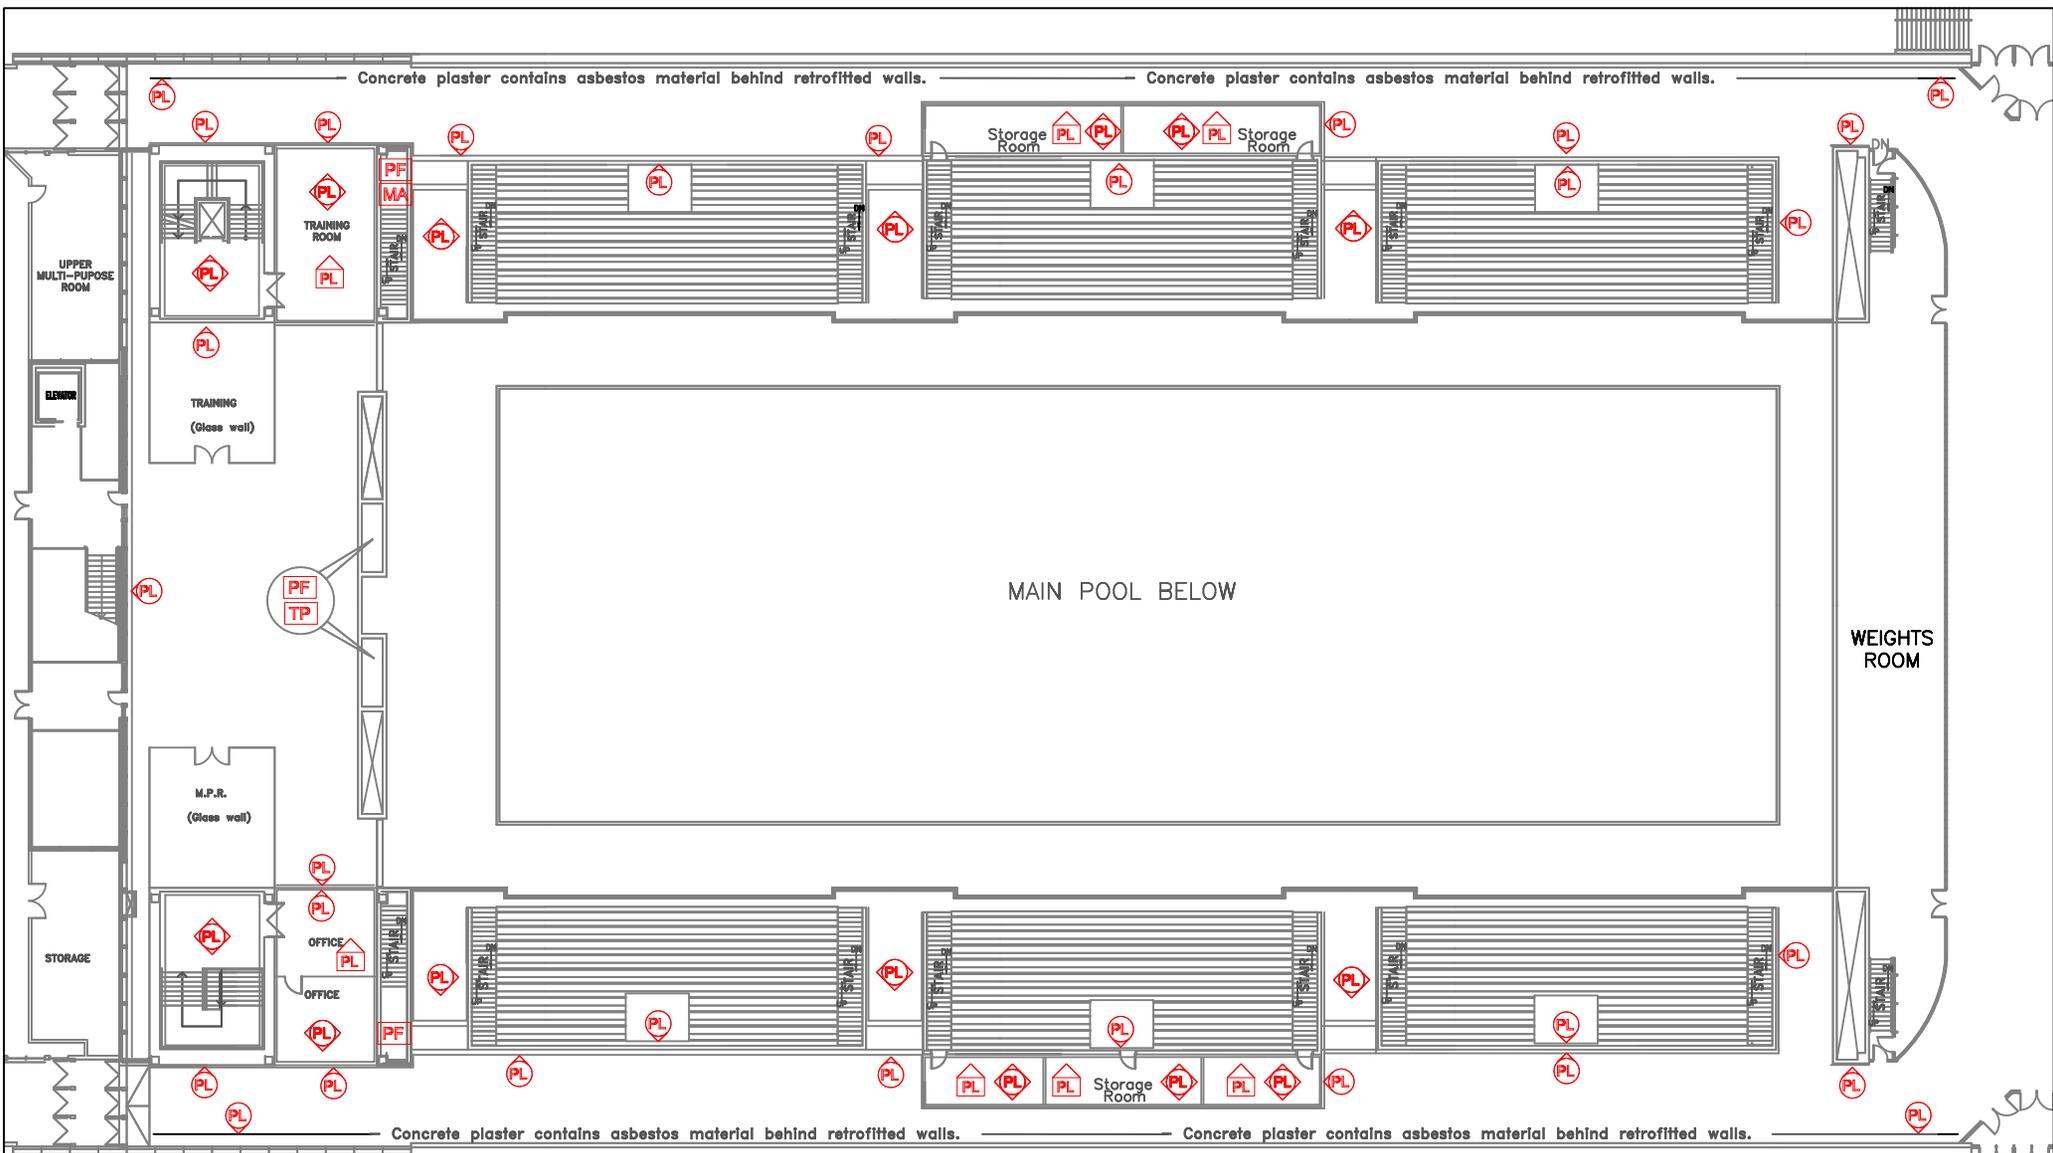
SECOND FLOOR PLAN - Mezzanine level

Remark:
 - All concrete plasters in ceilings and walls contained asbestos materials except for the retrofitted walls in north & south exterior concrete wall of which asbestos materials located behind that walls.

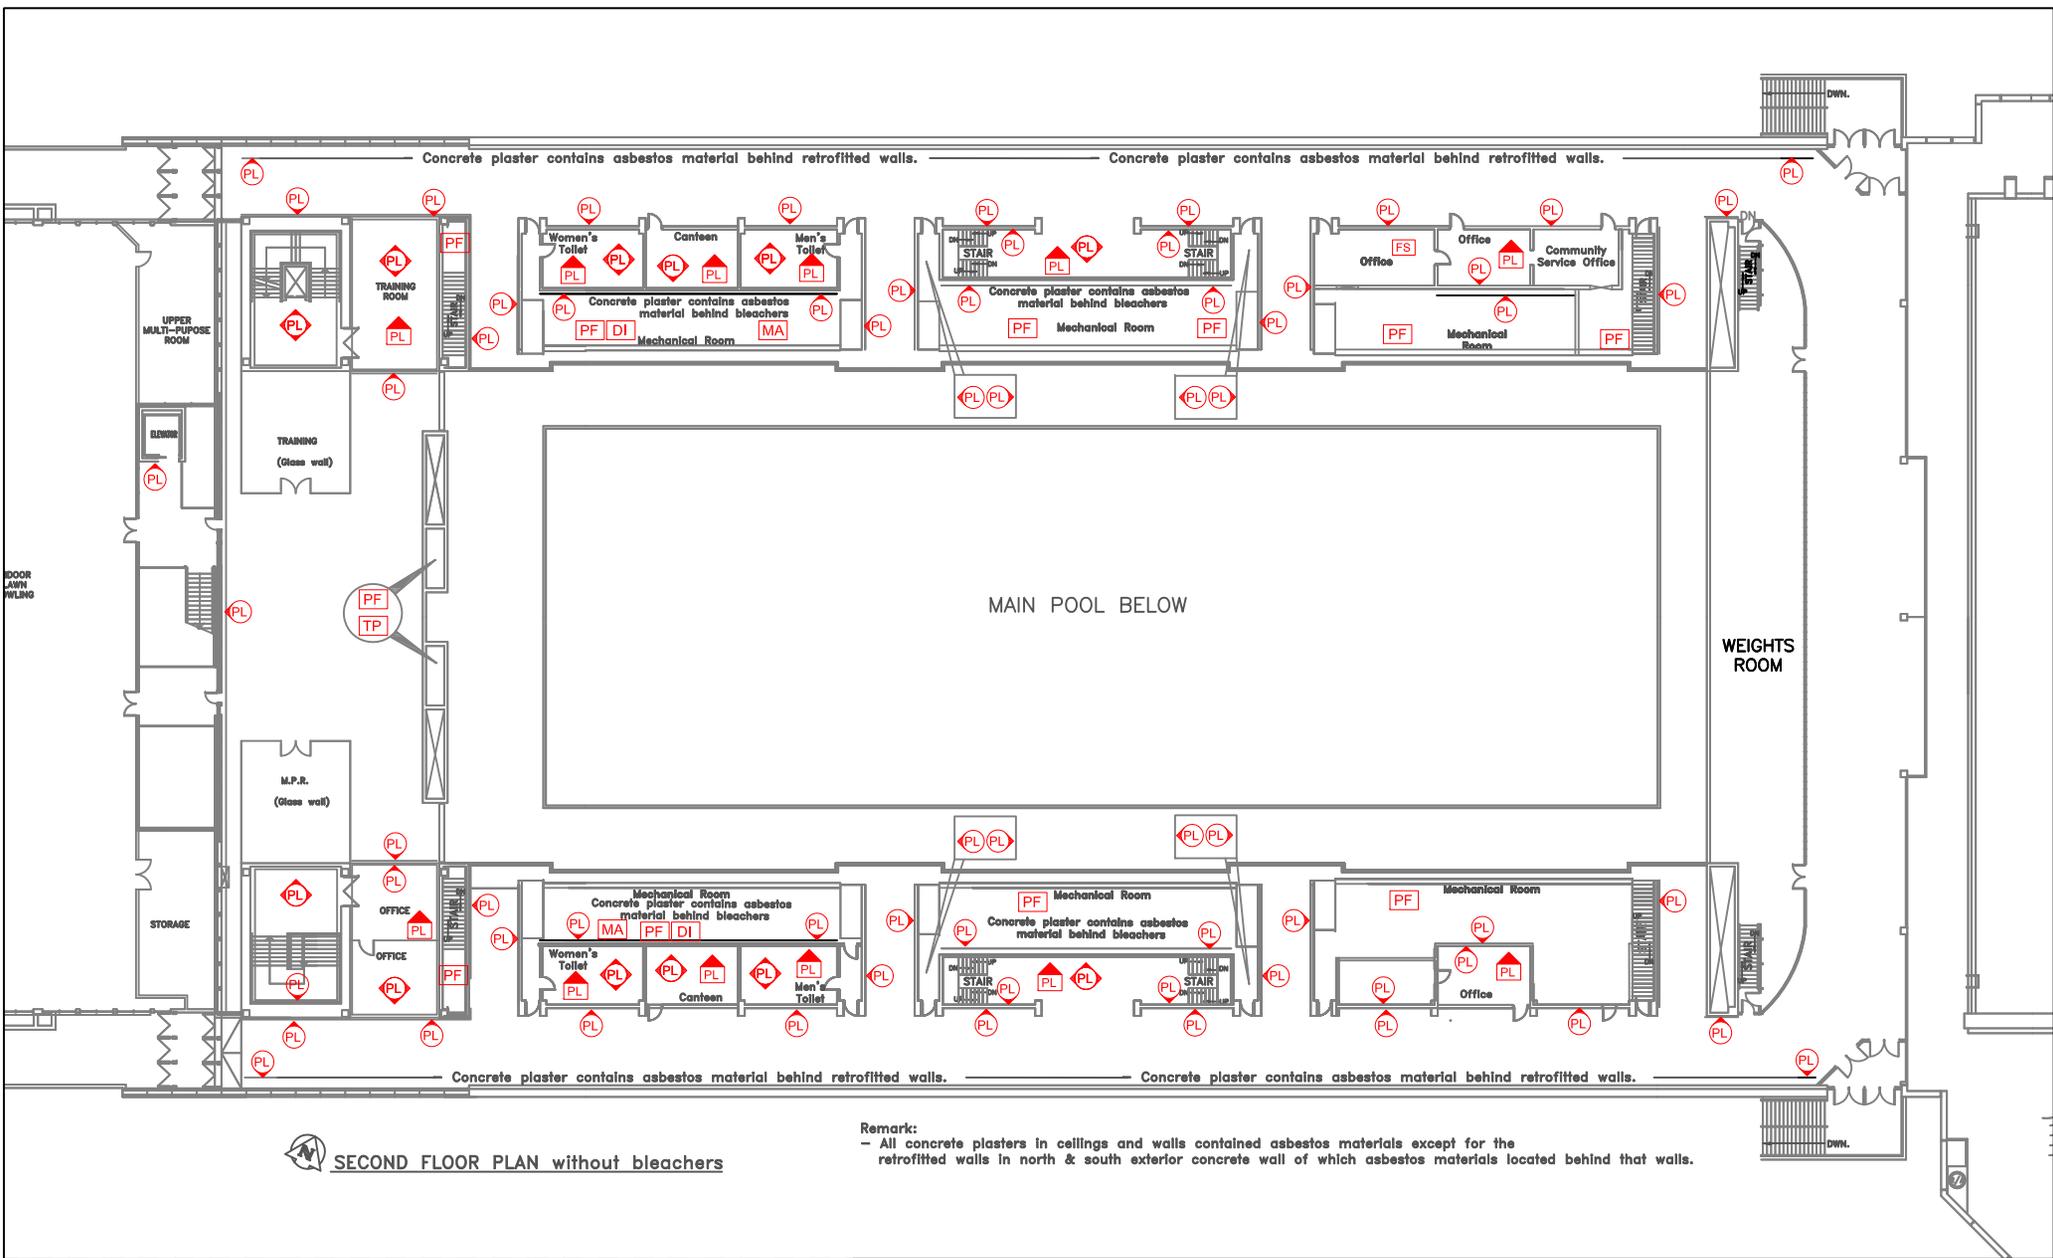
SECOND FLOOR PLAN without bleachers

Remark:
 - All concrete plasters in ceilings and walls contained asbestos materials except for the retrofitted walls in north & south exterior concrete wall of which asbestos materials located behind that walls.

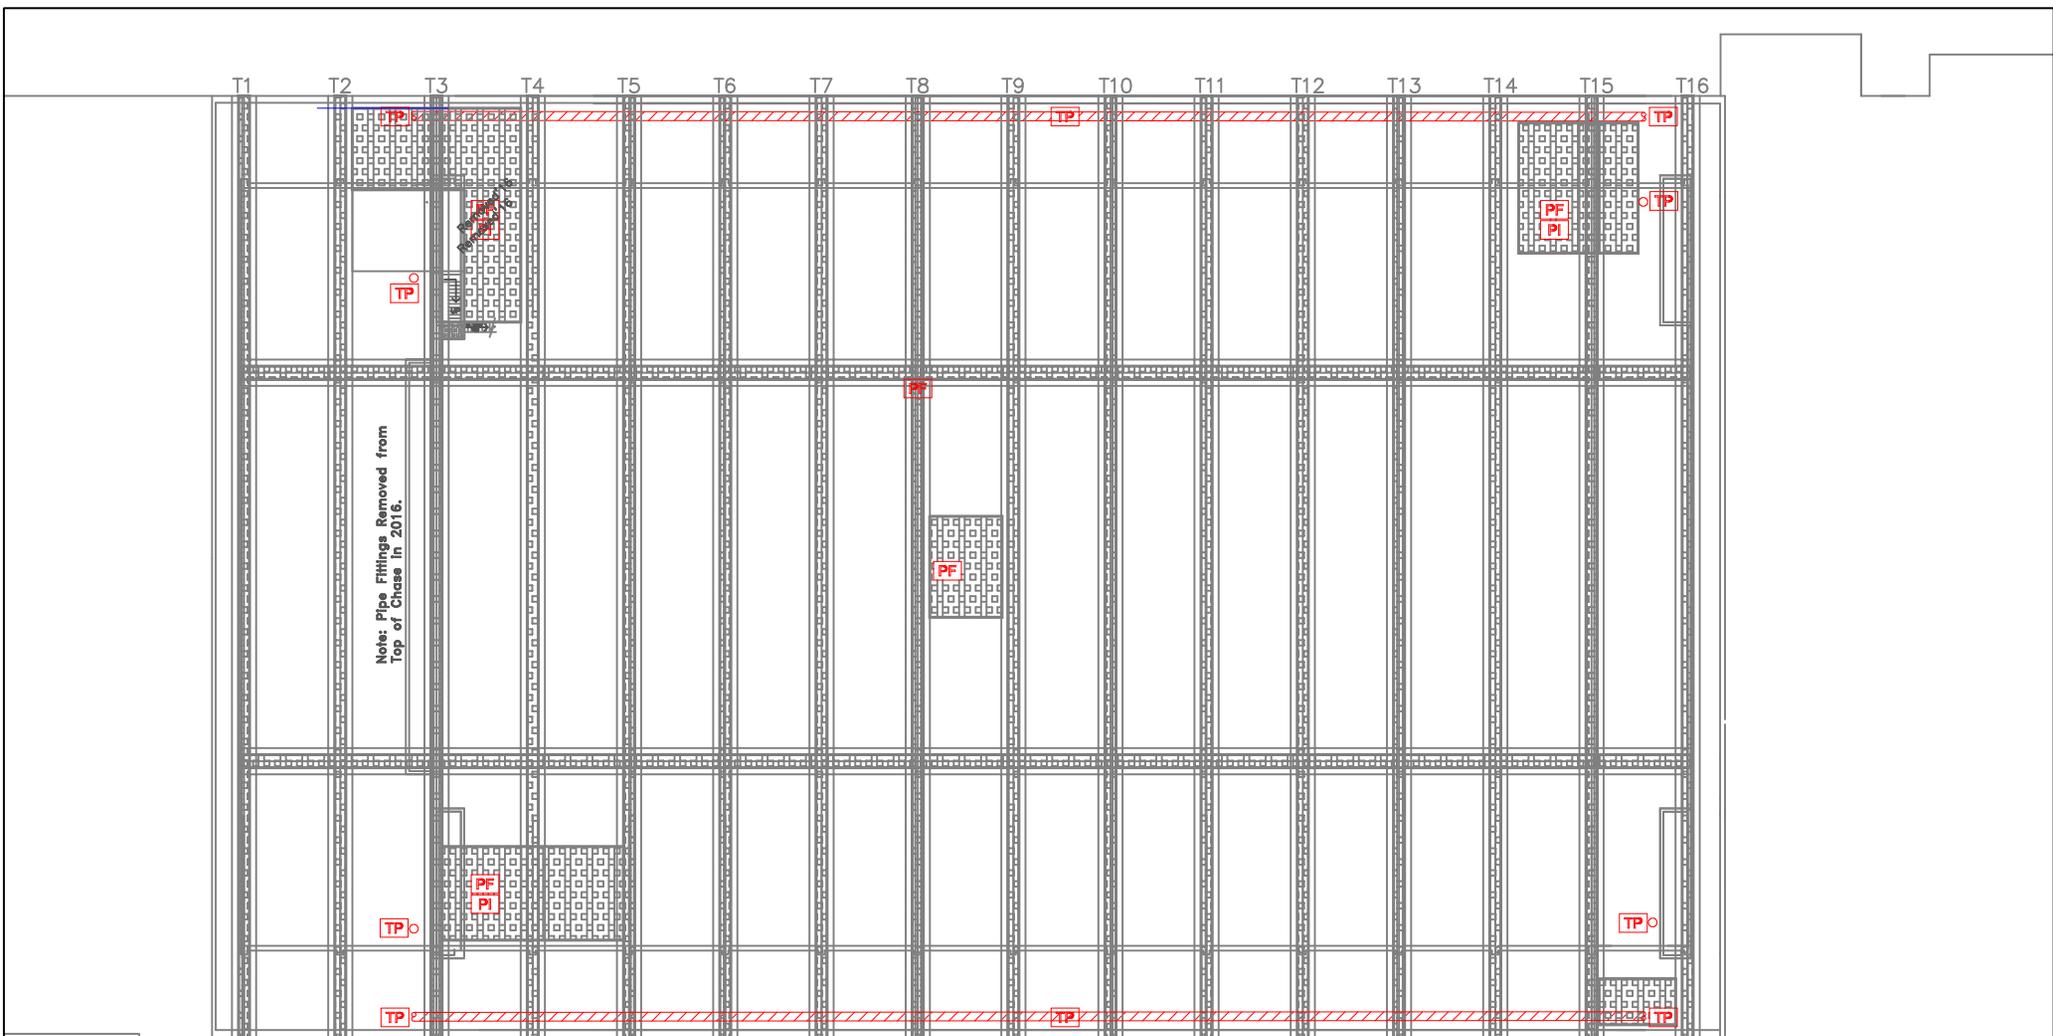
ROOF CATWALK PLAN

Remark:
- Asbestos containing pipe fittings are through out catwalk area in various locations.
