# ASBESTOS INVENTORY CONTROL

<b>Building Name:</b>	Civic Centre Arena (also see PI-05 & RC-22)	<b>Inspection Date:</b>	April 29, 2015
<b>Building Code:</b>	AR-03	<b>Inspected By:</b>	Ryan Matthews & James Neufeld
<b>Building Address:</b>	2055 Ness Avenue	<b>Construction Date:</b>	1967

**ASBESTOS LOCATIONS**

BUILDING: AR-03 Civic Centre Arena 2055 Ness Ave Winnipeg, Manitoba	
REVISED BY: A.B.	DATE: February 13, 2014
SCALE: N.T.S.	SHEET #: 1/1

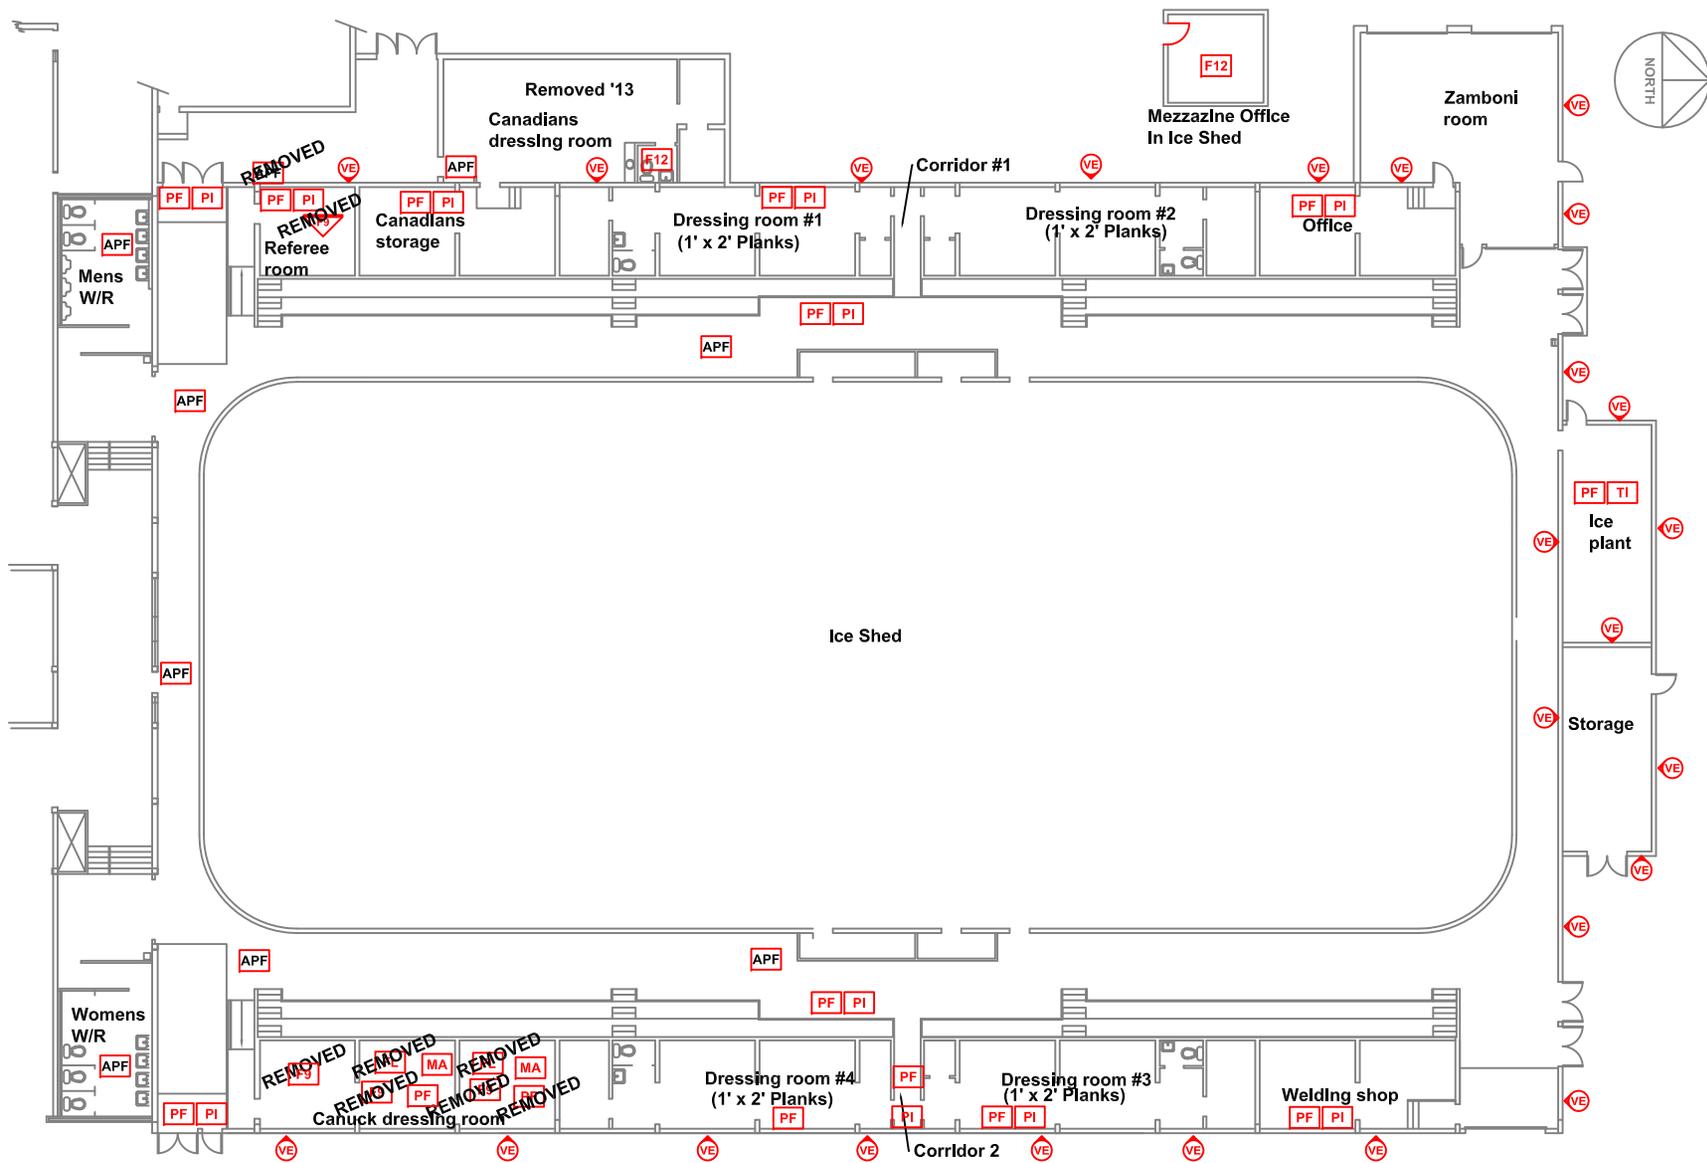
**AR-03**

Material Location	Material Description	Drawing Label	Material Condition	Testing Status	Date M/Y	Test %	Est. %
Men's Washroom & Entrance	Asphalt Plank Floor ( 1 x 4 )	APF	Needs Repair				5
Women's Washroom & Entrance	Asphalt Plank Floor ( 1 x 4 )	APF	Needs Repair				5
Ice Shed	Asphalt Plank Floor ( 1 x 4 )	APF	Good	TESTED	Oct/'12	5	
	Pipe Insulation	PI	Good				
	Pipe Fitting Insulation	PF	Good				
Mezzanine Office in Ice Shed	12x12 Floor Tile	F12	Needs Repair	TESTED	Jan/'13	3	
Referee room	9x9 Floor Tile - Under rubber mats	F9	Removed				
	Pipe Fitting Insulation	PF	Good				
	Pipe Insulation	PI	Good				
Dressing room #1	Pipe Fitting Insulation	PF	Good				
	Pipe Insulation	PI	Good				
	Asphalt Plank Floor ( 1 x 2 Planks)			TESTED	Oct/'12	0	
Dressing Room # 2	Asphalt Plank Floor ( 1 x 2 Planks)						0
West stands	Pipe Fitting Insulation	PF	Good				
	Pipe Insulation	PI	Good				
Office	Pipe Fitting Insulation	PF	Good

Pipe Insulation	PI	Good				
Ice plant	Pipe Fitting Insulation (Blue foam)	PF					
	Pipe Insulation (Blue foam)	PI					
Welding shop	Pipe Fitting Insulation	PF	Good				
	Pipe Insulation	PI	Good				
Dressing room #3	Pipe Fitting Insulation	PF	Good				
	Pipe Insulation	PI	Good				
	Asphalt Plank Floor ( 1 x 2 Planks)			TESTED	Nov/'12	0	
	Pipe Fitting Insulation	PF	Good

Material Location	Material Description	Drawing Label	Material Condition	Testing Status	Date M/Y	Test %	Est. %
Dressing room #4	Pipe Insulation	PI	Good	TESTED	Dec/'11	0	
	Asphalt Plank Floor ( 1 x 2 Planks)						0
Corridor #2	Pipe Fitting Insulation	PF	Good				
	Pipe Insulation	PI	Good				
East stands	Pipe Fitting Insulation	PF	Good				
	Pipe Insulation	PI	Good				
South arena corner @ east exit	Pipe Fitting Insulation	PF	Good				
	Pipe Insulation	PI	Good				
South arena wall @ west exit	Pipe Fitting Insulation	PF	Good				
	Pipe Insulation	PI	Good				
Canadians dressing room	Pipe Fitting Insulation	PF	Removed		Dec/'10		
	Pipe Insulation	PI	Removed		Dec/'10		
	Asphalt Plank Floor ( 1 x 4 Planks)	APF	Good				5
Canucks dressing room	9x9 Floor Tile	F9	Removed10/12	TESTED	Dec/'11	15	
	Mastic (on underside of floor tiles)	MA	Good	TESTED	Dec/'11	3	
	Leveling compound ( under floor tiles)	FL	Removed10/12	TESTED	Dec/'11	2

Pipe Fitting Insulation	PF	Removed				
Zamboni room	Stucco - Ceiling		Good	TESTED	Dec/'10	0	
	Stucco - Walls		Good	TESTED	Dec/'10	0	
Concrete block walls	Contains Vermiculite Insulation (Which May Contain Asbestos)	VE	Good				
Common wall between ice shed & lobby	Randomly Inspected & Appear To Be Empty (Do Not Contain Vermiculite Insulation)
