COVER PAGE

1.0 LIFT STATION INFORMATION

Station Name:	<u>Jessie Lift Station</u>
Location of Station:	<u>1 Mulvey Avenue East</u>
Date of Inspection:	<u>January 28, 2010</u>
Inspected By:	<u>Damir Muhurdarevic, EIT</u>
Inspecting Firm:	<u>MMM Group Limited (MMM)</u>
Client:	<u>City of Winnipeg – Water and Waste Department</u>

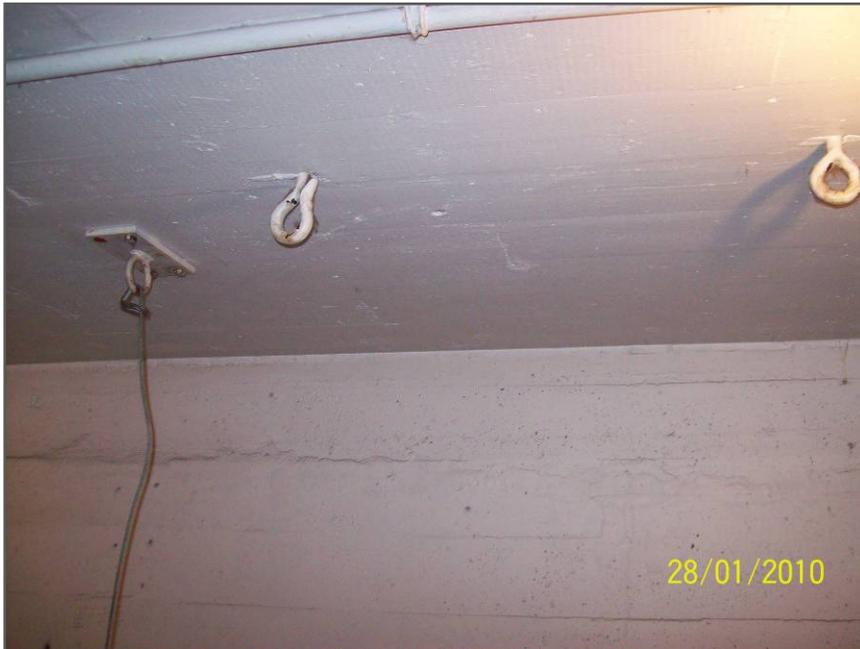
Photograph No. 1

The second floor chamber room has two (2) eye-shaped hooks, fabricated of 25.4mm diameter steel rod embedded into the underside of the cast-in-place concrete floor above. One of the motor room eye-shaped hooks is bent and cracked. The back room on the same floor contains one (1) additional eye hook that is currently not in use. Corrosion on the steel hook and deterioration of the surrounding concrete was observed.

The eye hooks were analyzed for pullout resistance of the embedment and the tension resistance of the hook. A concrete thickness of 200mm and an embedment 150mm were used. The governing factor in the hooks was the pullout resistance, which was calculated to be 3.5 tons for the 19.4mm diameter hooks and 3.6 tons for the 25.4mm diameter hooks. However, it is recommended that an additional factor of safety of 3.5 be applied to the hooks, to yield a **load rating of 1.0 ton. The bent and cracked eye-hook in the motor room and the rusted eye-hook with damaged concrete are deemed unsafe and should not be used.**

Various lifting hooks located in the pump and motor rooms
(eye-shaped hook bent and cracked in the motor room)

Ref.	Description	Priority
4.1	Remove motor room cracked eye hook and second floor corroded eye hook, replace as required.	A

MMM, through this inspection, does not warrant the lifting devices installation or warrant that the design complies with current codes or standards. As per MMM's analysis it was found that the eye-shaped hooks should be rated at 1.0 tons, and the U-shaped hooks welded to steel plates bolted to the ceiling at ½ tons. The main floor beam is rated at 1.0 ton. It is also imperative that the 1 bent/cracked and the 1 rusted eye hook not be used further and be replaced.

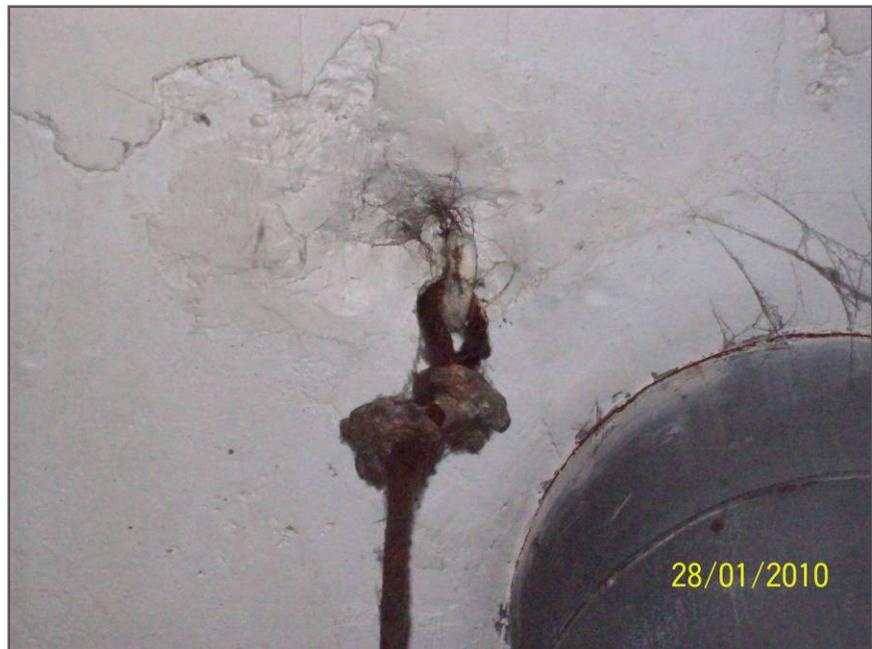
Photograph No. 2

Eye-shaped lifting hook located in the back room on the 2nd floor down
(corroded hook and deteriorating concrete)

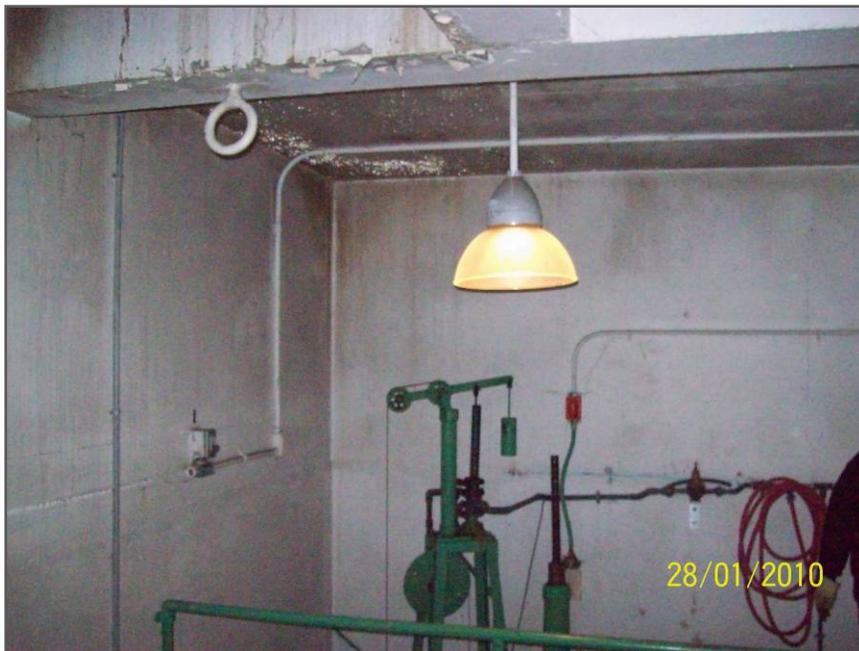
Photograph No. 3

Thick eye-shaped lifting hooks located on the 2nd floor down, embedded into concrete beams

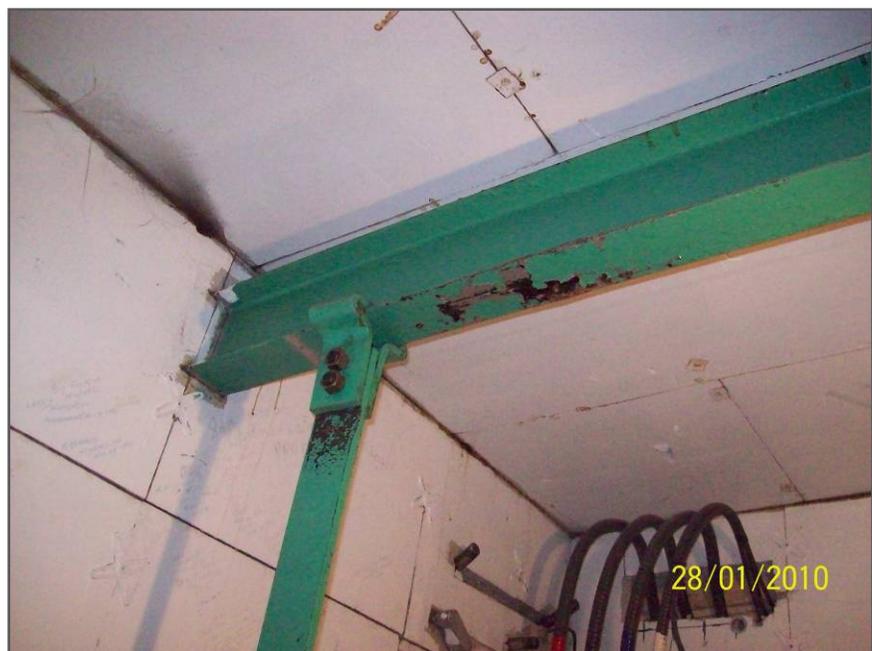
Photograph No. 4

The main floor has an S150x19 lifting beam that spans approximately 2900mm with an attached sliding plate hook. The end support connections were unable to be observed due to Styrofoam wall insulation. Slight corrosion was observed on the lifting beam. However, no significant loss of sectional area was observed on the lifting beam.

The main floor S-beam system was analyzed for bending resistance of the beam and shear resistance of the assumed wall connection. Bending resistance governed which was calculated to be 3.4 tons. Due to wall connection assumptions, it is recommended a safety factor of 3.4 be applied to yield a **load rating of 1.0 ton.**

Lifting beam located on the main floor
