Hazardous Materials Survey Report

Hawthorne Station

LOCATION: Hawthorne Station
1178 Kildonan Drive
Winnipeg, Manitoba

INSPECTION DATE: March 13, 2018

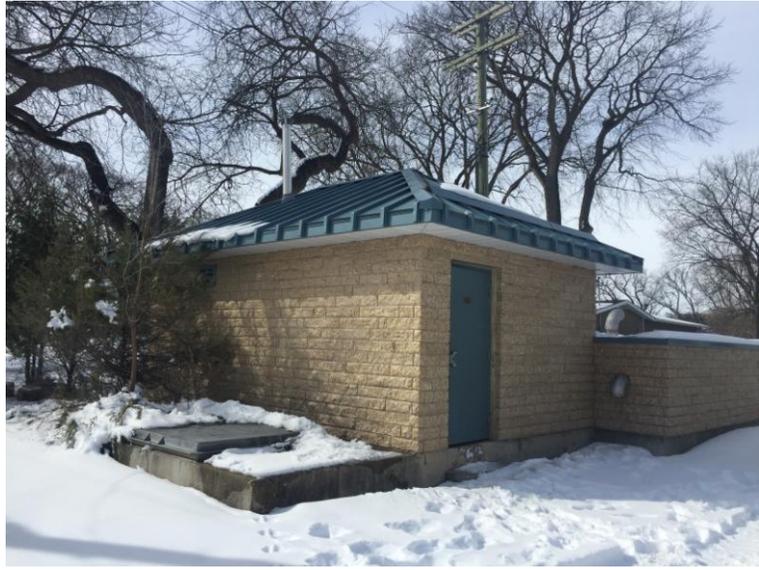
Photo 1

Exterior of subject property.

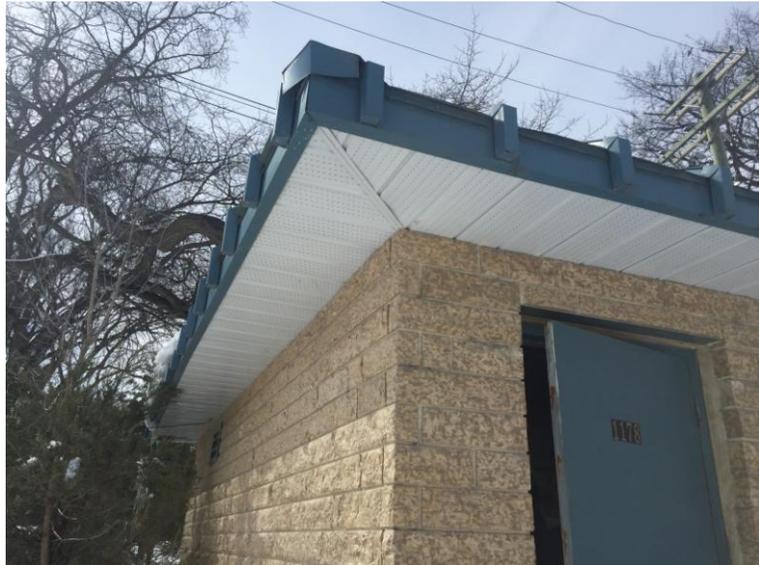
Photo 2

Exterior view of subject property, showing newer-style soffits. Attic space was not inspected.

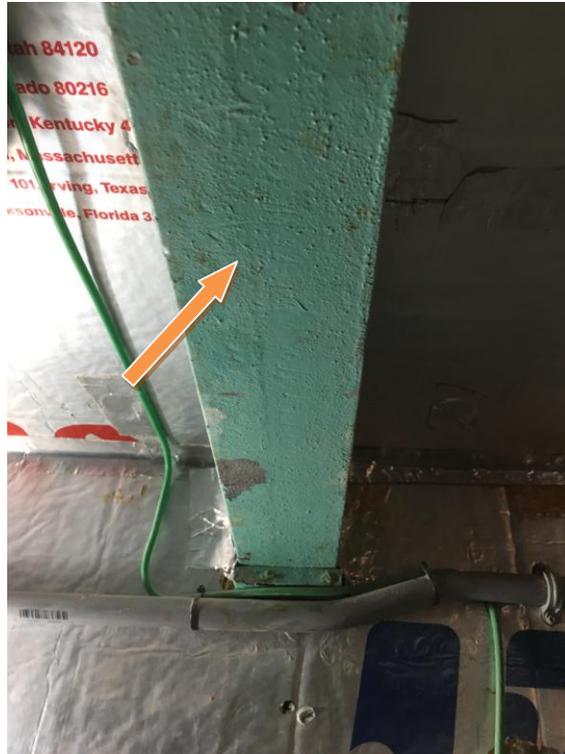
Photo 3

The green paint present on the beam (1st level) was found to contain 0.01% lead w/w.

Same or similar paint may be elsewhere in the building, and is present on walls behind foam insulation.

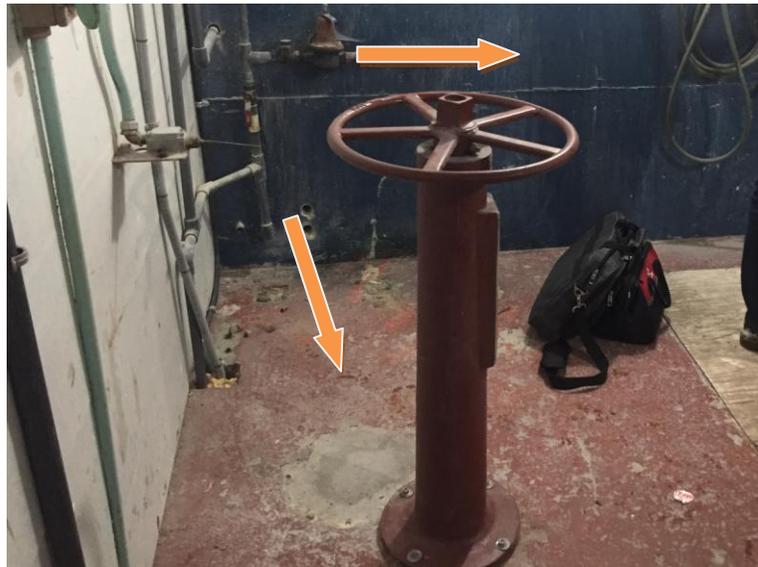
**Photo 4**

The red paint present on the floors for all four levels is suspected to be a lead-based paint. A sample of the paint from on the 2nd level floor (Comm Room) was found to contain 0.6% w/w lead, which is above the 0.5% threshold. The sample taken represents multiple layers of paints/coatings, as reliable separation was not possible (refer to Photo 4 and 5); the actual lead content of an individual layer may be higher than the reported result. Similar paints are present on floors for all levels, as well as other surfaces.

The red paint present on floors in Comm Room (2nd level) and Main Floor (1st level) likely contain lead-based paints.

Sample 3 represents a paint sample from the floor in Comm Rm (2nd level) which contained 0.6% w/w lead.

The blue paint on walls (sample 4) contained 0.02% w/w lead.

- 5.2.1. Lead-containing paints are present throughout the building/structure, including paints/coatings applied to floors, walls, conduit lines and process equipment.
- 5.2.2. The red paint sample from the floor of the 2nd level (Comm Room) was found to contain 0.6% w/w and meets criteria used for lead-based paints. This paint is present on the floors for all levels of the building, and may also be present on process equipment or other surfaces.
- 5.2.3. Certain additional precautions are warranted when removing lead-based paints, or paints containing lead at lower concentrations, depending on the type of work processes or work environments involved.
- 5.2.4. In general, a risk assessment should be undertaken to determine safe work procedures where removal of lead-containing paints is required.

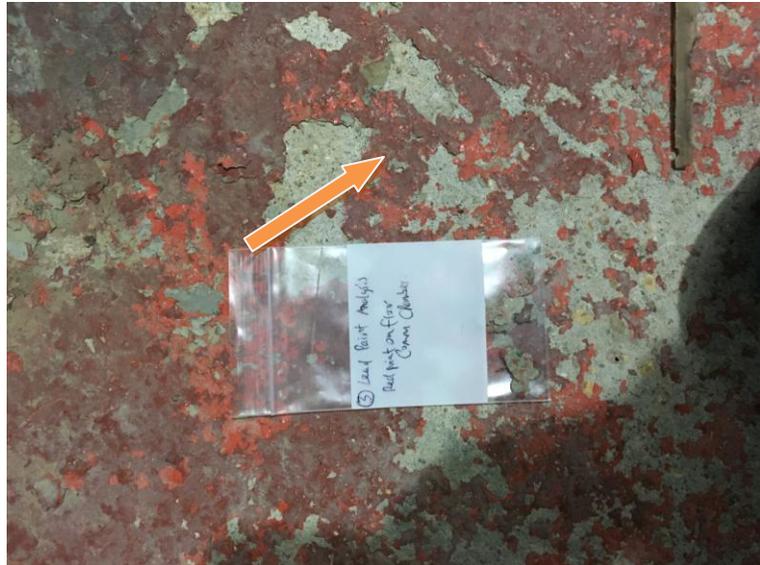
Photo 5

Sample location for Sample 3 of floor paint present in Comm Rm (2nd level).
Sample contained 0.6% ww lead.

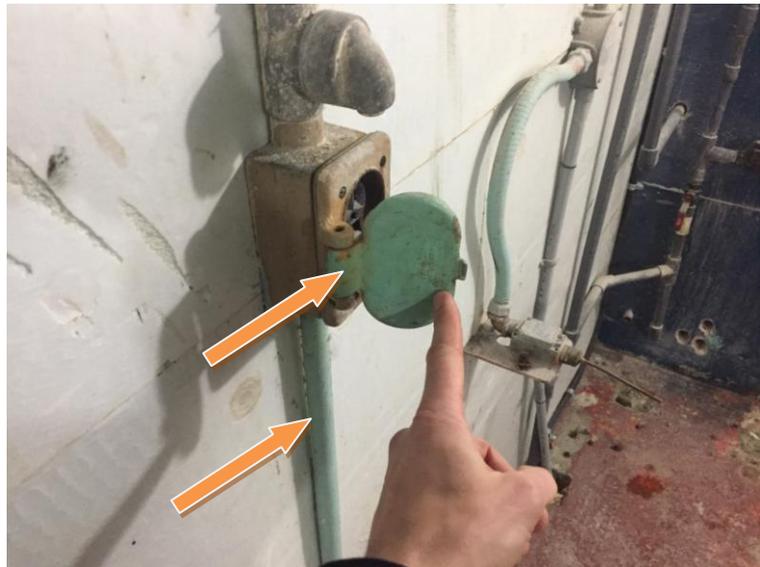
Photo 6

The green paint on electrical conduit and outlet in the 2nd level (comm room) was found to contain 0.02% w/w lead (sample 5).

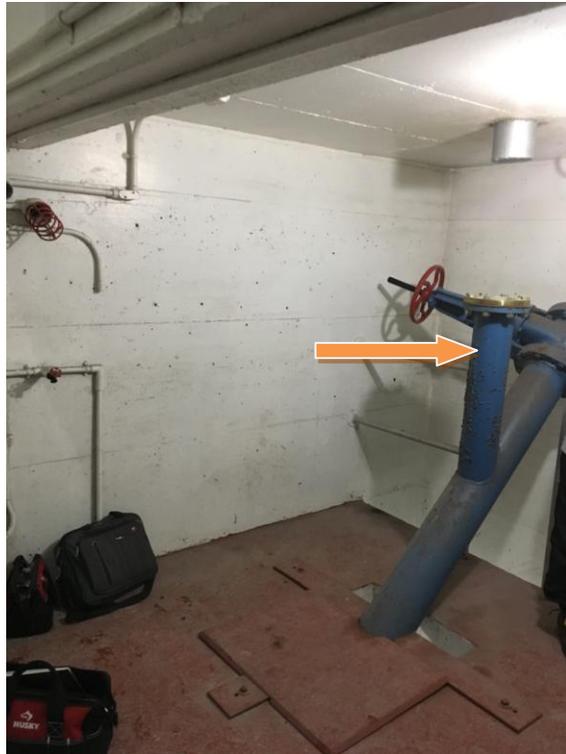
Photo 7

The white paint on walls in the motor room (3rd level) contained <math><0.005\%</math> w/w lead (sample 6).
The blue paint from the process pipe (sample 7) contained 0.02% w/w lead.

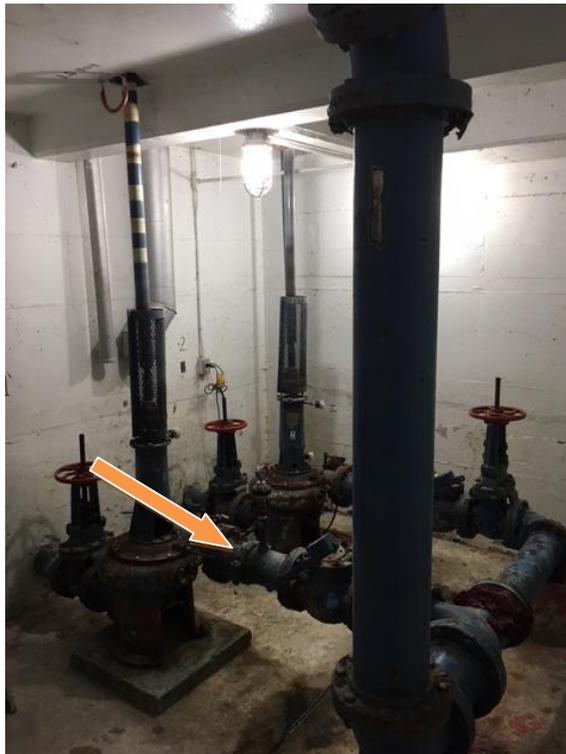
Photo 8

A paint sample from process lines in the pump room (4th level) was found to contain 0.06% w/w lead (sample 8)

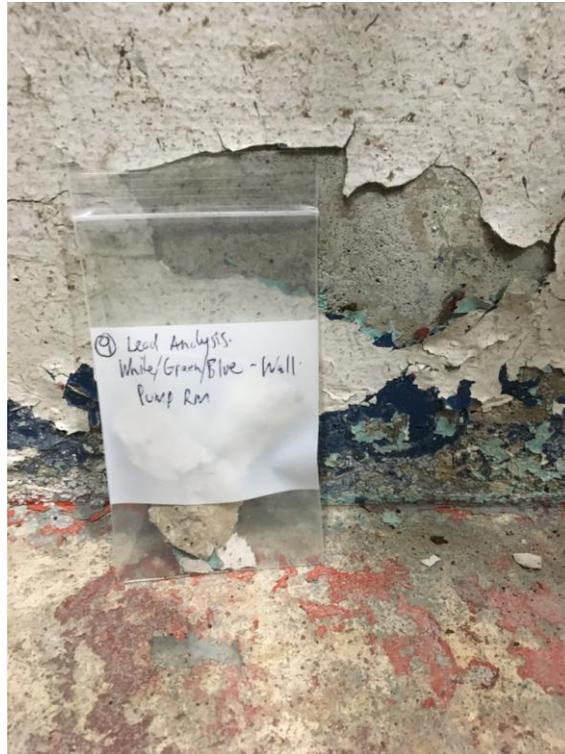
Photo 9

A sample taken of the blue/green/white paint present on walls in the Pump Room (4th level) was found to contain 0.02% w/w lead (sample 9).

The white paint on walls is presumed to be newer with no lead content (similar to sample 6), while blue/green paints will be similar to sample 8.

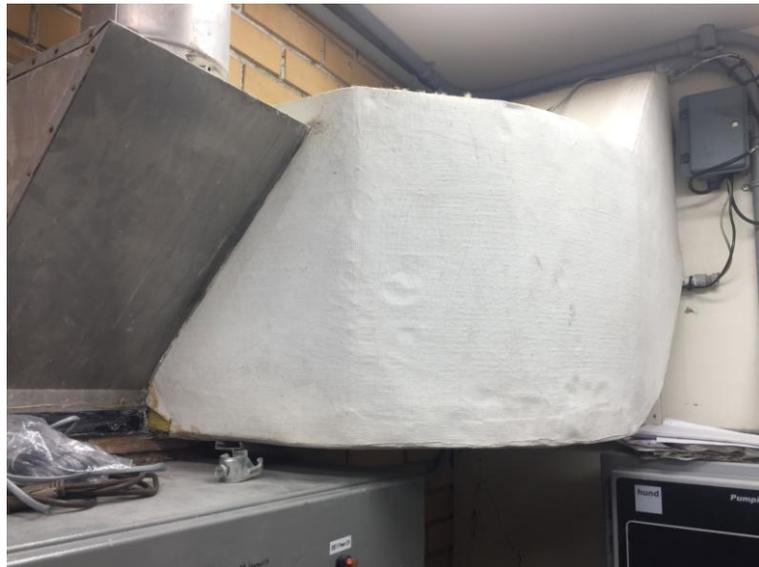
Photo 10

The only suspect ACM identified was the parging material used in conjunction with the fiberglass insulated duct in the ground level communications room.

No ACM were identified within the area.

A sample of the canvas/parging material associated with the ductwork shown in the photo was not found to contain asbestos.
