ASBESTOS INVENTORY CONTROL

Building Name:	Roland Michener Indoor Arena	Inspection Date:	November 7, 2017
Building Code:	AR-07	Inspected By:	A Brodbeck N Richardson
Building Address:	1121 Wabasha Street	Construction Date:	1967

ASBESTOS LOCATIONS

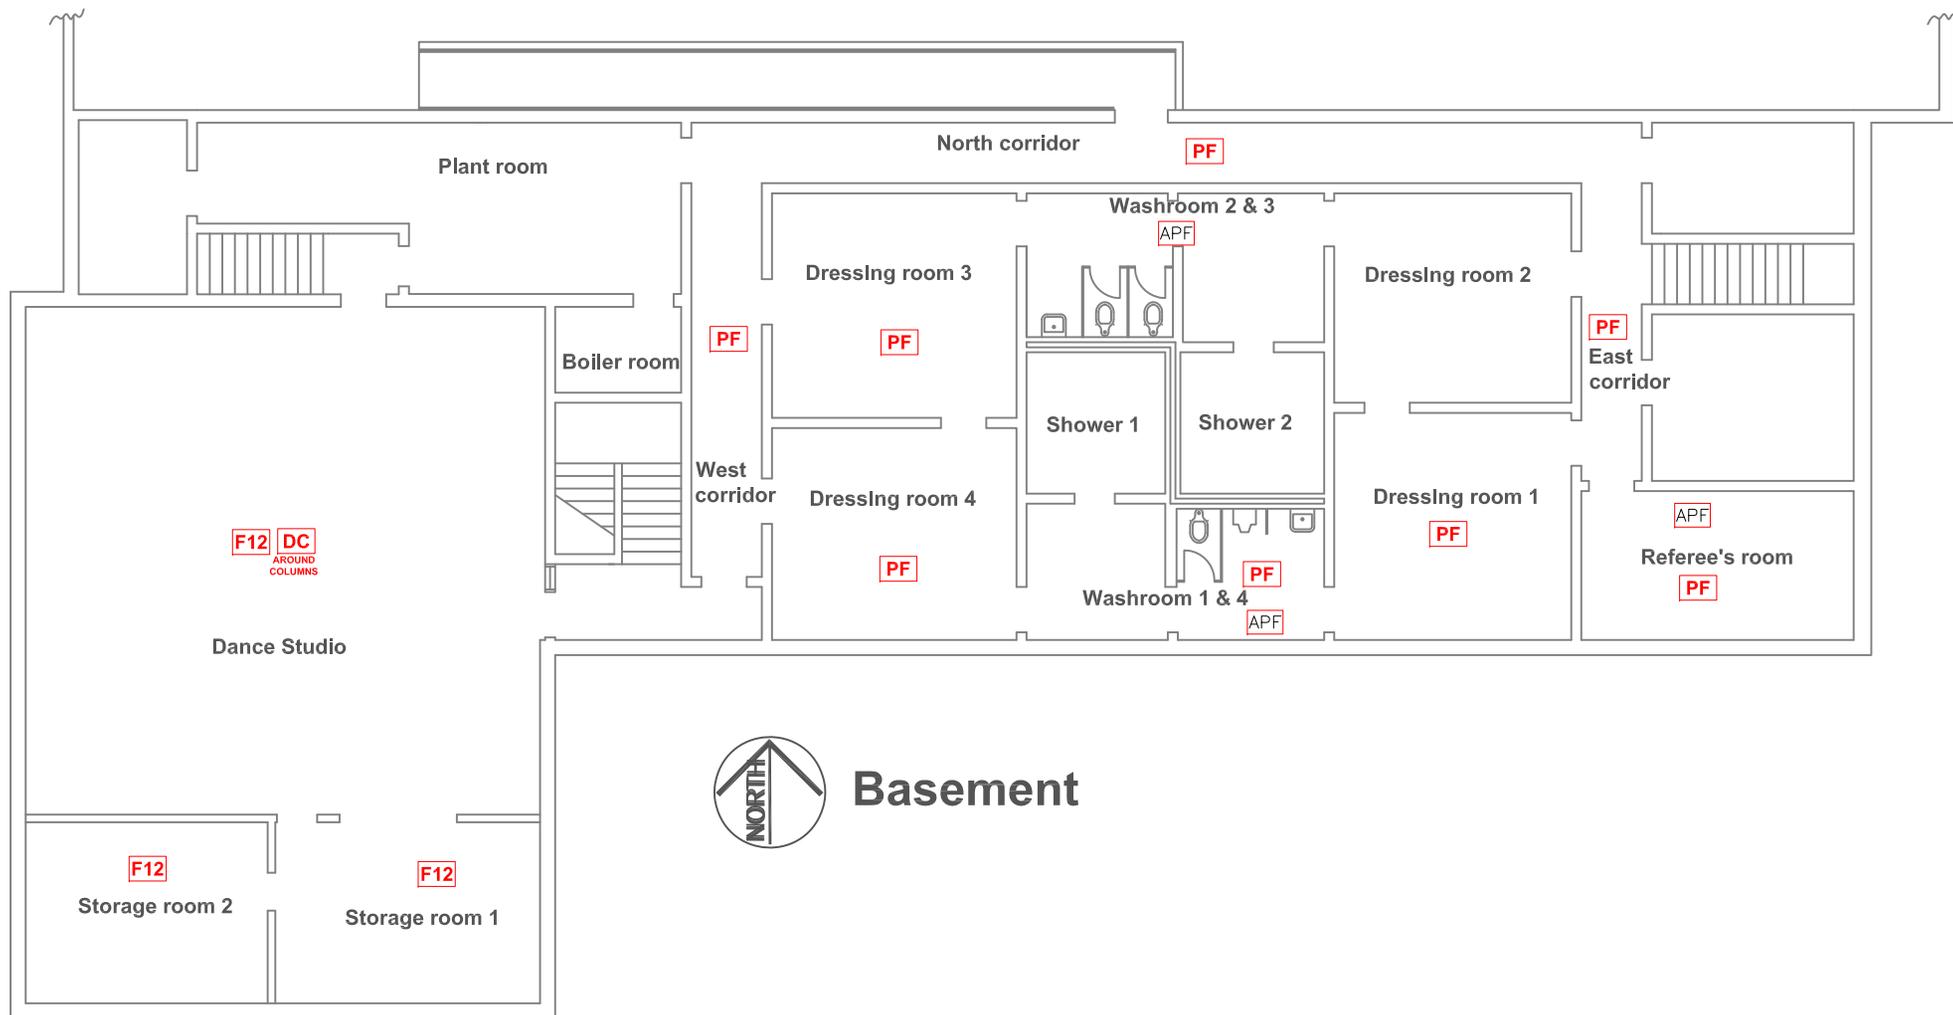
Material Location	Material Description	Drawing Label	Material Condition	Testing Status	Date M/Y	Test %	Est. %
Basement							
Storage Room 1	12x12 Floor Tile	F12	Good				2
Storage Room 2	12x12 Floor Tile	F12	Good				2
Dance Studio	12x12 Floor Tile	F12	Fair	TESTED	Mar'10	2	
	Drywall Compound - Columns	DC	Good				2
West Corridor	Pipe Fitting Insulation	PF	Good	TESTED	Mar'10	60	
North Corridor	Pipe Fitting Insulation	PF	Good	TESTED	Mar'10	40	
North/West/ East Corridor/ Dressing Rooms 1, 2, 3, 4	Asphalt Plank Floor (1 x 2 planks) (4 samples)			TESTED	Aug'15		0
East Corridor	Pipe Fitting Insulation	PF	Good				40-60
Referee's Room	Pipe Fitting Insulation	PF	Good				
	Asphalt Plank Floor (some 1 x 2 planks)						0
	Asphalt Plank Floor	APF	Good				5
Dressing Room 1	Pipe Fitting Insulation	PF	Good				50
1 2,3 4 Washrooms	Pipe Fitting Insulation	PF	Good				50
	Asphalt Plank Floor	APF	Good			3	
Dressing Room 4	Pipe Fitting Insulation	PF	Good	TESTED	Mar'10	50

Asphalt Plank Floor (1 x 2 planks)			TESTED	Jul'13	0	
	Pipe Trap Insulation			TESTED	Mar'10	0	
Dressing Room 3	Pipe Fitting Insulation	PF	Good				50
Water Meter Room	Pipe Elbow Insulation	PF	Removed				
Plant Room	Tank insulation is foam (not asbestos materials)						
	Pipe insulation is fiberglass or black foam			TESTED		0	
	Duct Insulation is fiber glass						
Hot Water / Boiler Room	Tank Insulation	TI		TESTED	Sep'10	0	
	Pipe insulation is fiberglass or black foam

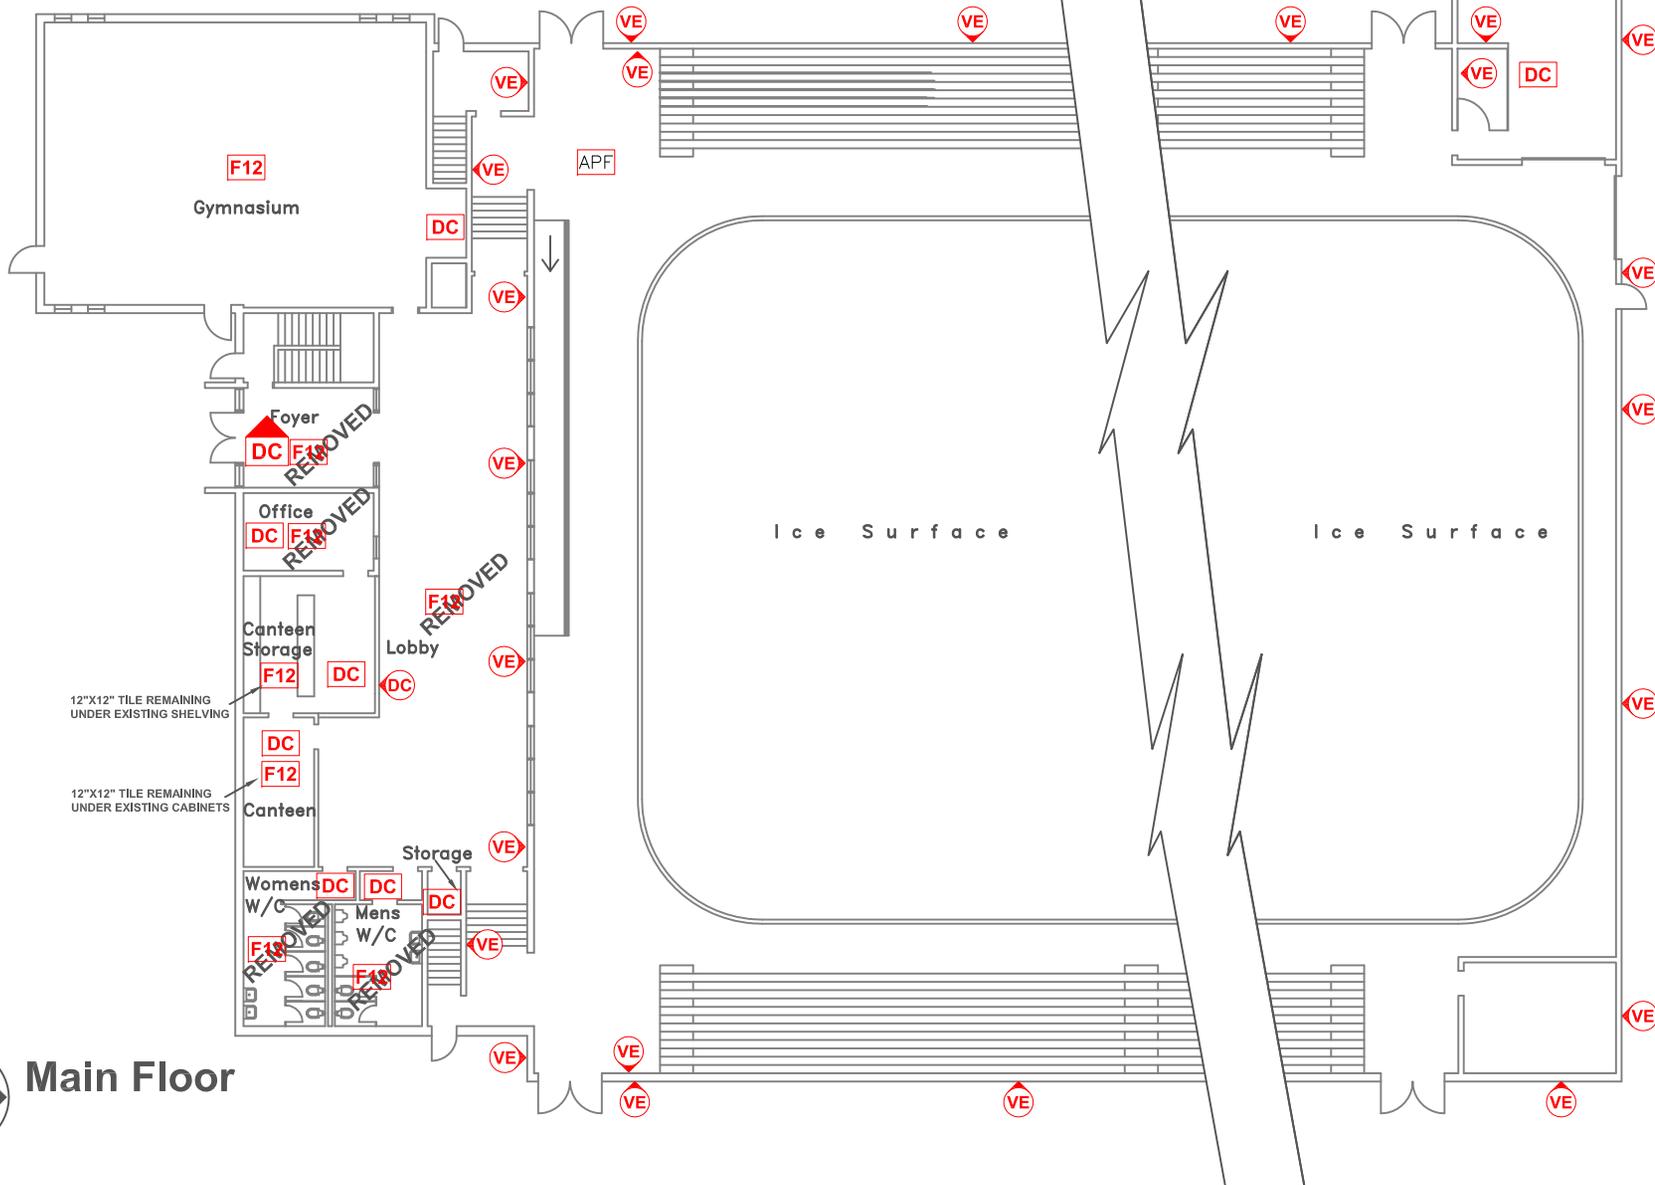
Material Location	Material Description	Drawing Label	Material Condition	Testing Status	Date M/Y	Test %	Est. %
	Drywall Compound throughout contains asbestos	DC					
Main Floor							
Gymnasium	12x12 Floor Tile	F12	Good				3
	Drywall Compound	DC	Good				2
Foyer	12x12 Floor Tile	F12	Removed				3
	Drywall Compound - Ceiling	DC					2
Office	12x12 Floor Tile	F12	Removed				3
	Drywall Compound	DC		TESTED	Aug'15	2	
Lobby	12x12 Floor Tile	F12	Removed	TESTED		3	
Canteen Storage	12x12 Floor Tile - Located under cabinets	F12	Removed				3
Canteen	12x12 Floor Tile - Located under cabinets	F12	Good				3
	Drywall Compound	DC					2
Storage Room	12x12 Floor Tile	F12	Good				3
	Drywall Compound						
Women's Washroom	12x12 Floor Tile	F12	Removed	TESTED		0	
	Drywall Compound - Ceiling	DC					2
Men's Washroom	12x12 Floor Tile	F12	Removed	TESTED		0	
	Drywall Compound - Ceiling	DC					2
Block Wall between lobby and ice surface	Vermiculite	VE	Good

Exterior block walls	Randomly inspected & appeared to be empty (Do not contain vermiculite insulation)						
Ice Shed							
Exterior block walls	Vermiculite	VE	Good				
Ice Shed (Southwest section)	Asphalt Plank Floor	APF	Good	TESTED	Oct'12	5
