CLARIFIER 3 BRIDGE - STRUCTURAL CONDITION ASSESSMENT REPORT

January 17, 2018

Subject: *Structural Condition Assessment of Primary Clarifier Travelling Bridge Collector No. 3 at the South End Sewage Treatment Plant, Revision 0*

INSPECTION REPORT

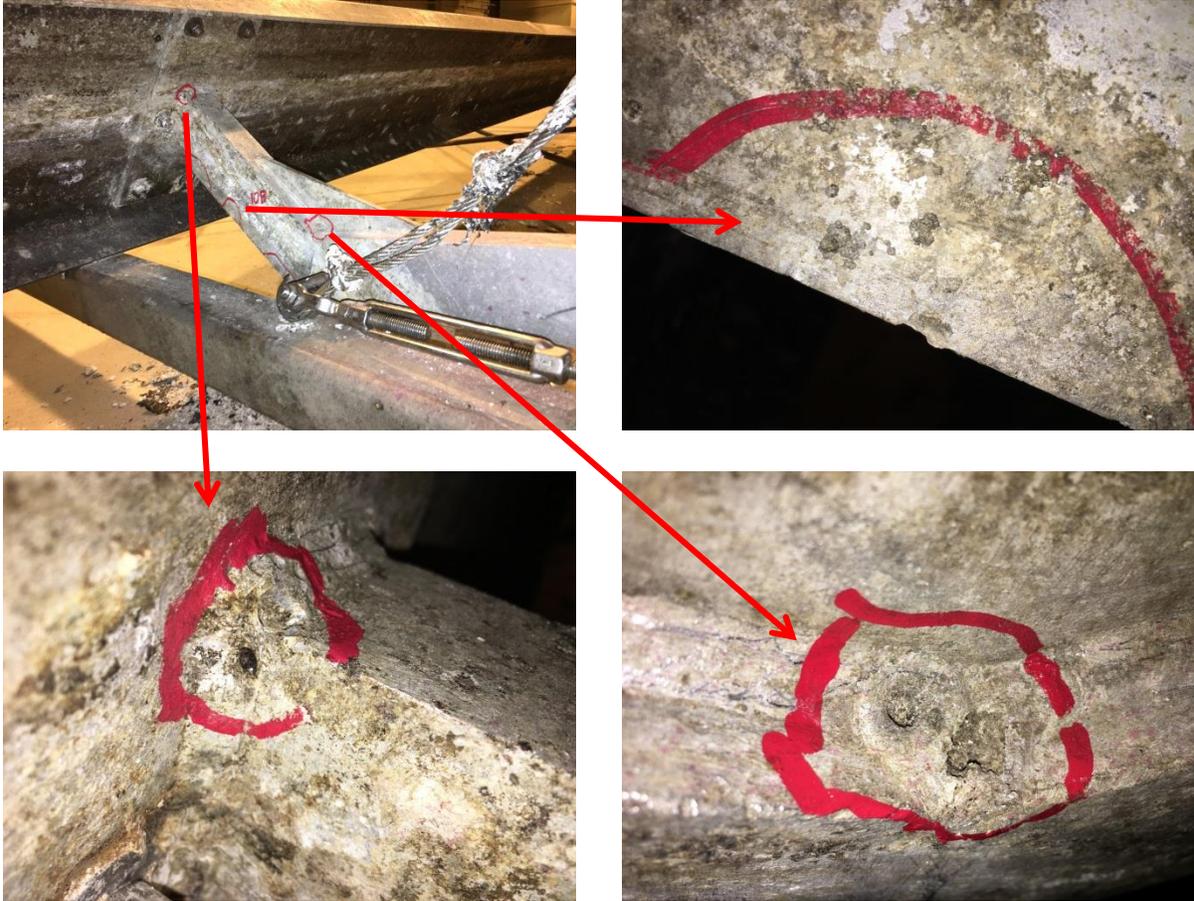
Figure 2: Skimmer Arm Corrosion

The front and rear skimmer arms have undergone extensive corrosion, affecting the main members and the welds at the elbow joint and the connection to the skimmer blade (Figure 2).

Due to the extensive corrosion, both front and rear skimmer arms should be replaced. This is not an immediate concern, but should be addressed within the next 3-5 years.

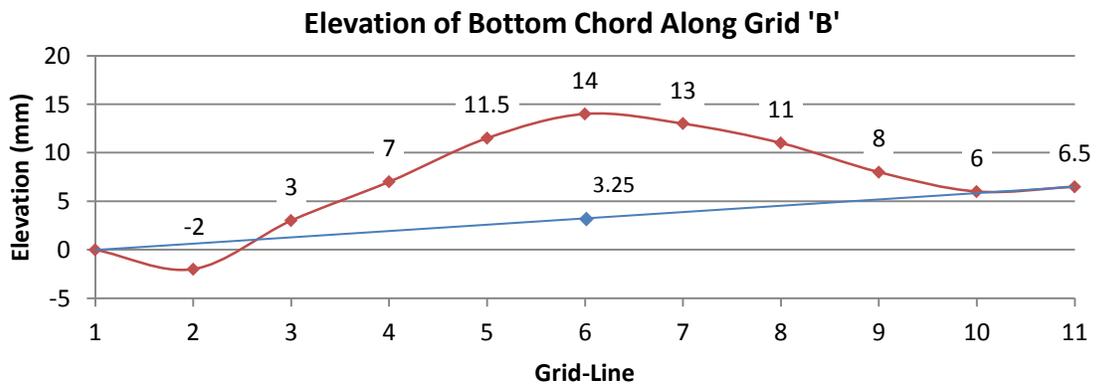
Figure 3: Bottom Chord Elevation

There is an elevation difference of 6.5mm (1/4") between the north and south sides of the bridge collector. The center of the bridge has deformed upwards approximately 10.75mm (7/16") relative to the theoretical straight line between the north and south end.

The 6.5mm difference in elevation between the north and south end-trucks probably did not contribute to the excessive wear or jerky motion, as this measurement was taken from the top of the end-trucks and not the rail. This may be an effect of the wear, rather than a cause.

After the rails are replaced, the top elevation of the end-trucks should be measured again to ensure that they are an equivalent height from their respective tracks and that they are level with respect to the horizontal plane. If they are not, then the wheels should be shimmed accordingly.

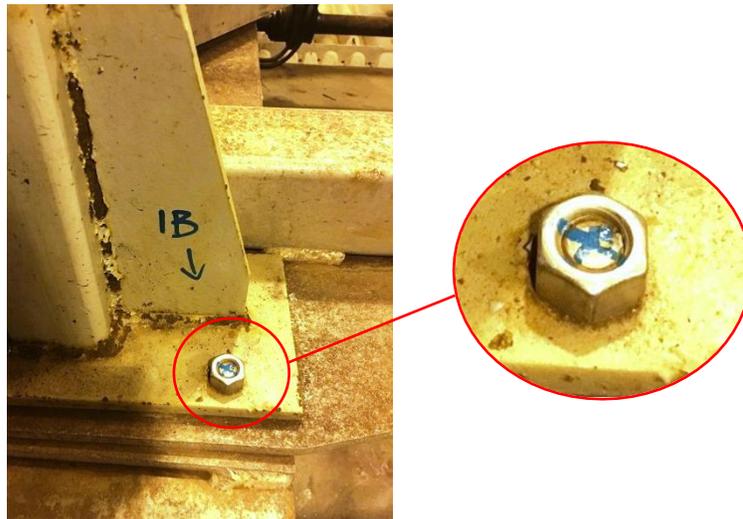
Figure 4: Bolt with Inadequate Length

A few of the bolts that connect the collector bridge to the end trucks were not long enough to bring the ends flush with the nut (Figure 4). This is a minimum requirement for structural bolts.

All bolts that are not long enough to be flush with outside face of the nut should be replaced with longer bolts of the same diameter and grade.

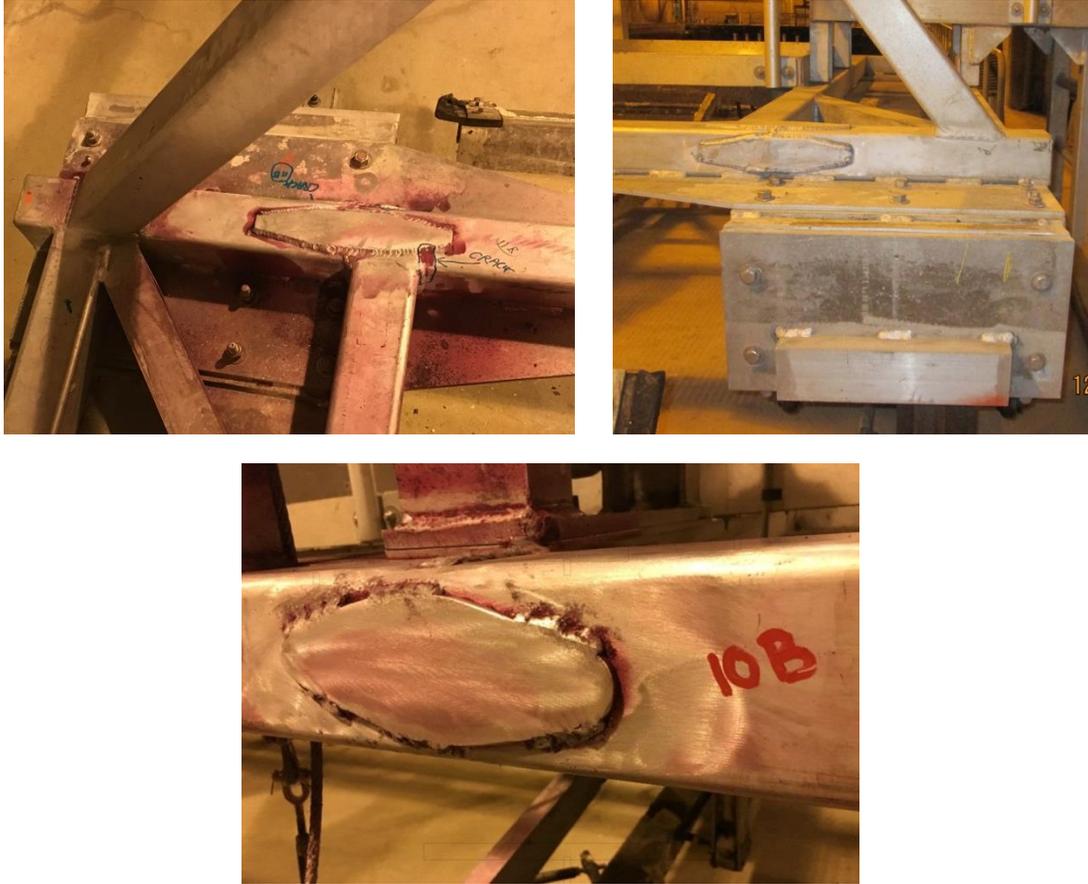
Figure 5: Field-Welded Plates

Three plates were field-welded to the bottom chord along grid 'B' on the south side of the bridge collector (Figure 5). Two were welded on the vertical and horizontal faces of the chord near grid 11. The other one was welded on the vertical face near grid 10.

The field-welded plates on the bottom chord along grid 'b' (Figure 5) should be removed and re-inspected to determine the reason that they were installed. Based on this information, an appropriate solution for reinforcement should be determined by a qualified professional engineer.

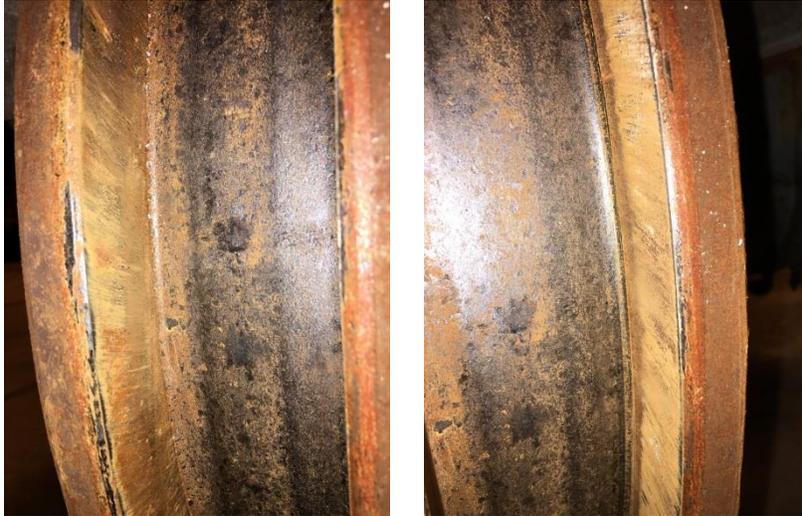
Figure 6: Wear on North End-Truck Wheels

On the north end-truck wheels, significant wear was observed on the interior radii where the flanges meet the bearing surface (Figure 6). One side had substantially more wear than the other. Significant wear was also noticed on the interior side of the top flange on the north rail, starting at the bridge collector's in-service position on the west side of the clarifier (Figure 7). On the south end-truck, approximately 2mm of wear was measured on the non-flanged wheels.

The City of Winnipeg has indicated that it intends to replace the rails, wheels cog-track and cog-wheels in the near future. Installation of the new rails should conform to tolerances specified in the original construction drawings.

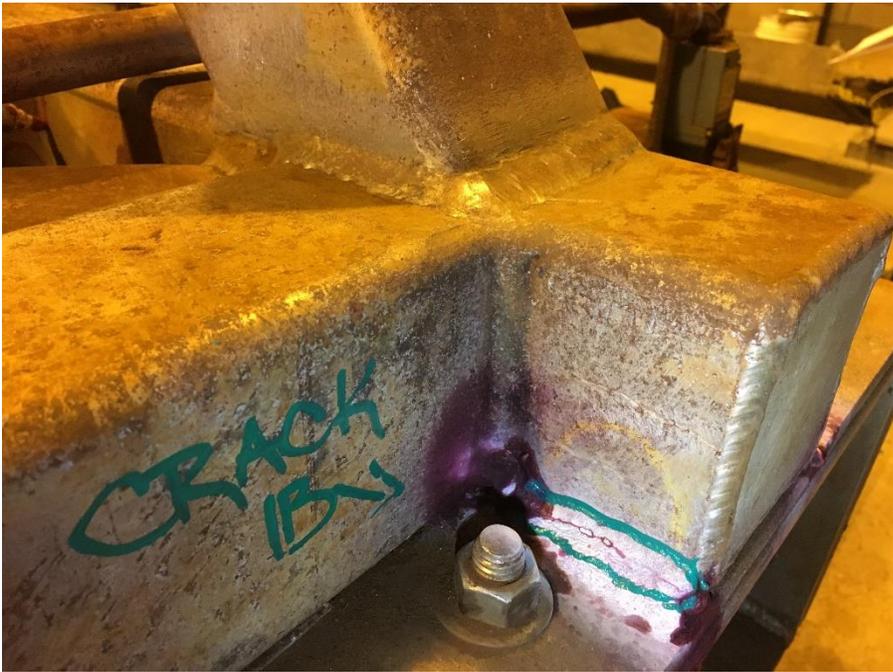
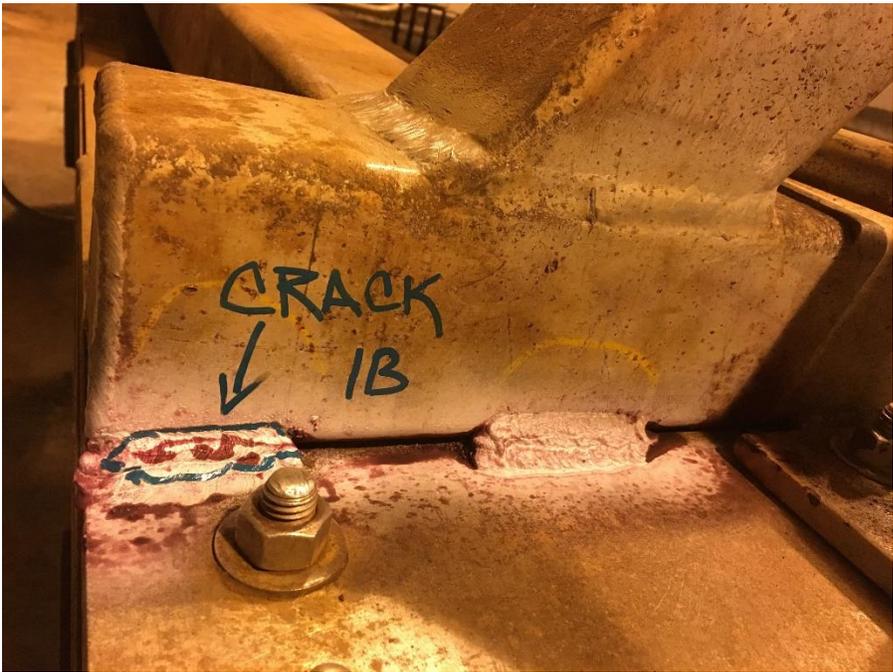
Crack at location 1B

All issues identified in the CQI report should be addressed. Welds should be repaired by a CWB certified welder with appropriate credentials for aluminum welding. The missing weld on grid 9A on the upper tube should be added.

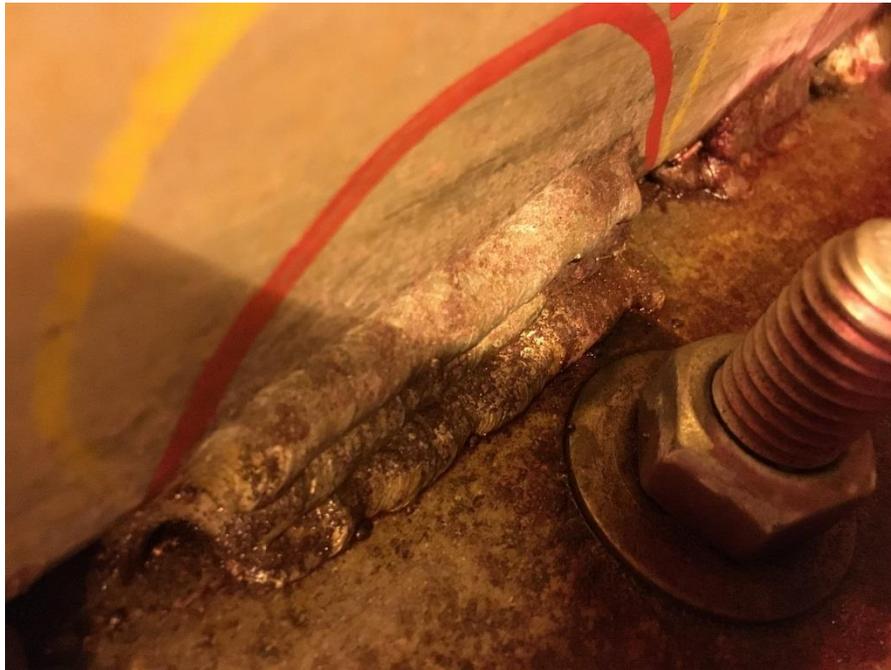
Lack of weld fusion on repair weld at location 1B

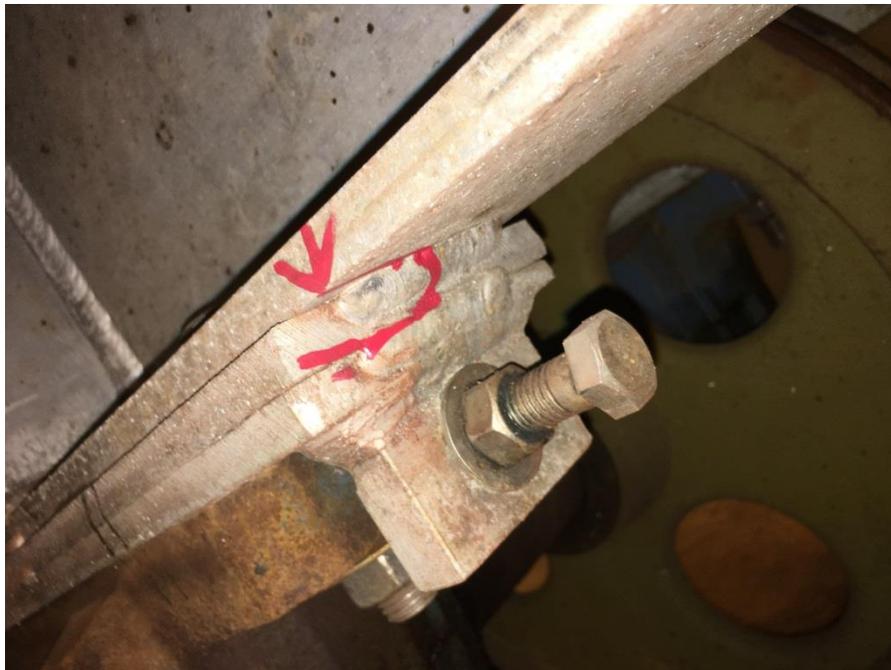
*Cracked bearing mount
plate weld at location 1B*

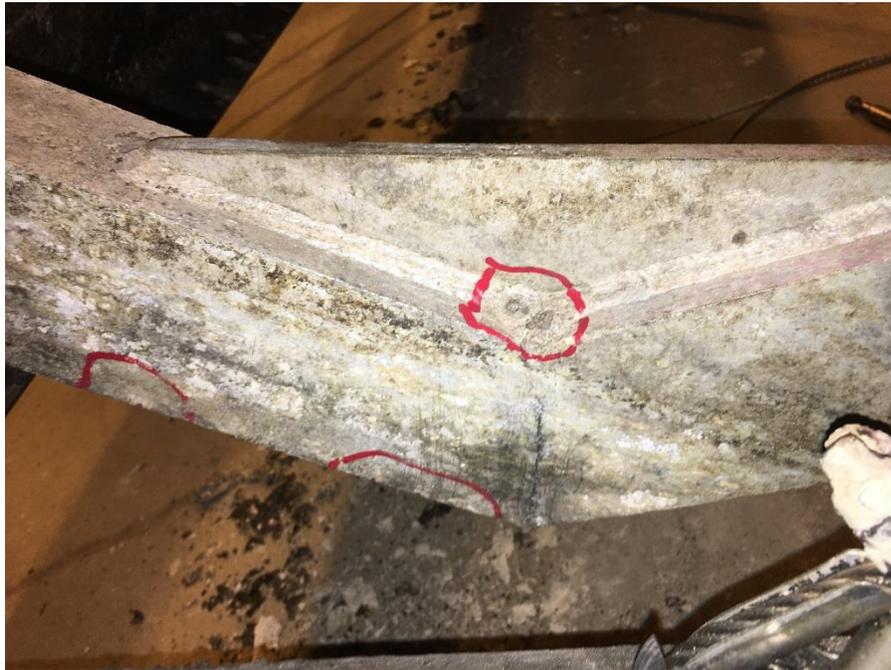
*Photo showing pitted corrosion in scum paddle arm
This is typical to all below water line aluminum members*

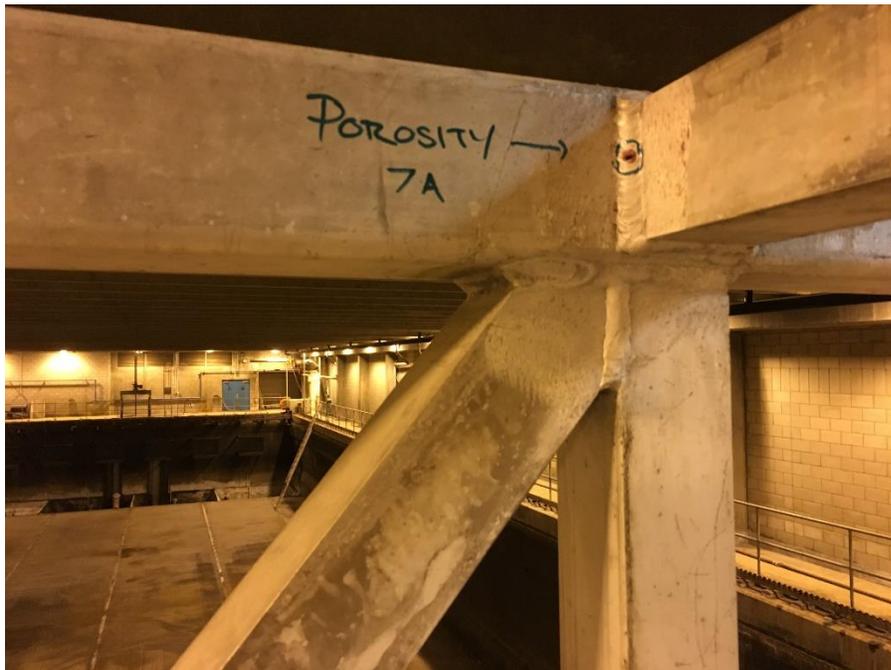
Porosity at location 7A

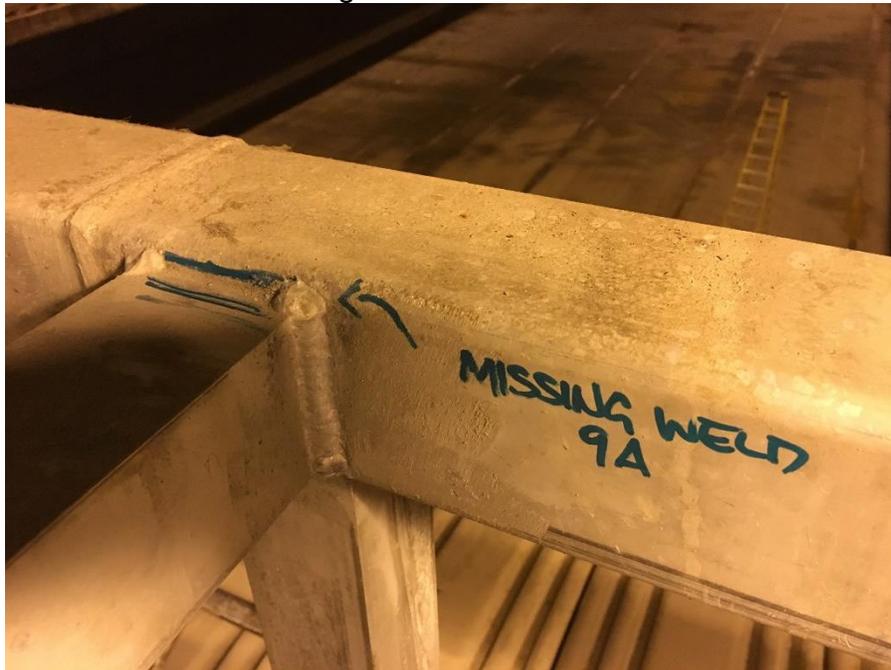
Missing Weld at location 9A

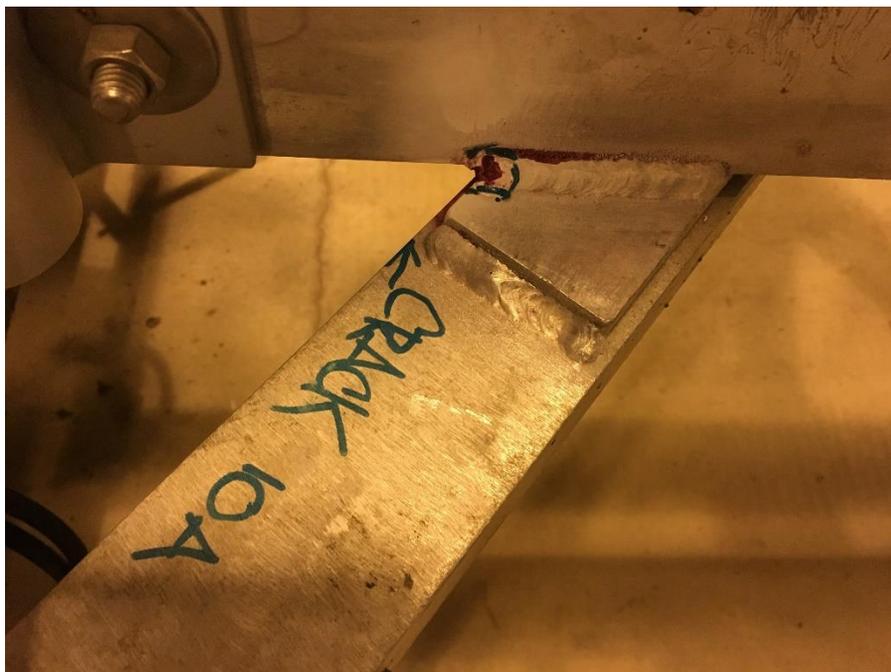
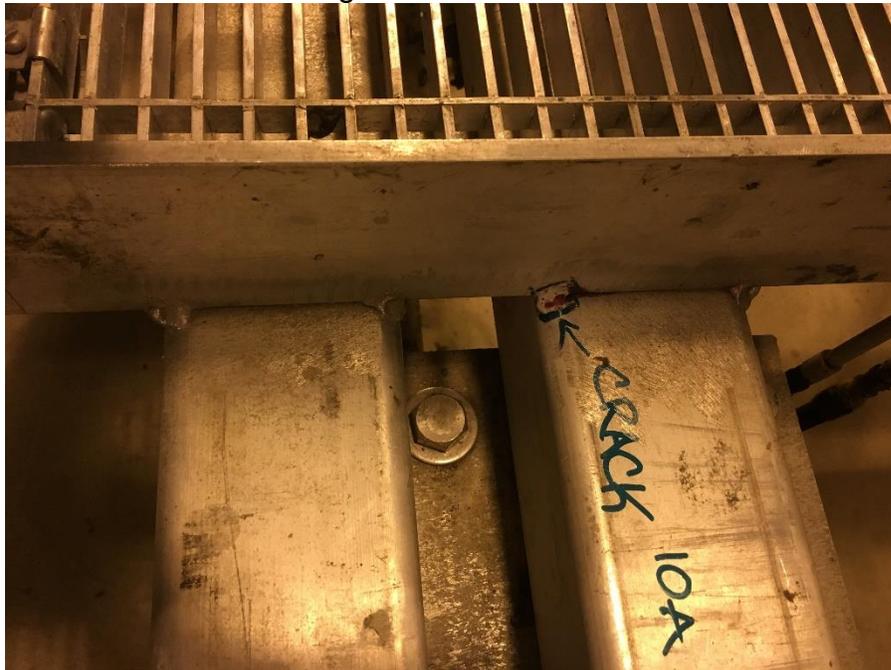
Crack at location 10A

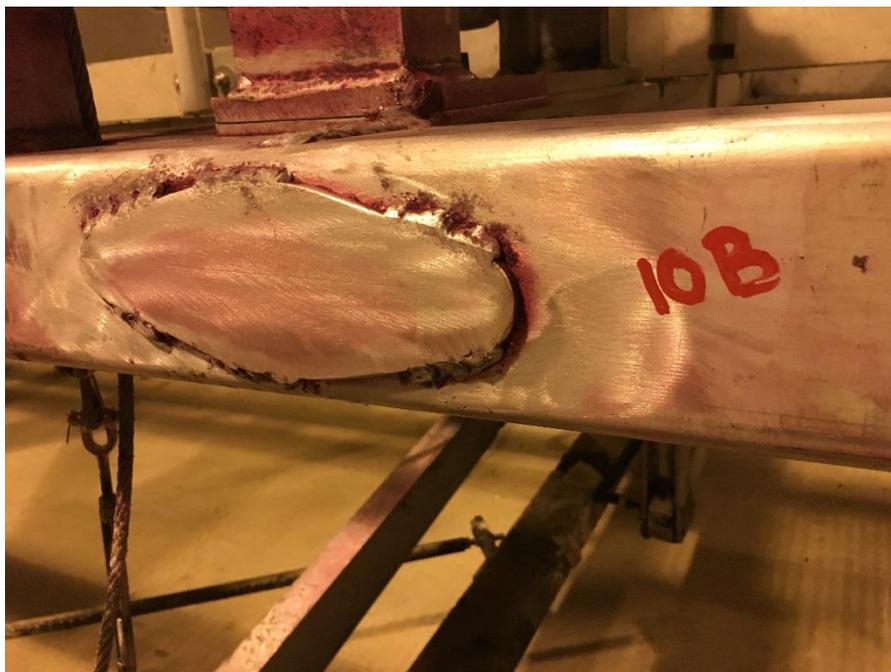
Photo of fish plate at location 10B. Poor weld quality

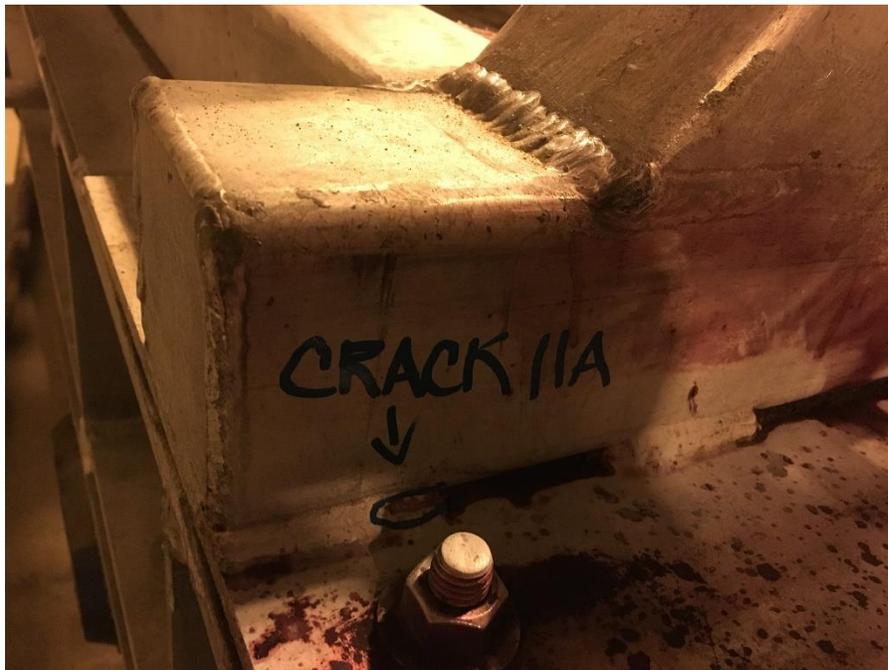
Crack at location 11A

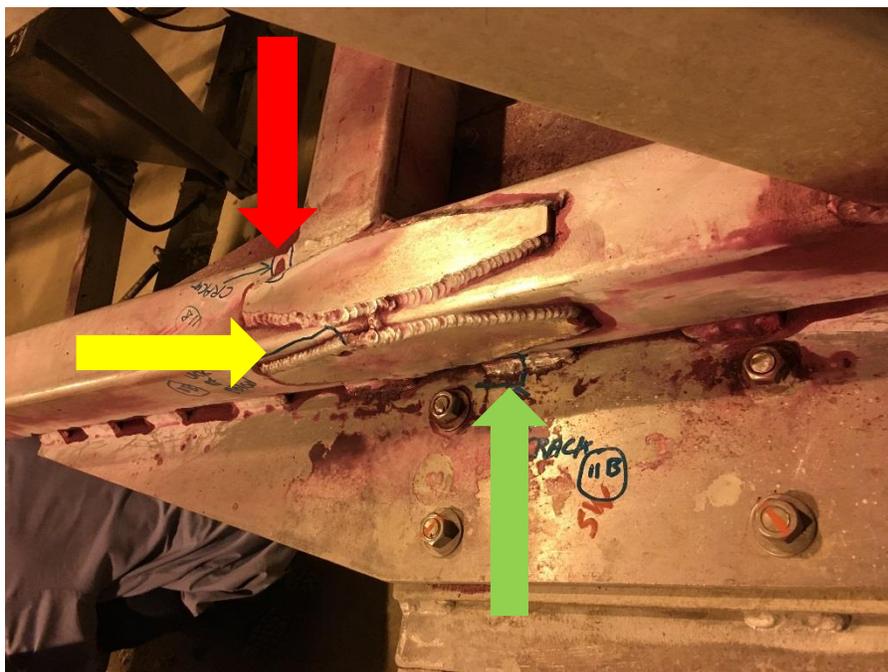
Photo of area 11B Red arrow shows location of crack in parent material yellow arrow shows lack of fusion on fish plate weld and green arrow shows crack on stitch weld. All at location 11B

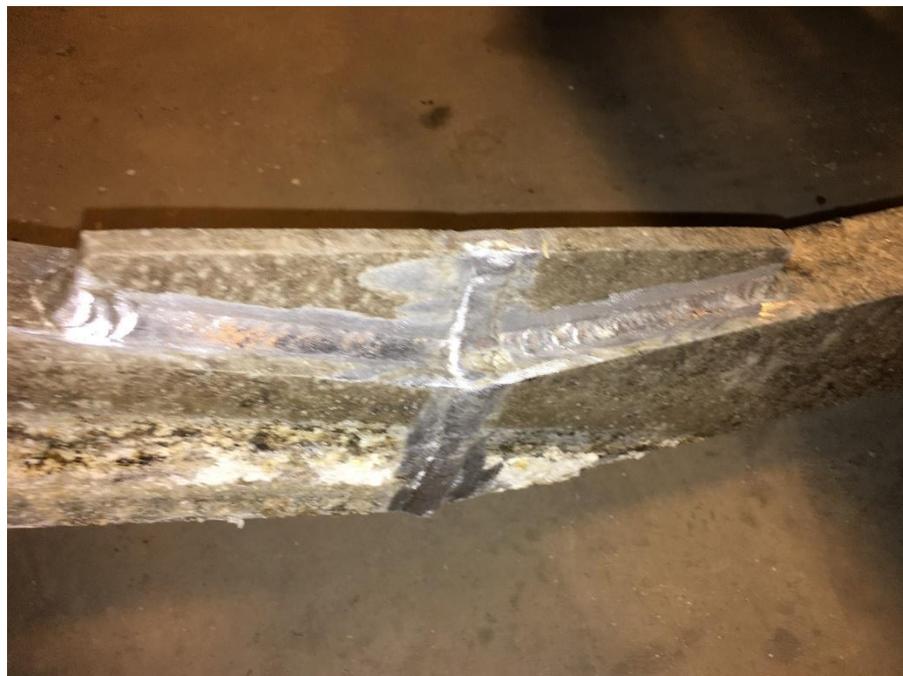
- All welding was found to be acceptable.
- No damage or deformation was found on the above noted items and locations.

Photo showing general condition of welds on Skimmer Arms
