Hazardous Building Materials Assessment of the Baltimore Flood Pumping Station

APRIL 17, 2018
ISSUED FOR REVIEW
FILE: 734-1800120700-REP-V0001-A

The City of Winnipeg
Corporate Finance Department
Materials Management Division
185 King Street, Main Floor
Winnipeg, MB R3B 1J1

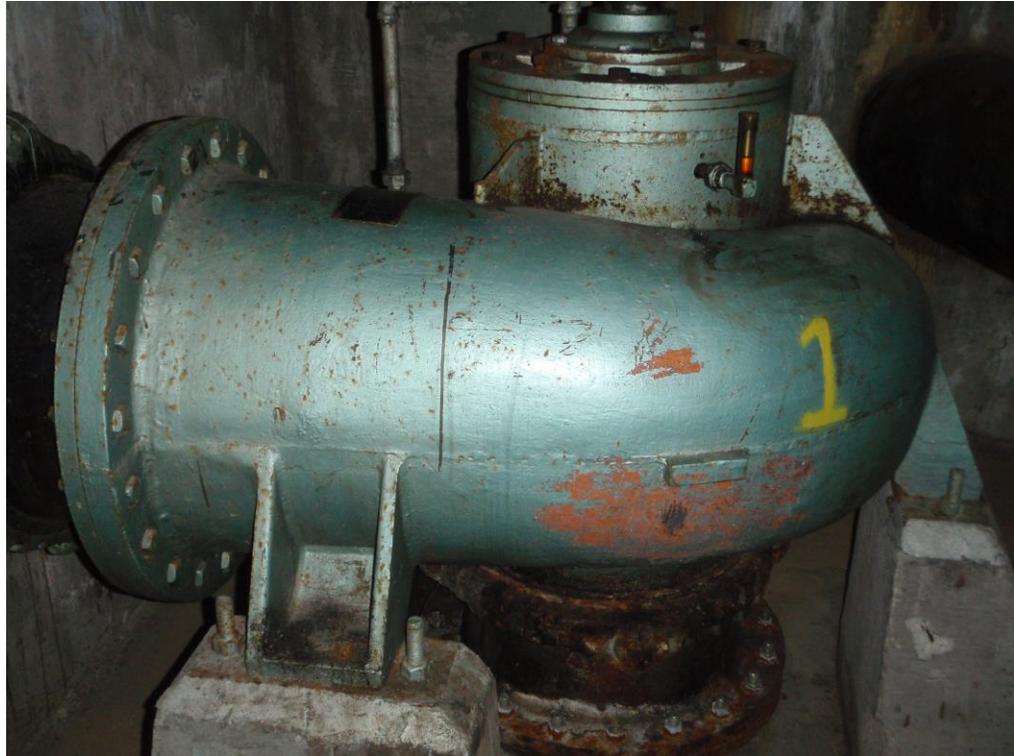
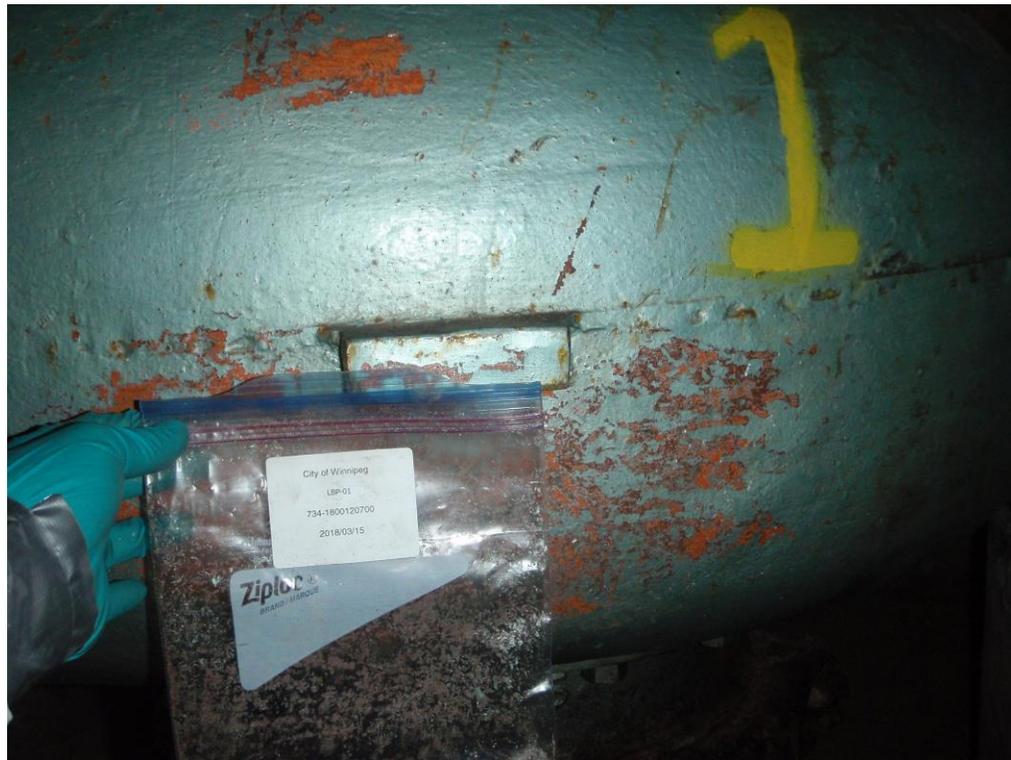
Photo 5: General view of pump 1 in the dry well. (March 15, 2018)

Photo 6: General view of paint chip sample LBP-01 location on pump 1 in the dry well. (March 15, 2018)

| Sample ID | Date Sampled | Material Description | General Condition | Paint Chip Samples | |
|--|---|--|---|---|---|
| LBP-01 | 15-Mar-18 | Green paint - pump 1 at bottom of dry well | Fair - some paint flaking due to corrosion at joints. (Photos 5 & 6) | 35 100 | 1.44 |

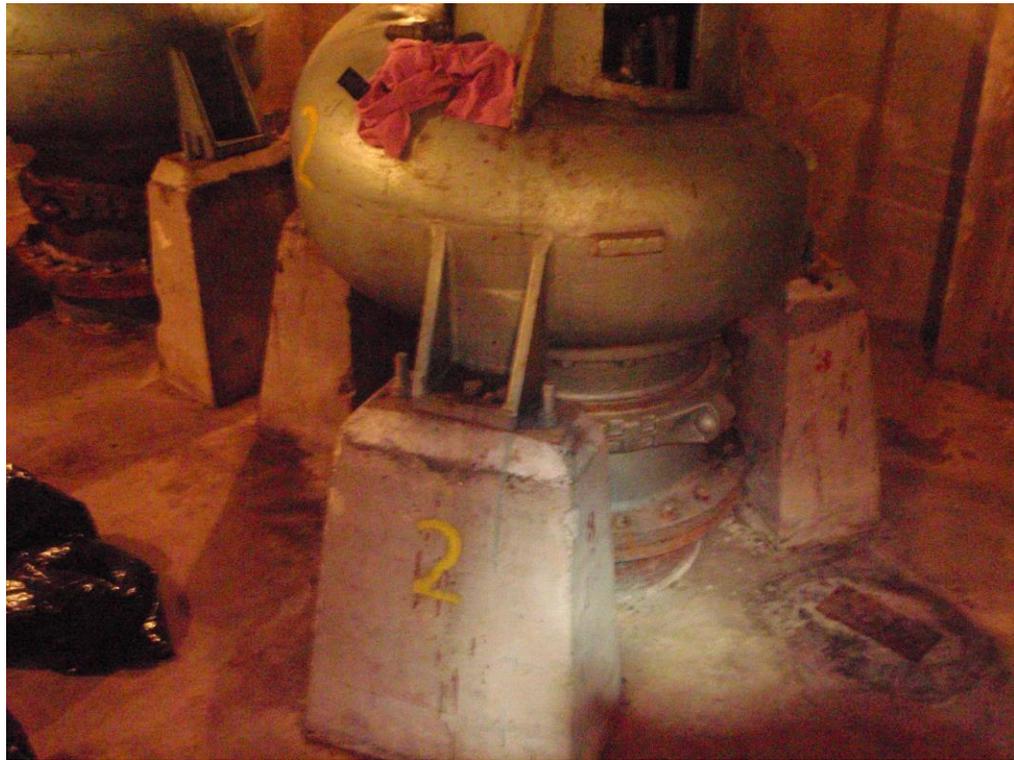
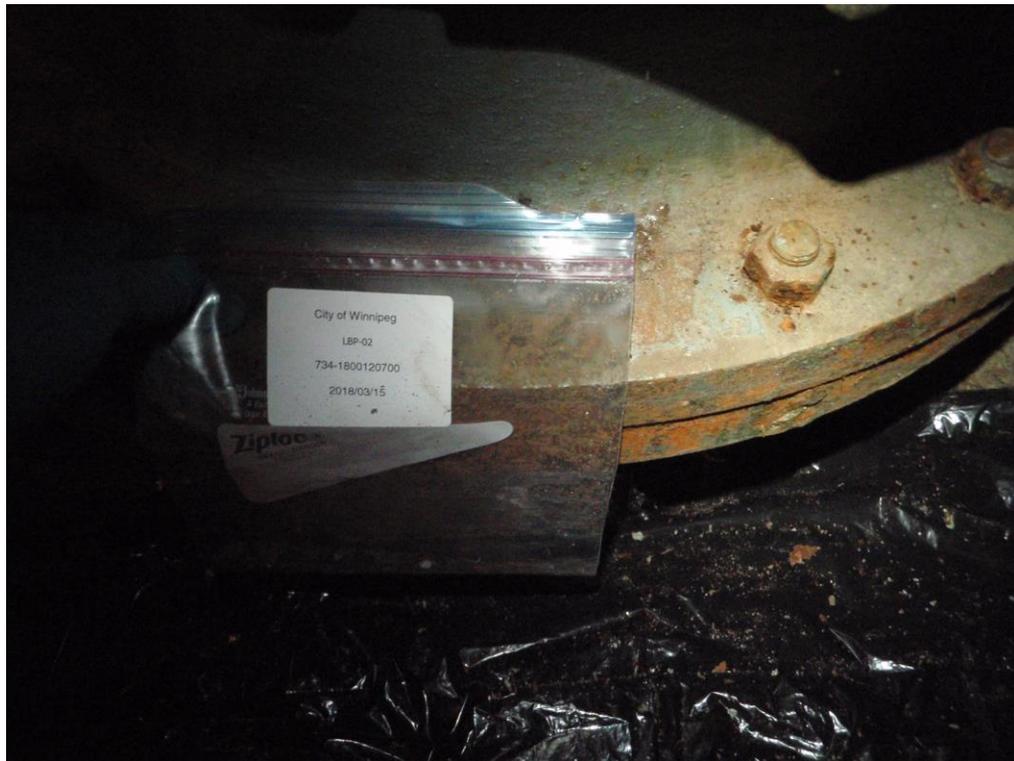
Photo 7: General view of pump 2 in the dry well. (March 15, 2018)

Photo 8: General view of the paint chip sample LBP-02 location on pump 2 in the dry well. (March 15, 2018)

| Sample ID | Date Sampled | Material Description | General Condition | Paint Chip Samples | |
|--|---|--|---|---|---|
| LBP-02 | 15-Mar-18 | Green paint - pump 2 at bottom of dry well | Fair - some paint flaking due to corrosion at joints. (Photos 7 & 8) | 9220 | 1.51 |

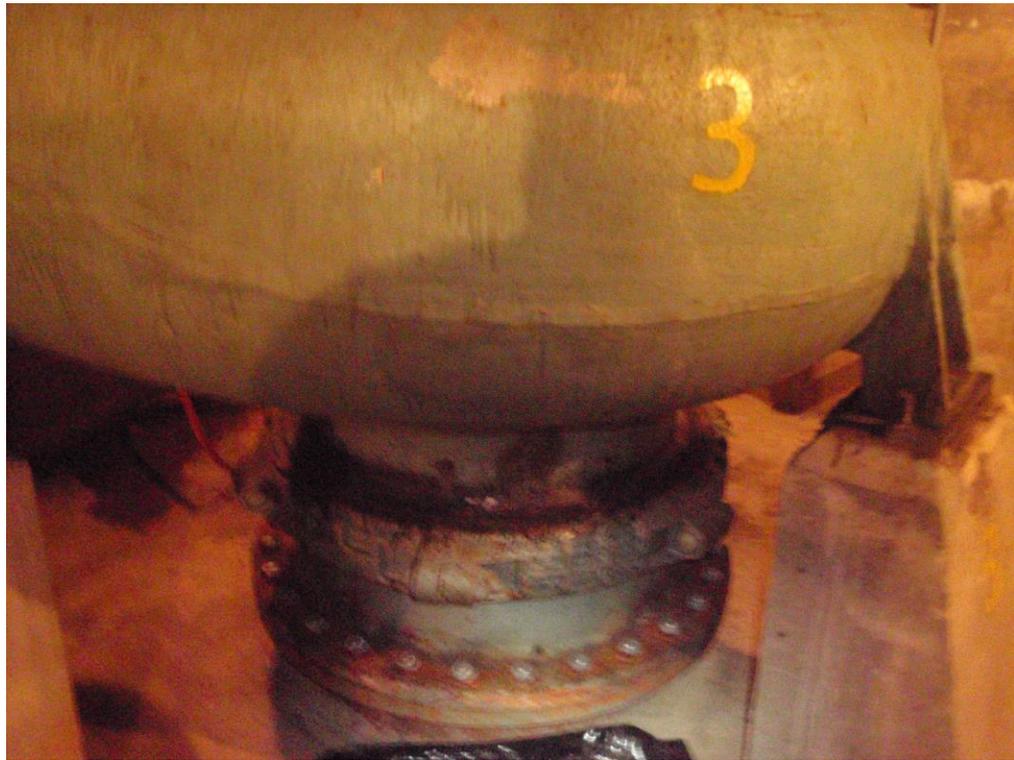
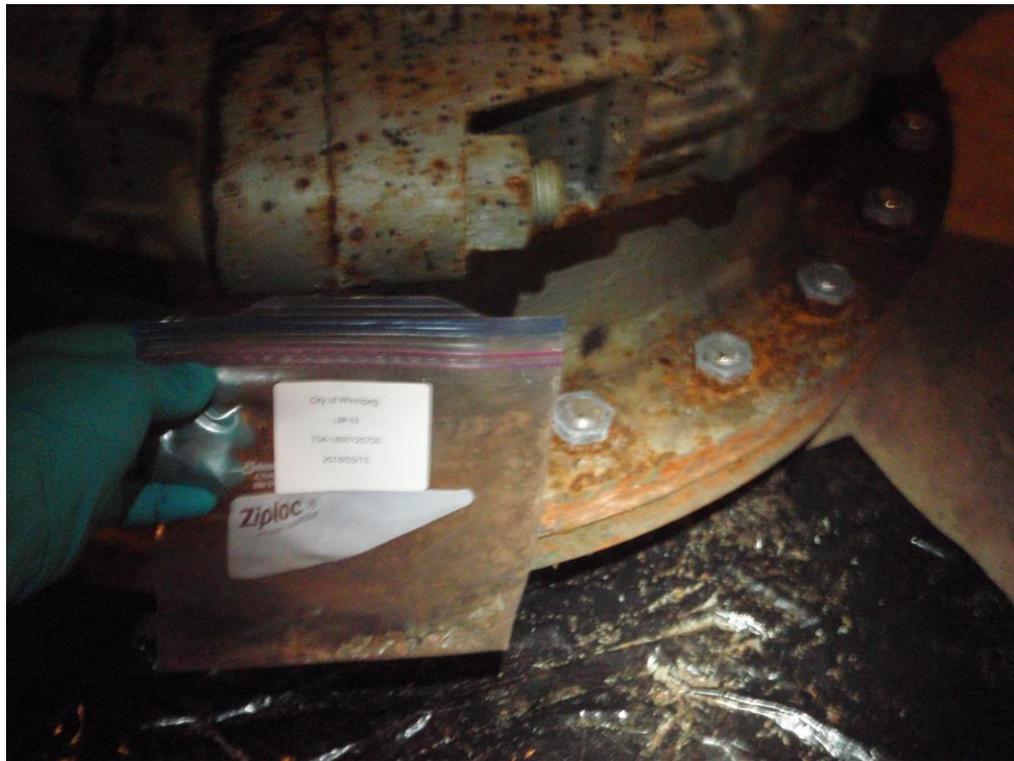
Photo 9: General view of pump 3 in the dry well. (March 15, 2018)

Photo 10: General view of paint chip sample LBP-03 location on pump 3 in the dry well. (March 15, 2018)

| Sample ID | Date Sampled | Material Description | General Condition | Paint Chip Samples | |
|--|---|--|---|---|---|
| LBP-03 | 15-Mar-18 | Green paint - pump 3 at bottom of dry well | Fair - some paint flaking due to corrosion at joints. (Photos 9 & 10) | 38 800 | 0.448 |

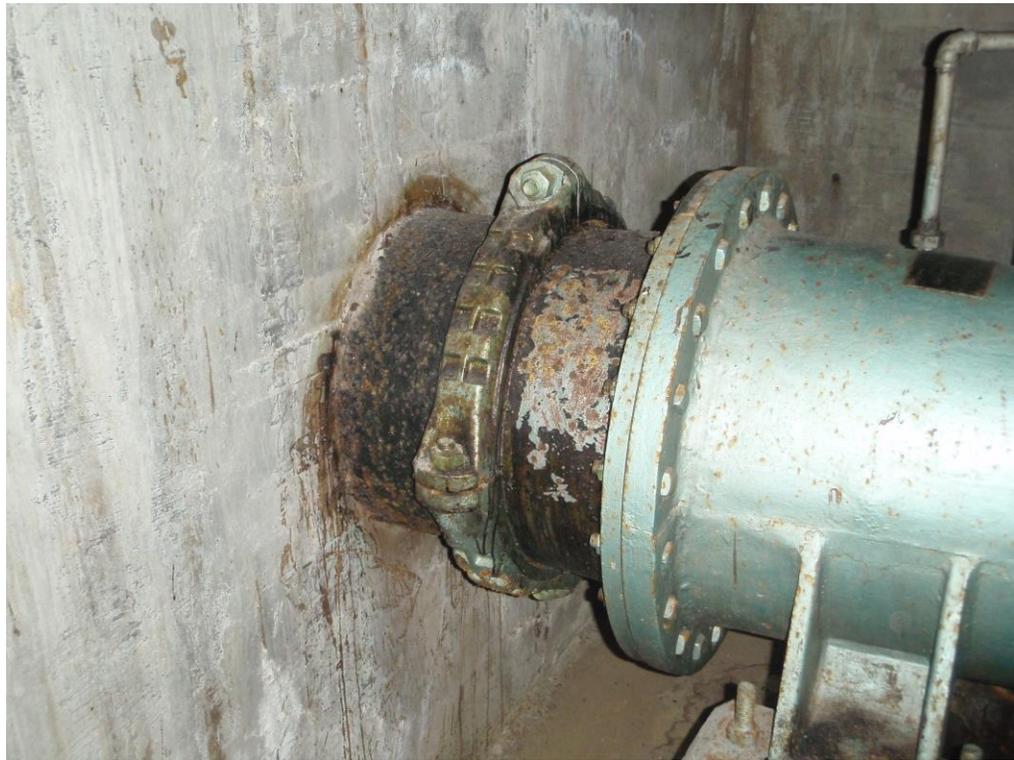
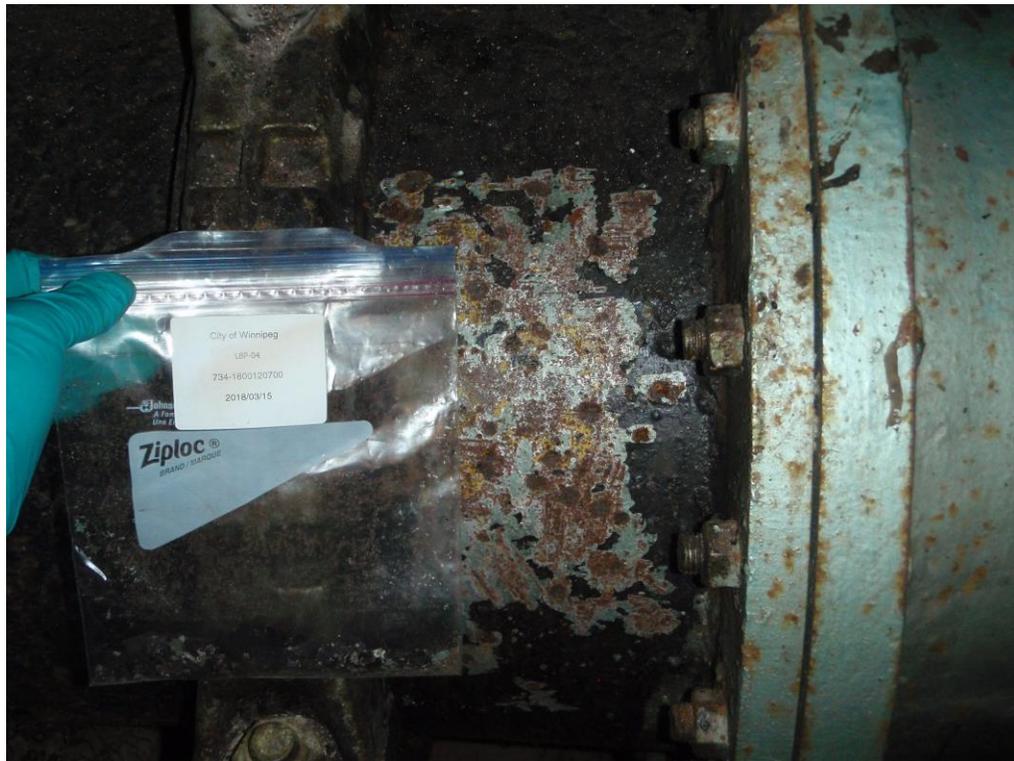
Photo 11: General view of the piping for pump 1 in the dry well. (March 15, 2018)

Photo 12: General view of paint chip sample LBP-04 location on the piping for pump 1 in the dry well. (March 15, 2018)

| Sample ID | Date Sampled | Material Description | General Condition | Paint Chip Samples | |
|--|---|--|---|---|---|
| LBP-04 | 15-Mar-18 | Black paint - pump 1 at bottom of dry well | Fair - some flaking due to pitting and corrosion of steel pipe. (Photos 11 & 12) | 4940 | 0.437 |

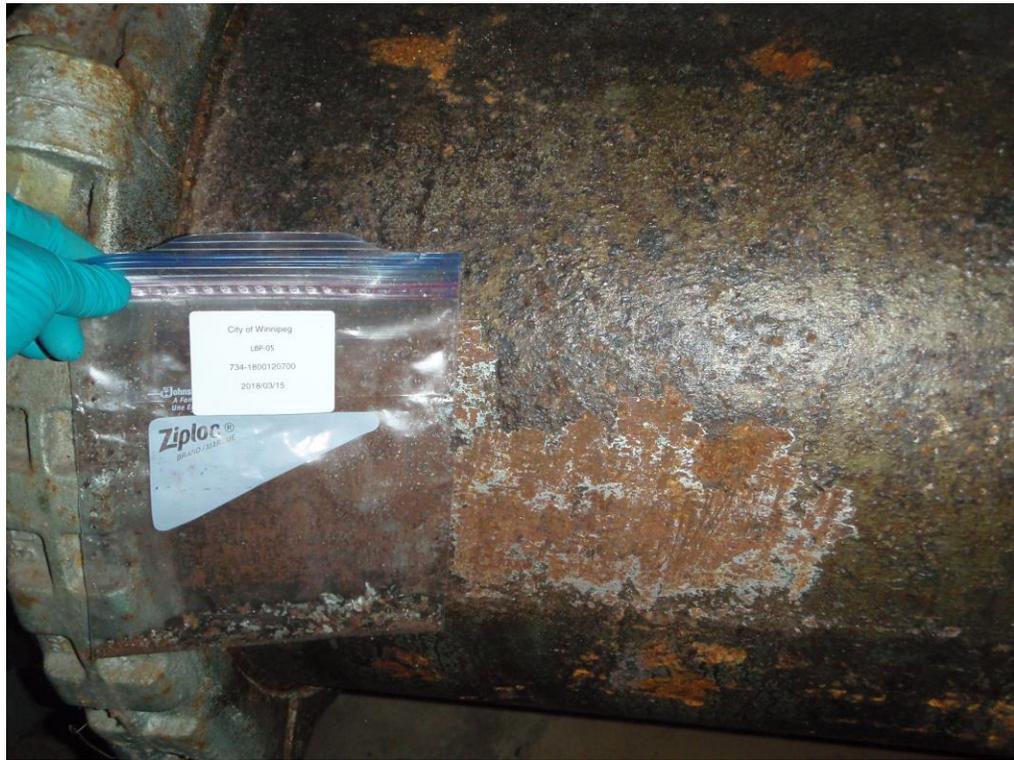
Photo 13: General view of paint chip sample location LBP-05 on the piping for pump 2 in the dry well. (March 15, 2018)

| Sample ID | Date Sampled | Material Description | General Condition | Paint Chip Samples | |
|--|---|--|---|---|---|
| LBP-05 | 15-Mar-18 | Black paint - pump 2 at bottom of dry well | Fair - some flaking due to pitting and corrosion of steel pipe. (Photo 13) | 12 100 | 0.896 |

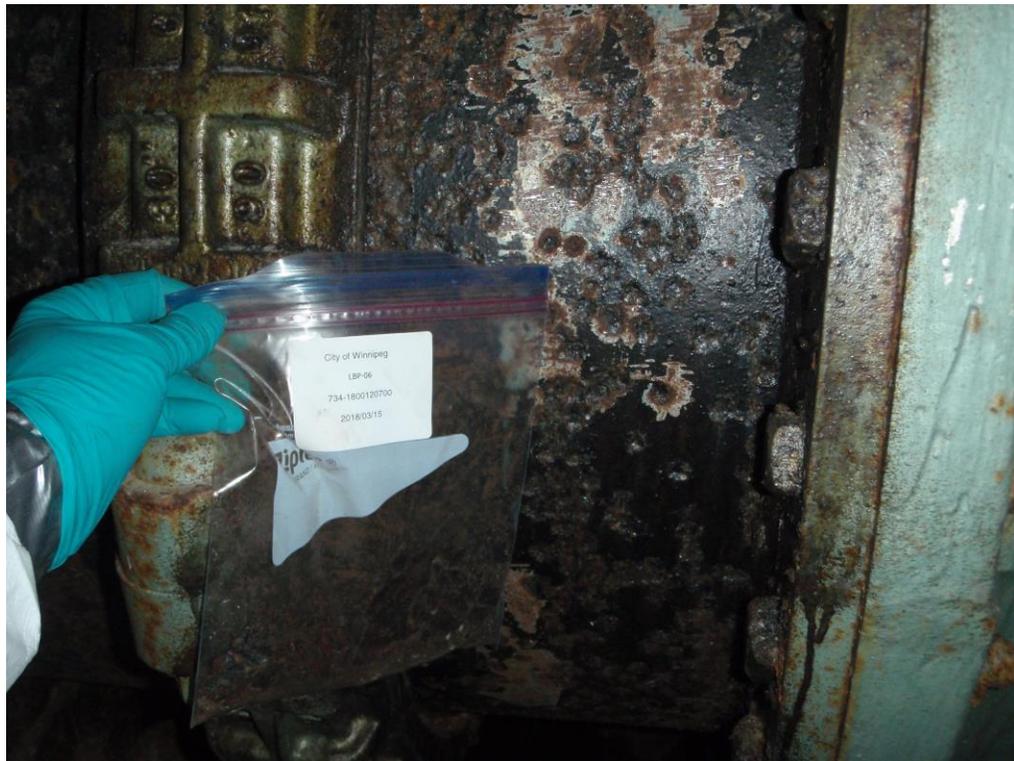
Photo 14: General view of paint chip sample LBP-06 location on the piping for pump 3 in the dry well. (March 15, 2018)

| Sample ID | Date Sampled | Material Description | General Condition | Paint Chip Samples | |
|--|---|--|---|---|---|
| LBP-06 | 15-Mar-18 | Black paint - pump 3 at bottom of dry well | Fair - some flaking due to pitting and corrosion of steel pipe. (Photo 14) | 1690 | 0.135 |

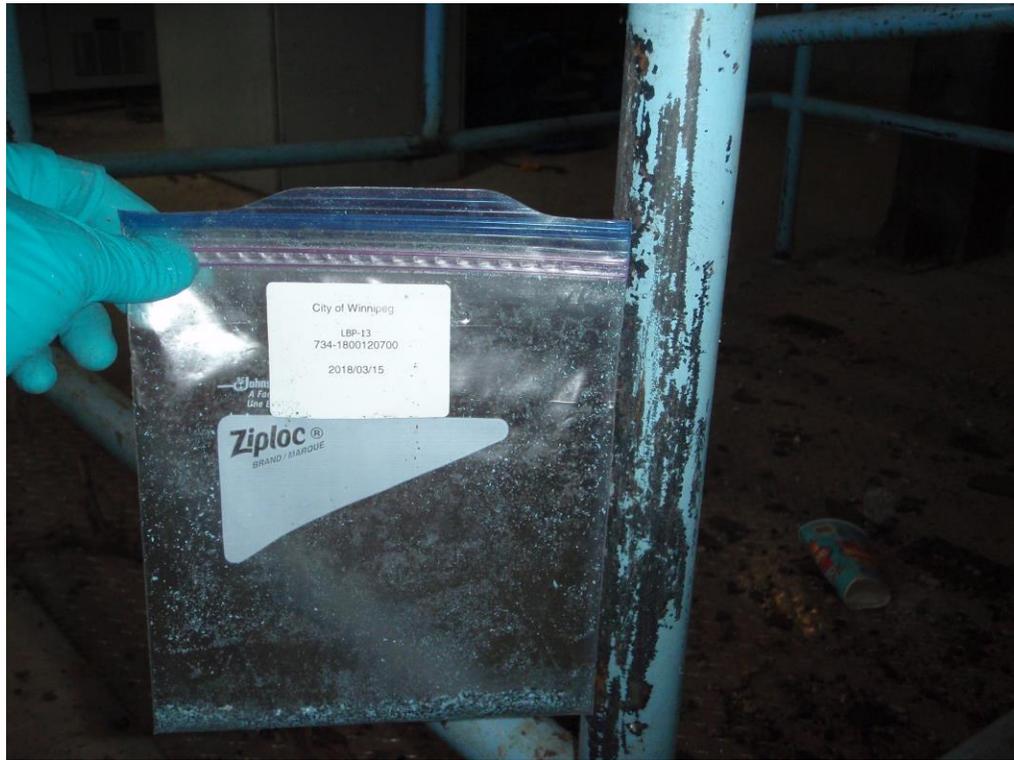
Photo 21: General view of paint chip sample LBP-13 location on the railing near the centre of the main level. (March 15, 2018)

| Sample ID | Date Sampled | Material Description | General Condition | Paint Chip Samples | |
|--|---|--|---|---|---|
| LBP-13 | 15-Mar-18 | Blue paint - railing near 2 and 3 on main floor | Fair - extensive physical wear (Photo 21) | 1180 | 0.793 |

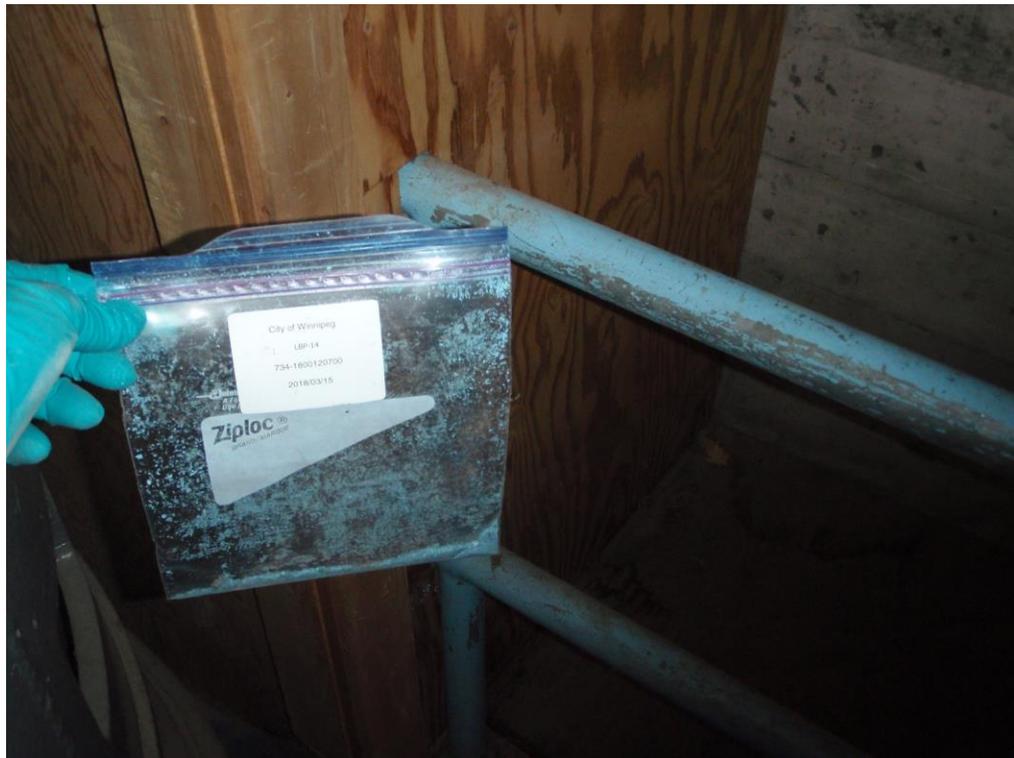
Photo 22: General view of paint chip sample LBP-14 location on the railing near the southwest corner of the main level. (March 15, 2018)

| Sample ID | Date Sampled | Material Description | General Condition | Paint Chip Samples | |
|--|---|--|---|---|---|
| LBP-14 | 15-Mar-18 | Blue paint - railing near southwest corner on main floor | Fair - extensive physical wear (Photo 22) | 1200 | 2.64 |

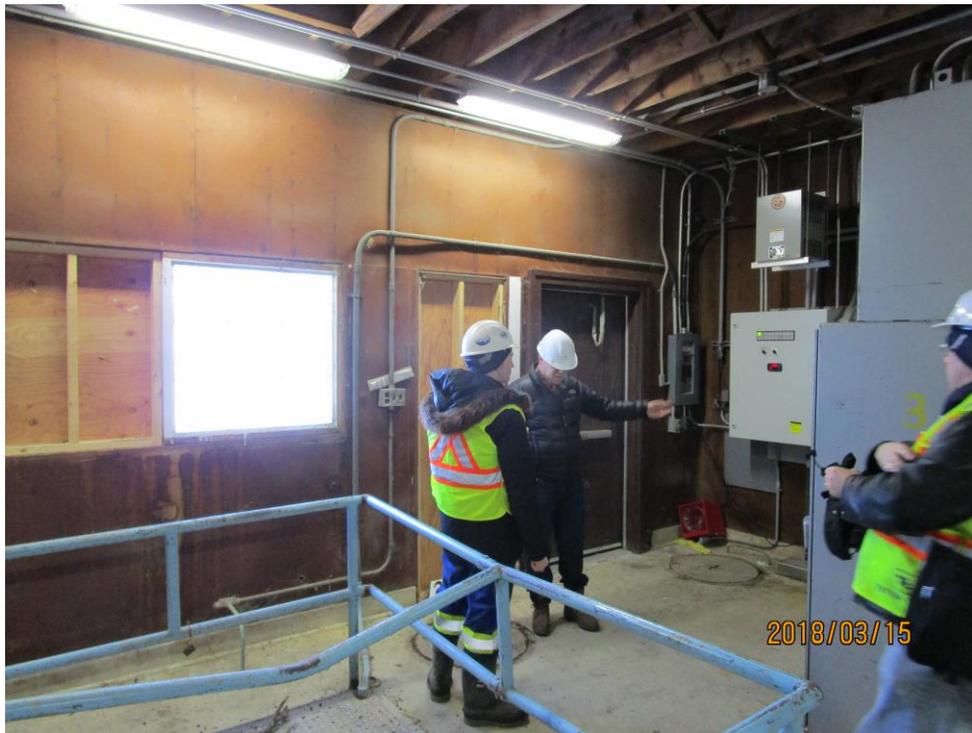
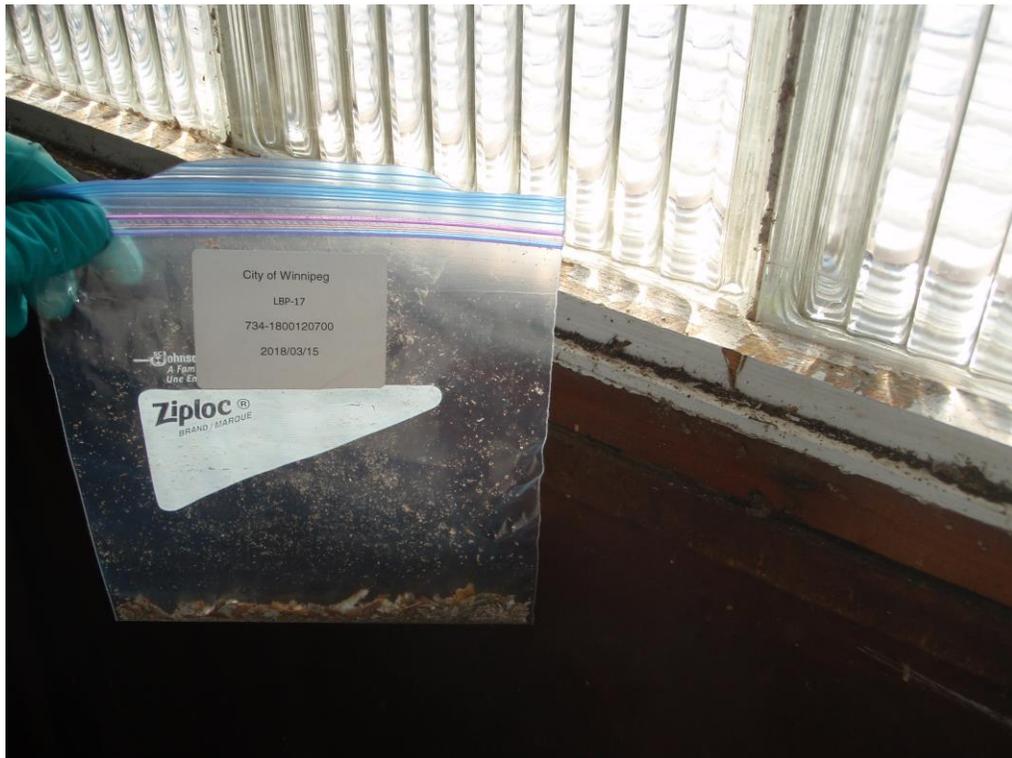
Photo 27: General view of the window in the west wall of the main level. (March 15, 2018)

Photo 28: General view of paint chip sample LBP-17 location on the frame around the window along the west side of the main level. (March 15, 2018)

| Sample ID | Date Sampled | Material Description | General Condition | Paint Chip Samples | |
|--|---|--|---|---|---|
| LBP-17 | 15-Mar-18 | White paint - frame around window along west wall of the main floor | Fair - weathering and water damage. (Photos 27 & 28) | 898 | 61.5 |

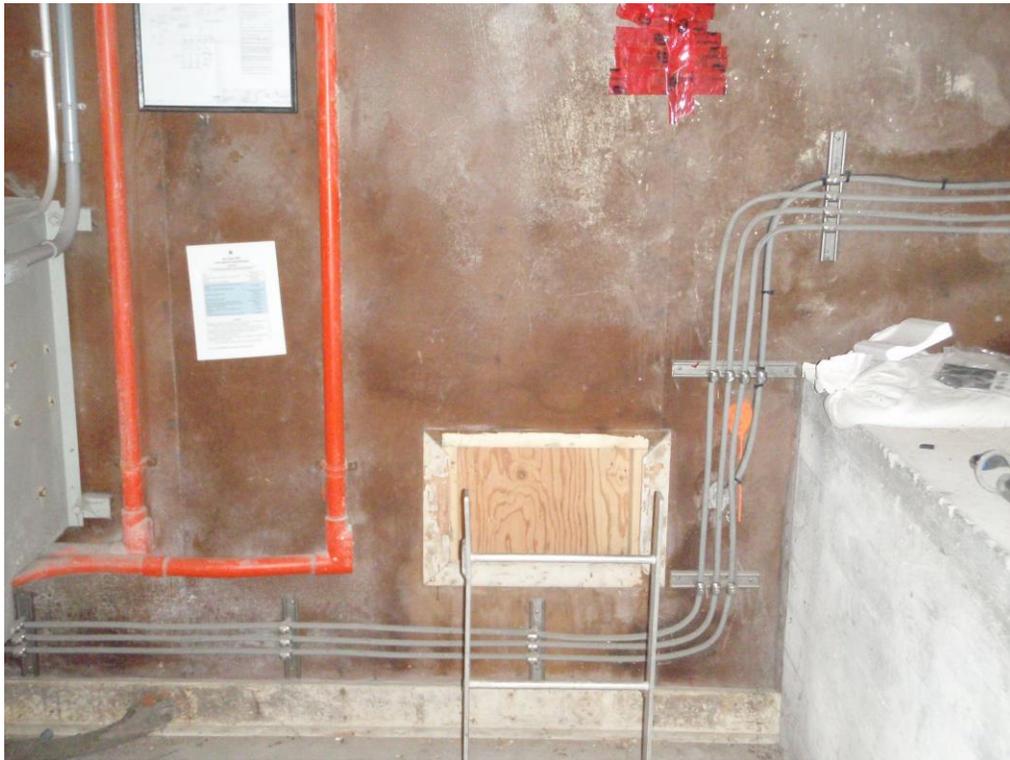
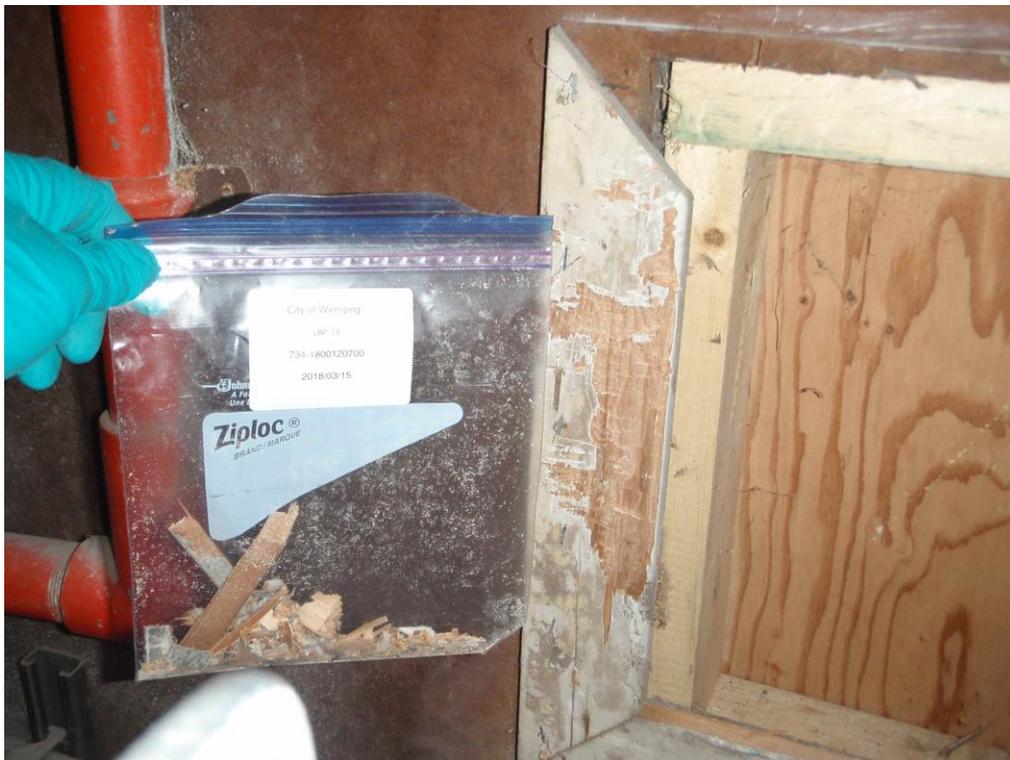
Photo 29: General view of the boarded opening on the north wall of the main level.
(March 15, 2018)

Photo 30: General view of paint chip sample LBP-18 location on the frame around the boarded opening on the north wall of the main level (March 15, 2018)

| Sample ID | Date Sampled | Material Description | General Condition | Paint Chip Samples | |
|--|---|--|---|---|---|
| LBP-18 | 15-Mar-18 | White paint - frame around boarded opening near electrical panels on the north wall and baseboards | Poor - only partially frames opening and extensive physical damage (photos 29 and 30) | 4340 | 2.69 |

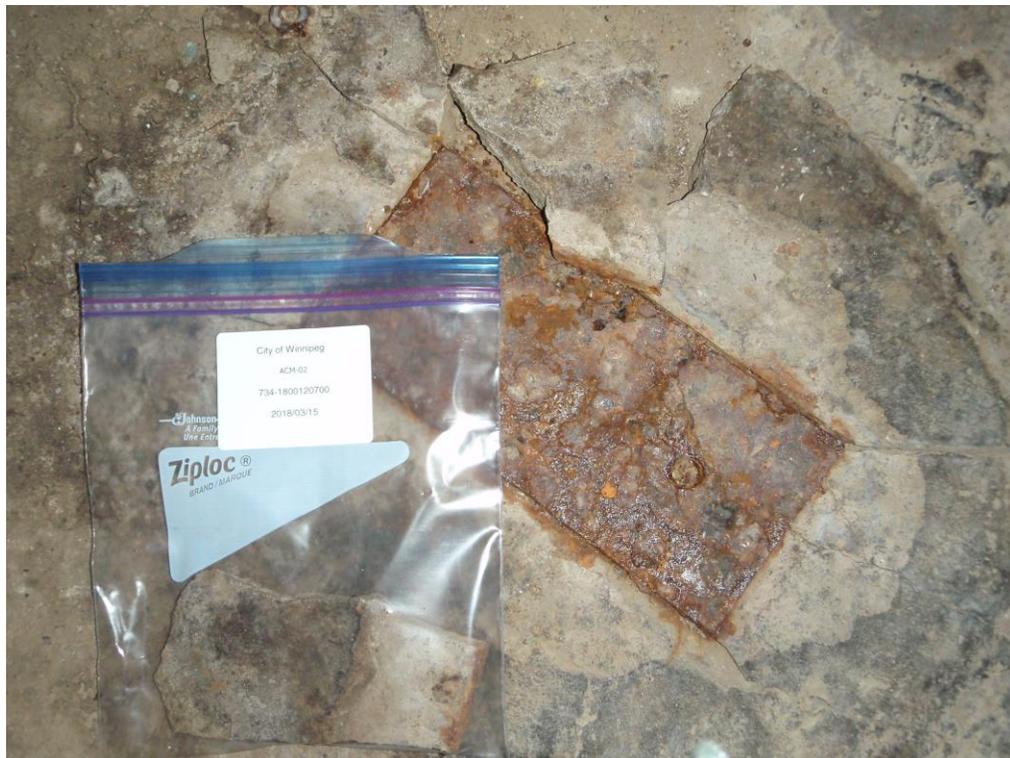
Photo 36: General view of bulk material sample ACM-02 location from the joint compound around a steel plate in the floor between pumps 2 and 3 in the dry well. (March 15, 2018)

| Sample ID | Date Sampled | Material Description | General Classification | General Condition | Asbestos Content (%) |
|--|---|--|---|---|---|
| ACM-02 | 15-Mar-18 | Concrete filler around metal plate on floor of dry well between pumps 2 and 3. | Non-Friable | Poor - extensive cracking and some missing portions. (Photo 36) | <1 |

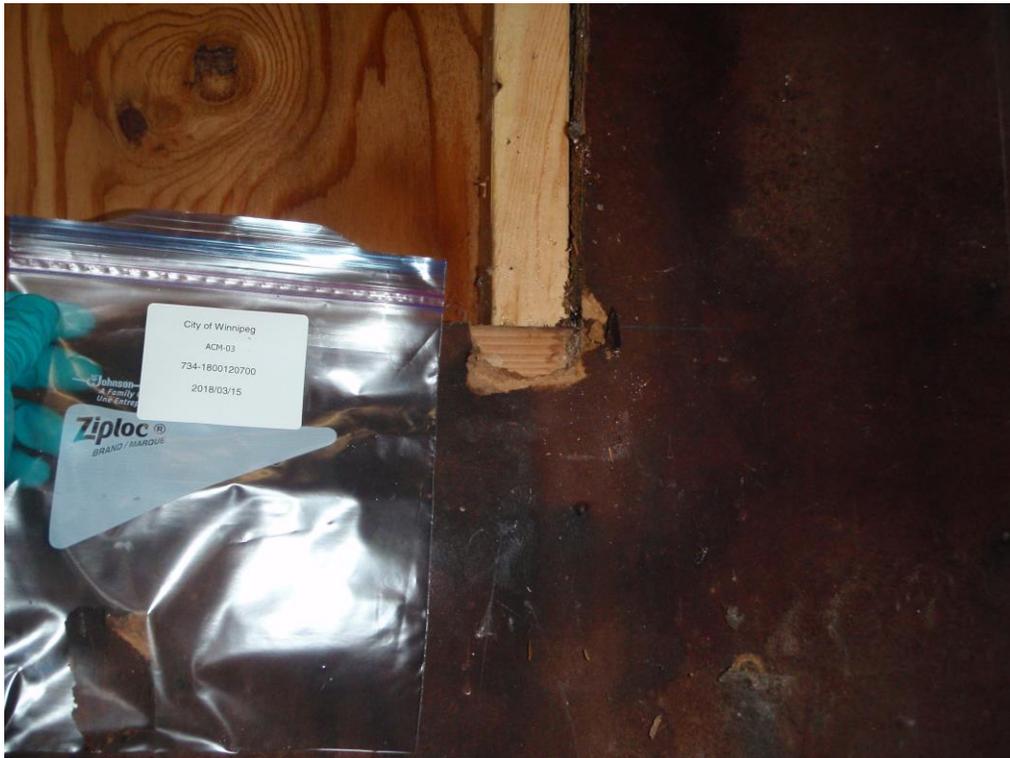
Photo 37: General view of bulk material sample ACM-03 location from the brown press board paneling on the east wall of the main level. (March 15, 2018)

| Sample ID | Date Sampled | Material Description | General Classification | General Condition | Asbestos Content (%) |
|--|---|--|---|---|---|
| ACM-03 | 15-Mar-18 | Brown press board on the east wall of the main floor. | Non-Friable | Fair - some minor physical damage and water staining. (Photos 3 & 37) | <1 |

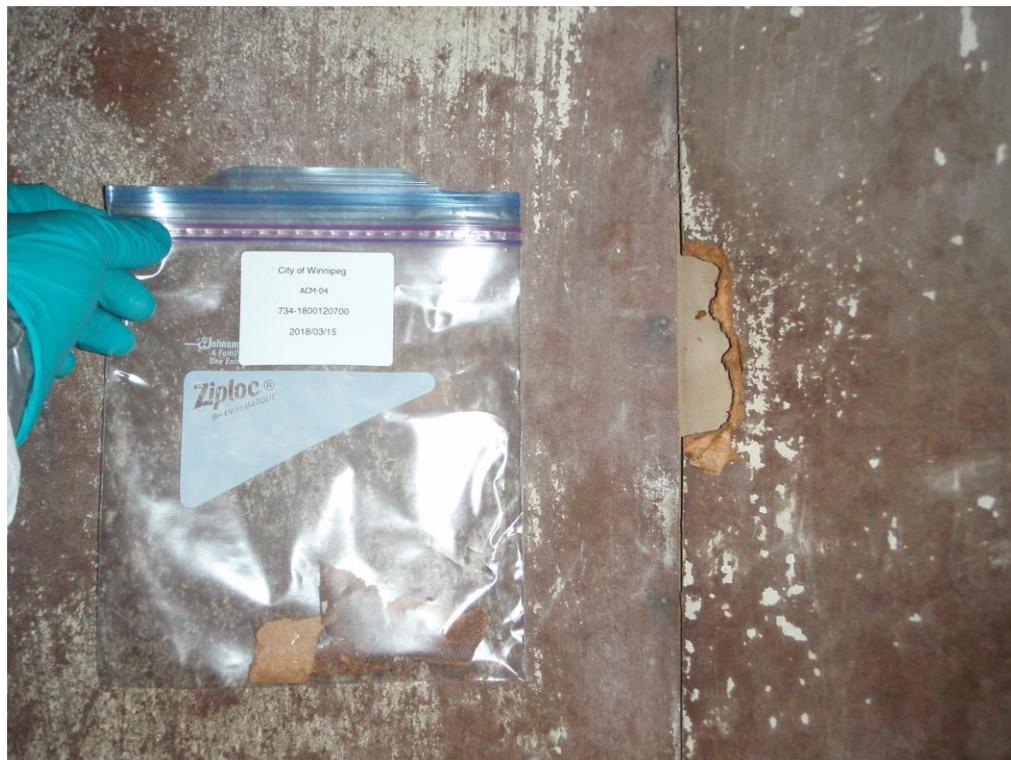
Photo 38: General view of bulk material sample ACM-04 location from the brown press board paneling on the north wall of the main level. (March 15, 2018)

| Sample ID | Date Sampled | Material Description | General Classification | General Condition | Asbestos Content (%) |
|--|---|--|---|---|---|
| ACM-04 | 15-Mar-18 | Brown press board on the north wall of the main floor. | Non-Friable | Fair - some minor physical damage and water staining. (Photos 2 & 38) | <1 |

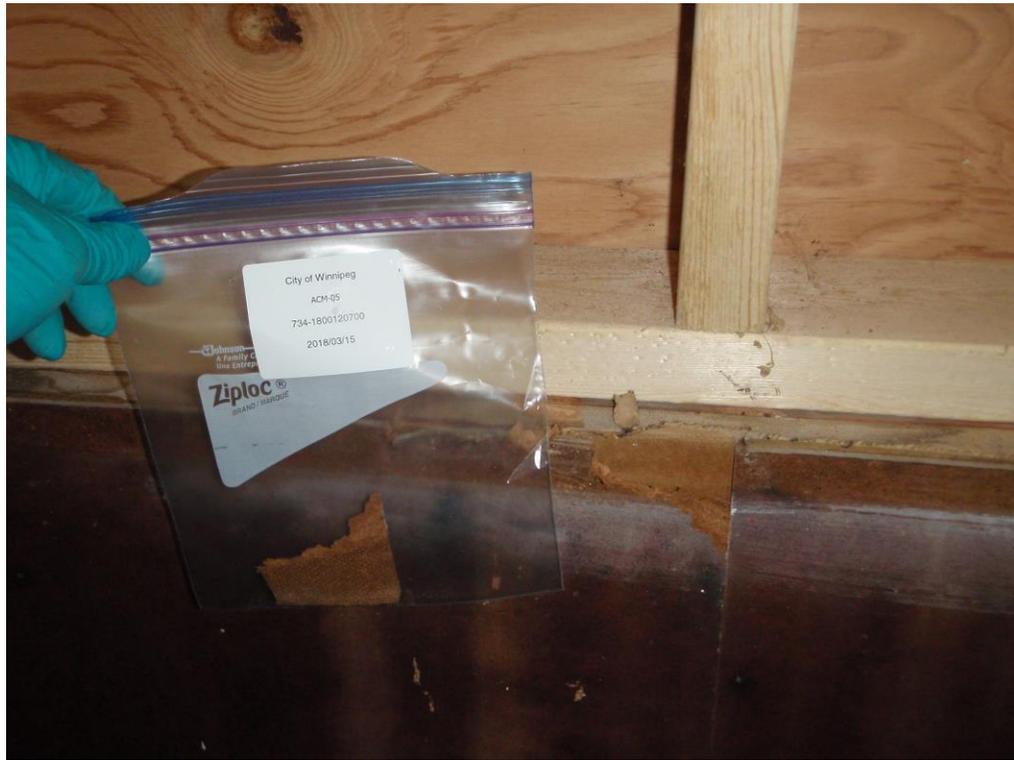
Photo 39: General view of bulk material sample ACM-05 location from the brown press board paneling on the west wall of the main level. (March 15, 2018)

| Sample ID | Date Sampled | Material Description | General Classification | General Condition | Asbestos Content (%) |
|--|---|--|---|---|---|
| ACM-05 | 15-Mar-18 | Brown press board on the west wall of the main floor. | Non-Friable | Fair - some minor physical damage and water staining. (Photos 27 & 39) | <1 |

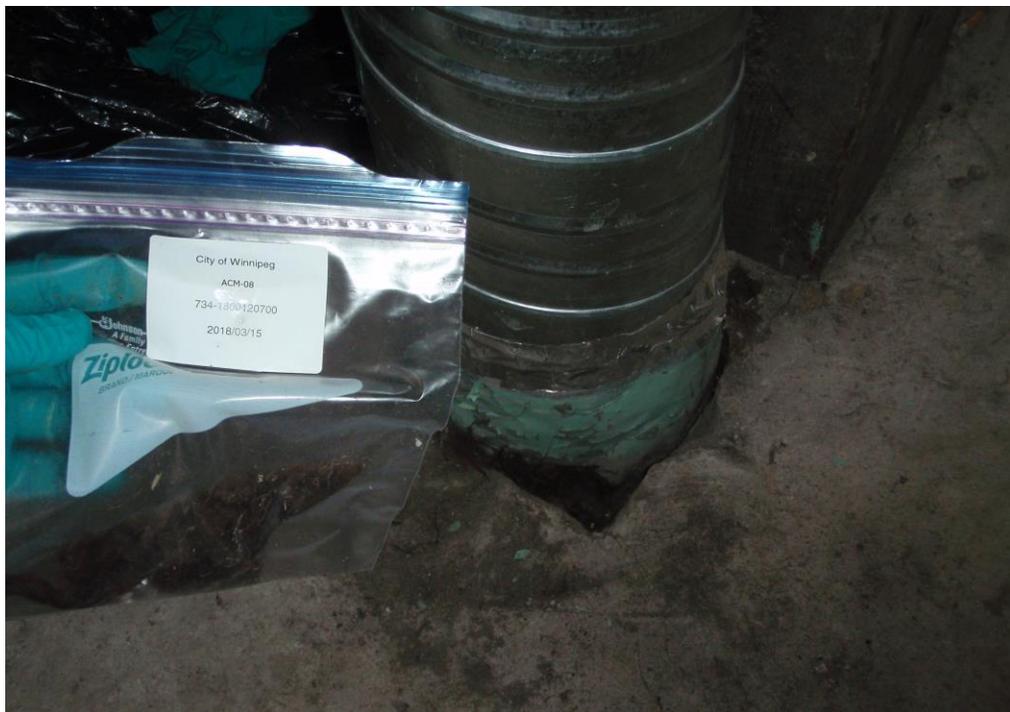
Photo 42: General view of bulk material sample ACM-08 location from the loose fibre insulation from the floor gap around the duct near the centre of the main level. (March 15, 2018)

| Sample ID | Date Sampled | Material Description | General Classification | General Condition | Asbestos Content (%) |
|--|---|--|---|---|---|
| ACM-08 | 15-Mar-18 | Loose fibre insulation from the floor gap around the duct in the center of the main floor. | Friable | Poor - coarse, dirty hair like substance with limited sealing capability. (Photo 42) | <1 |

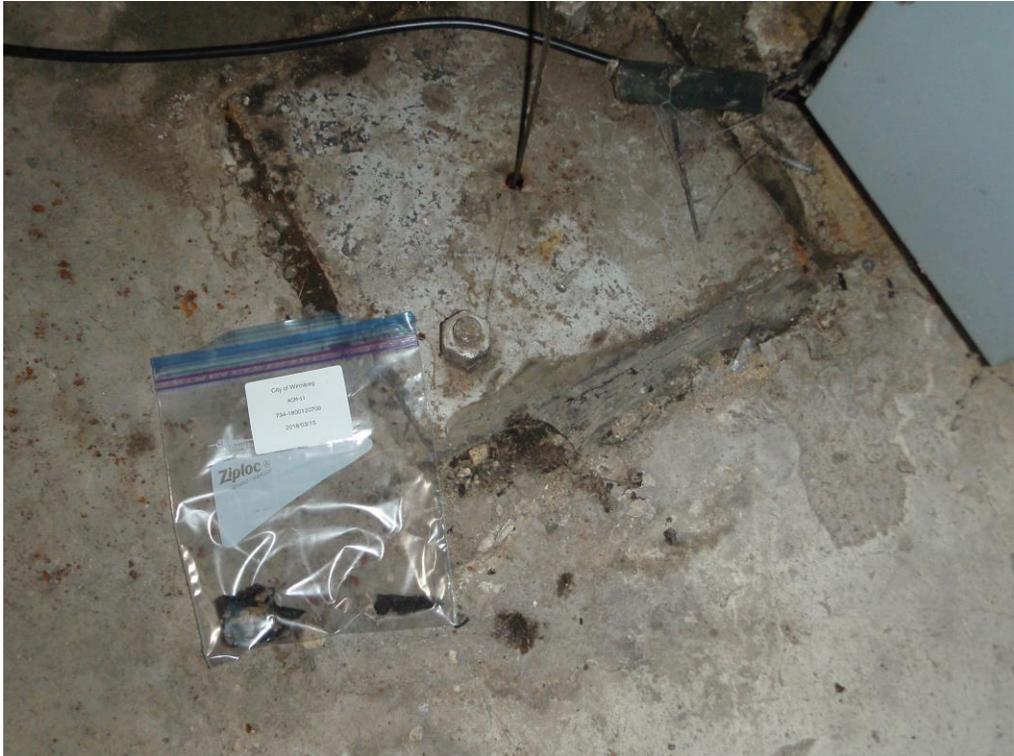
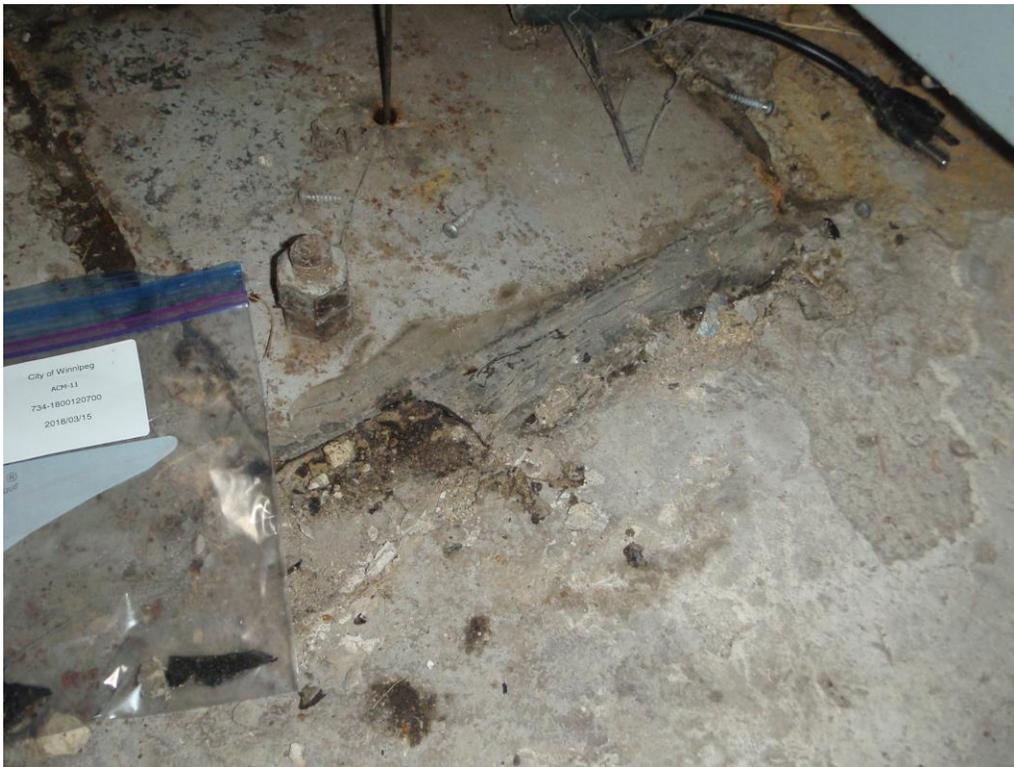
At the time of this inspection, this material was found to be in poor condition with only limited sections of the surficial tar-like, grey painted surface still showing around the perimeter of the steel plate. This joint compound was not found around any of the other covered openings in the concrete floor of the main floor level.

Photo 45: General view of bulk material sample ACM-11 from the sealant around a metal plate on the floor of the main level along the north wall. (March 15, 2018)

Photo 46: General view of condition of the sealant found to contain asbestos around the metal plate for the wet well float level on the floor of the main level along the north wall. (March 15, 2018)

| Sample ID | Date Sampled | Material Description | General Classification | General Condition | Asbestos Content (%) |
|--|---|--|---|---|---|
| ACM-11 | 15-Mar-18 | Sealant around metal plate in concrete floor for wet well float level near the north wall on the main floor. | Non-Friable | Poor - dry and brittle, paint surface coating broken off over most of the plate perimeter. (Photos 45 & 46) | 10 - 25 (Chrysotile) |

Based on the limited amount of asbestos containing materials present, and its relatively poor condition, it is suggested that this material be removed from the site by a qualified asbestos abatement contractor and the remaining joint between the concrete floor and the steel plate be resealed with an appropriate, environmentally friendly material. If the asbestos containing joint compound is left in place, a formal Asbestos Management Plan, prepared in accordance with current Provincial Health and Safety regulations will be required, encompassing,
