# ASBESTOS INVENTORY CONTROL

<b>Building Name:</b>	Council Building Civic Centre Complex	<b>Inspection Date:</b>	December 3, 2017
<b>Building Code:</b>	CB-60	<b>Inspected By:</b>	A Brodbeck & N Richardson
<b>Building Address:</b>	510 Main Street	<b>Construction Date:</b>	1964

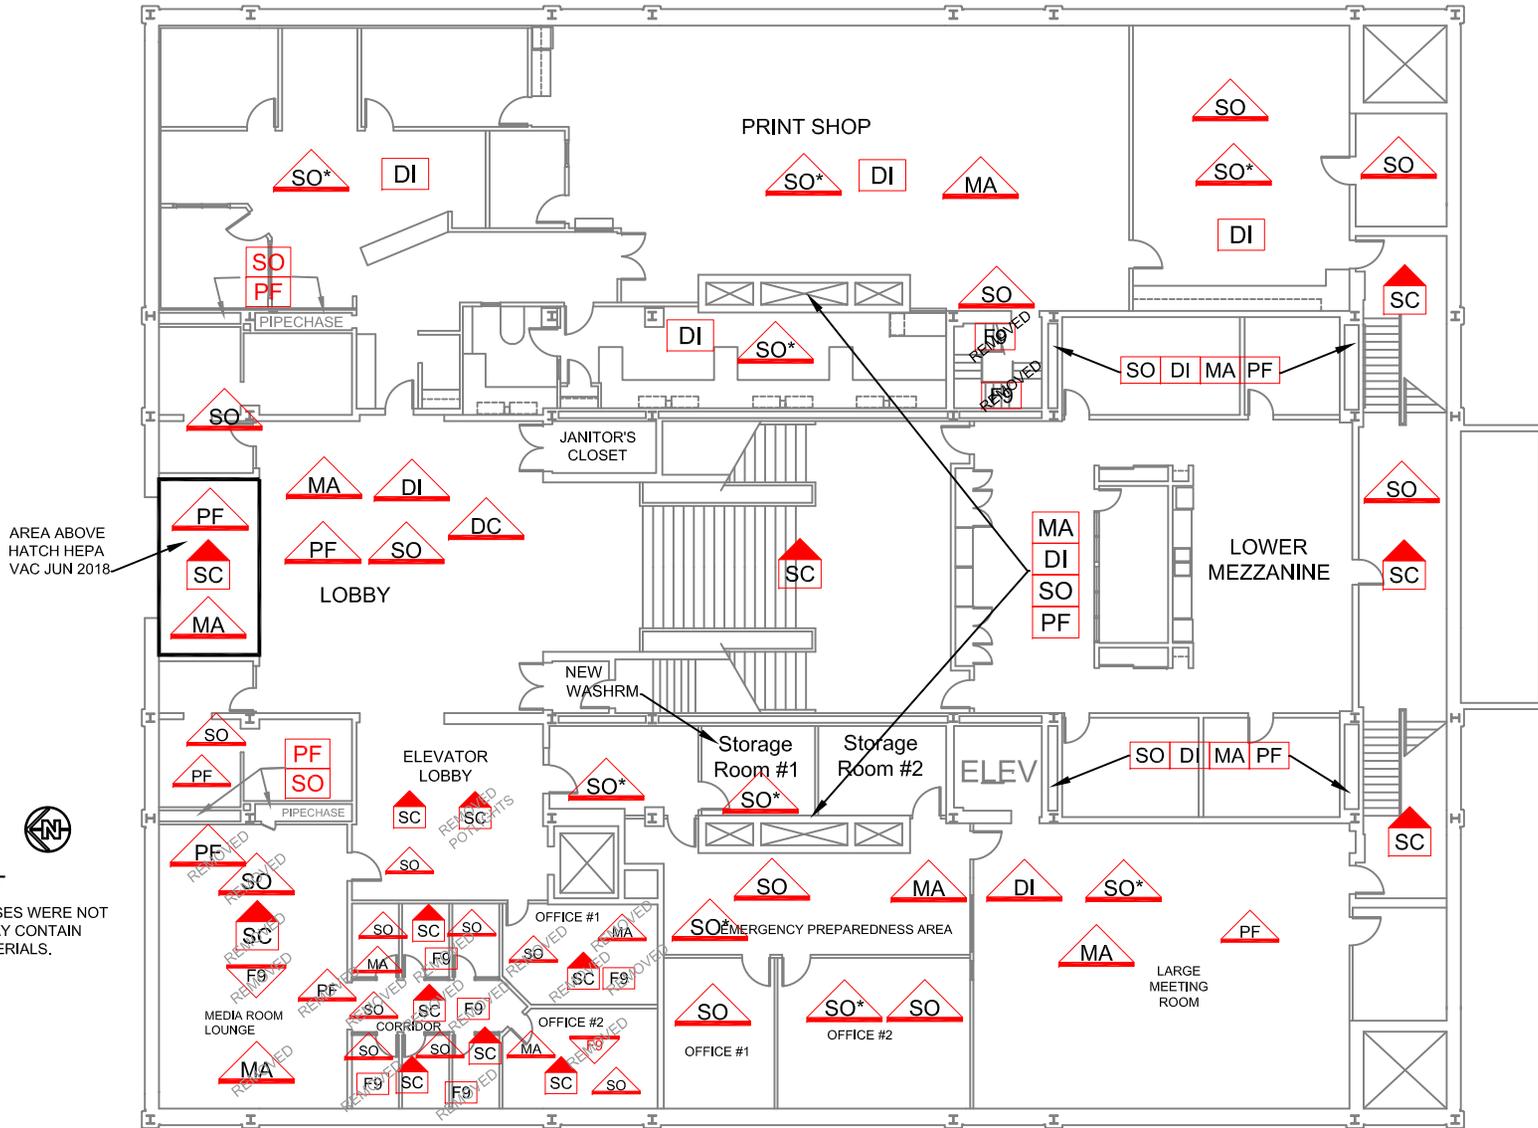
**BASEMENT**  
NOTE: ALL CHASES WERE NOT ABATED AND MAY CONTAIN ASBESTOS MATERIALS.

AREA ABOVE HATCH HEPA VAC JUN 2018

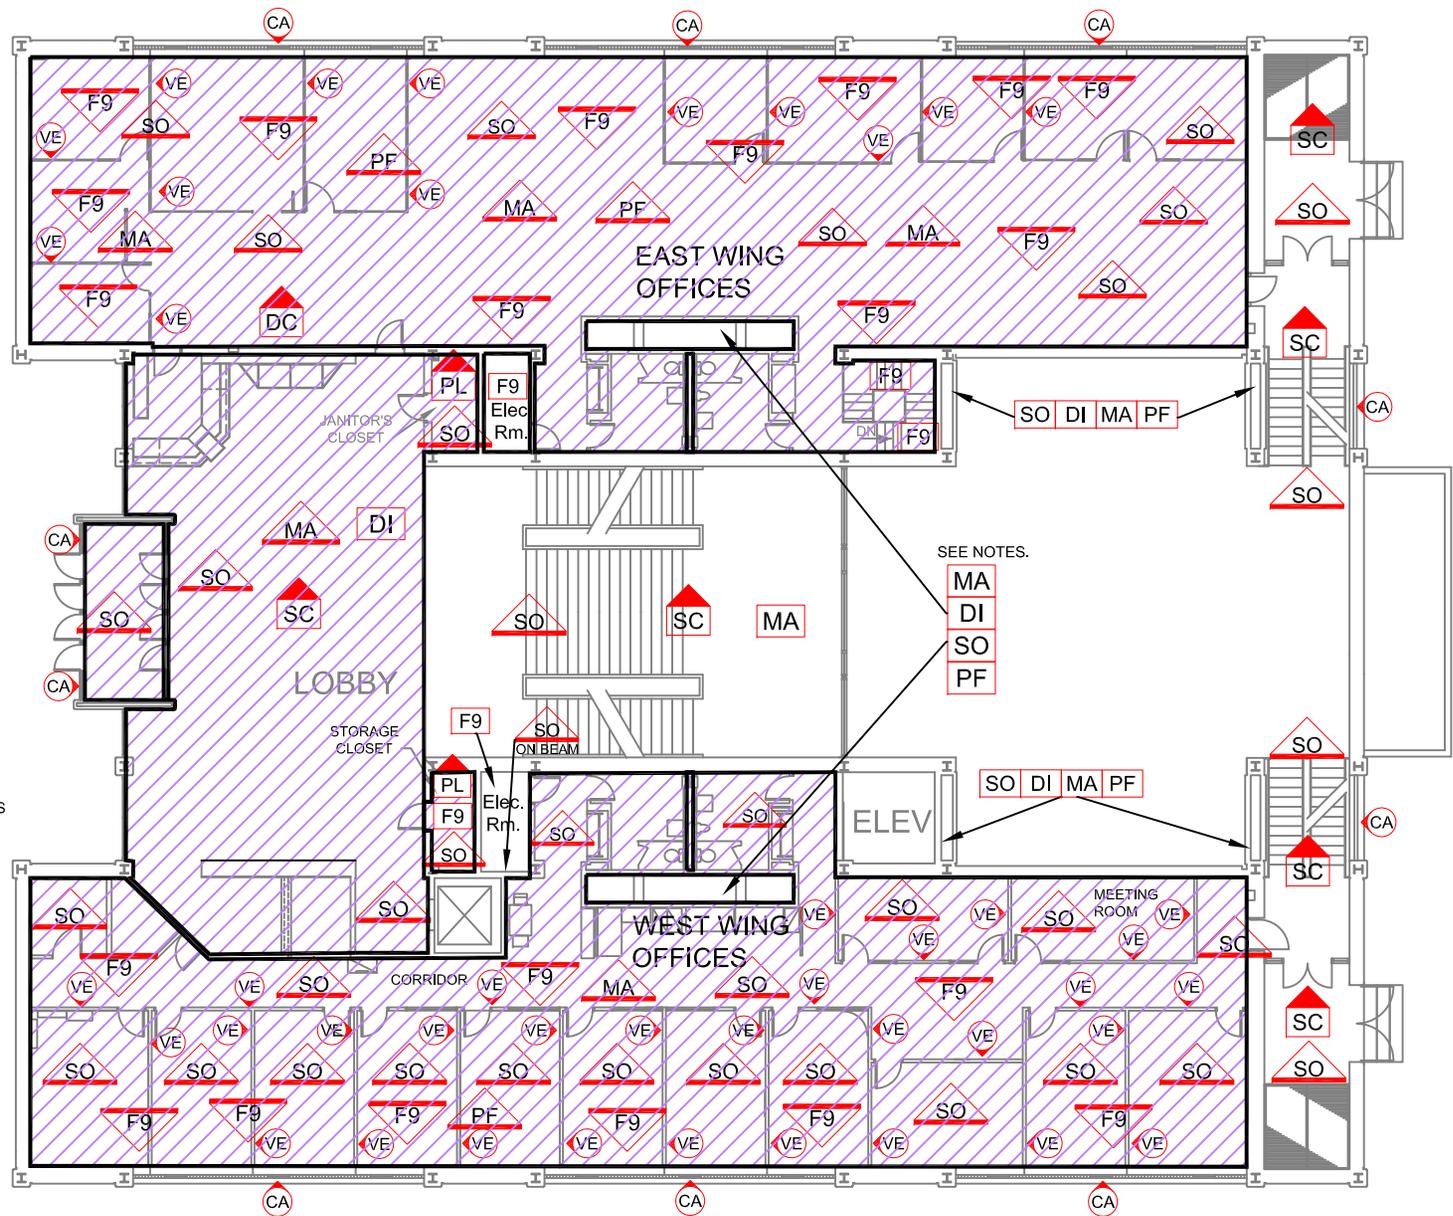
# MAIN FLOOR

- NOTE:
1. ALL CHASES/ELEVATOR SHAFTS WERE NOT ABATED AND MAY CONTAIN ASBESTOS MATERIALS
  2. EXTERIOR WINDOWS: EXTERIOR/INTERIOR WINDOW CAULKING CONTAINS ASBESTOS.
  3. ASBESTOS CONTAINING FIREPROOF SPRAY-ON INSULATION MAY BE BEHIND OR BETWEEN WALLS/PARTITION/ELEVATOR SHAFTS

ASBESTOS REMOVED AUG 2016

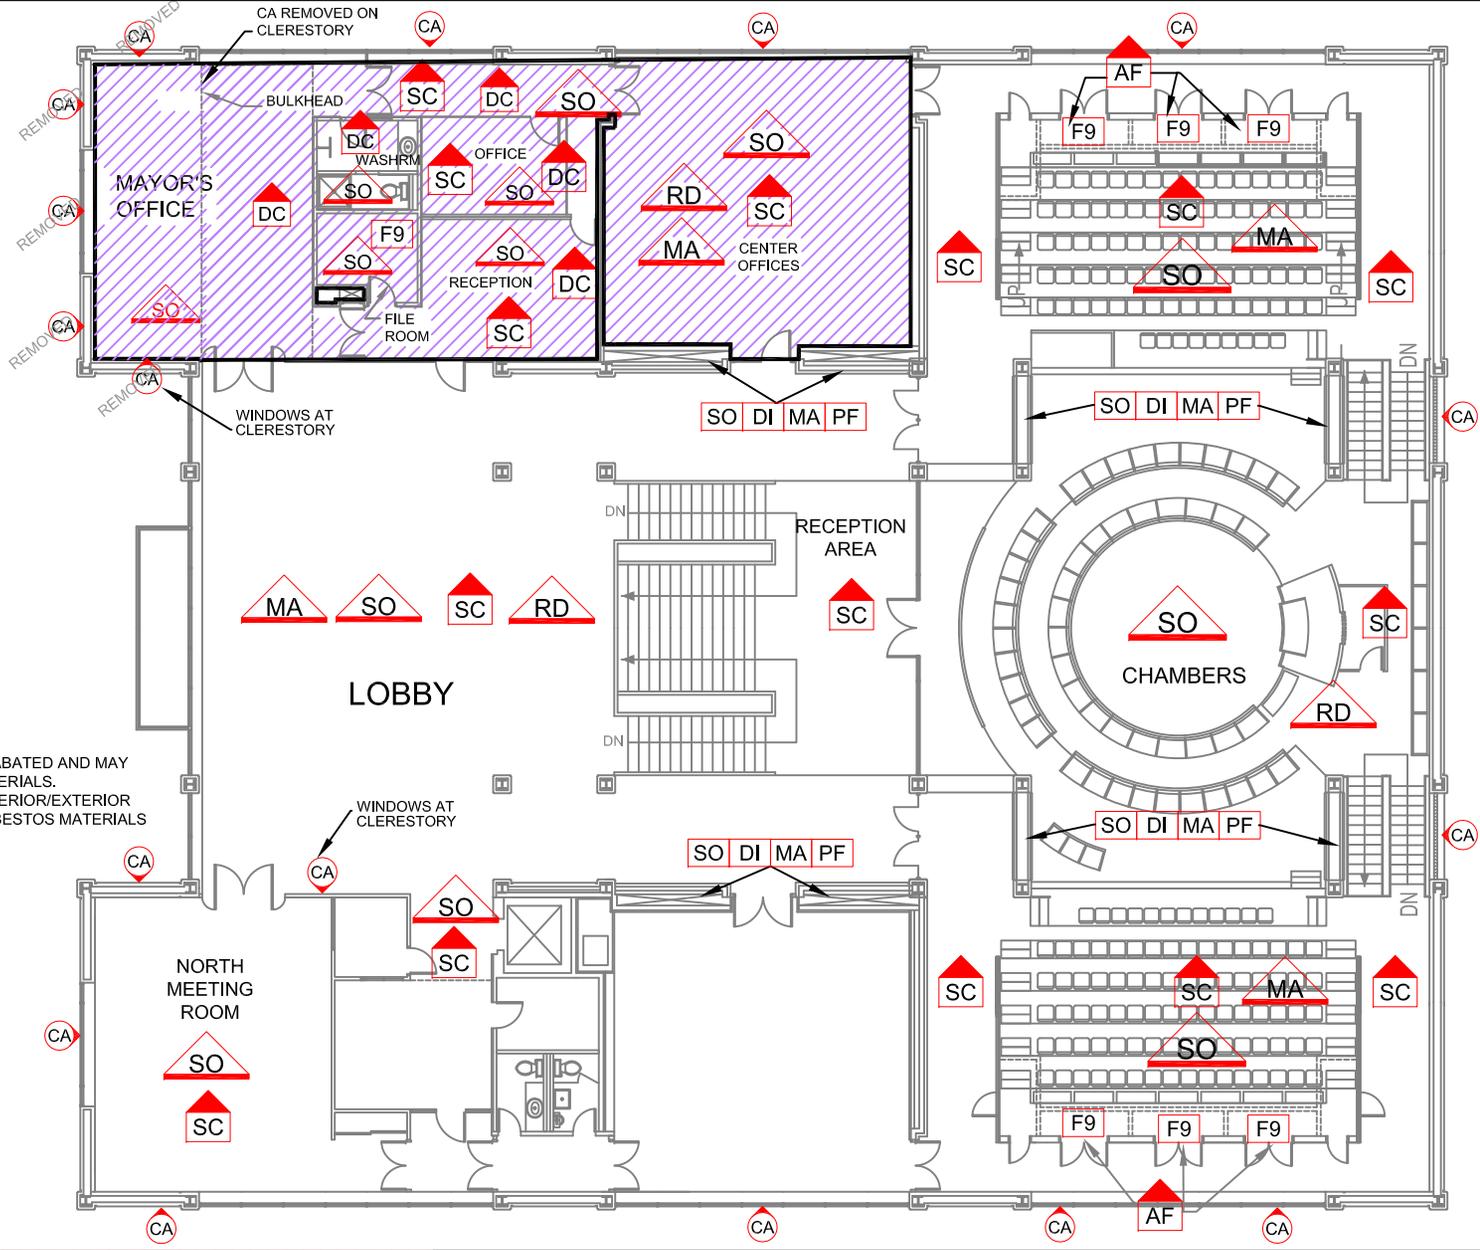
### SECOND FLOOR

1. ALL CHASES WERE NOT ABATED AND MAY CONTAIN ASBESTOS MATERIALS.
2. EXTERIOR WINDOWS: INTERIOR/EXTERIOR CAULKING CONTAINS ASBESTOS MATERIALS

ASBESTOS REMOVED AUG 2016
--	---------------------------
