# ASBESTOS INVENTORY CONTROL

<b>Building Name:</b>	Council Building Civic Centre Complex	<b>Inspection Date:</b>	December 3, 2017
<b>Building Code:</b>	CB-60	<b>Inspected By:</b>	A Brodbeck & N Richardson
<b>Building Address:</b>	510 Main Street	<b>Construction Date:</b>	1964

# CB-60

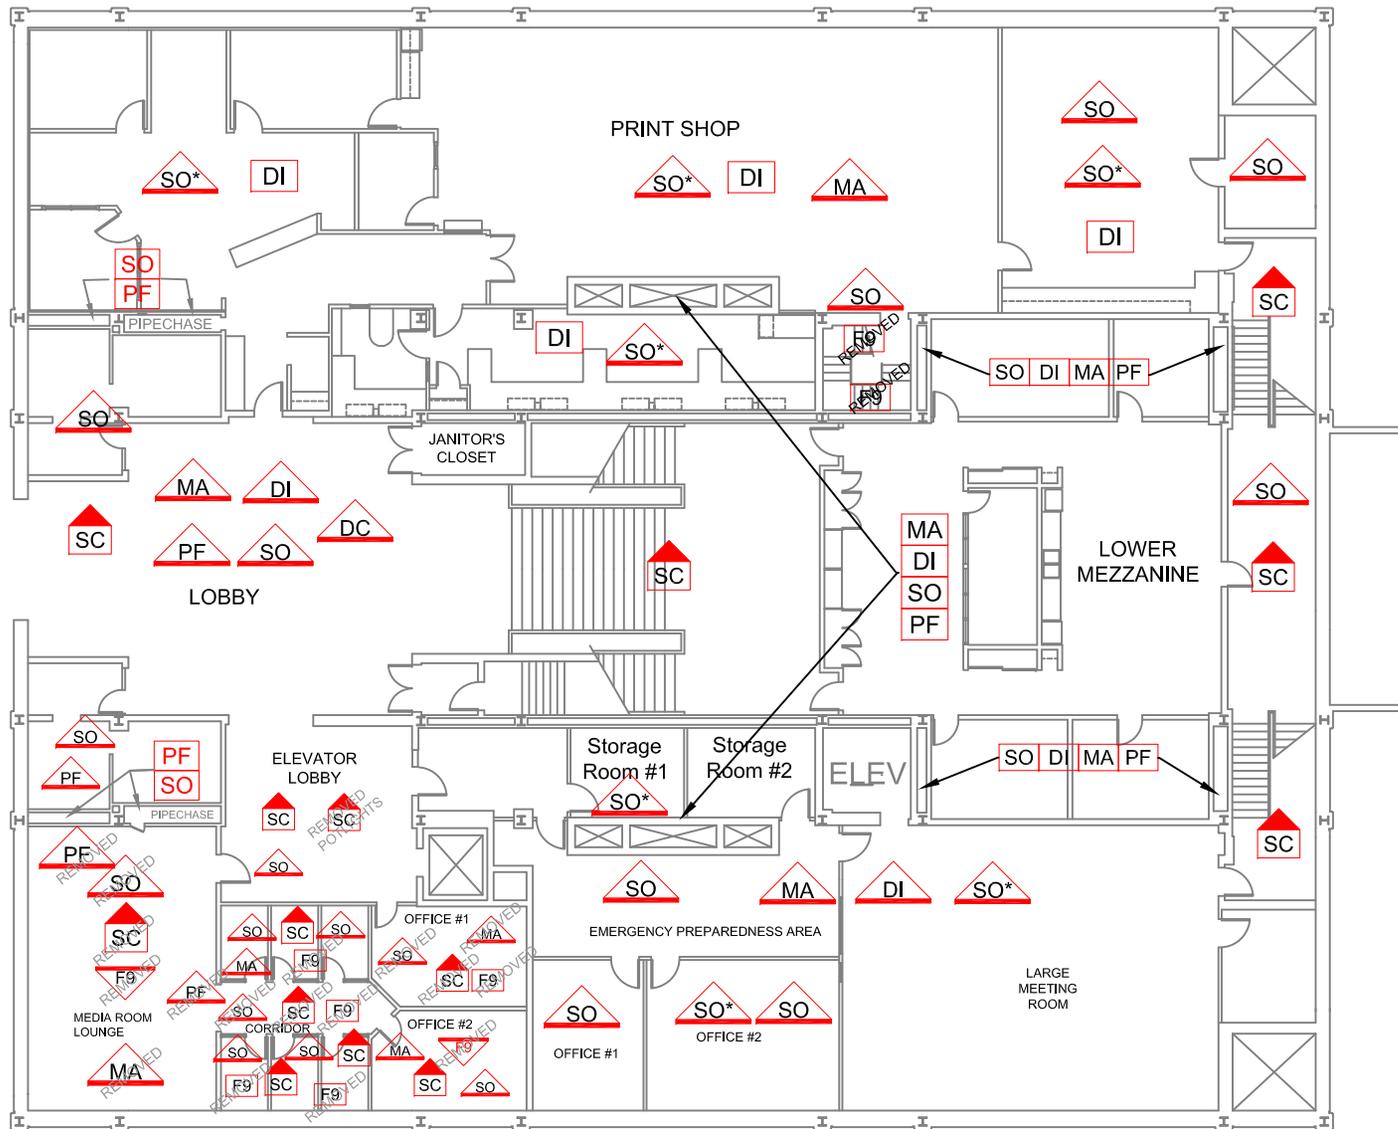
**BASEMENT**  
NOTE: ALL CHASES WERE NOT ABATED AND MAY CONTAIN ASBESTOS MATERIALS.

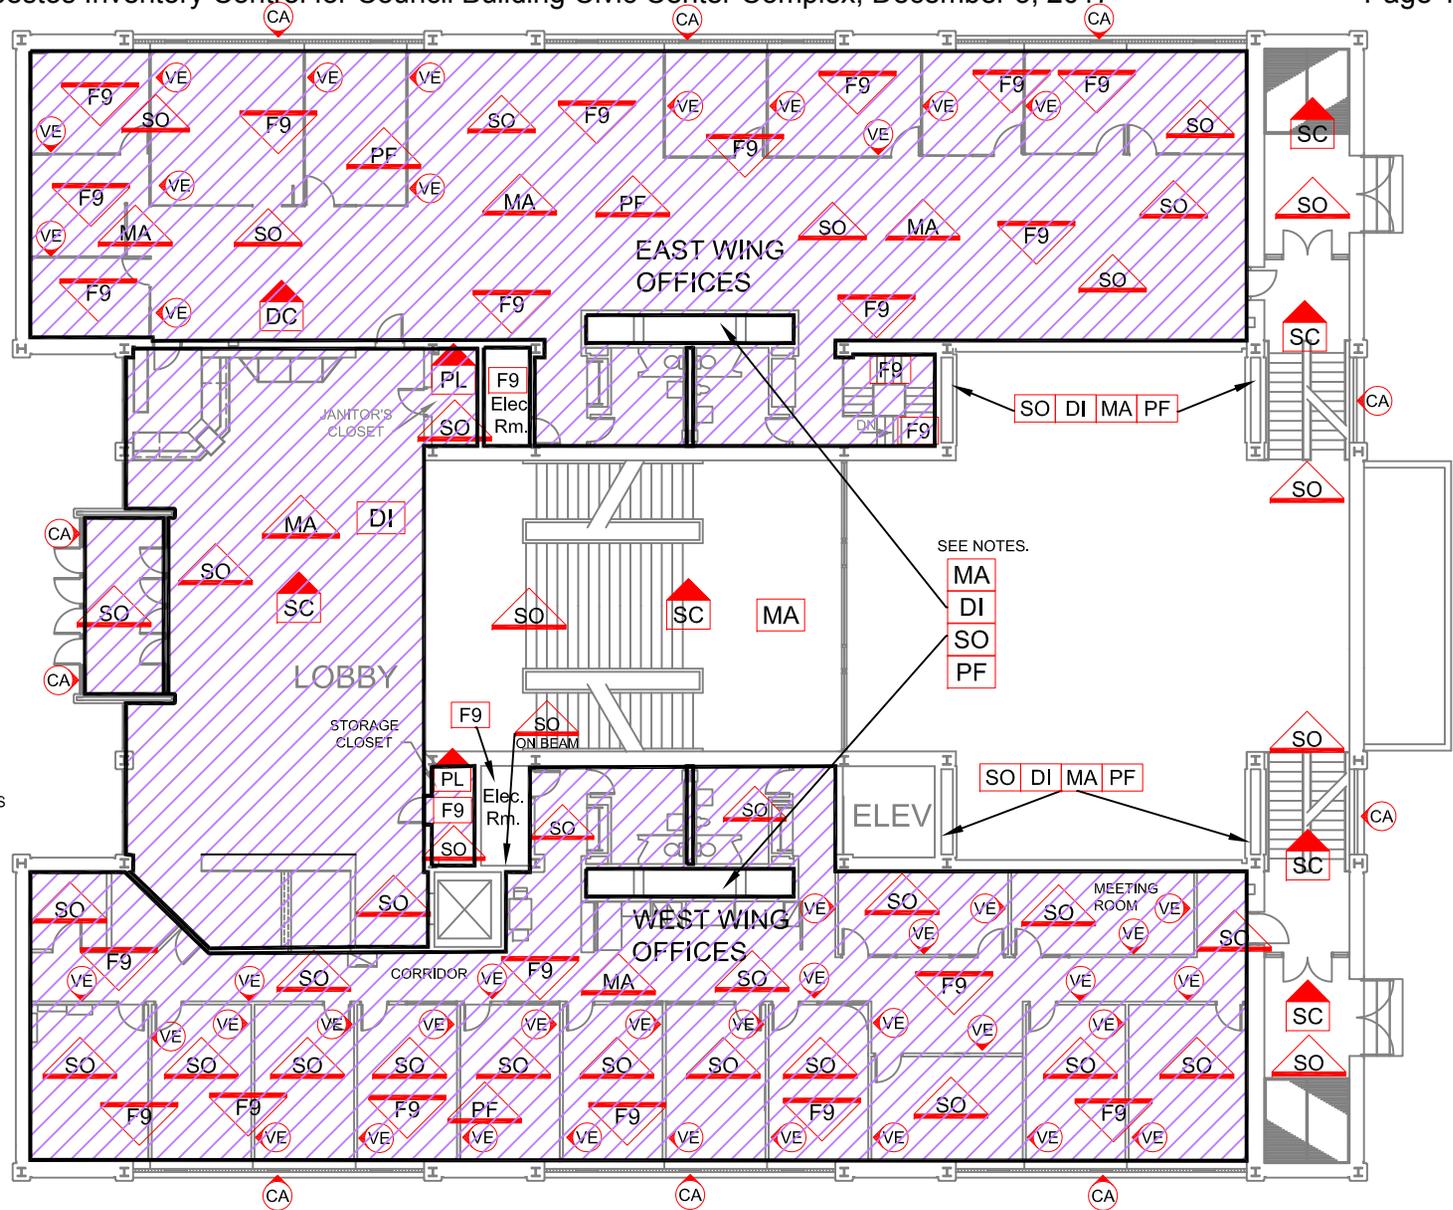
**MAIN FLOOR**

- NOTE:**
1. ALL CHASES/ELEVATOR SHAFTS WERE NOT ABATED AND MAY CONTAIN ASBESTOS MATERIALS
  2. EXTERIOR WINDOWS: EXTERIOR/INTERIOR WINDOW CAULKING CONTAINS ASBESTOS.
  3. ASBESTOS CONTAINING FIREPROOF SPRAY-ON INSULATION MAY BE BEHIND OR BETWEEN WALLS/PARTITION/ELEVATOR SHAFTS

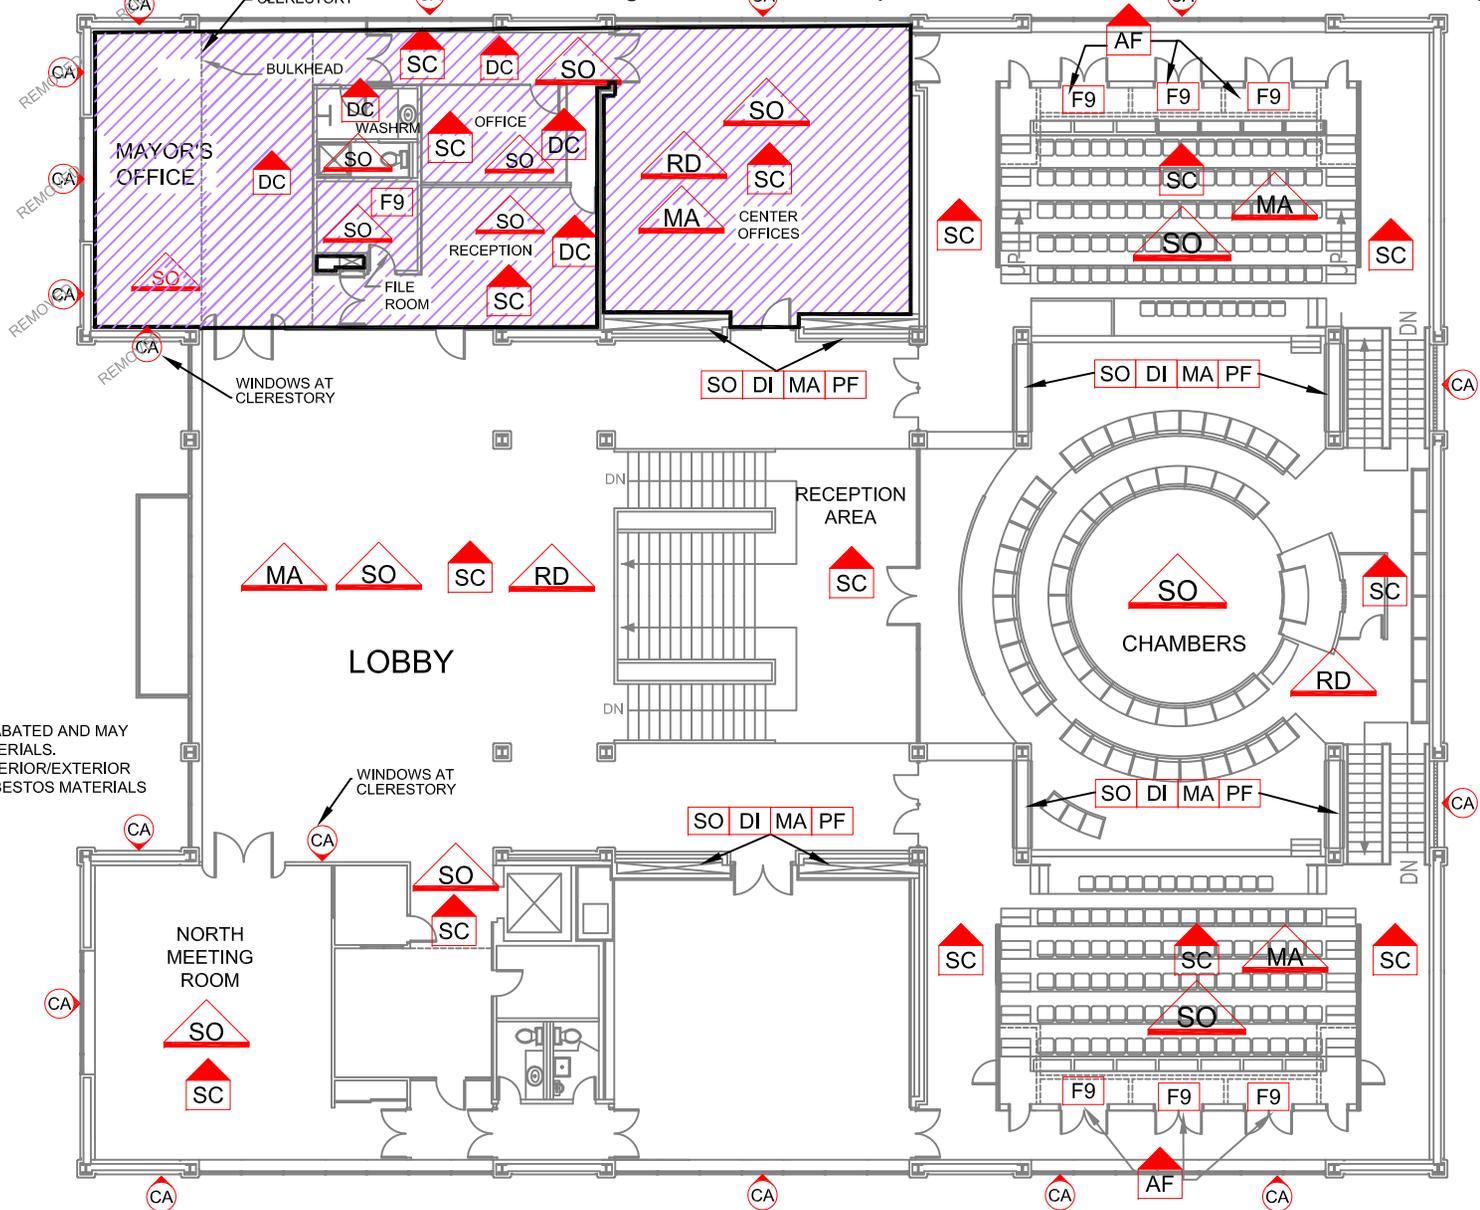
**SECOND FLOOR**

1. ALL CHASES WERE NOT ABATED AND MAY CONTAIN ASBESTOS MATERIALS.
2. EXTERIOR WINDOWS: INTERIOR/EXTERIOR CAULKING CONTAINS ASBESTOS MATERIALS

ASBESTOS REMOVED AUG 2016
