COMPOSITE SITE INSPECTION REPORT

City of Winnipeg Water and Waste Department

Inspection of: Sodium Hydroxide Tank Equipment No. TNK-S320A
 Serial No. N/A
 Built in 2008

Location: Deacon WTP
 Hwy 207, Access Road 57802
 Springfield, MB

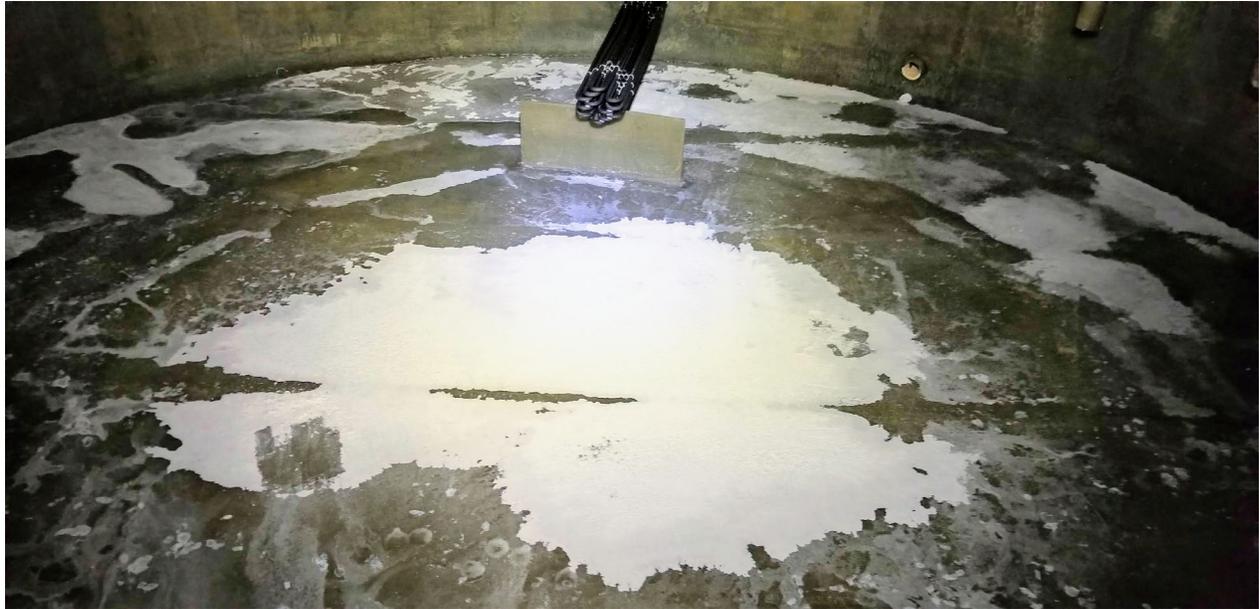
BH-1a

Floor/Bottom Head:

Prior to entering the tank, the floor had noticeable scum/residue remaining in the tank covering approximately 50% of the surface area.

Upon entering the tank, we found that the bottom head/floor appears to be in poor condition. In locations that were visible, appearance of a dry glass NEXUS VEIL was evident and exposed to the environment.

Small baffle type plates bonded to the floor (possible heater droop supports) were found to be in poor condition. In locations that were visible, appearance of a dry glass NEXUS VEIL was evident and exposed to the environment.

Floor/Bottom Head:

Remove existing corrosion barrier to natural glass and resin matrix.

Reline corrosion barrier using 2 plies of 1.5oz mat or chop strand mat + 2 plies of synthetic NEXUS surfacing veil for a nominal thickness of 0.11" ensuring each layer is minimum of 0.5" wider than the previous layer.

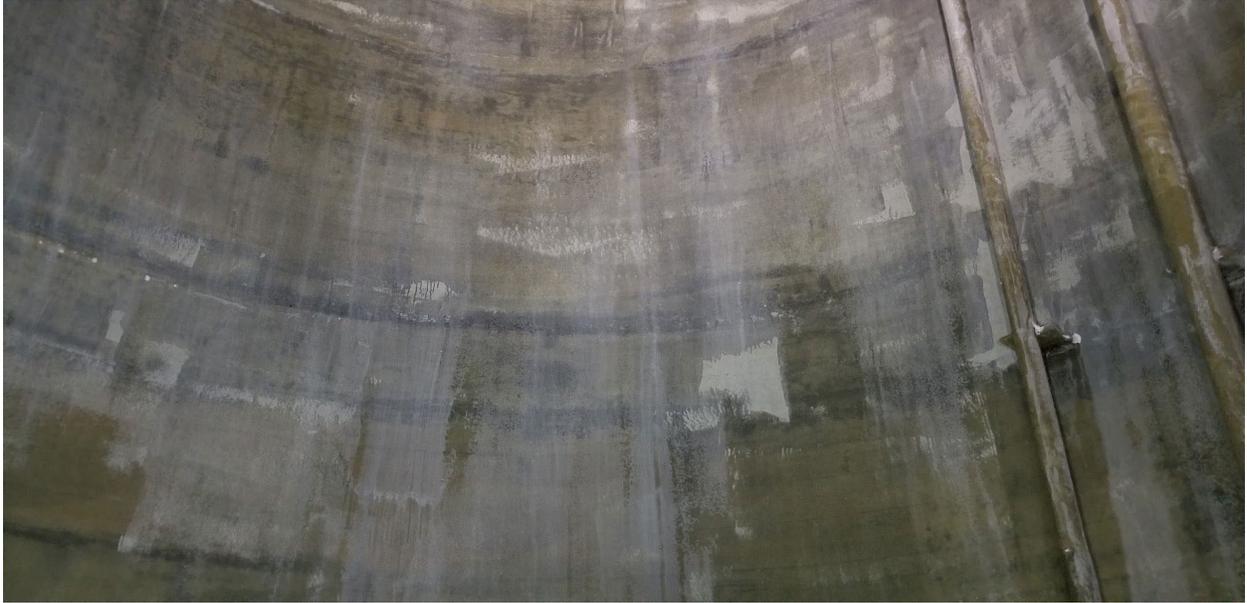
TW-1a

Tank wall appears to be in poor condition with some scum/residue remaining on walls covering approximately 25% of the visible area.

In locations that were visible, the extent of the dry glass NEXUS VEIL appearance was evident throughout a majority of the tank wall. Due to the resin rich interior coating being deteriorated this has exposed the surfacing veil and deteriorated corrosion barrier to the environment.

The top 250mm (10") of the tank wall appear to be in acceptable condition but due to the distance/height for inspection we cannot 100% guarantee this does not require reconditioning.

Remove existing corrosion barrier to natural glass and resin matrix.

Reline corrosion barrier using 2 plies of 1.5oz mat or chop strand mat + 2 plies of synthetic NEXUS surfacing veil for a nominal thickness of 0.11" ensuring each layer is minimum of 0.5" wider than the previous layer.

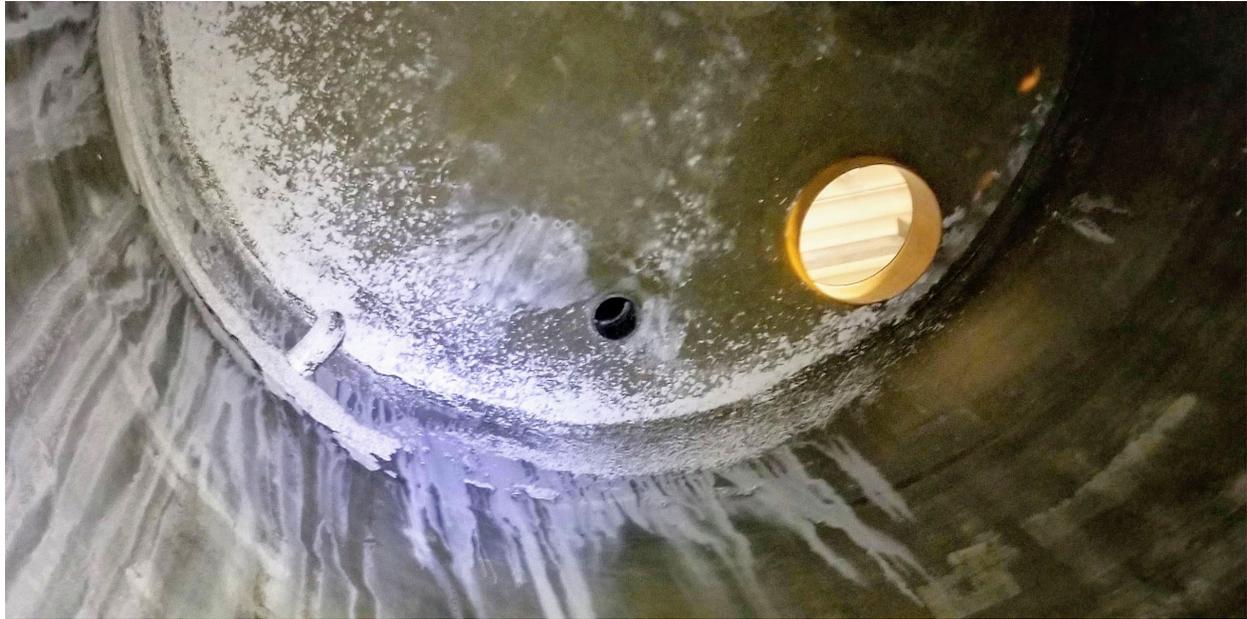
TW-1e

Tank lid/Top Head appears to be in acceptable condition with large deposits of scum/residue remaining on the top head covering approximately 15% of the visible area which looks to be from splashing during fill.

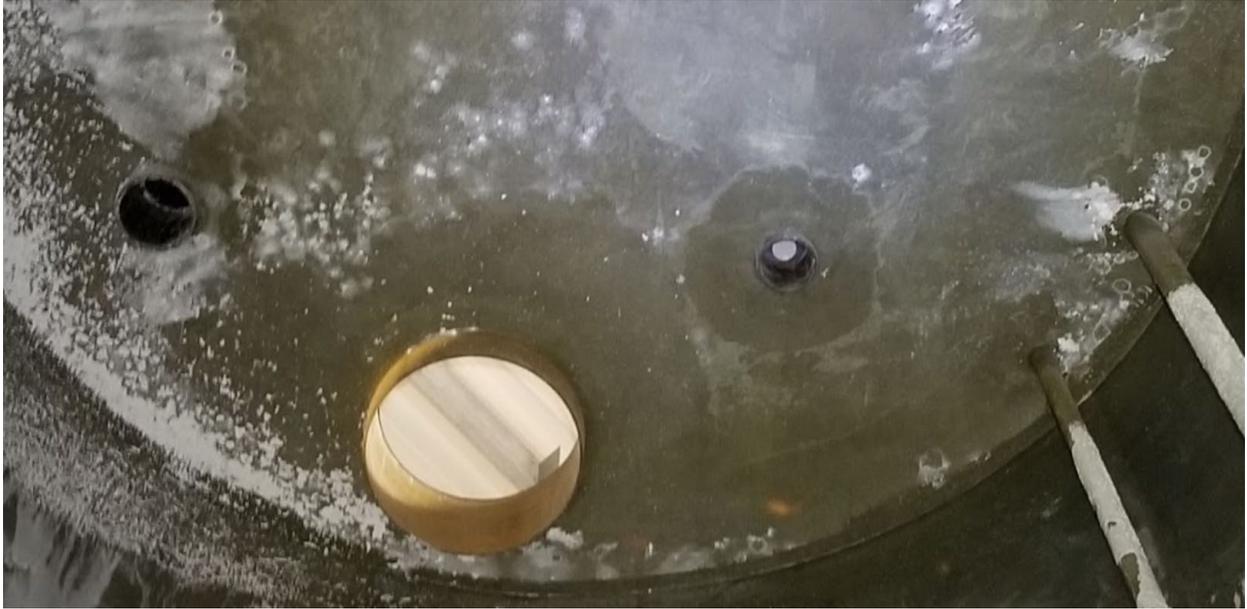
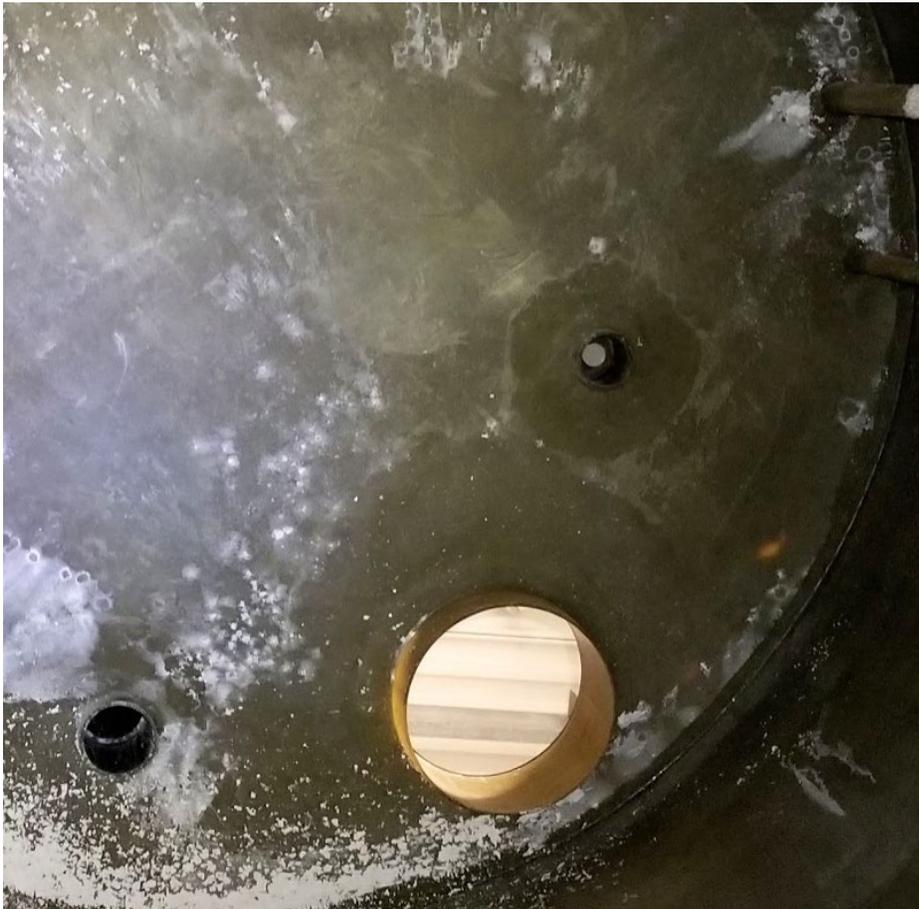
N1, N2, N3, N4, M1

Nozzle 1 (VENT), 2 (FILL), 3 (FILL), 4 (LEVEL ELEMENT), 5 (TOP HEAD MANWAY) – From visual inspection of the top head manway access port these fittings appear to be in good condition.

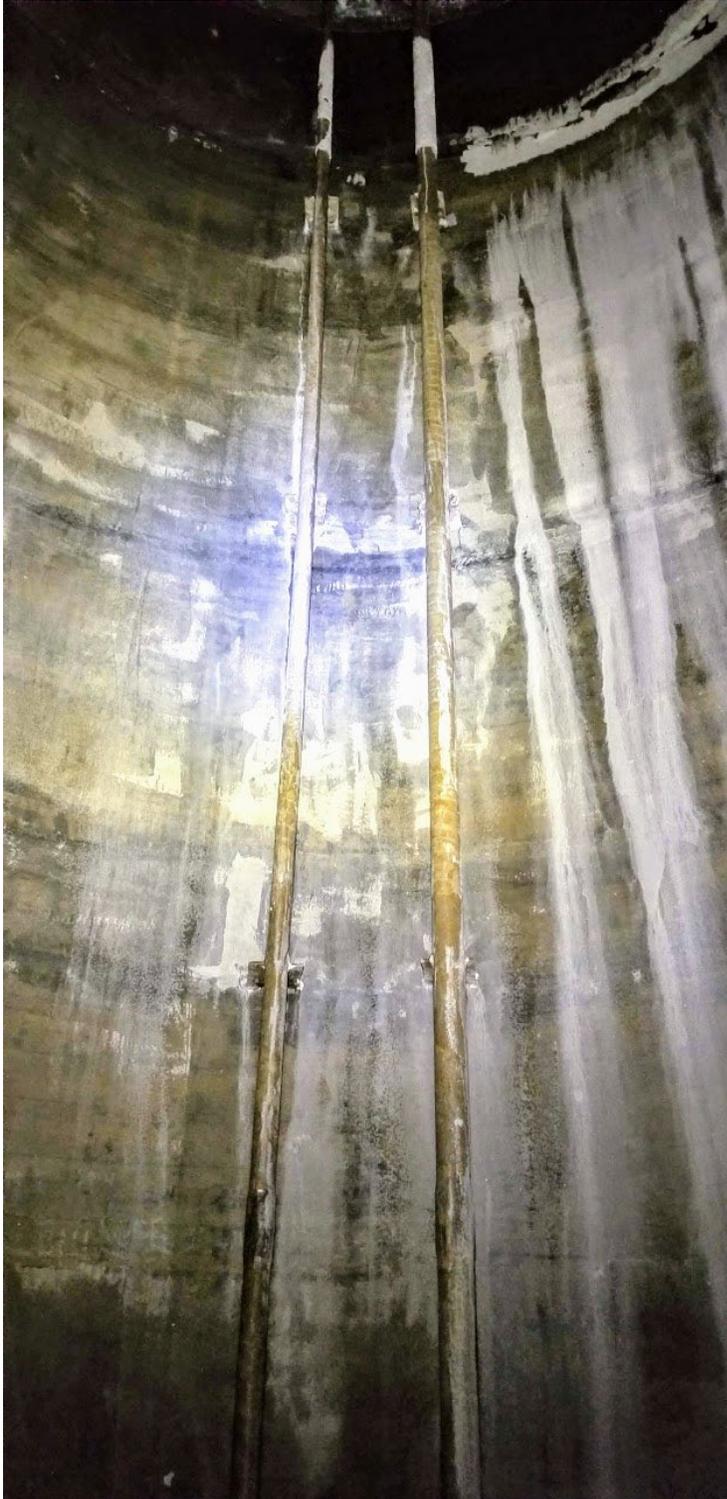
N-2a, N-3a DOWNCOMERS

Nozzle 2 and 3 have downcomers running the height of the tank to 450mm from the bottom head. These downcomers appear to be in poor condition externally with some scum/residue

remaining on exterior of piping. Appearance of what appears to be only a single ply of dry glass C-VEIL on exterior of pipe was evident and exposed to the environment

All downcomer piping will require an external relining of the corrosion barrier and to include 2 plies of 1.5oz mat or chop strand mat + 2 plies of synthetic NEXUS surfacing veil for a nominal thickness of 0.11" as well as creating an end seal to protect the downcomer structure of the penetrating stub. We would require the nozzle to be unbolted from the connecting external pipe and a new gasket supplied for us to field fit a new nozzle made from Derakane 411.

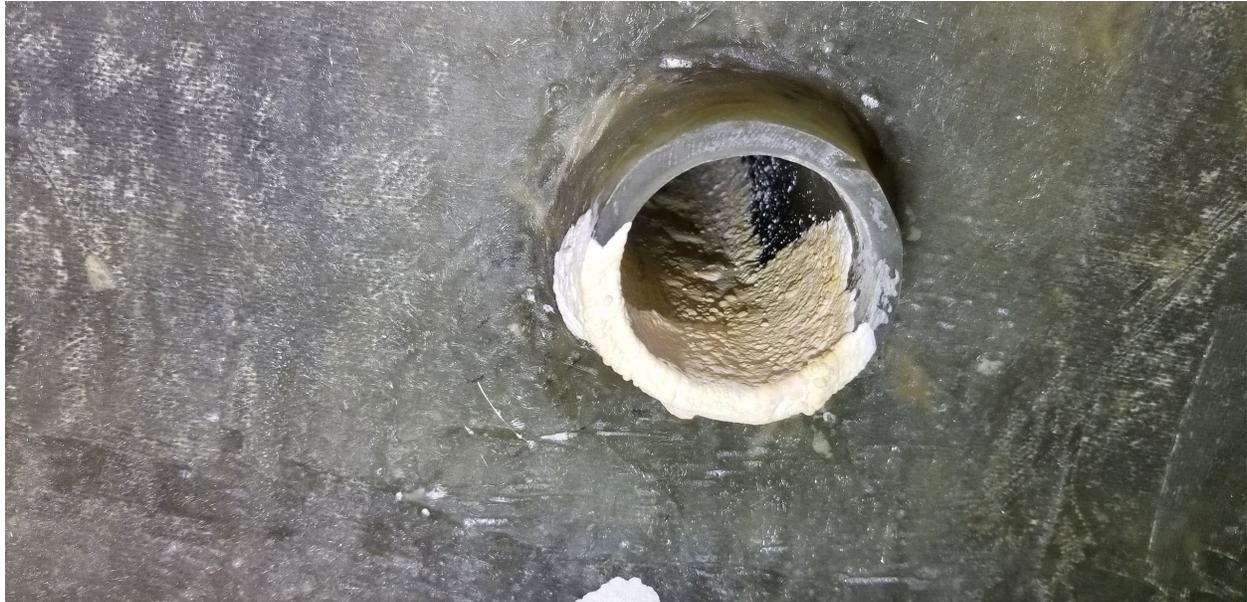
N-6a

Nozzle 6 (SUCTION LINE) – Appears to be in good condition with only a slight buildup of scum/residue remaining on the interior and exterior of the penetrating stub

All fittings excluding fitting on the top head require an external relining of the penetrating stub corrosion barrier creating an end seal to protect the structure of the stub.

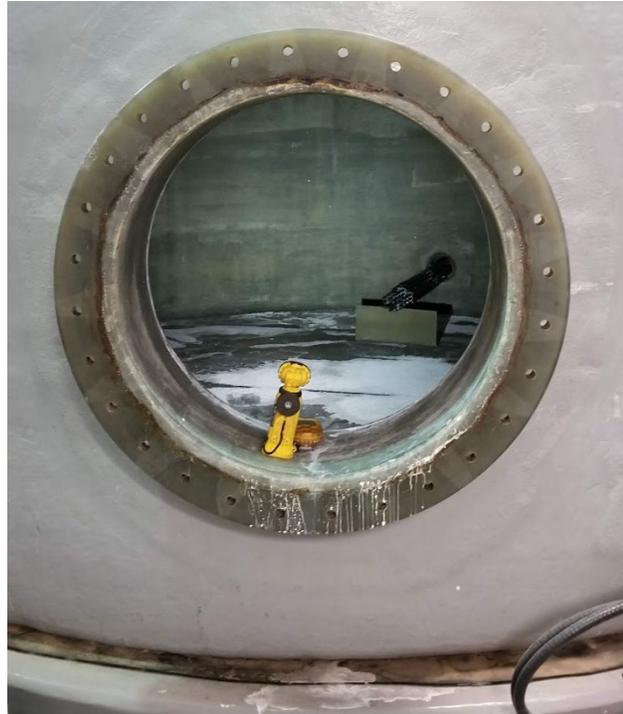
N7 - M-1a

Side Manway and Lid appears to be in poor condition with some scum/residue remaining on each component. Appearance of a dry glass NEXUS VEIL was evident and exposed to the environment.

Bolting flange of manway and lid appear to be in good condition and was protected from chemical attack by the gasket seal.

Nozzle 7 (Top MANWAY) – Appears to be in good condition with no action required

Reline manway access port and interior side of lid

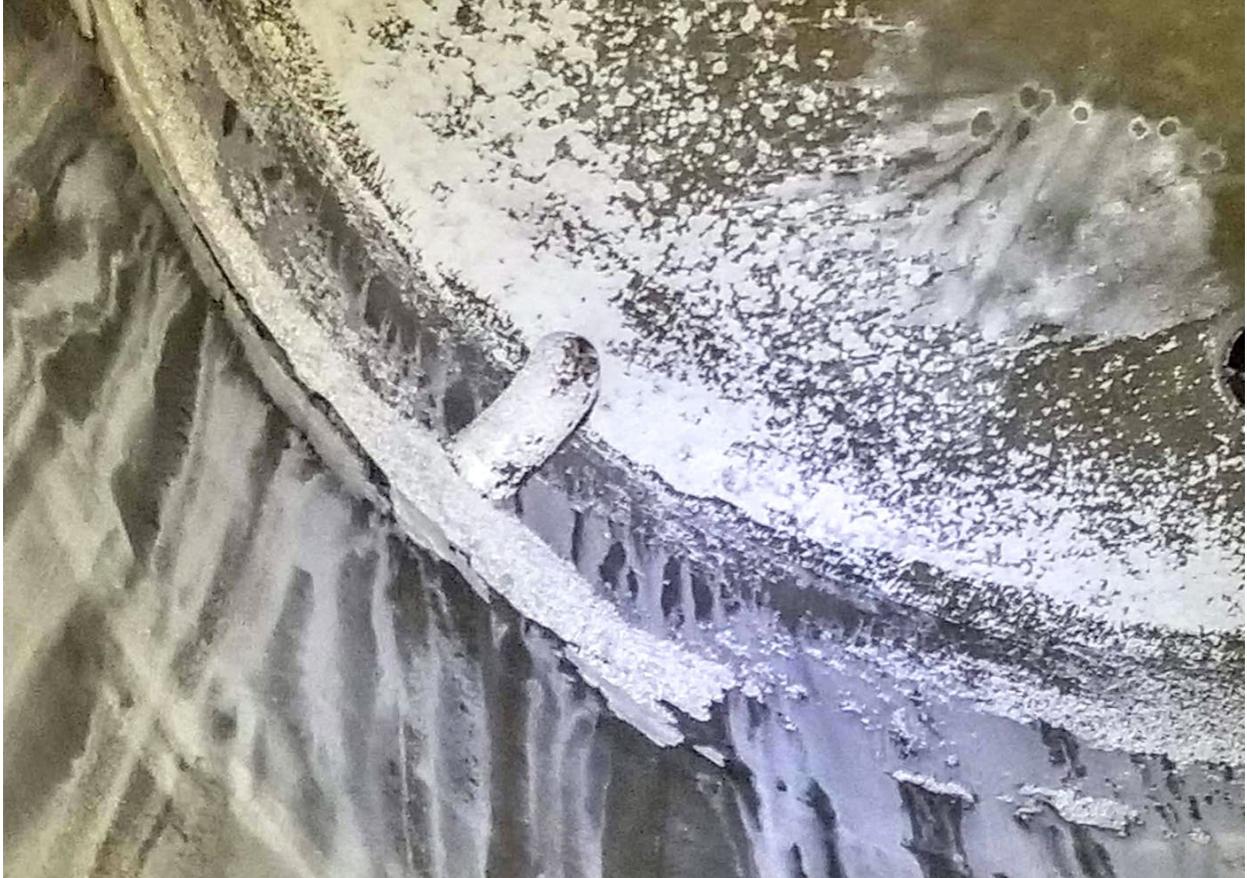
N-8a

Nozzle 8 (OVERFLOW W/INTERNAL ELBOW) – Cannot determine condition due to the entire fitting being covered in scum/residue.

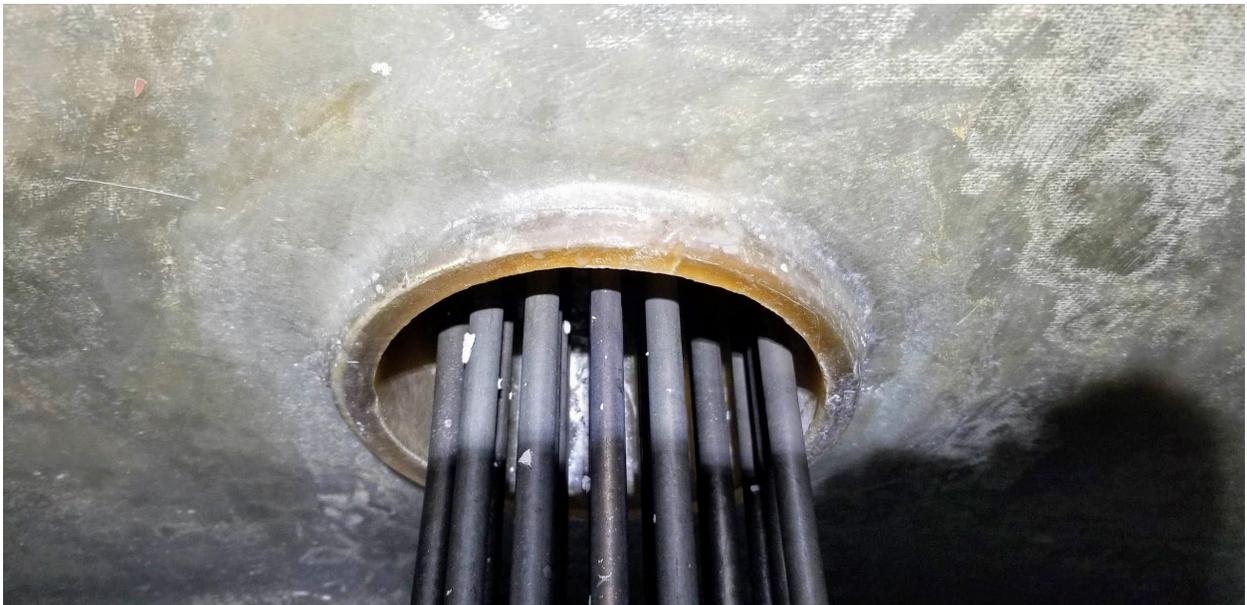
N9

Nozzle 9, 10, & 11 (HEATER) - The extent of the dry glass NEXUS VEIL appearance was evident.

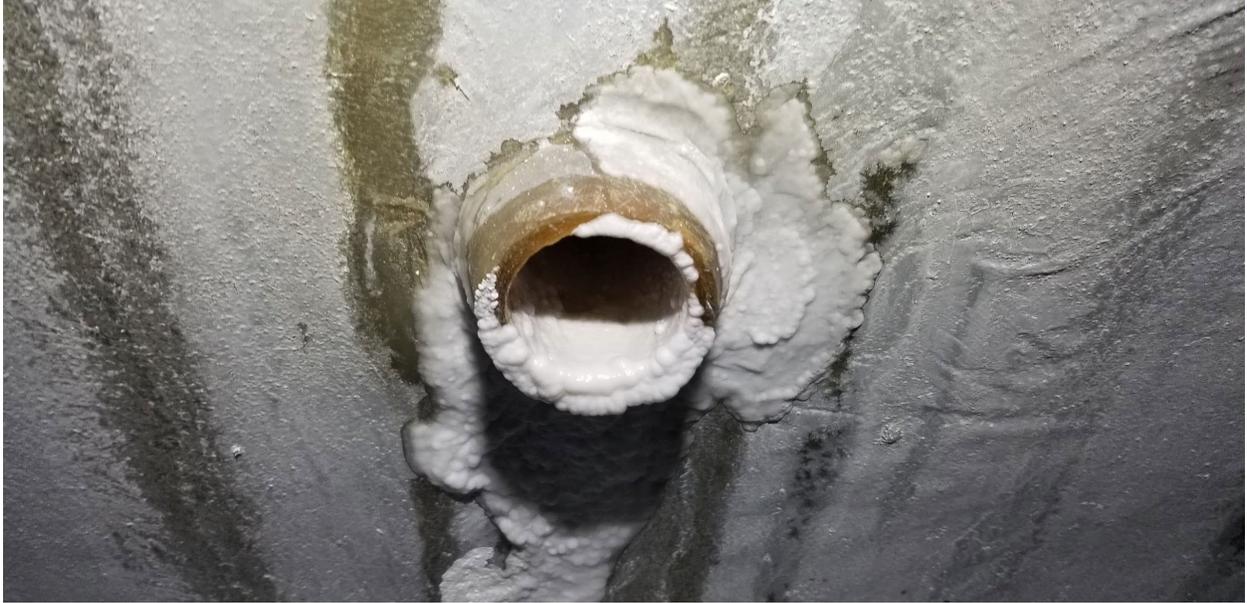
N-12

Nozzle 12 (DRAIN) – There is an excessive amount of scum/residue remaining on the interior and exterior of the penetrating stub and the extent of the dry glass NEXUS VEIL appearance was evident.

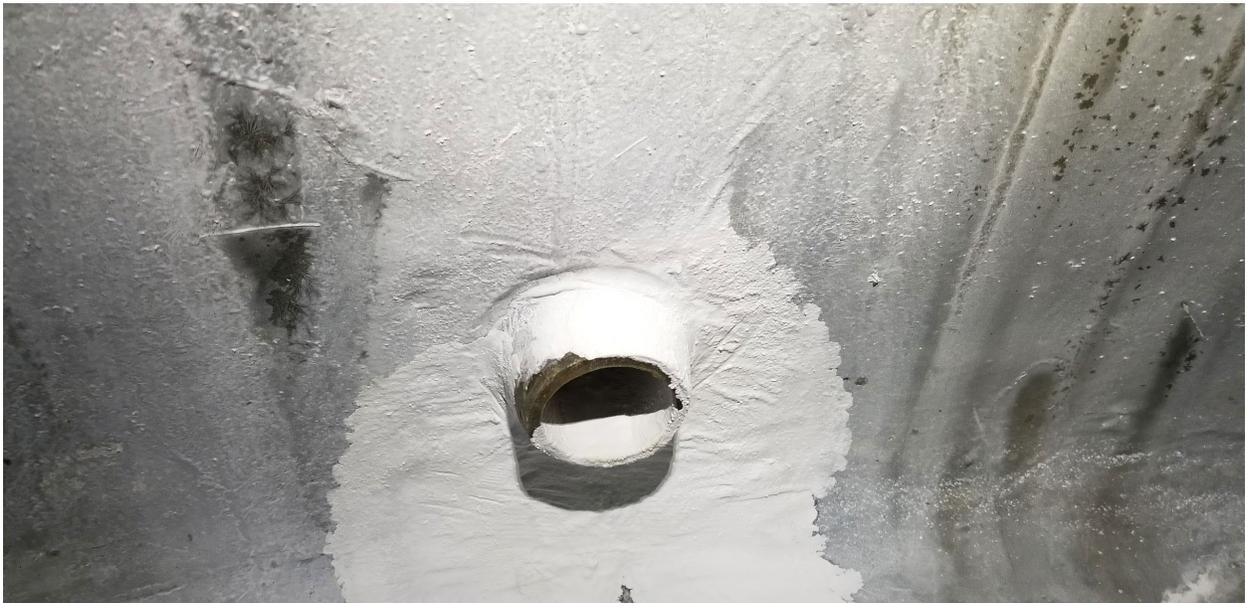
N-13

Nozzle 13 (LEVEL GUAGE) - There is an excessive amount of scum/residue remaining on the interior and exterior of the penetrating stub. Condition can not be determined.

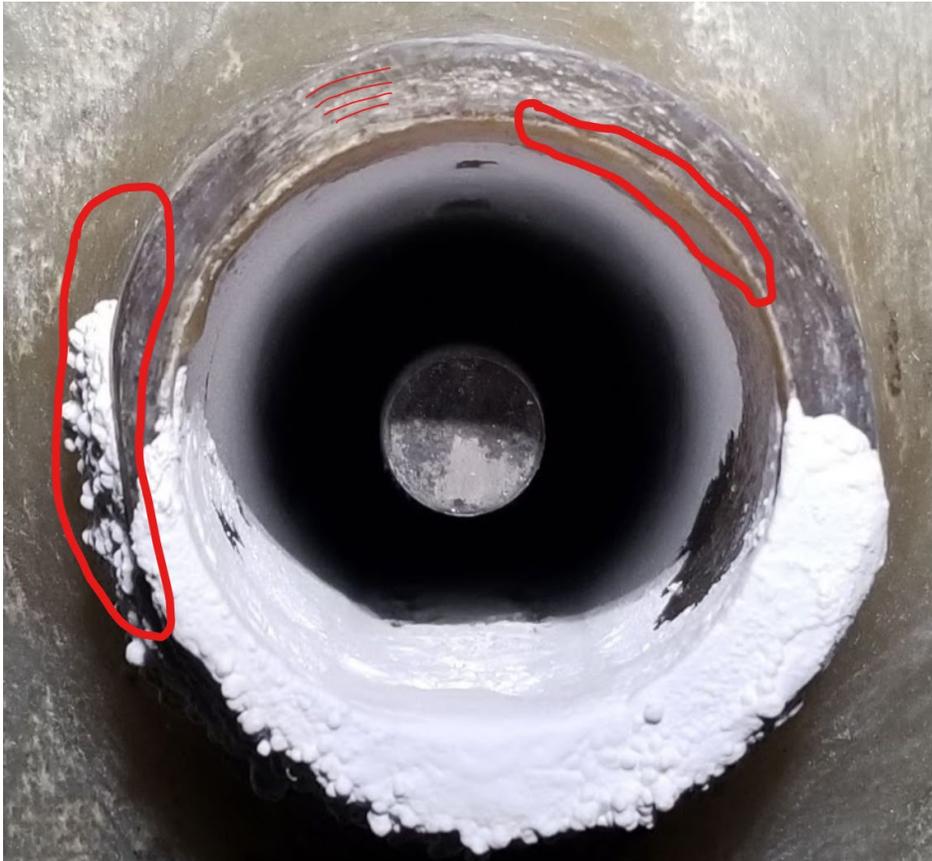
N-14a

Nozzle 14 (TEMPERATURE TRANSMITTER) - This is bonded as a penetrating nozzle and was found to have **NOT** been bonded correctly to create an end seal which is to prevent chemical attack to the structure of the flange.

Delamination of external secondary bond on penetrating stub and internal stub flange corrosion barrier due to improper secondary bonding.

Nozzle 14 may require replacement due to the corrosion barrier of the penetrating stub delaminating internally and externally from the structure of the stub.

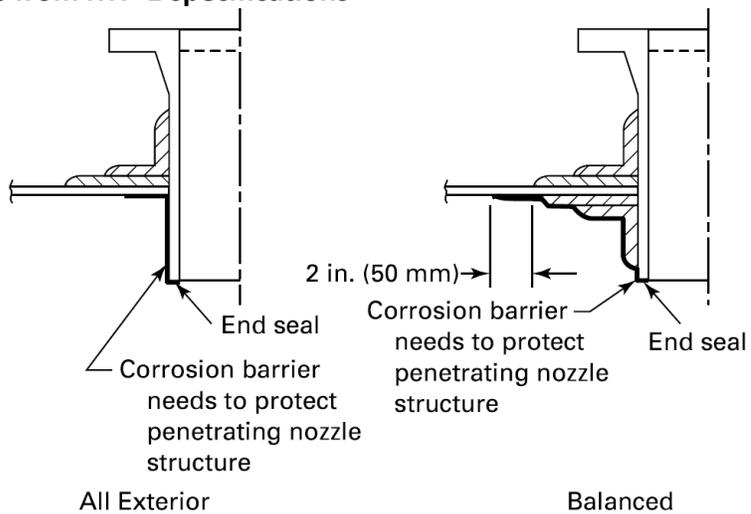
N-14b from RTP-1 specifications

All fittings appear to have external conical gussets adding 360° loading strength to the fittings. Conical gussets should **ALWAYS** have a minimum 0.25" weeping hole drilled in the lowest area of the gusset to allow external inspection of fitting for secondary bonding failure and leakage through the weeping hole.

This is extremely critical in outdoor applications and part of the RTP-1 standard for all applications where conical gussets are used.

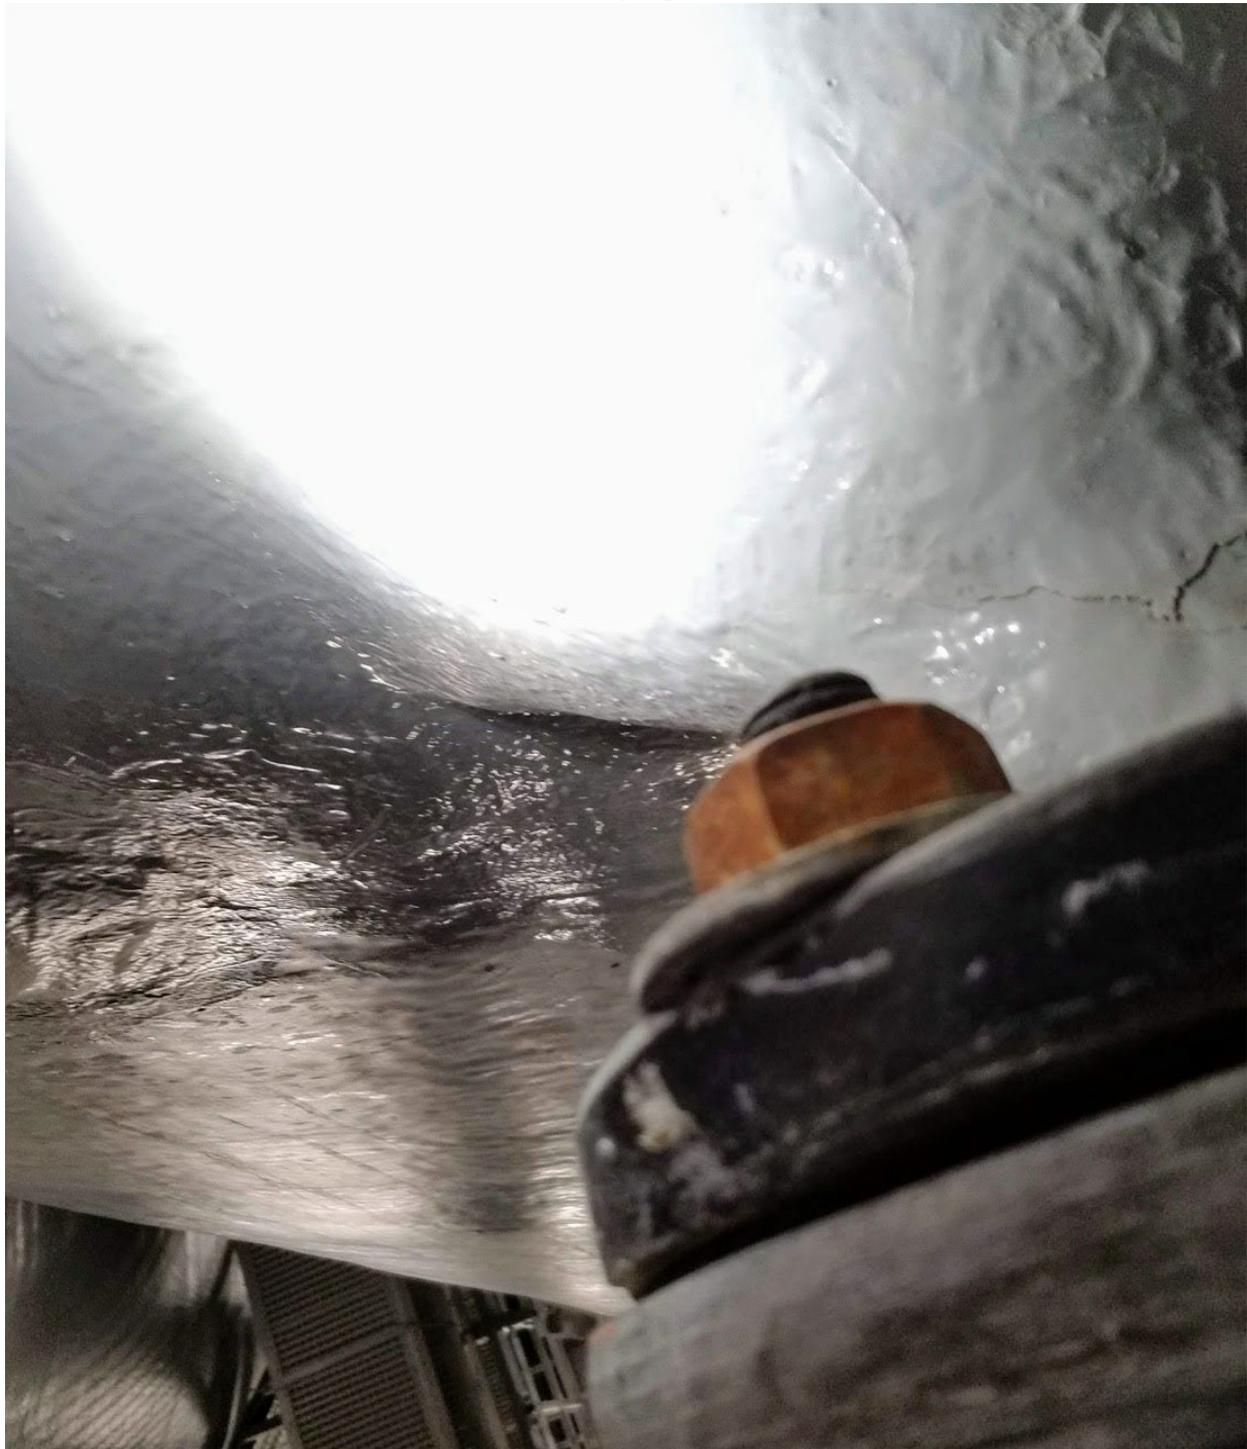
There does not appear to be any cracks or leaks from the nozzles/flanges. Due to improper installation based on RTP-1 specifications and the fabricator neglecting to install a weeping hole, any leaking from the tank wall through the stub penetration into the conical gusset cannot be determined.

Bottom of Conical Gusset WITHOUT 0.25" weeping hole.
