APPENDIX D

2782 ASSINIBOINE AVENUE OUTFALL – INTERNAL INSPECTION PHOTOS

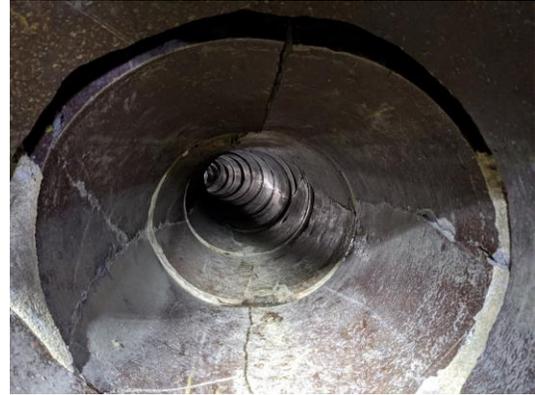
**Photo 8: Looking D/S from Approx. Sta. 1+30.7
(Existing Clay Pipe to be Lined)**
