# APPENDIX C – GEOTECHNICAL ASSESSMENT 1916, 1918, 1920 ST. MARY'S ROAD, WINNIPEG MANITOBA

Waterway Permit No. 017/2022 - Riverbank Stabilization Works at

1916/1918/1920 St. Mary's Road, Winnipeg, Manitoba

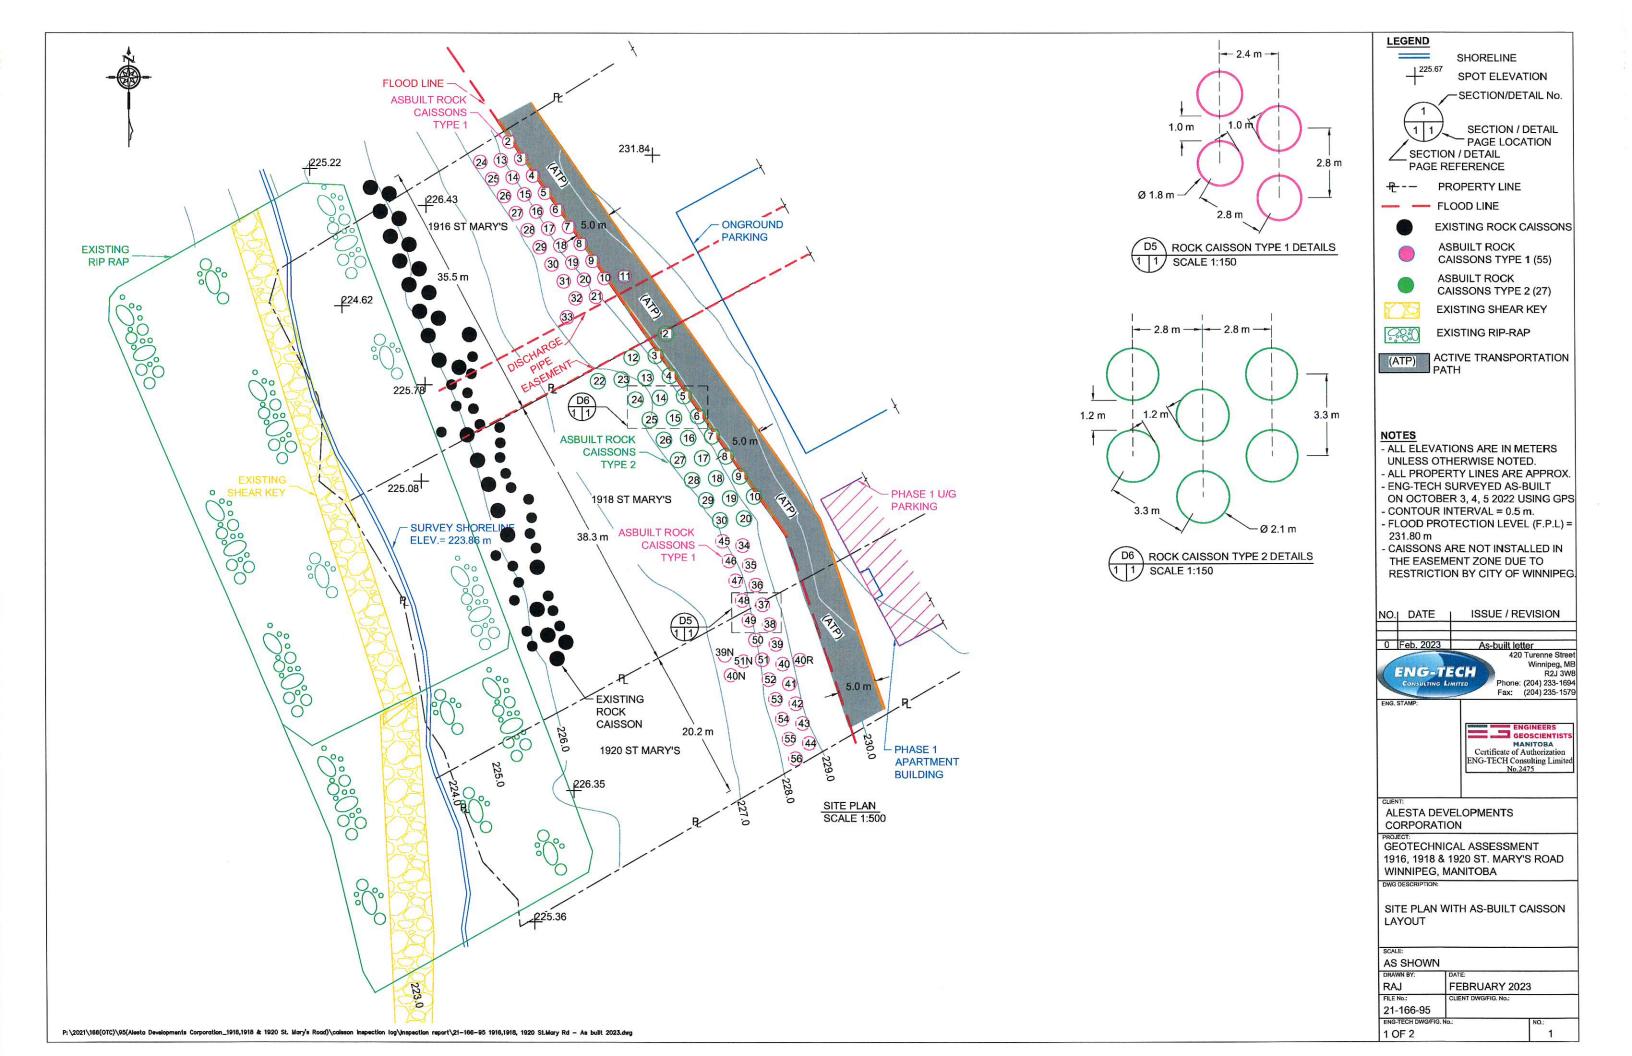
Figure 1 - Site Plan With As-Built Caisson Layout

- Twenty nine (29) Type 1 rockfill caissons plus twenty seven (27) Type 2 rockfill caissons were installed in three rows on the northwest side of the property. Twenty-three (23) plus three (3) Type 1 rockfill caissons were installed on the southwest side of the property. Sloughing/Caving of the some boreholes were encountered during the construction of Type 1 caissons such as a40. This caissons was relocated (a40R) but still encountered the same issue. Type 1 caisson number a40, a40R were abandoned and a39 and a51 were not installed due to ground conditions in that area. After further assessments, new caissons (a51N, a39N, a40N) were installed at locations shown on Figure 1.

ENG-TECH completed the site inspection of the riverbank stabilization works at the above property. Type 1 caissons No. a39, a40, a51 were relocated, as shown on Figure 1, due to sloughing/caving of the boreholes. All the work including the side grading and construction of the caissons were completed to ENG-TECH's satisfaction.
