# The City of Winnipeg

### FLOOD PUMPING STATION CONDITION ASSESSMENT

**APPENDIX B16**  
**JESSIE FLOOD PUMPING STATION - FINAL REPORT**  
**DECEMBER 2006**

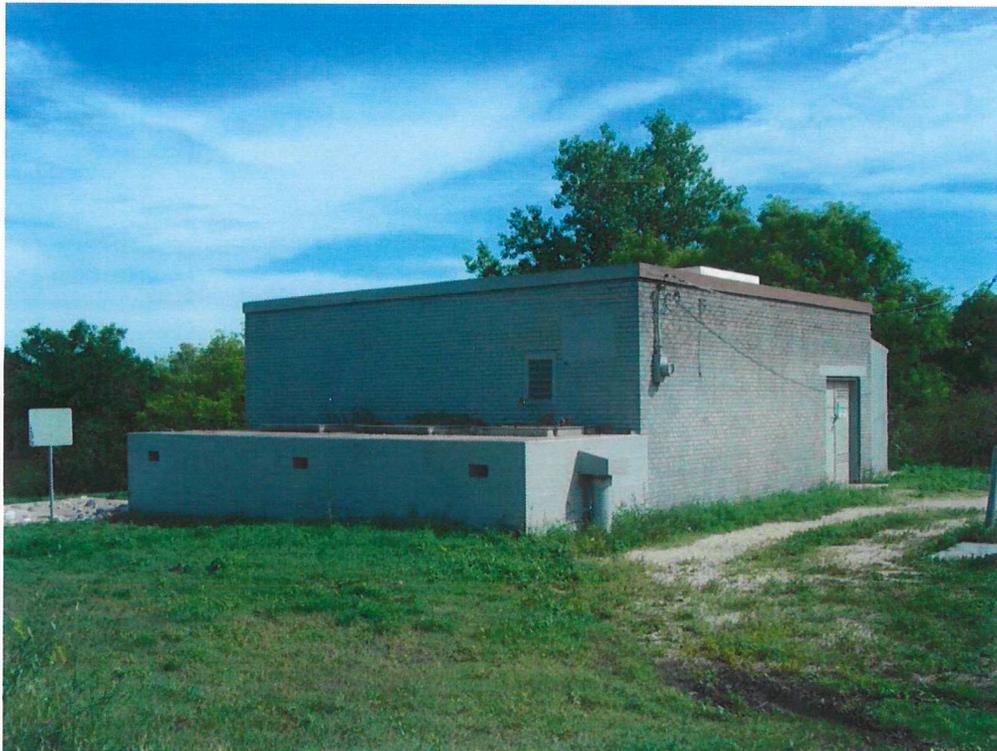
**PHOTO A16-2**

In general the masonry walls are in good condition. The exterior face (approximately 6 mm thick) has spalled off a small number of bricks immediately above the concrete discharge block on the north side (Photo A16-2). This appears to be caused by the absorption of water from the surface of the concrete due to the lack of a curb or flashing, and the effects of freeze/thaw cycling. It is difficult to determine definitively what the cause is, as this may also be exacerbated by the paint finish trapping moisture behind.

**DISCHARGE BLOCK ON NORTH SIDE**

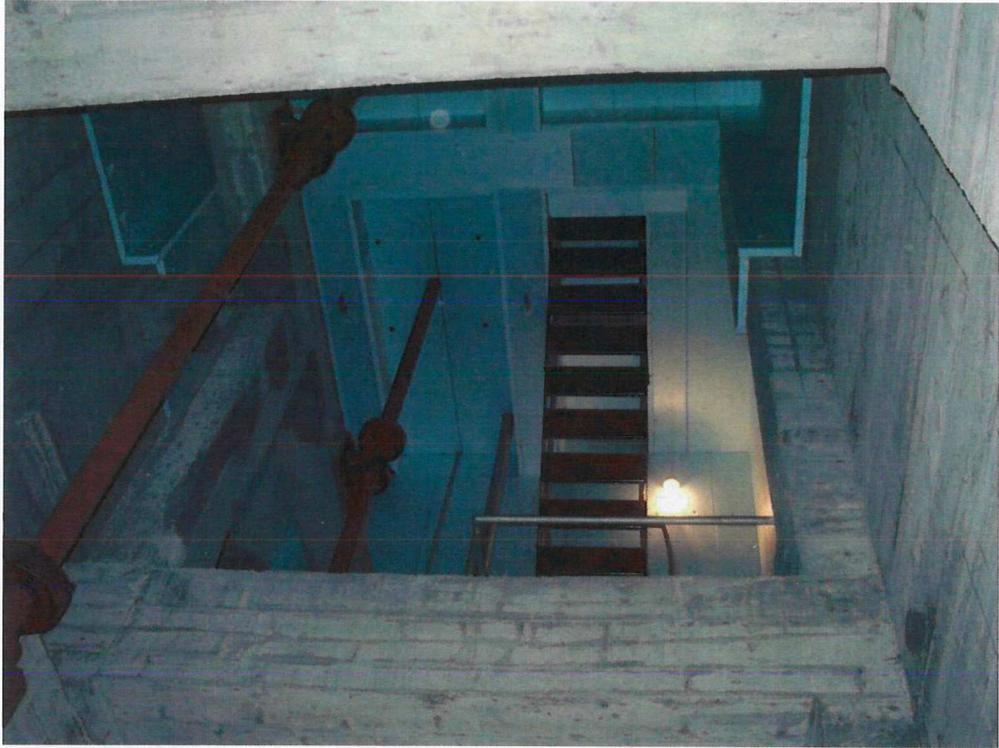
PHOTO A16-9

The drywell ceiling and the upper 2 400 mm of the drywell walls are lined with 50 mm of flammable foamed plastic insulation (extruded polystyrene – STYROFOAM) which is a potential fire/safety hazard.

FOAMED PLASTIC INSULATION AT TOP OF DRY WELL

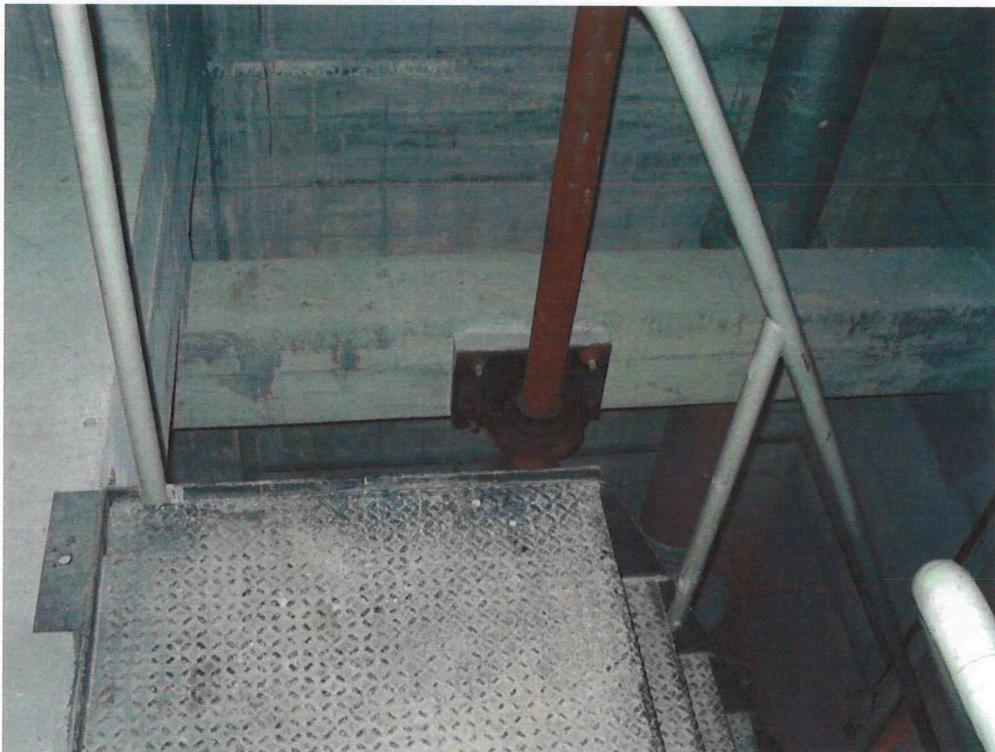
PHOTO A16-10

A galvanized steel stair with intermediate landings provides access to the drywell below (Photo A16-9). The stairs are steep but allowable by code for service areas. Due to the installation of the foamed plastic insulation around the top of the drywell there is insufficient hand clearance along the stair handrails at these locations creating a potentially unsafe condition when using the stair. The height of the guardrails around the intermediate landings is approximately 900 mm (less than the 1 070 mm required by the current Manitoba Building code), and only a top rail is provided (Photo A16-10).

DRY WELL ACCESS STAIR - NO INTERMEDIATE RAIL

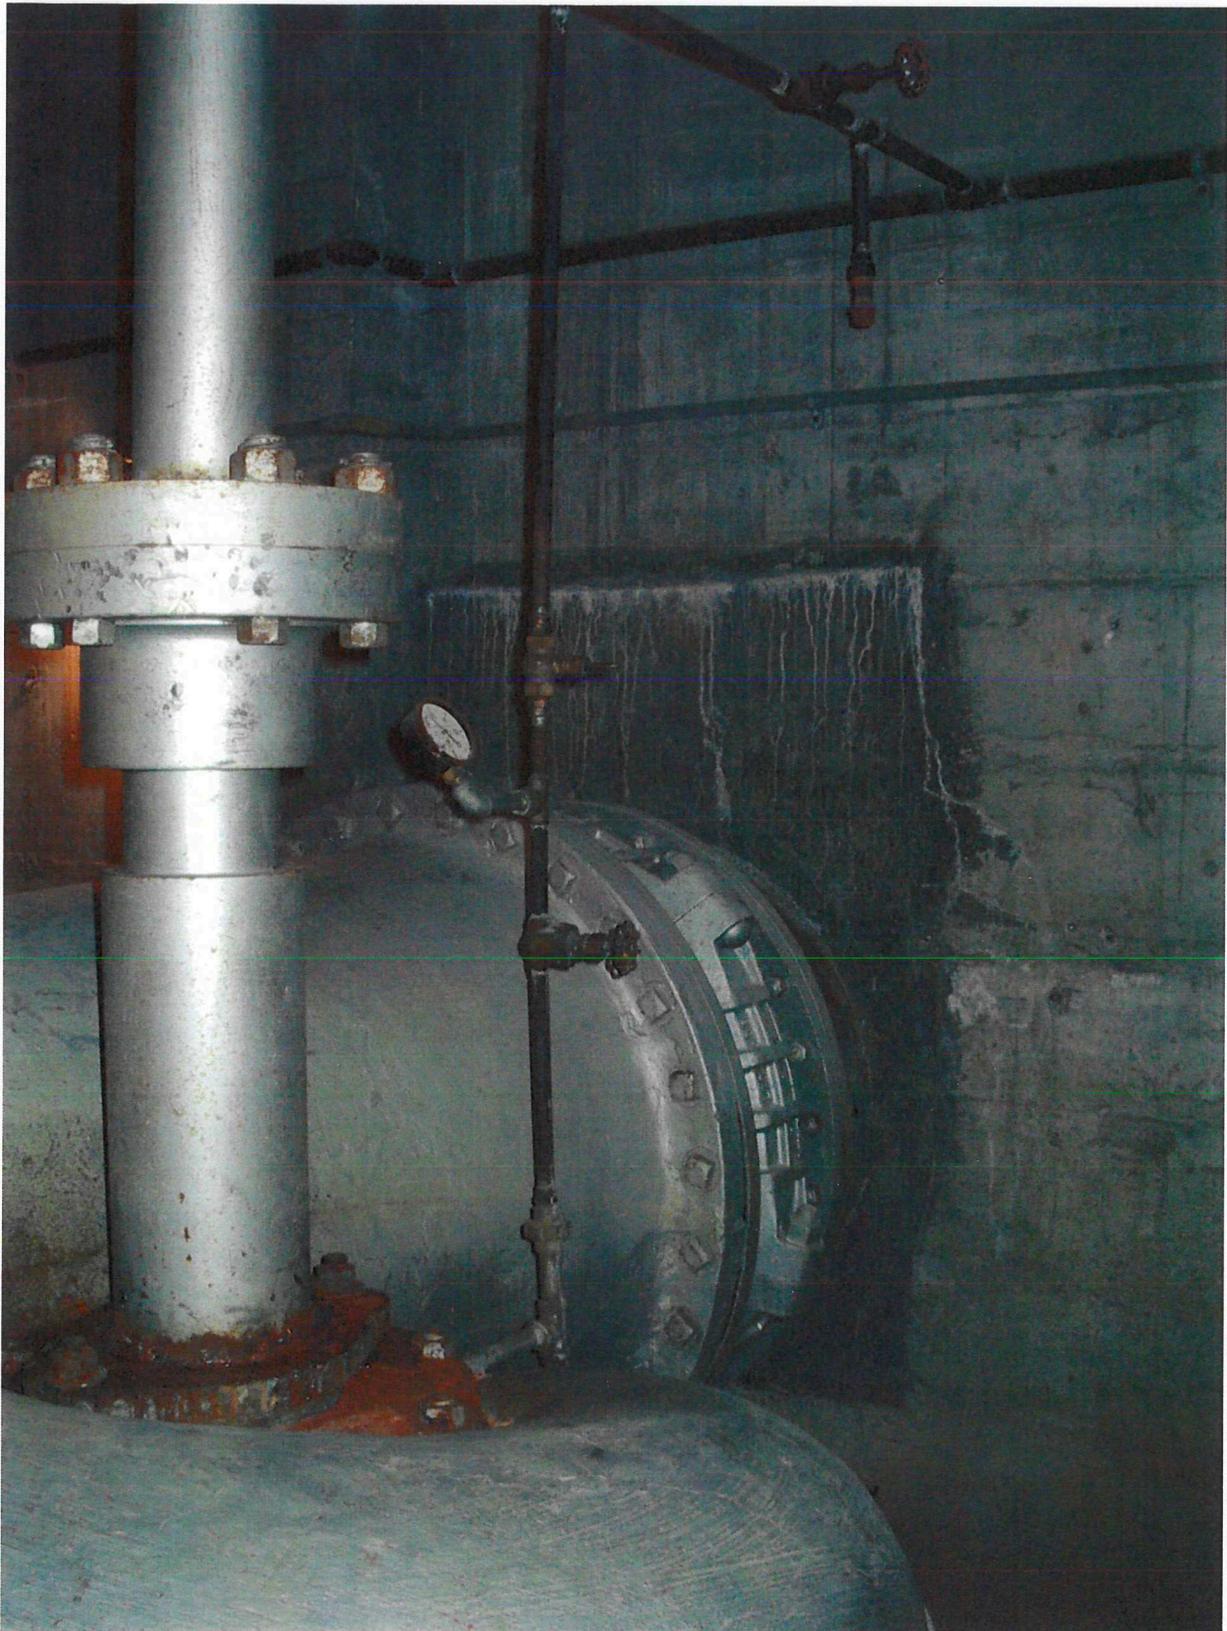
**PHOTO B16-1**

The shaft seal water line provides water to the packing gland for cooling and lubrication. This station's shaft seal water piping has only been partially converted over to PVC, the remaining piping is copper with a small portion of carbon steel threaded into the packing gland itself (Photo B16-1). Minor surface corrosion is present on the strainer and valves installed on this piping (Photo B16-2). Corroded piping and valves should be considered for replacement. Large sections of copper piping at this station may be replaced with PVC to avoid the potential for corrosion damage where copper was previously installed.

**SHAFT SEAL WATER LINE - COPPER PIPING**

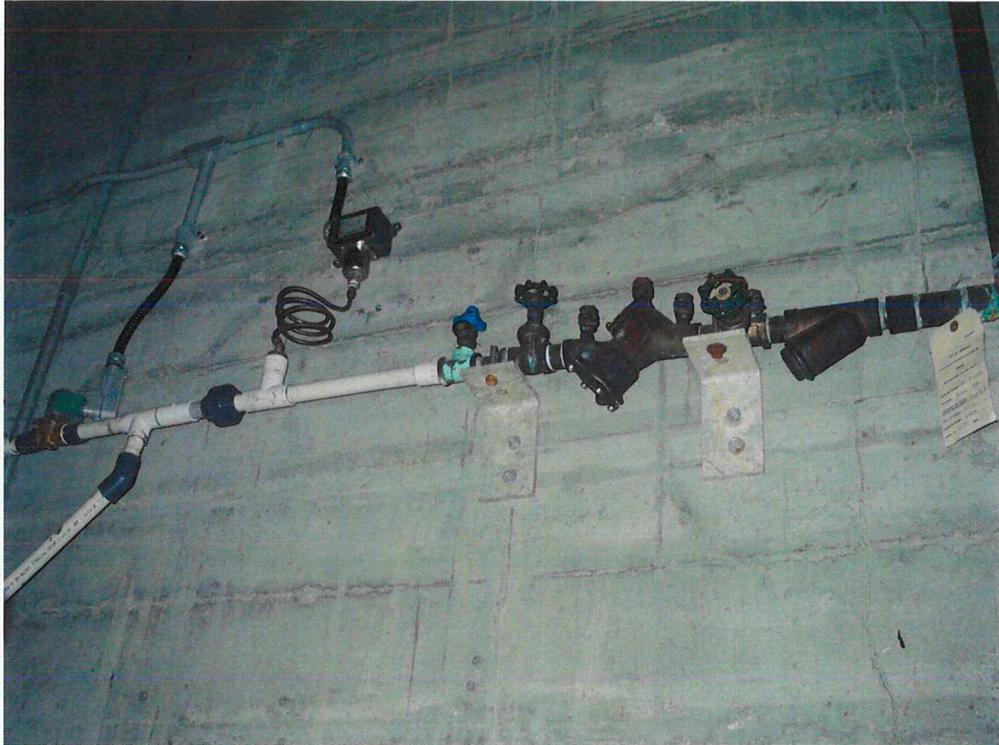
PHOTO B16-2

SHAFT SEAL WATER MAIN LINE VALVES - CORROSION ON STRAINER, CHECK VALVE AND GATE VALVES

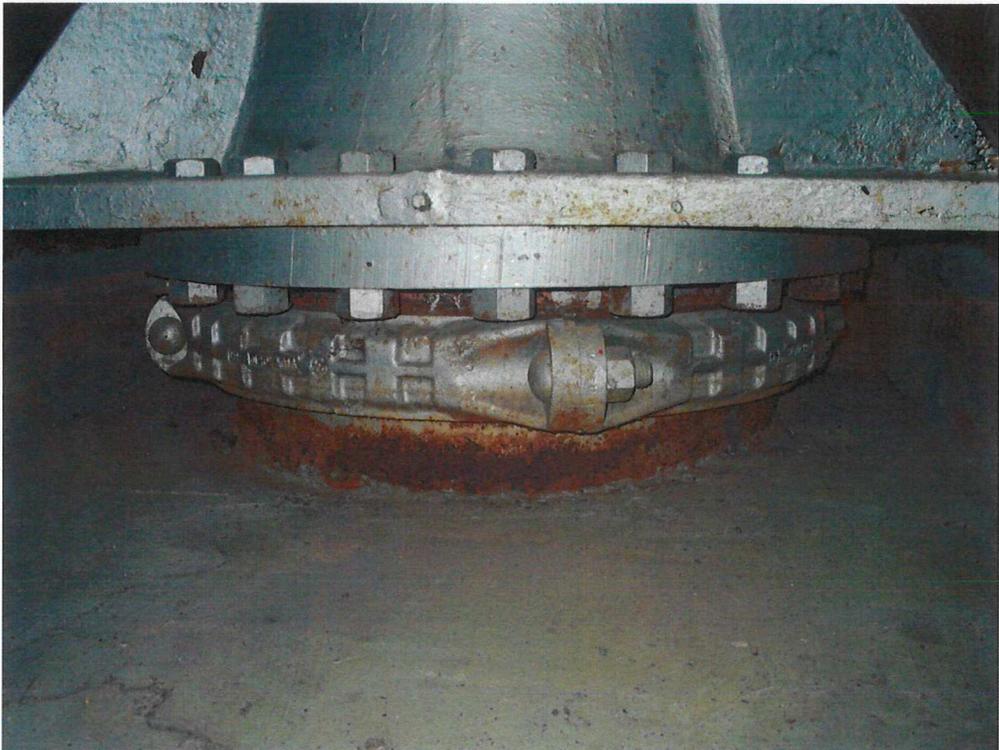
PHOTO B16-3

The suction lines on Pumps 105, 106, and 107 are corroding and have lost their protective paint where the pipe meets the floor (Pump 105 = Photo B16-3, Pump 106 = Photo B16-4, Pump 107 = Photo B16-5).

CORROSION ON PUMP 105 SUCTION LINE

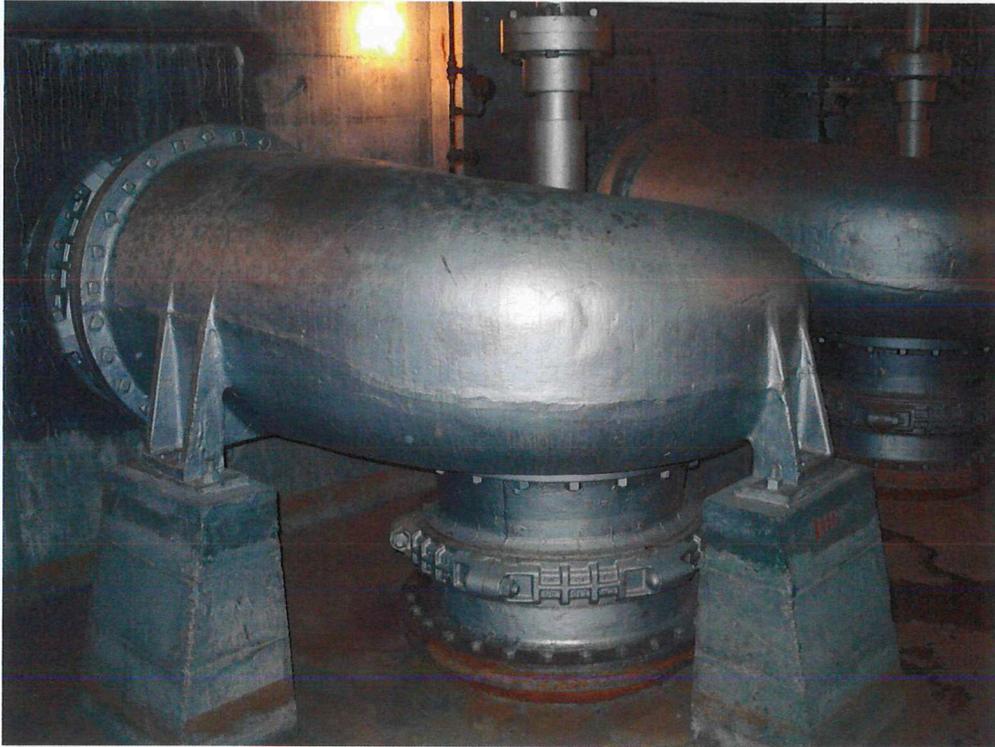
PHOTO B16-4

CORROSION ON PUMP 106 SUCTION LINE

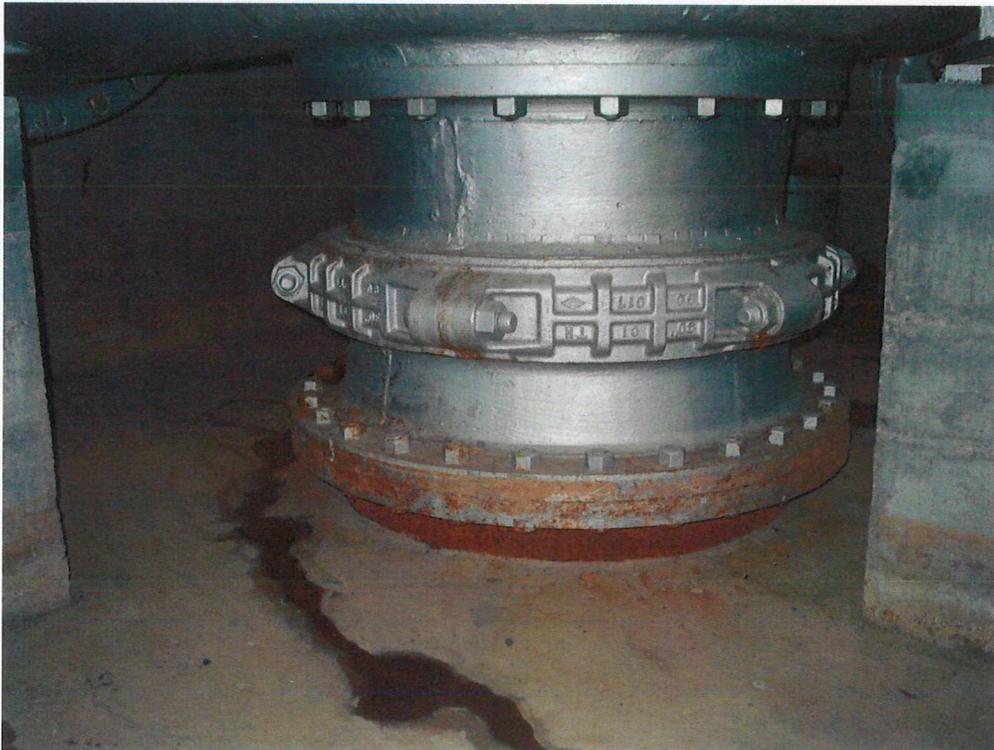
PHOTO B16-5

CORROSION ON PUMP 107 SUCTION LINE

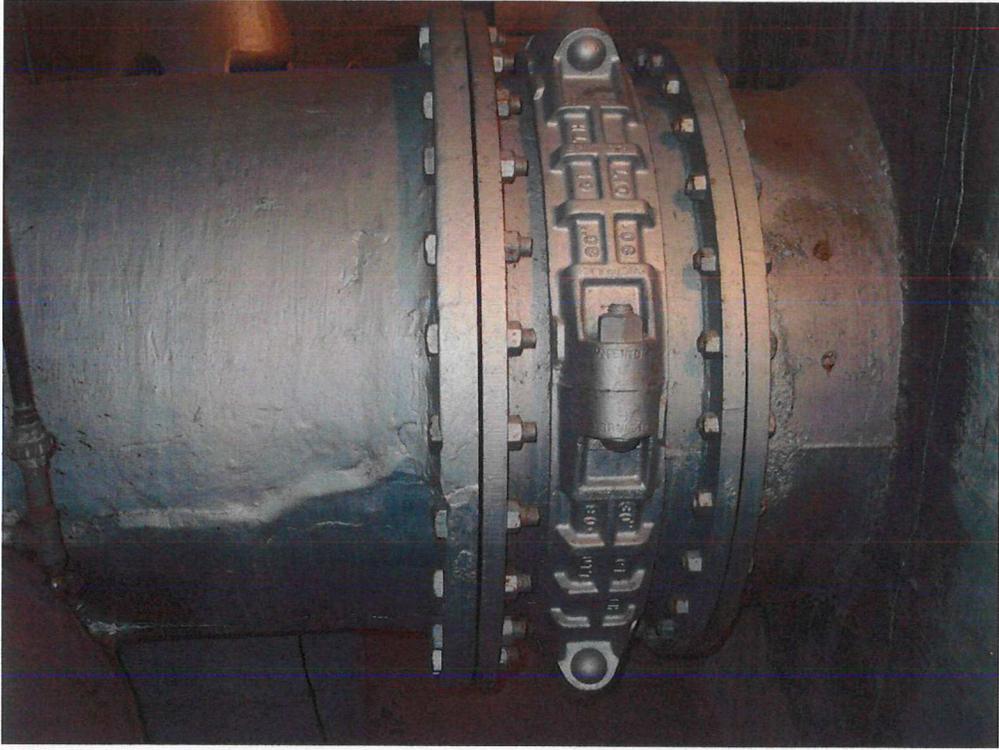
**PHOTO B16-6**

The discharge piping at this FPS runs horizontally and exits the drywell just above the floor level. Minor surface corrosion is present on the flood pump discharge piping (Pump 106 = Photo B16-6).

**CORROSION ON PUMP 106 DISCHARGE LINE (CORROSION IS PAINTED OVER)**

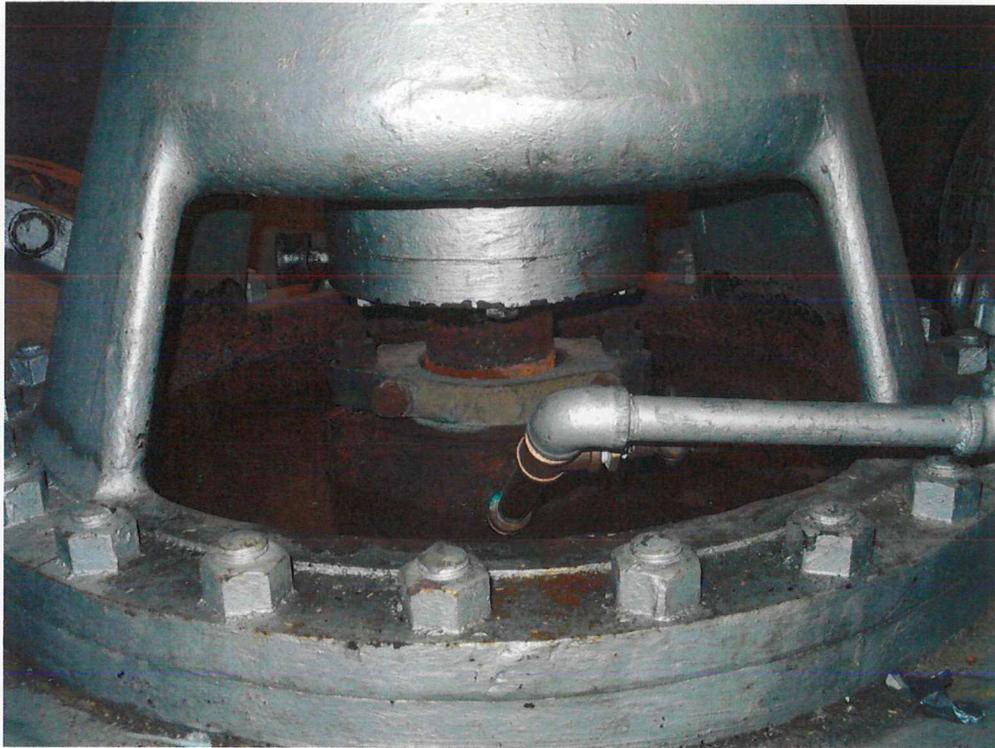
**PHOTO B16-8**

1. Pump bowl paint is flaking.
2. Water is pooling within the shroud (Photo B16-8) because the drain hole is too high and is plugged (Photo B16-9).
3. The line shaft is becoming very corroded (Photo B16-9) due to splashing and water accumulation in the shroud.

**PUMP 105 - PACKING GLAND COVER AND SHROUD**

The corroded surfaces mentioned above should be sandblasted and re-painted while the water-pooling problem can be mitigated by paint application and possibly drain hole modification. All other components not addressed above as areas of concern are considered to be in acceptable condition, this assessment should be re-evaluated in another 8 to 10 years.

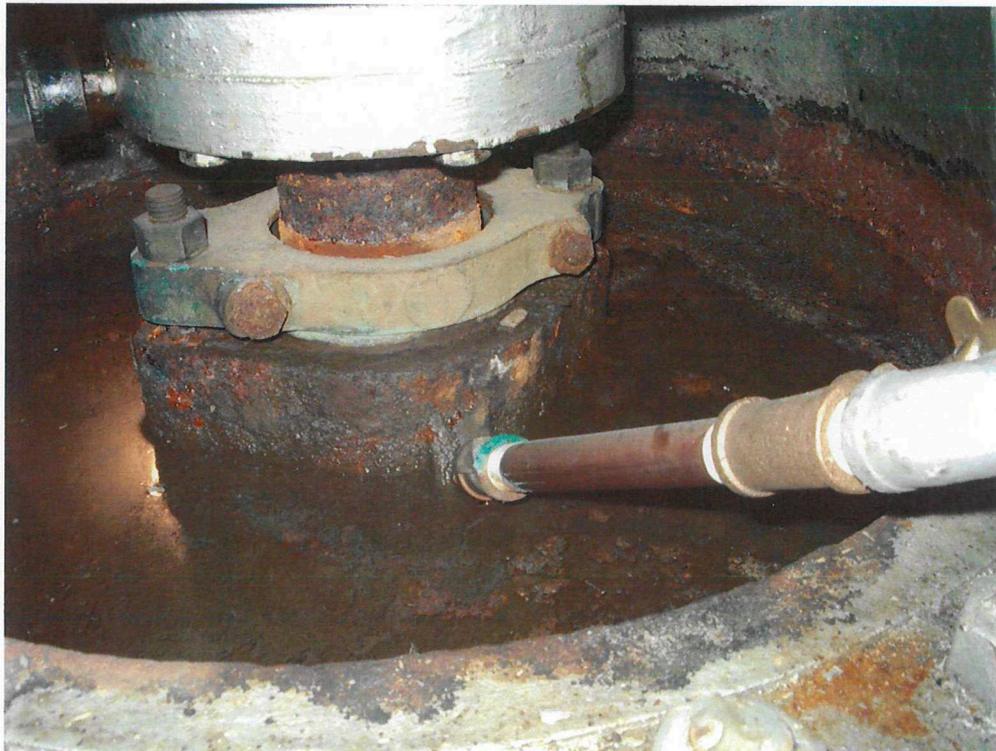
**PHOTO B16-9**

**PUMP 105 - WATER POOLING AROUND PACKING GLAND**

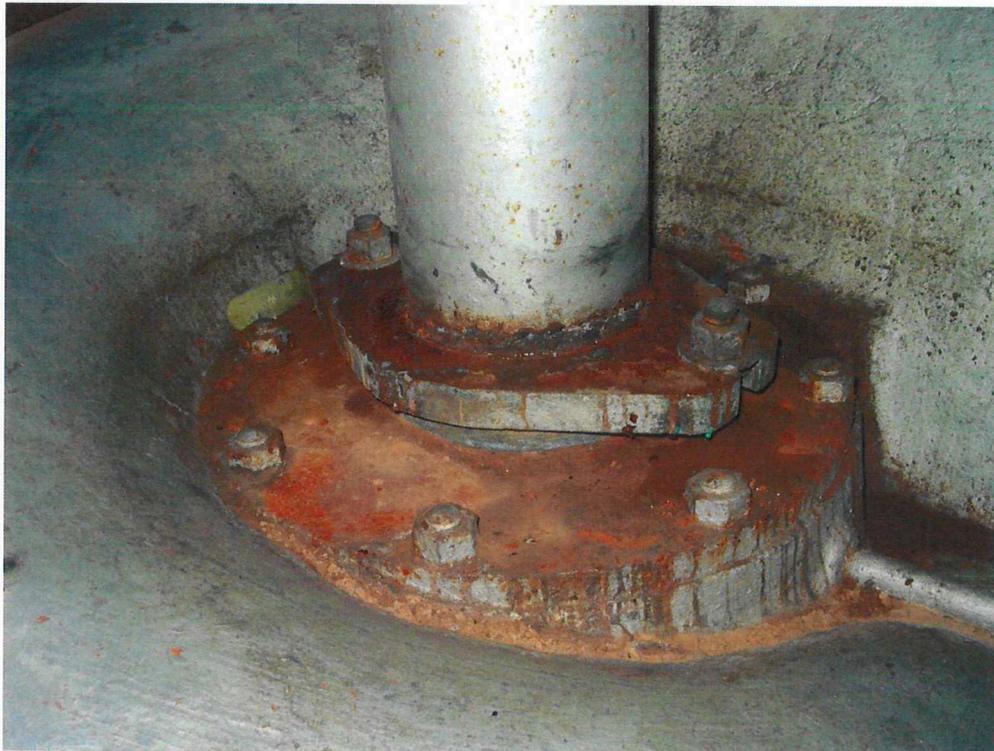
**PHOTO B16-11**

1. The pump bowl paint is flaking due to corrosion on and around the bearing cover (Photo B16-11).

**PUMP 107 - CORROSION ON BEARING COVER**

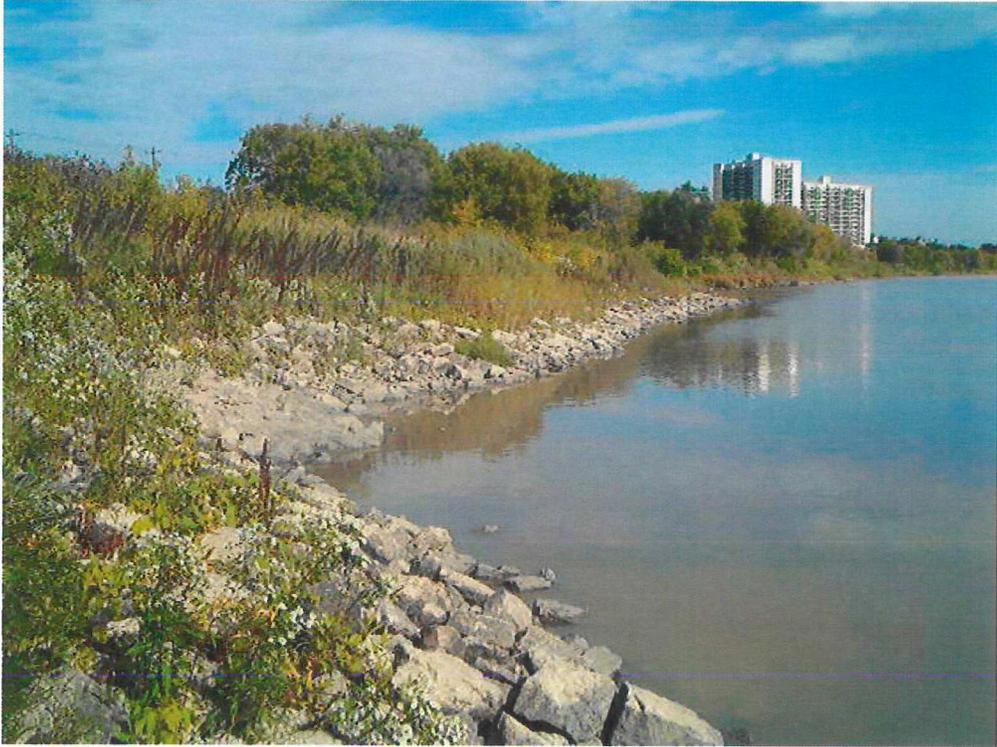
**PHOTO C16-3**

There was no visual evidence of overall riverbank instability within the limits of the slope stability improvement works. In general, the existing riprap in place along the shoreline appeared to be in good condition, as shown on Photo C16-3. The material ranged in size from 50 to 450 mm, with a  $D_{50}$  of approximately 300 mm and extended approximately 50 m downstream and 100 m upstream of the outfall pipe.

**JESSIE AVENUE FPS SEPTEMBER 16, 2004 - LIMESTONE RIPRAP ALONG SHORELINE LOOKING NORTH.**

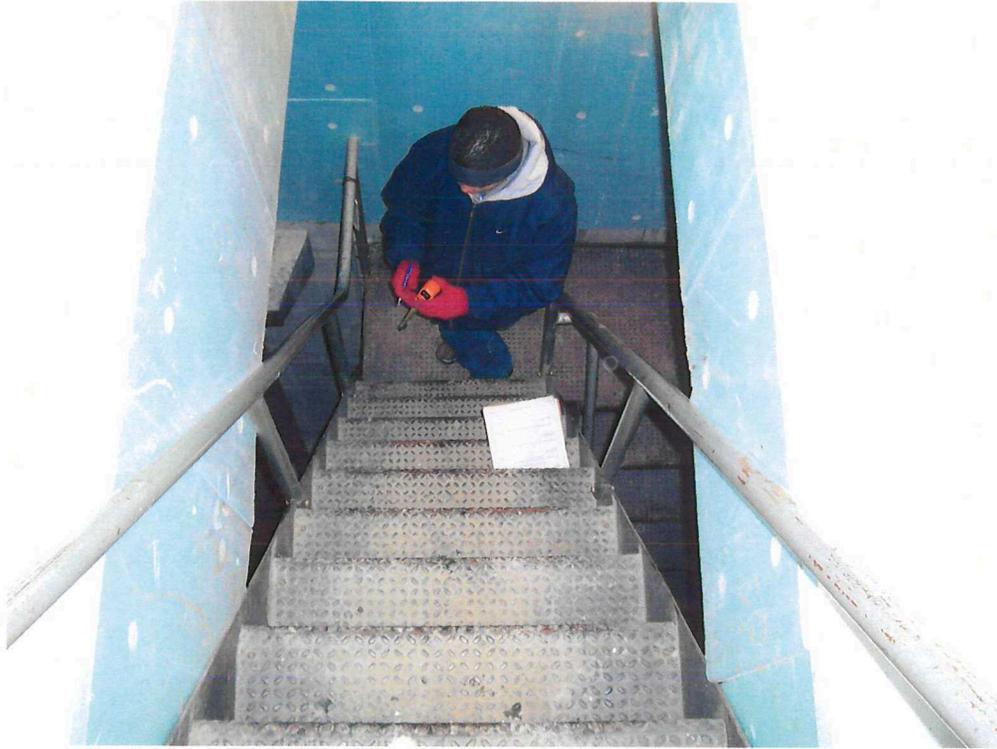
**PHOTO D16-1**

**DRY WELL ACCESS STAIR - STEEP AND MISSING MID-RAILS**

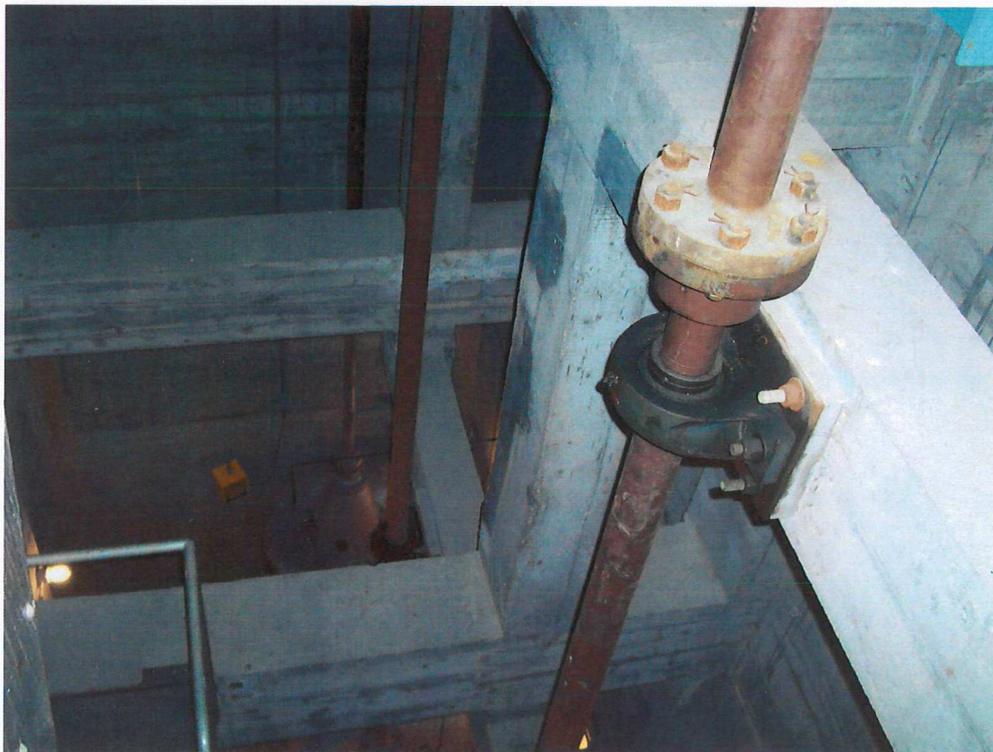
**PHOTO D16-2**

**SHAFT MOUNTS - MINOR CORROSION ON NUTS AND BASEPLATE EDGES**

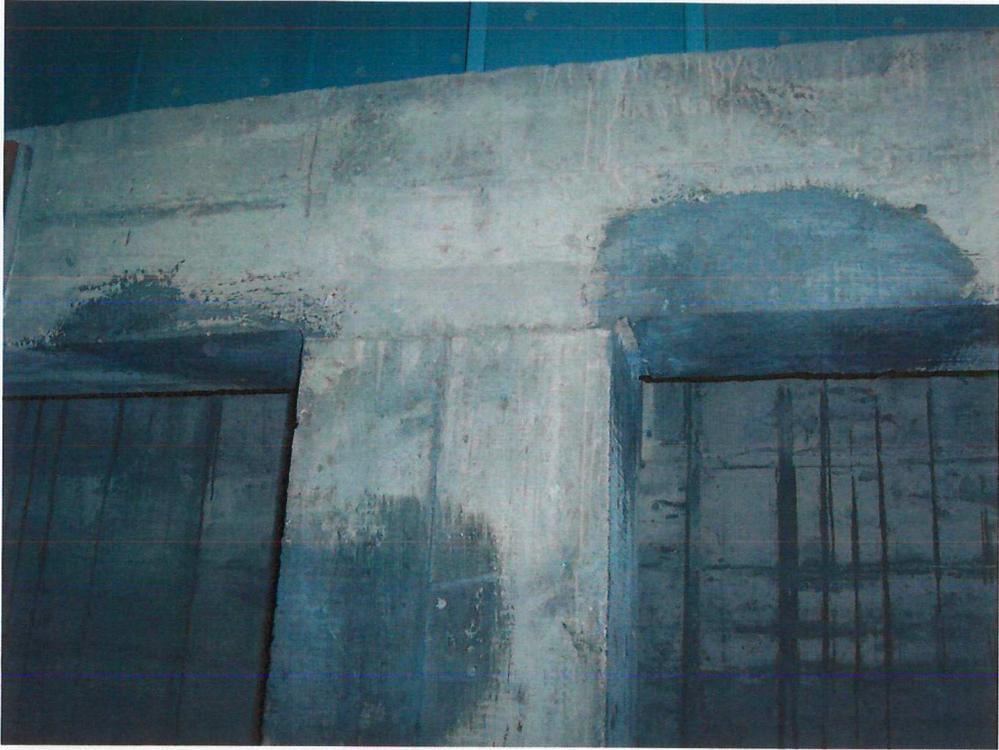
**PHOTO D16-3**

The dry well concrete beams and shaft guide mounts are in a good condition. The concrete beams have been patched at a few locations along the bottom and sides but these repairs

appear to be performing well (Photo D16-3). There are minor cracks on all walls around the perimeter of the dry well. White residue (efflorescence) and staining is evident along some cracks indicating past seepage and some corrosion of wall reinforcement. This is particularly evident at the concrete in-fills around the pump intake pipes (Photo D16-5). There is evidence of patching from previous crack repairs.

**INTERMEDIATE BEAMS AND COLUMNS (DRY WELL) - MULTIPLE PATCHED LOCATIONS**

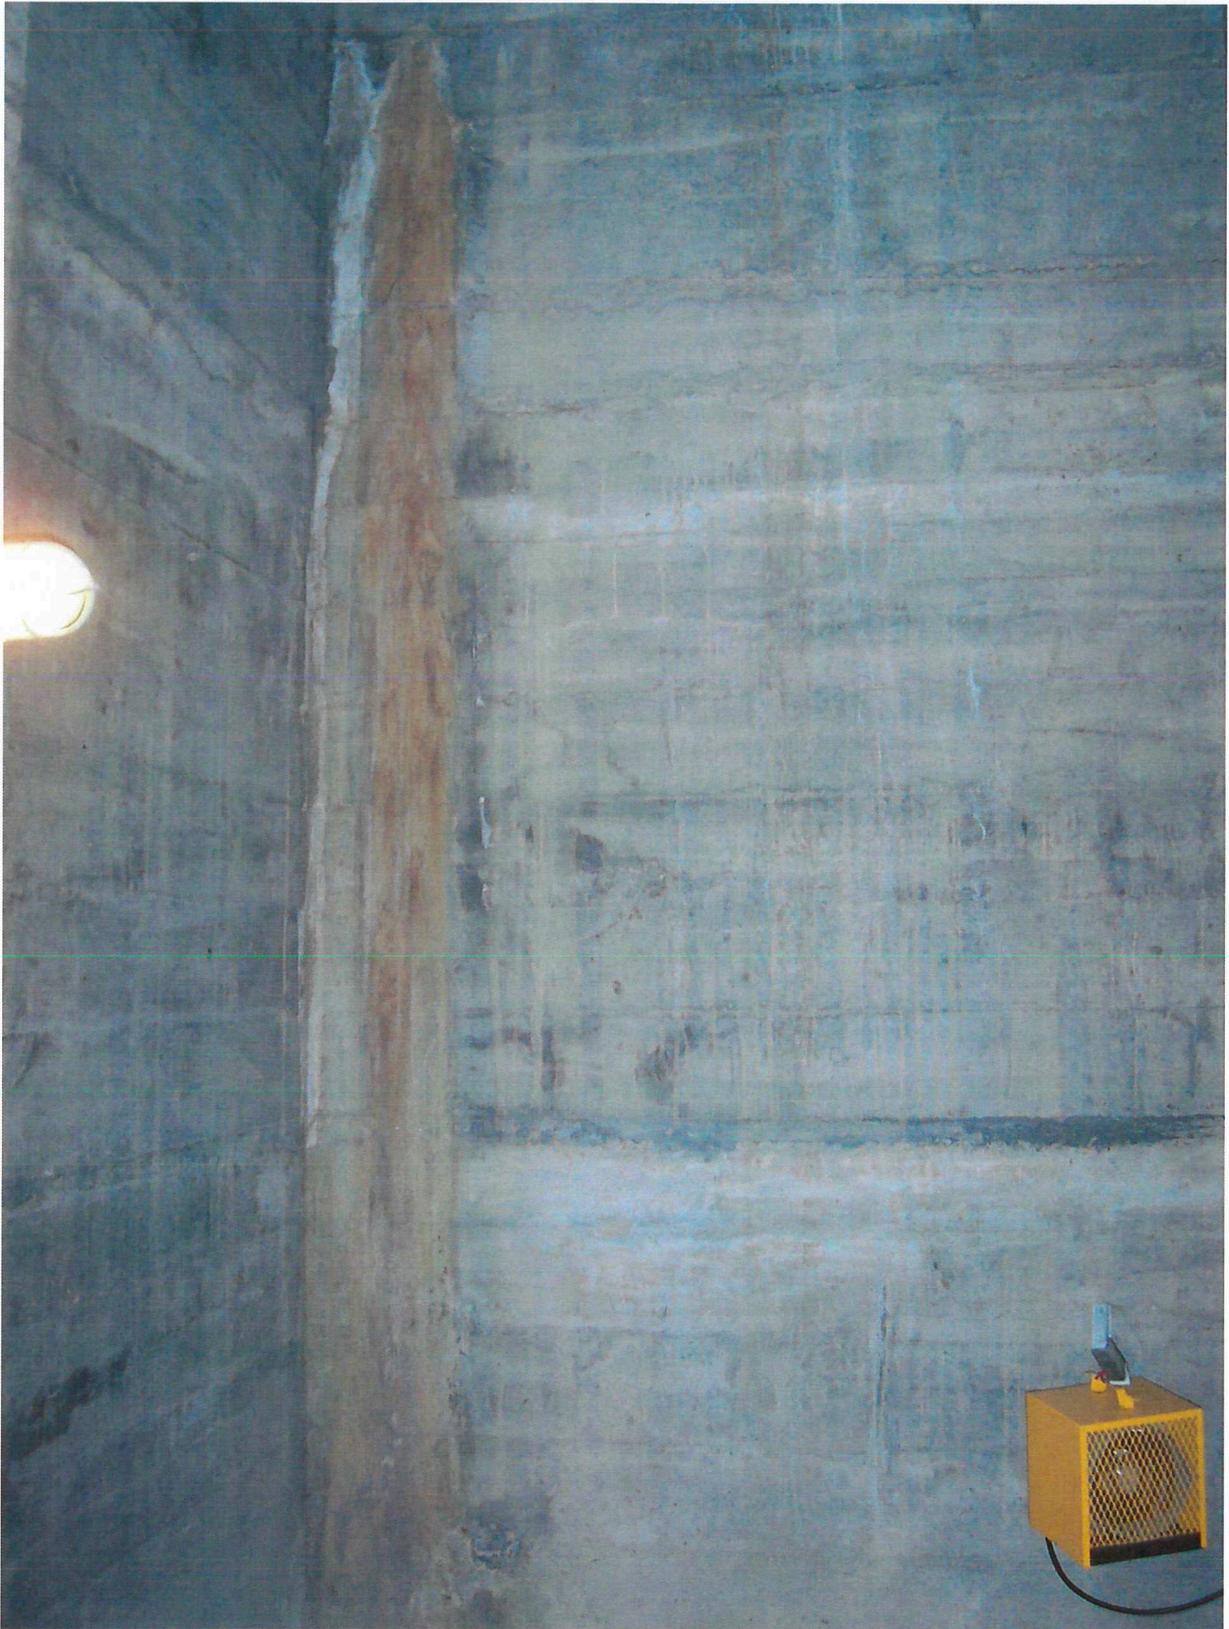
PHOTO D16-4

DRY WELL WALLS - WHITE DEPOSITS (EFFLORESCENCE) AND ORANGE STAINS

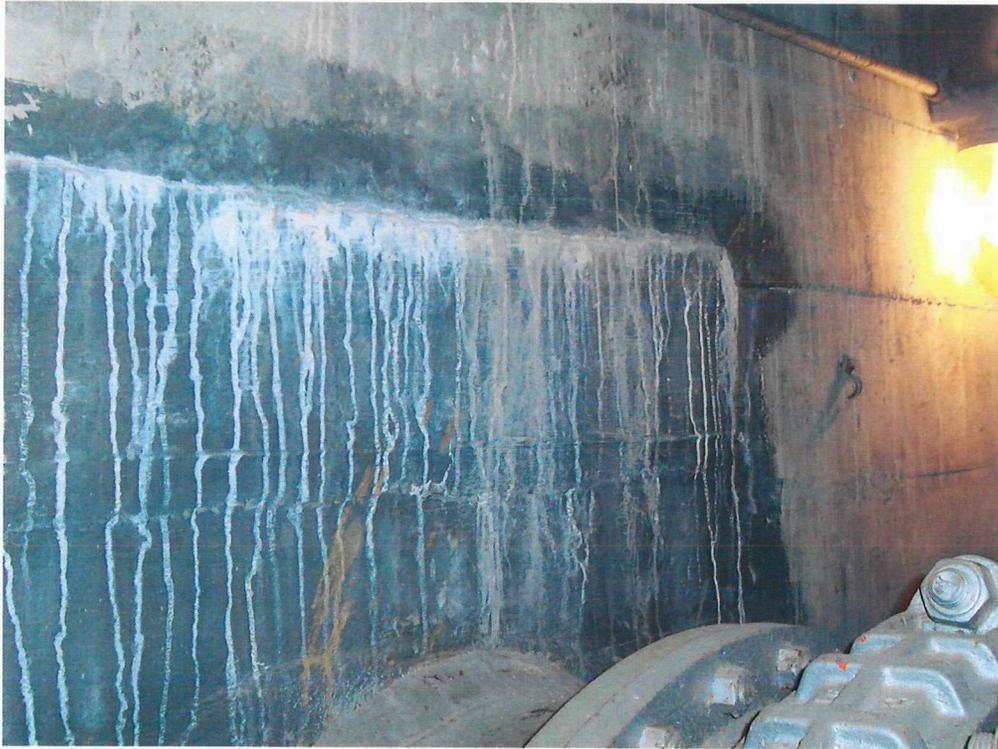
PHOTO D16-5

DRY WELL WALLS - WHITE DEPOSITS (EFFLORESCENCE) FROM HAIRLINE CRACKS AT CONCRETE INFILLS

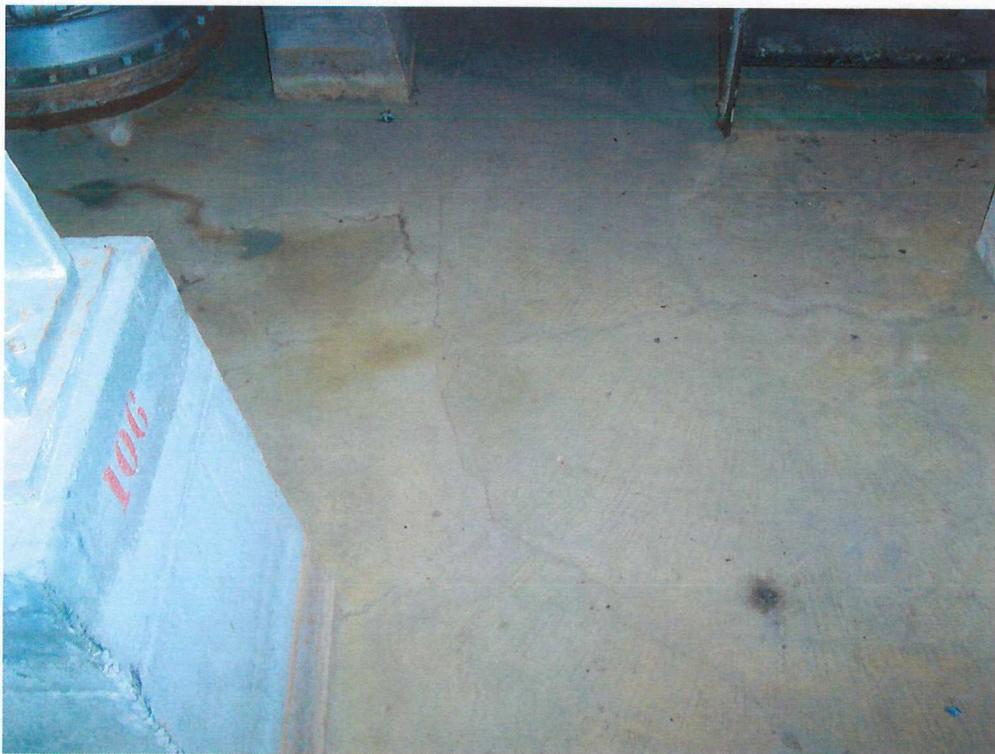
PHOTO D16-6

DRY WELL FLOOR SLAB - MINOR CRACKS

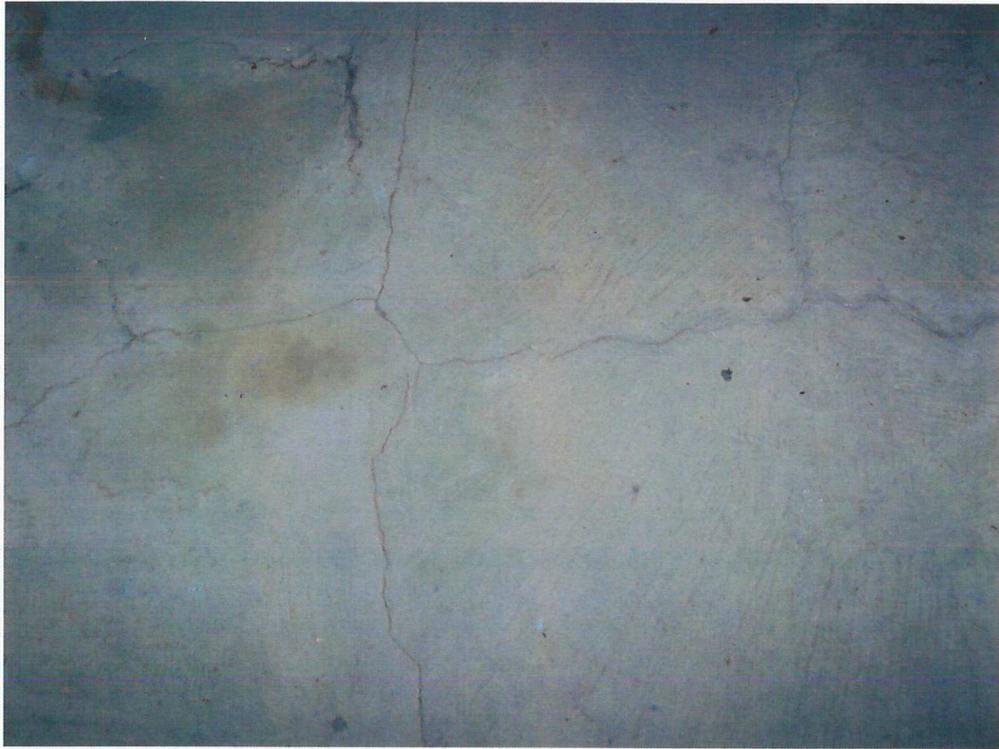
**PHOTO D16-7**

The floor condition is fair as it has many significant cracks throughout that propagate in all directions (Photo D16-7). The pump bases are in a good/fair condition. There are hairline cracks evident on most grout shoulders. At least two concrete pedestals have major spalling at the base with exposed reinforcing (Photo D16-8). Some base plates and anchor bolts have minor surface corrosion.

**DRY WELL FLOOR SLAB - MULTIPLE MINOR CRACKS**

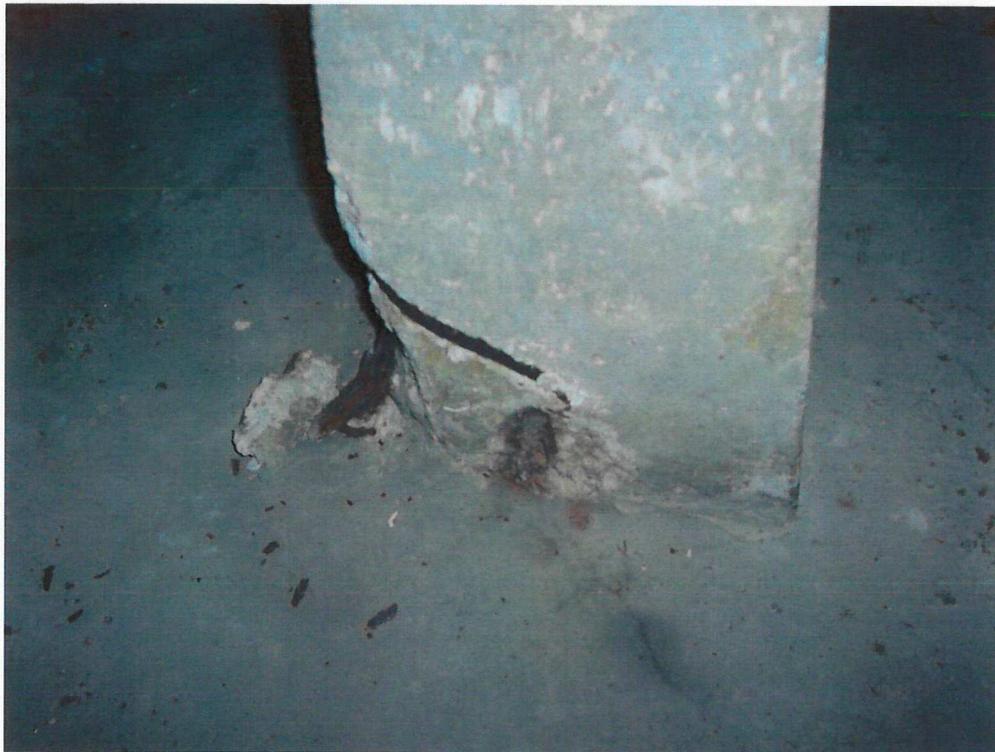
**PHOTO D16-8**

**PUMP BASE - BOTTOM CORNER SPALLED OFF AND EXPOSED REINFORCING STEEL (CORRODED - SECTION LOSS)**

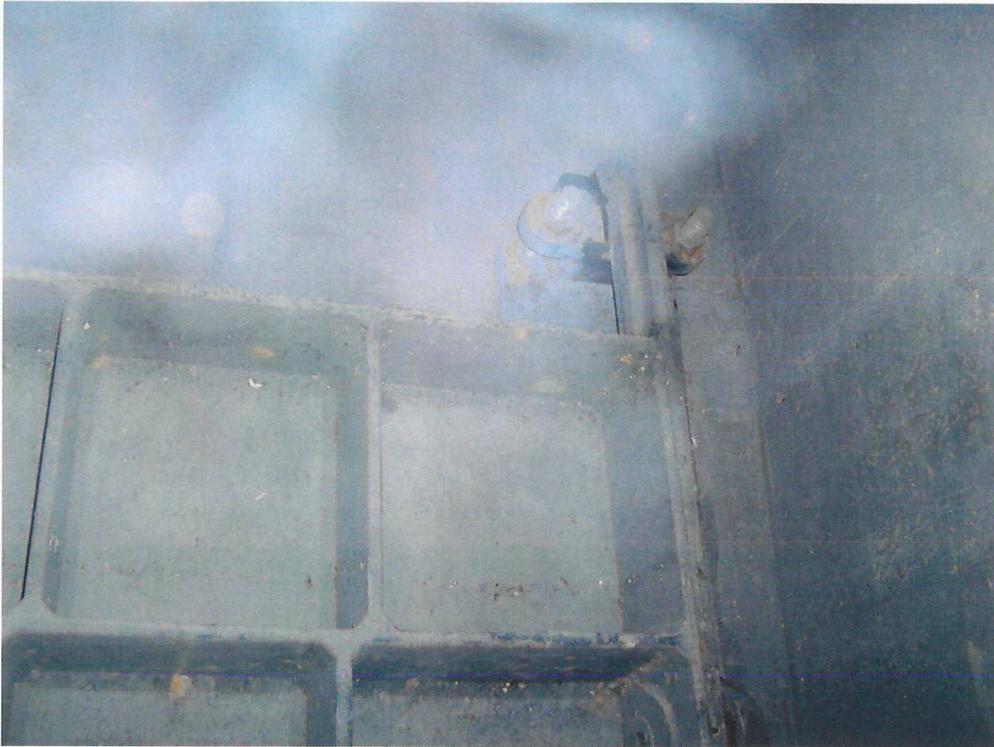
PHOTO D16-9

The flap gate was installed in 1998 (new flap on the existing slide thimble) and is in a good condition. Minor corrosion is beginning on the surface of the gate stiffeners and at the edges of the thimble (Photo D16-9). The gate seating face was not accessible for inspection.

FLAP GATE - MINOR CORROSION

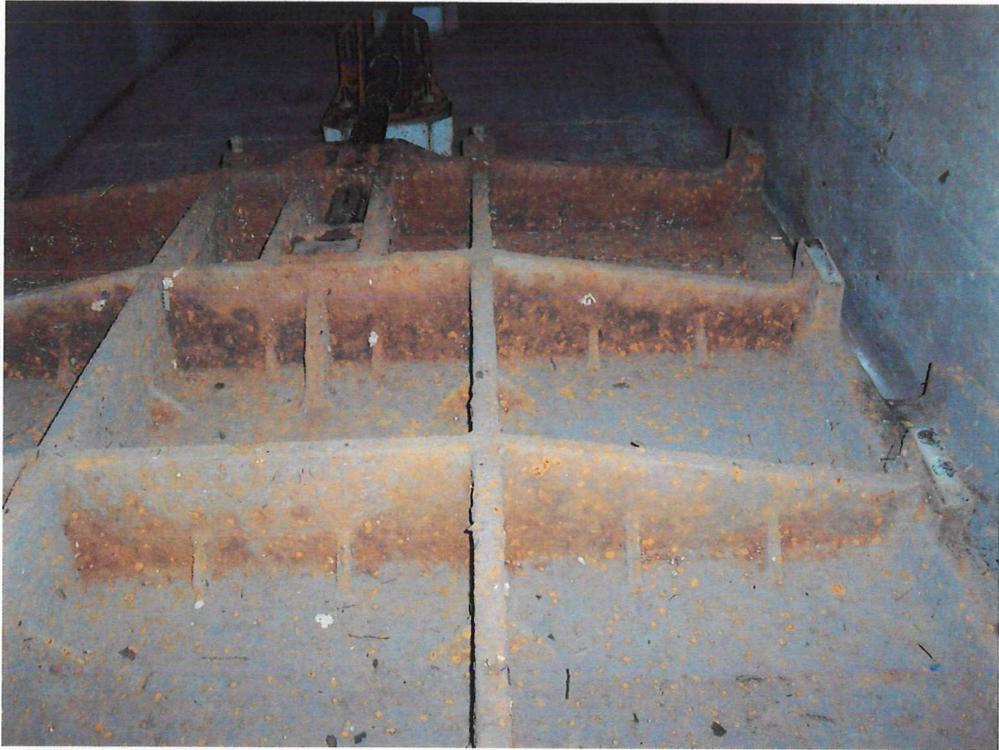
**PHOTO D16-11**

The slide gate & thimble were relocated in 1998 (re-used original 1954 gate) and are in a poor condition (Photo D16-11). The slide gate is very heavily corroded throughout with significant section loss. The slide frame anchor bolts are newer and in a good condition. The thimble has heavy surface corrosion but no section loss. The gate seating face is fairly smooth with some corrosion.

**SLIDE GATE - SECTION LOSS**
