# The City of Winnipeg

### FLOOD PUMPING STATION CONDITION ASSESSMENT

**APPENDIX B16**  
**JESSIE FLOOD PUMPING STATION - FINAL REPORT**  
**DECEMBER 2006**

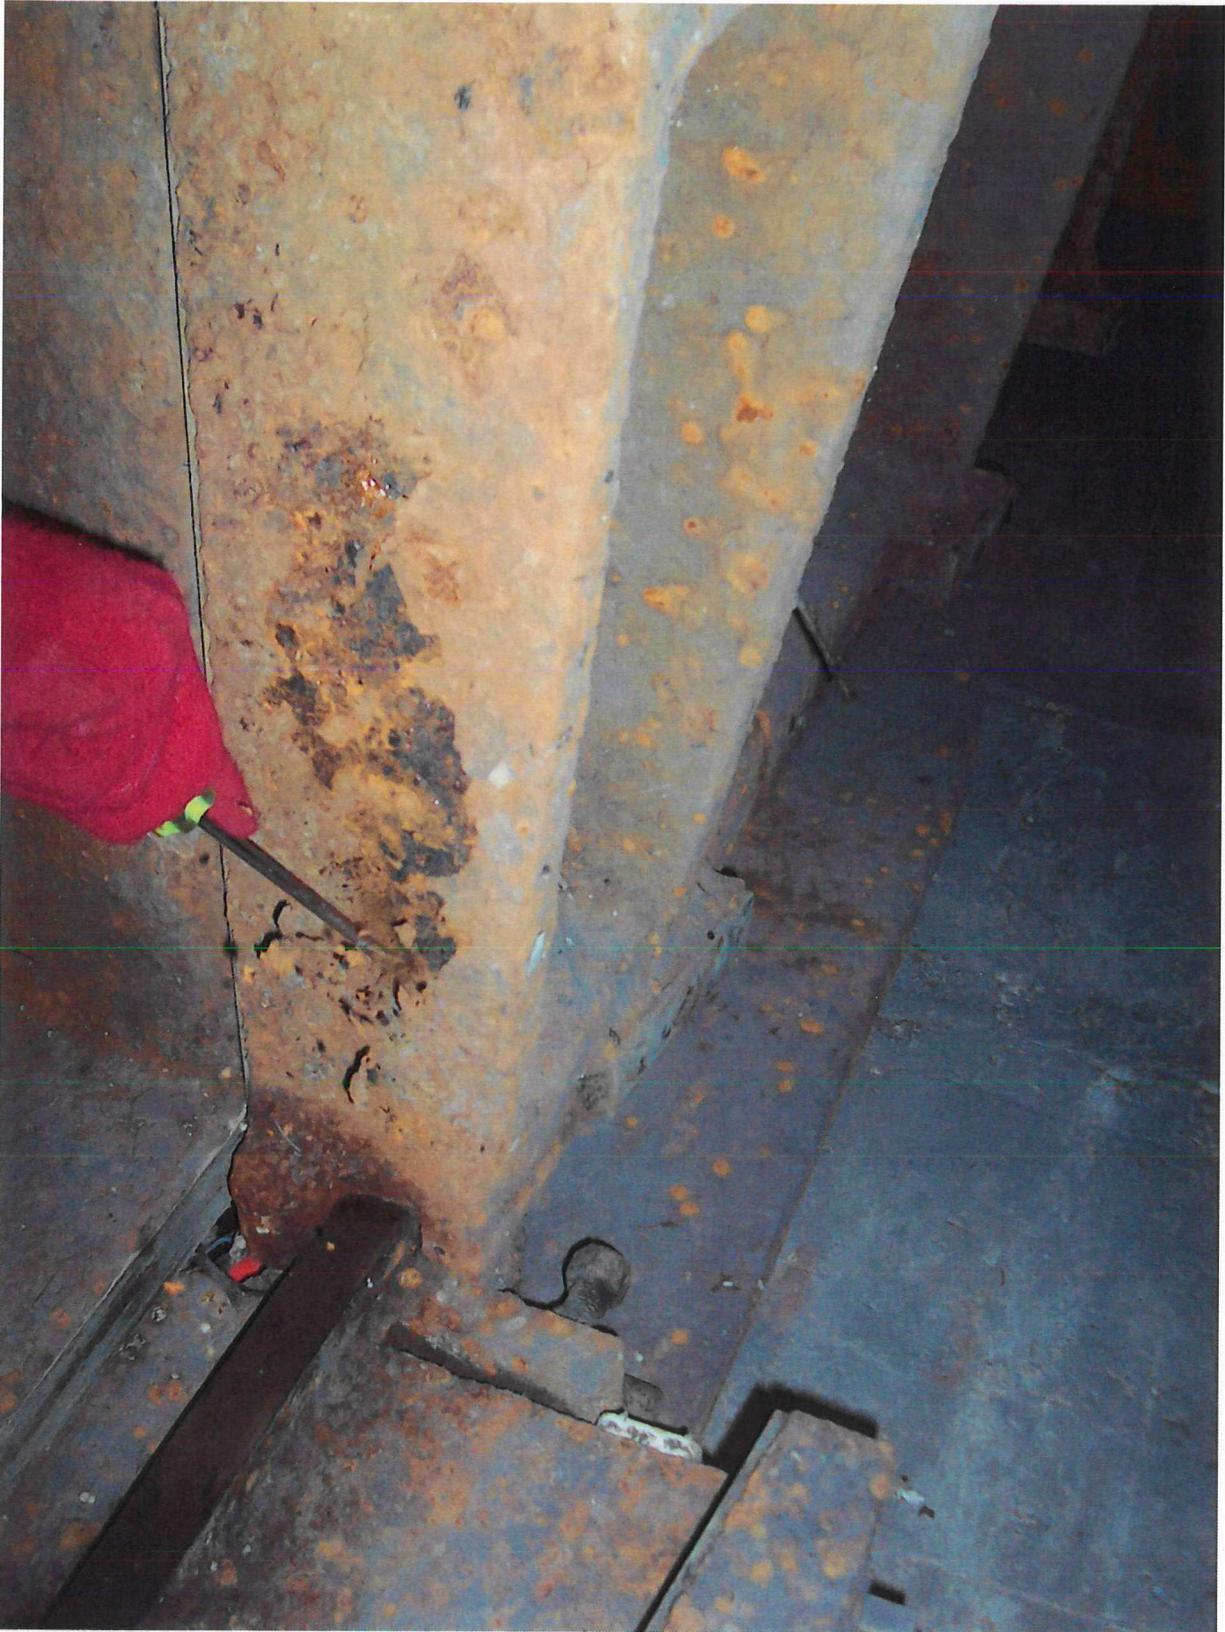
**PHOTO D16-12**

**UNDERSIDE OF SLIDE GATE - HEAVY SECTION LOSS**

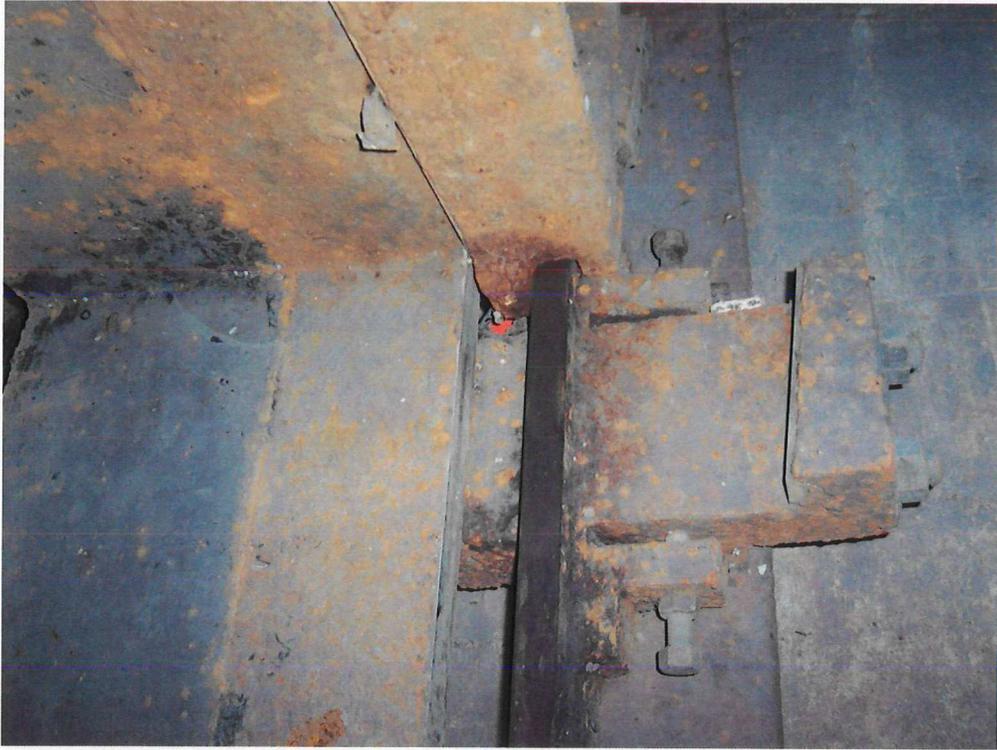
**PHOTO D16-13**

**EMBEDDED SLIDE GATE THIMBLE - HEAVY CORROSION**

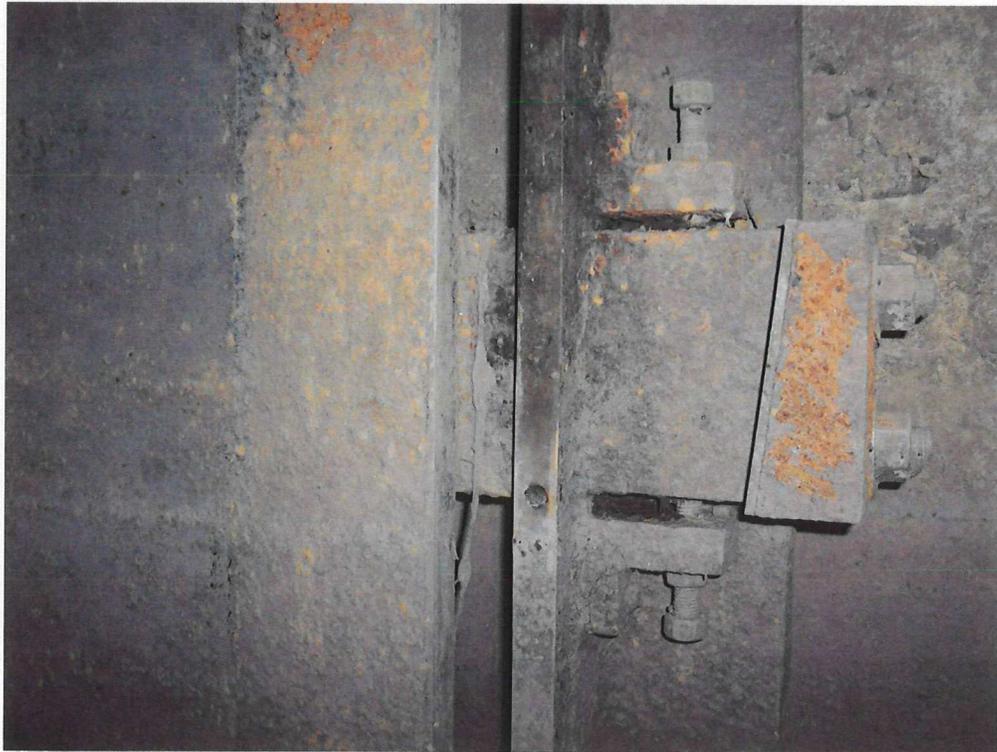
**PHOTO D16-14**

**WEDGE BLOCK (SLIDE GATE) - CORRODED (ALL ANCHOR BOLTS IN GOOD CONDITION)**

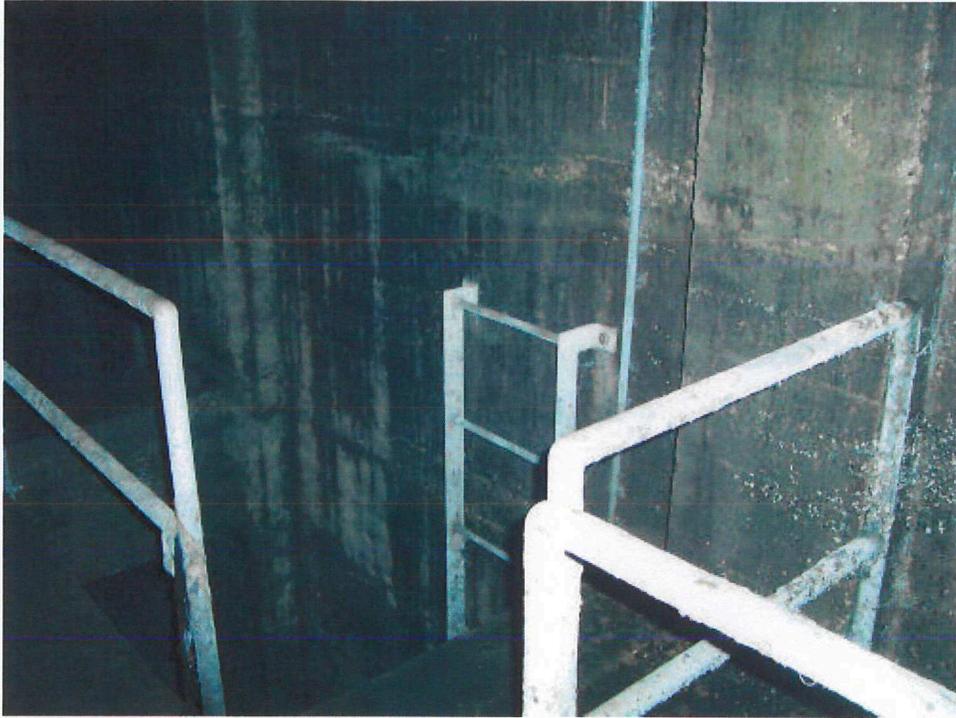
**PHOTO D16-19**

The intermediate slab and beams are in good condition with no concrete spalling or cracking. There is exposed rebar on the underside but it is not causing the concrete to spall. The railings on the intermediate slab are in good condition, but do not provide adequate protection and safety. There is a large gap near the ladder to the lower level that requires a section of guardrail to be installed (Photo D16-19). The ladder is new and in good condition with no safety cage.

**WET WELL INTERMEDIATE RAILING - SECTION MISSING**

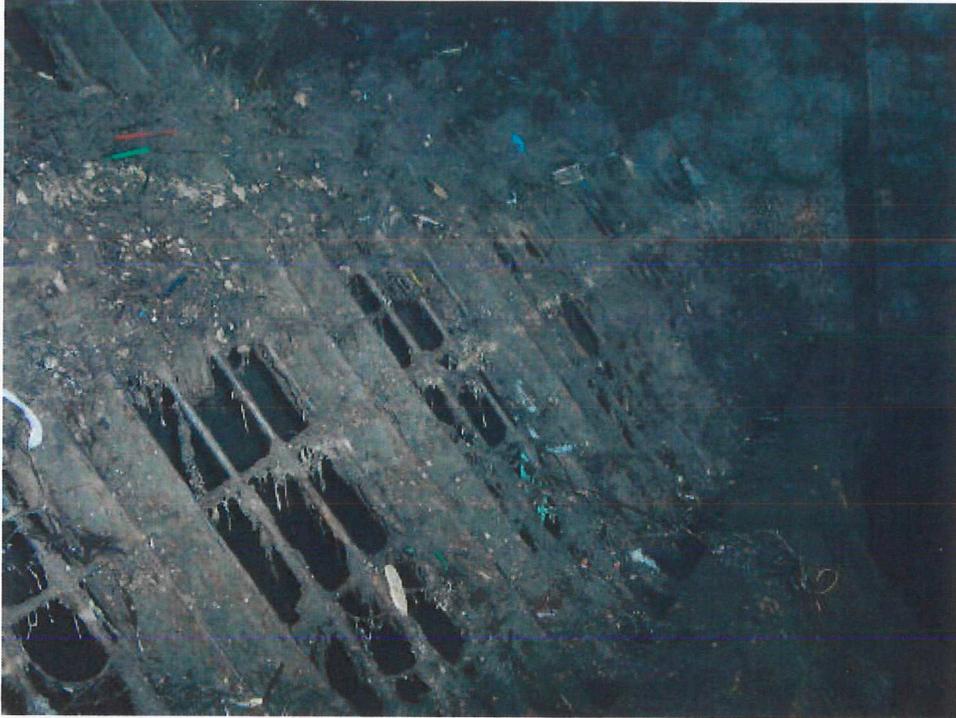
**PHOTO D16-21**

The trashracks have a lot of debris and silt covering them (Photo D16-21). They look to be in good to fair condition with no damage. The trashracks have corrosion but no section loss (Photo D16-22). There are two slide gate shafts attached to the walls with guides. The shafts are in poor condition with heavy corrosion and section loss (Photo D16-23). The guides are damaged and in poor condition with heavy corrosion and section loss (Photo D16-24). The

**WET WELL TRASHRACKS - LOTS OF DEBRIS**

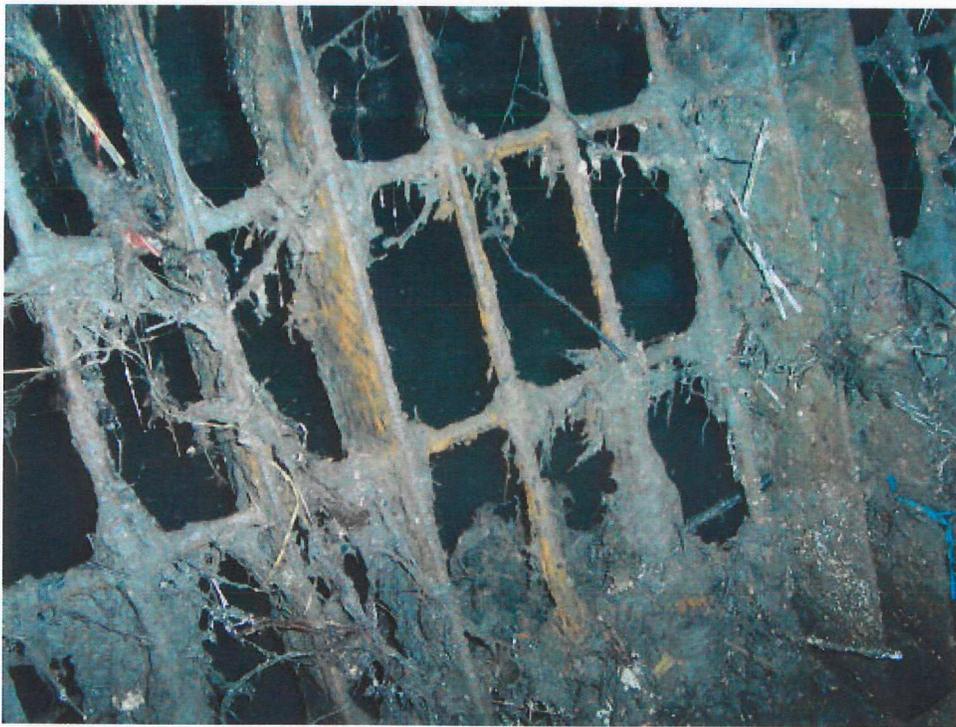
**PHOTO D16-22**

**WET WELL TRASHRACKS - CORRODED**

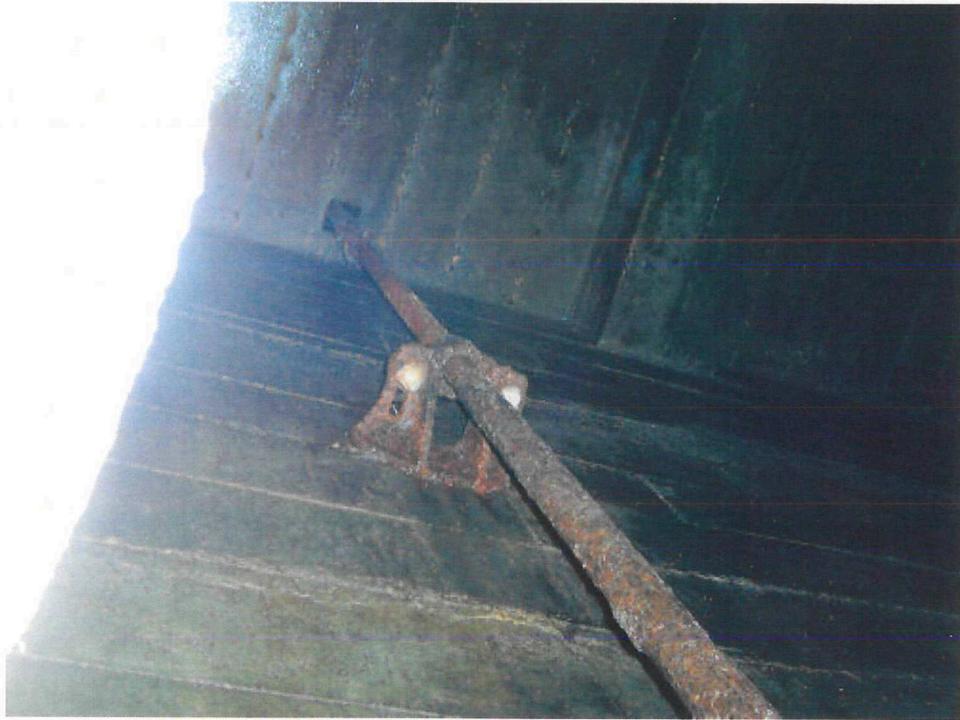
**PHOTO D16-23**

**SLIDE GATE SHAFTS AND GUIDES - CORRODED**

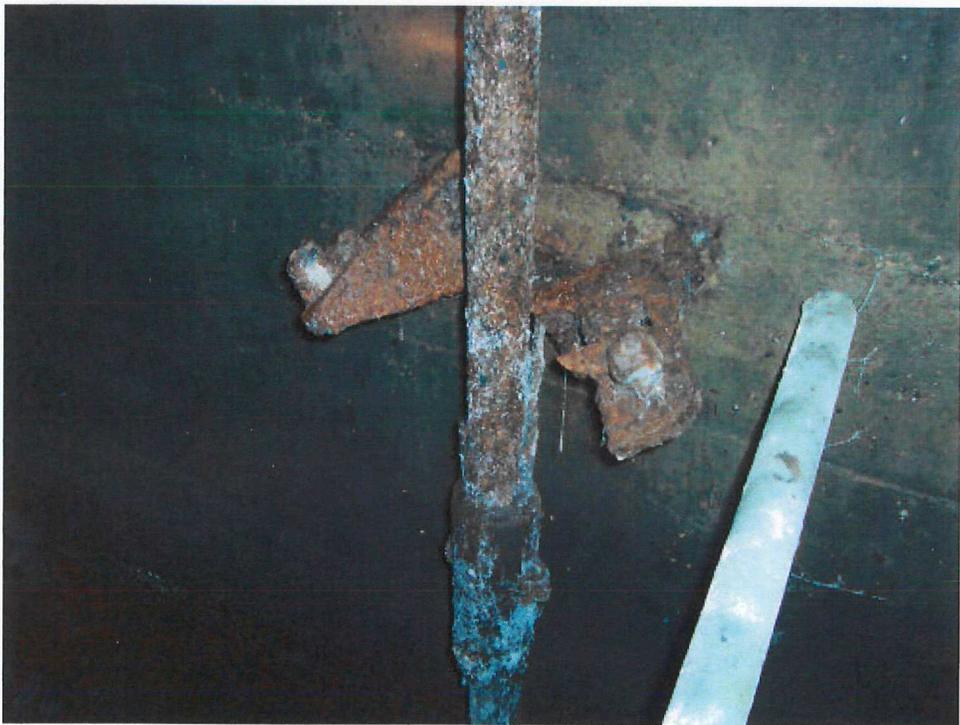
**PHOTO D16-24**

**SLIDE GATE SHAFTS AND GUIDES - CORROSION WITH SECTION LOSS AND DAMAGE**
