APPENDIX A

SITE PHOTOGRAPHS

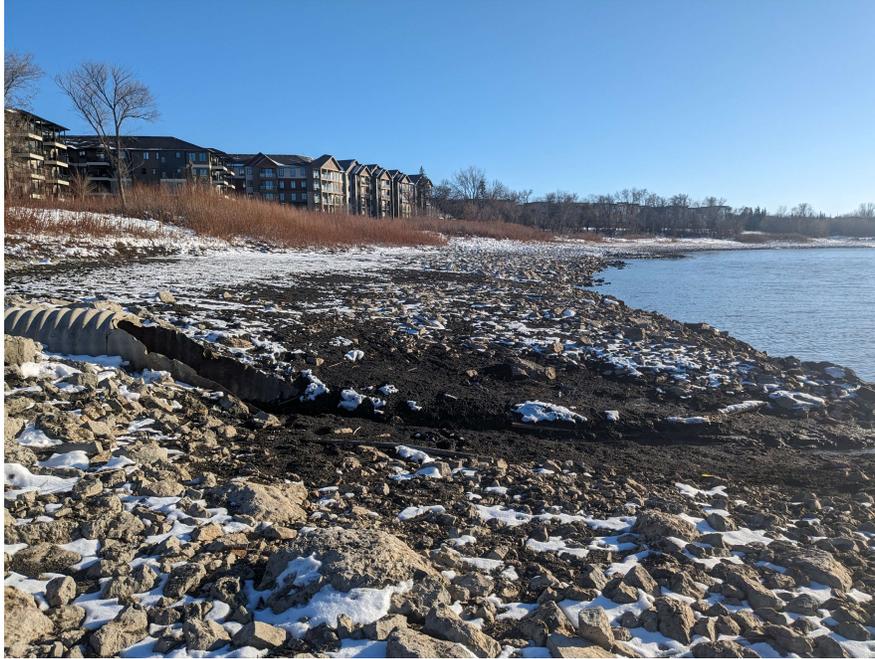
Photo 1: Pipe outlet, looking south along lower bank

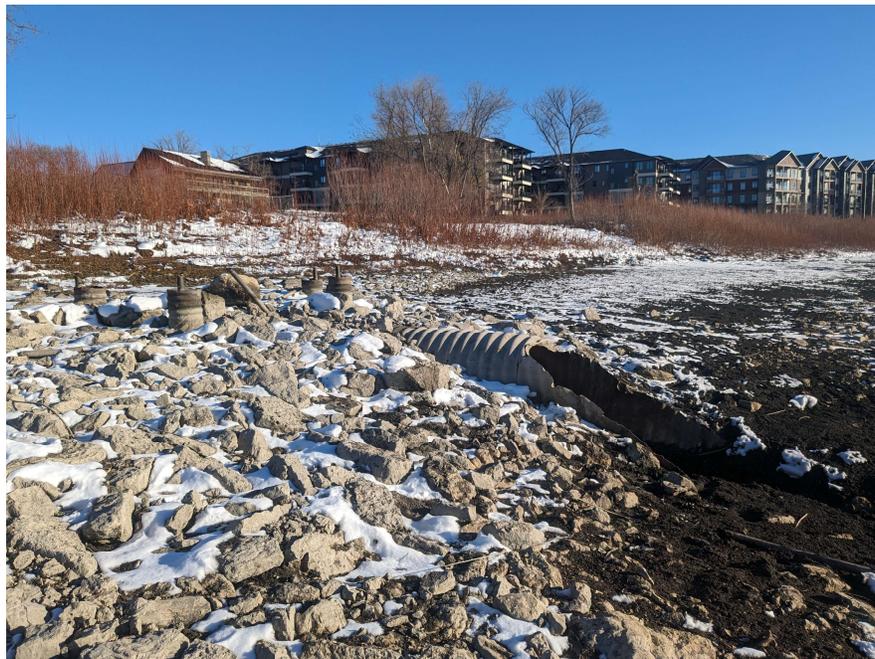
Photo 2: Pipe outlet, looking southeast

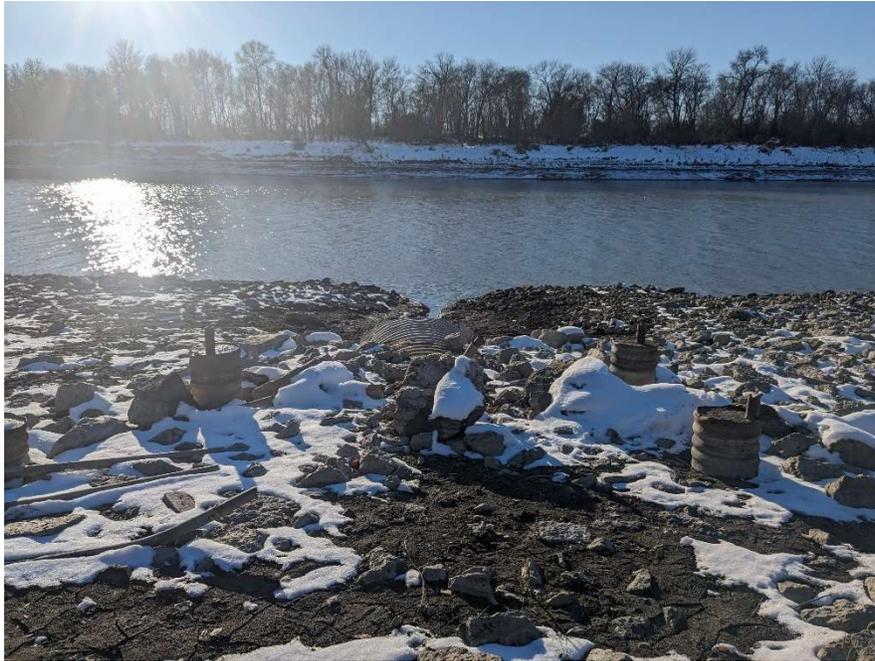
Photo 3: Existing concrete piles (to be removed), looking west towards Red River

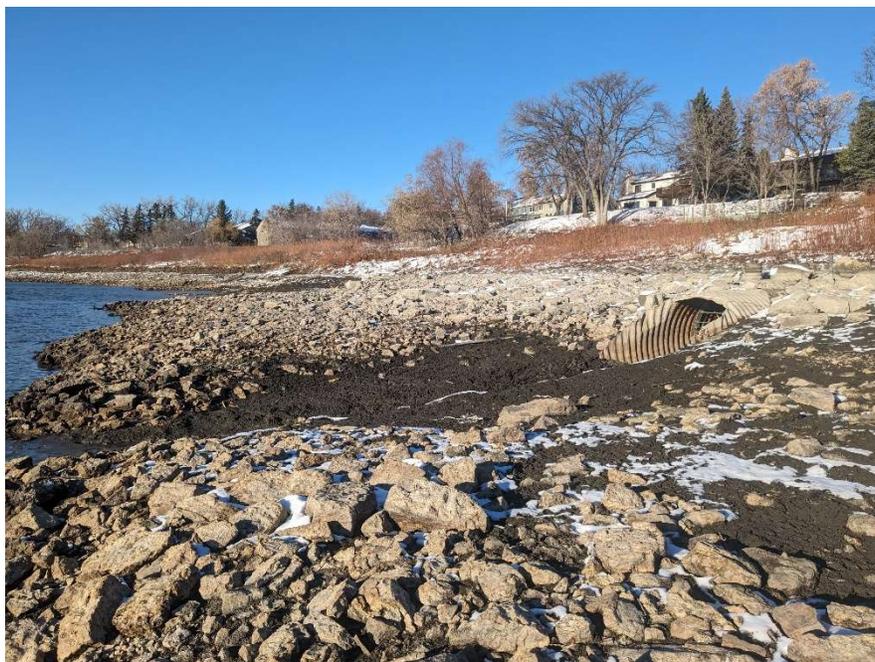
Photo 4: Pipe outlet, looking north

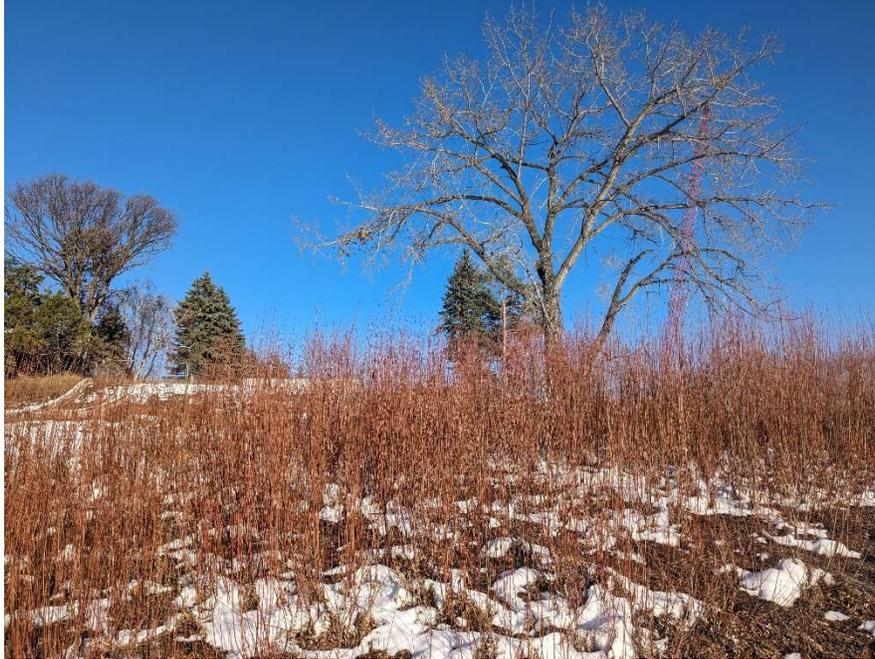
Photo 5: Looking upslope (east) from pipe outlet

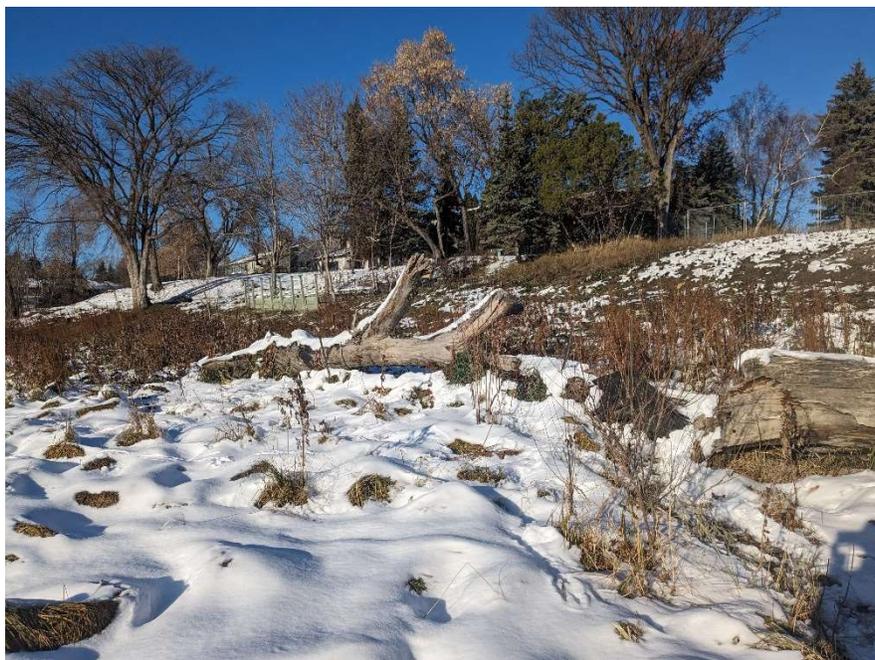
Photo 6: Looking north along mid-bank at existing deadfall (deadfall to be removed)

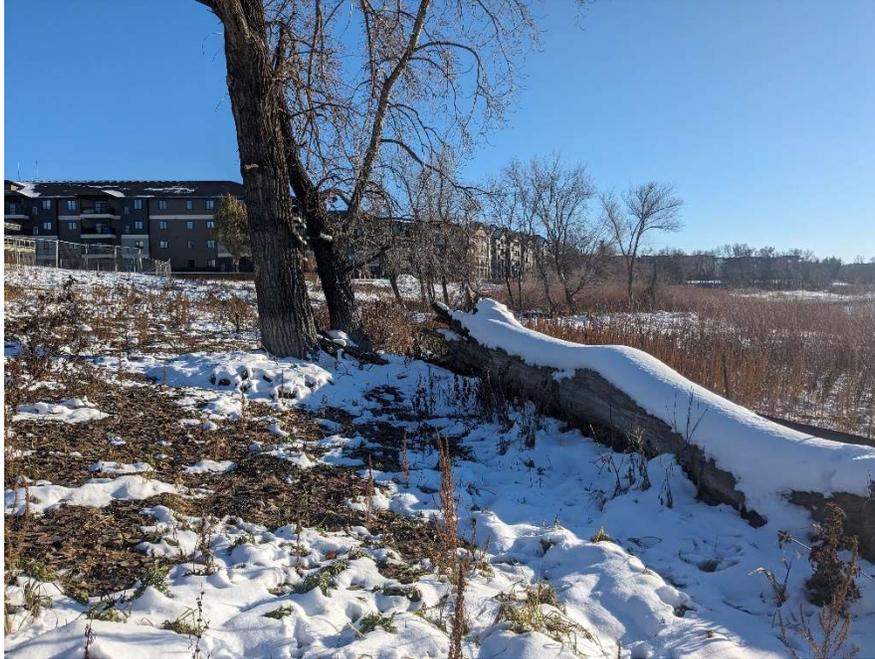
Photo 7: Looking south along mid-bank at existing trees and deadfall (deadfall to be removed)

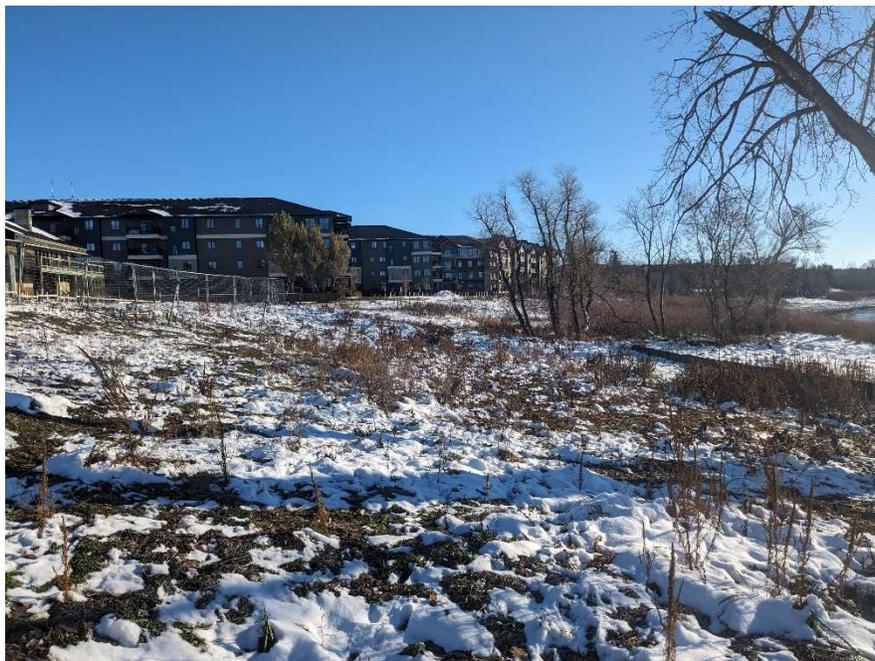
Photo 8: Looking south along mid-bank

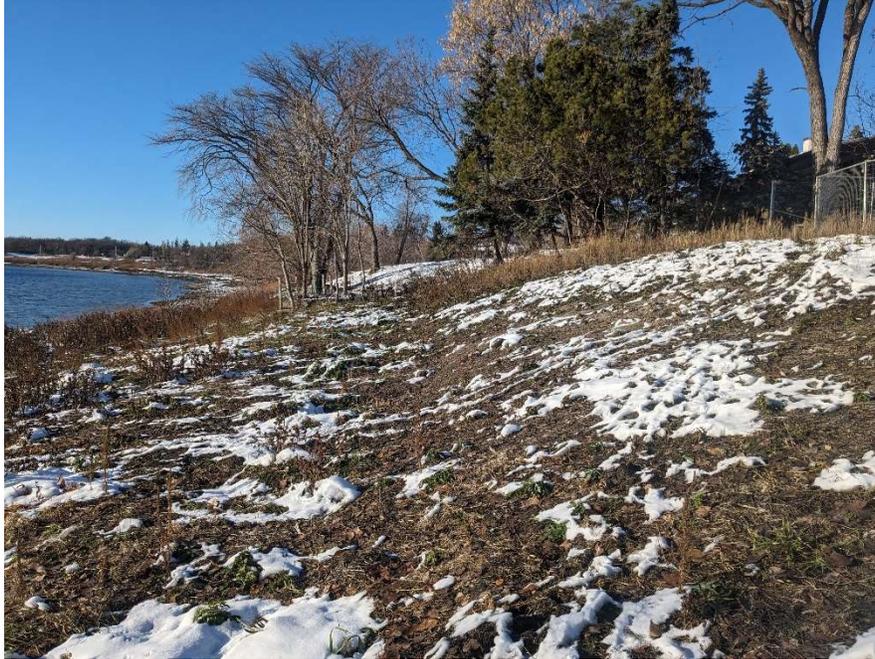
Photo 9: Looking north along mid-bank

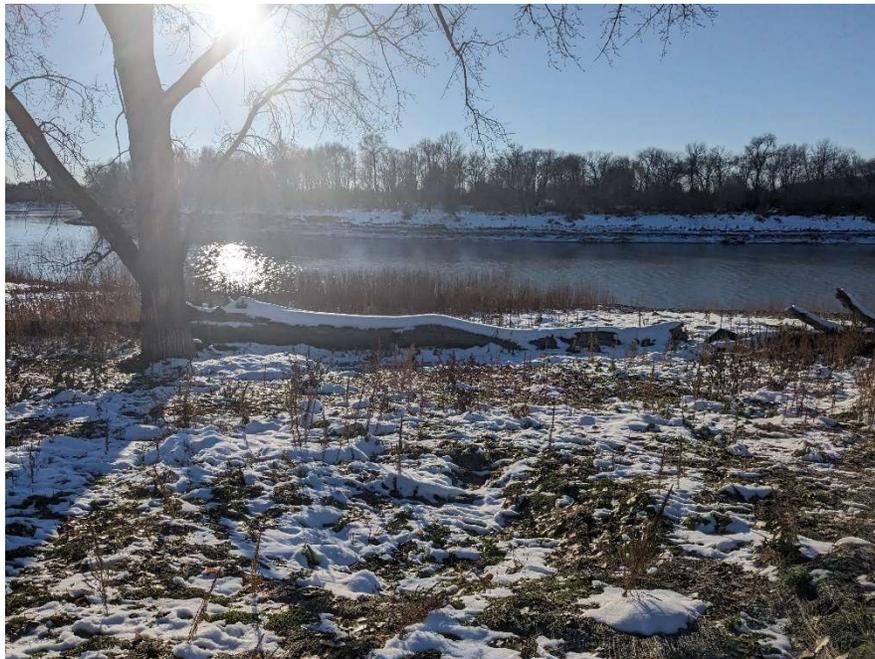
Photo 10: Looking downslope (west) at mid-bank along pipe alignment

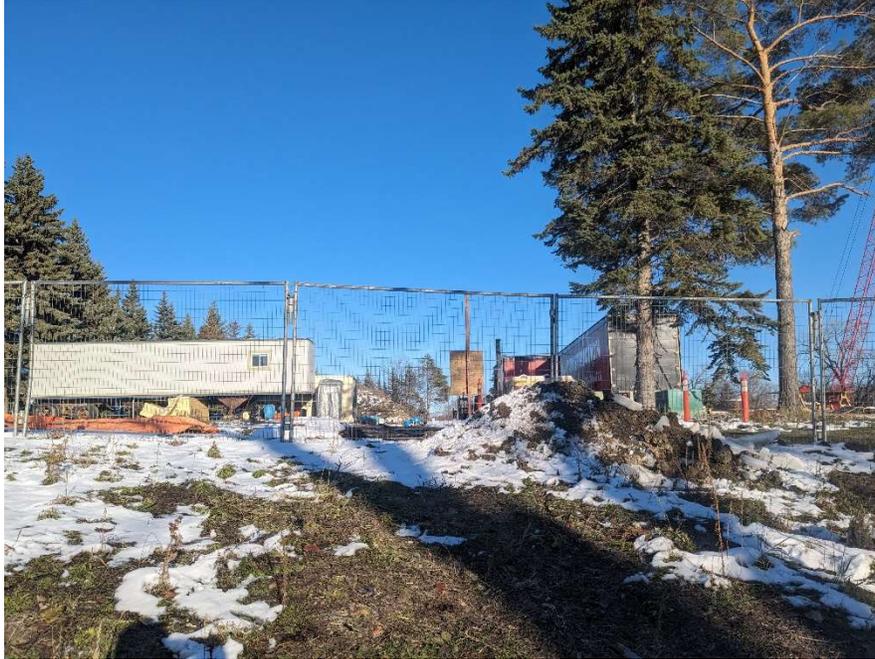
Photo 11: Looking east from mid-bank along pipe alignment

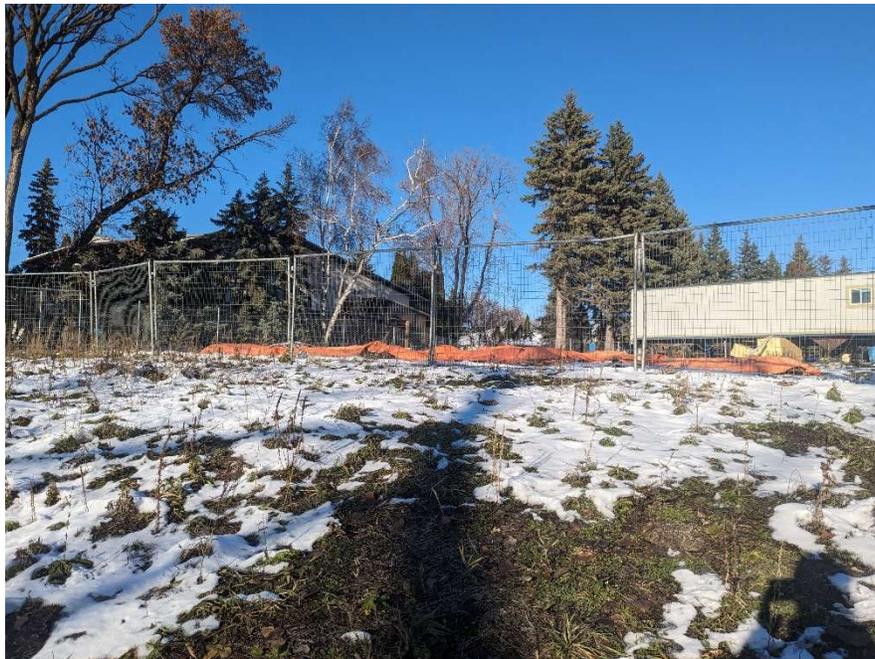
Photo 12: Looking northeast from mid-bank

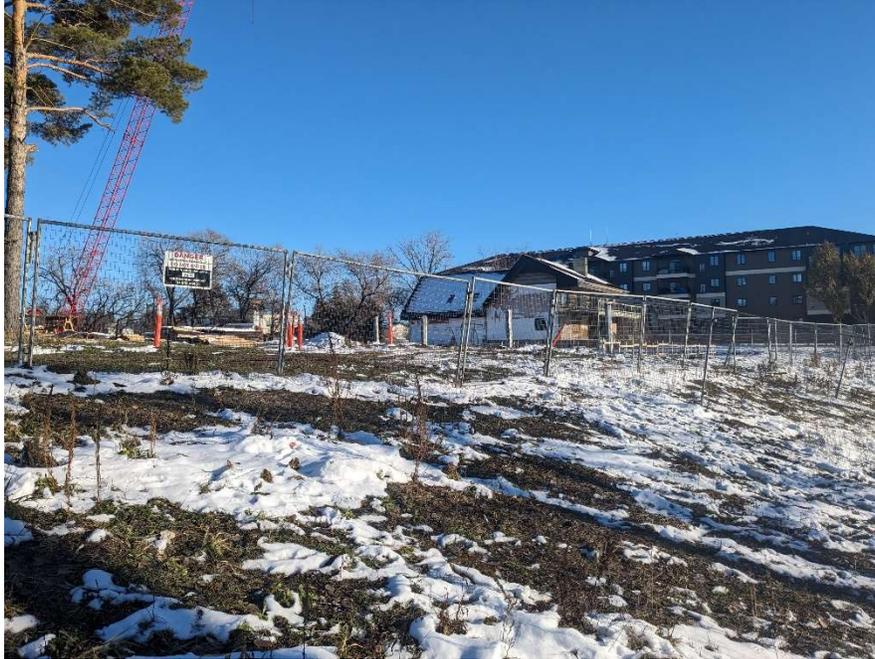
Photo 13: Looking southeast from mid-bank

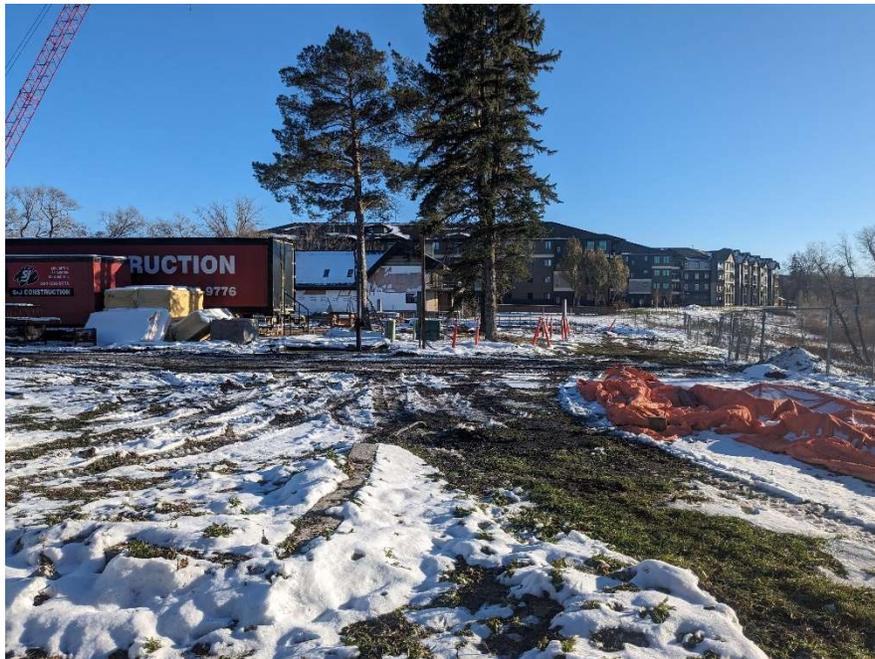
Photo 14: Looking south from upper bank

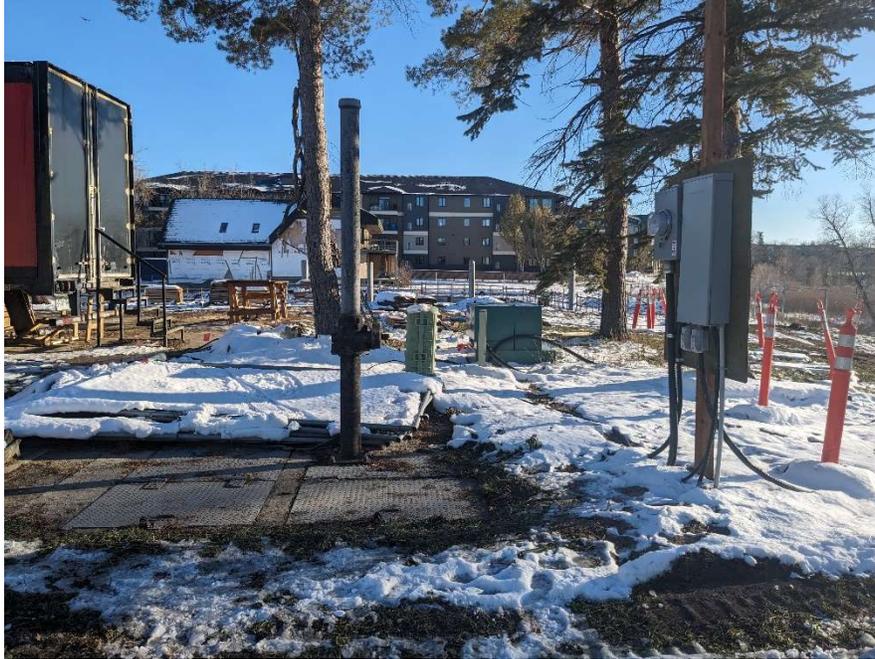
Photo 15: Upstream chamber (looking south)

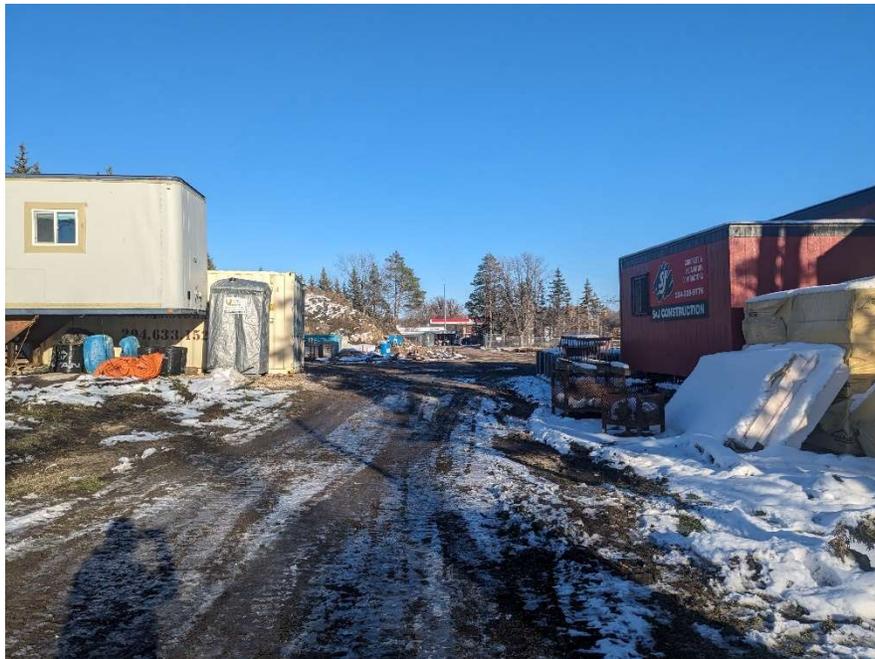
Photo 16: Looking east towards St. Mary's Road from chamber (site access route)

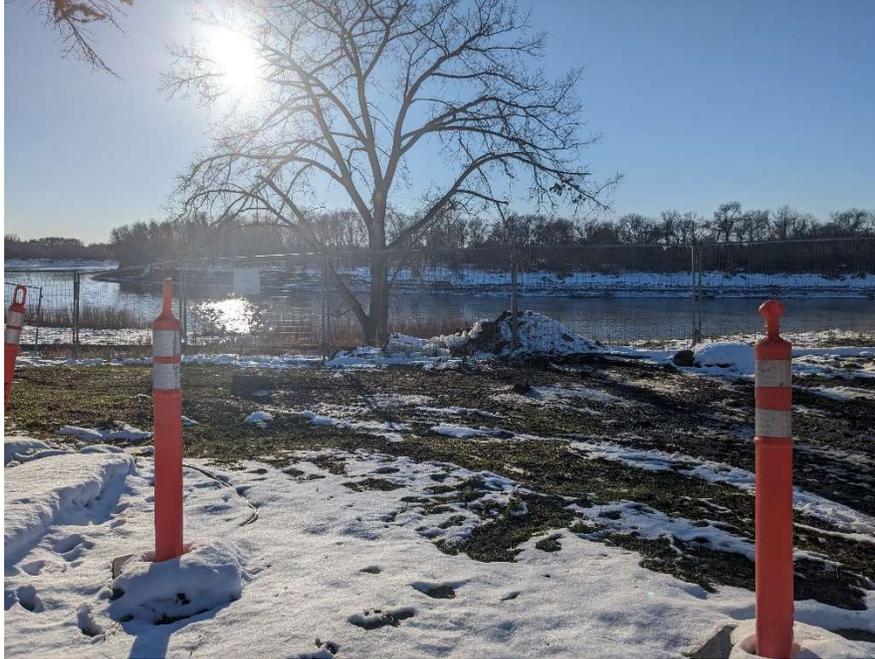
Photo 17: Looking west from chamber/upper bank towards the Red River

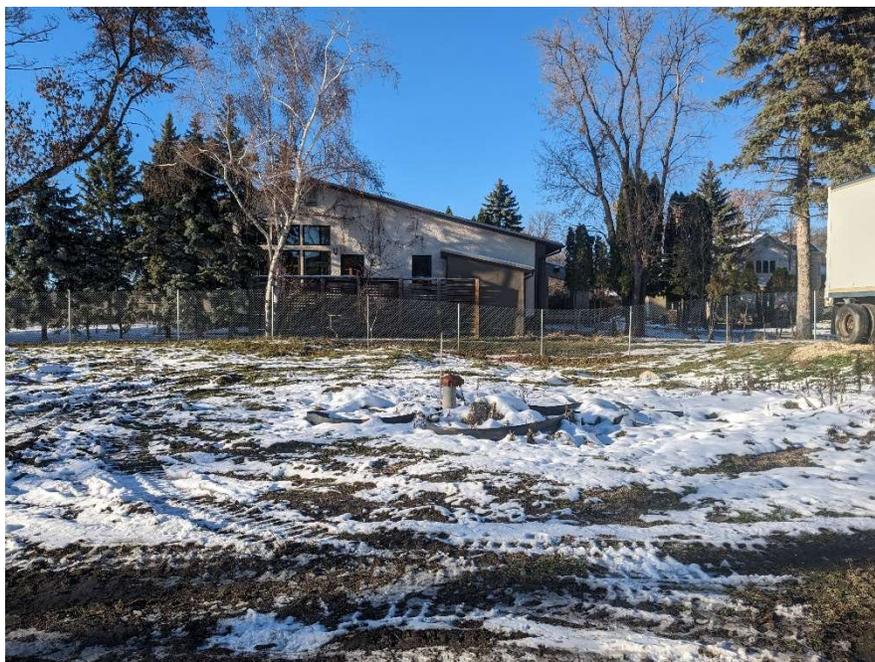
Photo 18: Looking north from chamber at upper bank
