Pan Am Indoor Pool 25 Poseidon Bay, Winnipeg MB Structural Condition and Building Envelope Assessment

Submitted to: City of Winnipeg
Planning, Property, and Development Department
Accommodation Services

Date: February 15th, 2022

Our File No. 2021-0268

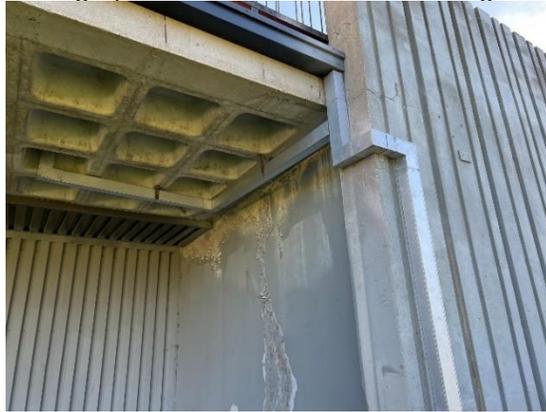
Evidence of leakage was observed at the west end of the podium (Photograph 3.1.1.1-3). The source of the leakage could not be determined. A drain line and rainwater leader is located along the wall which may be the source of the leakage. Further investigation is required to determine the source of the apparent leakage

Photograph 3.1.1.1-3: Evidence of leakage below northwest podium.

Recommendation 3.1.1.1-1: Investigate condition of the podium waterproofing. The proposed investigation would include removal of an area of the existing precast pavers and insulation on the north and south podiums to confirm cross-section and assess the condition of the existing waterproofing membrane. A flood test is also recommended to determine the source of leakage at the north podium.

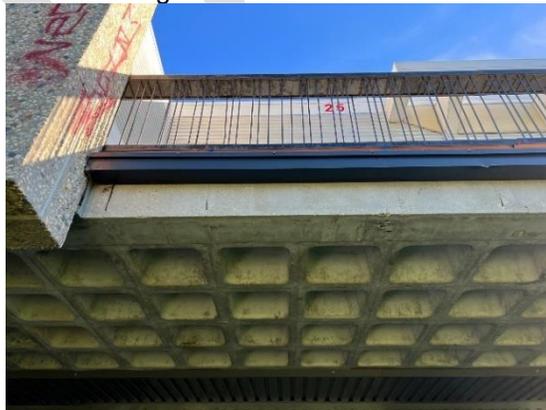
- .2 The concrete waffle slab supporting the podium at the northwest corner of the building is in fair to good condition. Exposed reinforcing steel was observed along the north face of the spandrel beam due to a lack of cover over the reinforcement. The conditions are related to an original construction. Repairs are recommended.

Photograph 3.1.1.2-1: concrete waffle slab supporting the podium at the northwest corner of the building.

Recommendation 3.1.1.2-1: Localized concrete repairs are recommended to address delamination and a lack of cover over the existing reinforcing steel. Repairs would include removal of all loose and delaminated concrete to expose and reposition the reinforcing steel and patching with a suitable concrete repair mortar. Materials and methods would be chosen to help match the existing finish.

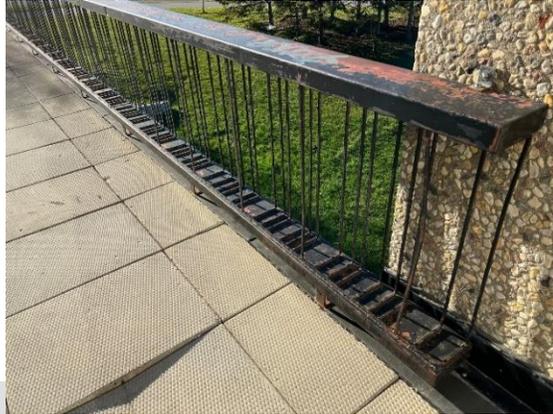
- .3 The metal guard rails at the northwest and southwest podiums appears to be original to the building. Although a formal review was not completed, visual observations indicate that the guardrails are not code compliant with respect to pick spacing and climbability. Note that the guards are considered an existing condition and upgrading to meet current building codes would not be required. The guards exhibit minor to moderate surface corrosion and repainting is required in the short term.

Photograph 3.1.1.3-1: Partial view of guardrail at northwest podium.

Recommendation 3.1.1.3-1: Repaint existing podium guardrails. Painting would include sandblasting to remove the existing coating and application of a high-performance steel coating.

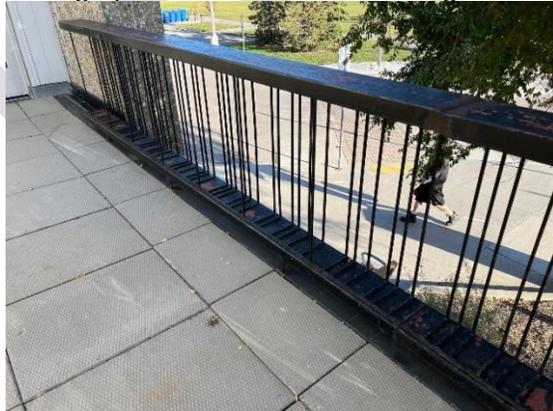
Photograph 3.1.1.3-2: Partial view of guardrail at southwest podium.

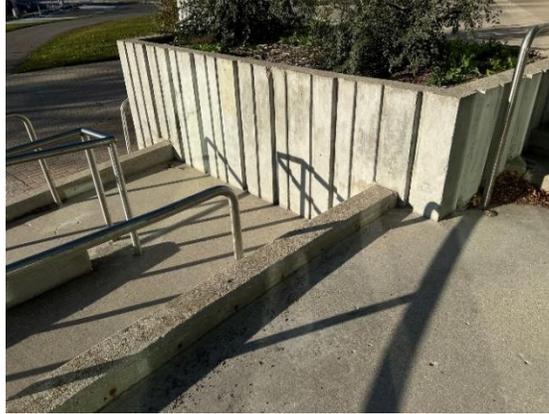
- .5 An existing handrail stops short on the accessible ramp at the northwest corner of the property resulting in an unprotected edge (Photograph 3.1.1.5-1). The fall height appears to be less than 24 inches (600 mm) and guard is therefore not required by code. However, the conditions represent a potential a safety hazard for pedestrians.

Photograph 3.1.1.5-1: Partial view of accessible ramp.

Recommendation 3.1.1.5-1: Install guardrail along ramp edge.

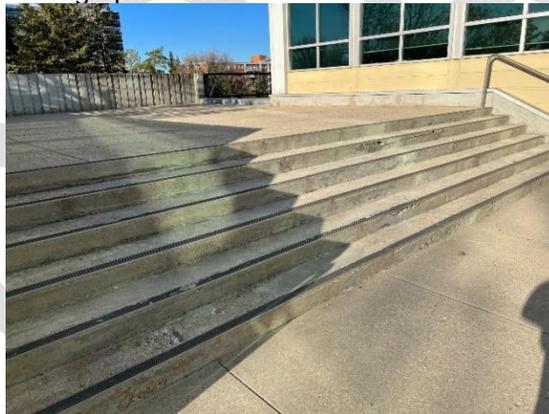
- .6 Delamination of the stair treads between the lower and upper podiums on the west end of the building was observed on both sides of the building (Photographs 3.1.1.6-1, 2). Repair of the stair treads is required.

Photograph 3.1.1.6-1: Partial view of stair tread to northwest podium

Recommendation 3.1.1.6-1: Repair delaminated and deteriorated stair treads. Repairs will include removal of the deteriorated concrete and infilling with a concrete repair material and new concrete nosing with detectable warning strip.

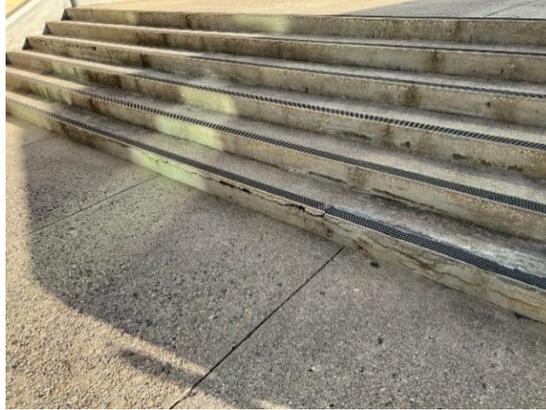
Photograph 3.1.1.6-2: Partial view of stair tread to southwest podium

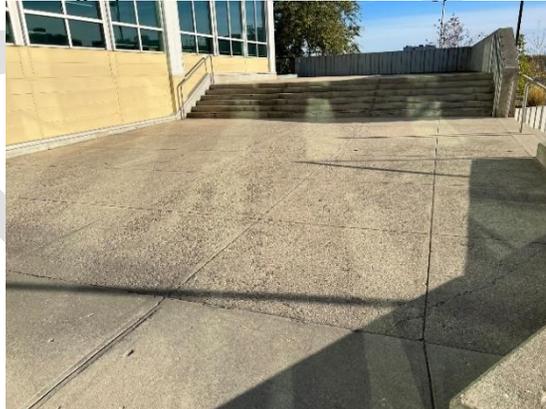
- .7 The surface of the upper podium concrete exhibits minor to moderate scaling (Photograph 3.1.1.7-1). Chain drag sounding do not indicate that the scaling is progressing beyond what already exists. Localized delamination was observed on the southwest corner due to lack of concrete cover over the top steel (Photograph 3.1.1.7-2).

Photograph 3.1.1.7-1: Partial view of podium concrete scaling.

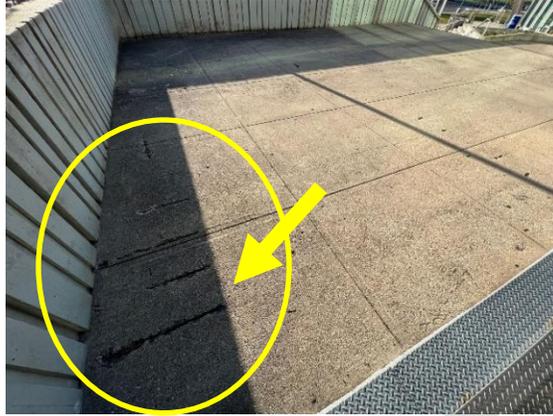
Photograph 3.1.1.7-2: Delamination of podium concrete.

Recommendation 3.1.1.7-1: Complete localized top surface concrete repairs in areas of delamination.

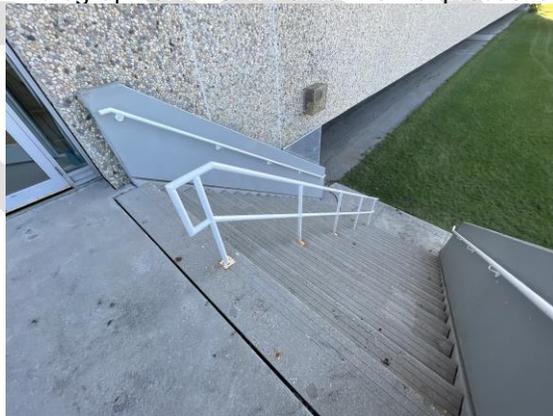
- .8 The precast stair and landing at the north end of the lap pool (Photograph 3.1.1.8-1). The joints are open and unsealed allowing water seepage through the joints and corrosion of the precast connections (Photograph 3.1.1.8-2). Sealing of the joints and cleaning and painting of the steel connections is recommended. The slab-on-grade landing at the bottom of the stairs has sunk creating a higher step and a potential tripping hazard. Replacement of the landing or jacking back into place is recommended.

Photograph 3.1.1.8-1: Partial view of precast stair and landing on north elevation.

Recommendation 3.1.1.8-1: Seal precast joints with an elastomeric joint sealant. Clean and paint precast connections.

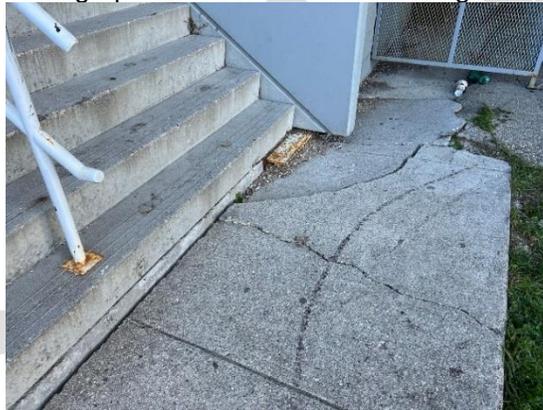
The slab-on-grade landing at the bottom of the stairs has sunk creating a higher step and a potential tripping hazard. Replacement of the landing or jacking back into place is recommended.

Photograph 3.1.1.8-3: Concrete landing at base of precast stair.

Recommendation 3.1.1.8-2: Replace existing concrete landing.

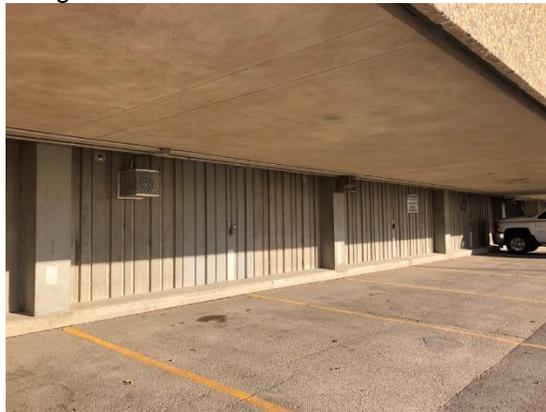
bead of sealant at the base. The sealant was found to be largely intact, though crazed and hardened in localized areas. The wall along the north elevation was coated with an unknown material which was delaminating at the base of wall. The base of wall did not incorporate a sealant cant bead. Localized cracking and spalling of the concrete was observed. To protect the repairs and provide a consistent finish, consideration may be given to the application of a coating over the exposed concrete. Coating options are discussed in further detail in Recommendation 3.3.1.4-1.

Photograph 3.1.1.9-1: Partial view of cast-in-place 10" thick corrugated concrete wall along south elevation.

Recommendation 3.1.1.9-1: Complete localized concrete repairs in areas of delamination and freeze-thaw deterioration.

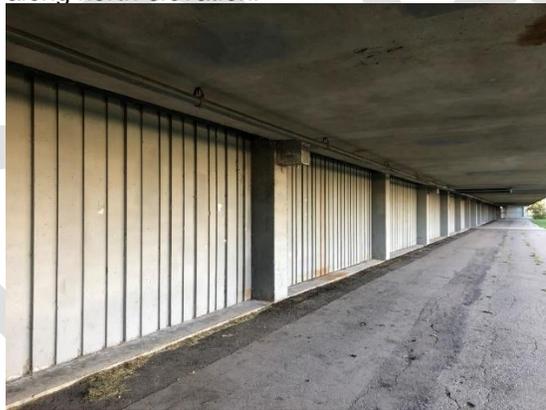
Photograph 3.1.1.9-2: Partial view of cast-in-place 10" thick corrugated concrete wall along north elevation.

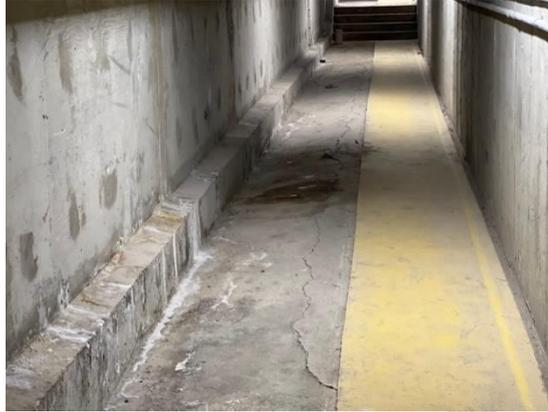
Photograph 3.2.1.2-1: South service tunnel. Cracking heaving of floor slab visible.

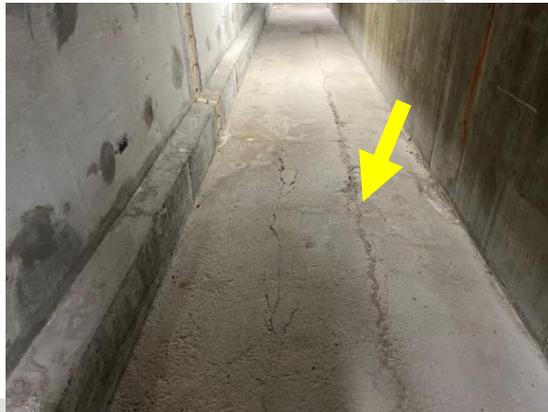
Photograph 3.2.1.2-2: North service tunnel. Cracking heaving and delamination of floor slab visible.

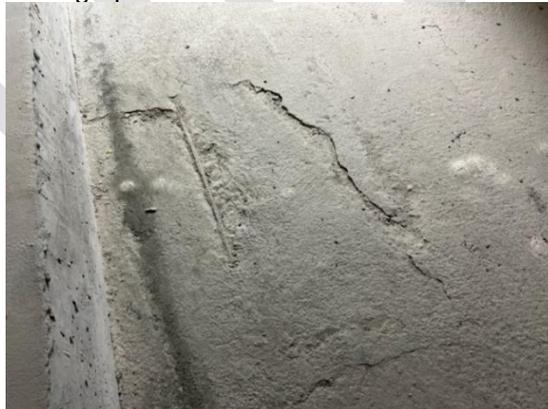
Photograph 3.2.1.2-3: Delamination of floor slab.

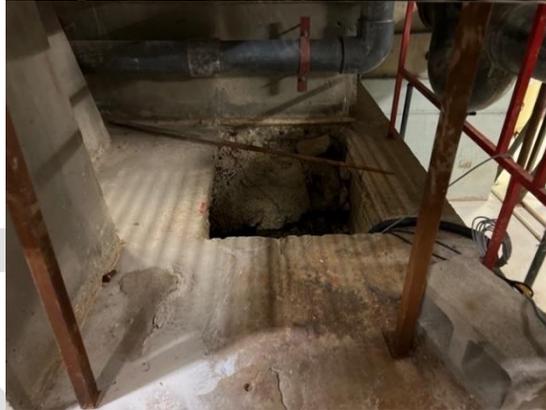
Photograph 3.2.1.3-1: Raised structural slab within the Chlorination Room.

Recommendation 3.2.1.3-1: Infill existing opening.

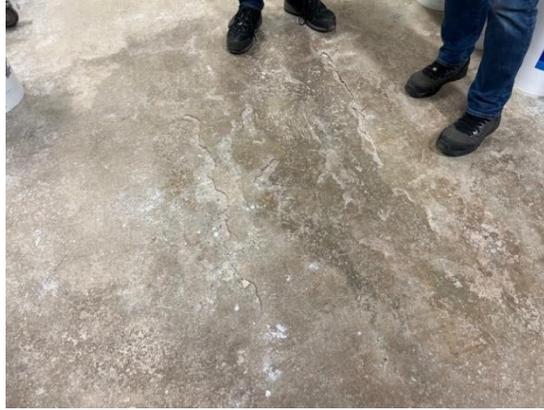
Photograph 3.2.1.5-1: Delamination of Chlorination Room floor slab.

Recommendation 3.2.1.5-1: Complete top surface concrete repairs.

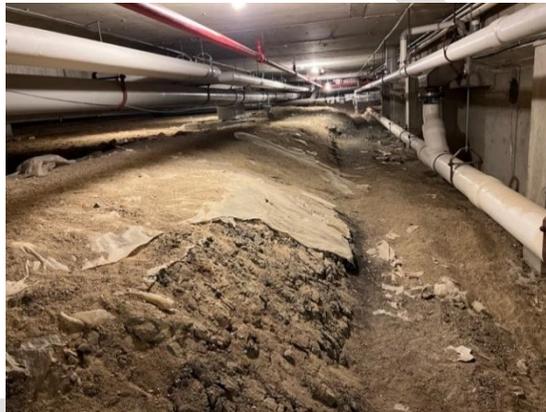
Photograph 3.2.2.1-5: Crawlspace on west side of the Lap Pool. Discontinuous vapour visible.

Recommendation 3.2.2.1-1: The crawlspace does not have a functioning vapour barrier. The absence of effective vapour barrier can lead to elevated humidity levels, corrosion of mechanical electrical services, corrosion of embedded reinforcing steel, and poor air-quality within occupied space. Remediation of the crawlspace is recommended including grading of the existing soil to direct water away from structural members, installation of a new drainage system and sump pits, and installation of a vapour retarder and sand cover. Installation of new sub-surface drainage, vapour barrier, and sand cover is recommended within 5 years.

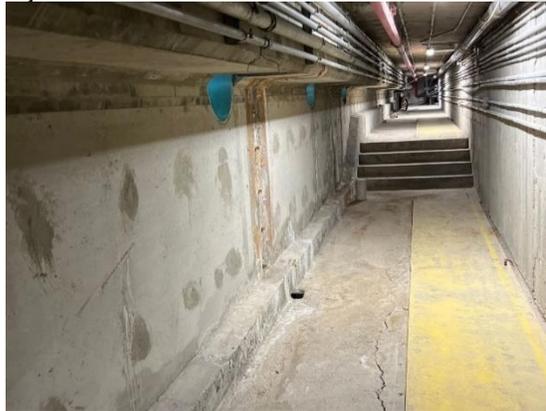
Photograph 3.2.3.1-1: Partial view of south pool wall via service tunnel looking east. Injected crack visible.

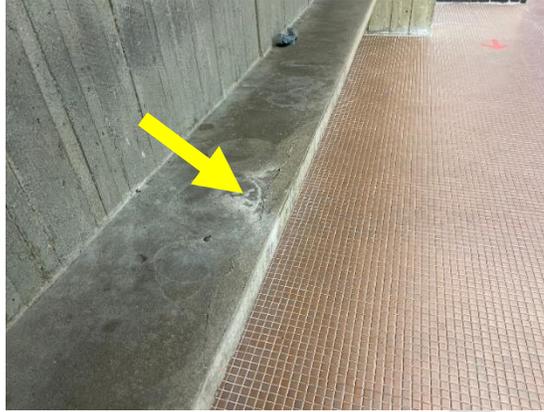
Photograph 3.2.3.3-1: Concrete bench delamination.

Recommendation 3.2.3.3-1: Complete concrete repairs concrete pool benches.

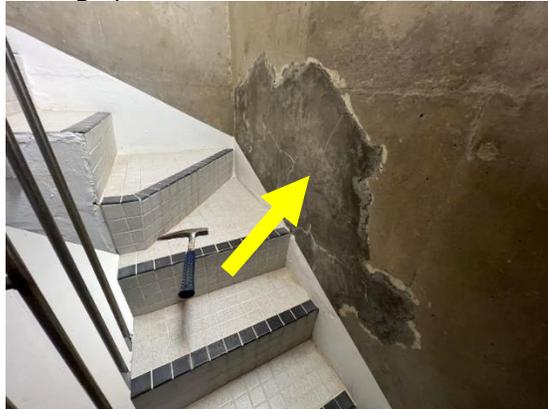
Photograph 3.2.3.4-3: Delamination on internal stairwell walls.

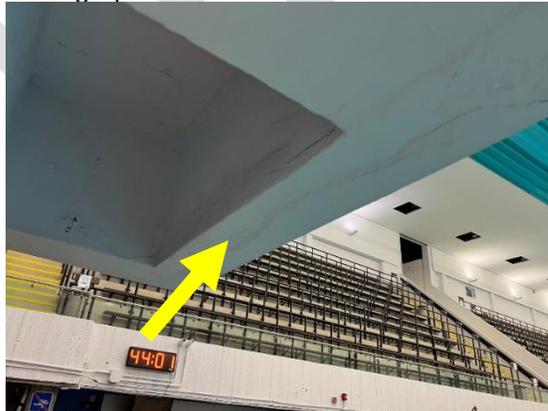
Delamination was also observed on the sides of the north 3 metre springboard platform (Photographs 3.2.3.4-4). Localized repairs are recommended.

Photograph 3.2.3.4-4: Delamination on north 3 m springboard platform.

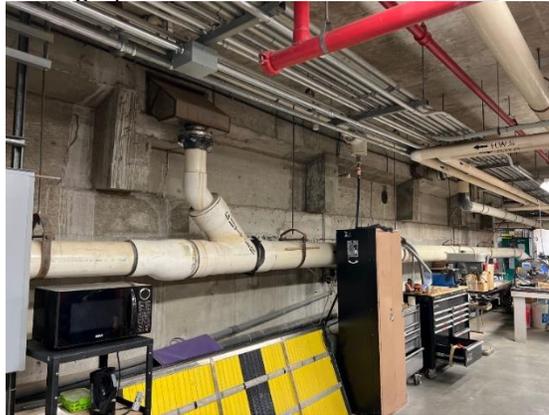
Photograph 3.2.4.1-1: Partial view of west tank wall. Evidence of leakage visible.

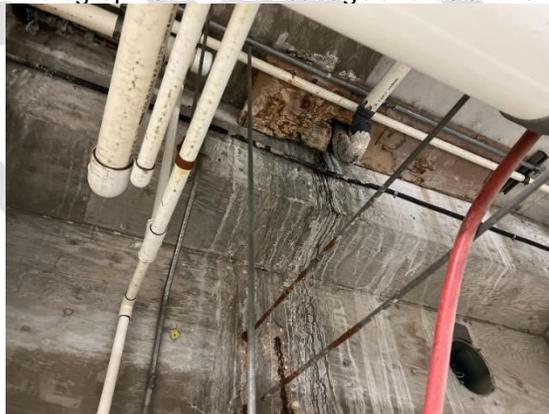
Photograph 3.2.4.1-2: Leakage and delamination at mechanical penetration.

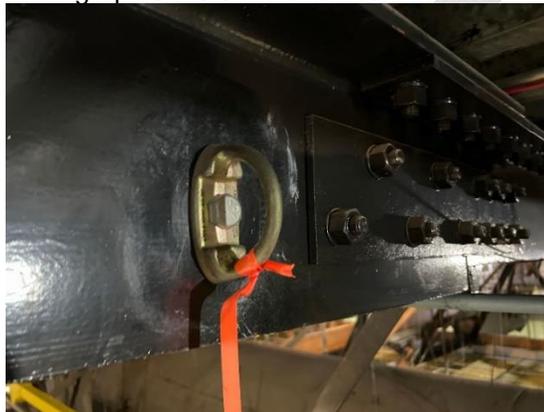
Photograph 3.2.6.3-1: Fall arrest anchor.

Recommendation 3.2.6.3-1: Remove fall arrest anchors if not required.

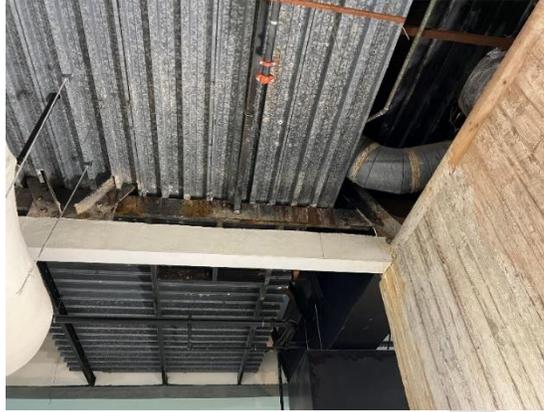
Photograph 3.2.6.4-1: Corroded steel beam.

Recommendation 3.2.6.4-1: Clean and paint corroded steel beam.

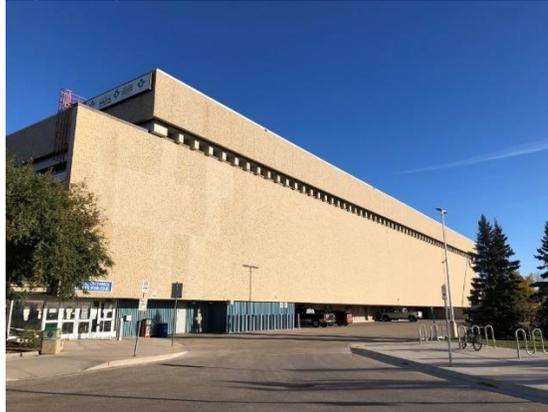
Photograph 3.3.1.1-1: Overview of south elevation, facing east, showing overall condition of pre-cast panels. Note panels near the west end exhibit slightly different colouring than adjacent panels.

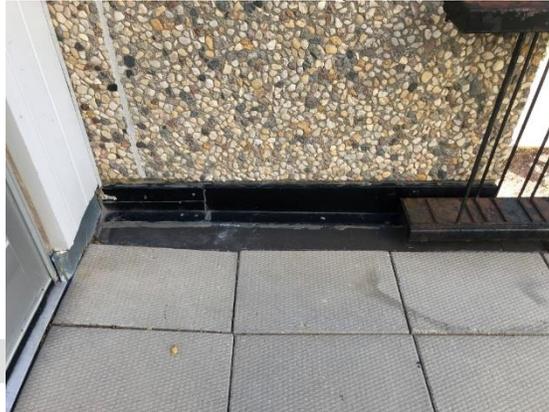
Photograph 3.3.1.1-10: Base of wall transitions from pre-cast panel to flashing at with wing walls adjacent the entrance on the west elevation were found to be severely degraded. Entrance on south side of Aquatic Hall of Fame shown.

Recommendation 3.3.1.1-1: It is recommended that the cause of the pre-cast panel displacement be investigated further to assess the condition of the underlying anchorage. We recommend investigating the panels located above the main pool entrance on the south elevation as a starting point. The scale of the investigation, including access and selective demolition is outside the scope of this report.

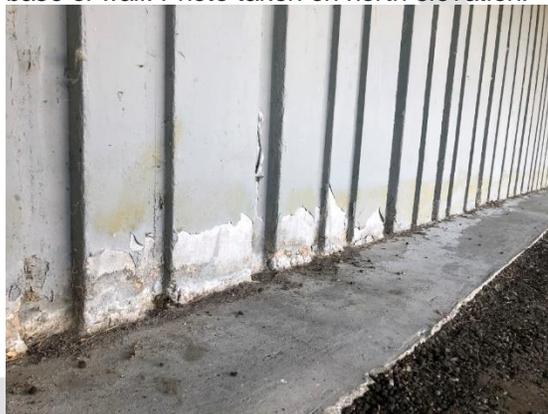
Photograph 3.3.1.4-3: Typical example of delaminating coating and missing sealant at base of wall. Photo taken on north elevation.

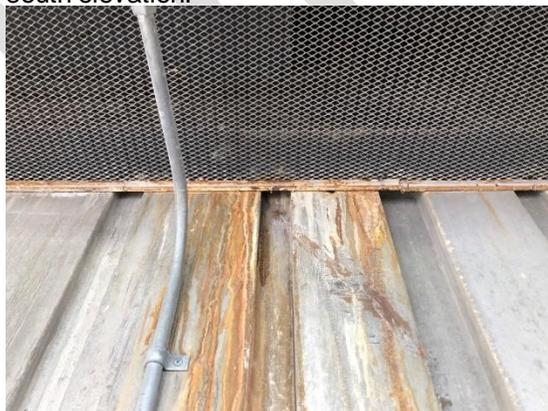
Photograph 3.3.1.4-4: Typical example of water staining and rust marks originating from within the mesh soffit, appeared to align with mechanical exhaust ducts. Photo taken on south elevation.

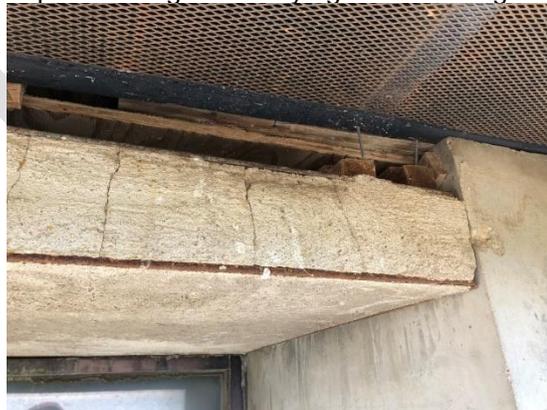
Photograph 3.3.1.6-2: Typical example of stucco clad soffits showing displacement from underlying wood framing, evidence of corrosion of metal corners and lath, and evidence of prior wetting of underlying wood framing.

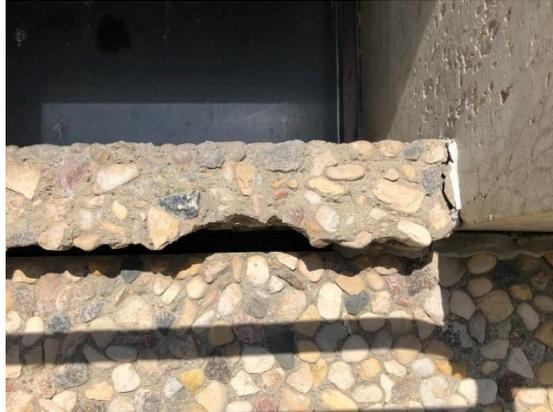
Photograph 3.3.1.6-3: Typical example of pre-cast exposed aggregate sloped sill showing missing or degraded joint sealant at base of sill to top of pre-cast panel below and at sill to jamb interface.

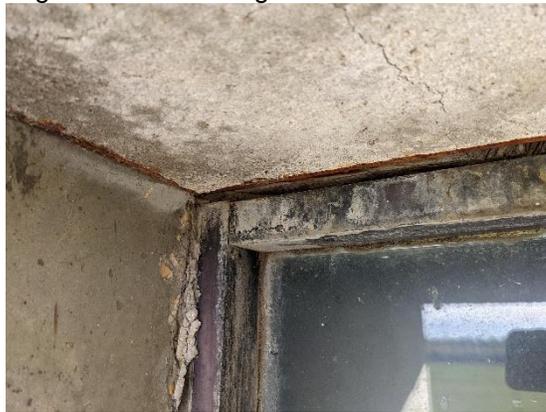
Photograph 3.3.1.6-5: Typical example of water staining on the window frame head below the soffit, emanating from the soffit above, suggestive of condensation within the unconditioned and ventilated soffit. Note also corrosion of metal stucco corners and degraded and missing sealants.

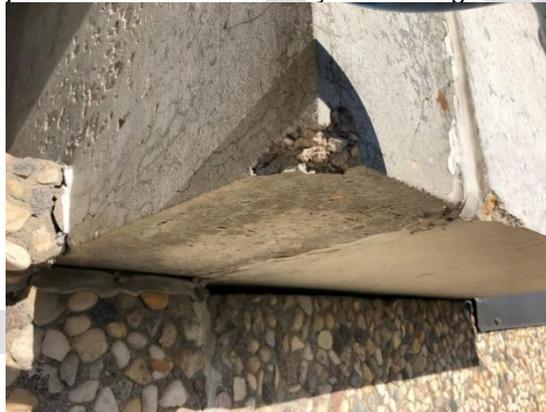
Photograph 3.3.1.6-6: Example of localised damage of a pre-cast concrete feature at jambs/between window bays exhibiting localized deterioration, cracking and spalling.

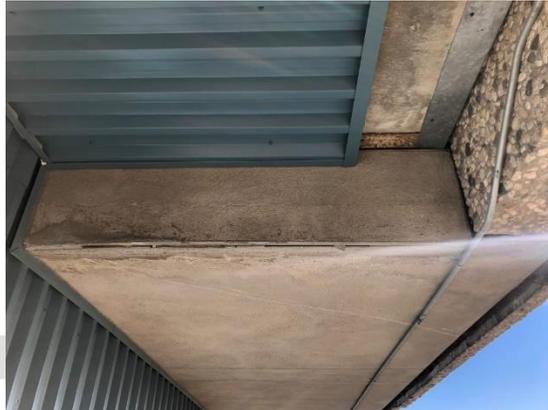
Photograph 3.3.1.7-2: Localized repairs required at the west end of the south soffit, at the underside outside corner where the stucco has cracked and the corner does not appear to be reinforced with mesh.

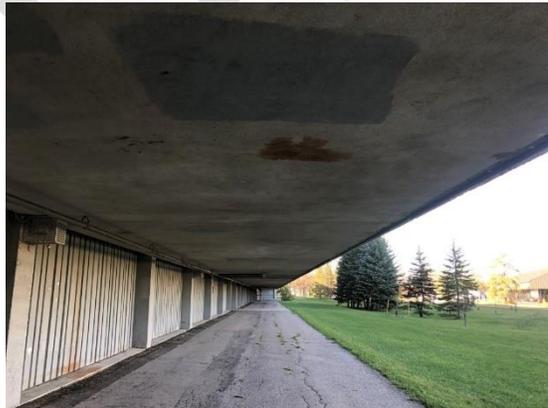
Photograph 3.3.1.7-3: Partial view showing typical condition of stuccoed soffit along north elevation (looking west) showing typical example of localized patch repair/painting and stains.

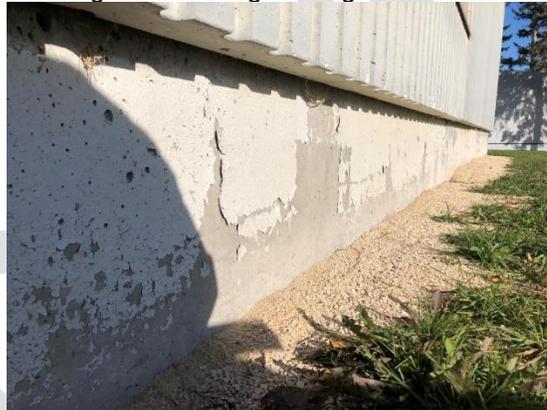
Photograph 3.3.1.11-1: Partial view of the 1993 Swim Manitoba Addition foundation wall showing delaminating coatings.

Recommendation 3.3.1.11-1: Insulating of the foundation wall is addressed in Section 3.3.1.10 above. Though primarily an aesthetic preference, consideration could be given to cleaning via pressure washing and refreshing the foundation wall with parging conceal repair work, staining, and graffiti/vandalism.

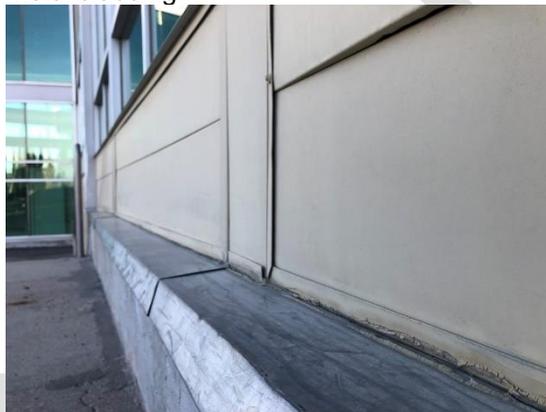
Photograph 3.3.1.13-5: Typical example of delaminating coating observed on horizontal metal cladding.

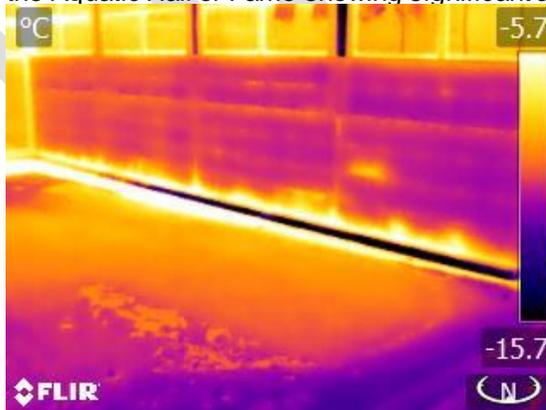
Photograph 3.3.1.13-6: Thermographic image of base of wall along the west elevation of the Aquatic Hall of Fame showing significant air leakage at curb.

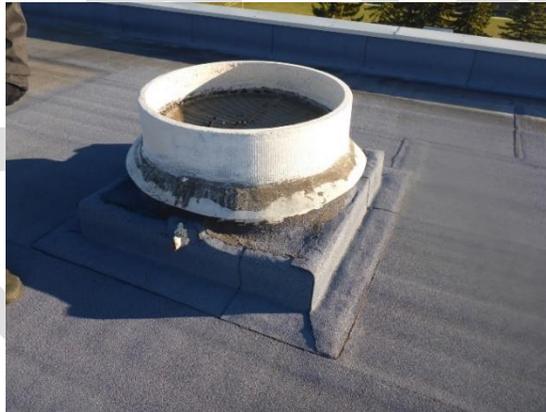
Photograph 3.3.3.3-2: Showing typical deficiency at mechanical unit and flashing membrane
