### DETAILED BRIDGE CONDITION SURVEY

## Pembina Highway Bridge Over Abinojii Mikanah (Bishop Grandin)

(Site No. B-215)

November 22, 2024

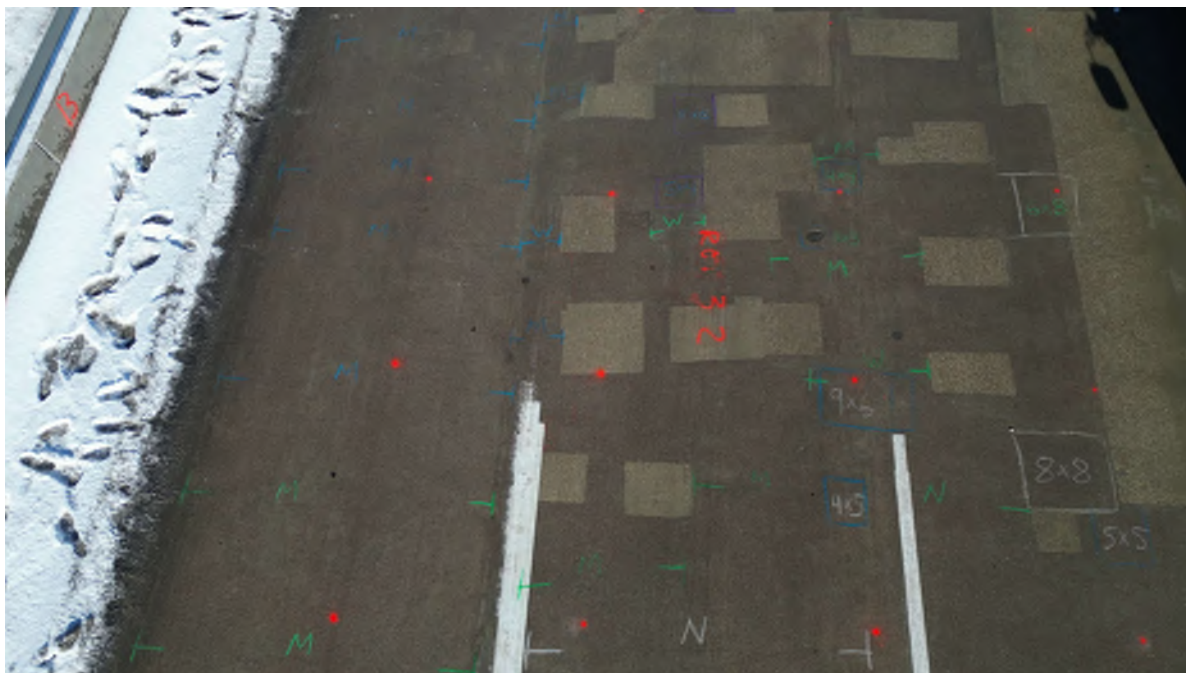
**Photo 54 - Typical deck top cracking and delaminations**

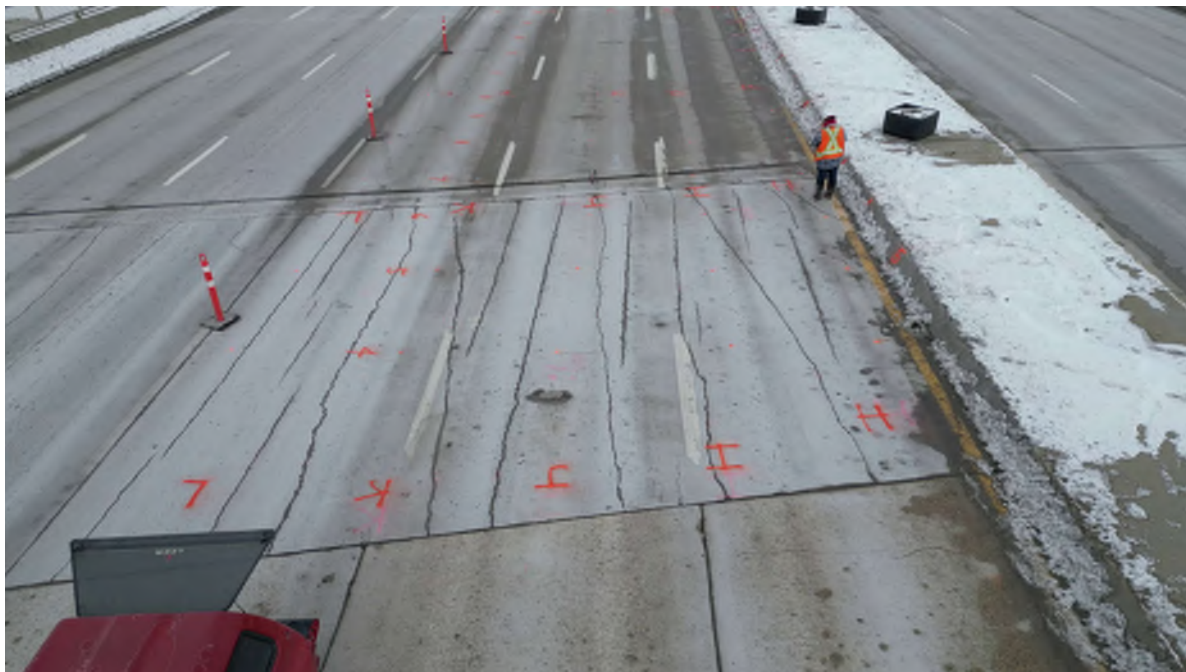
**Photo 55 - Typical approach slab medium to wide cracking**

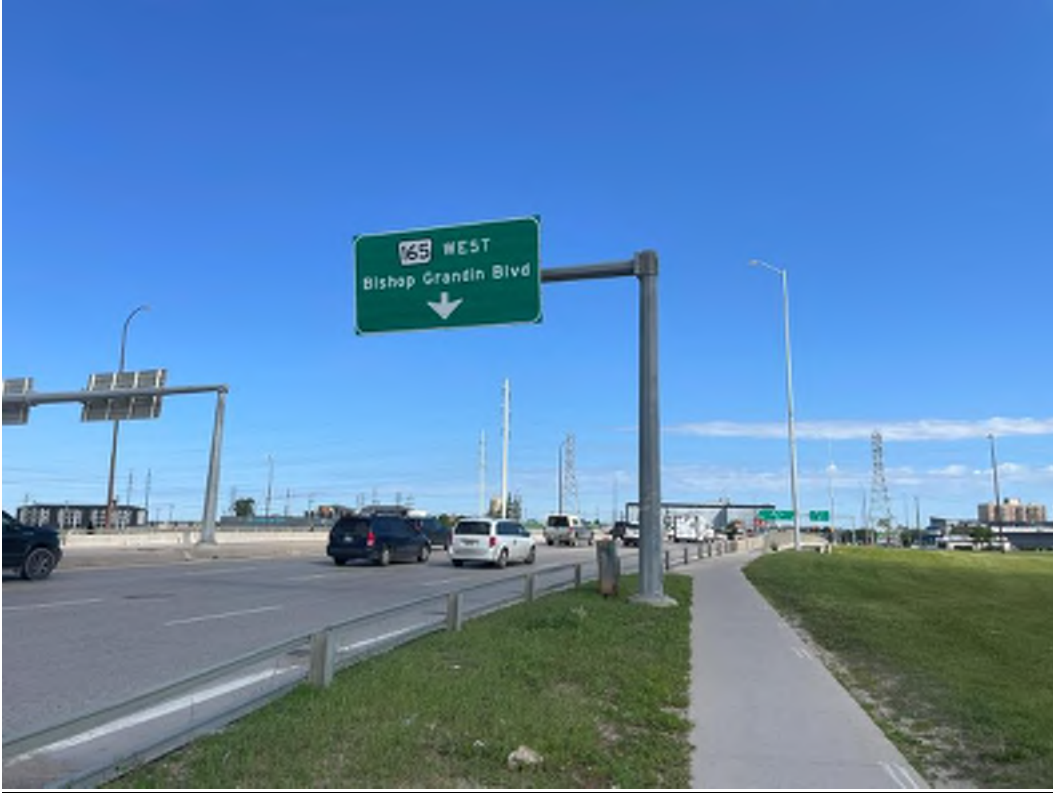
2. S-649: NB Pembina Exit to WB Abinodji Ramp (Advance Warning)  
Cantilever Structure

- Date of inspection: October 26, 2023, and June 21, 2024
- Leg / Bases – light spalling on top of foundation, below grout pad (0.2m x 0.1m & 0.1m x 0.1m),
- Arm – generally good condition
- Front of signs – generally good condition
- Sign Attachments – generally good condition

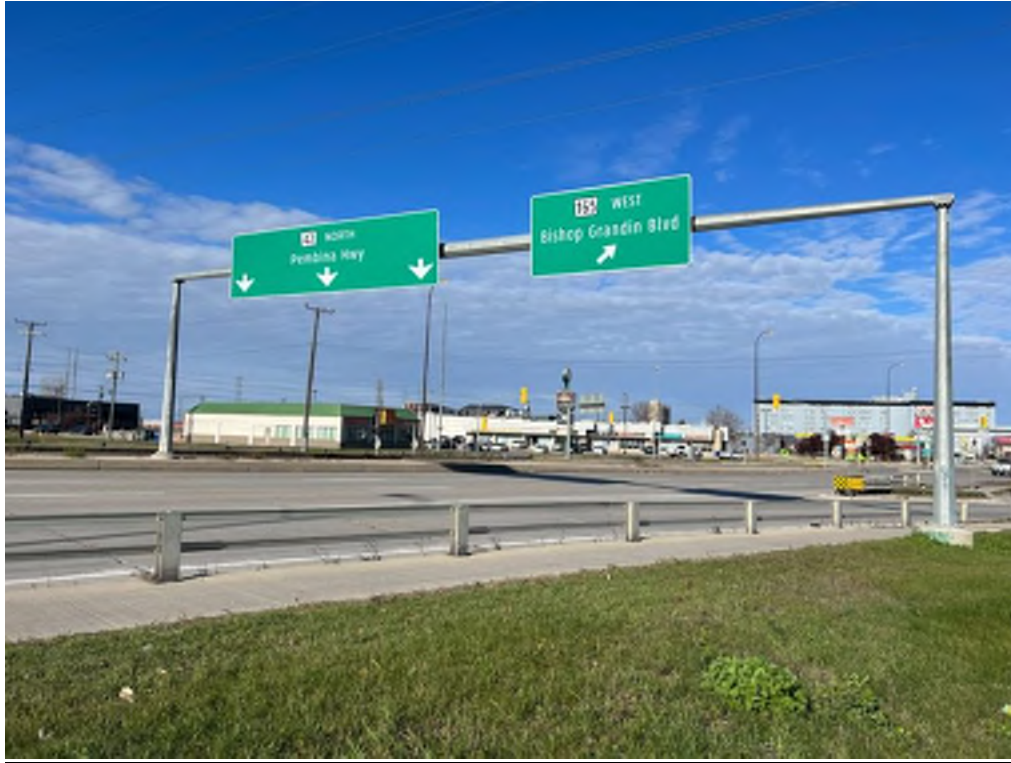
#### 4. S-653 NB Pembina at WB Abinojii Exit Ramp Monotube Bridge Structure

- Date of inspection: October 26, 2023, and June 21, 2024
- West Leg / Bases – narrow cracking on grout pads, generally good condition
- East Leg / Bases – narrow cracking on grout pads, generally good condition
- Top Chord – generally good condition
- Front of Signs – generally good condition
- Sign Attachments – generally good condition

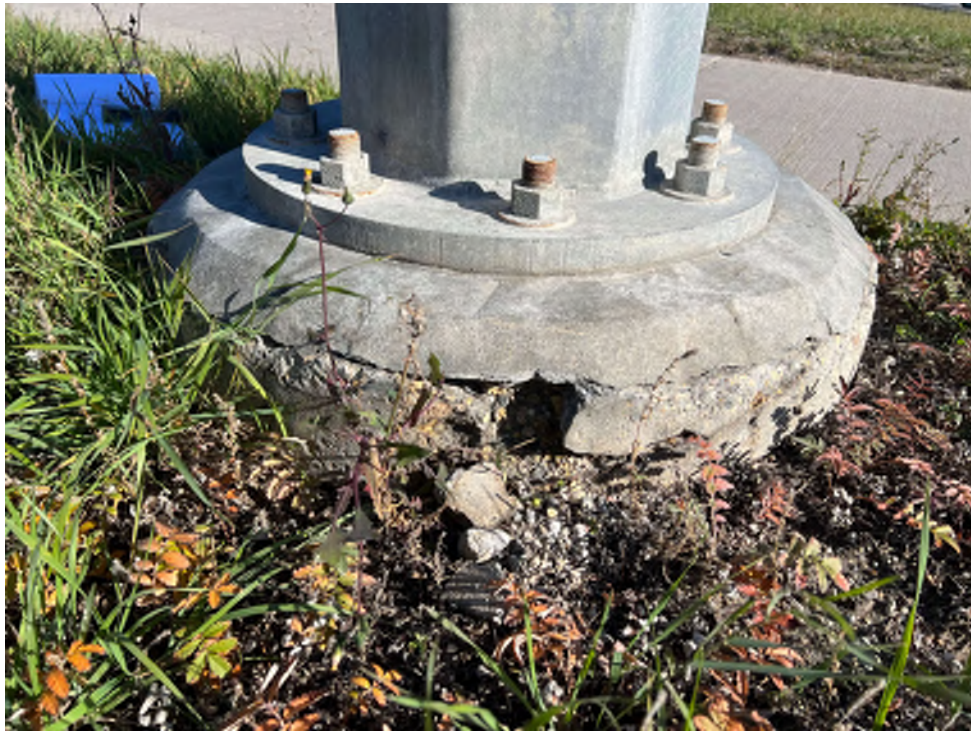
**Photo 5 - Spalling on foundation top**

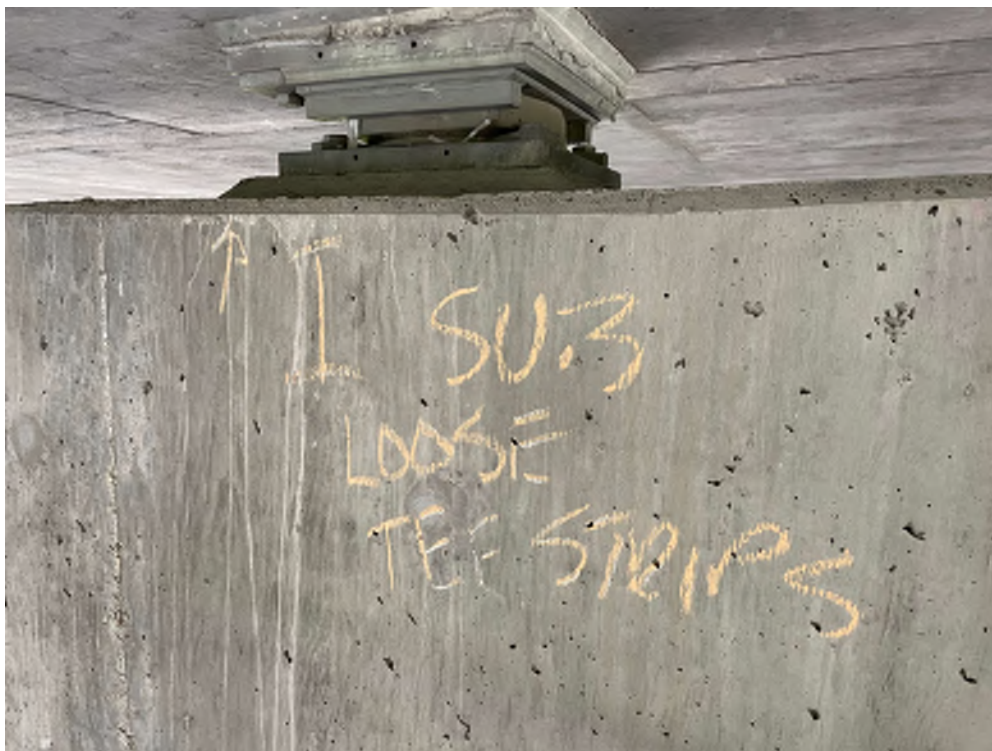
**Photo 06 - SU3 Pier, Line "I" bearing, loose Teflon strip on south side**

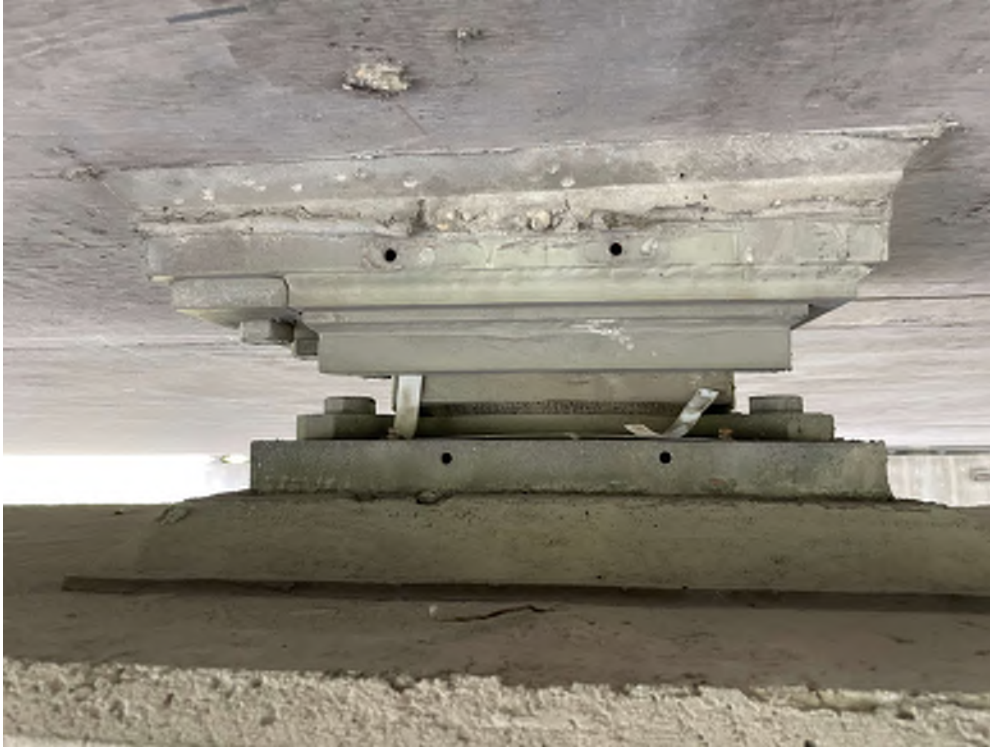
**Photo 07 - SU3 Pier, Line "I" bearing, loose Teflon strips on south side, close up view**

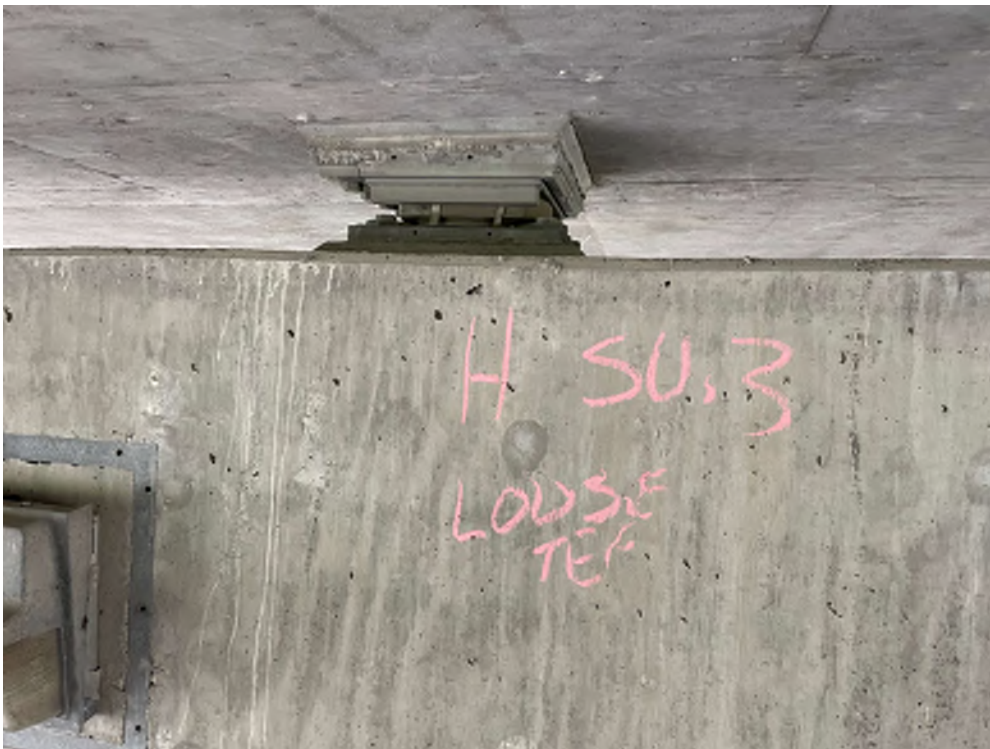
**Photo 08 - SU3 Pier, Line "H" bearing, loose Teflon strips on south side**

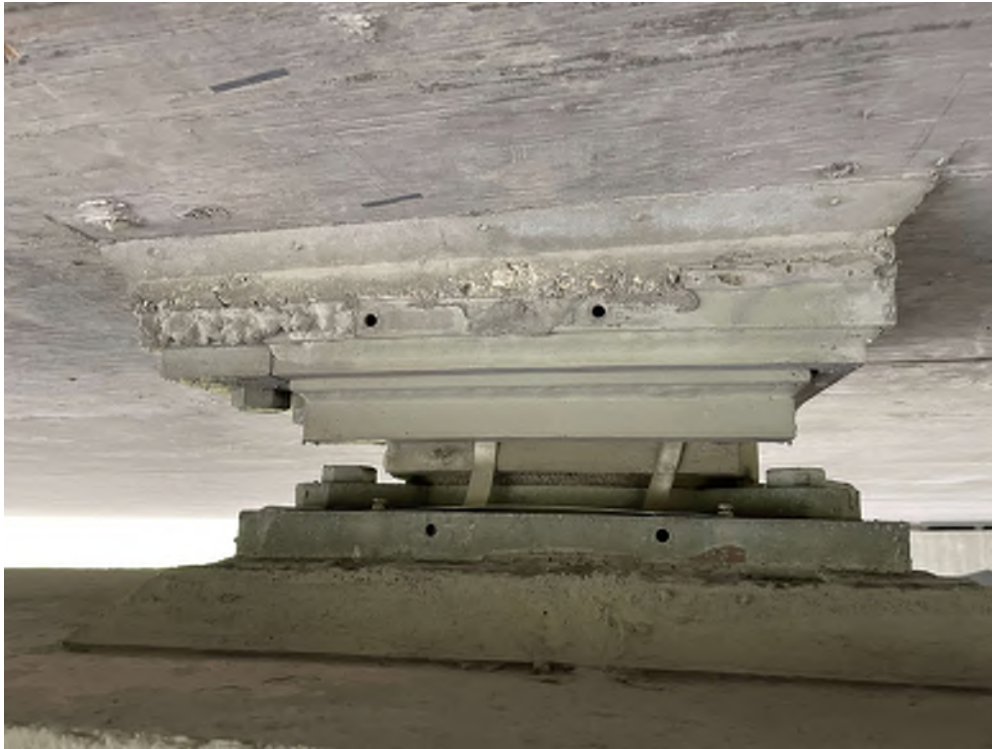
**Photo 09 - SU3 Pier, Line "H" bearing, loose Teflon strips on south side, close up view**

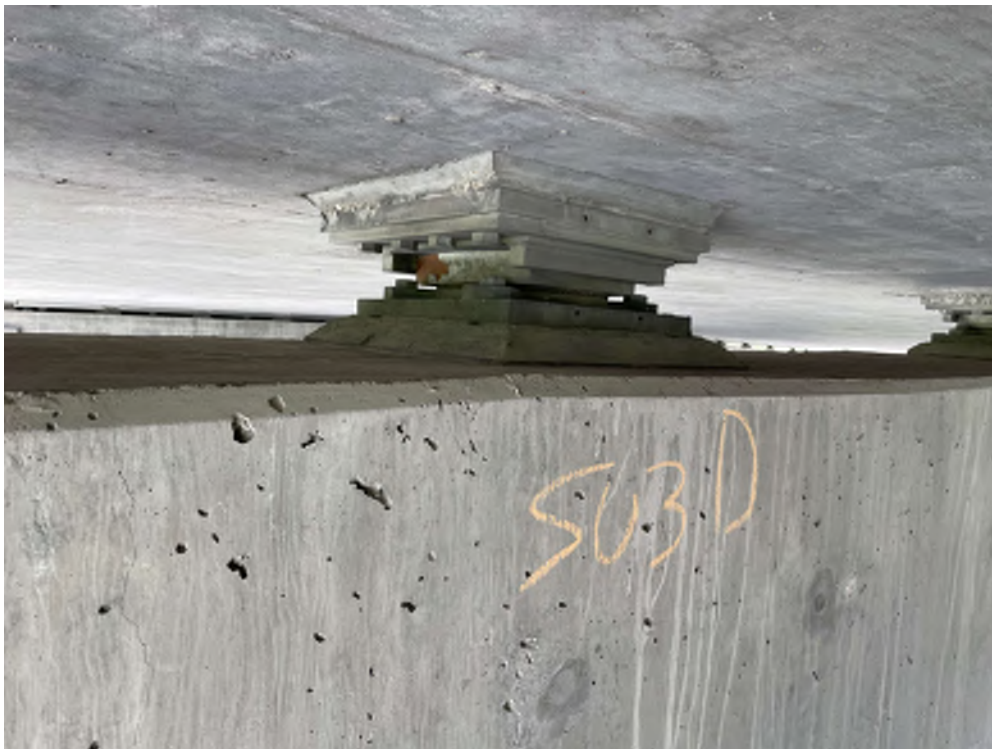
**Photo 10 - SU3 Pier, Line 'D' bearing, coating failure on west side of bearing**

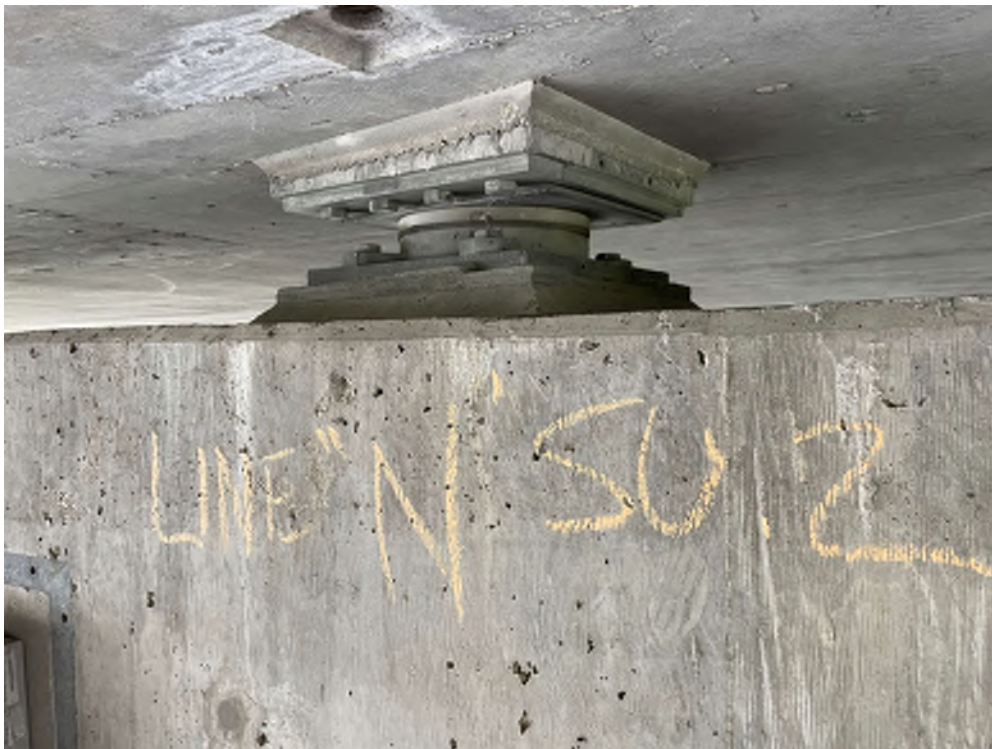
**Photo 12 - SU2 Pier, Line "N", coating spatter on sliding plate**

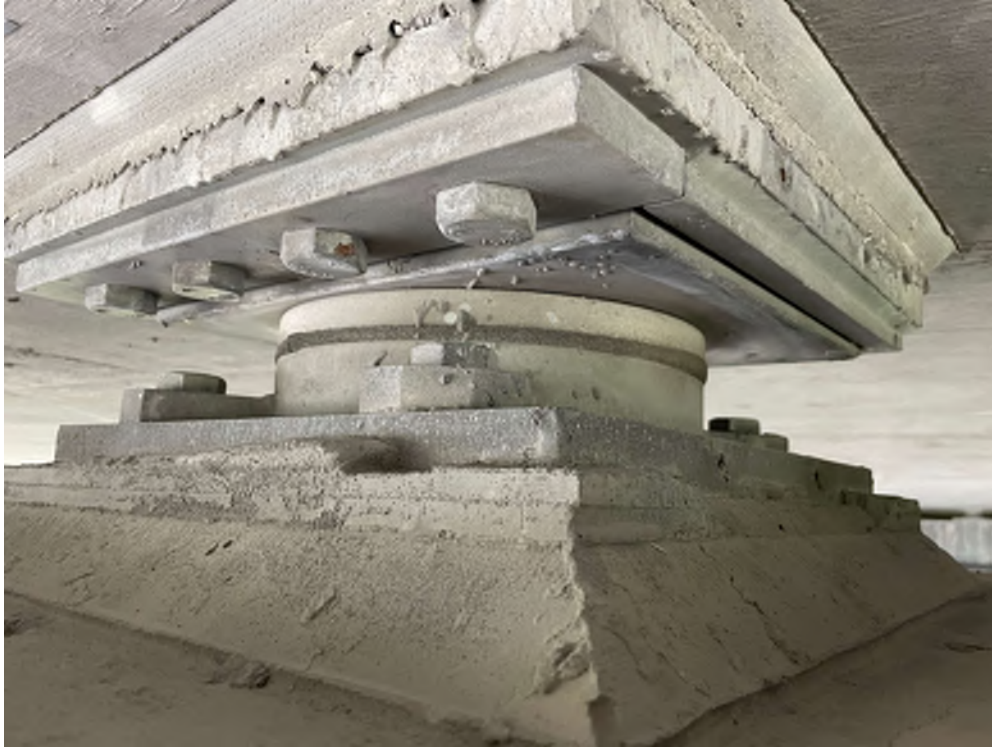
**Photo 13 - SU2 Pier, Line "N", coating spatter on sliding plate, closer view**

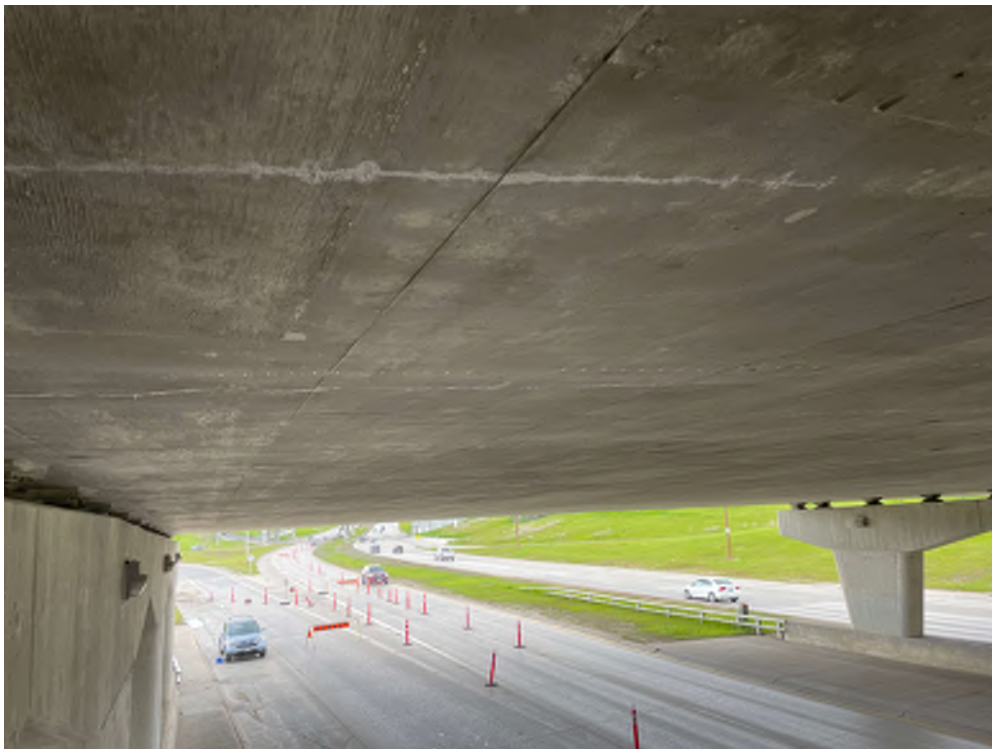
**Photo 14 - Span 2, narrow crack with efflorescence near SU2 Pier**

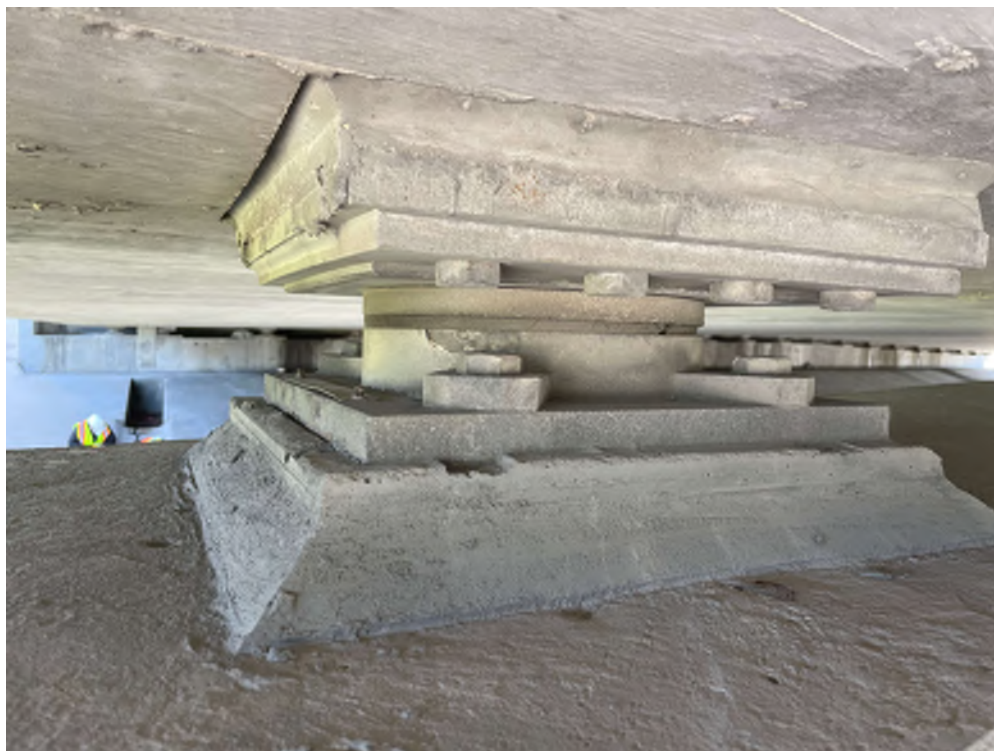
**Photo 20 - SU4, Line "B" bearing, minor coating failure, Line "D" and "H" similar**

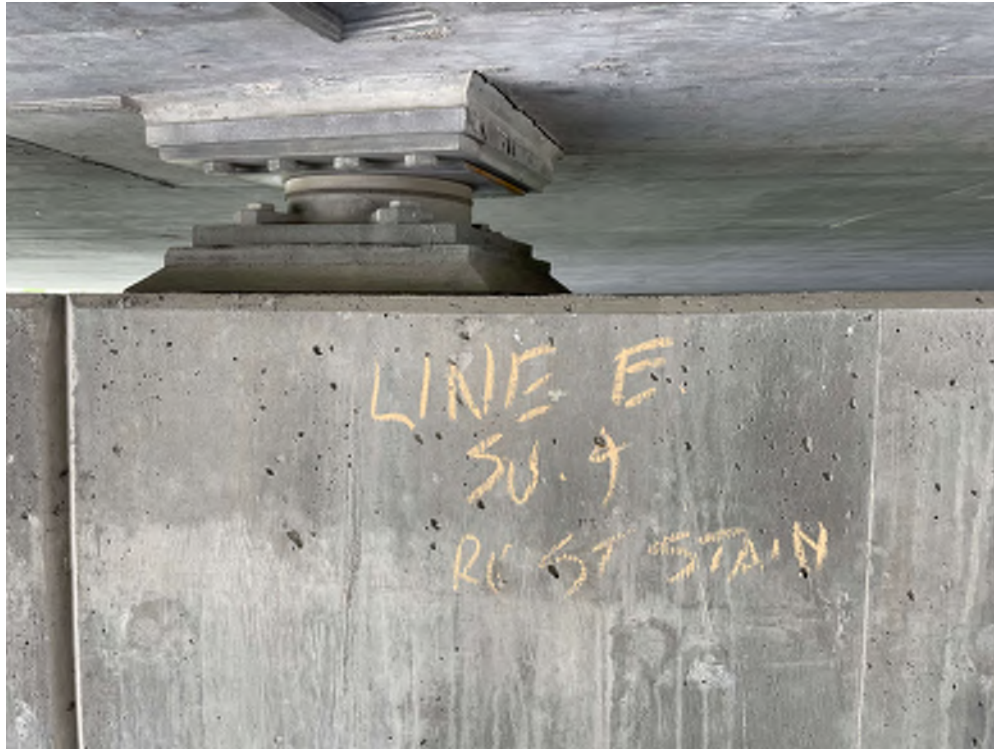
**Photo 21 - SU4, Line "E" bearing, minor rust stain**

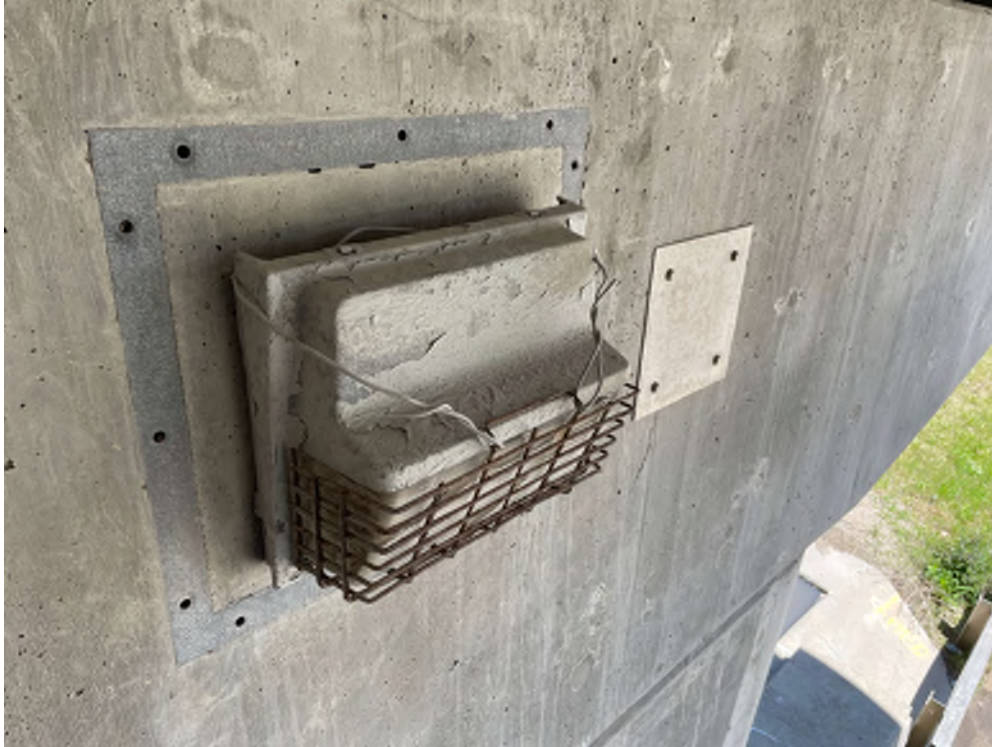
**Photo 23 - SU4, light temporarily repaired near east end on south face**

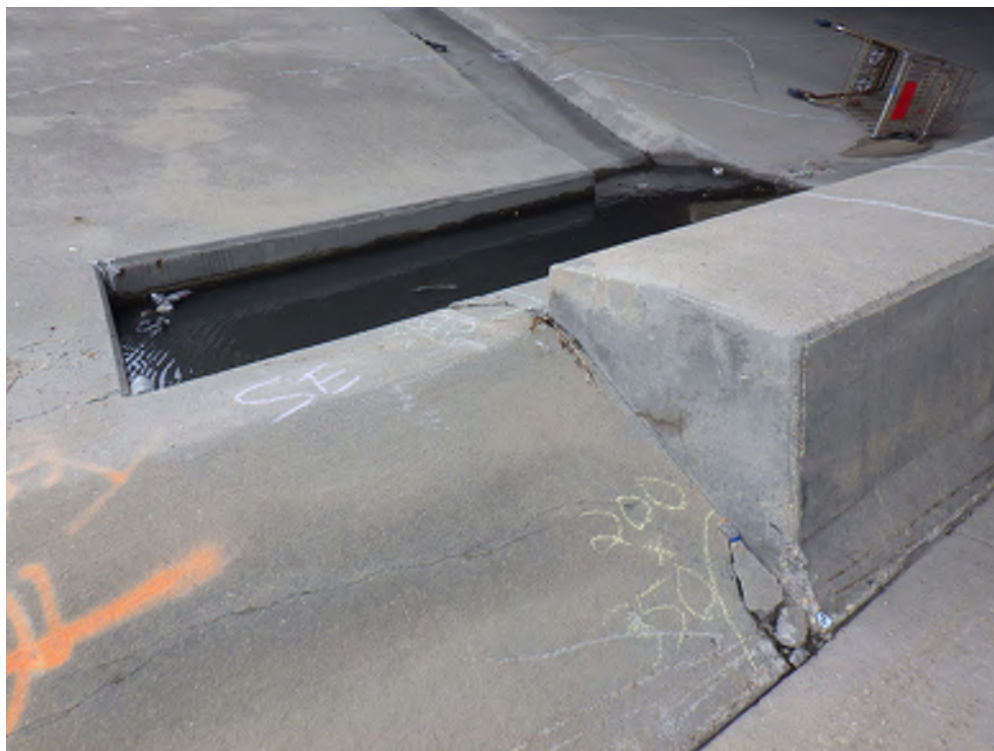
**Photo 28 - SE slope paving lower catch basin, small areas of delamination and spalling**

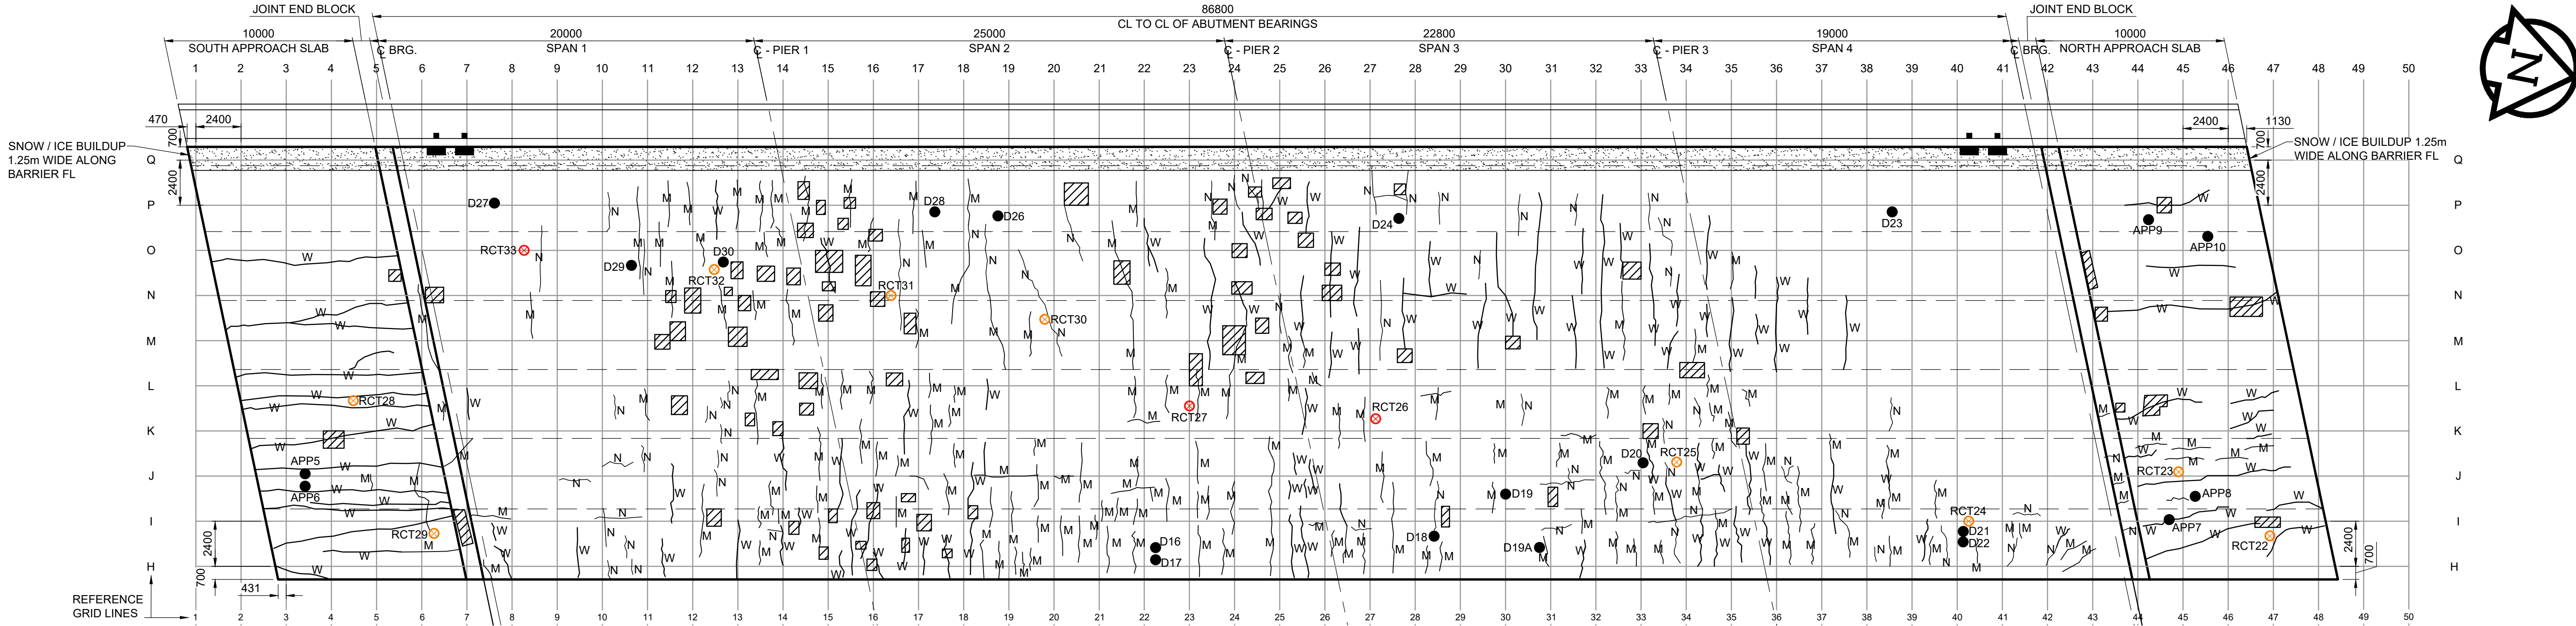
**SOUTHBOUND DECK TOP**

Extensive narrow to wide transverse cracking was noted throughout the deck area, with the most notable cracking occurring over the piers in negative moment regions. Similar transverse cracking, although not as severe / extensive as noted at the piers' negative moment regions, was also noted in the girder positive moment areas. Localized longitudinal cracking in both lane directions was typically located in the two traffic lanes adjacent to the median in each lane direction. The deck cracking appears predominantly related to top mat reinforcing design with respect to serviceability limits.

Extensive delaminated areas were noted throughout the deck area that ranged in size from 0.3 m x 0.3 m to 0.9 m x 0.9 m. Depth of delamination sounded as though delaminations were shallow; this may due to actual shallow delaminations being present and also cores partially becoming cracked or debonded deeper in deck section based on deck coring observations, e.g. at or approaching the HDO / box girder top concrete layers

Delaminations were concentrated over pier locations but were also noted between piers (e.g. in positive bending moment superstructure areas). Delaminations were noted to be present between maintenance patches but not surrounding the patches themselves, which is an indication the patches are not causing “halo” corrosion effects.
