APPENDIX H: TETRA TECH GIRDER AND SUBSTRUCTURE CONDITION ASSESSMENT

Date: March 1, 2024

Project: Professional Consulting Services for Lagimodiere Blvd. Twin Overpasses Rehabilitation (Over Concordia Ave. and CPR Keewatin)

Subject: Bridge Condition Assessment Report

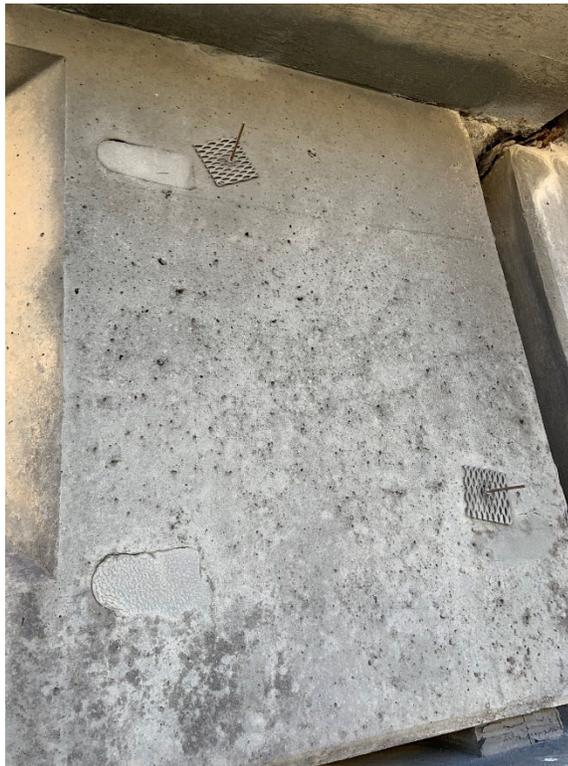
Figure 1 – Metalized Coating on Exterior Girder Ends

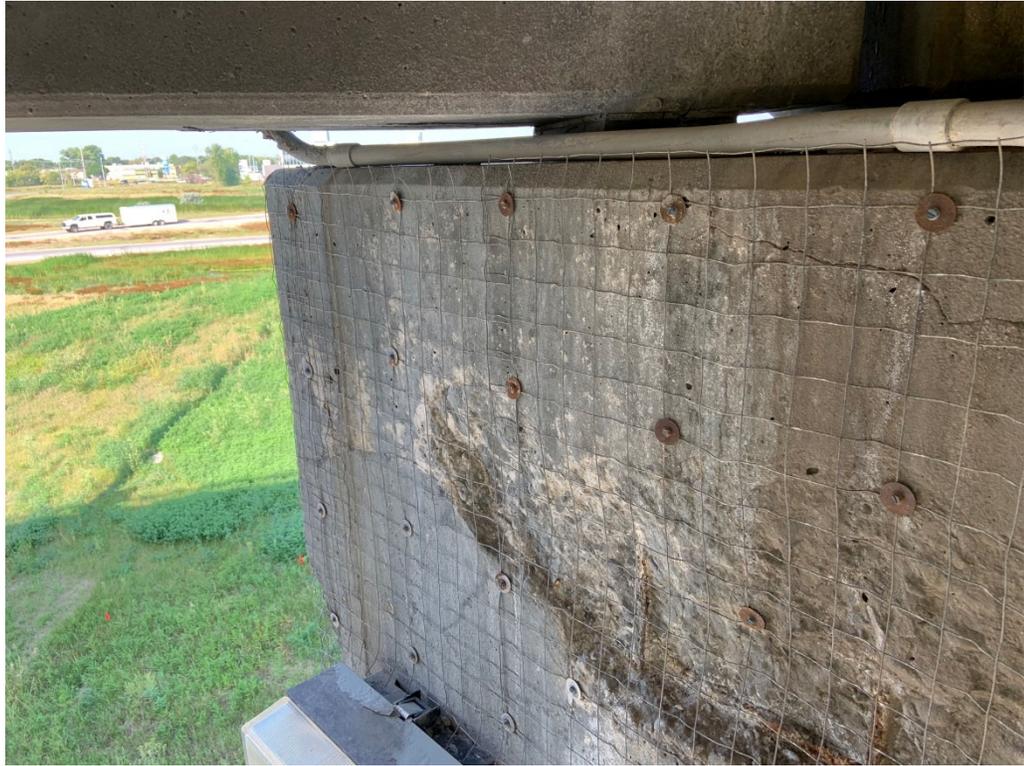
Figure 4 – Containment Meshing on Pier Hammerheads

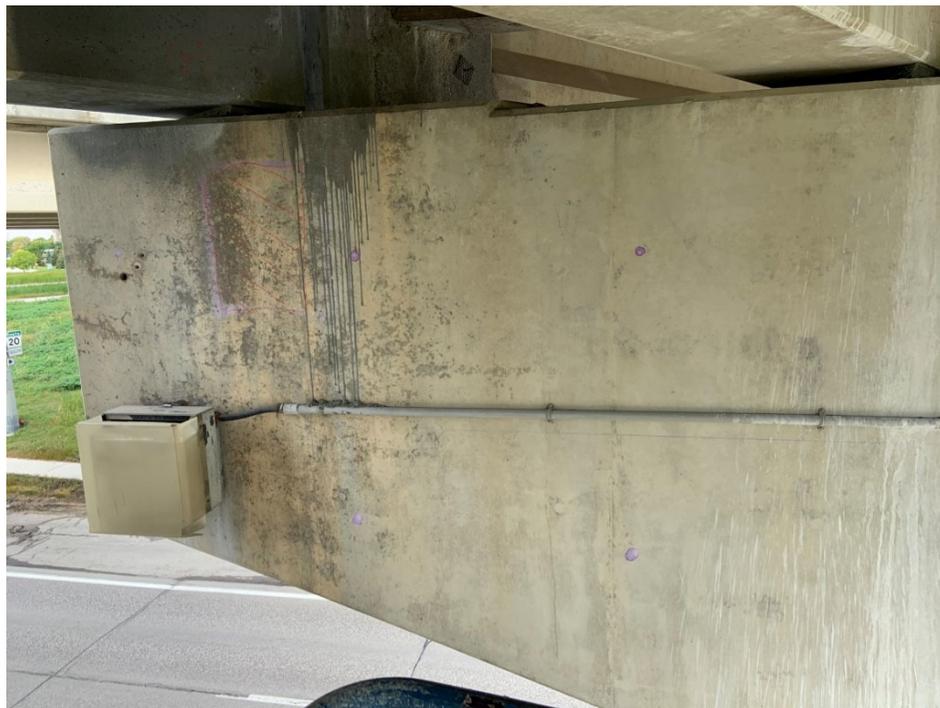
Figure 1 – Delamination in NB Pier 3 Hammerhead

Concrete repairs will be required for a major rehabilitation of the concrete piers to increase their remaining service life. This will most likely include a partial depth concrete replacement for at least the pier hammer heads. Based on the test results from the half-cell testing, we anticipate that the reinforcing in the hammer heads is undergoing corrosion, and replacement of some, if not all, the reinforcing will be required. The results from the WSC tests at the 100-110mm, do not indicate that the chlorides have progressed past the depth of reinforcing in the concrete, and that there should be no concerns with the pier base concrete.

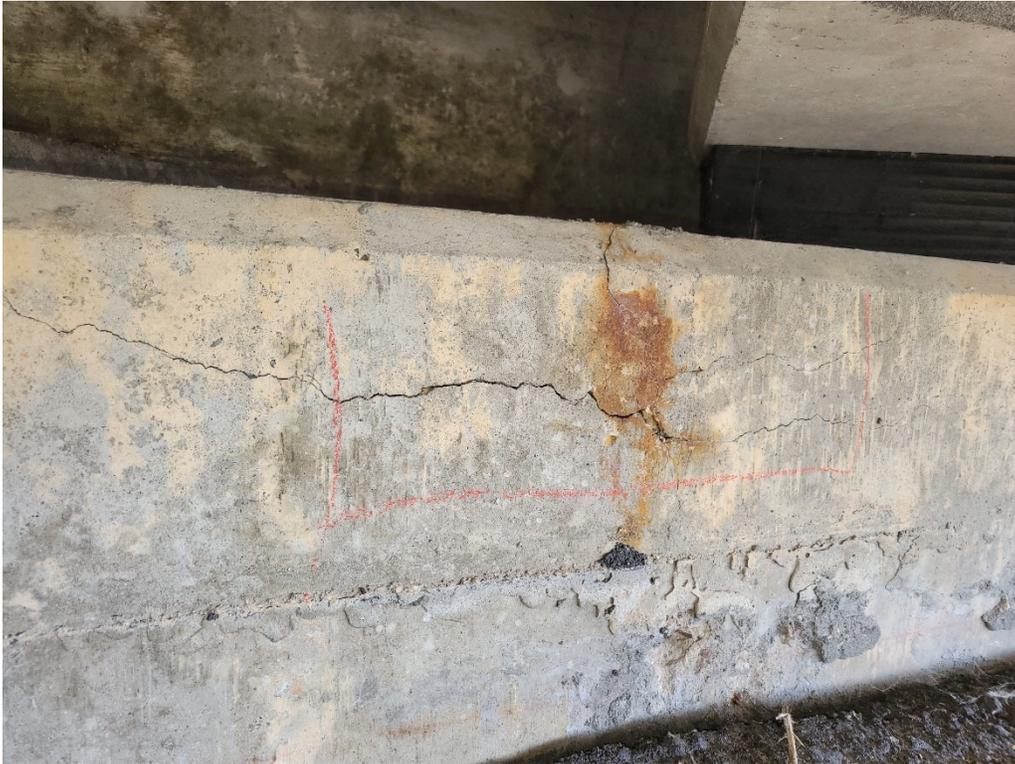
Figure 4 – Delamination in NB North Abutment

Concrete repairs will be required for a major rehabilitation of the concrete abutments to increase their remaining service life. This will most likely include a partial depth concrete replacement for the areas with concrete delaminations. Based on the test results from the half-cell testing, we anticipate that the reinforcing in the abutments is undergoing corrosion, and replacement of some, if not all, the reinforcing within concrete repair areas will be required. The results from the WSC tests at the 100-110mm, indicate that the chlorides have progressed past the depth of reinforcing in the concrete in a few locations. Repairs details may need to consider methods to address high chlorides in areas without concrete repairs, including cathodic protection.

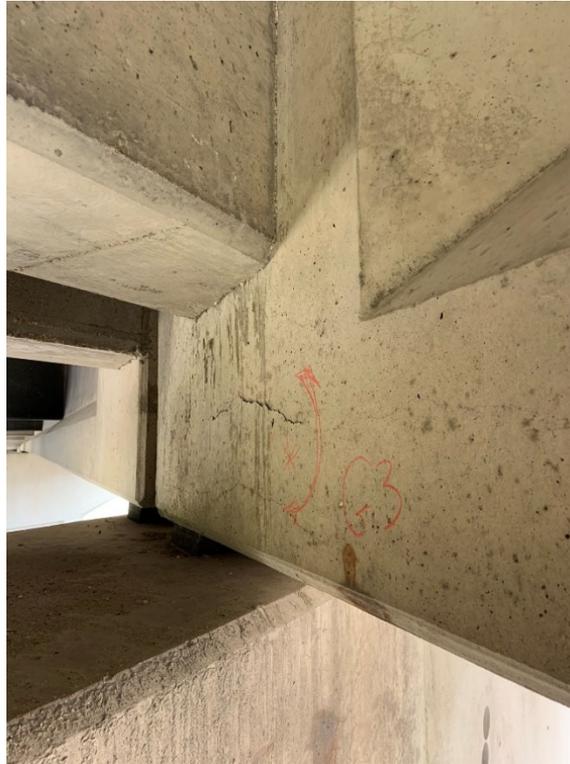
Figure 12: Delaminated GE, G3 – SB Structure, Span 1, at Pier 1

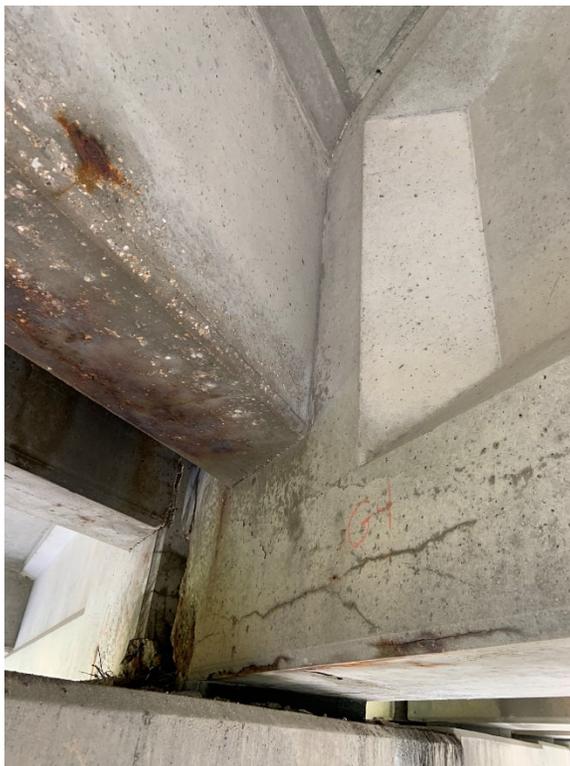
Figure 12: Cracked GE Bottom, G4 - SB Structure, Span 3, at Pier 3

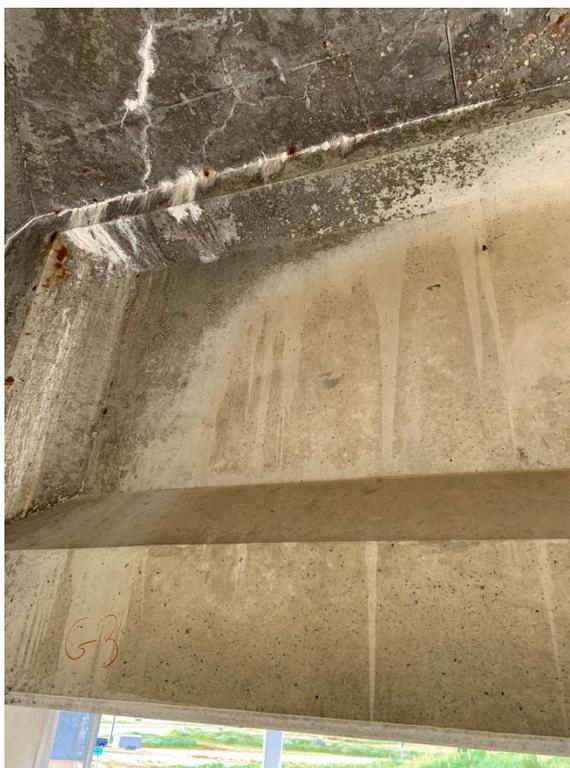
Figure 12: Surface Scaling Found at Various Locations

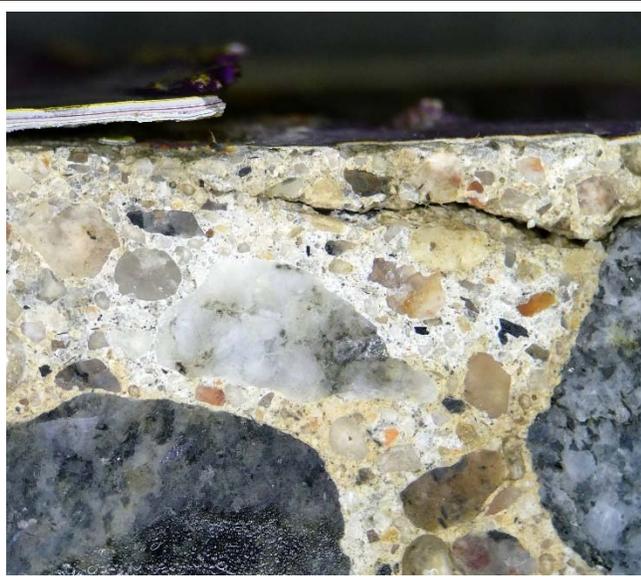
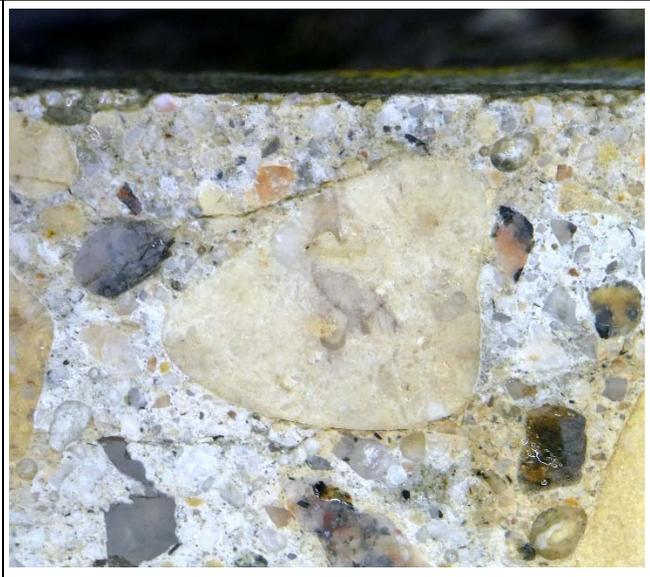
Views at upper/outer face of core, in profile, showing cracks in paste, delamination of paint coatings (left view), and discoloured paste at surface. Magn. 10x, fov = 13 mm

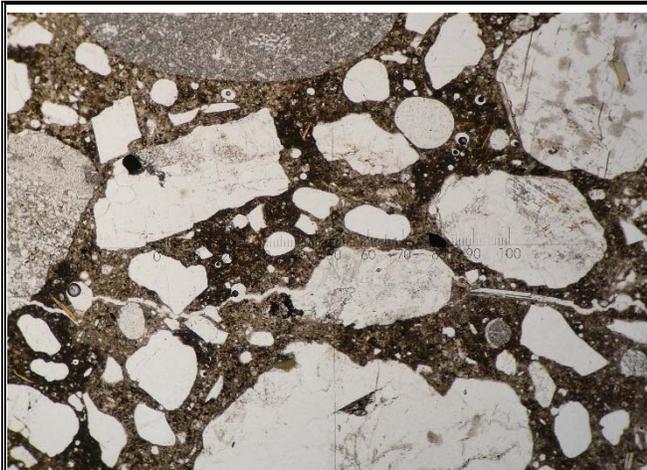
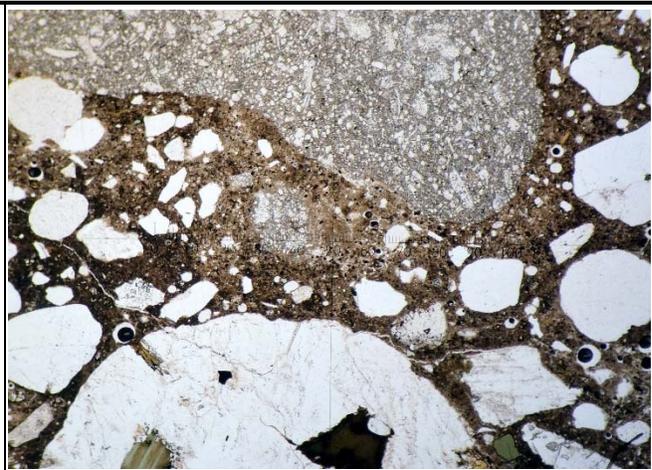
Cracks are observed in the paste, in thin-section. These are generally devoid of deposits of secondary materials, are fine, and are overall uncommon. 50x magnification, field of view 3 mm.

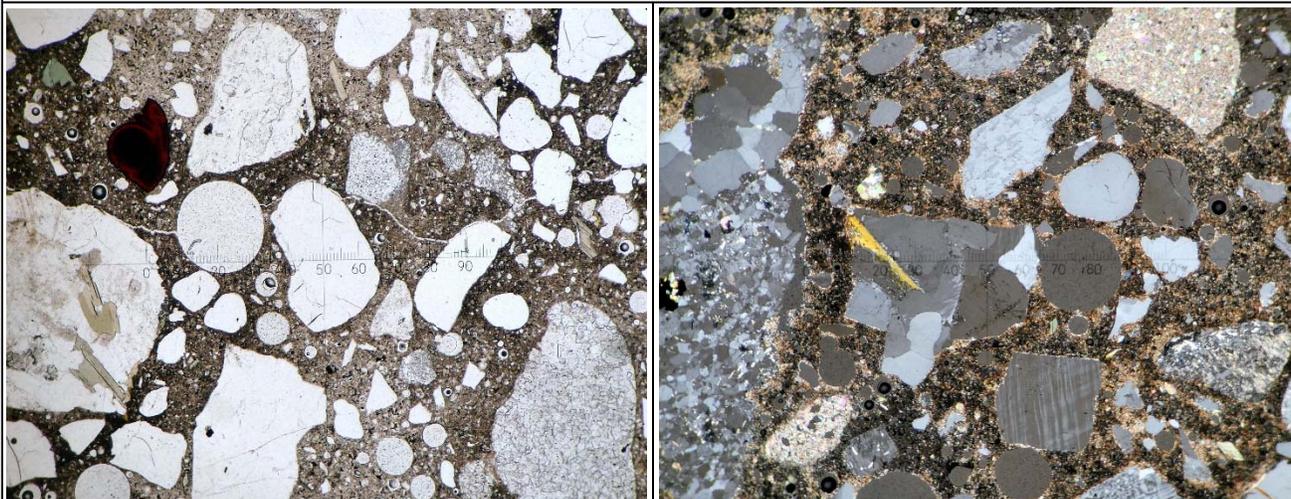
Thin-section views showing (left) microcrack extending through paste and (right) generally dense but slightly carbonated paste that encapsulates aggregates. Magnification 50x, fields of view 3 mm across.

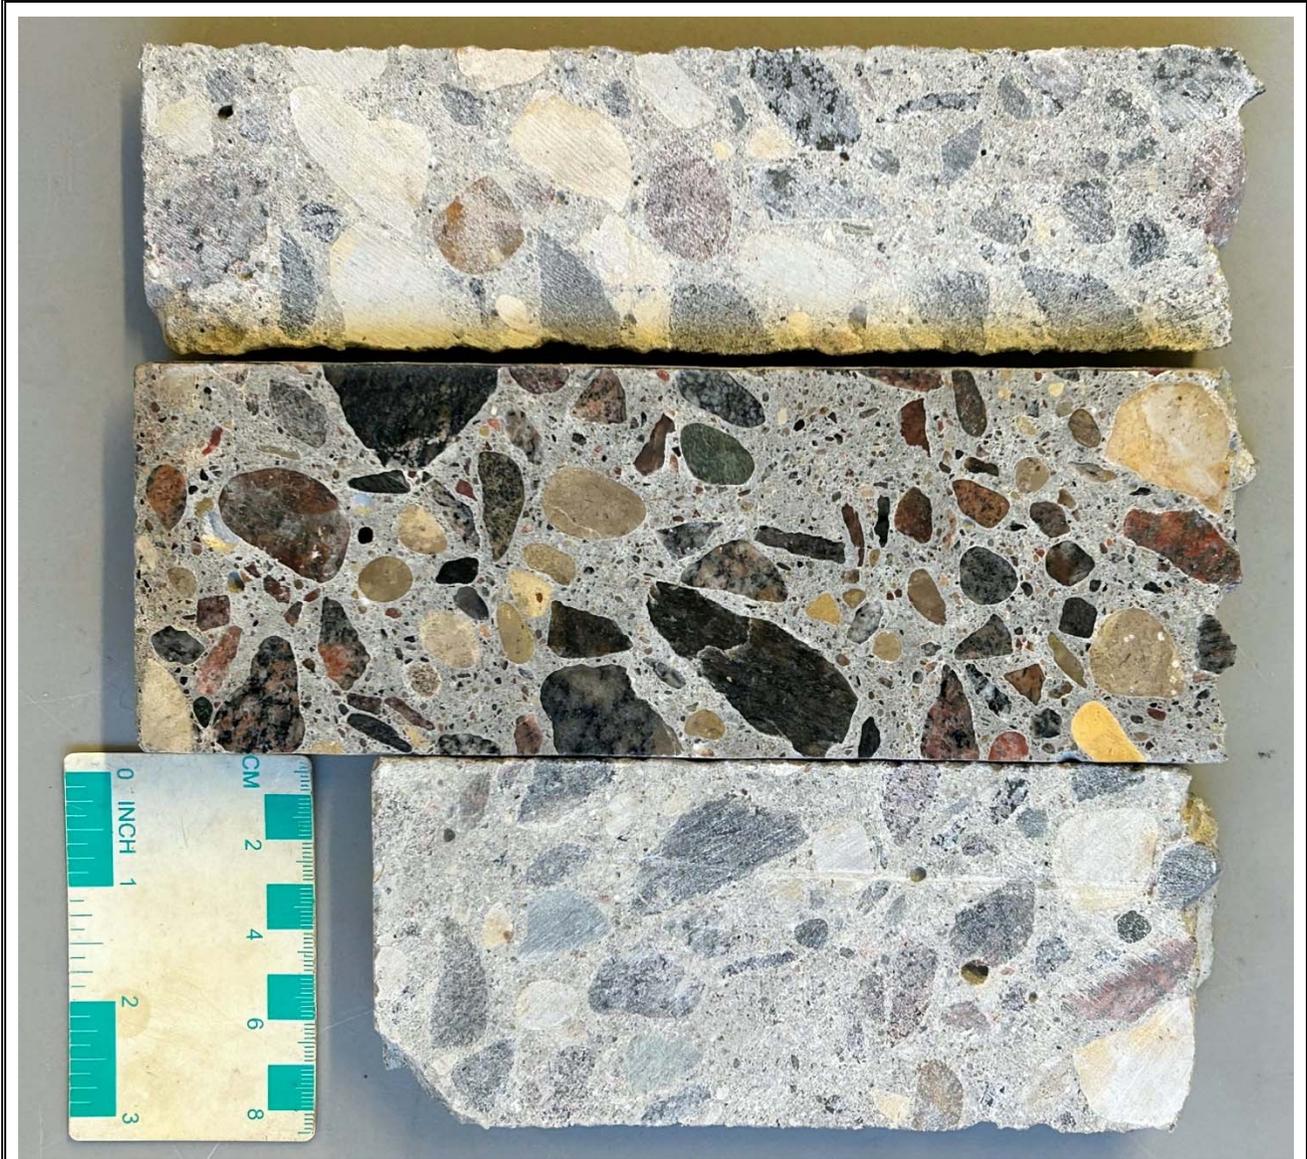
Core after cutting and polishing. Outer end is discoloured to a depth of about 15 mm.

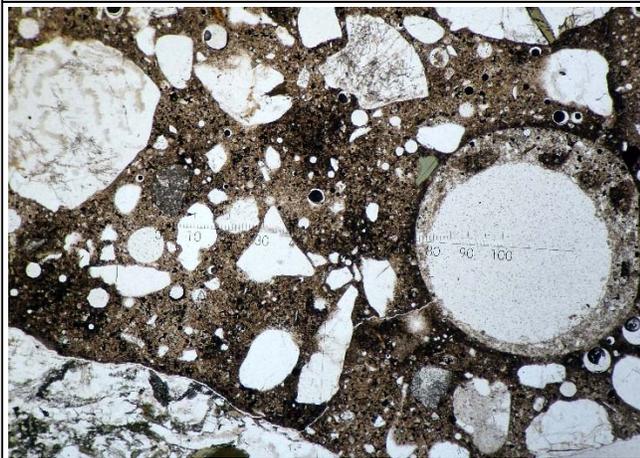
A thin microcrack extends through paste in this thin-section image; 50x magnification.

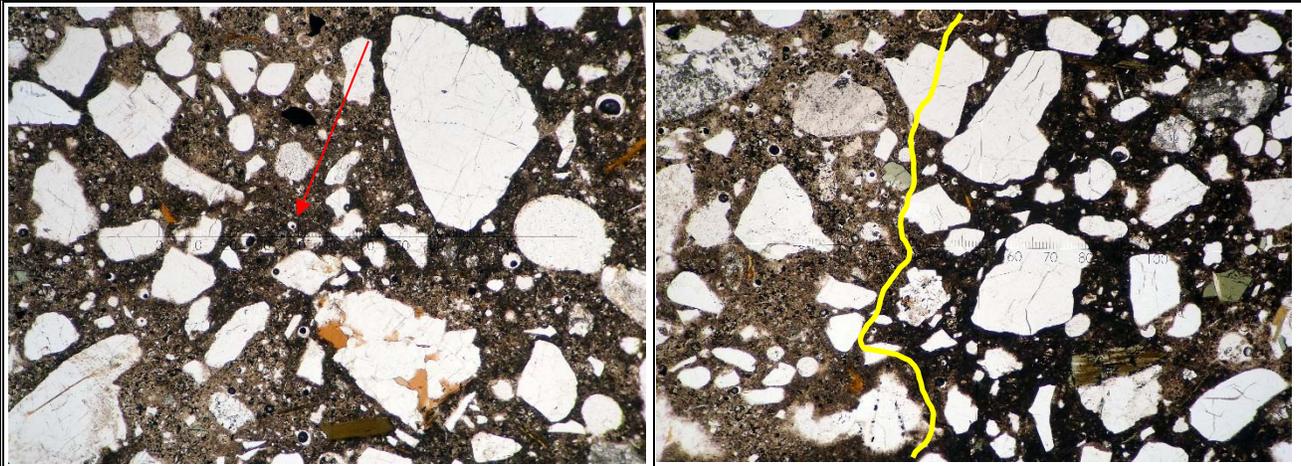
Thin section views, both in plane polarized light showing (left image) tiny microcrack (arrow) in paste and (right image) variegated paste represented by darker brown on right portion of image and contrasting light-medium brown paste in left portion of image. Both views at 50x magnification with fields of view of 3 mm in length.

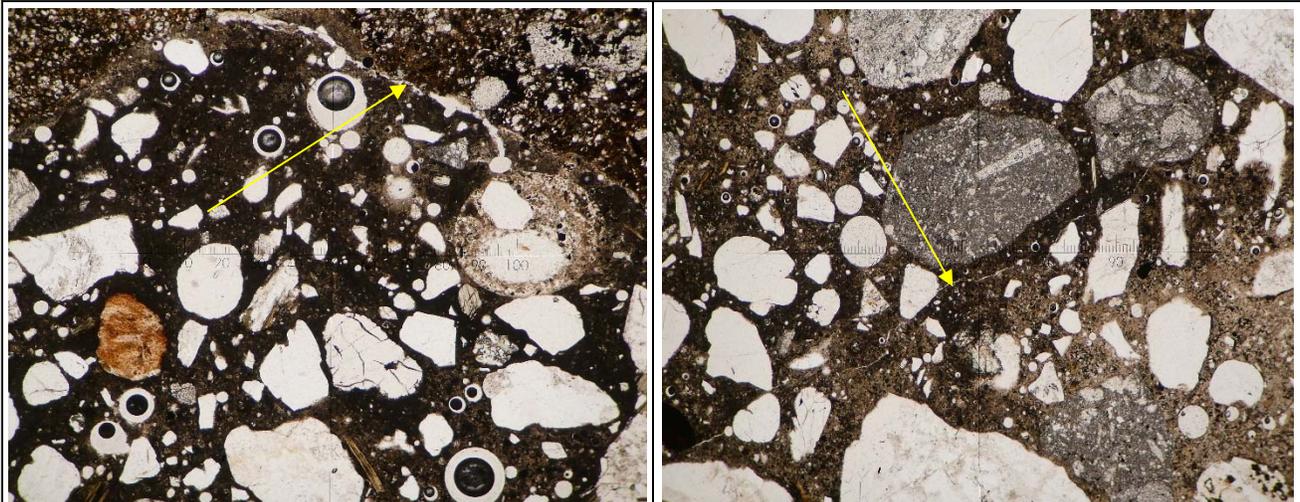
Thin-section images showing fine and very fine microcracks in cement paste; 50x magnification.

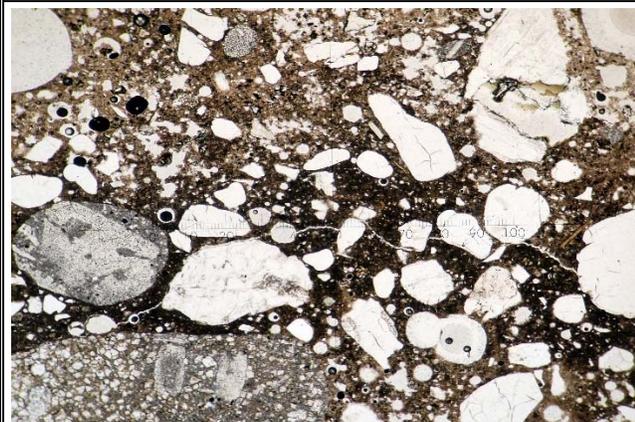
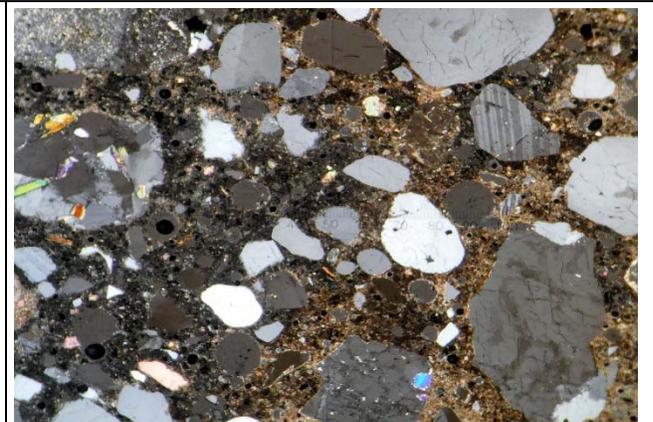
Crack in paste (left) and carbonated paste at right in right image, in thin-section. 50x magn., fov 3 mm

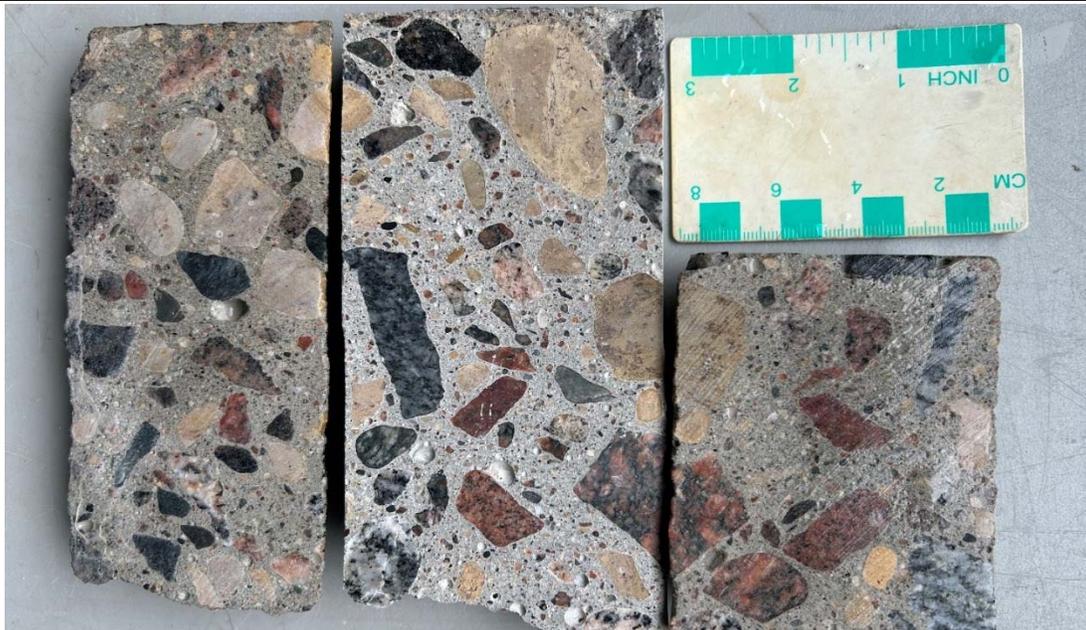
Core after cutting and polishing. Slightly discoloured paste is evident at outer surface, and appears as a slightly brownish layer.
