B.M. ELEV.					CONSULTANT DRAWING NO. 704-INF-MBI03007.01-DWG-S2103
			DESIGNED BY RL	REVIEWED BY SA	
			DRAWN BY EV	APPROVED BY KA	
			SCALE: AS NOTED	ACCEPTED BY CAM WARD, P.ENG.	DATE 25.08.07
0	ISSUED FOR TENDER	25.08.07	SA		
NO.	REVISIONS	DATE	BY	DATE	25.08.07

<b>THE CITY OF WINNIPEG</b> PUBLIC WORKS DEPARTMENT ENGINEERING DIVISION	
LAGIMODIERE TWIN OVERPASSES OVER CPKC KEEWATIN REHABILITATION AND RELATED WORKS	CITY DRAWING NUMBER B123-25-2103
SOUTHBOUND STRUCTURE SOUTH ABUTMENT S-0 - DEMOLITION AND REPAIR DETAILS	SHEET 3 OF 47
	2103

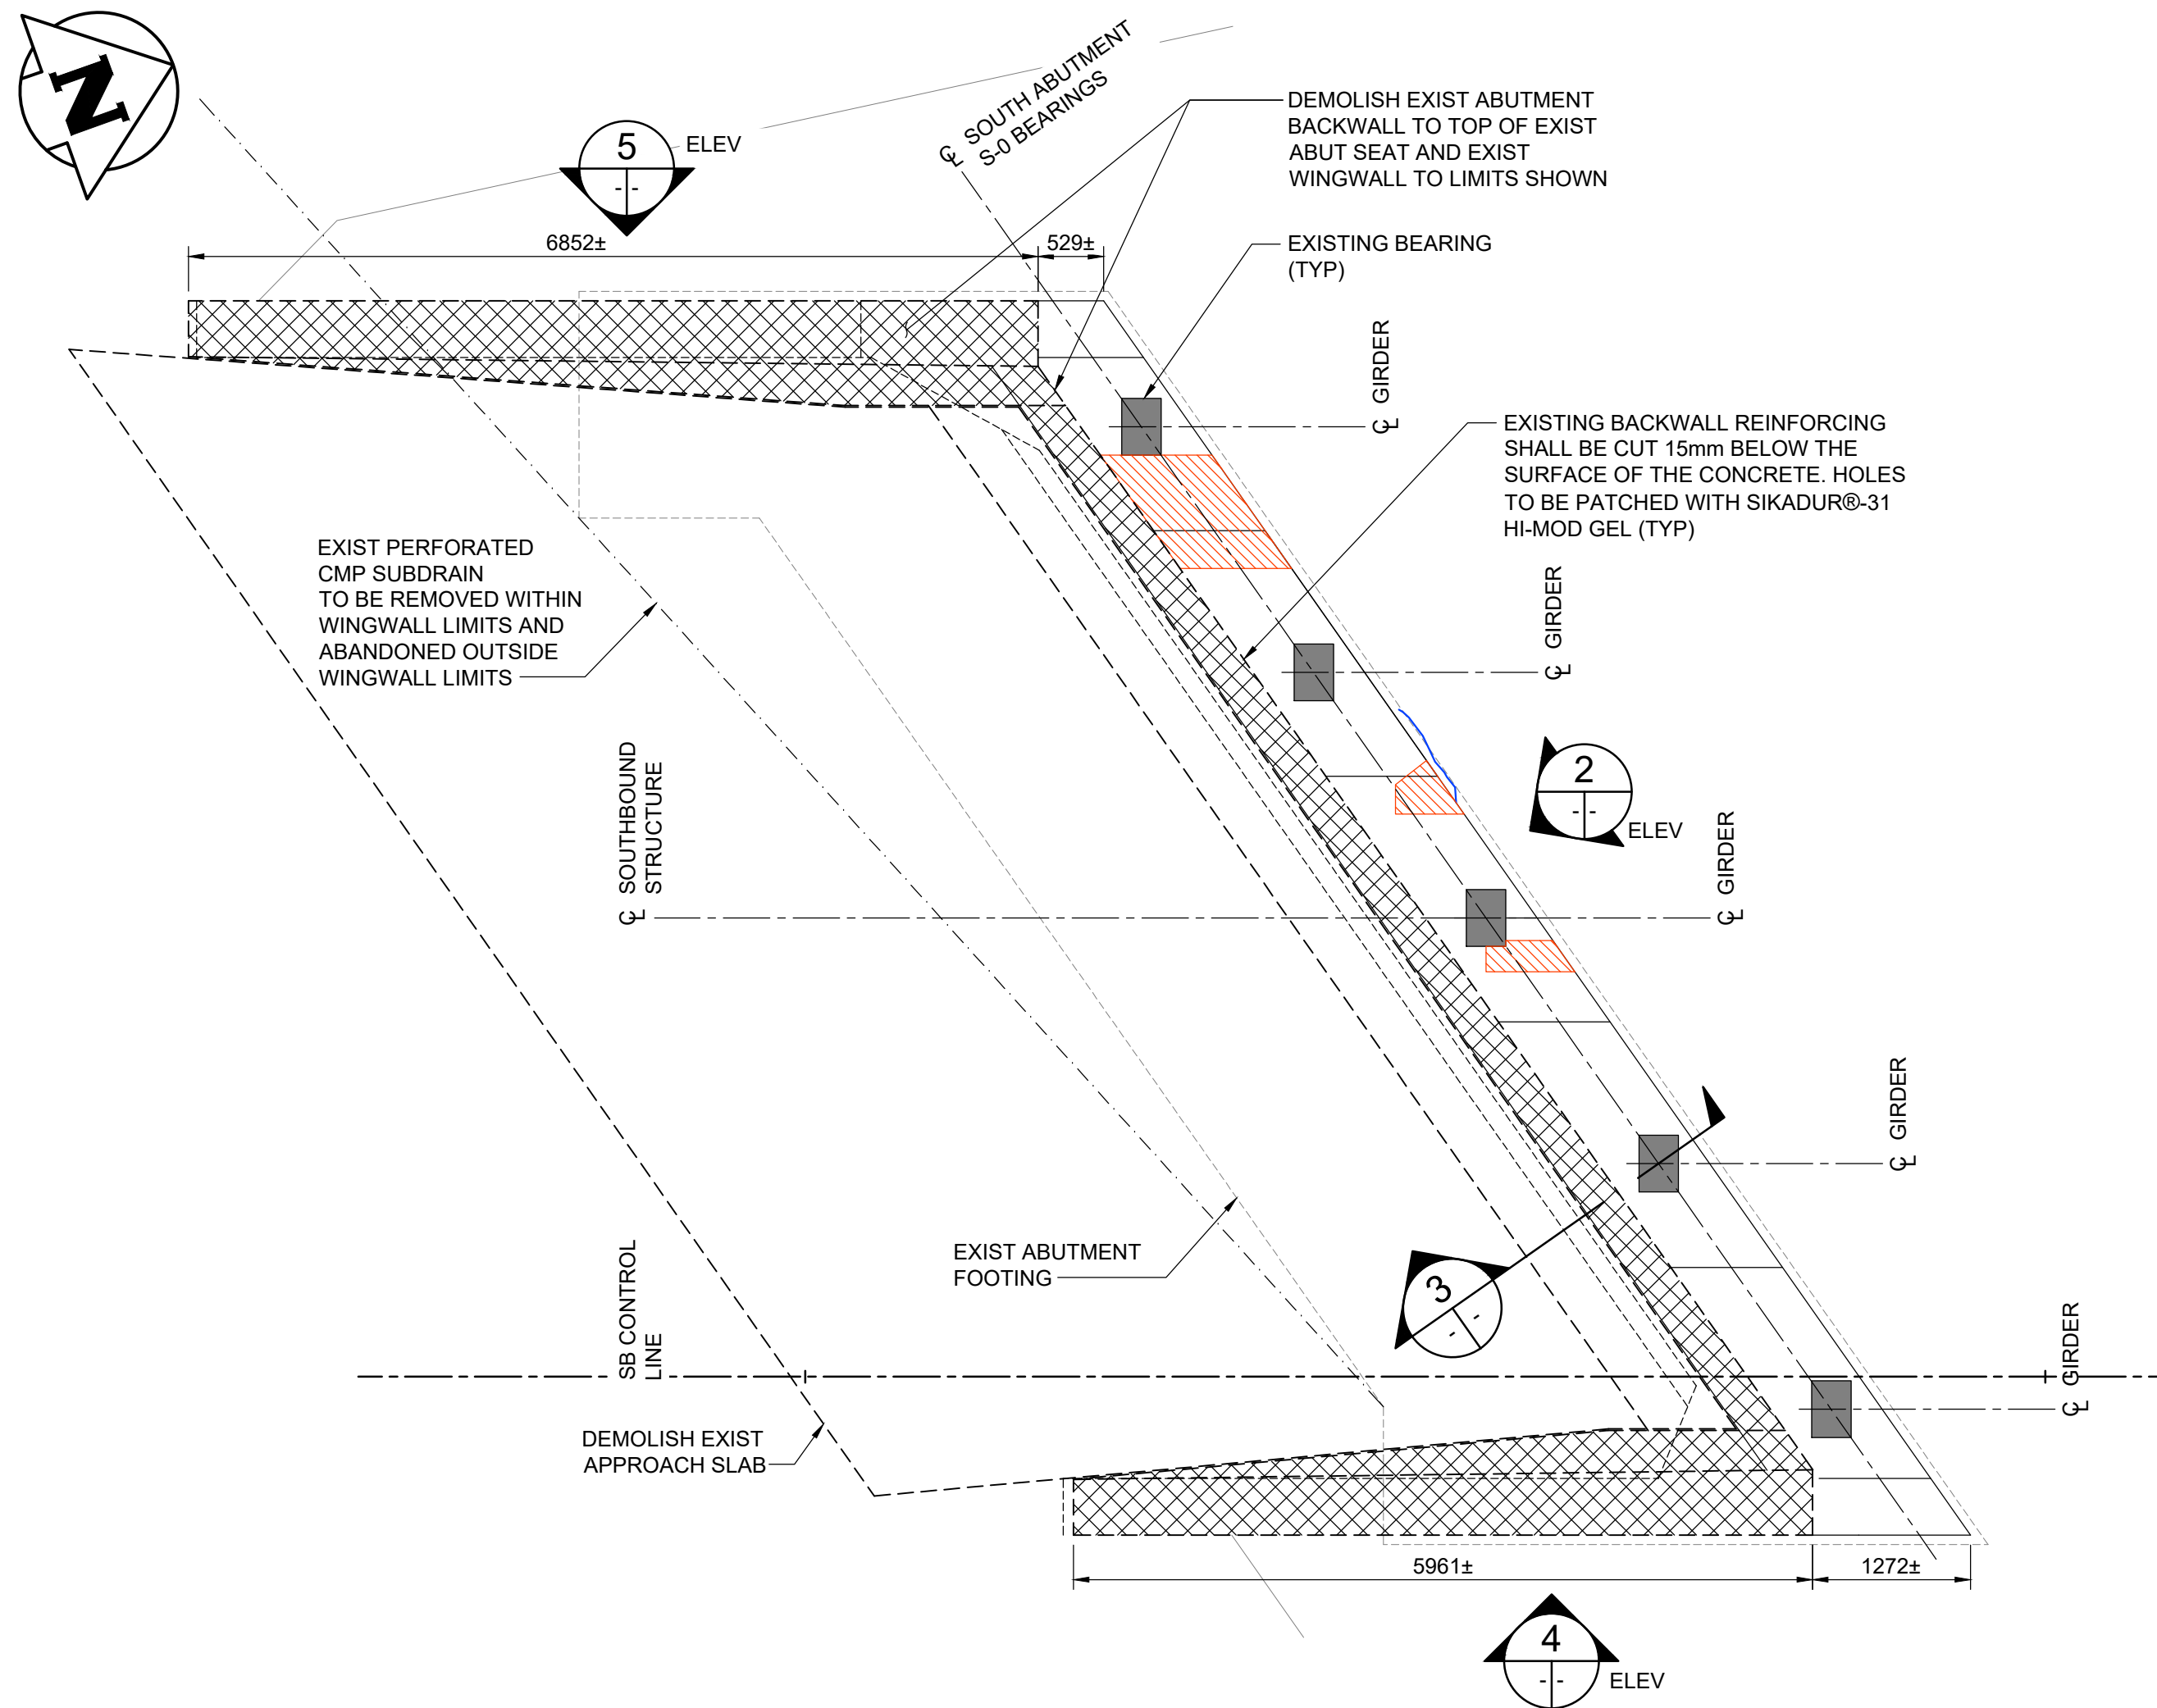
1  
- -  
PLAN - ABUTMENT S-0  
1 : 50

- CRACK LOCATIONS ARE APPROXIMATE. CRACK WIDTH VARIED
- THIS DRAWING DEPICTS SELECT FINDINGS/AREAS OF CONCERN. ACTUAL REPAIR AREAS MAY BE DIFFERENT AND WILL BE IDENTIFIED ON SITE BY THE CONTRACT ADMINISTRATOR. REPAIR AREAS TO BE MARKED OFF TO SQUARE OR RECTANGULAR SHAPES.
- ASSUMED REPAIR AREAS ARE PROVIDED IN TABLE 1.
- REFER TO SHEET 1004 FOR TYPICAL REPAIR NOTES.
