THE CITY OF WINNIPEG PUBLIC WORKS DEPARTMENT ENGINEERING DIVISION

CITY DRAWING NUMBER LAGIMODIERE TWIN OVERPASSES B123-25-2111 OVER CPKC KEEWATIN REHABILITATION AND RELATED WORKS SOUTHBOUND STRUCTURE 2111 PIER S-3 - REPAIR DETAILS

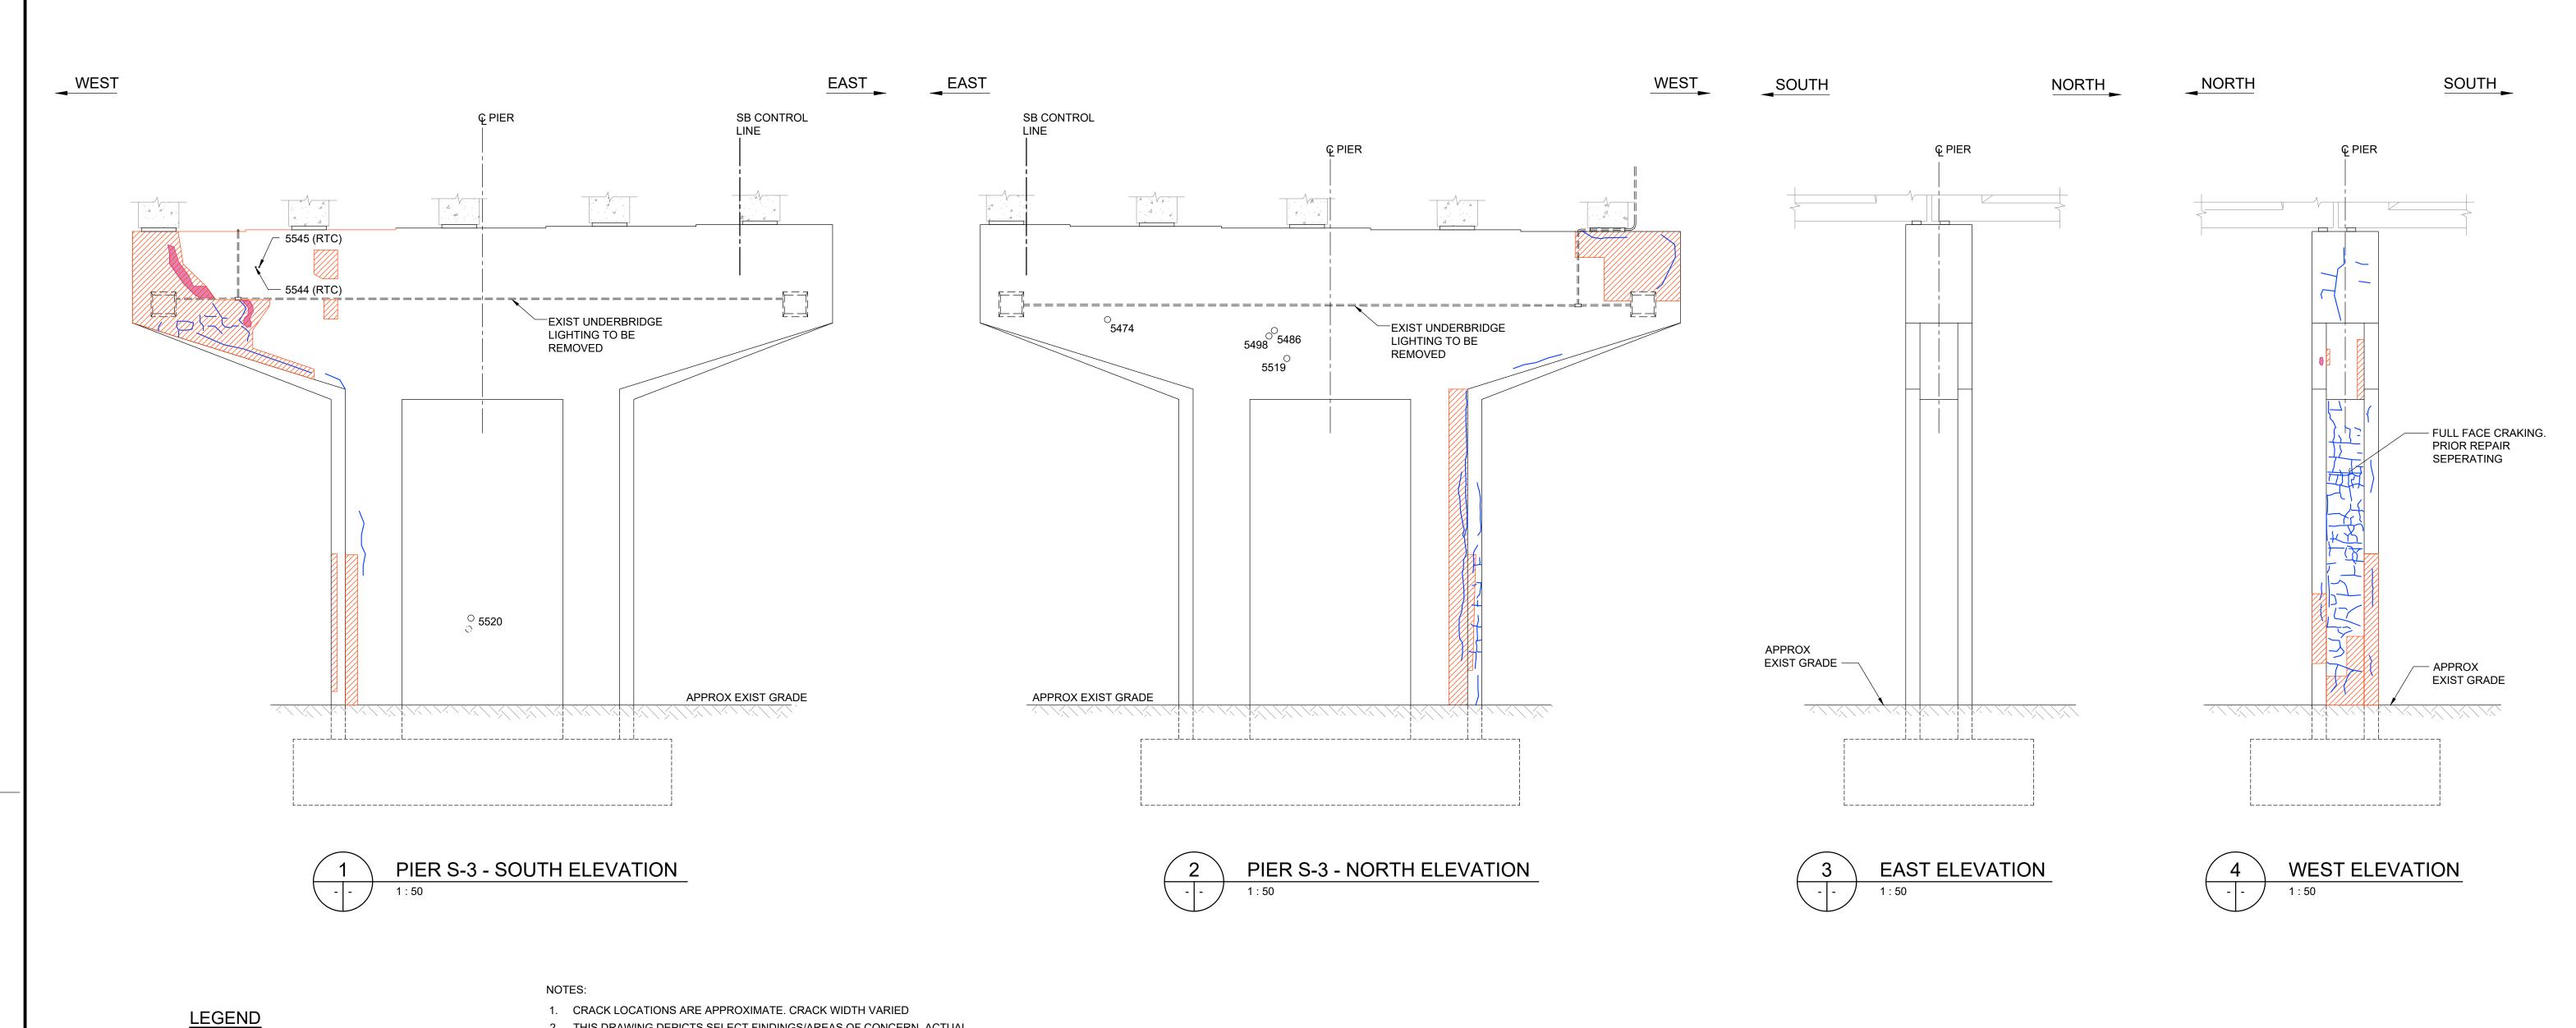
- 2. THIS DRAWING DEPICTS SELECT FINDINGS/AREAS OF CONCERN. ACTUAL REPAIR AREAS MAY BE DIFFERENT AND WILL BE IDENTIFIED ON SITE BY THE CONTRACT ADMINISTRATOR. REPAIR AREAS TO BE MARKED OFF TO SQUARE OR RECTANGULAR SHAPES.
- 3. ASSUMED REPAIR AREAS ARE PROVIDED IN TABLE 1.
- 4. REFER TO SHEET 2109 FOR TYPICAL REPAIR DETAILS AND NOTES.
- 5. AREAS NOTED WITHIN CAP MODIFICATION AREA ARE TO BE POURED MONOLITHICALLY WITH PIER CAP MODIFICATION CONCRETE.

TABLE 1: REPAIR QUANTITIES							
	APPROX REPAIR UNITS						
S-3	SUBSTRUCTURE REPAIRS - 12.0 m ²						
0 0	MONOLITHIC WITH SUBSTRUCTURE MODIFICATIONS - 6.0 m ²
