B.M. ELEV.										THE CITY OF WINNIPEG PUBLIC WORKS DEPARTMENT ENGINEERING DIVISION		
DESIGNED BY RL		REVIEWED BY SA		SCALE: AS NOTED				ACCEPTED BY DATE CAM WARD, P.ENG. 25.08.07		LAGIMODIERE TWIN OVERPASSES OVER CPKC KEEWATIN REHABILITATION AND RELATED WORKS		CITY DRAWING NUMBER B123-25-2112
DRAWN BY EV		APPROVED BY KA								SHEET 12 OF 47		
0 ISSUED FOR TENDER		25.08.07		SA						SOUTHBOUND STRUCTURE PIER S-4 - REPAIR DETAILS		2112
NO. REVISIONS		DATE		BY		DATE 25.08.07

CONSULTANT DRAWING NO.
704-INF-MBI03007.01-DWG-S2112

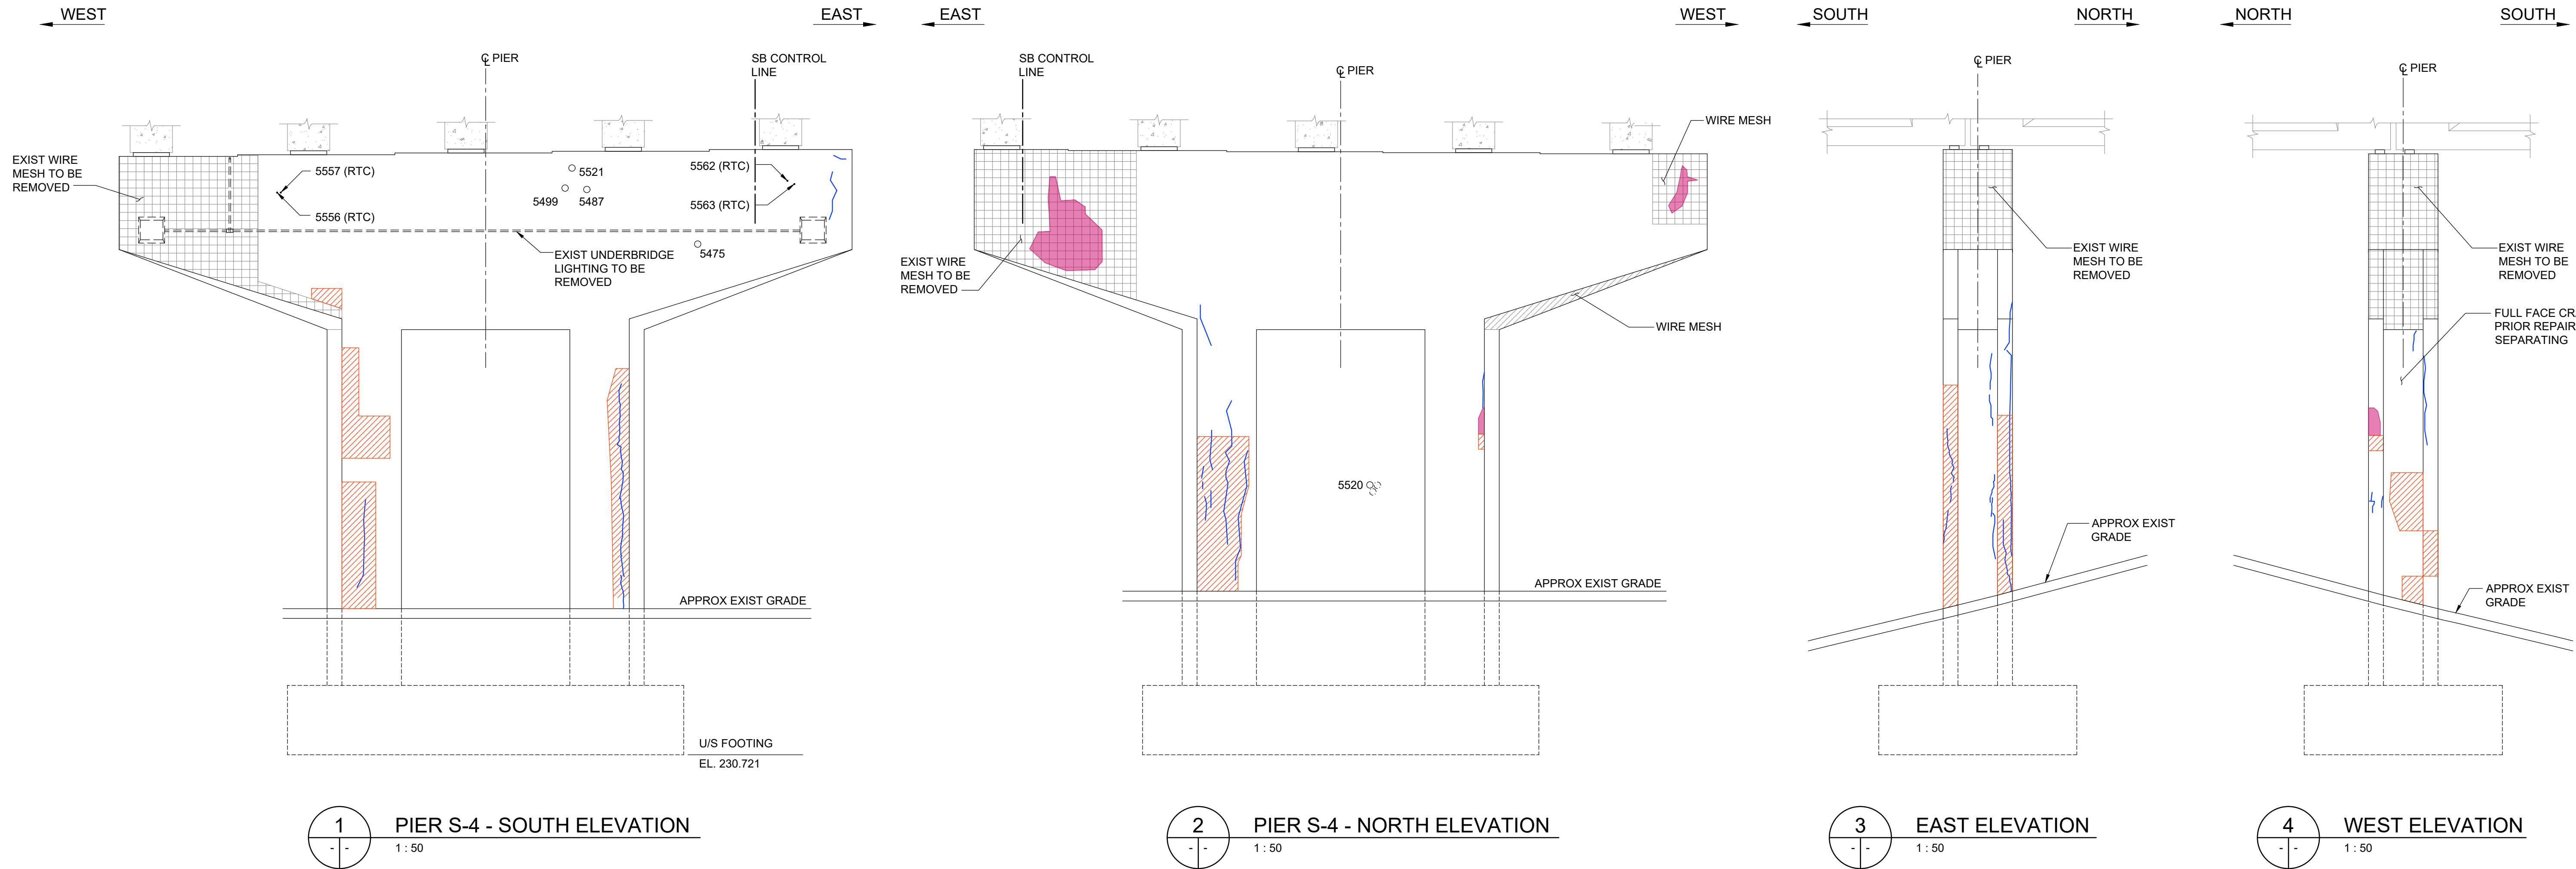
- NOTES:
- CRACK LOCATIONS ARE APPROXIMATE. CRACK WIDTH VARIED
 - THIS DRAWING DEPICTS SELECT FINDINGS/AREAS OF CONCERN. ACTUAL REPAIR AREAS MAY BE DIFFERENT AND WILL BE IDENTIFIED ON SITE BY THE CONTRACT ADMINISTRATOR. REPAIR AREAS TO BE MARKED OFF TO SQUARE OR RECTANGULAR SHAPES.
 - ASSUMED REPAIR AREAS ARE PROVIDED IN TABLE 1.
 - REFER TO SHEET 2109 FOR TYPICAL REPAIR DETAILS AND NOTES.
 - AREAS NOTED WITHIN CAP MODIFICATION AREA ARE TO BE POURED MONOLITHICALLY WITH PIER CAP MODIFICATION CONCRETE.

TABLE 1: REPAIR QUANTITIES	
	APPROX REPAIR UNITS
S-4	SUBSTRUCTURE REPAIRS - 20.0 m ² MONOLITHIC WITH SUBSTRUCTURE MODIFICATIONS - 15.0 m ²
