## **PIPELINE ELECTROMAGNETIC INSPECTION REPORT**

## 600 mm Charleswood-Assiniboia Feeder Main

### Condition Assessment Report, Standard Analysis

**PICA Project: 8054**

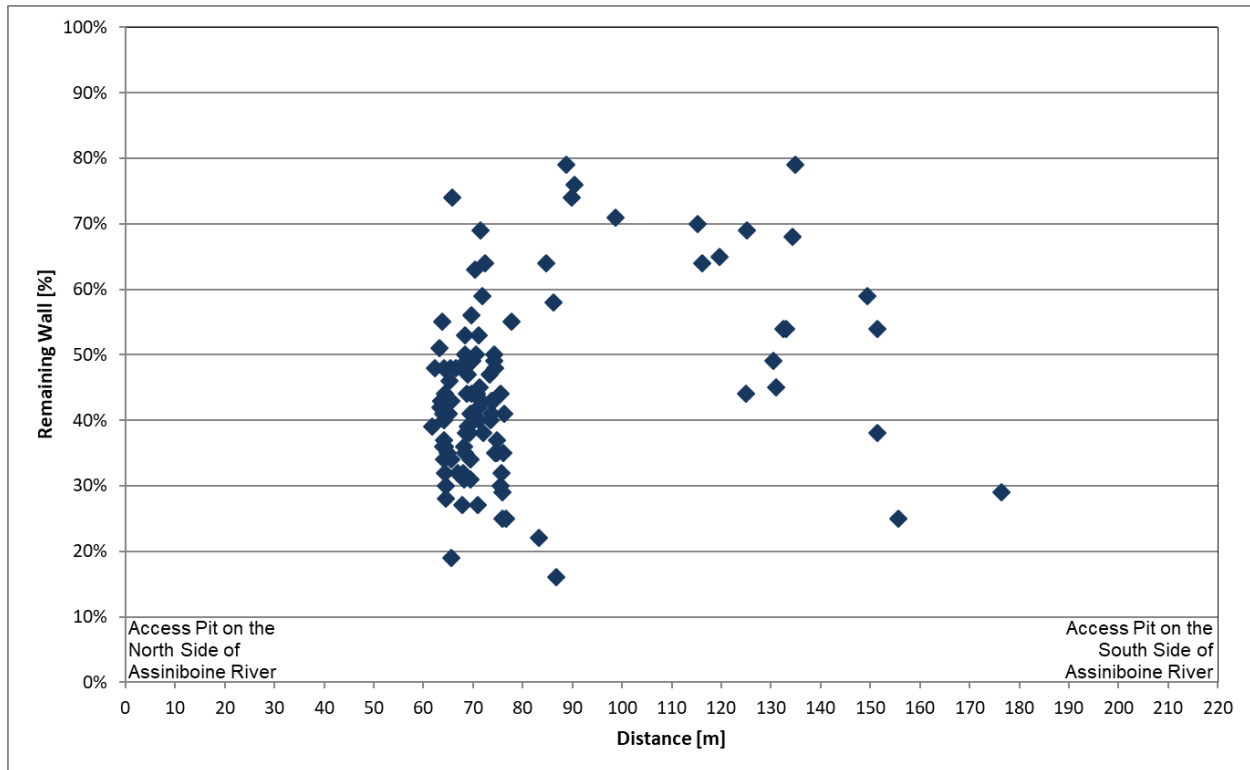
A total of 111 localized wall loss indications were identified in the inspection data. Among these defects, two (2) defects measured <20% remaining wall (RW): a 19% RW indication in pipe 0100, and a 16% RW indication in pipe 0130. An additional 36 indications were measured as *deep* (20-39% RW), 62 were classified as *medium* (40-64% RW), and 11 were *shallow* ( $\geq 65\%$  RW). Most (89) of the defect indications are located within a single stretch of the Feeder Main spanning from about 61m to 78m, corresponding to pipes 0100 and 0110 (PICA designation).

Figure 1. Axial distribution of defect indications and remaining wall (%) within the scanned length of the Charleswood-Assiniboia Feeder Main

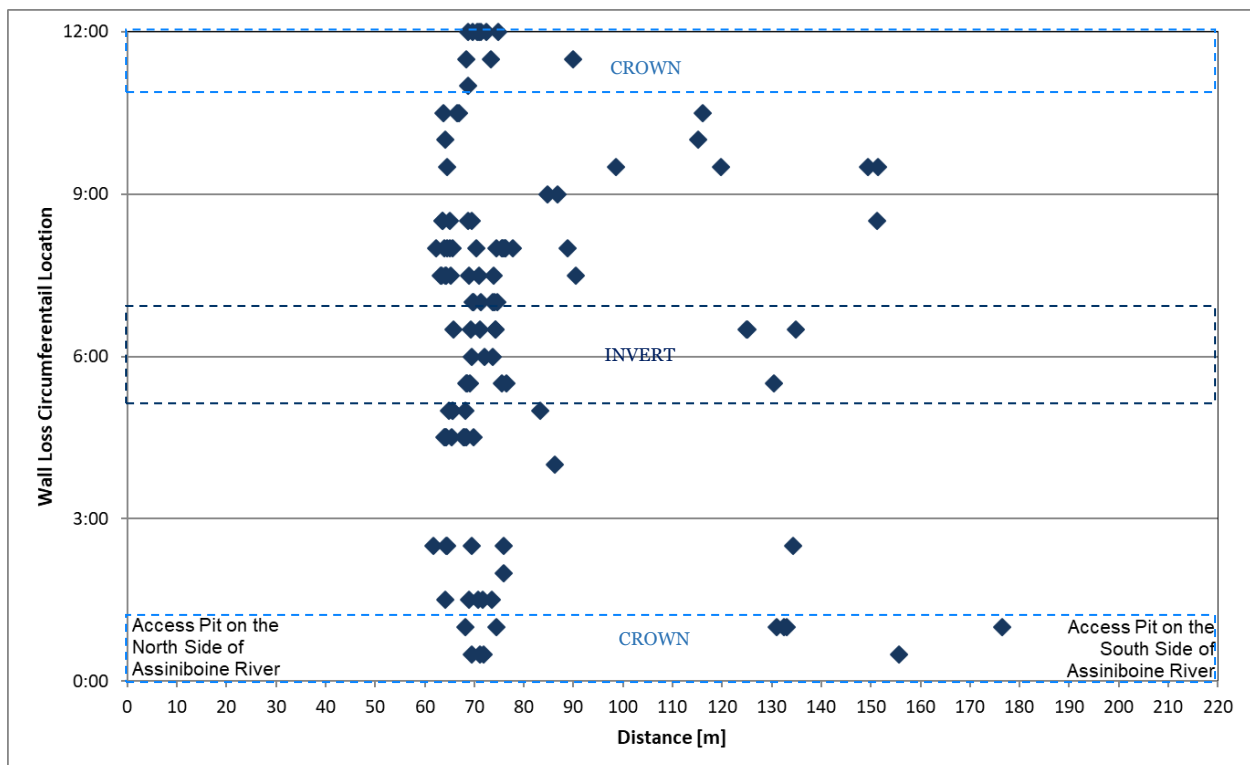
Figure 2. Circumferential distribution of pitting regions along the Charleswood-Assiniboia Feeder Main, described with clock positions referenced by looking from north to south

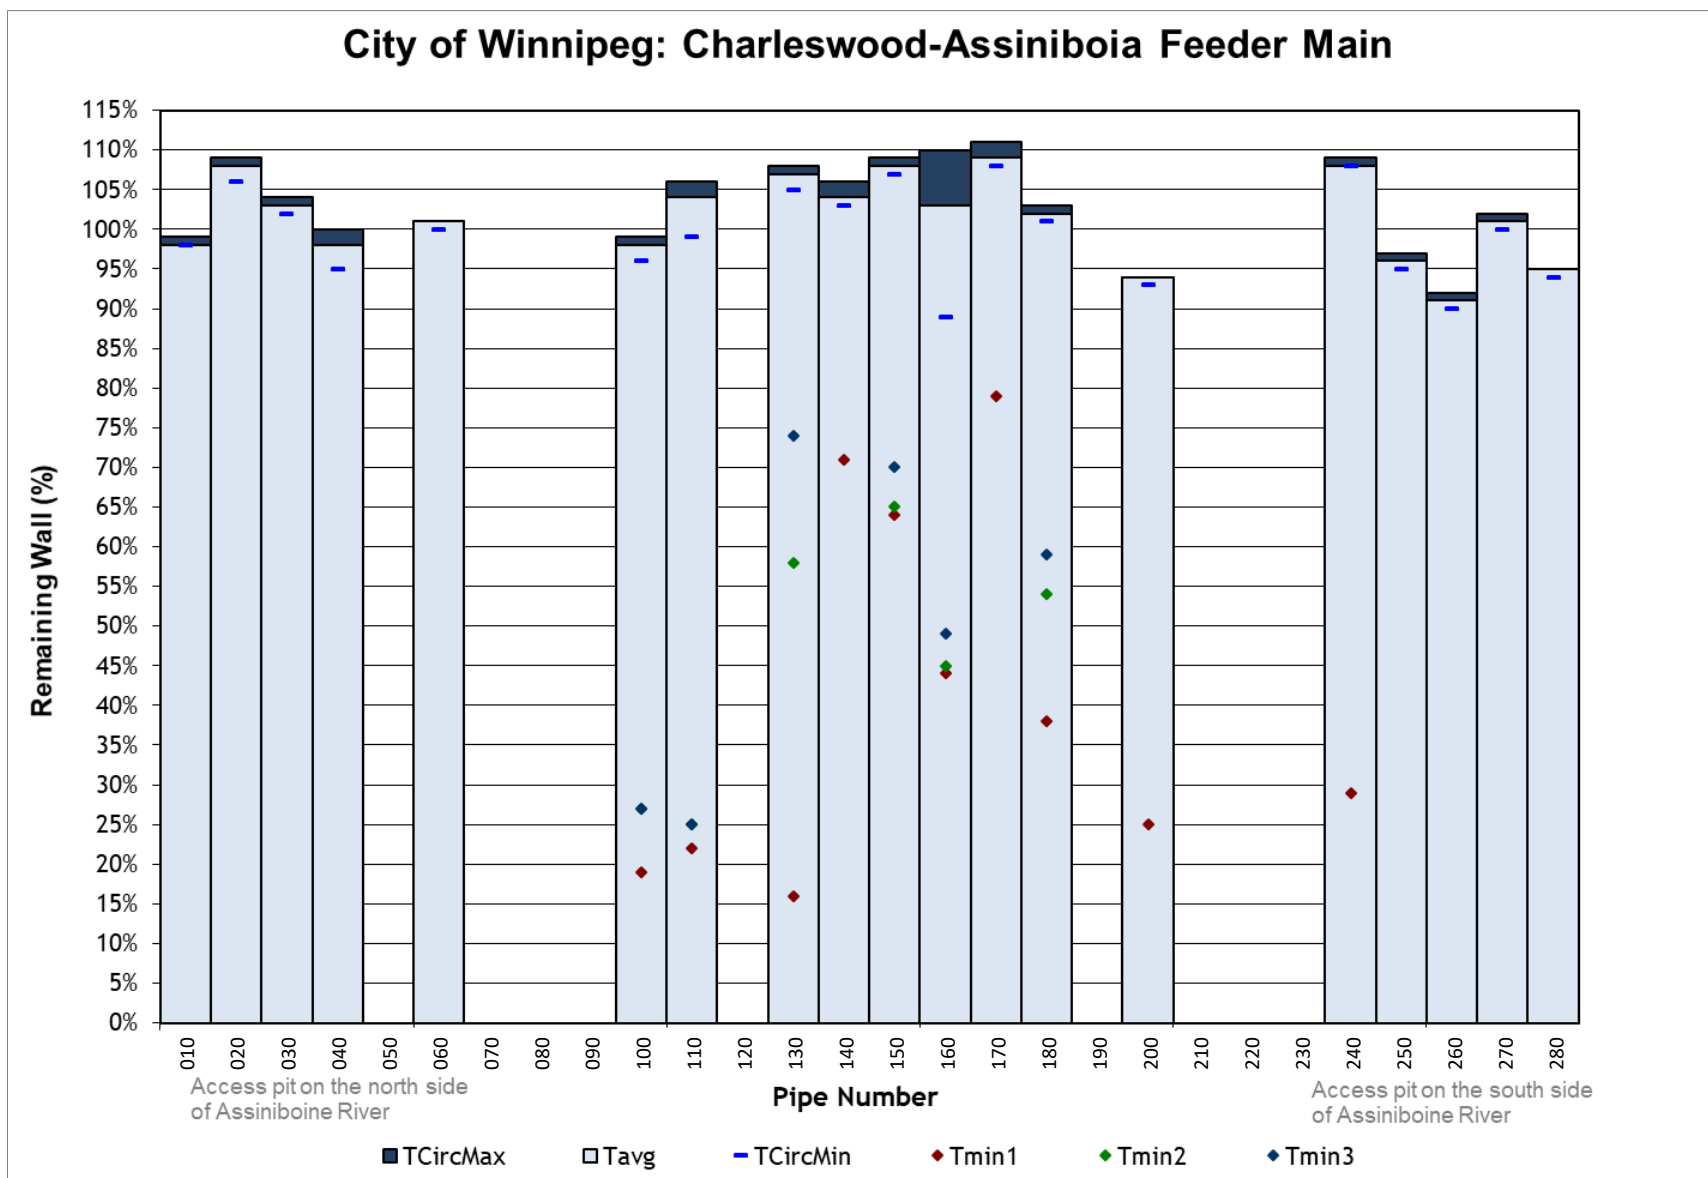
Figure 3. Condition assessment summary for the Charleswood-Assiniboia Feeder Main. Pipes less than 2.4 meters in length were not analyzed for pipe average remaining wall values.

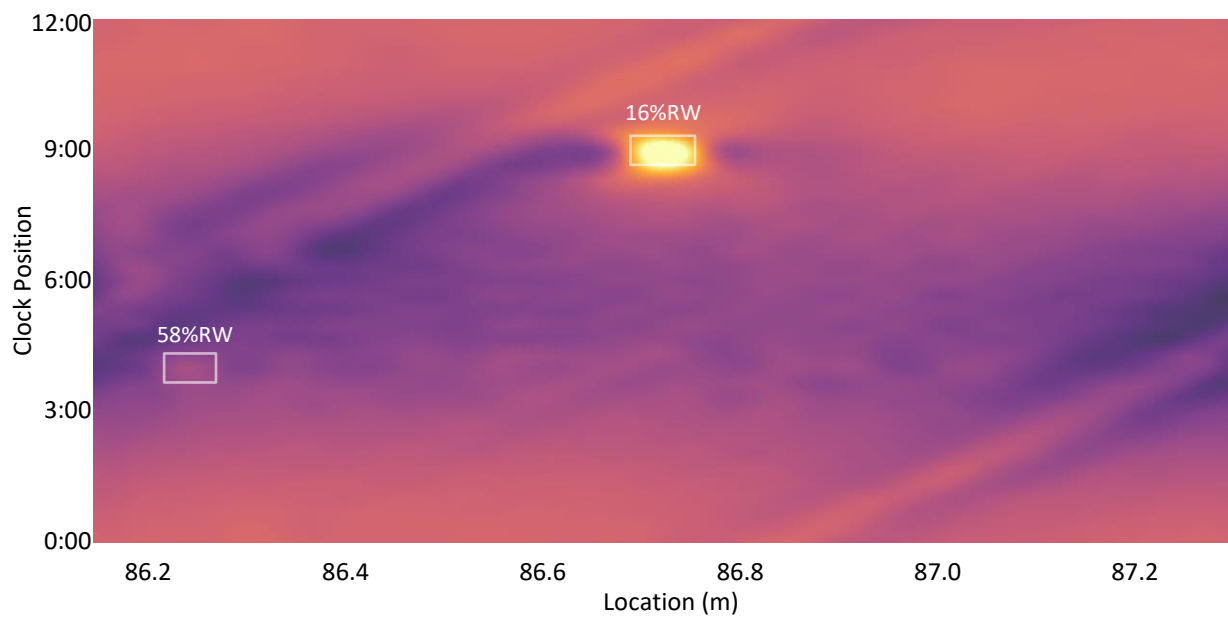
A colour map of the area with the smallest remaining wall indication recorded (16% RW in pipe 0130), located at 86.75m from the ZRD, is shown in Figure 12. Colour maps can highlight wall loss, wall gain, and material stresses within the pipe. Figure 13 to Figure 24 in Appendix 1 show additional colour maps of the data for all sections of pipe with reported wall loss indications, with defect indications annotated. Defect indications are highlighted in the figures with bounding boxes.

Figure 12. Colour map showing a close up of the 16% RW indication detected in pipe 0130, 86.75m from the ZRD on the north side of the river crossing

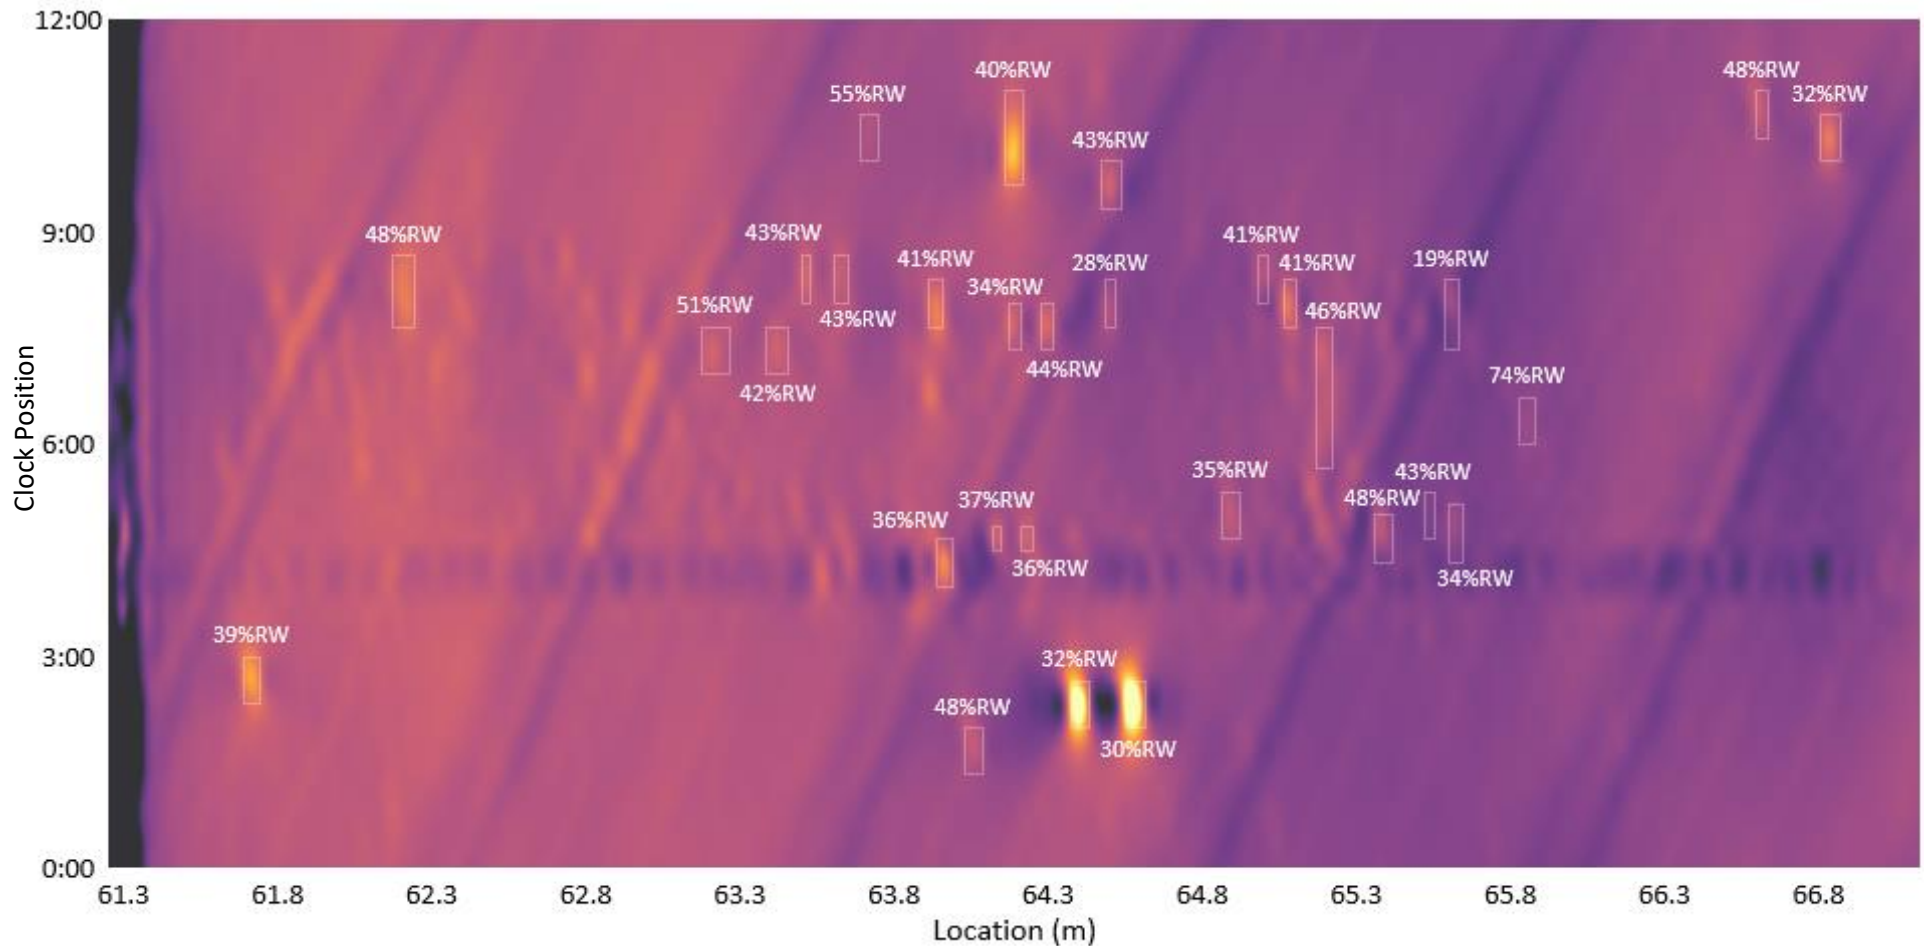
0100	61.3	73.0	11.7	98%	99%	96%	19%	65.61	8:00	27%	67.81	4:30	27%	70.92	12:00	Numerous indications (see defect list for details)
0110	73.0	85.2	12.2	104%	106%	99%	22%	83.21	5:00	25%	75.86	2:30	25%	76.56	5:30	North side AGM is located on north river bank,

Figure 13. Colour map showing locations of defect indications reported within pipe number 0100 (Client pipe segment P10). A total of 66 indications have been reported in this pipe segment, continued in Figure 14. One deep defect (19% RW) was reported in this pipe segment, located 65.85m from the ZRD. Flange connection at beginning of pipe (61.29m) shown on left of colour map.

If AECOM and the City decide to perform verification and repair work on the onshore portions of the feeder main crossing (for example for pipe 0100), please let your PICA representative know. PICA can assist by providing dig sheets for the selected areas.

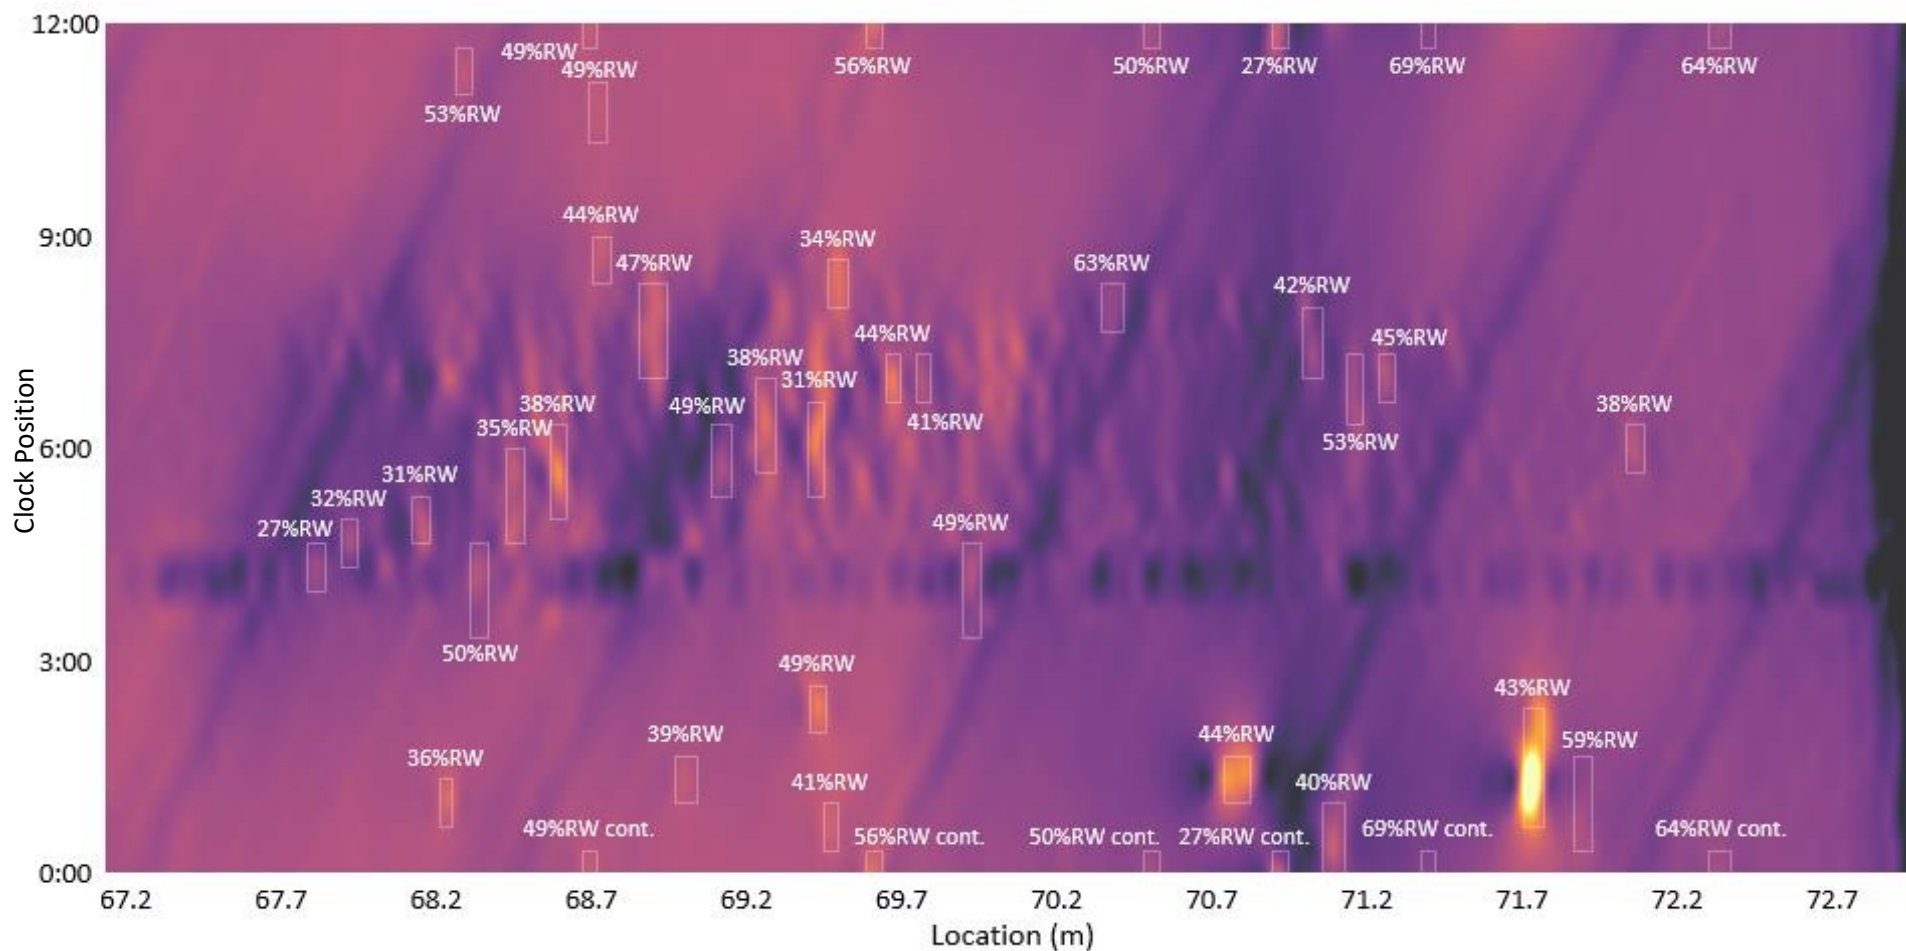
Figure 14. Continuation of pipe number 0100 colour map with defect indication locations shown. Flange connection at end of pipe (72.95m) shown on right of colour map.

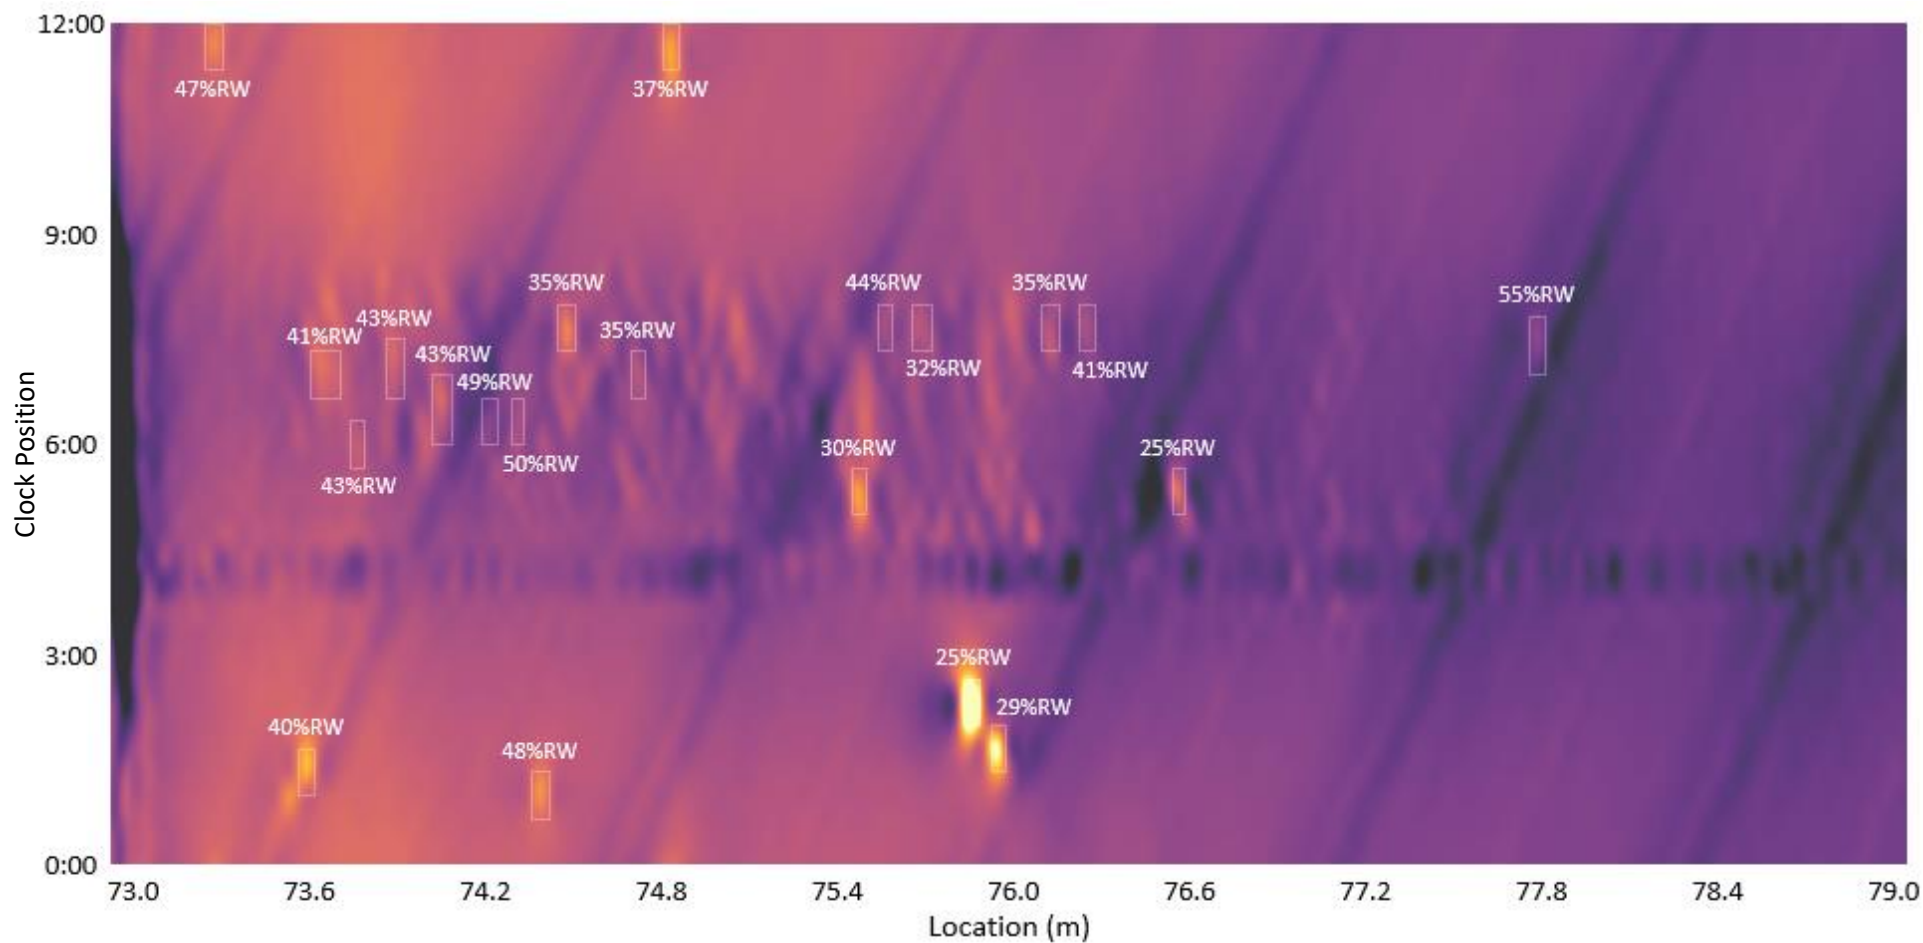
Figure 15. Pipe number 0110 colour map showing defect indication locations. A total of 23 indications have been reported in this pipe segment. Continued in Figure 16. Flange connection at start of pipe shown on left of colour map (72.95m).

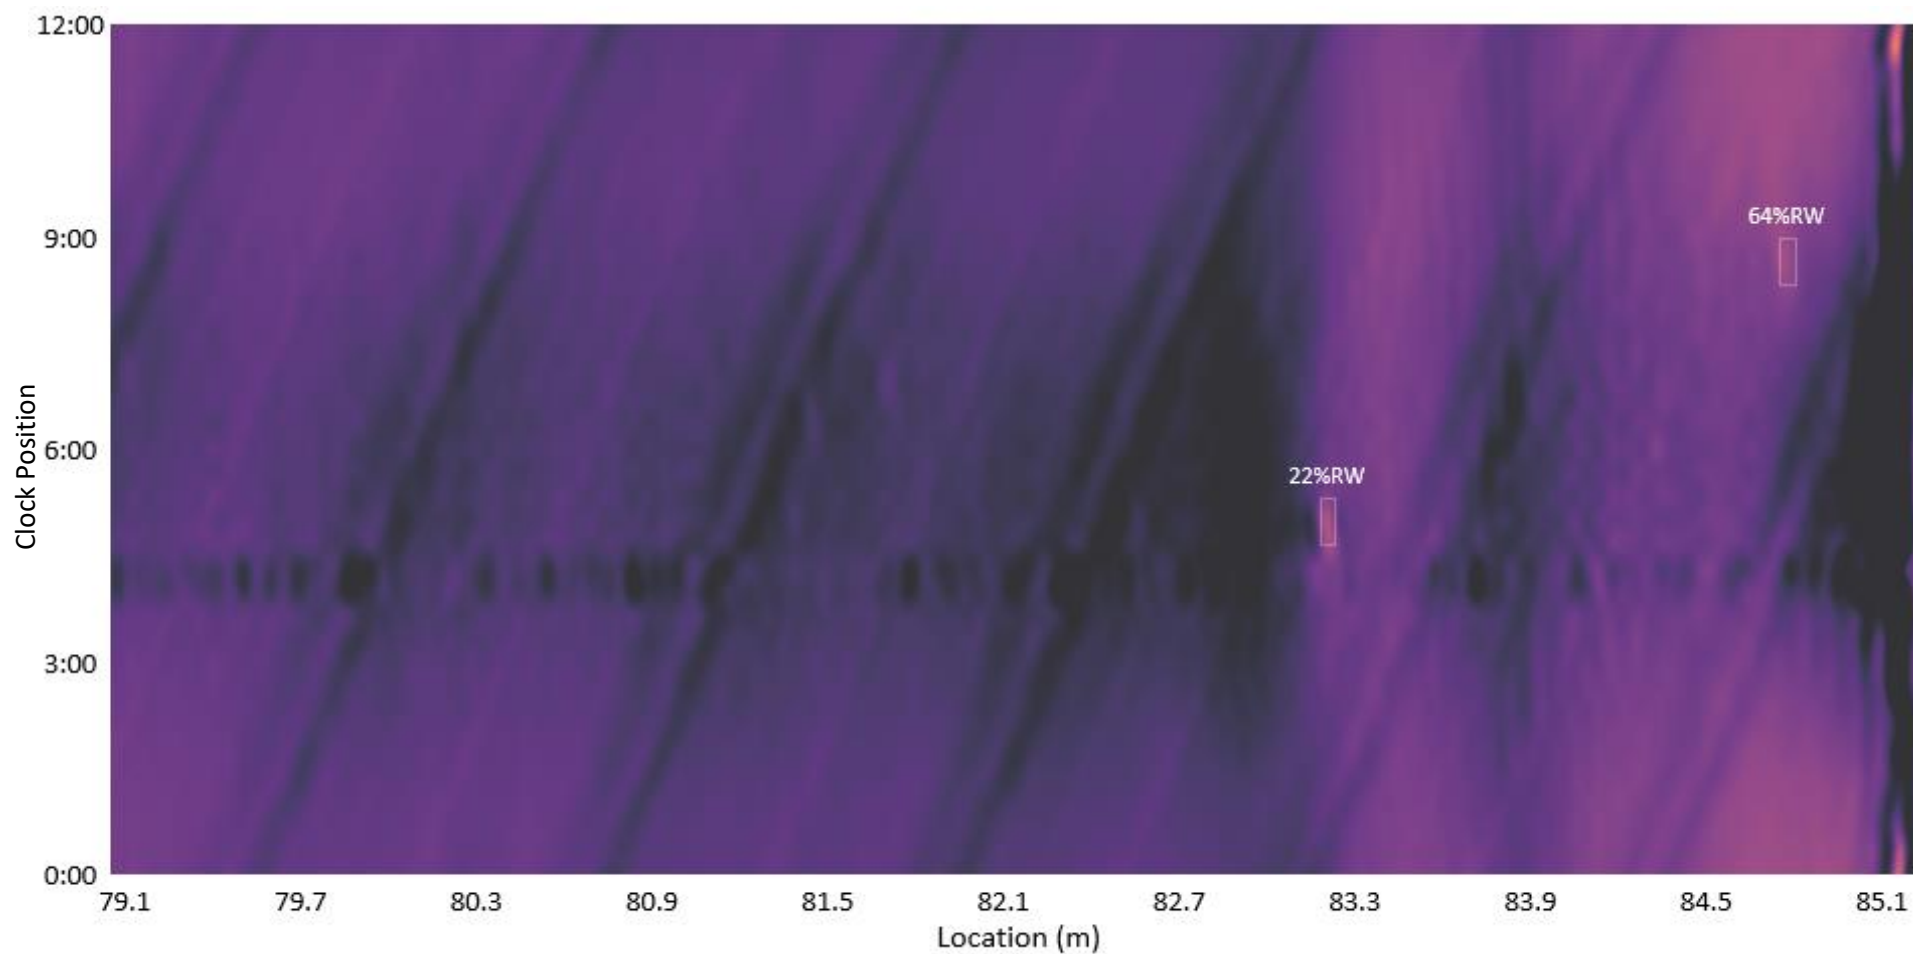
Figure 16. Continuation of pipe number 0110. Flange connection at end of pipe (85.15m) shown on right of colour map.

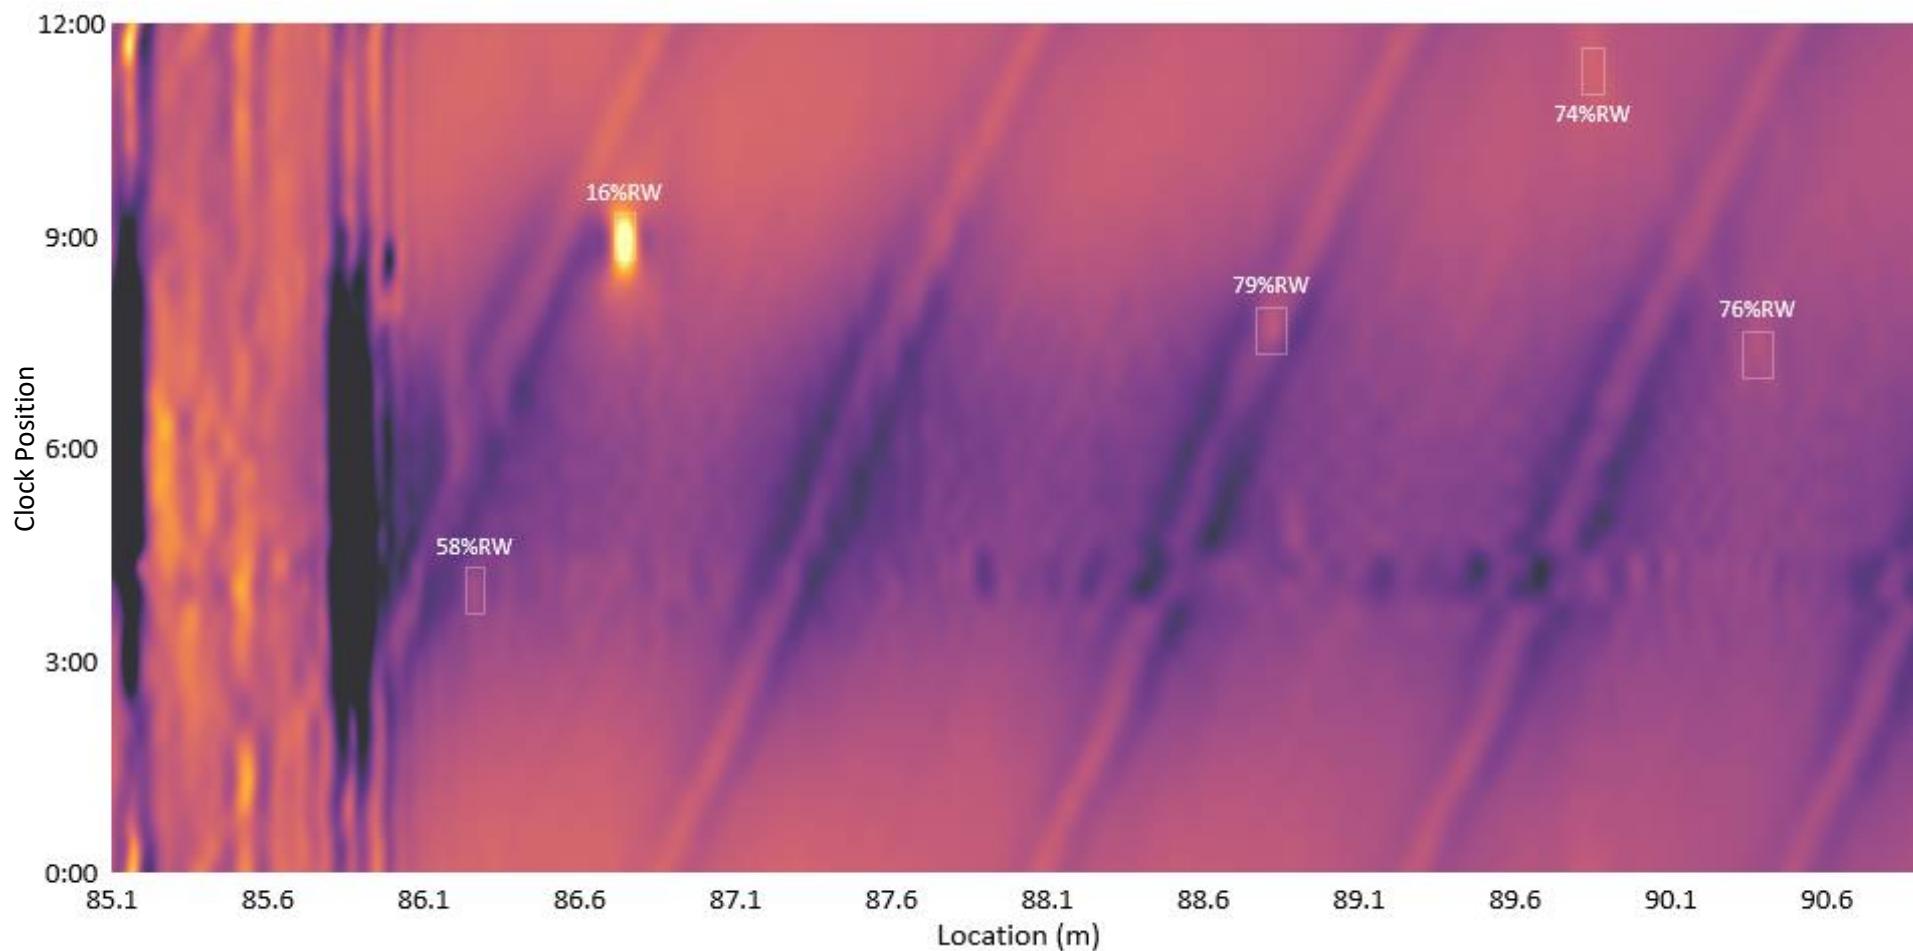
Figure 17. Pipe numbers 0120 (two piece mitered elbow extending from 85.15m to 85.86m) and 0130. A 6.6° pitch change was recorded at the elbow. Five defect indications were reported in pipe 0130, including a 16% RW indication at 86.75m from the ZRD.

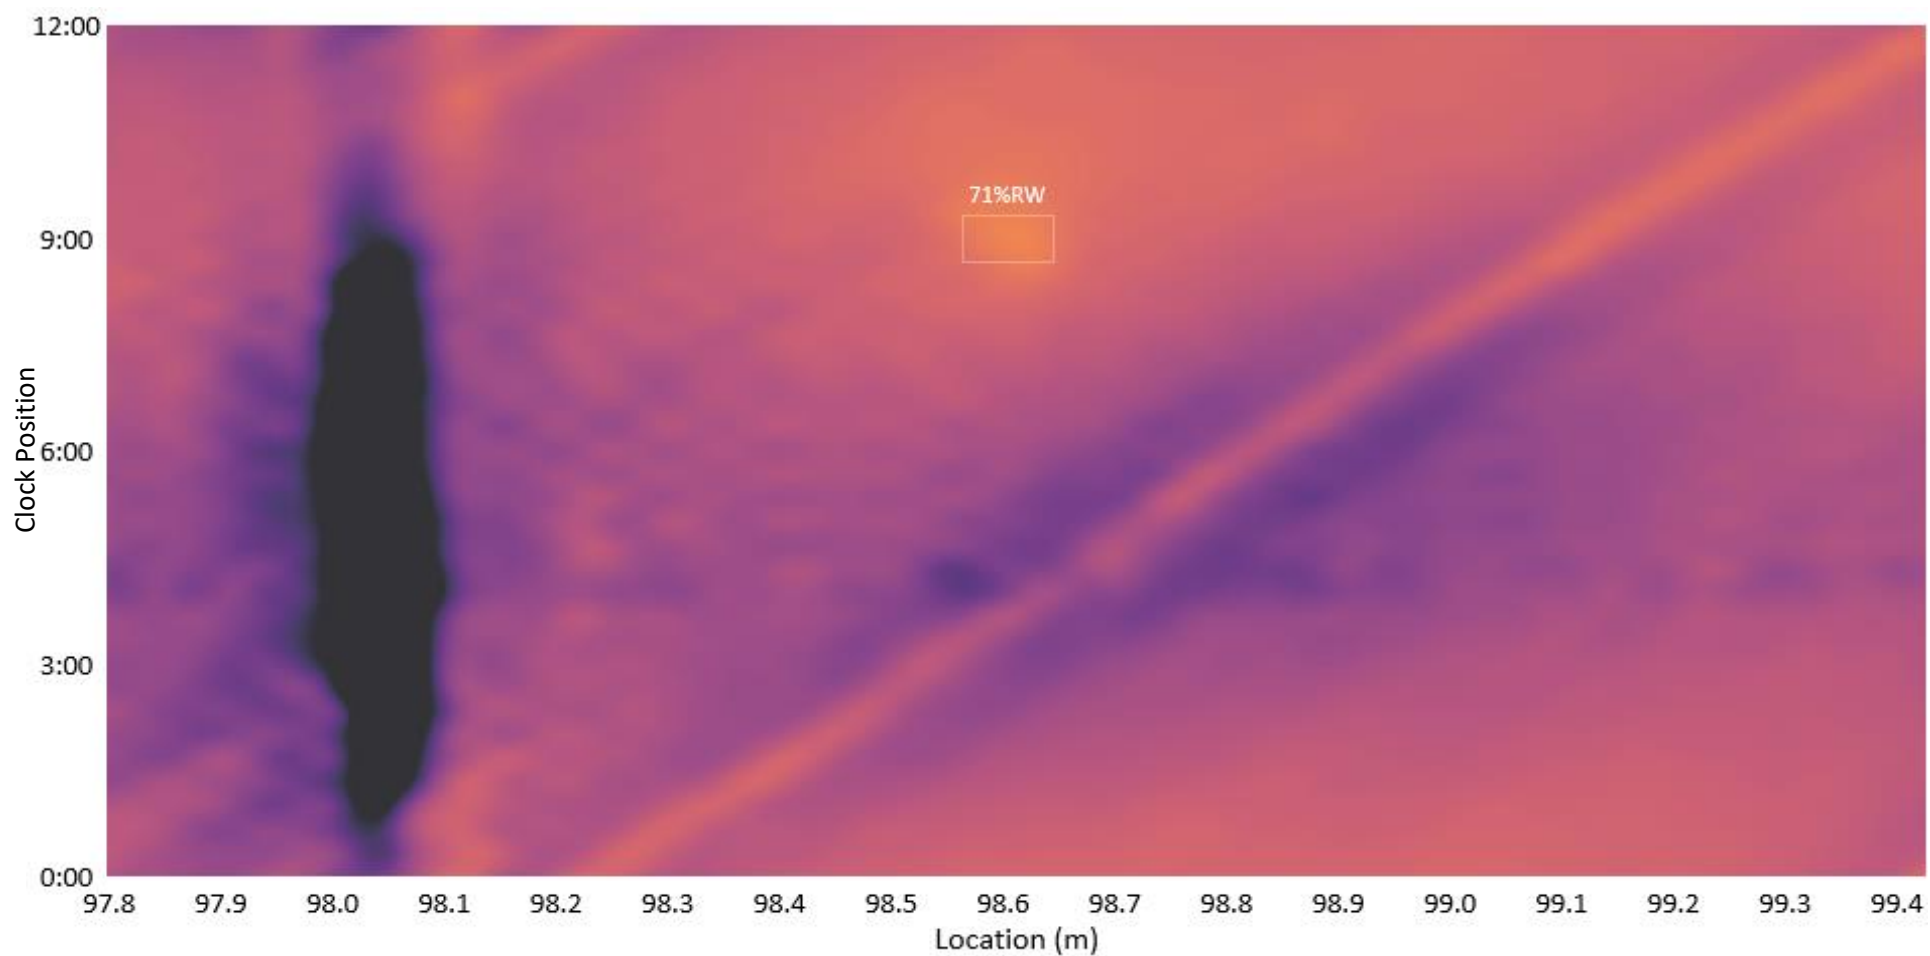
Figure 18. Pipe number 0140 colour map showing the single defect indication reported in this segment. A flange connection is visible beginning at 98.03m.

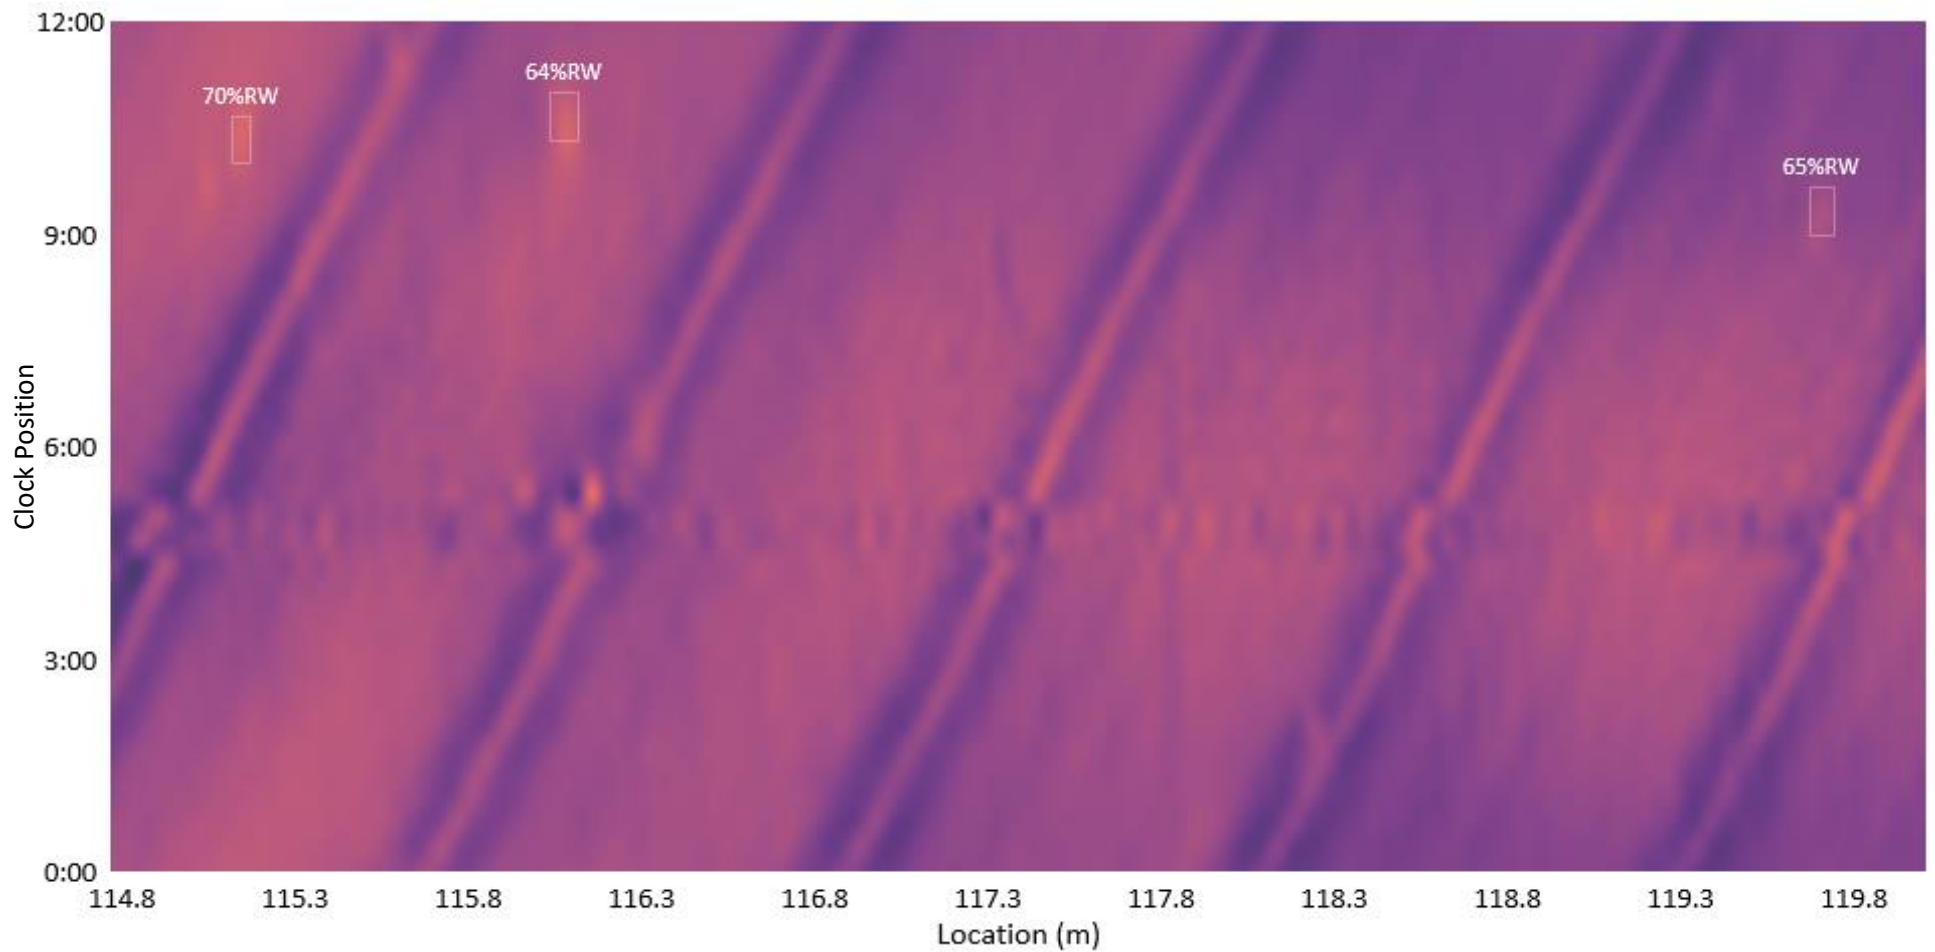
Figure 19. Pipe number 0150 colour map with three reported indications.

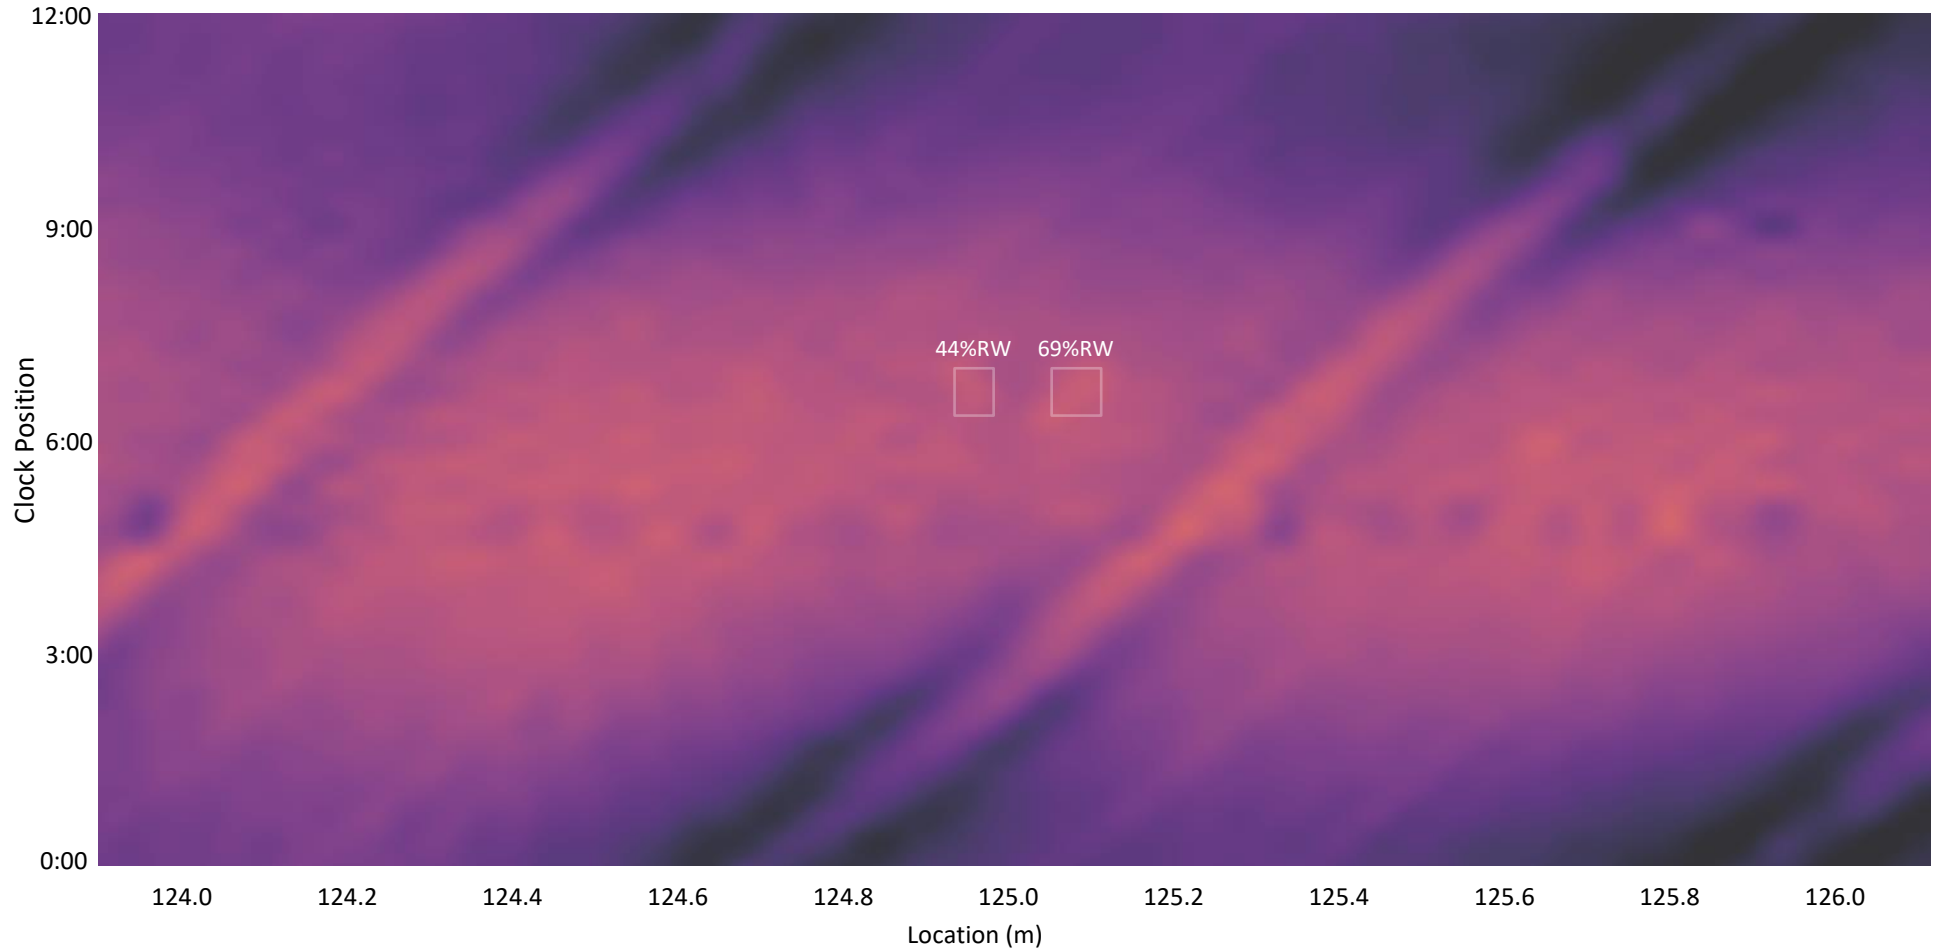
Figure 20. Pipe number 0160 showing locations of two of the seven defects reported within this pipe segment. Continued in Figure 21.

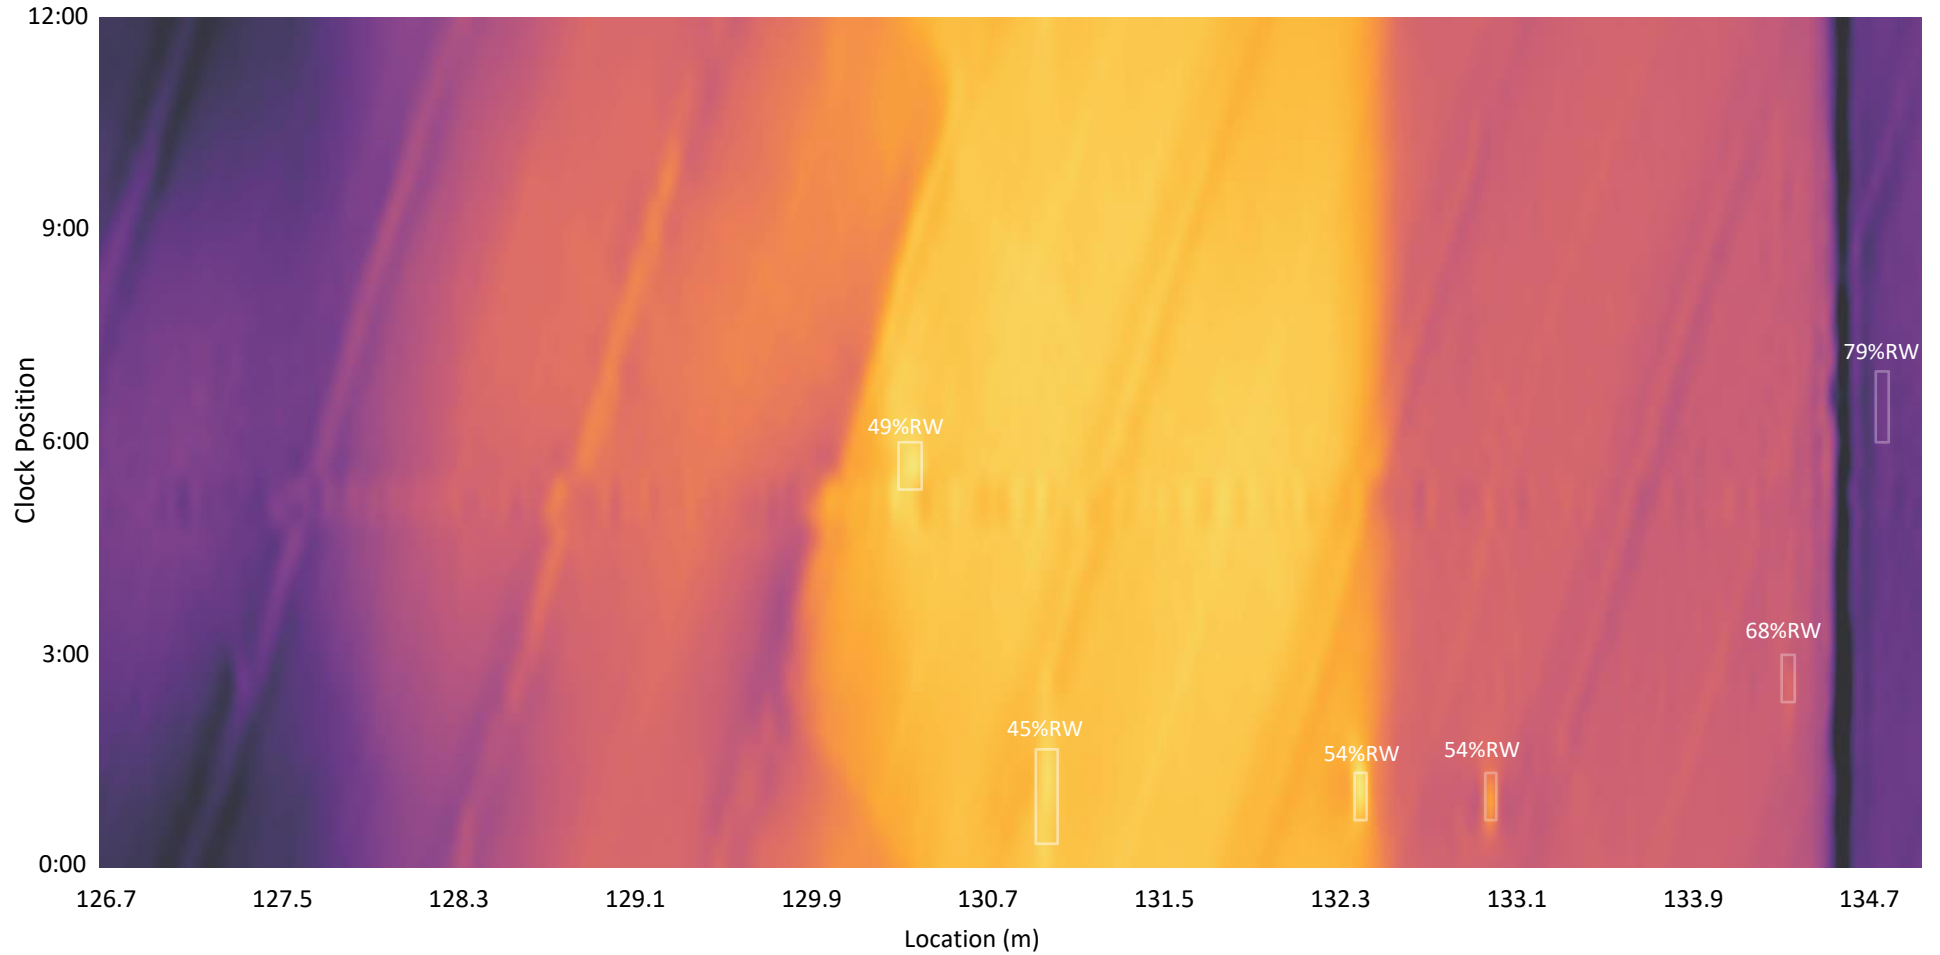
Pipe stress can be detected with RFT technology and correlated with locations of construction features such as anchor blocks. A fully circumferential indication of pipe stress was observed from 129.82m to 134.60m, within pipe 0160, corresponding to the location of an anchor block (listed as anchor block No. 3 in drawing D-1111, at Sta. 6+45). A list of all four anchor block locations is presented in Table 3. The Station Numbers in this Table are derived from client records.

Figure 21. Colour map of pipe numbers 0160 and 0170. Seven defect indications were reported within pipe 0160, along with detected stress located from 129.82m to 134.60m corresponding to the location of an anchor block. The single reported indication within pipe number 0170 is shown past the flange connection at 134.6m.
