## **PIPELINE ELECTROMAGNETIC INSPECTION REPORT**

## 600 mm Charleswood-Assiniboia Feeder Main

### Condition Assessment Report, Standard Analysis

**PICA Project: 8054**

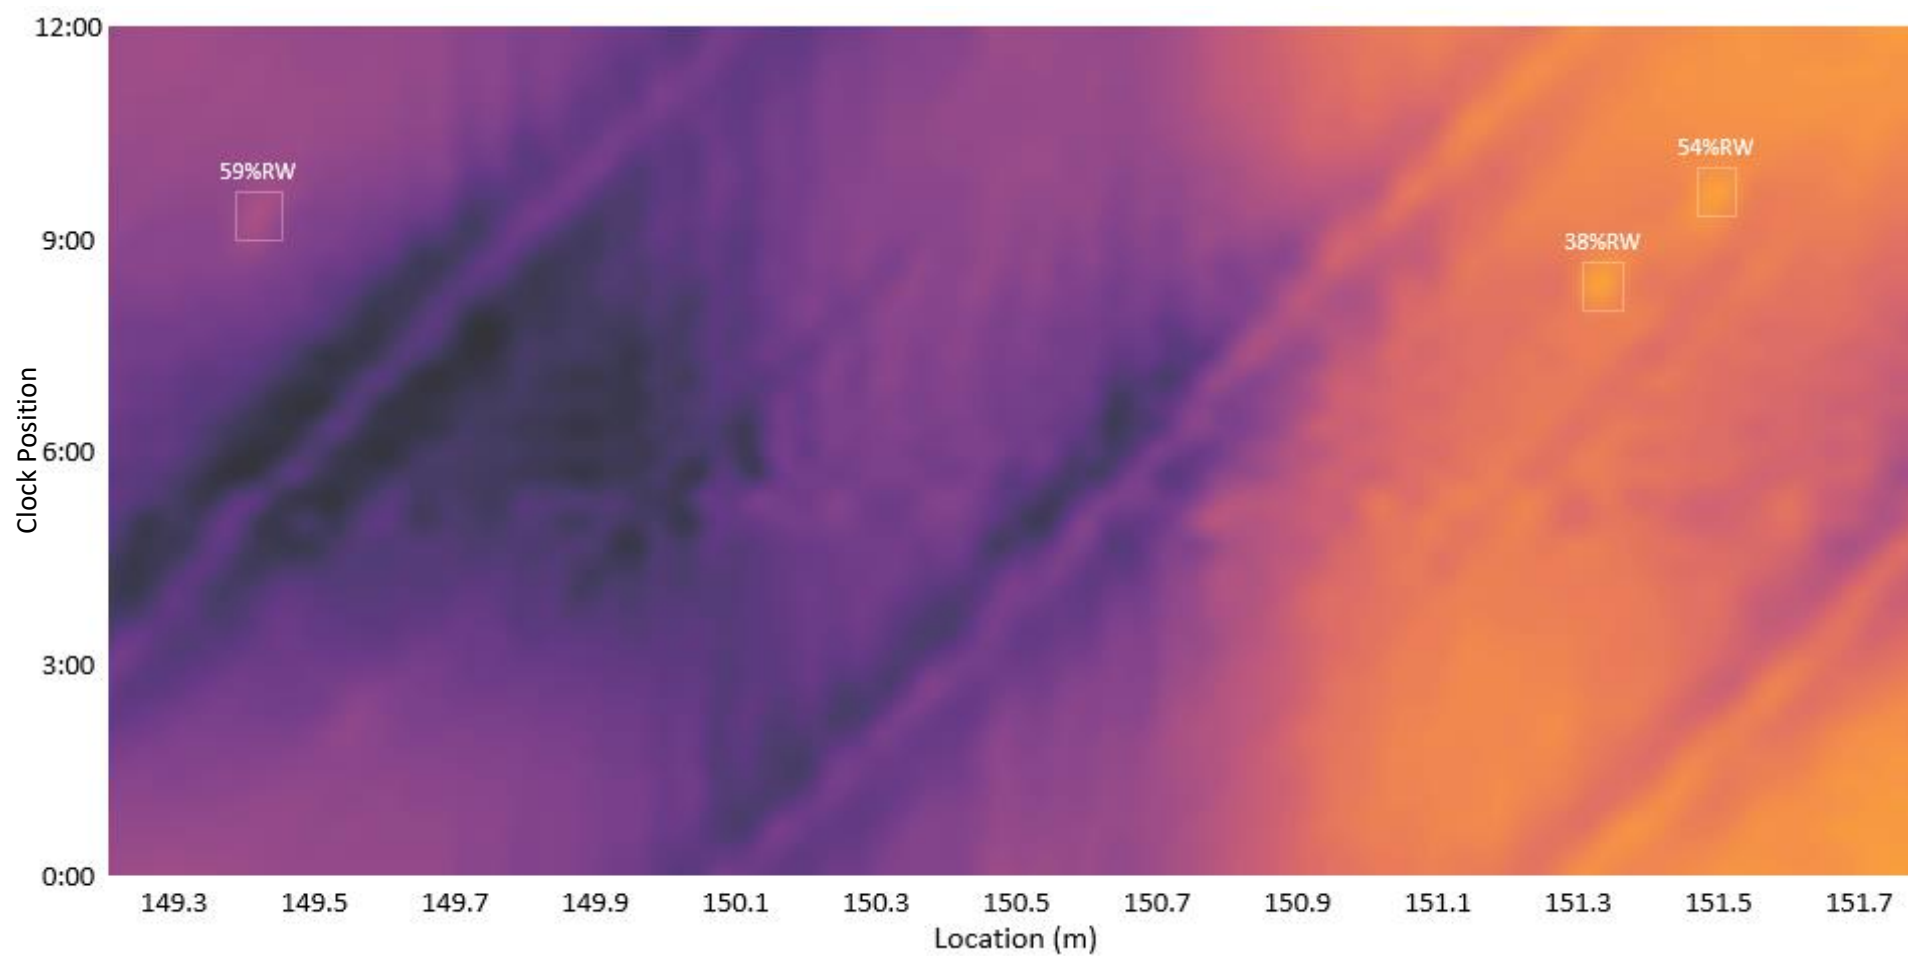
Figure 22. Pipe number 0180 showing the three indications reported within this pipe segment.

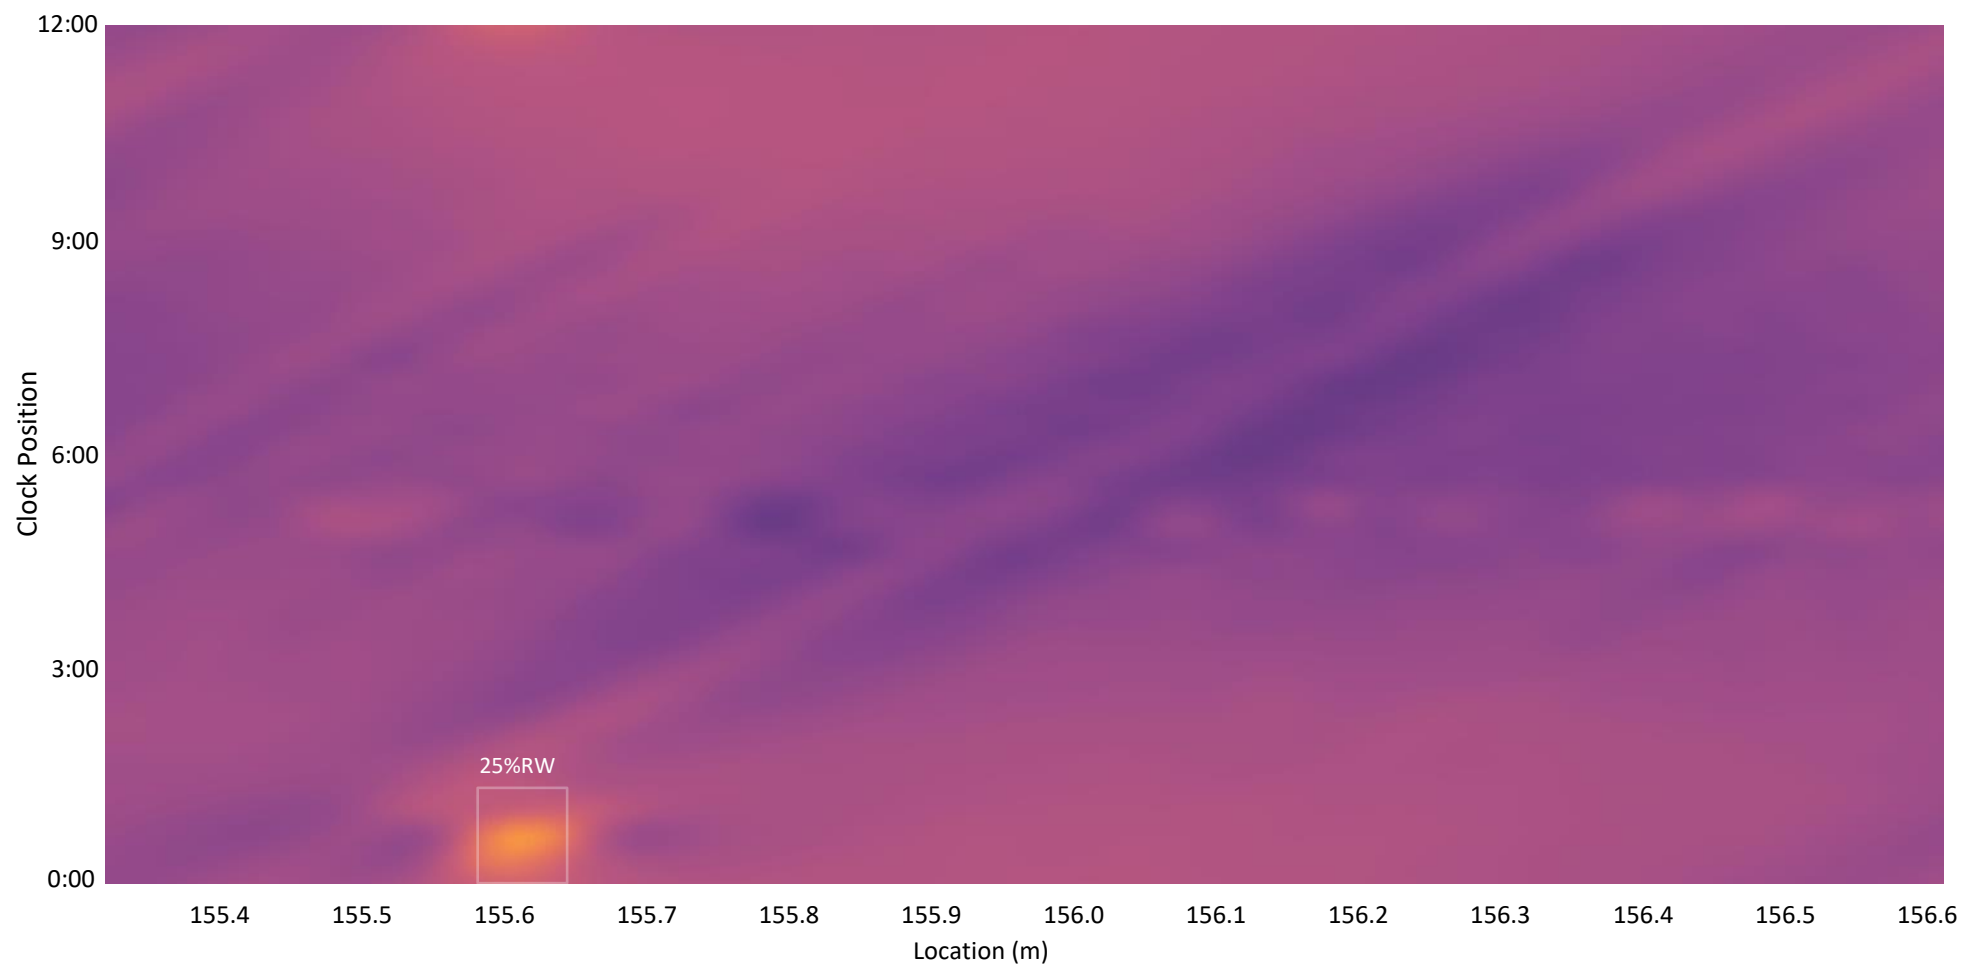
Figure 23. Pipe number 0200 colour map showing the single reported defect indication location within this pipe segment

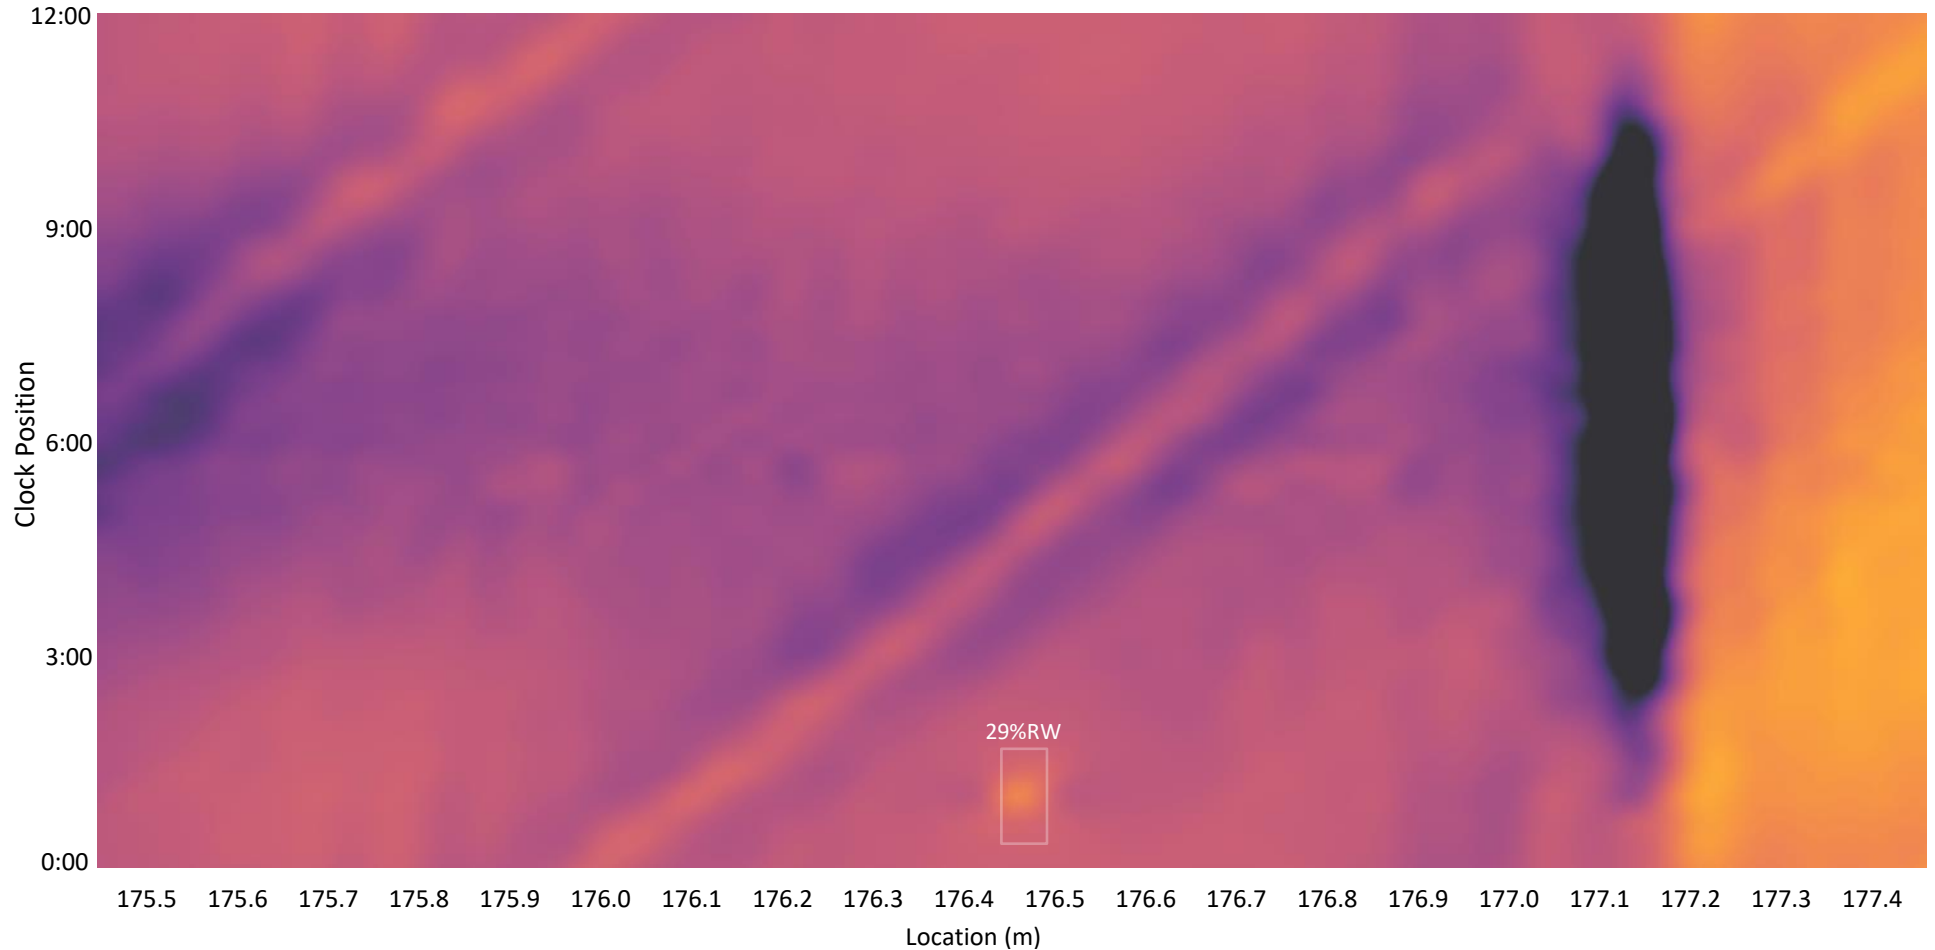
The flange connection between pipes 0240 and 0250 was noted to be leaking in 1965 (drawing number 7183/64B). Extra attention was given to this area near the flange connection during analysis to determine if any anomalous signal indications were recorded.

Figure 24. Pipe number 0240 colour map showing the single defect indication reported in this segment, along with a flange connection at 177.14m. This flange connection was noted to be leaking during installation on drawing 7183/64B in 1965. During analysis, special attention was given to this area near the flange connection, though no other wall loss indications were detected.
