Building Condition Report 242/244/246 Princess St. Winnipeg, MB

Issued Date: February 22, 2022
Revised: March 7, 2022

File No.: W22-059

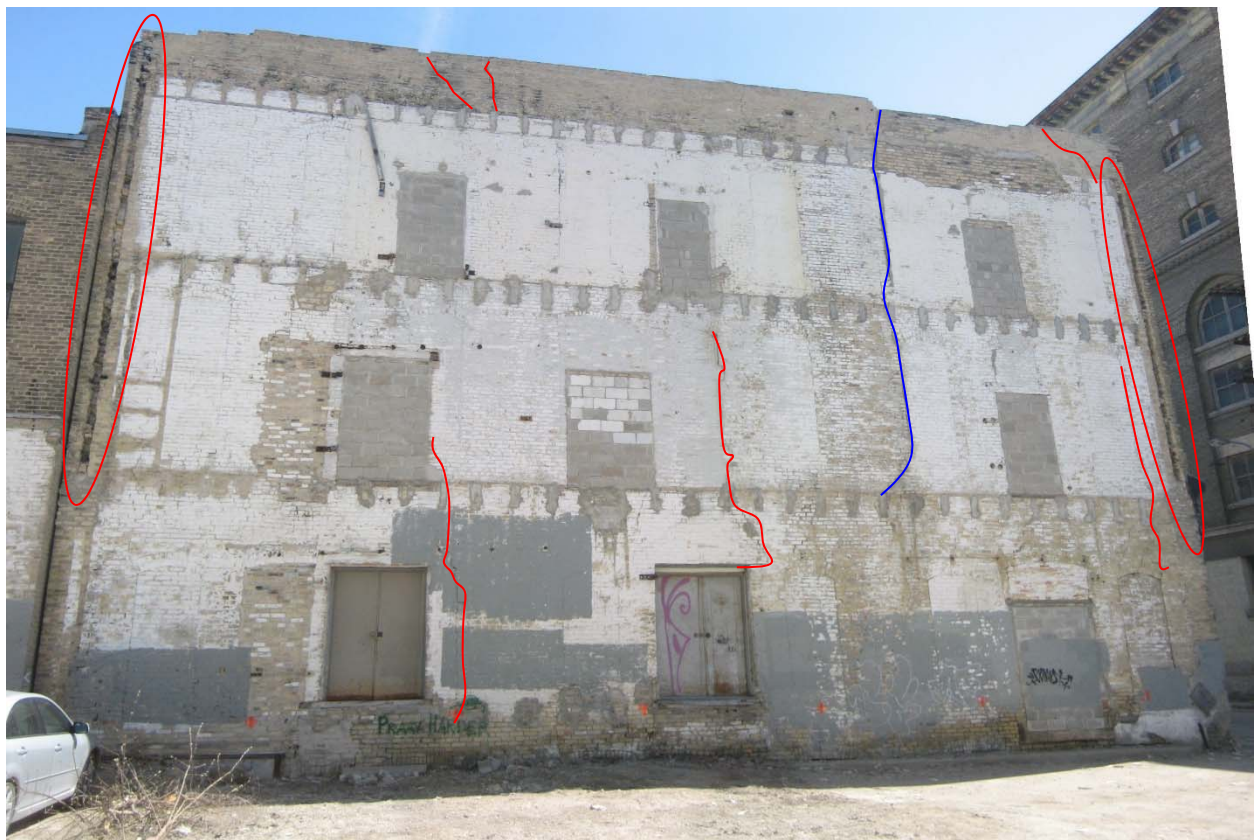
Photo 1: West Façade with Cracks Indicated (2013)

1. The vertical crack in building 242, indicated in blue, was widened significantly the full height of the building.
2. The main-second floor wall of 244 mortar has deteriorated significantly with repointing required.

3. The remainder of the building façade is in similar condition to our 2013 report.

4. The exterior basement walls of 242 Princess are to have all damaged mortar repointed.
5. The west façade are to have all weak mortar repointed and all cracks repaired. The large vertical crack along 242 princess is to have brick stitch work completed and the crack repointed.

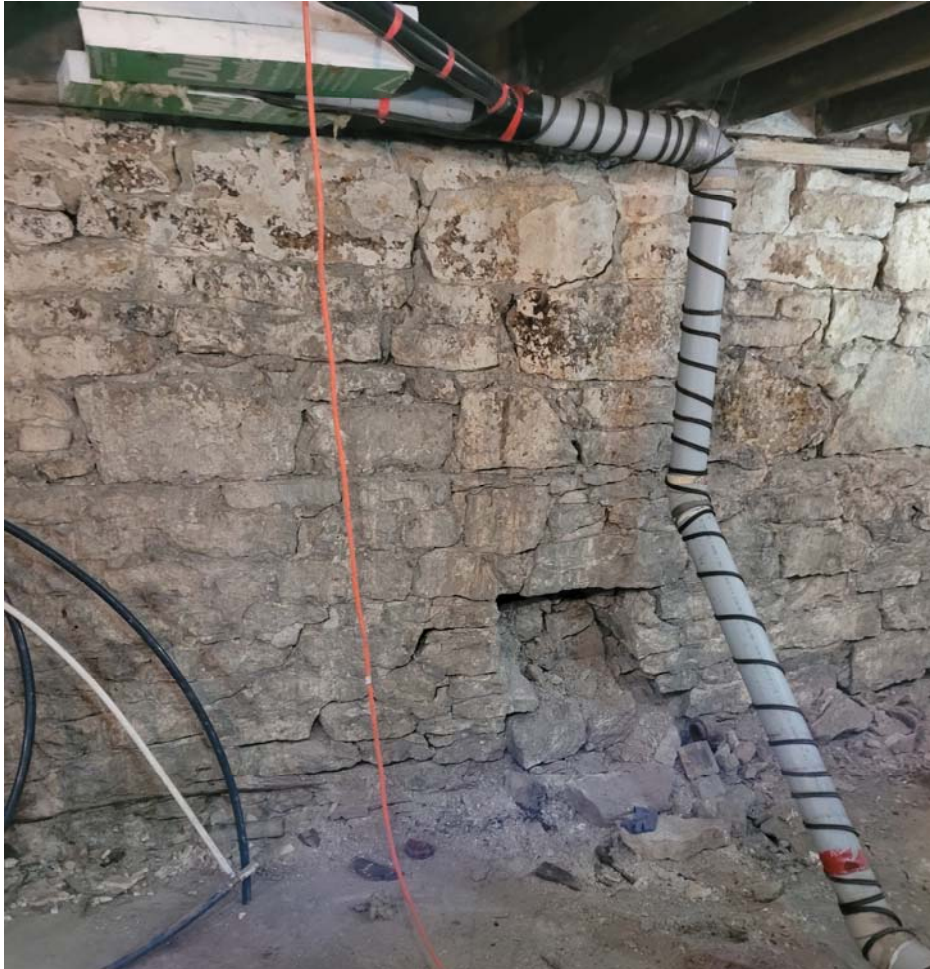
1. The rubble wall has been damaged at the southwest wall. The wall has significant deformation with loose rubble. Shoring is required immediately.
2. The rubble wall requires repointing of the mortar between stones. The location and severity of the mortar damage varies but is most prevalent along the exterior walls.
3. The steel beam and columns are moist and are experiencing corrosion.
4. The east wall, towards Princess Street, has settled. The steel connection to this wall is visibly sloped. It is unclear if this is a recent development or if this condition has existed for some time.

Photo 2: 242 Princess – Rubble wall bulge/damage at south-west corner.

1. The basement wall of 242 Princess is to be shored at the stairs to prevent further displacement of the bulged section until a full repair can be performed.
2. The roof joists of 244 Princess are to have their shoring redesigned by a professional engineer.
3. Materials are not to be stored leaning against walls, materials are to be disposed of or laid flat on floors.

1. The bulged wall in 242 Princess is to be repaired to plumb condition.
2. Repair or replace damaged roof joists in 244 Princess.
3. The previously repaired roof joists of 242 Princess are to have an additional ply installed at the center splice.

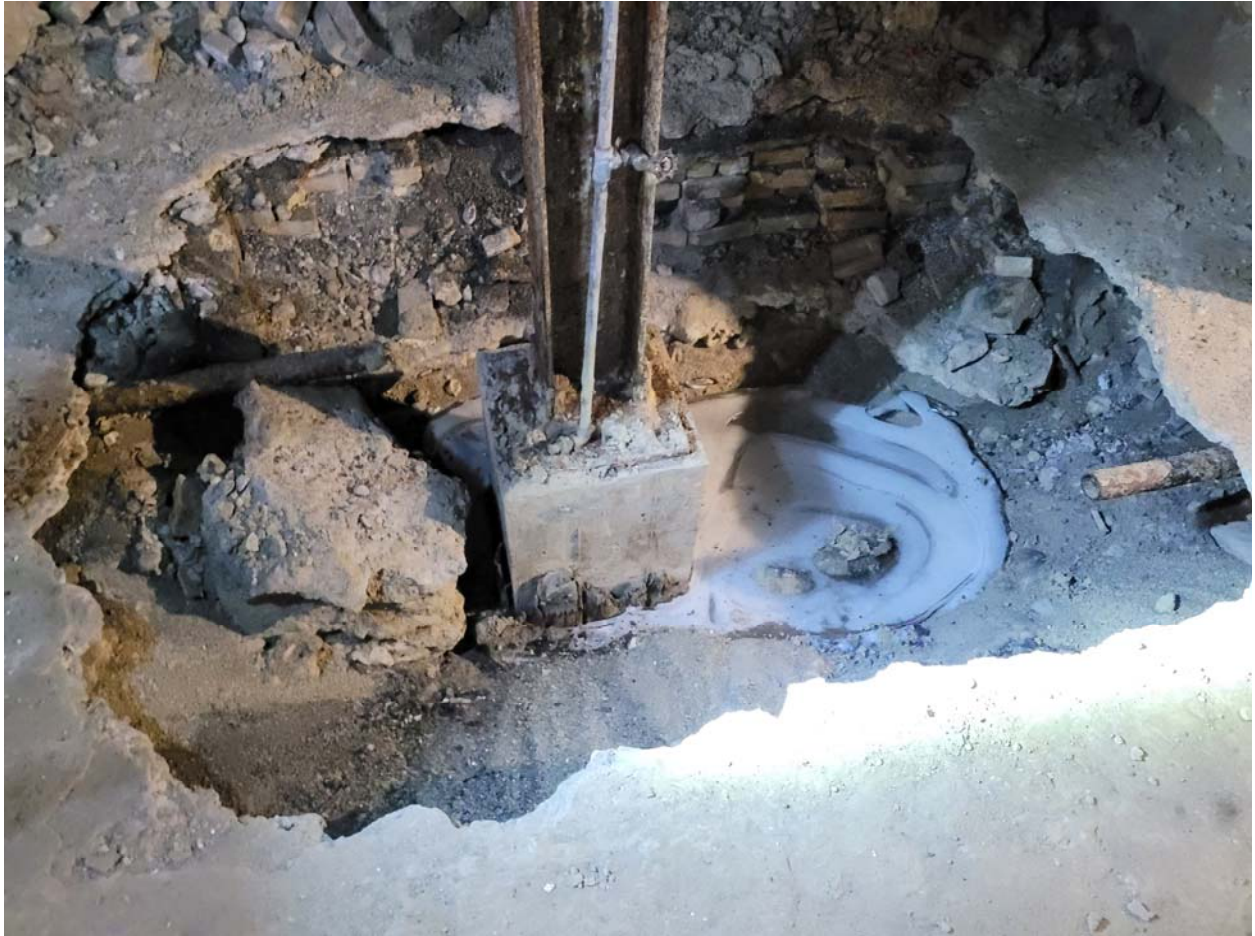
Photo 3: 242 Princess – Exposed foundation to be infilled.

2. Repair or replace all cut/modified joists.
3. At the main floor level of 244 Princess the gap between the steel column and masonry wall is to be concrete infilled.
4. Exposed foundations are to be infilled back to original condition.

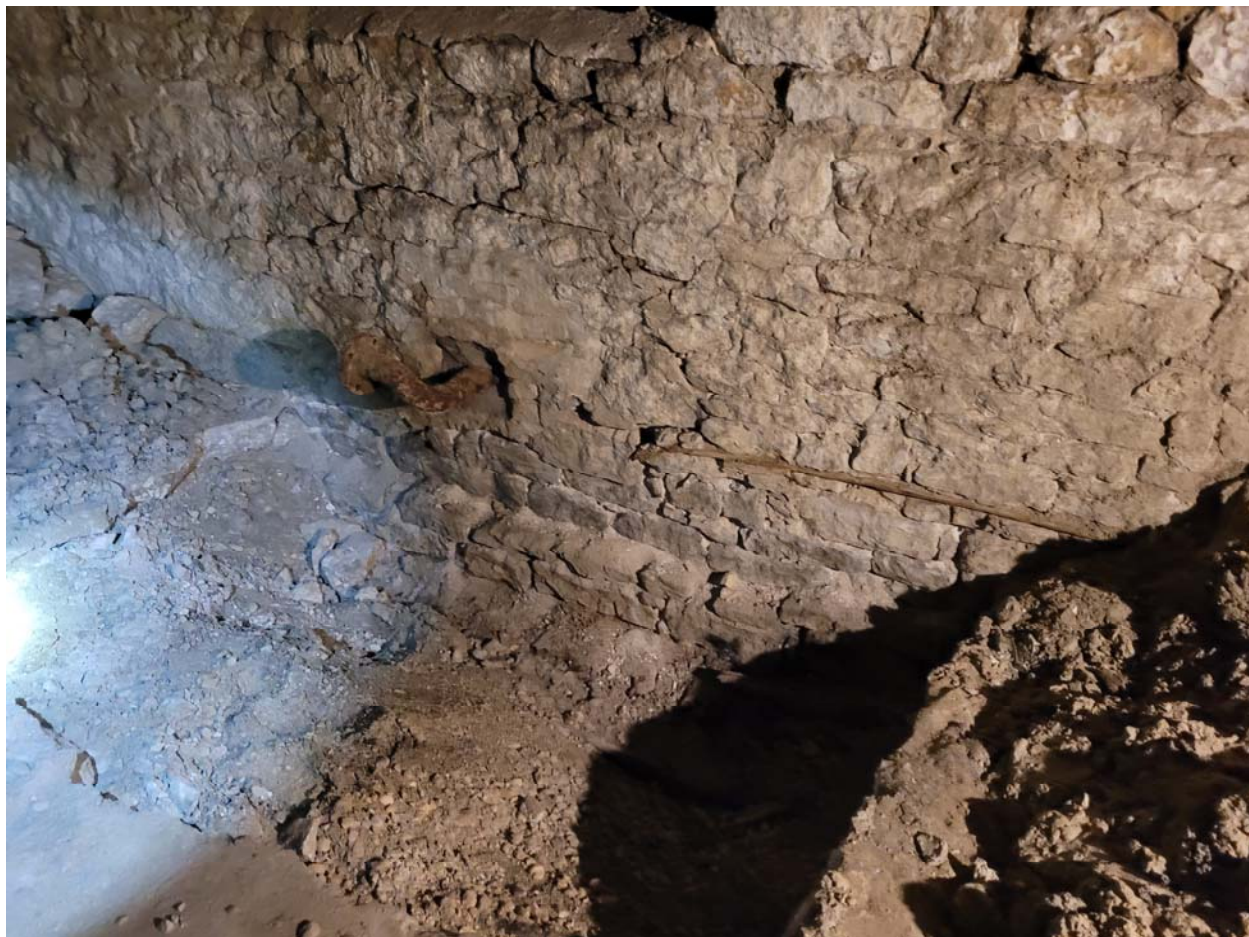
Photo 4: 242 Princess – Exposed foundation to be infilled and typical rubble wall requiring repointing.

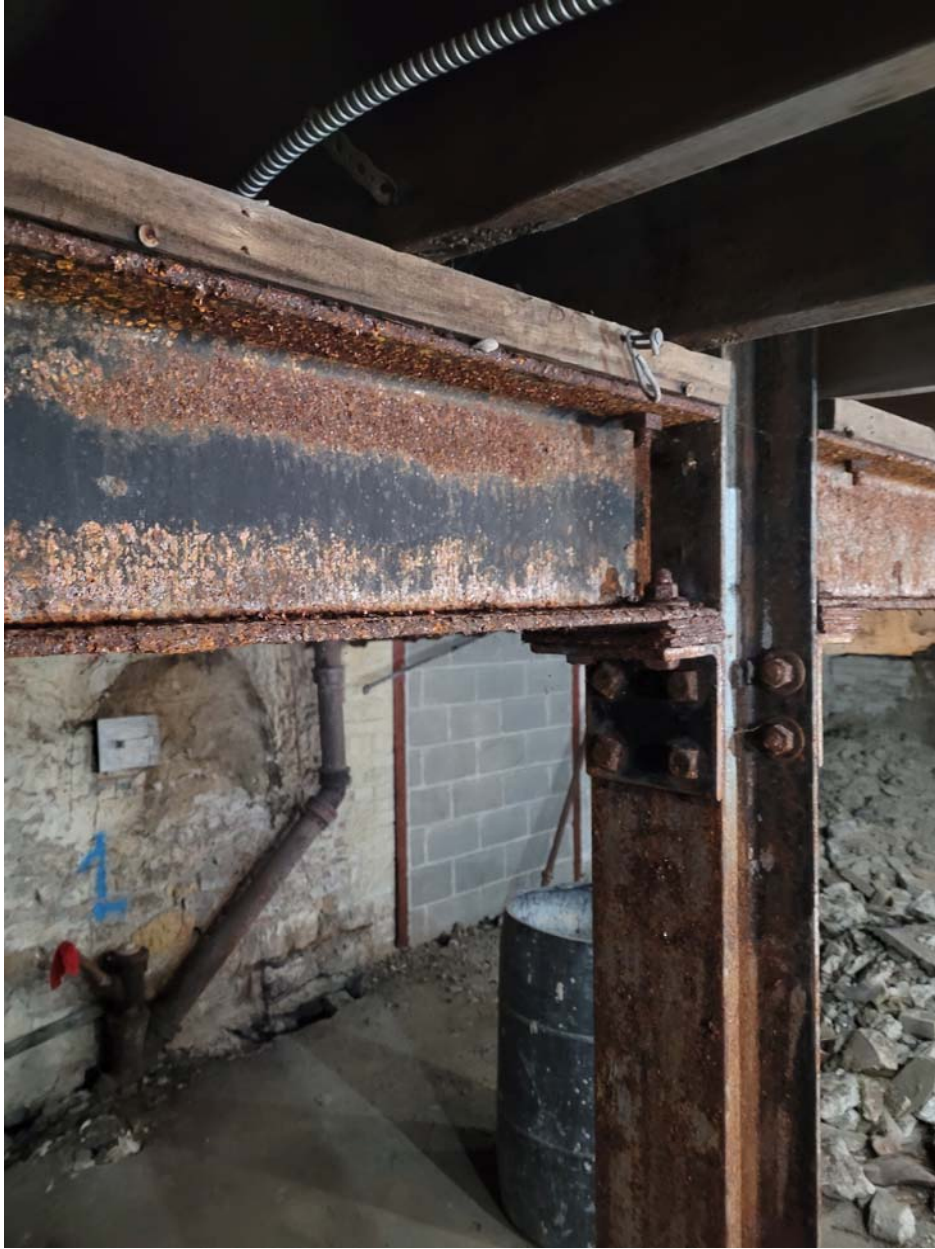
Photo 5: 242 Princess – Steel beam/column corrosion.

1. South exterior wall and remaining interior demising walls between buildings are to have all damaged mortar repointed for the full height of the building. Repoint all weak mortar in interior rubble demising walls.
2. The east façade is to have all weak mortar repointed and all cracks repaired.
3. All steel in the basement is to be sandblasted to remove corrosion and to be primed/repainted.
4. Reinforce infill framing at old stairwell in 242 Princess.

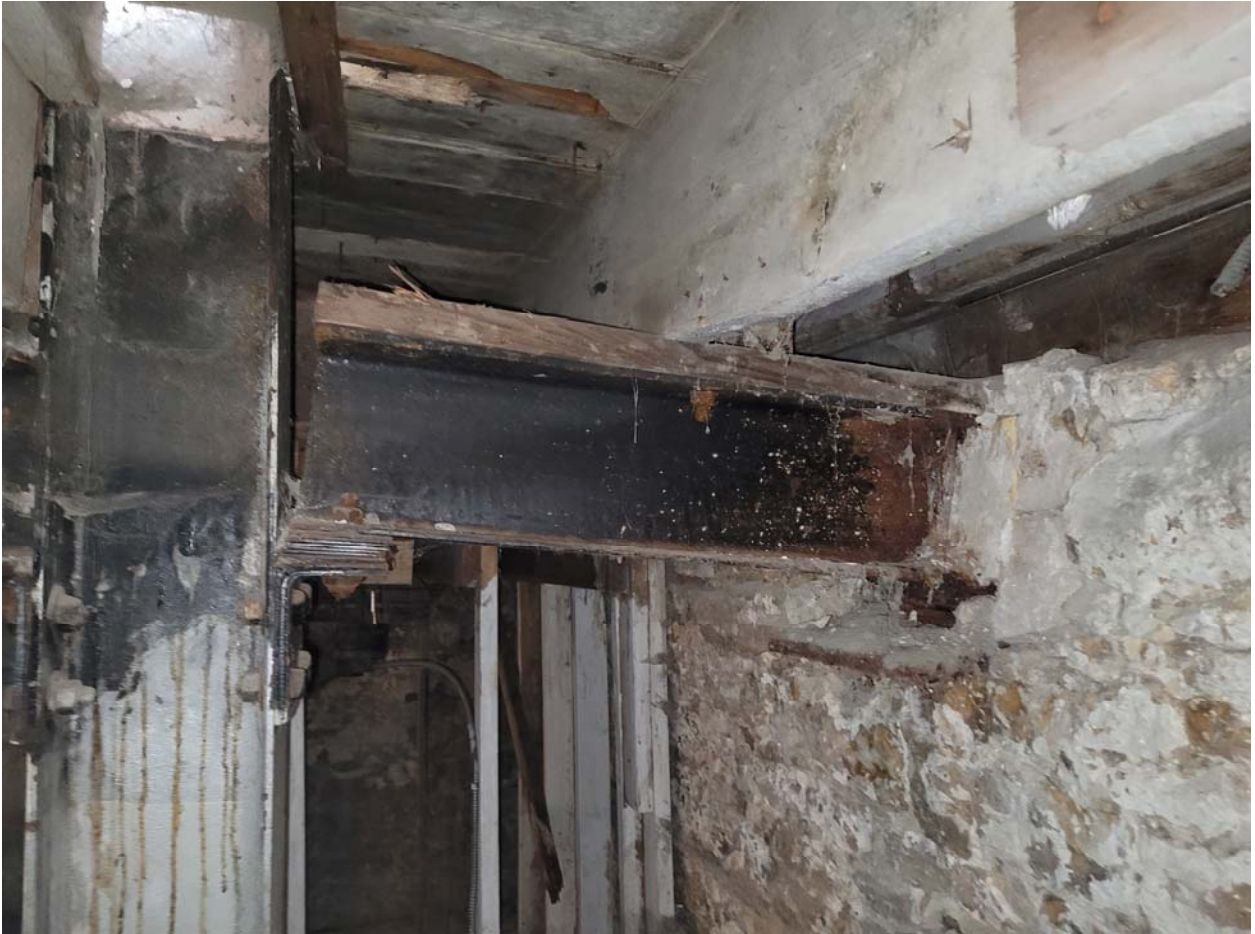
Photo 6: 242 Princess - Steel beam connection to east wall with signs of settlement.

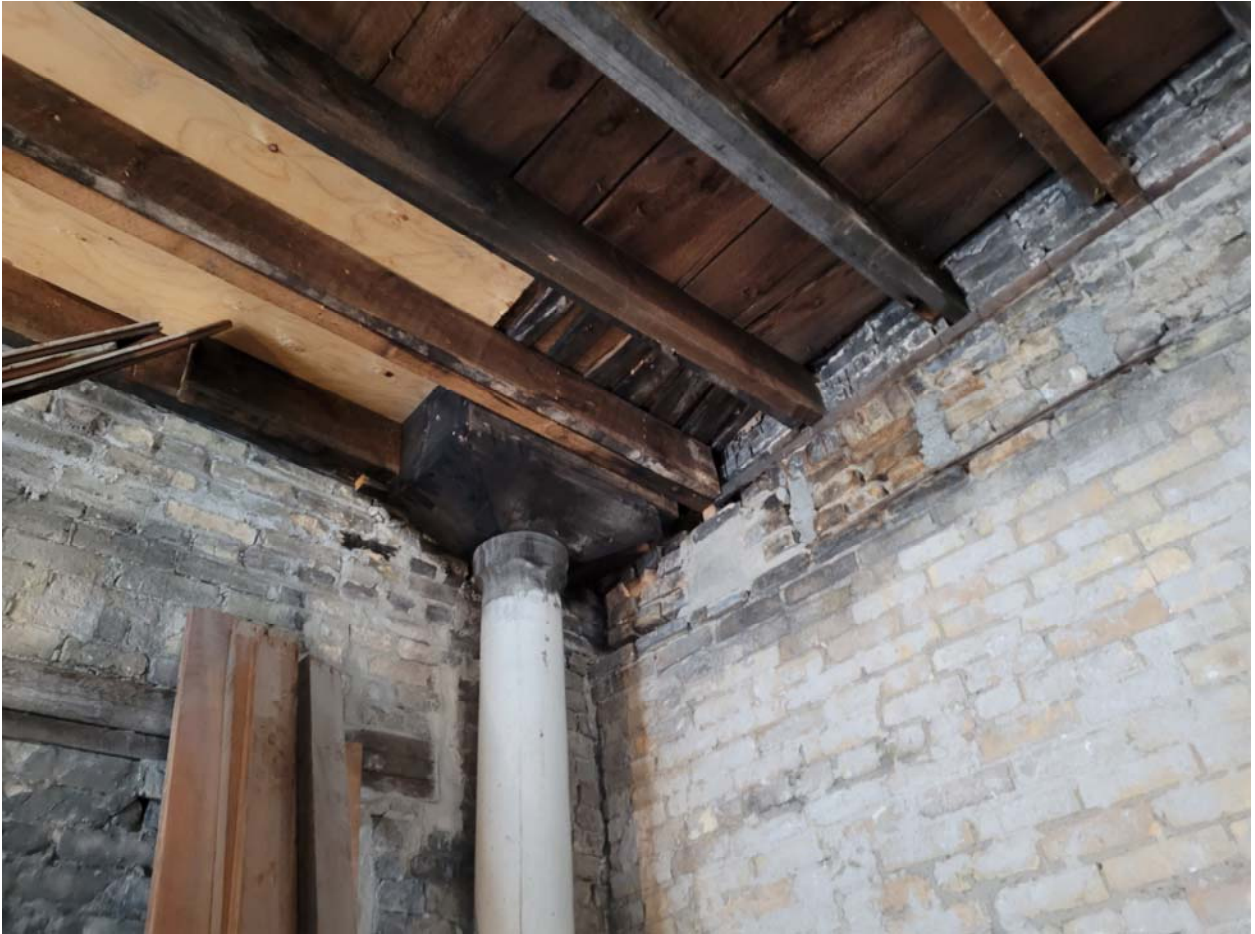
10. Roof decking is water damaged at the west end.
11. Joists were damaged at the west end and have been sistered with an additional ply. The splice of the additional ply is at the center of the joist span. This splice location will require an additional reinforcing ply
12. Repointing is required along the east/west end walls and along the interior dividing wall.
13. The east masonry wall appears to be leaning towards the street and has caused a gap at the dividing masonry wall connection and at the 3rd floor connection to the brick.

Photo 7: 242 Princess – Roof drain with damaged roof framing.

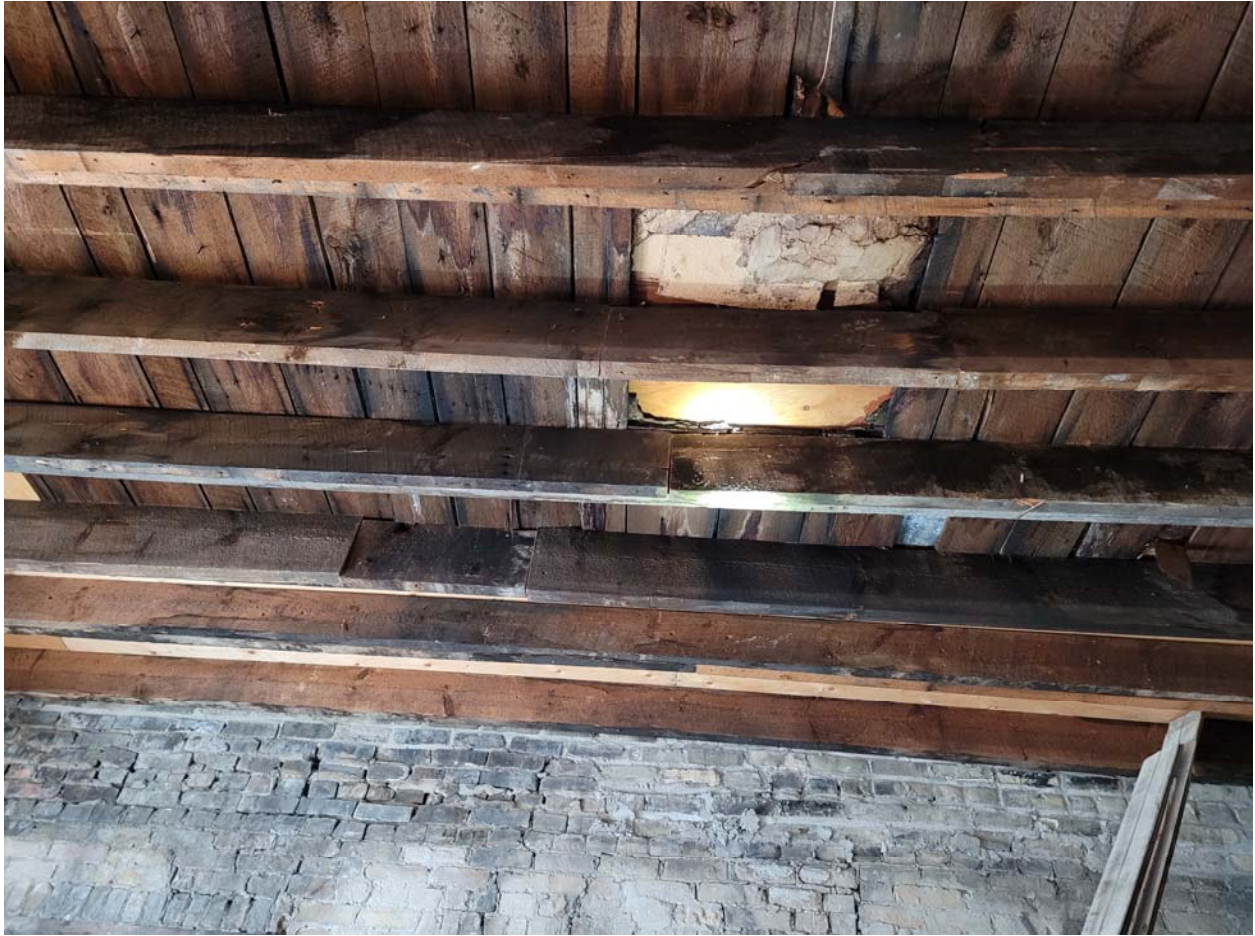
Photo 8: 242 Princess – Water damage and roof joists reinforcing spliced mid-span.

8. Engage an architect to provide direction on all building envelope conditions and coordinate with structural repairs. Specific direction is required on the water damage to the roof decking of 242 and 244 Princess. Architect is also to provide direction on minimum temperature to heat building to maintain building condition.

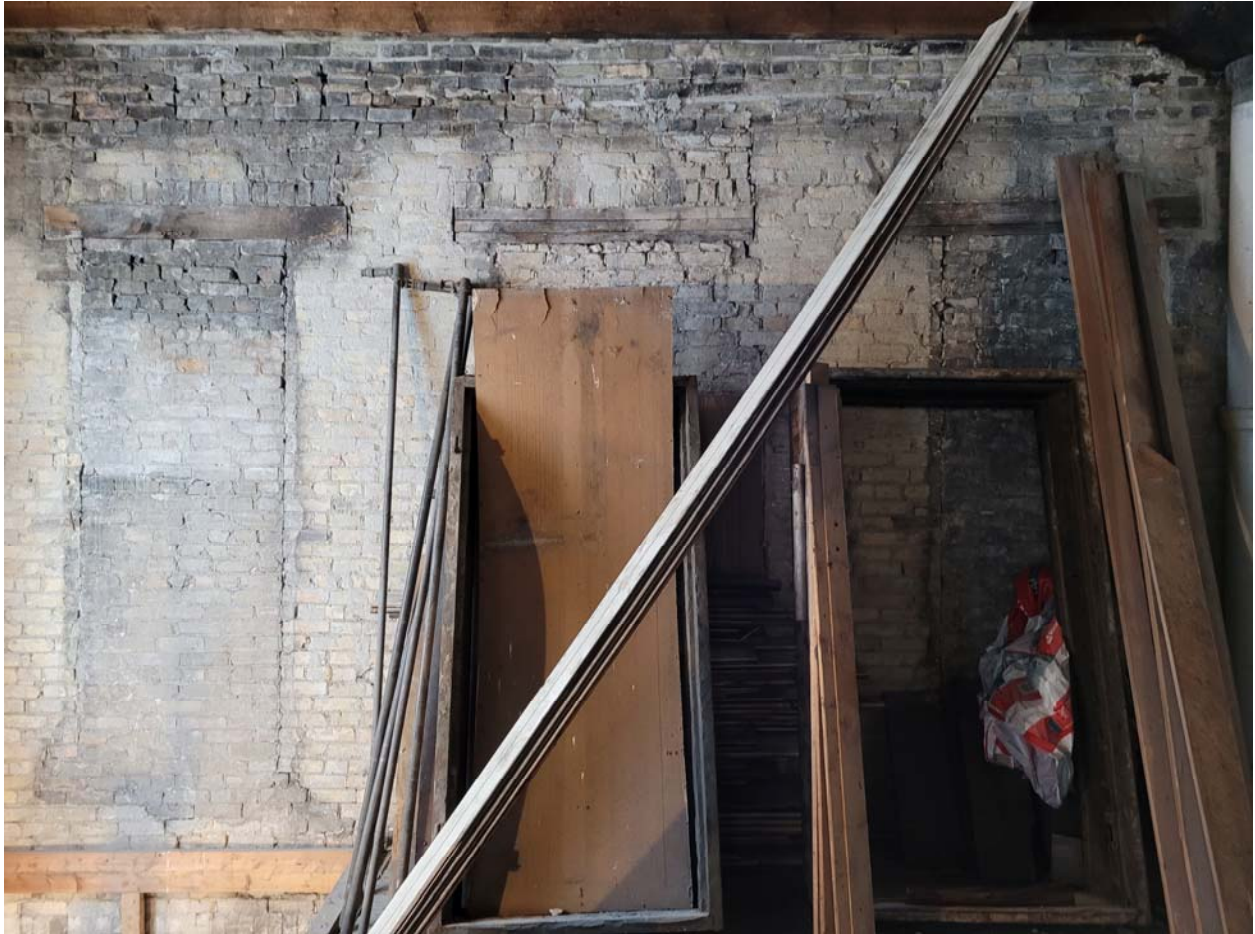
Photo 9: 242 Princess – interior of west wall with cracking.

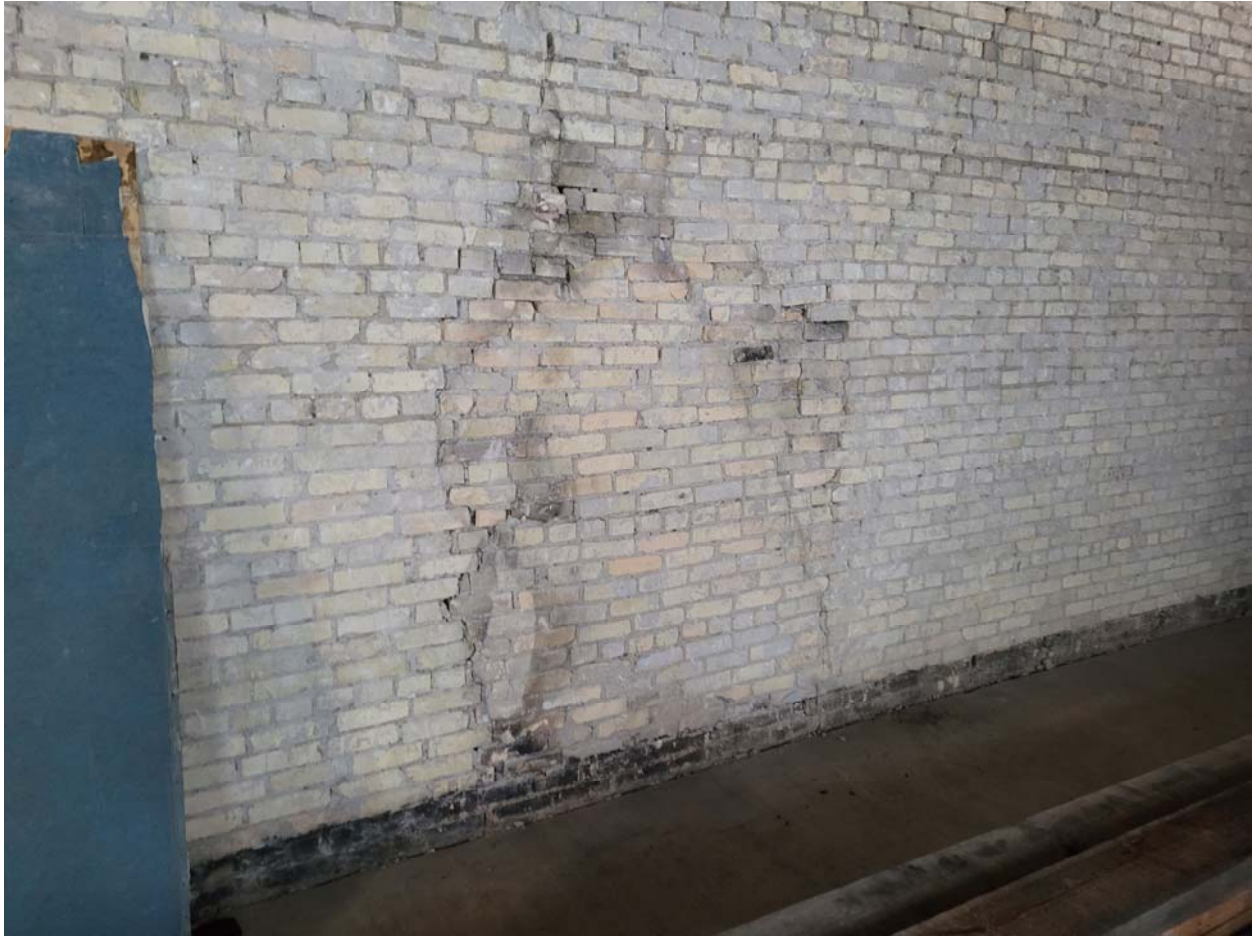
Photo 10: 242 Princess – Cracking and brick deterioration at center of dividing walls.

6. The interior demising walls are to be repointed and have all large cracks repaired by brick stitch work within 30ft of the east façade.
7. The east façade is to be tied back to the third floor and dividing walls from 3rd to roof with plate tie back supports.

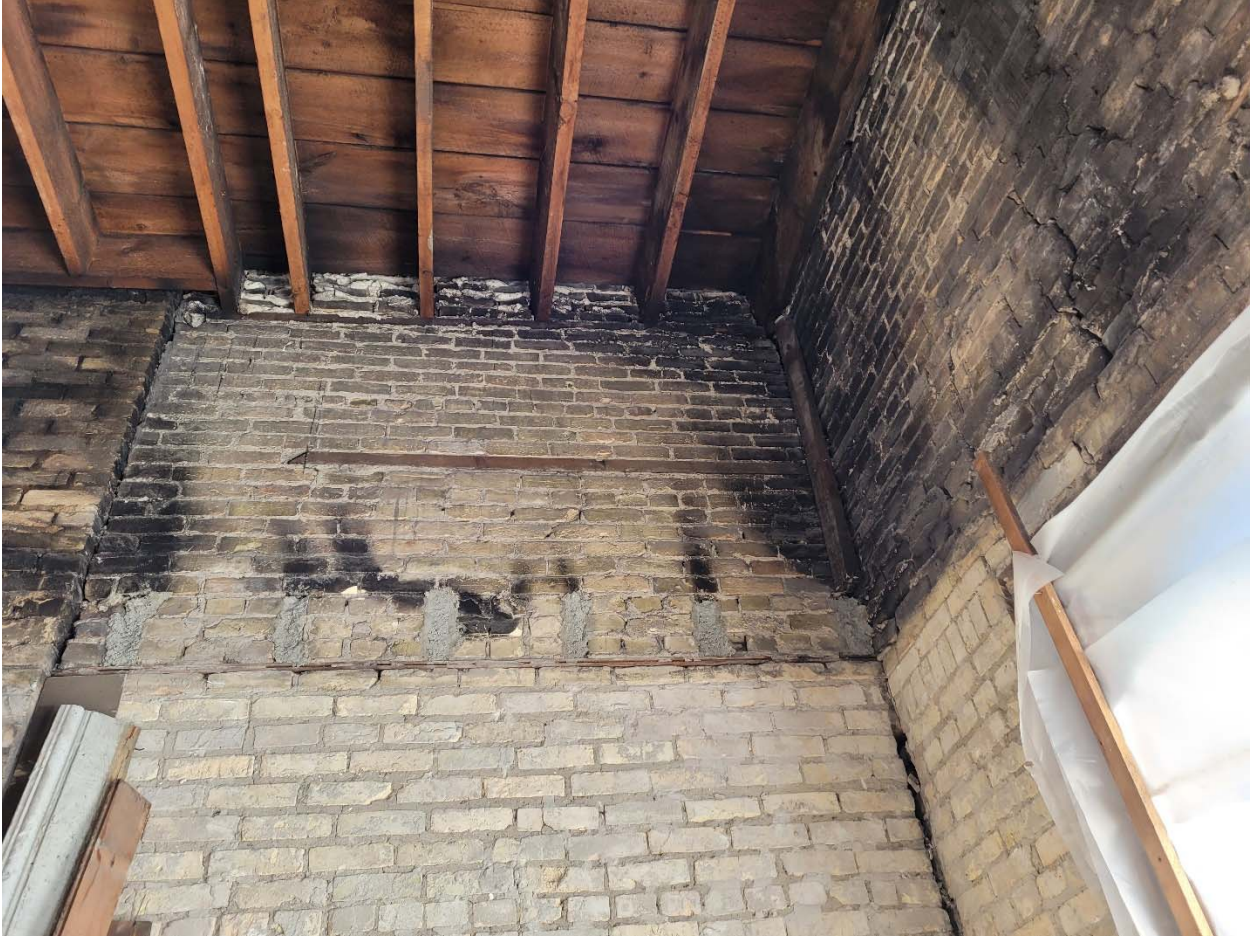
Photo 11: 242 Princess – Possible fire damage in north-east corner of roof framing.

1. Repair or replace all fire-damaged joists.

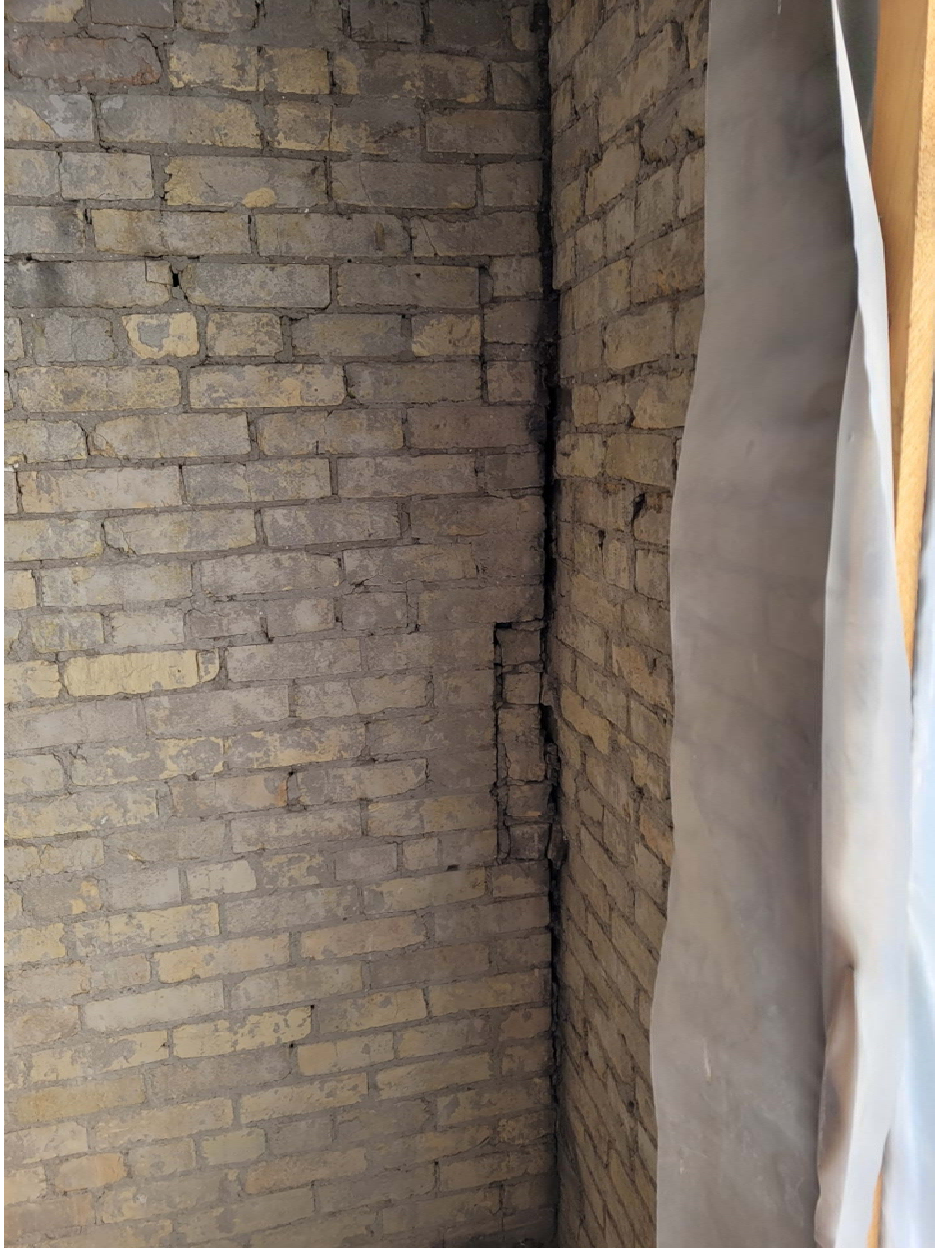
Photo 12: 242 Princess – Brick separation where east façade meet demising wall.

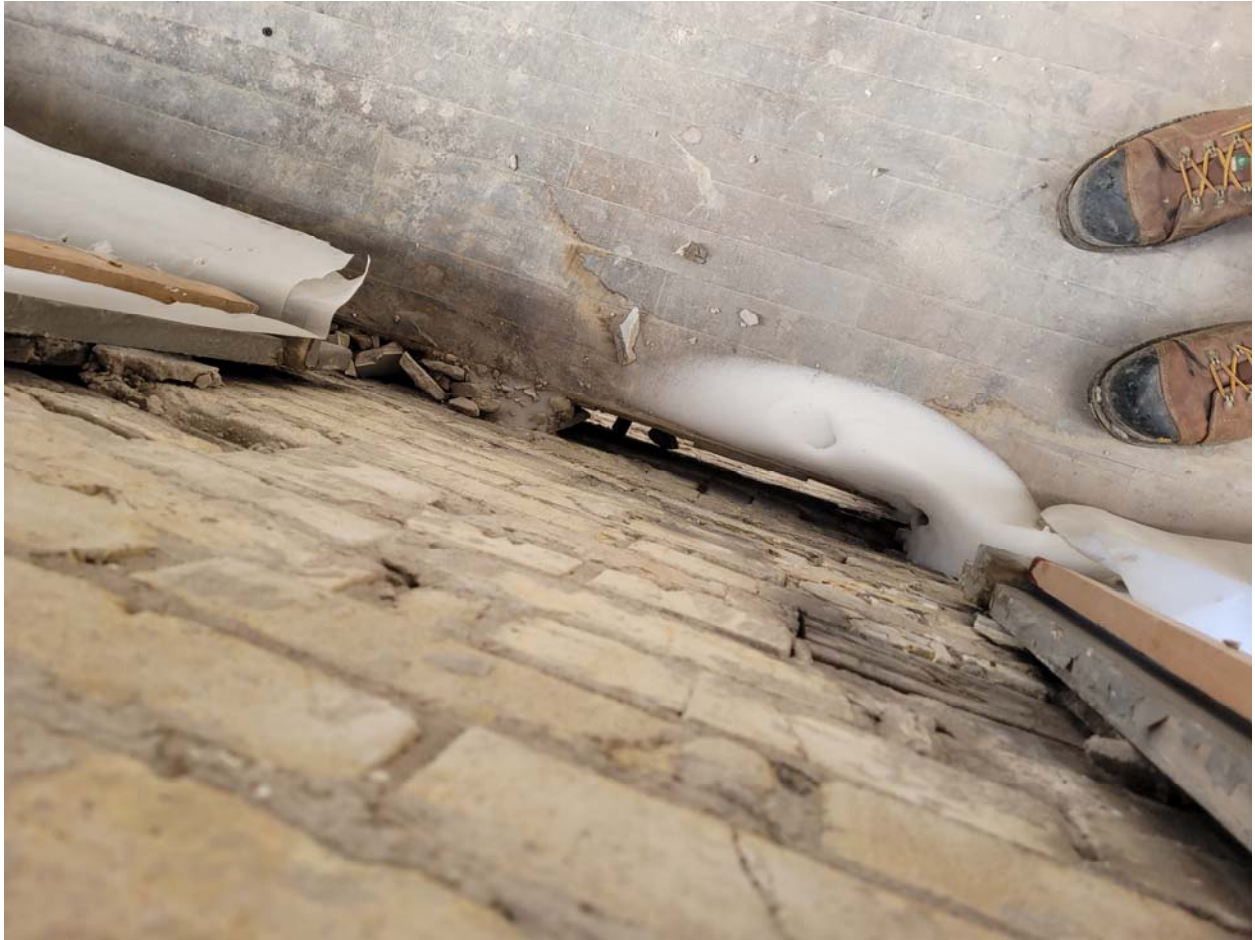
Photo 13: 242 Princess – Gap between east façade and third floor framing.

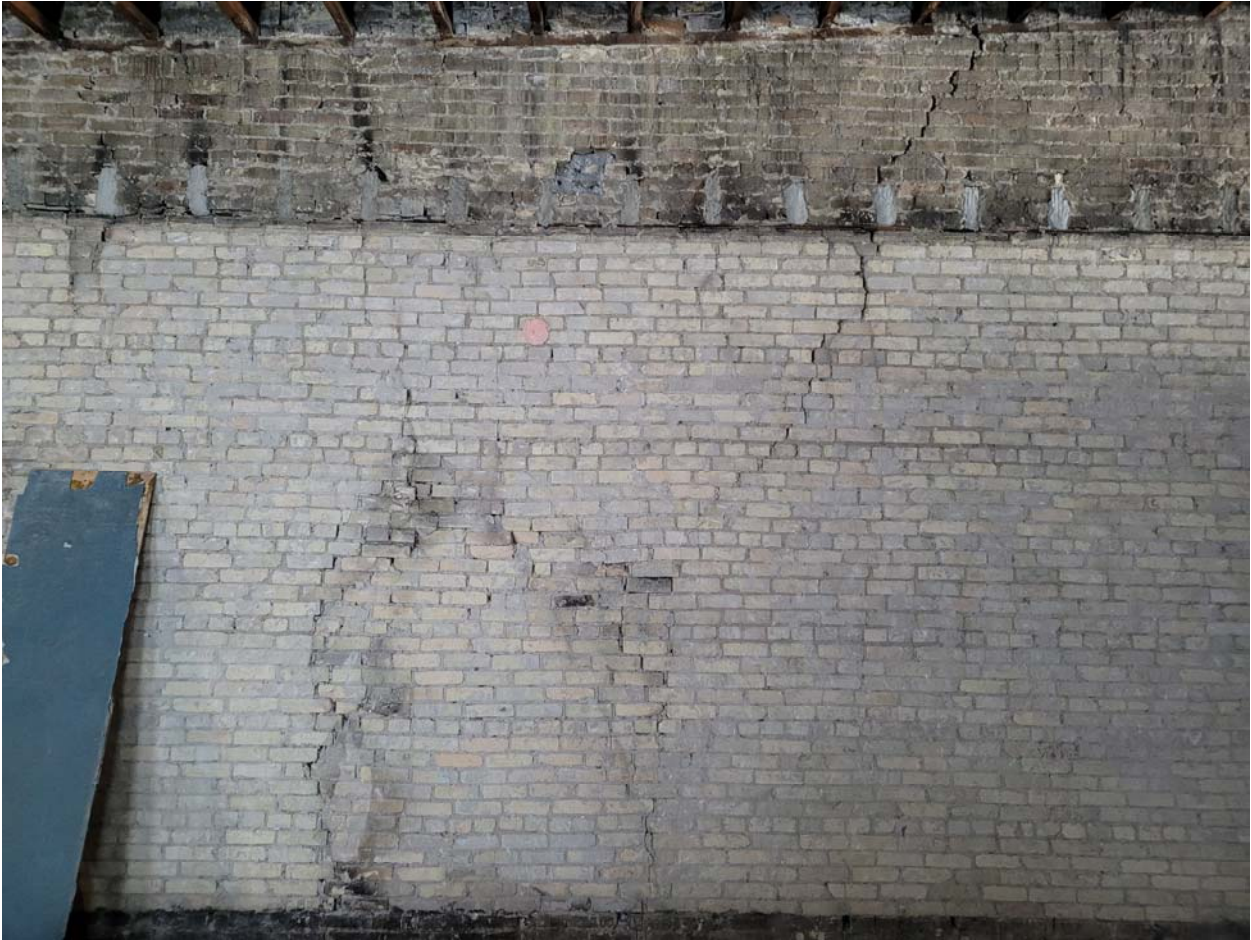
Photo 14: 242 Princess – Cracking and brick deterioration at center of dividing walls.

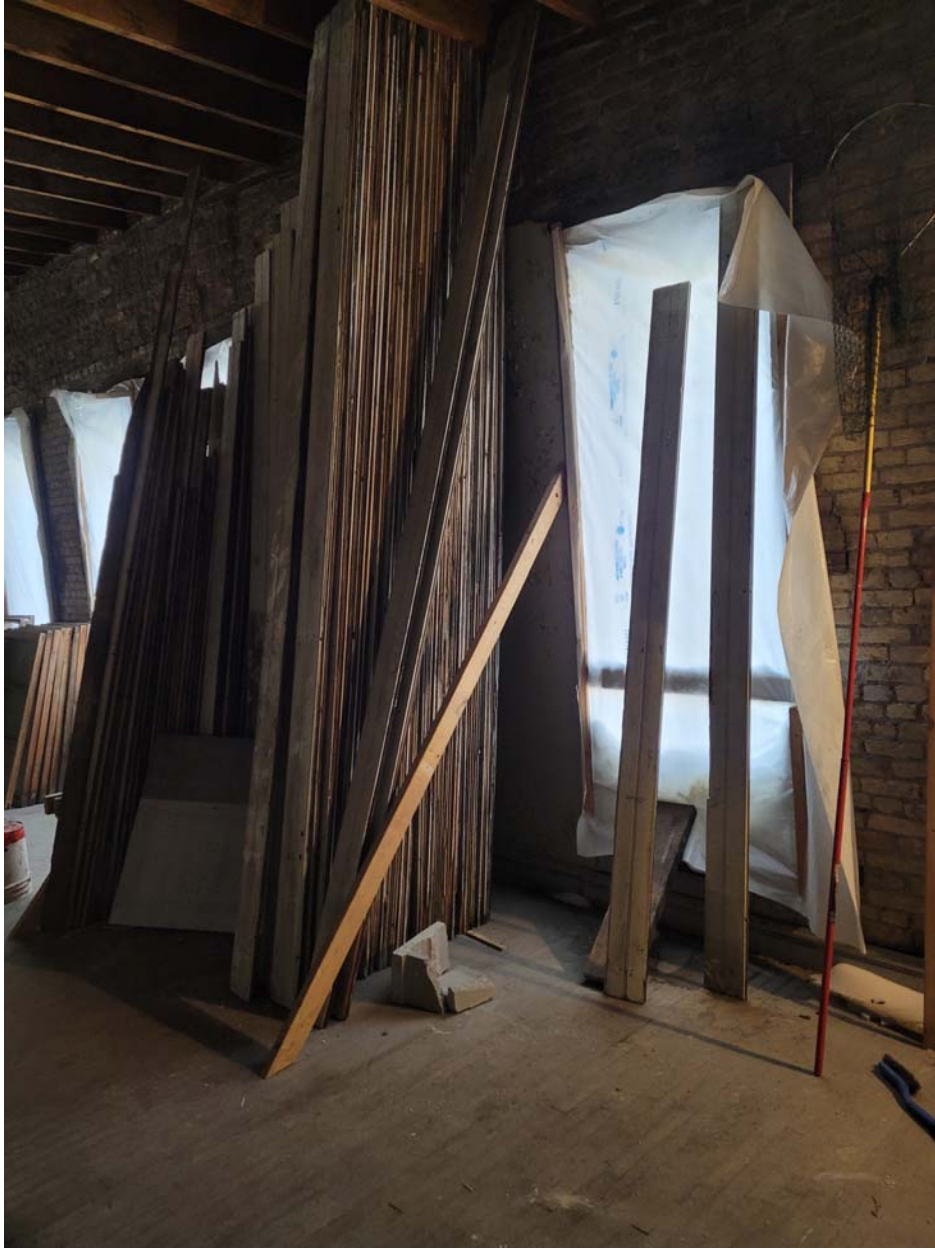
Photo 15: 242 Princess – Material leaned against masonry walls.

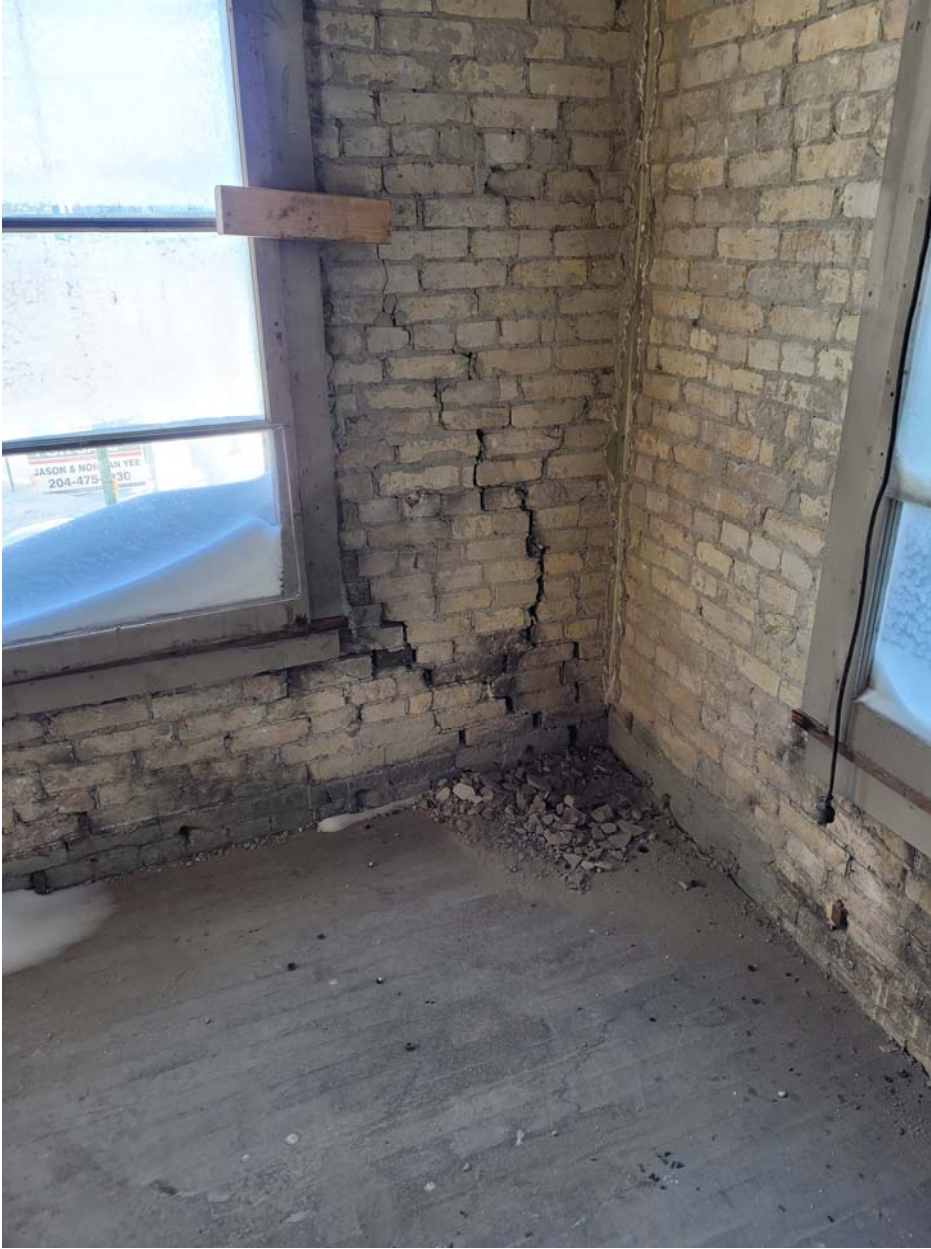
Photo 16: 242 Princess – Masonry cracking at south-east corner.

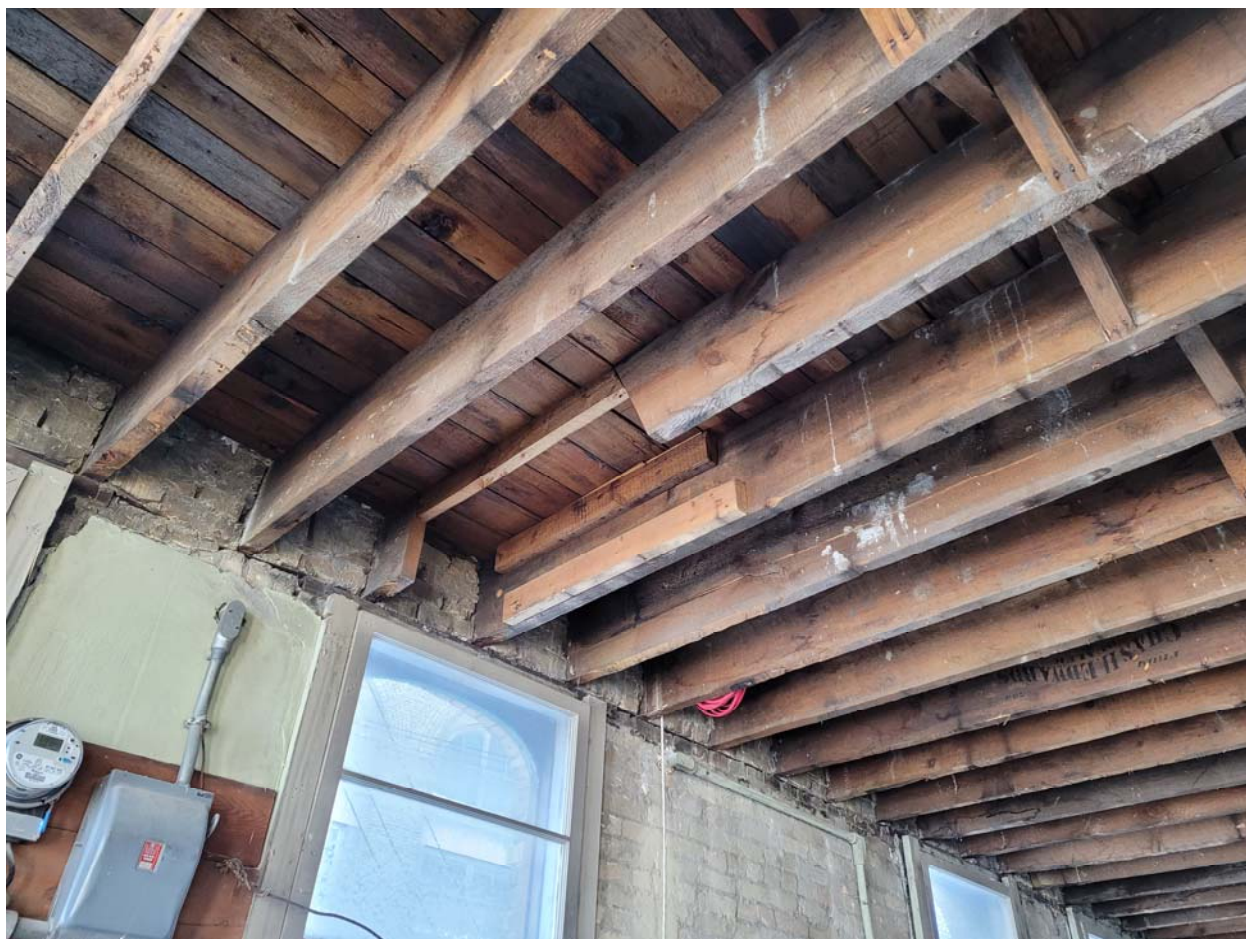
5. Several joists have fire damaged.
6. Several joists have had large cuts made in them which severely reduce their capacity.
7. A large section of the second floor framing towards the dividing wall have inadequate framing of a stair opening infill. The header of the infill requires column supports or flush framed beam supports.

Photo 17: 242 Princess – Typical example of cut floor joists to be repaired

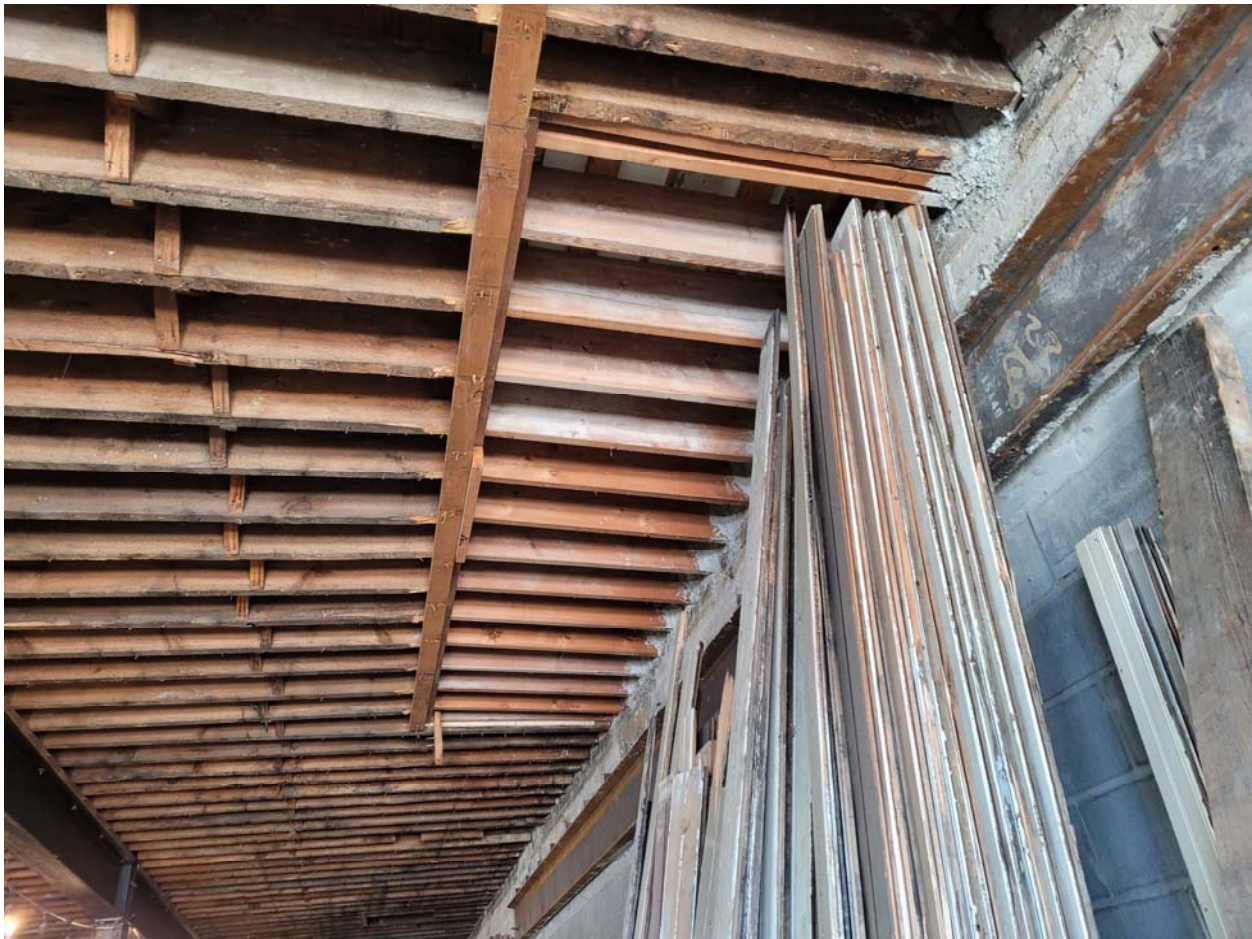
Photo 18: 242 Princess – Inadequate stairwell infill.
