Building Condition Report 242/244/246 Princess St. Winnipeg, MB

Issued Date: February 22, 2022
Revised: March 7, 2022

File No.: W22-059

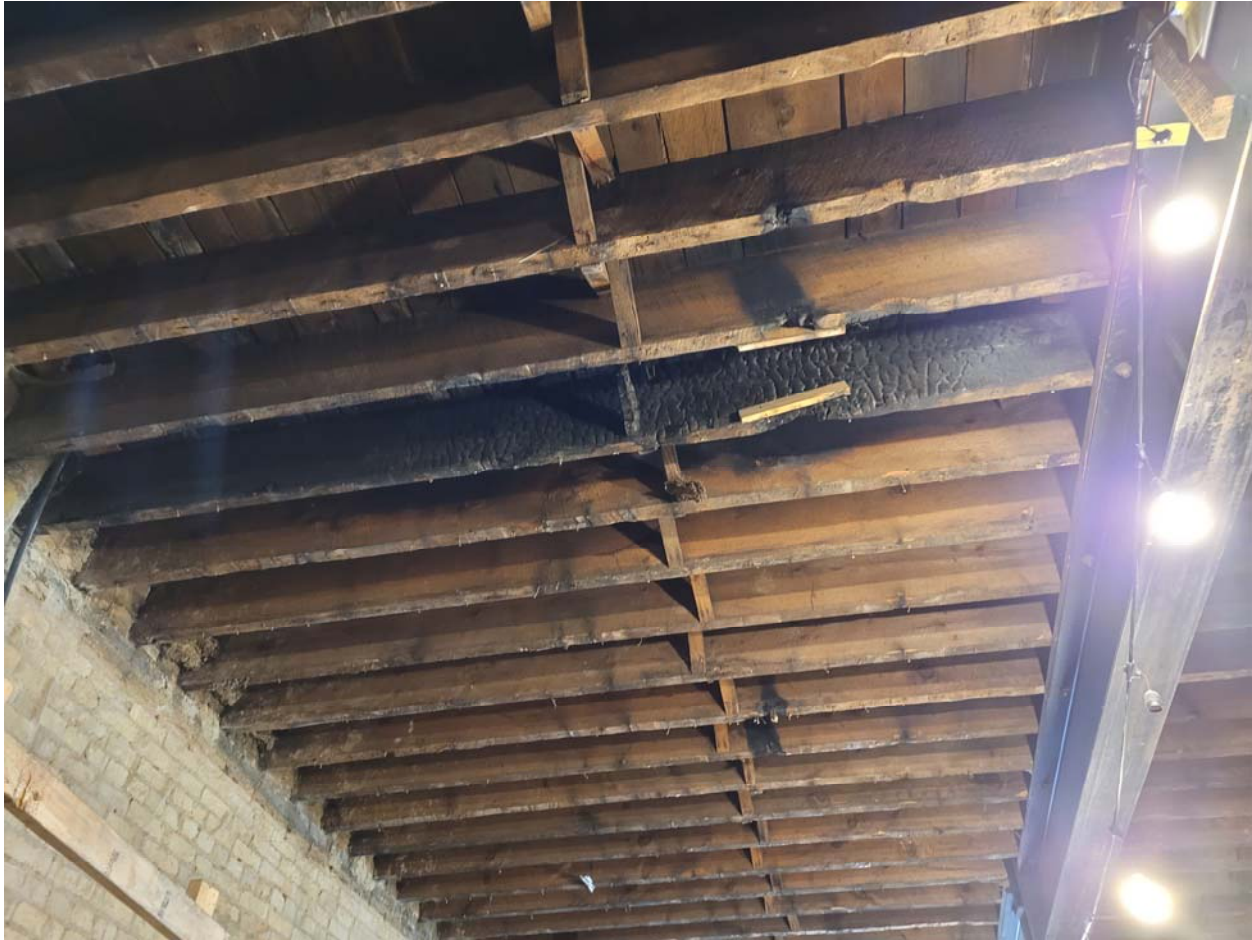
5. Several joists have fire damaged.
6. Several joists have had large cuts made in them which severely reduce their capacity.
7. A large section of the second floor framing towards the dividing wall have inadequate framing of a stair opening infill. The header of the infill requires column supports or flush framed beam supports.

Photo 19: 242 Princess – Typical example of fire damaged joist.

1. Repair or replace all fire-damaged joists.

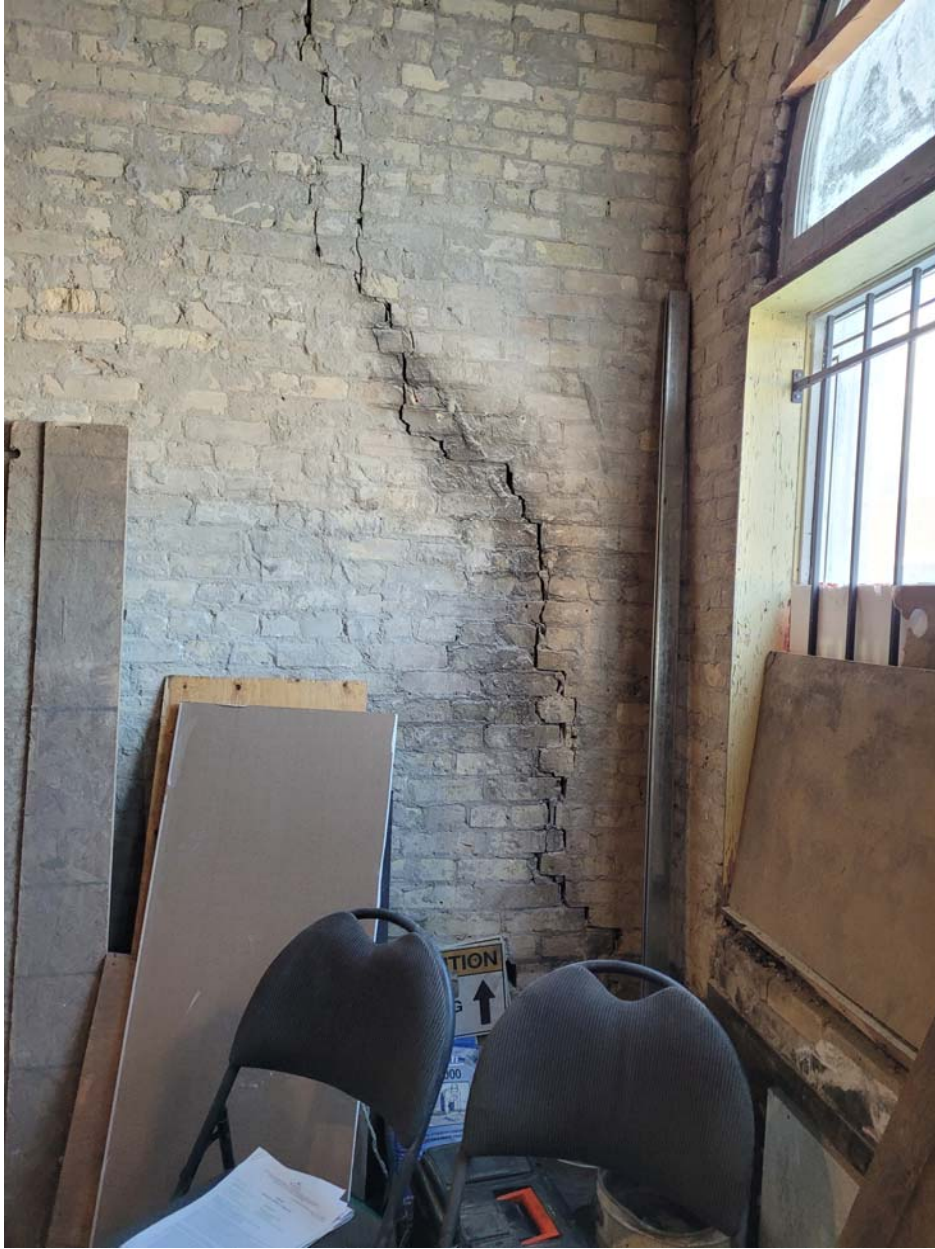
Photo 20: 244 Princess – Significant crack at demising wall at connection to east façade.

6. The interior demising walls are to be repointed and have all large cracks repaired by brick stitch work within 30ft of the east façade.
7. The east façade is to be tied back to the third floor and dividing walls from 3rd to roof with plate tie back supports.

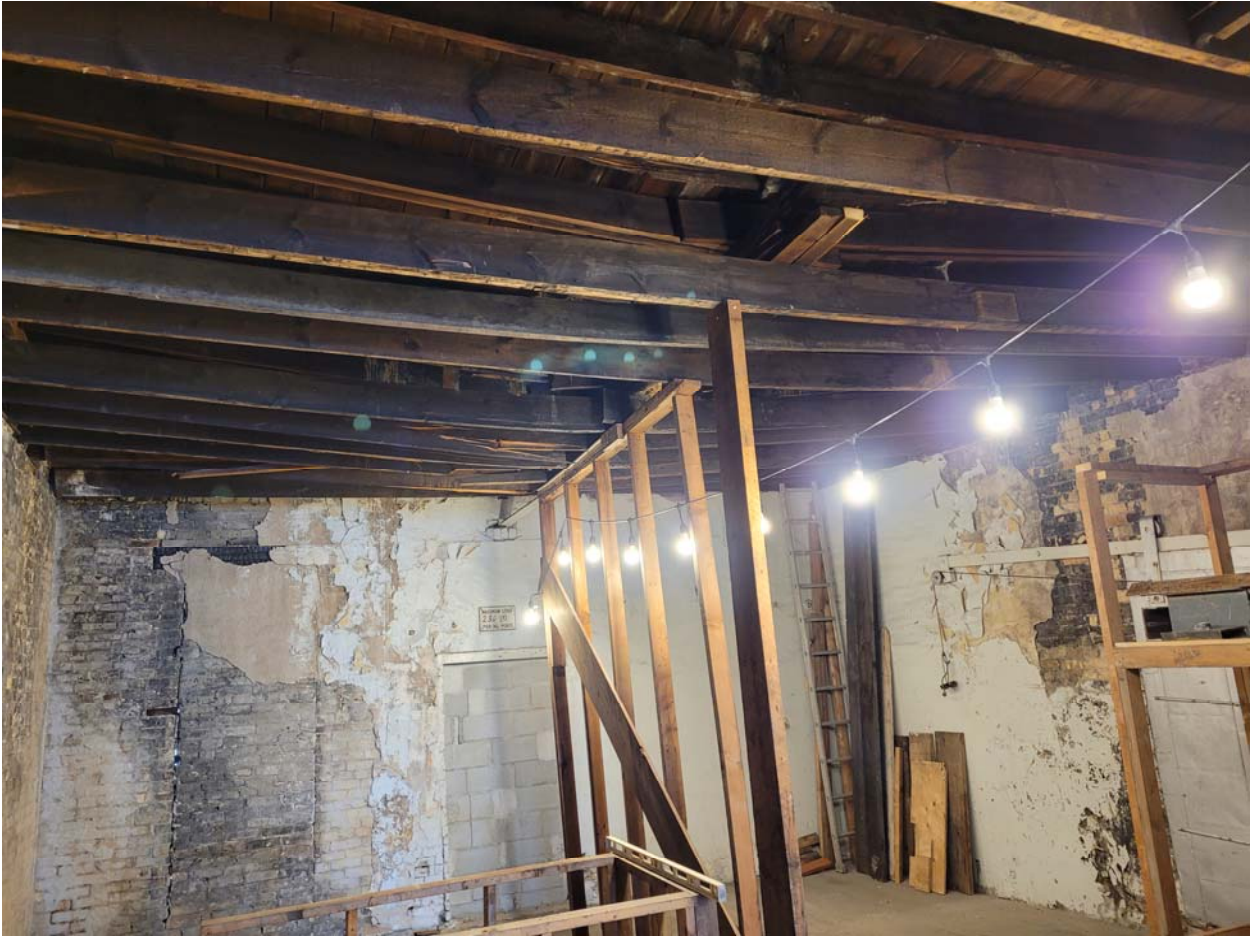
6. The east masonry wall appears to be leaning towards the street and has caused a gap at the dividing masonry wall connection and at the 3rd floor connection to the brick.
7. The interior dividing walls require repointing along the mid-length of the wall
8. The roof joists have failed at the west end. The joists have a mid-span shoring wall supporting them.

Photo 21: 244 Princess – Broken roof joists with shoring wall below.

1. The basement wall of 242 Princess is to be shored at the stairs to prevent further displacement of the bulged section until a full repair can be performed.
2. The roof joists of 244 Princess are to have their shoring redesigned by a professional engineer.
3. Materials are not to be stored leaning against walls, materials are to be disposed of or laid flat on floors.

1. The bulged wall in 242 Princess is to be repaired to plumb condition.
2. Repair or replace damaged roof joists in 244 Princess.
3. The previously repaired roof joists of 242 Princess are to have an additional ply installed at the center splice.

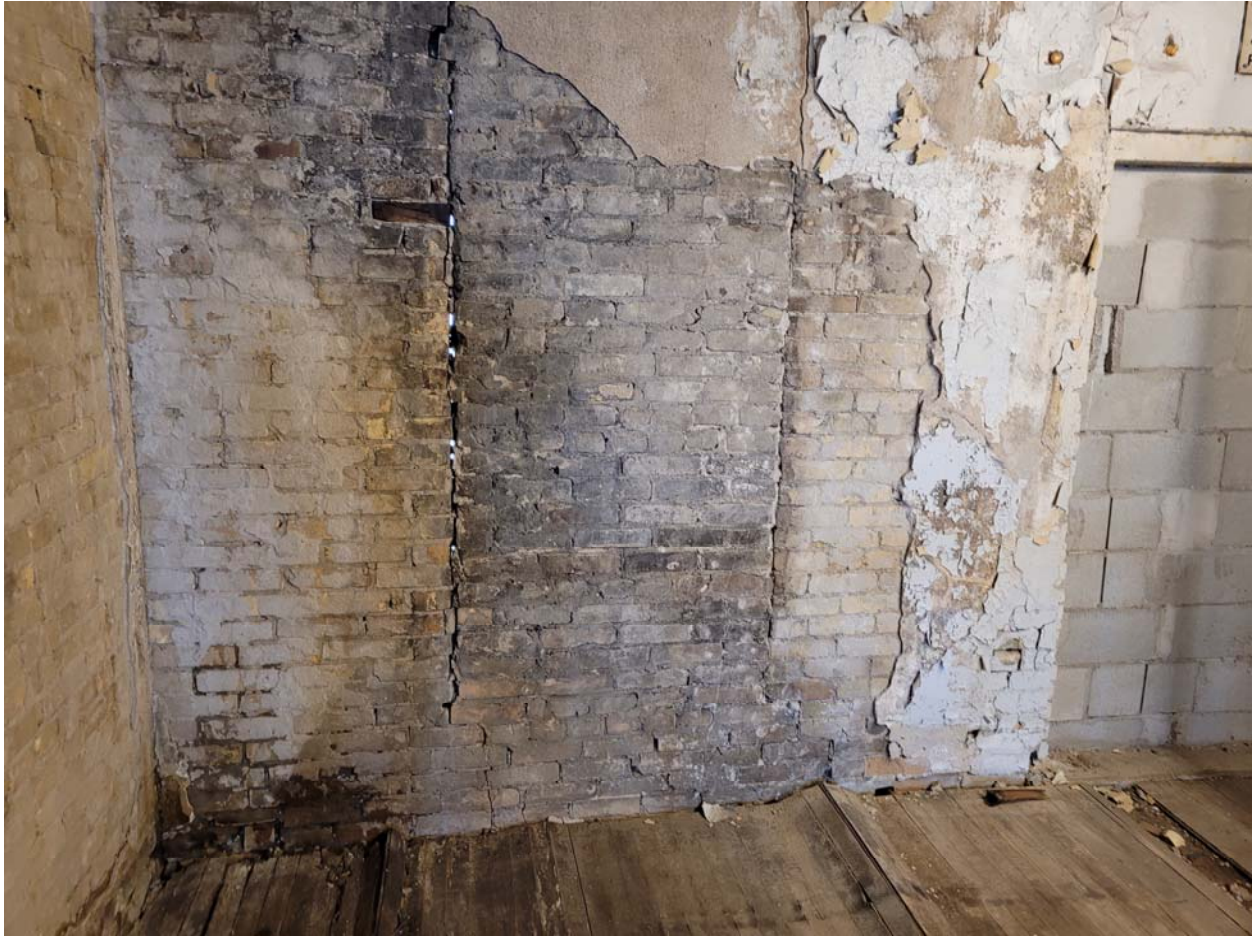
Photo 22: 244 Princess –Signicant crack in west façade.

4. The exterior basement walls of 242 Princess are to have all damaged mortar repointed.
5. The west façade are to have all weak mortar repointed and all cracks repaired. The large vertical crack along 242 princess is to have brick stitch work completed and the crack repointed.

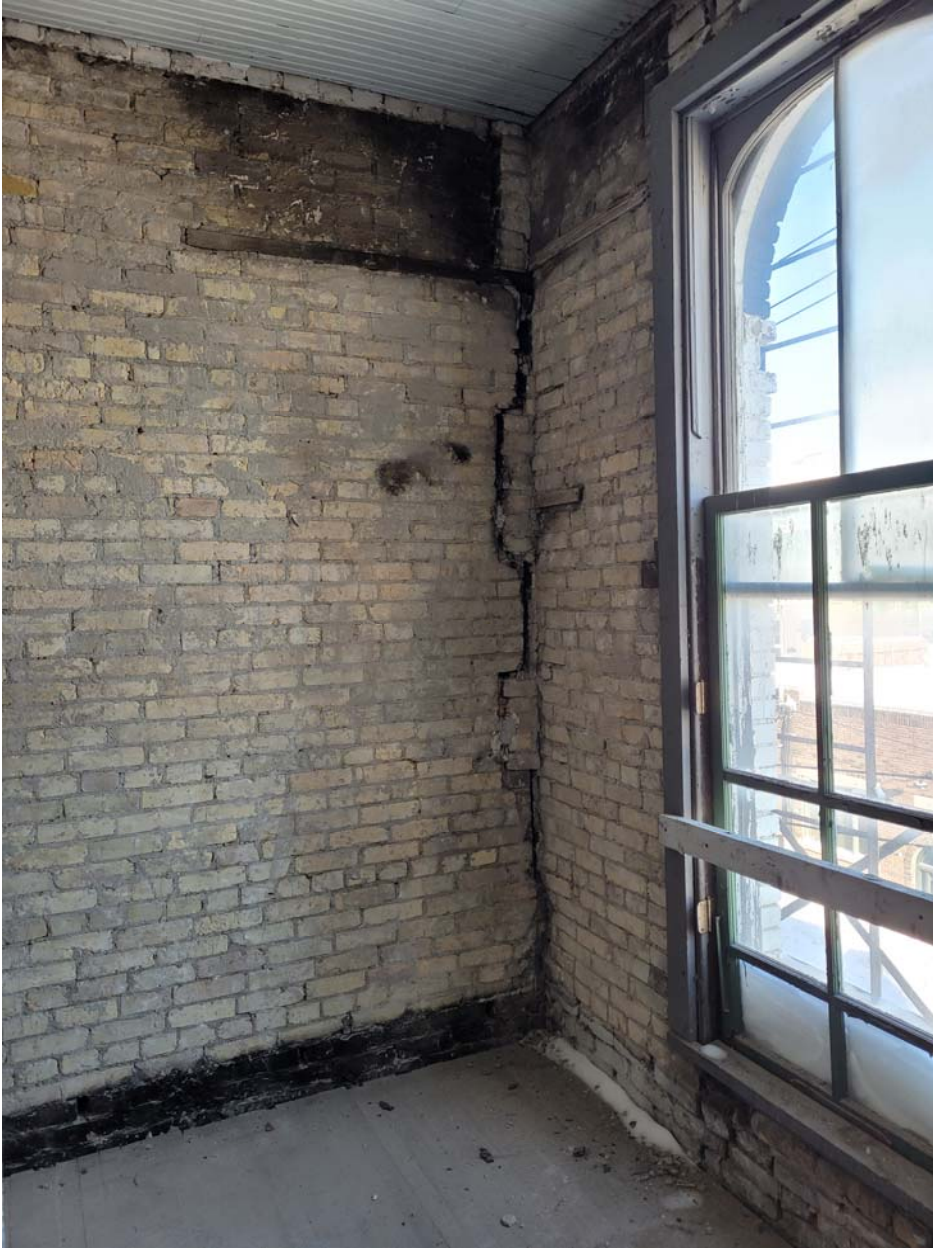
Photo 23: 244 Princess – Brick separation where east façade meet demising wall.

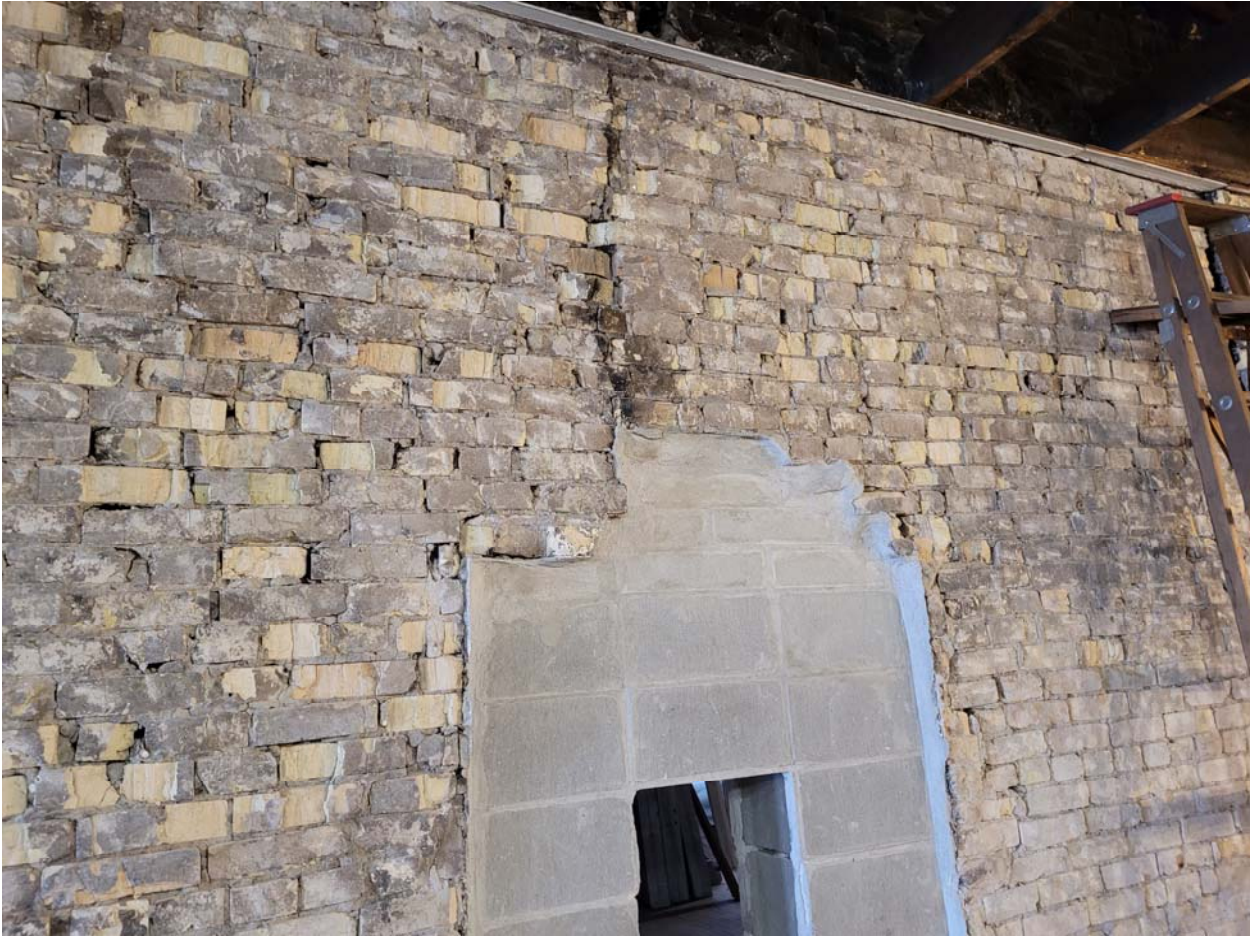
Photo 24: 244 Princess – Interior demising wall requiring repointing.

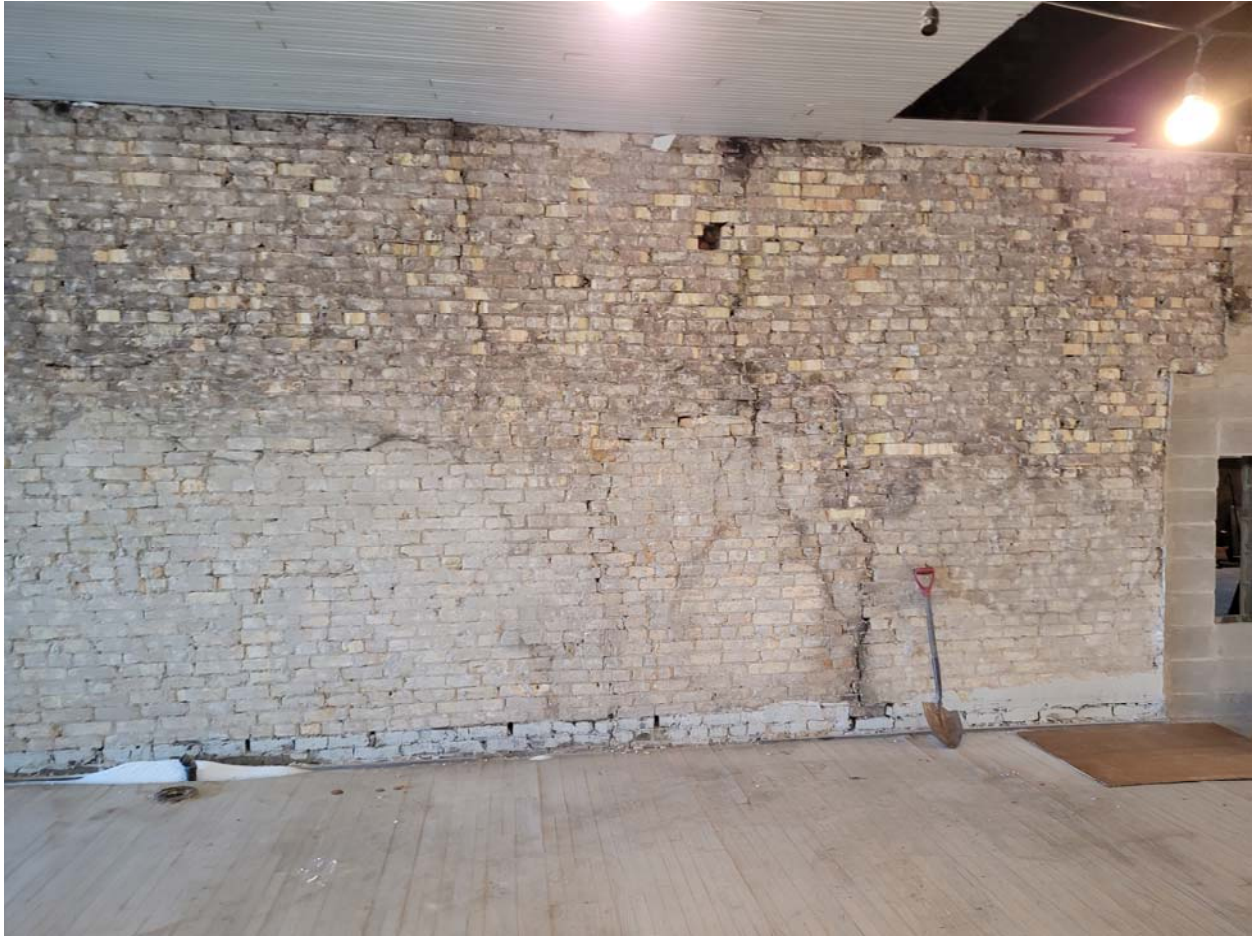
Photo 25: 244 Princess – Interior demising wall requiring repointing.

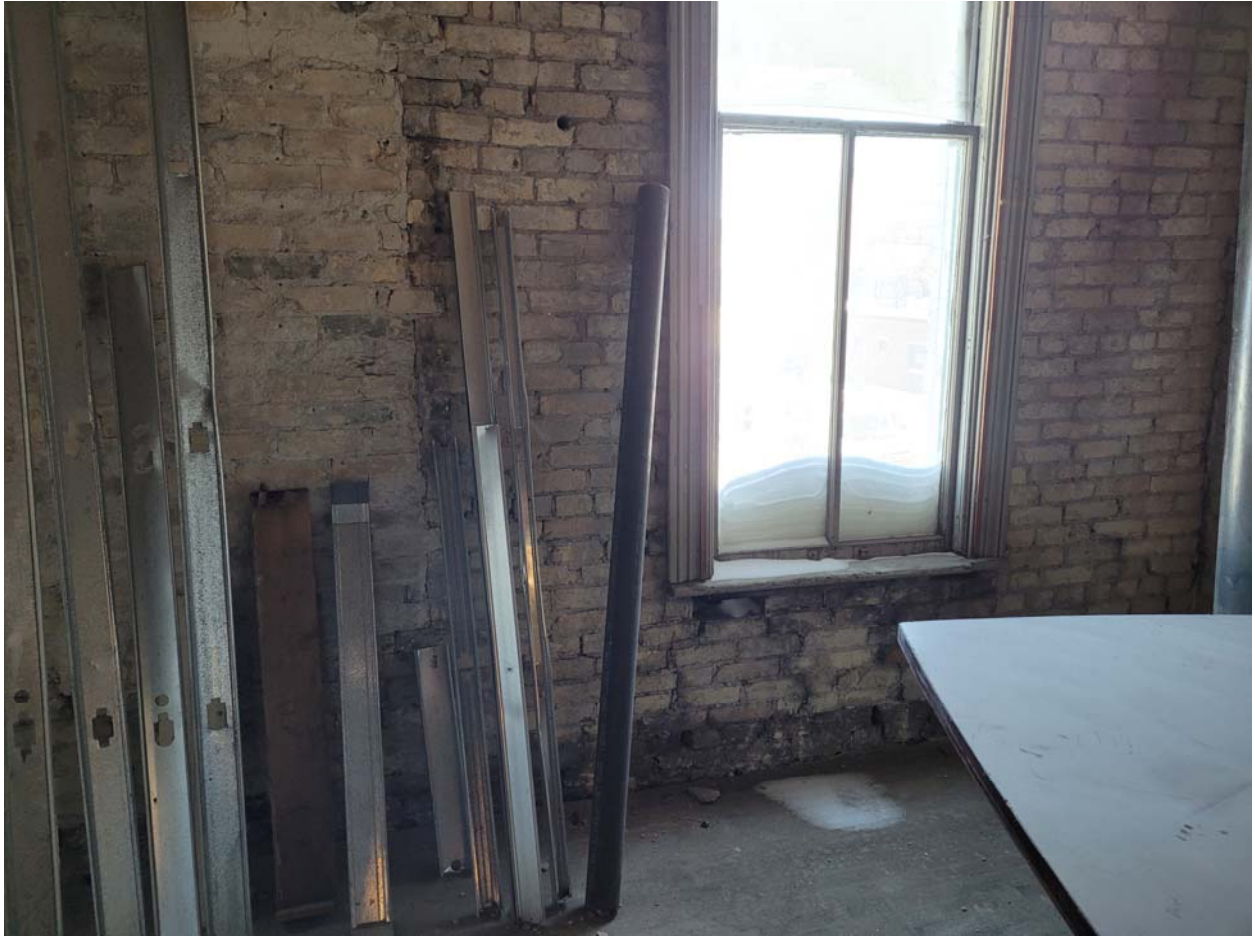
Photo 26: 244 Princess – Perimeter wall requiring repointing.

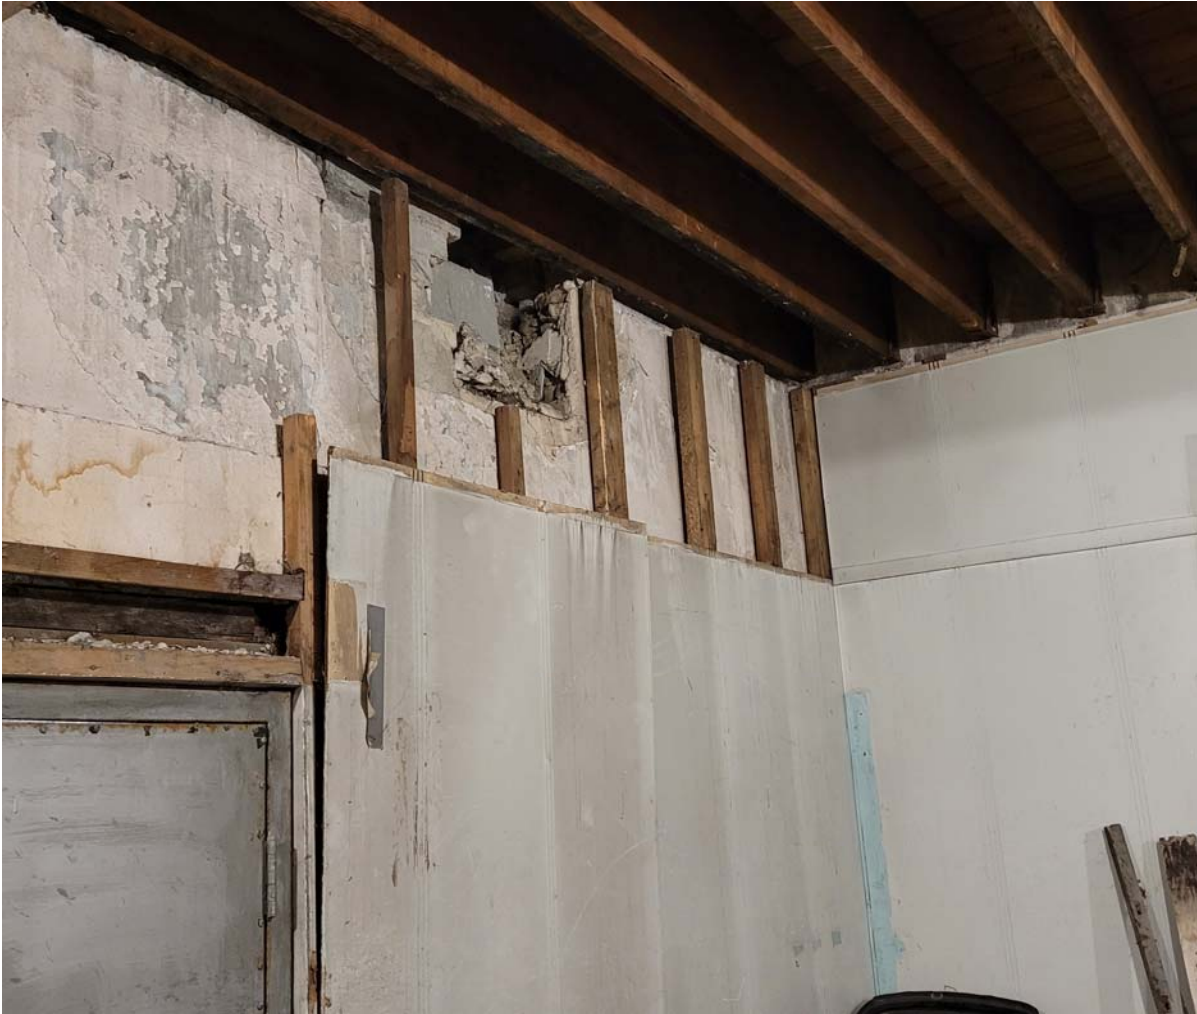
Photo 27: 244 Princess – Damaged perimeter wall at west façade.

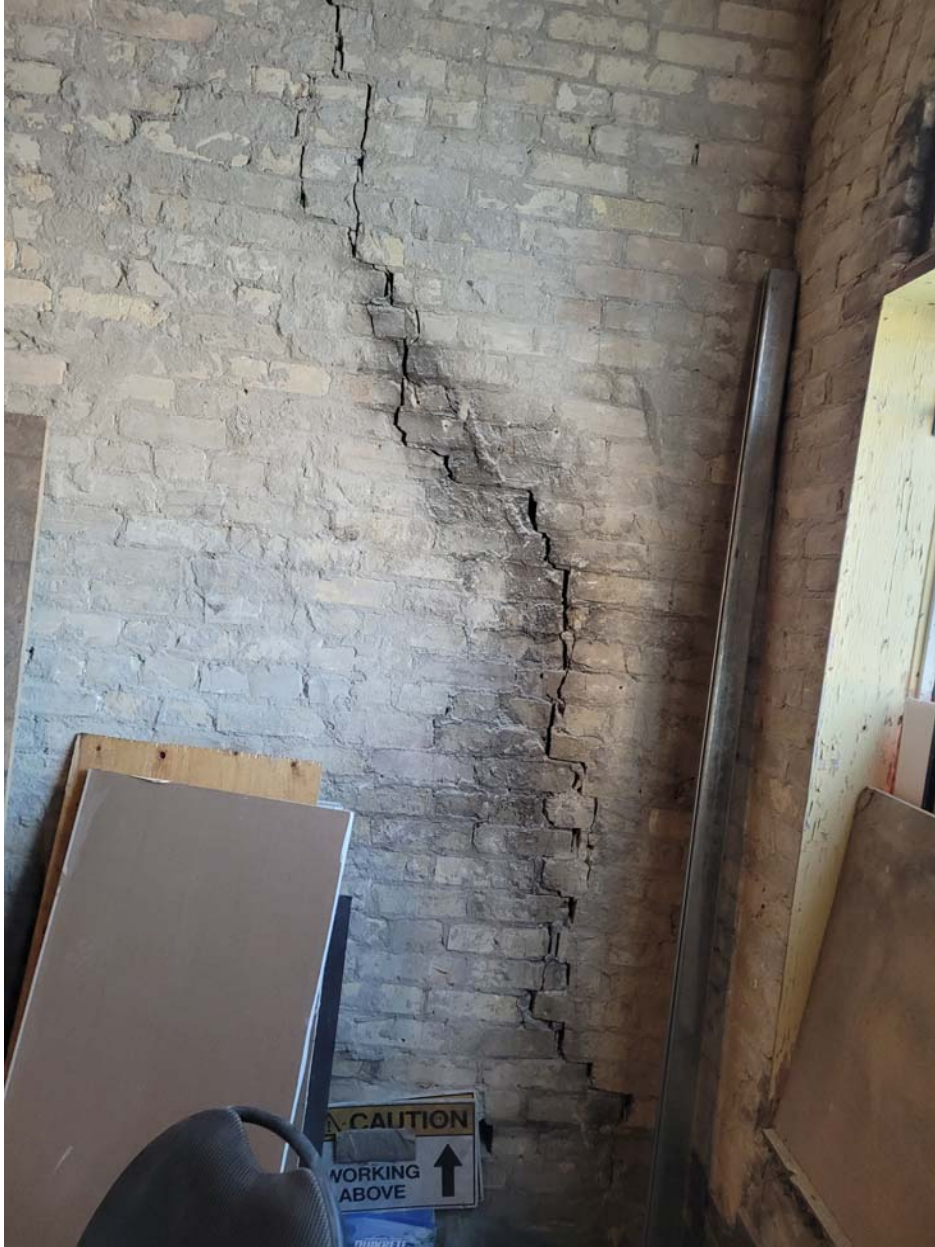
Photo 28: 244 Princess – Significant crack at demising wall at connection to east façade.

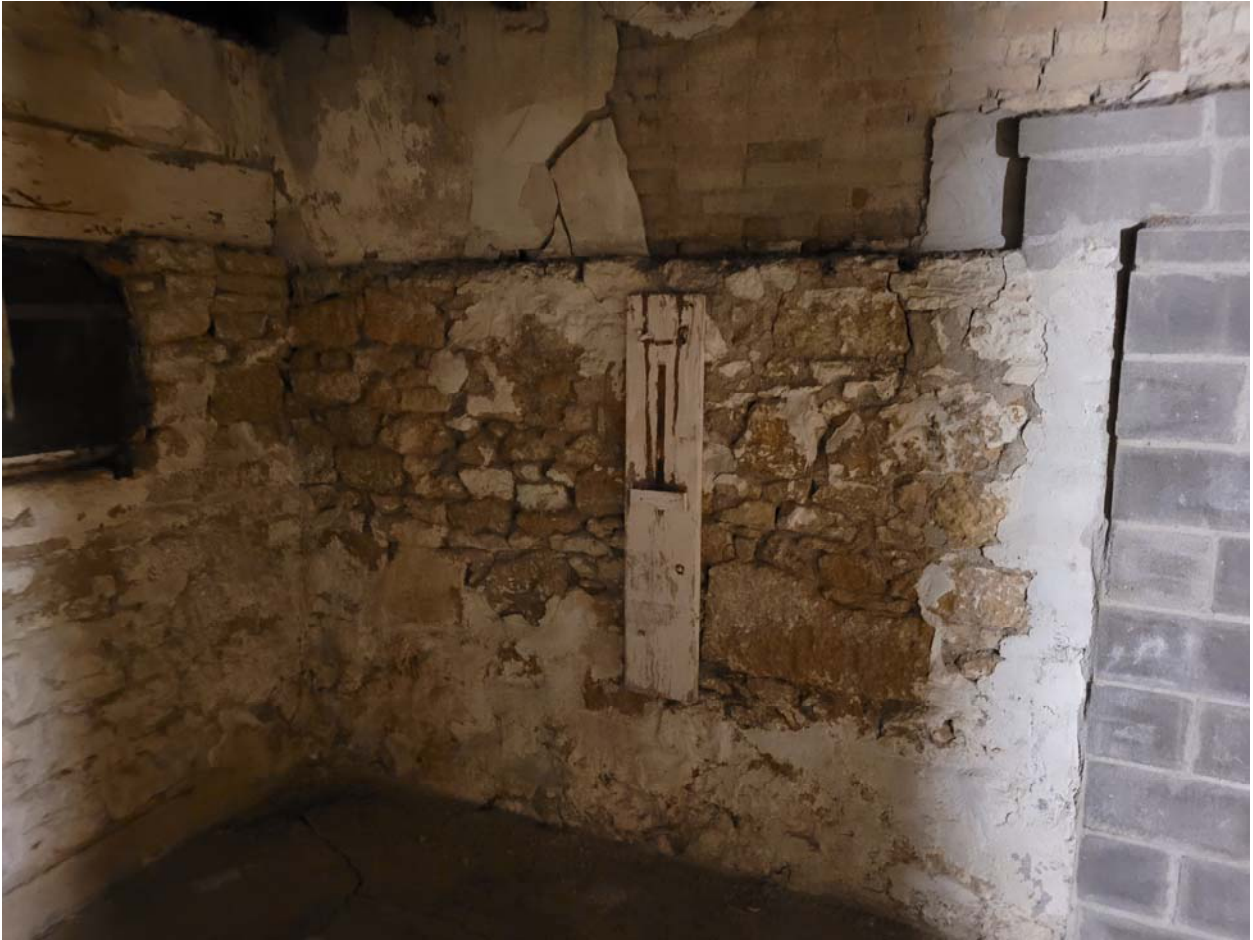
Photo 29: 244 Princess – Rubble demising wall requiring repointing.

1. South exterior wall and remaining interior demising walls between buildings are to have all damaged mortar repointed for the full height of the building. Repoint all weak mortar in interior rubble demising walls.
2. The east façade is to have all weak mortar repointed and all cracks repaired.
3. All steel in the basement is to be sandblasted to remove corrosion and to be primed/repainted.
4. Reinforce infill framing at old stairwell in 242 Princess.

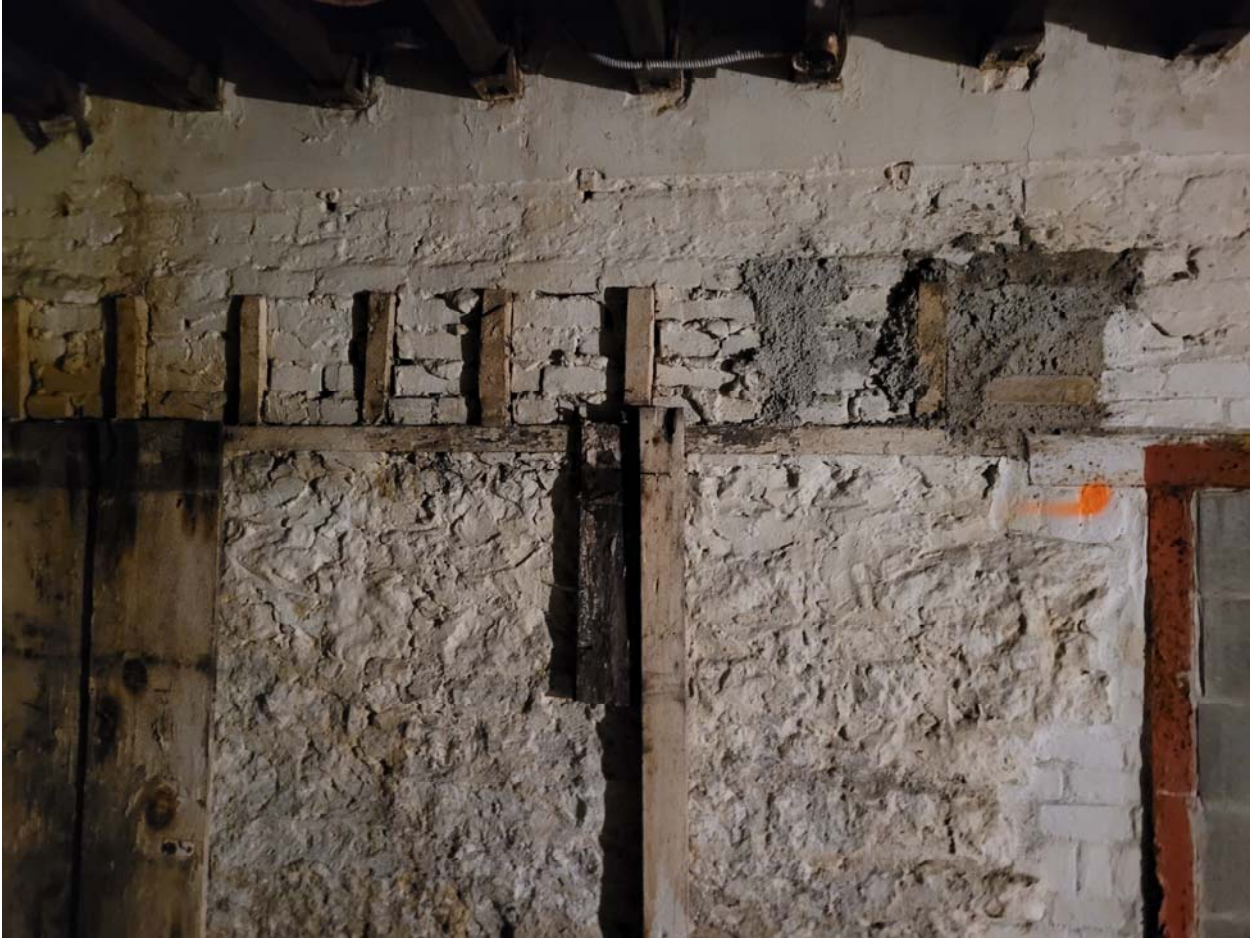
Photo 30: 244 Princess – Rubble demising wall requiring repointing.

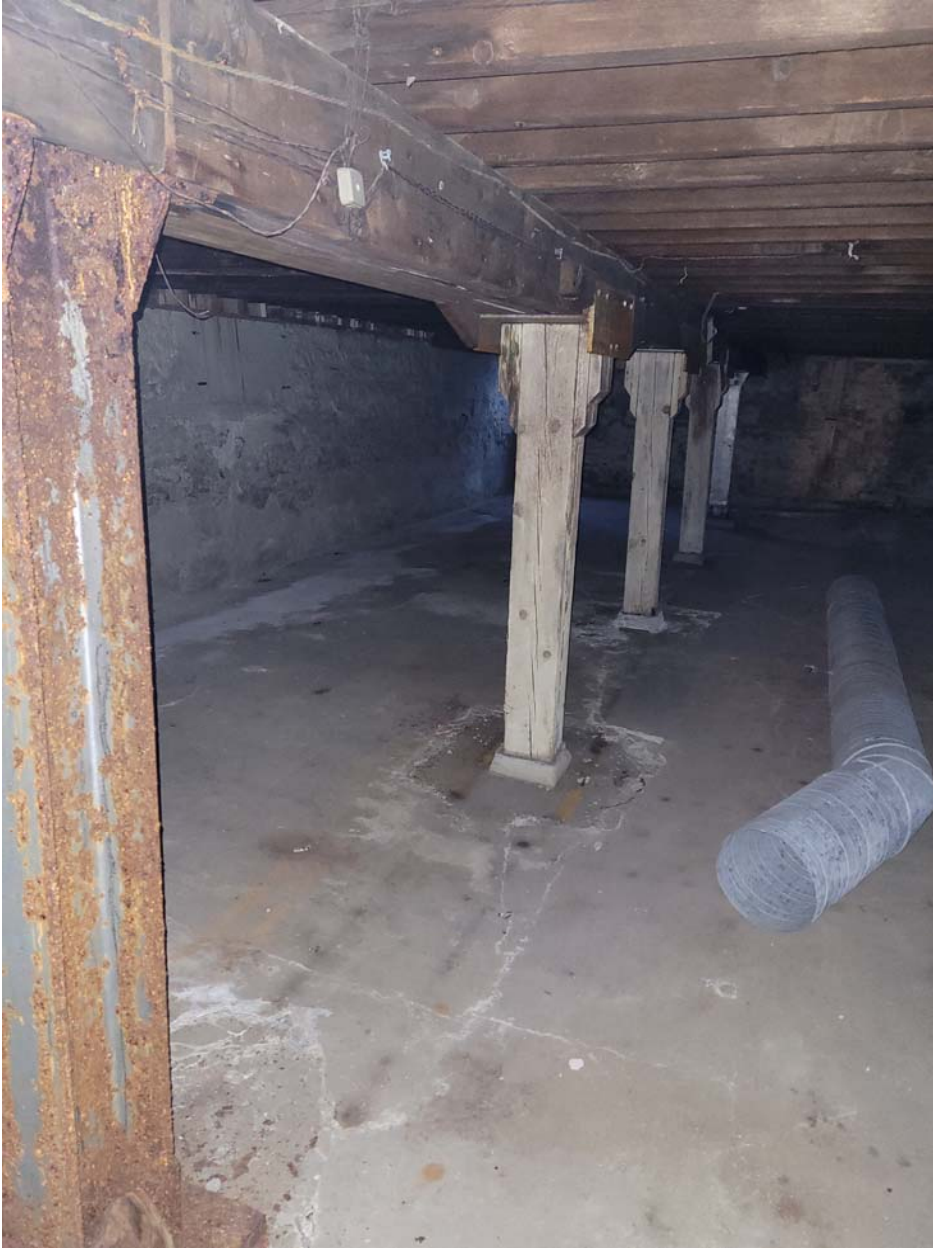
1. Steel columns are damp and experiencing corrosion.
2. Minor repointing of the rubble wall is required.

Photo 31: 244 Princess – Corrosion of columns in basement.

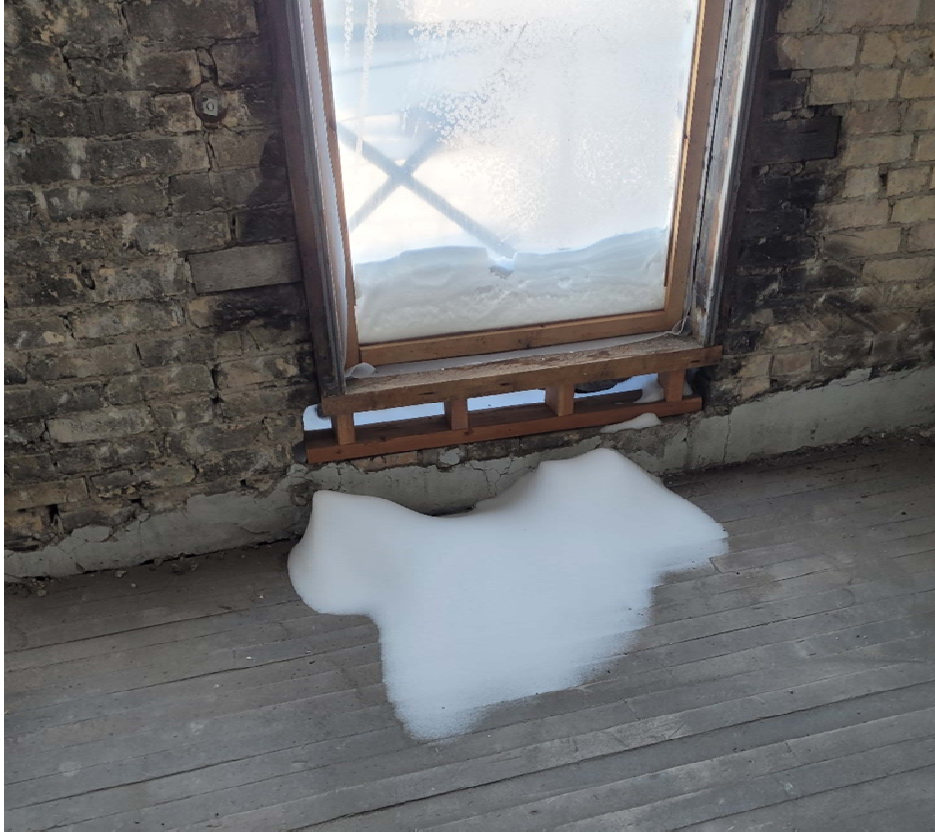
Photo 32: 246 Princess – Brick repair required at window on east façade

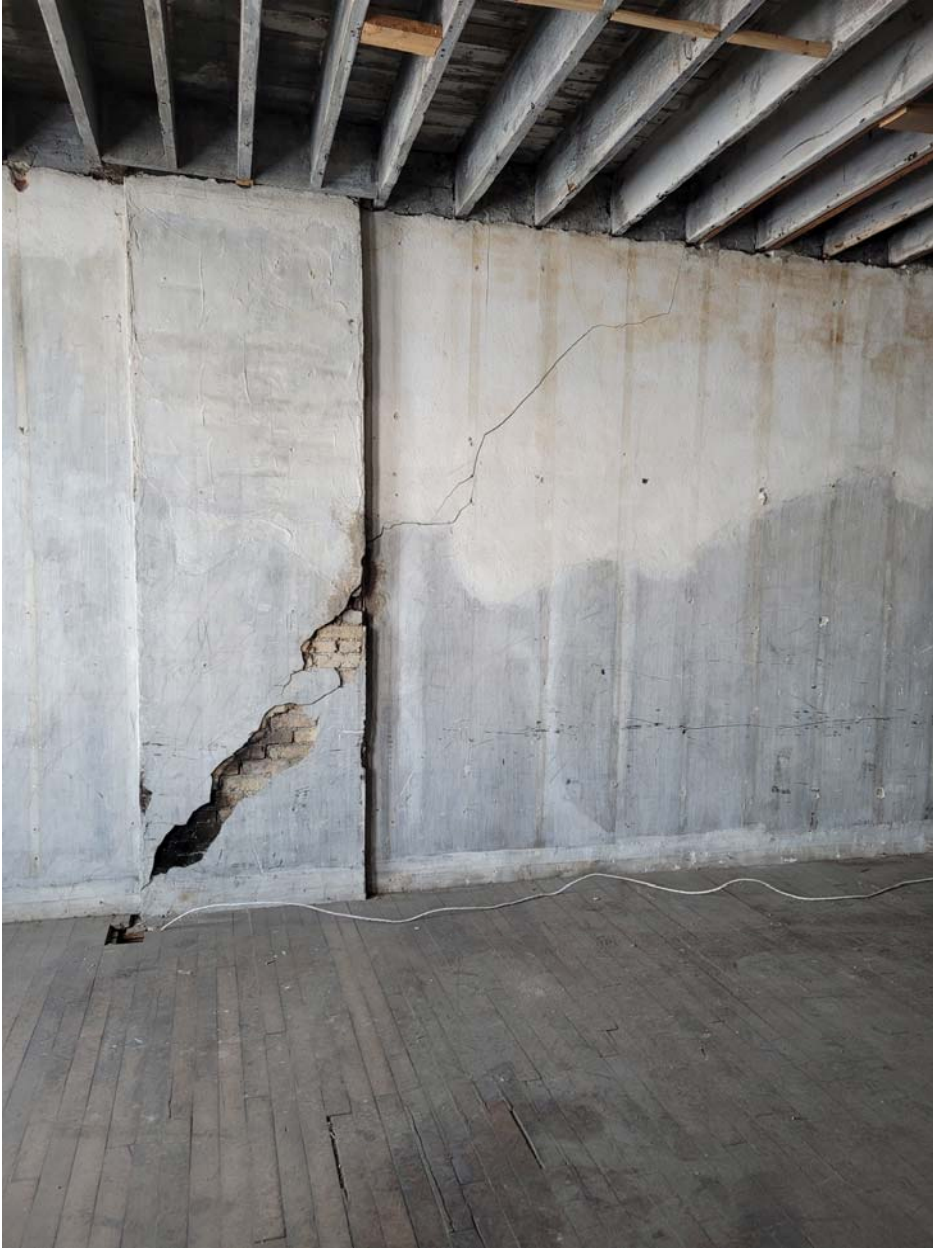
Photo 33: 246 Princess – Crack at demising wall near east façade with large crack.

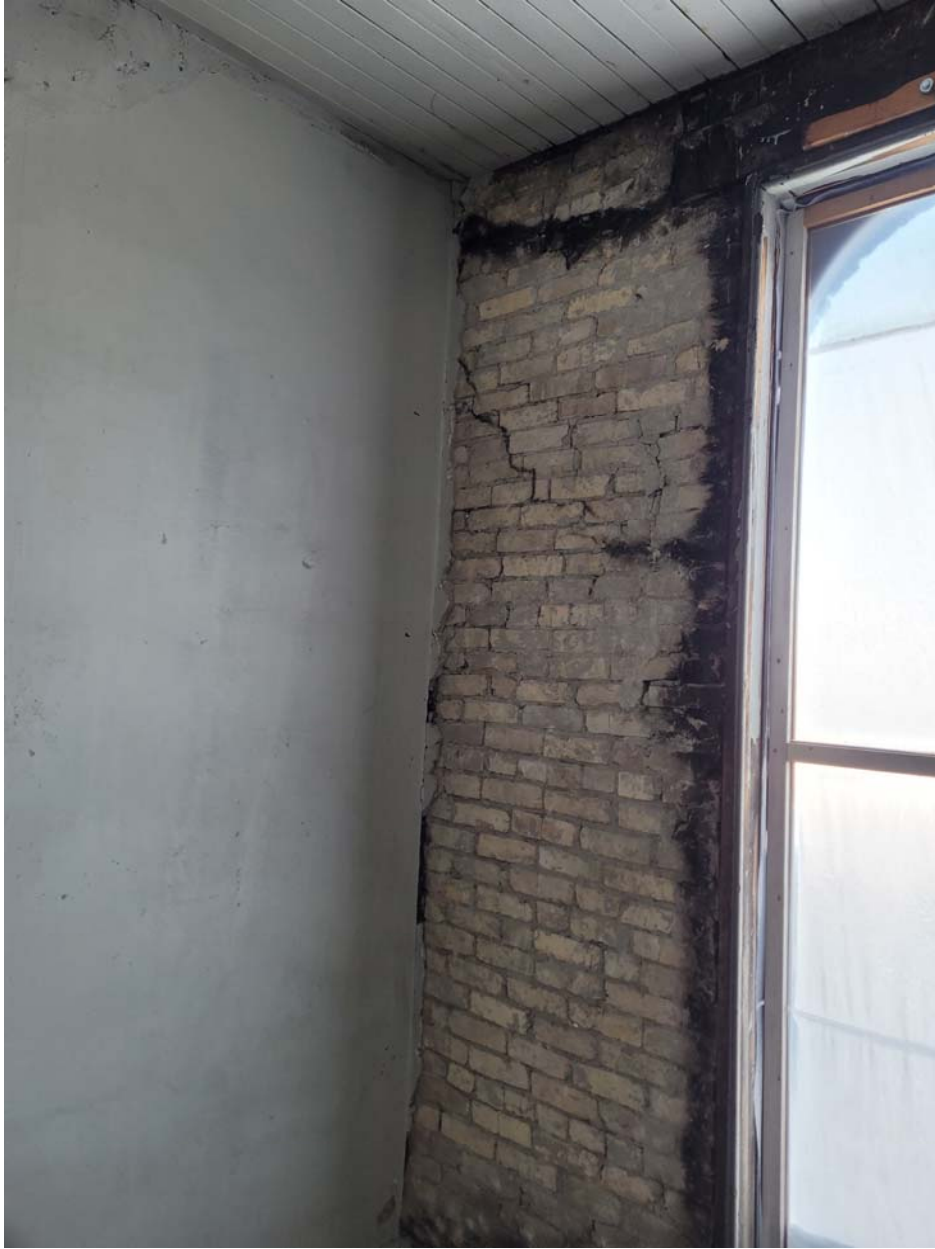
Photo 34: 246 Princess – Repointing required at east façade.

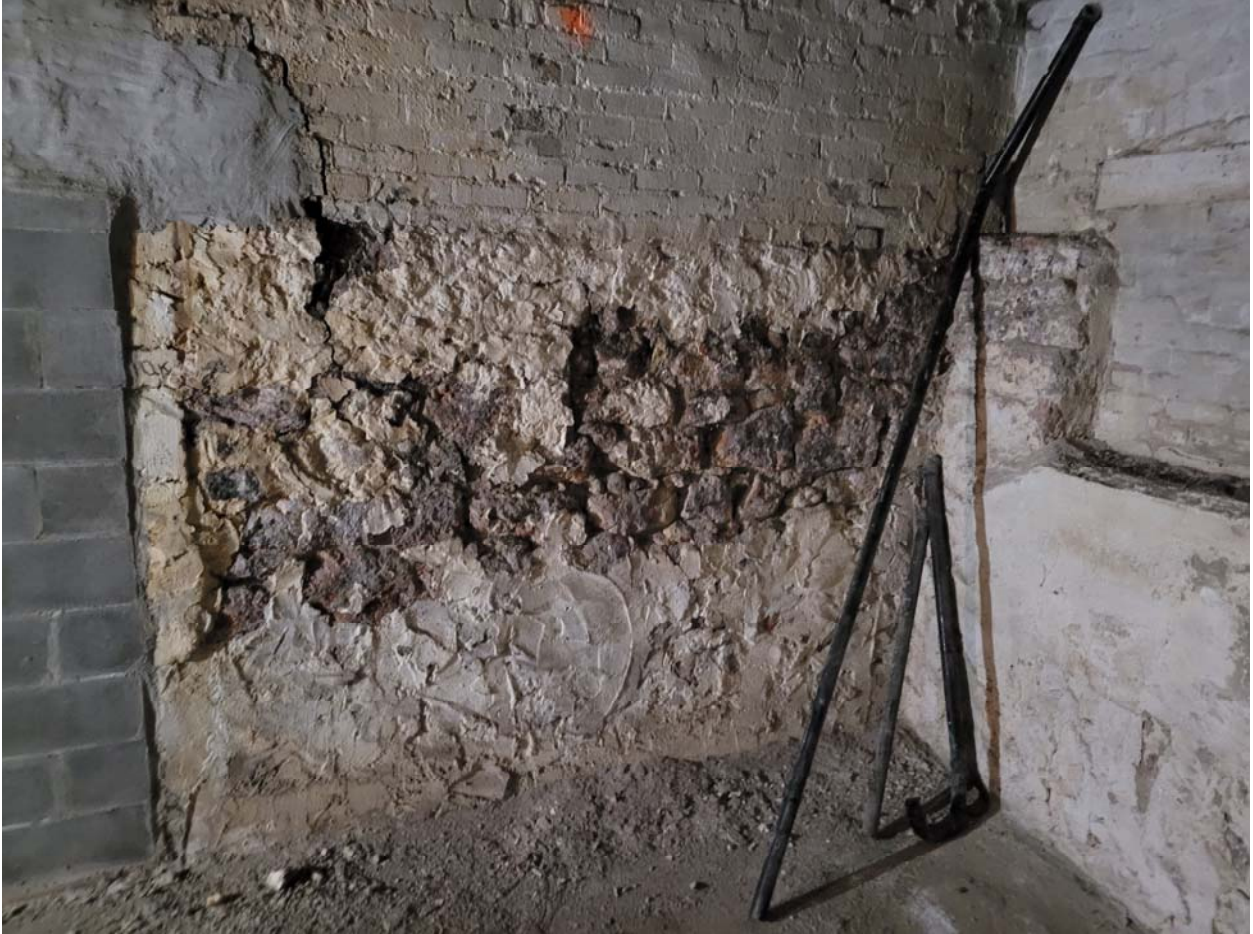
Photo 35: 246 Princess – Demising rubble wall requiring repointing.

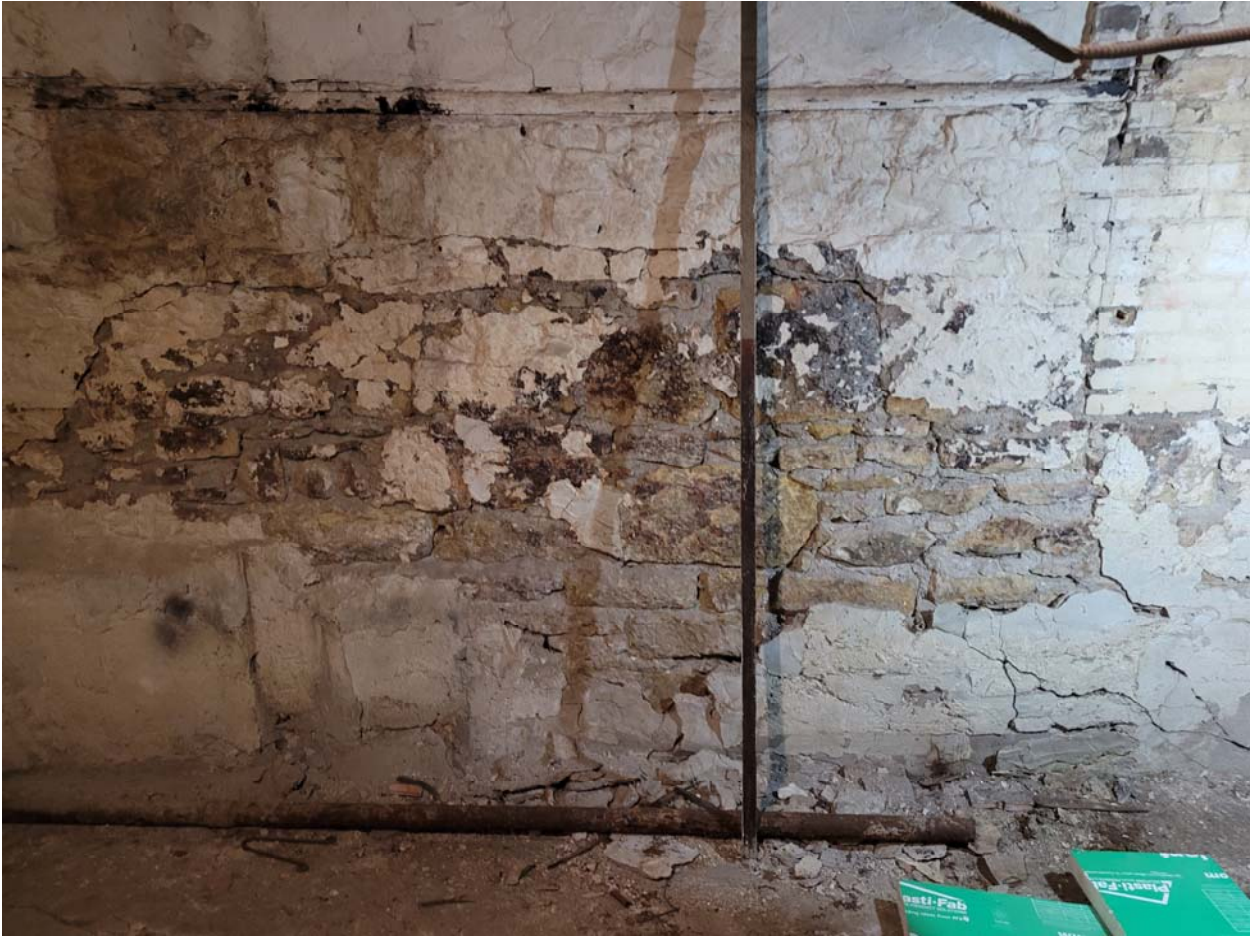
Photo 36: 246 Princess – Demising rubble wall requiring repointing.
