City of Winnipeg
Chlorine Ventilation Upgrades
At Regional Pumping Stations
Tender Opportunity 415-2025

APPENDIX F
Asbestos Reports

2023 Asbestos Reassessment

G.C MacLean Pumping Station
and Reservoir
875 Lagimodiere Boulevard,
Winnipeg, Manitoba

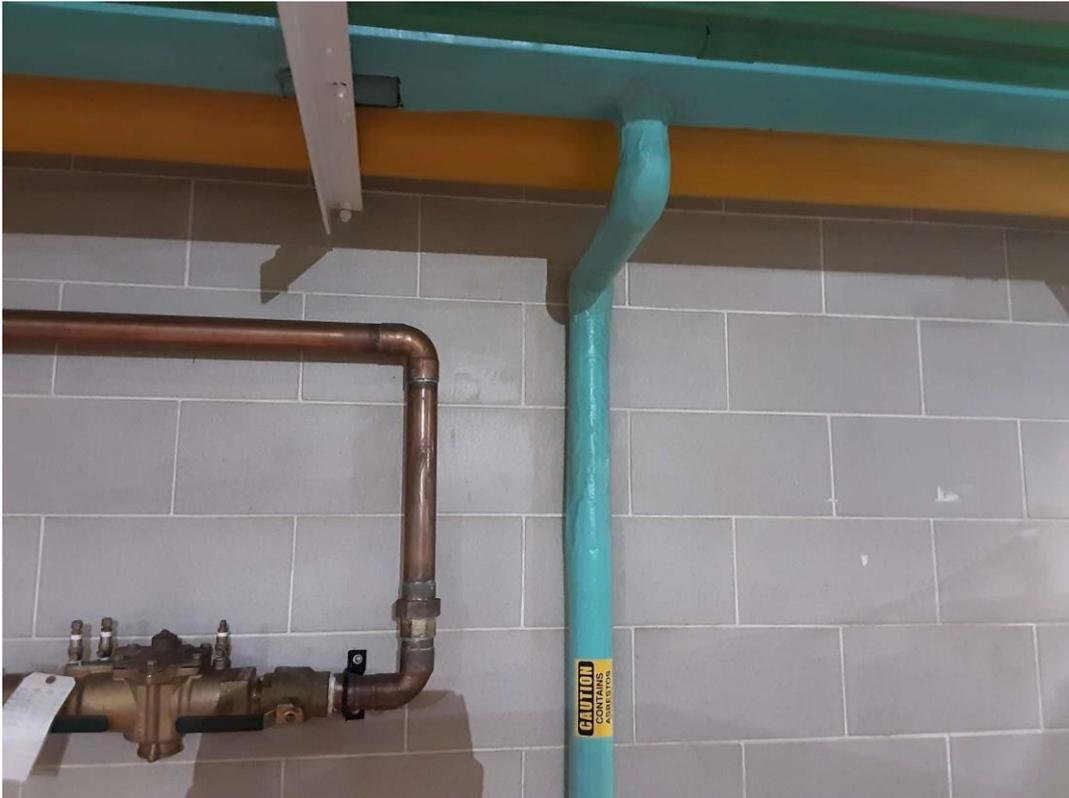
V0002 (Confirmed Asbestos), Piping, Domestic Water (Hot and Cold), Parging over Fiberglass, Pump Floor (Location #: 19)

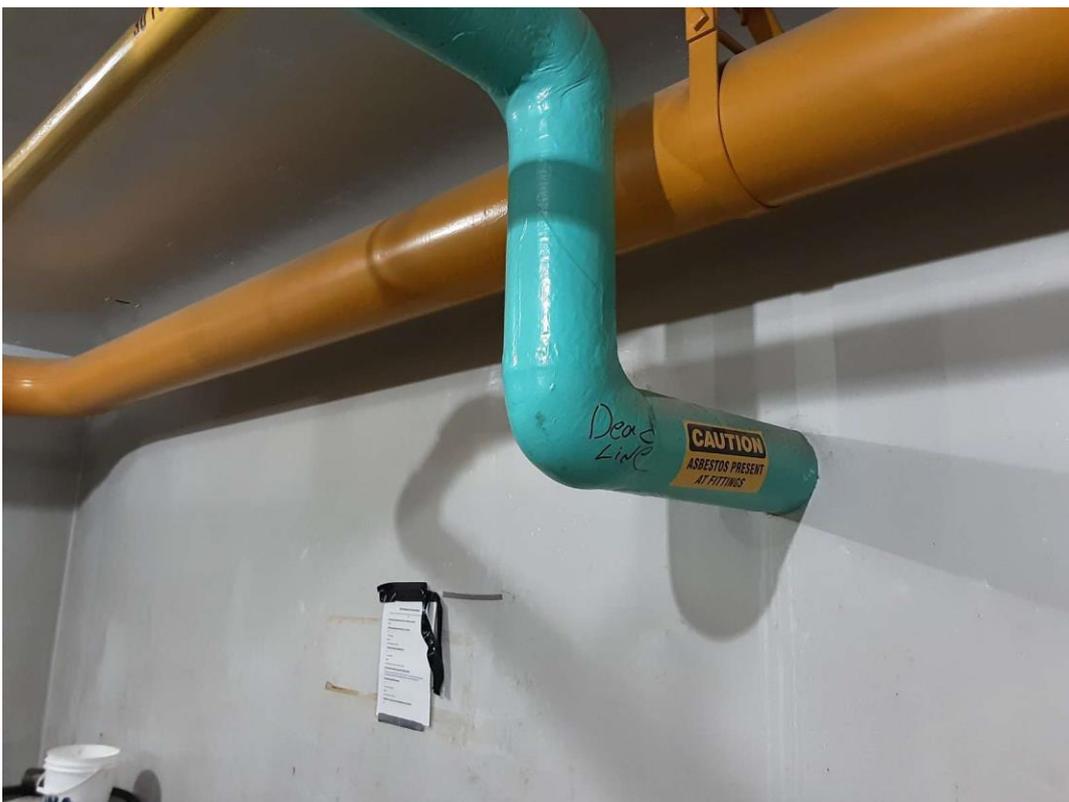
V0002 (Confirmed Asbestos), Piping, Domestic Water (Hot and Cold), Parging over Fibreglass, Maintenance Room (Location #: 20)

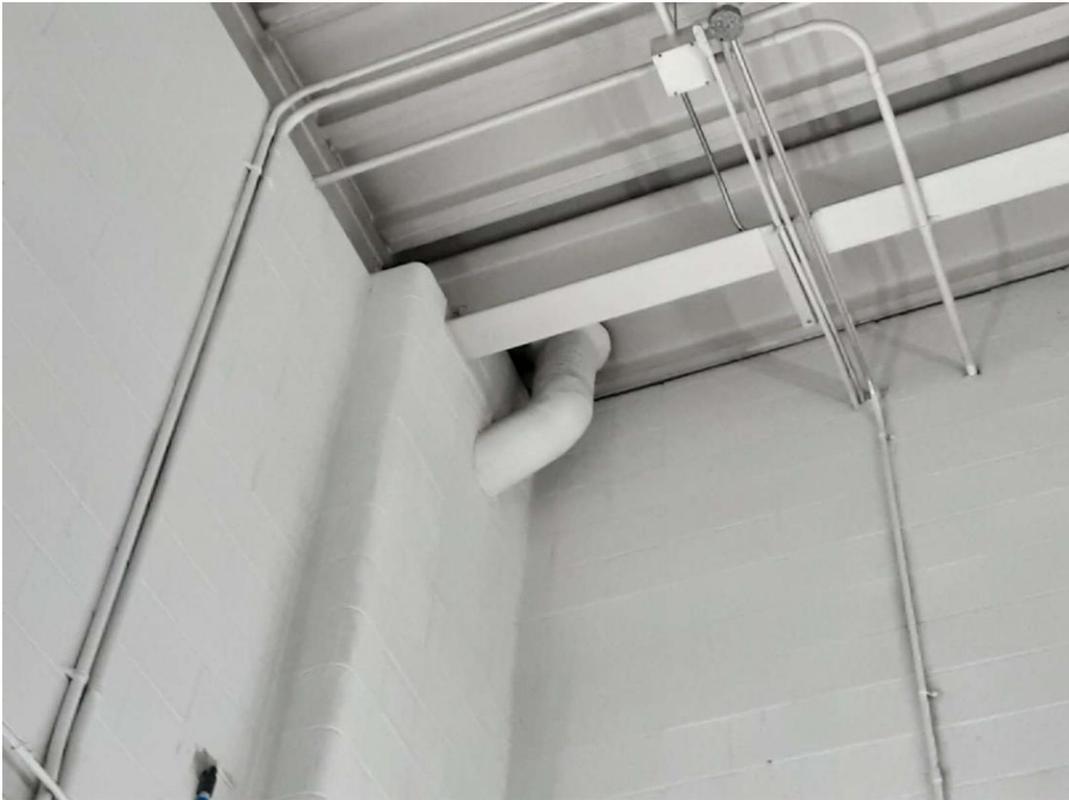
V0002 (Confirmed Asbestos), Piping, Rain Water Leader, Parging over Fibreglass, Chlorine Scale Room (Location #: 7)

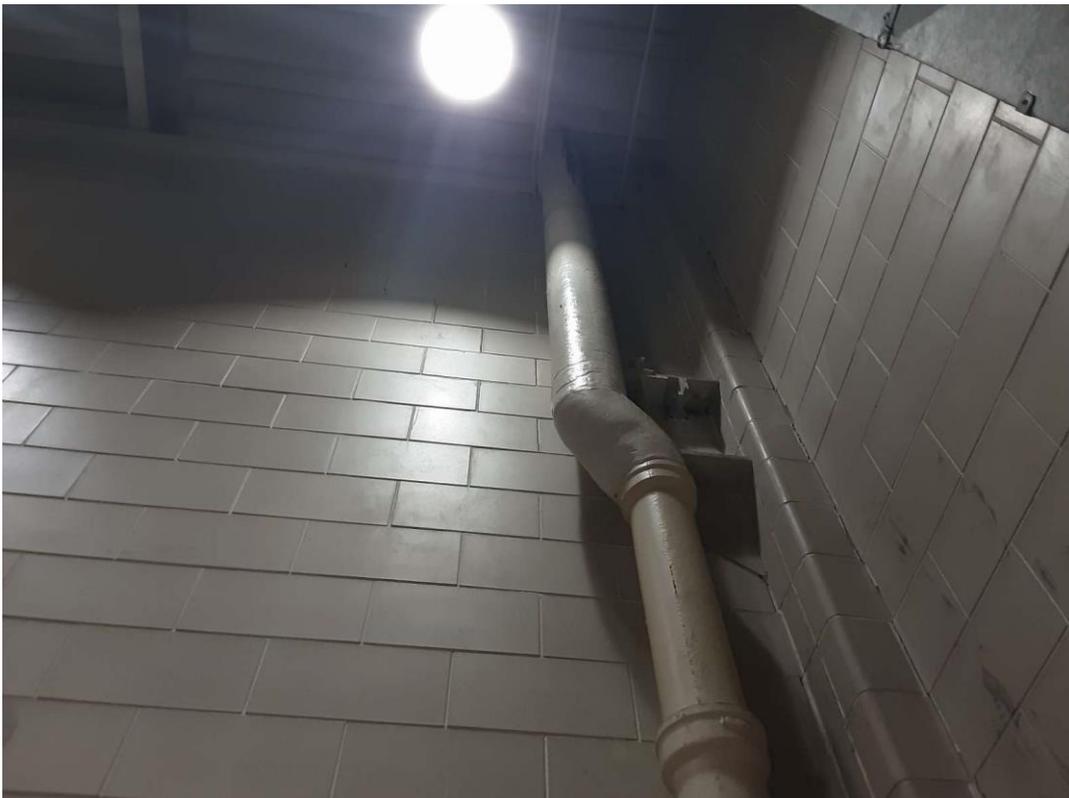
V0004 (Confirmed Asbestos), Piping, Rain Water Leader, Parging over Fibreglass, Ammonia Room (Location #: 11)

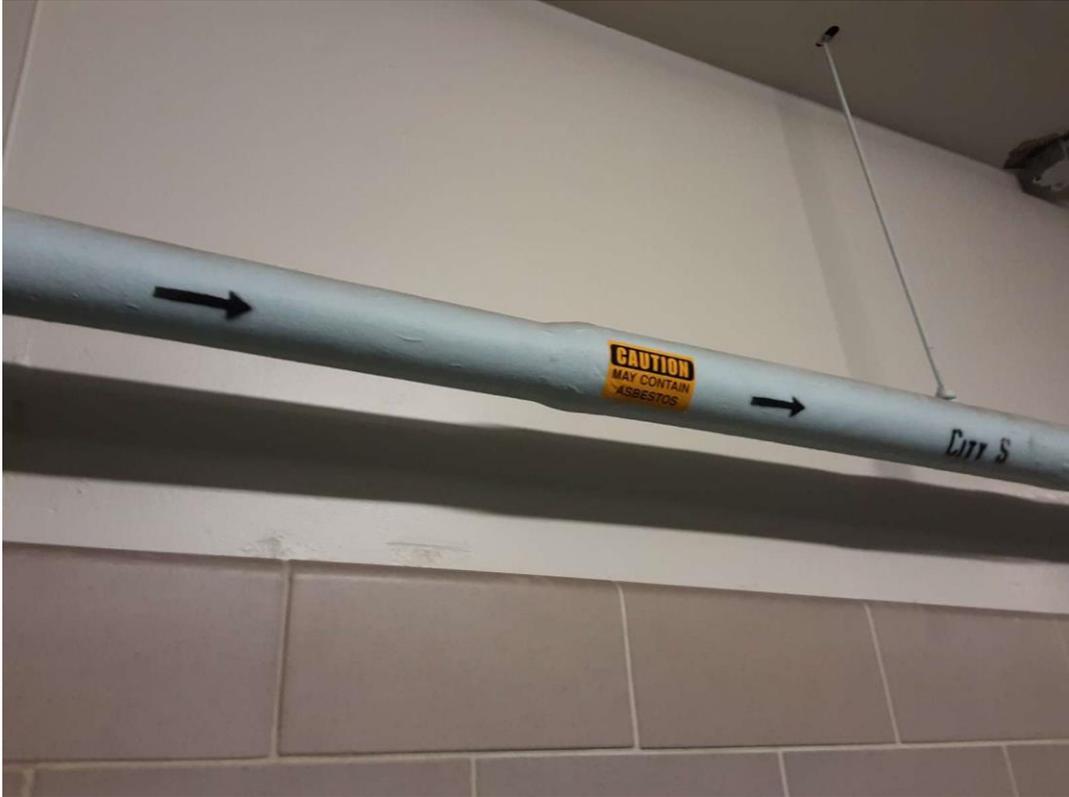
V0004 (None), Piping, Domestic Water (Hot and Cold), Abated Material, North Mezzanine (Location #: 15)

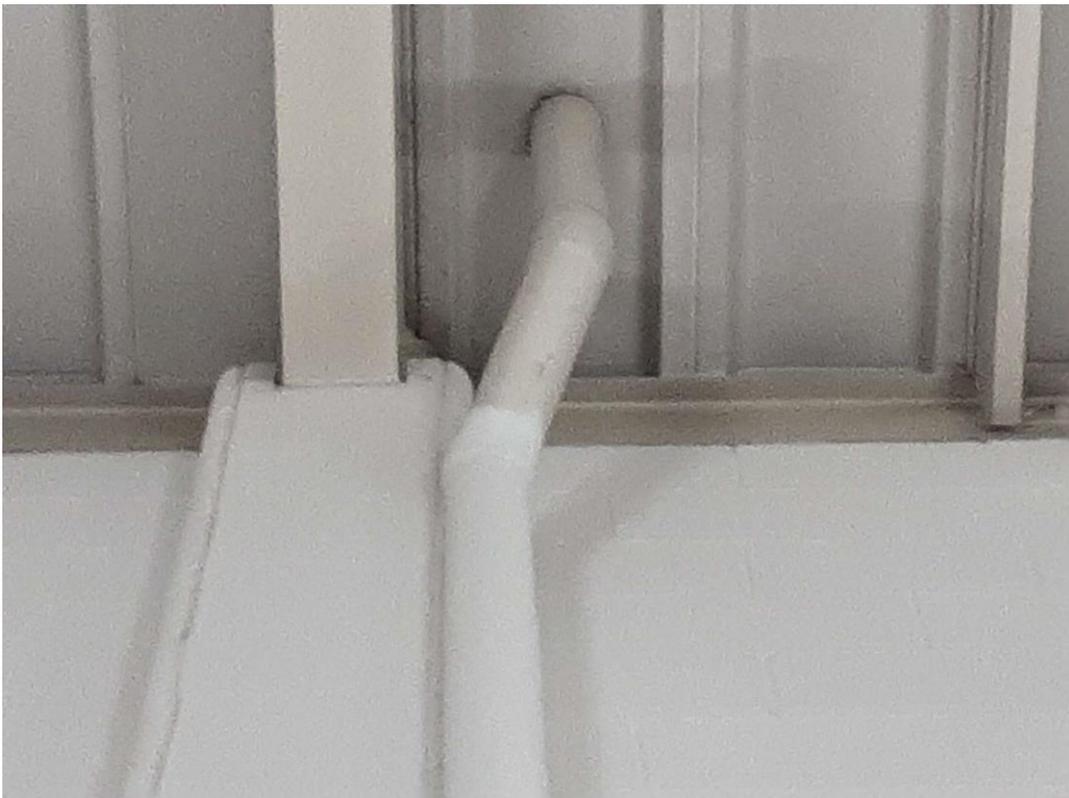
V0004 (Confirmed Asbestos), Piping, Rain Water Leader, Parging over Fiberglass, Chlorine Tonner Room (Location #: 9)

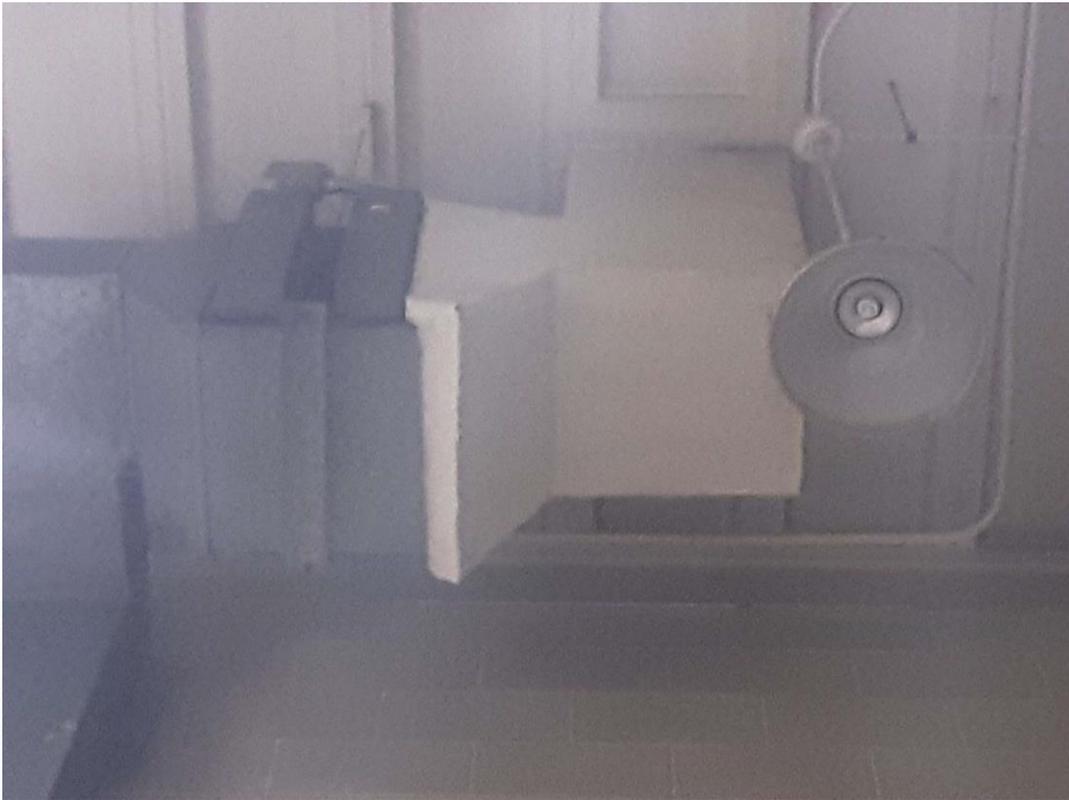
V0005 (Confirmed Asbestos), Duct, Fresh Air Intake, Fiberglass w/Parging, Ammonia Room (Location #: 11)

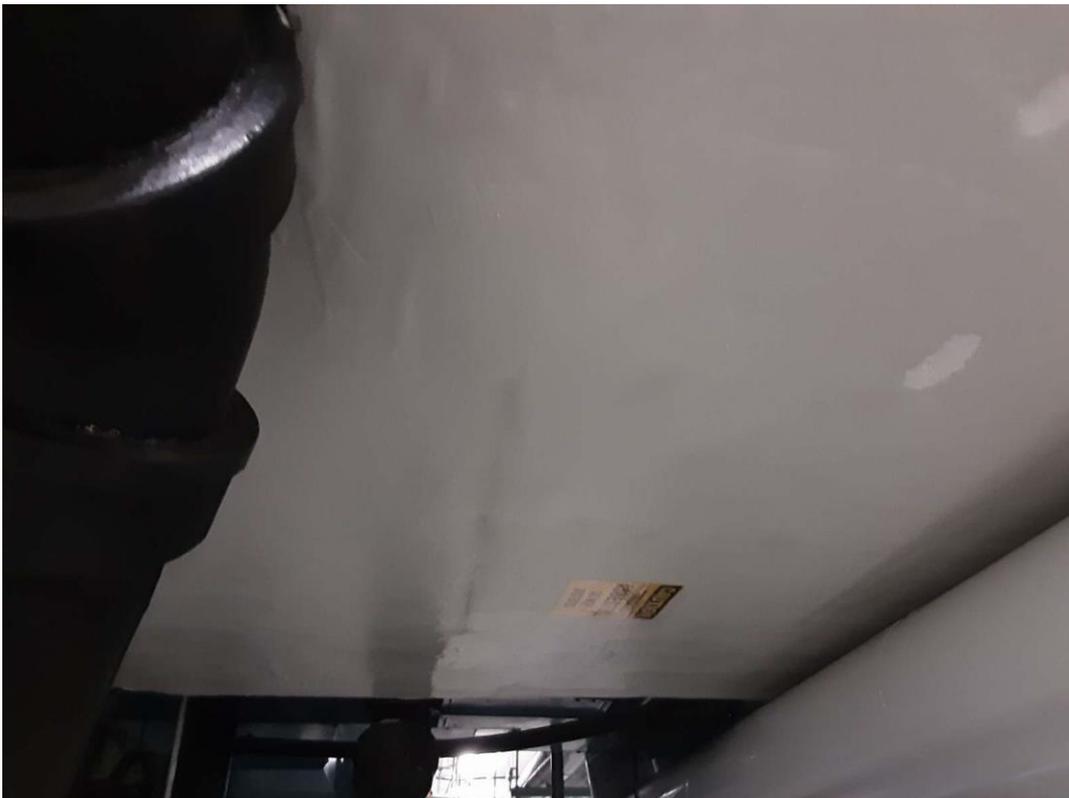
V0005 (Confirmed Asbestos), Duct, Fresh Air Intake, Fiberglass w/Parging, Fan Room (Location #: 16)

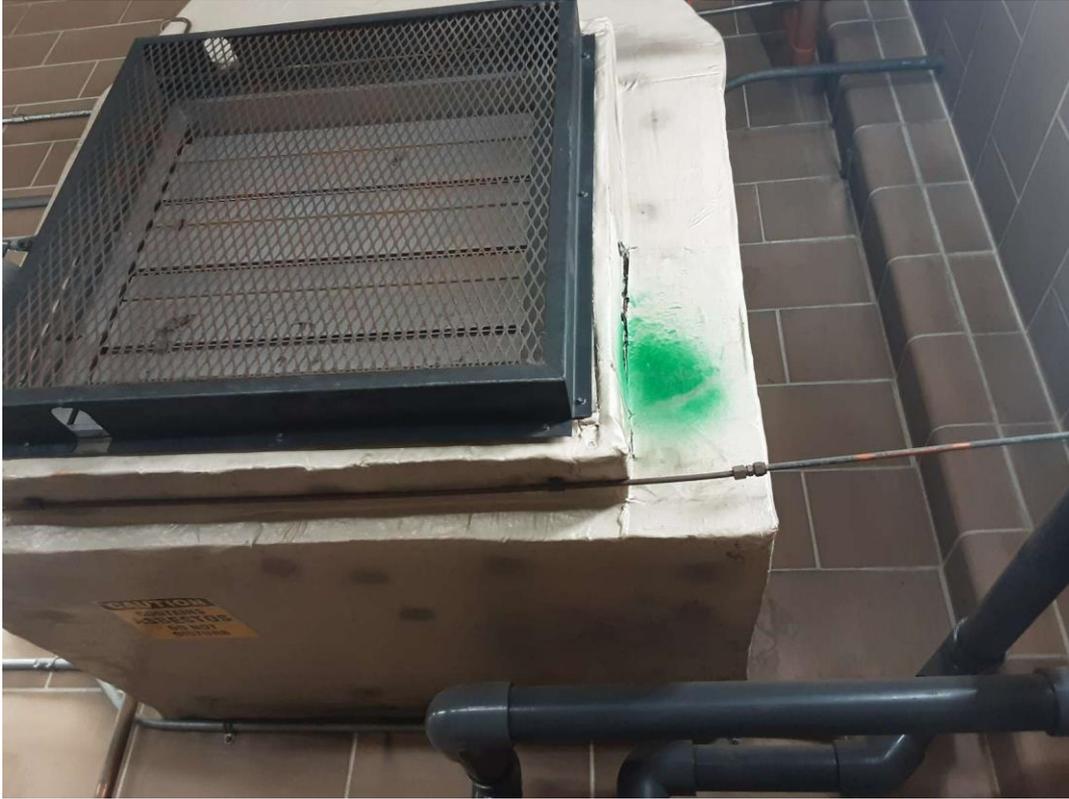
Asbestos-containing parging cement is present as duct insulation within the Chlorine Analyser Room (Location No. 6), Chlorine Scale Room (Location No. 7), Ammonia Room (Location No. 11), Fan Room (Location No. 16), and Pump Floor (Location No. 19). Parging cement is a friable material which is jacketed with canvas and is in GOOD condition except for 1 SF of damage rated in FAIR condition within Location No.6.

V0005 (Confirmed Asbestos), Duct, Fresh Air Intake, Fiberglass w/Parging, Chlorine Analyzer Room (Location #: 6)

| Material, Quantity & Condition | Location Name (Location #) | Recommended Procedure |
|---|---|---|
| Parging cement, 1 SF fair condition | Ducting within Location No.6 | Repair in accordance with moderate risk procedures. |

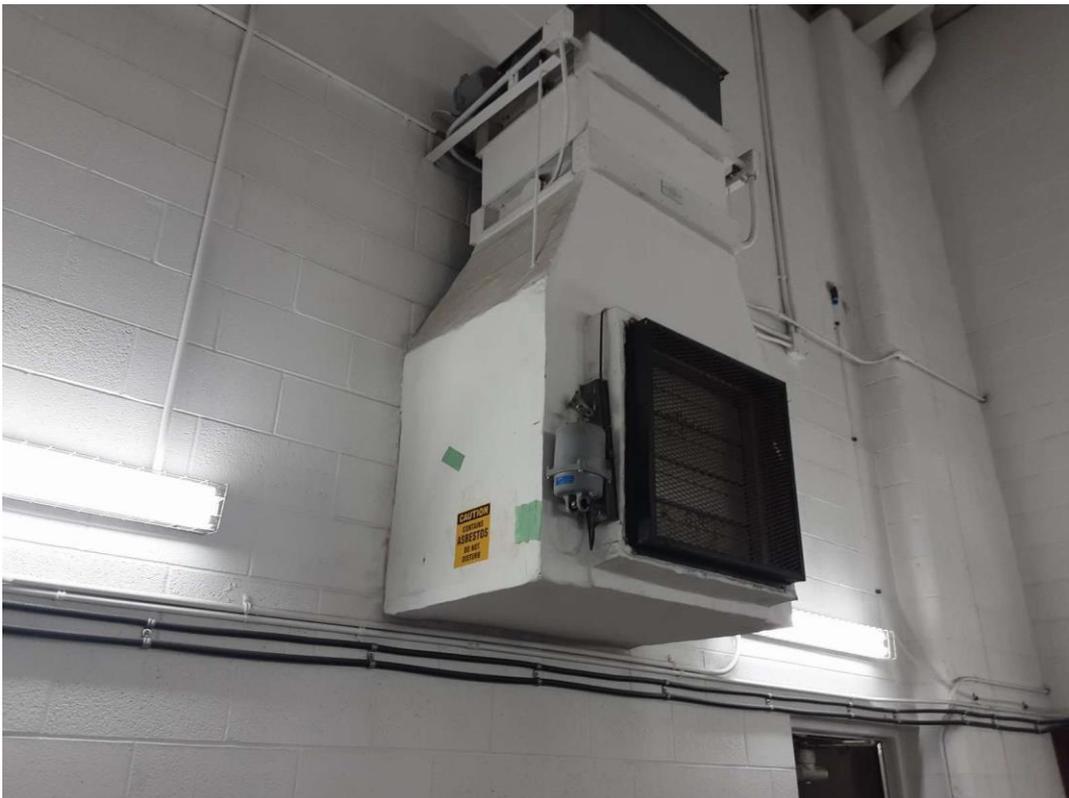
S0005 (Confirmed Asbestos), Duct, Fresh Air Intake, Fiberglass w/Parging, Chlorine Scale Room (Location #: 7)

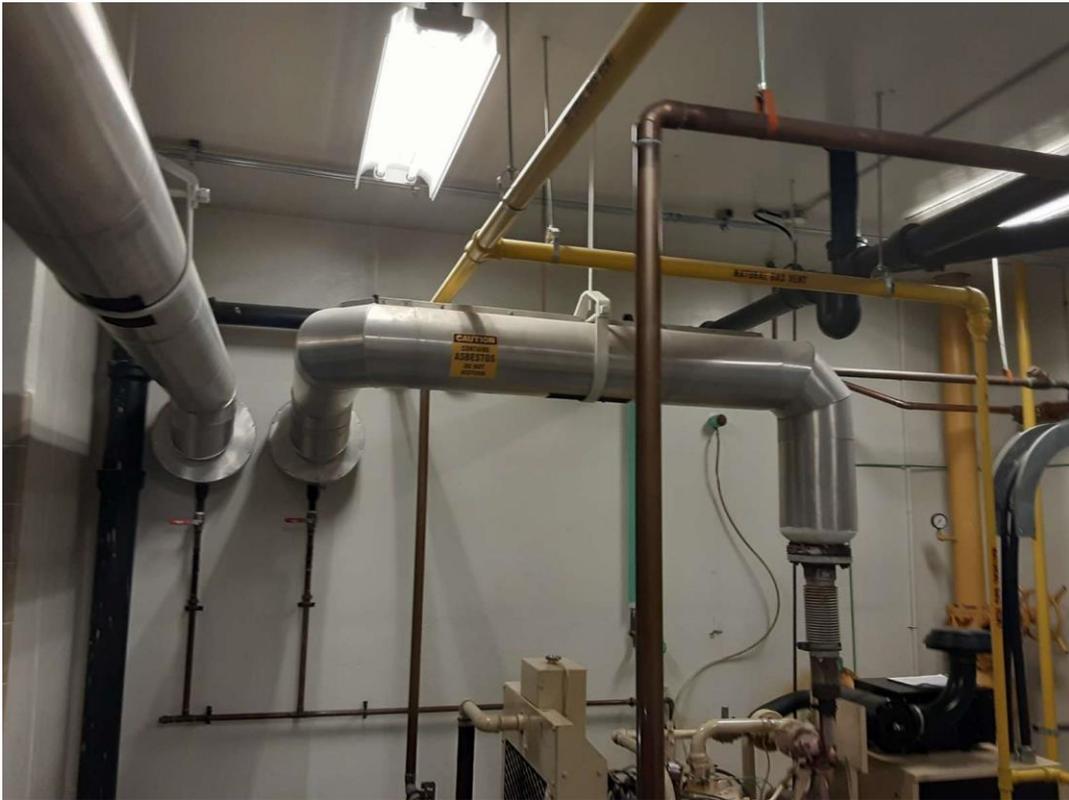
S0006 (Confirmed Asbestos), Mechanical Equipment, Generator Exhaust, Magnesia block, Generator Room (Location #: 18)

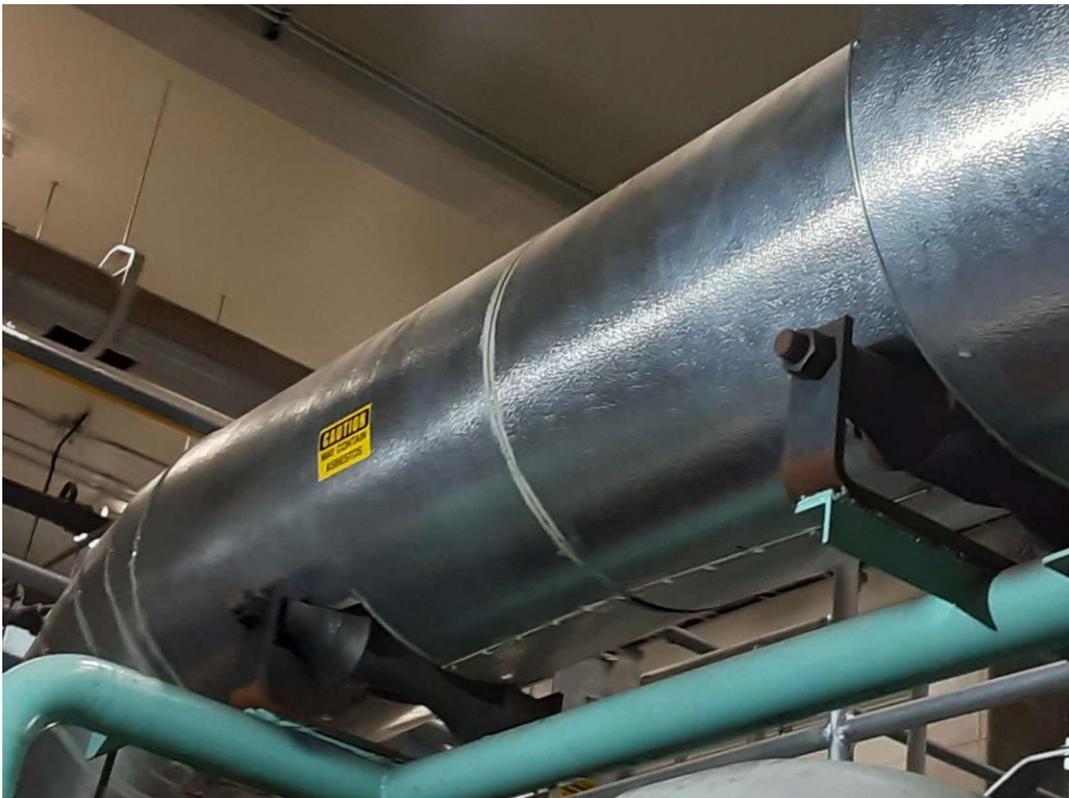
V0006 (Confirmed Asbestos), Duct, Exhaust, Magnesia block, Pump Floor (Location #: 19)

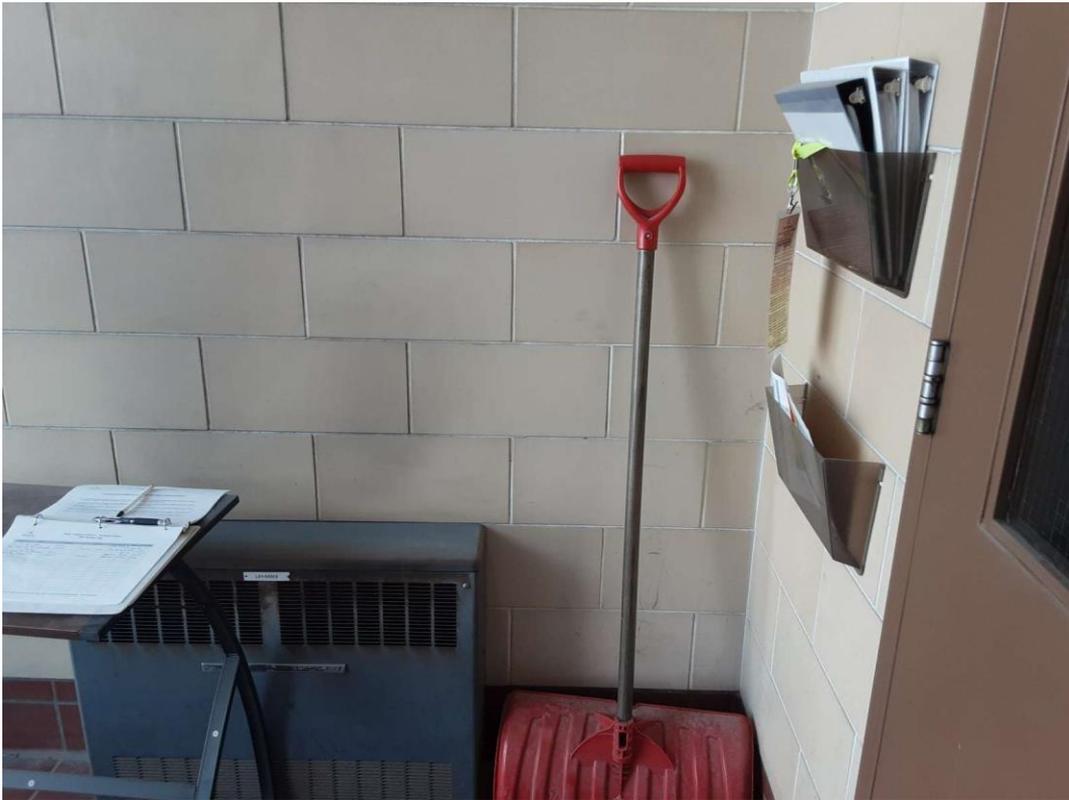
V9500 (Presumed Asbestos), Wall, All, Vermiculite/concrete block walls, Vestibule (Location #: 1)

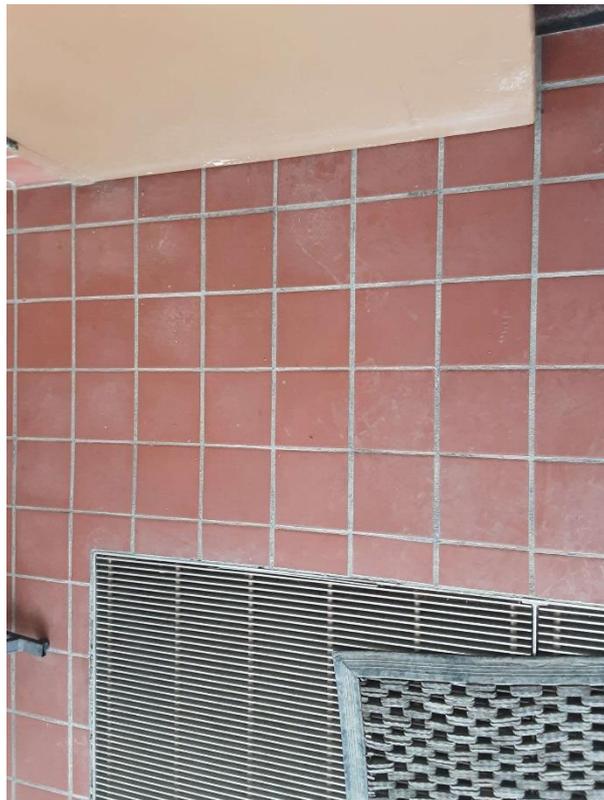
V9500 (Presumed Asbestos), Floor, All, Mortar, Vestibule (Location #: 1)

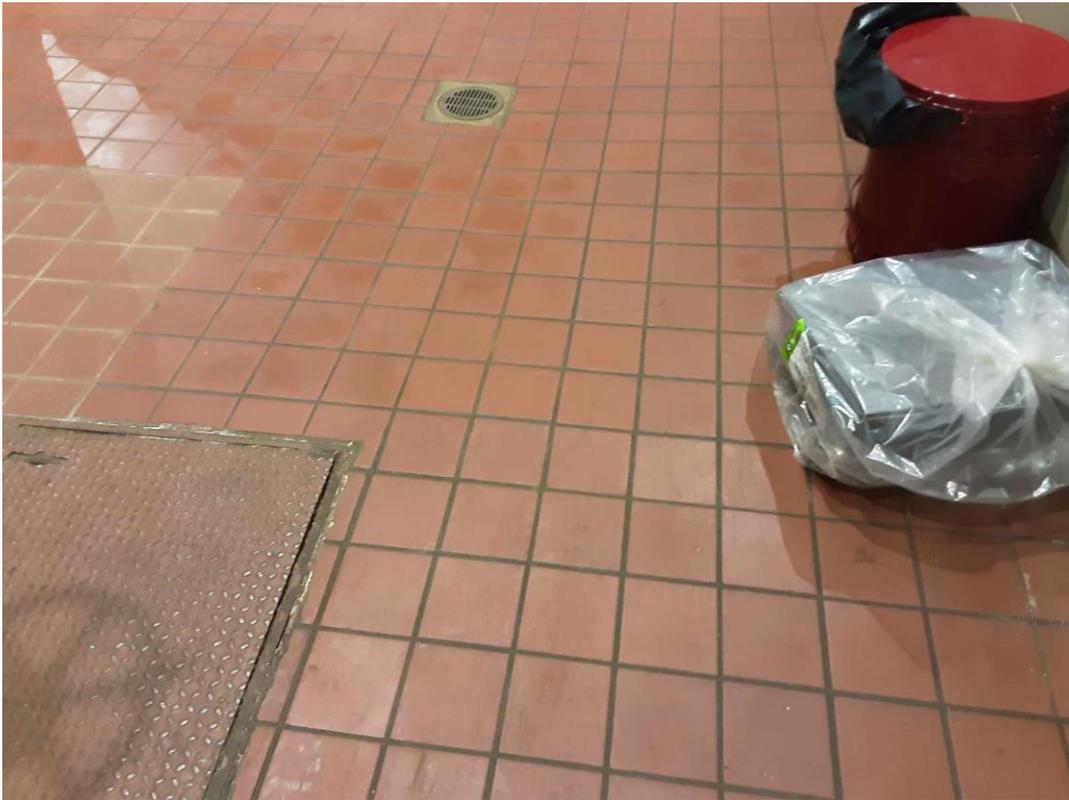
V9500 (Presumed Asbestos), Floor, All, Mortar, Pump Floor (Location #: 19)

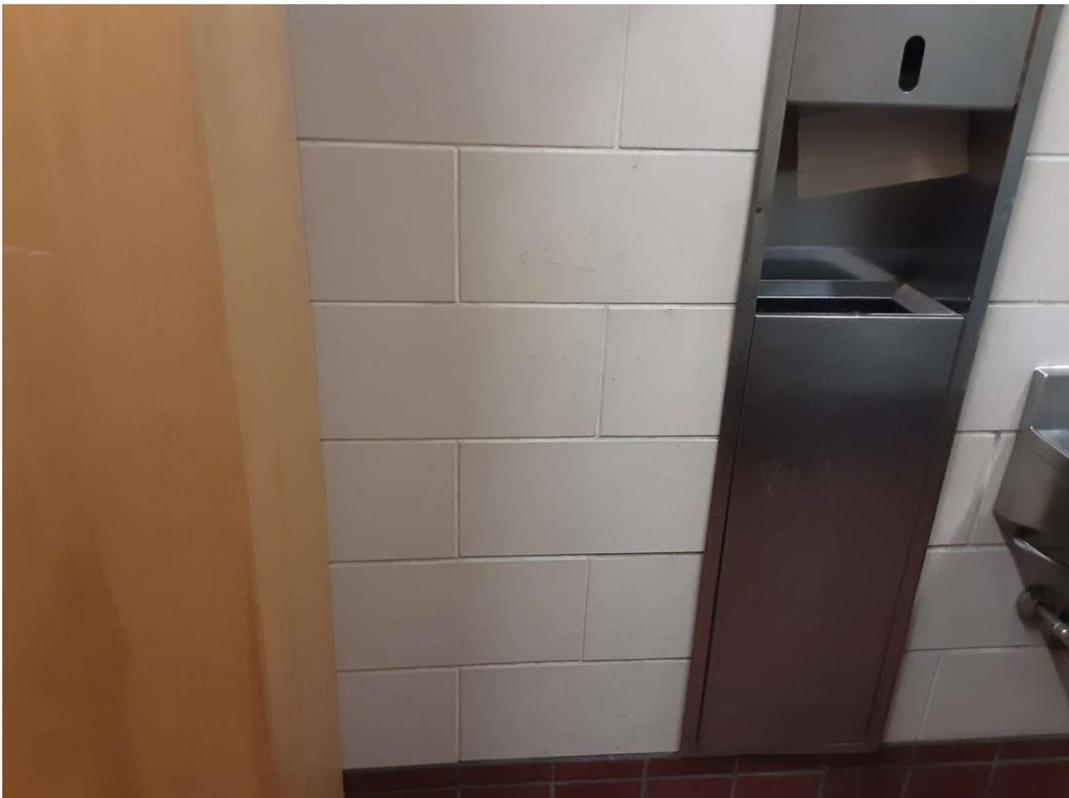
V9500 (Presumed Asbestos), Wall, All, Vermiculite/concrete block walls, Washroom (Location #: 3)

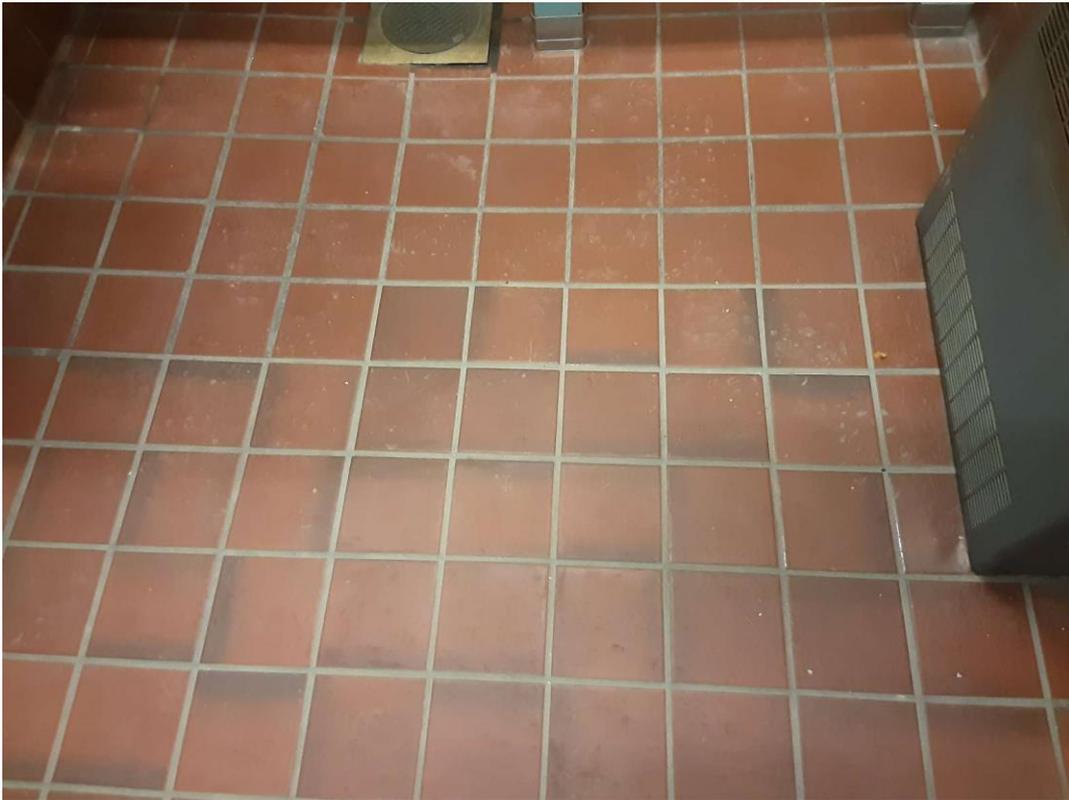
V9500 (Presumed Asbestos), Floor, All, Mortar, Washroom (Location #: 3)

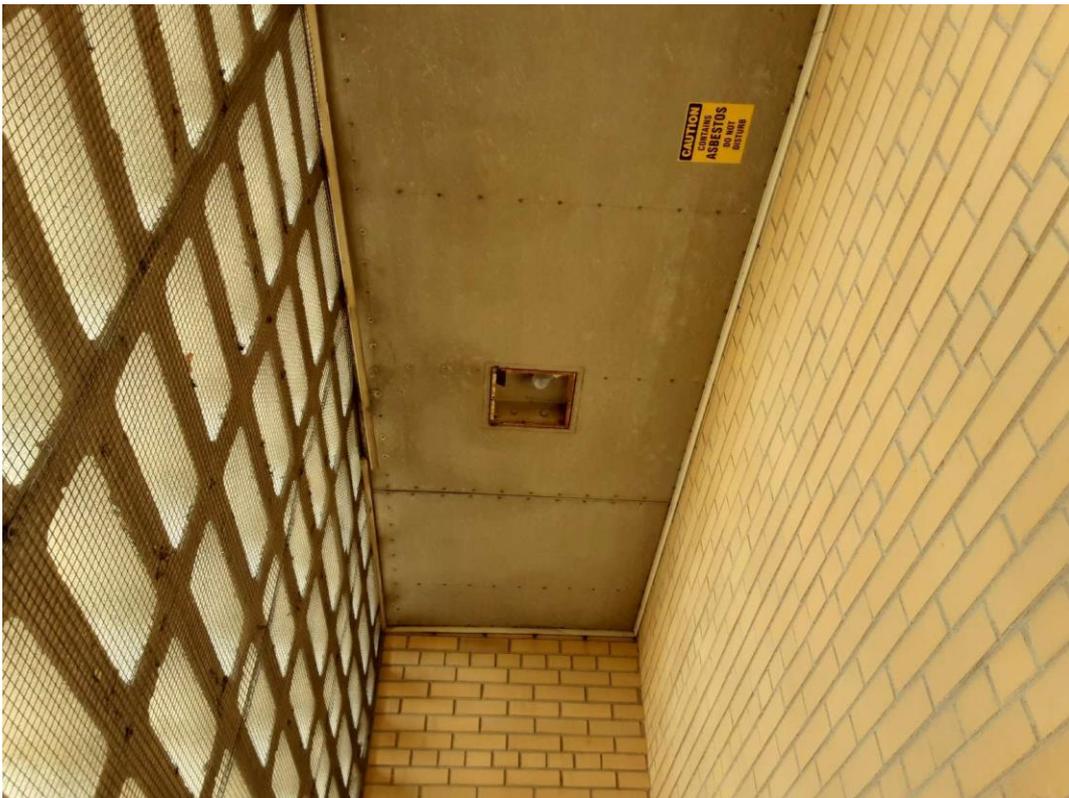
Structure, Vestibule (Location #: 10)

Asbestos-containing transite boards present as a ceiling finish in the Main Floor Vestibule (Location No. 10) are non-friable and are in GOOD condition.

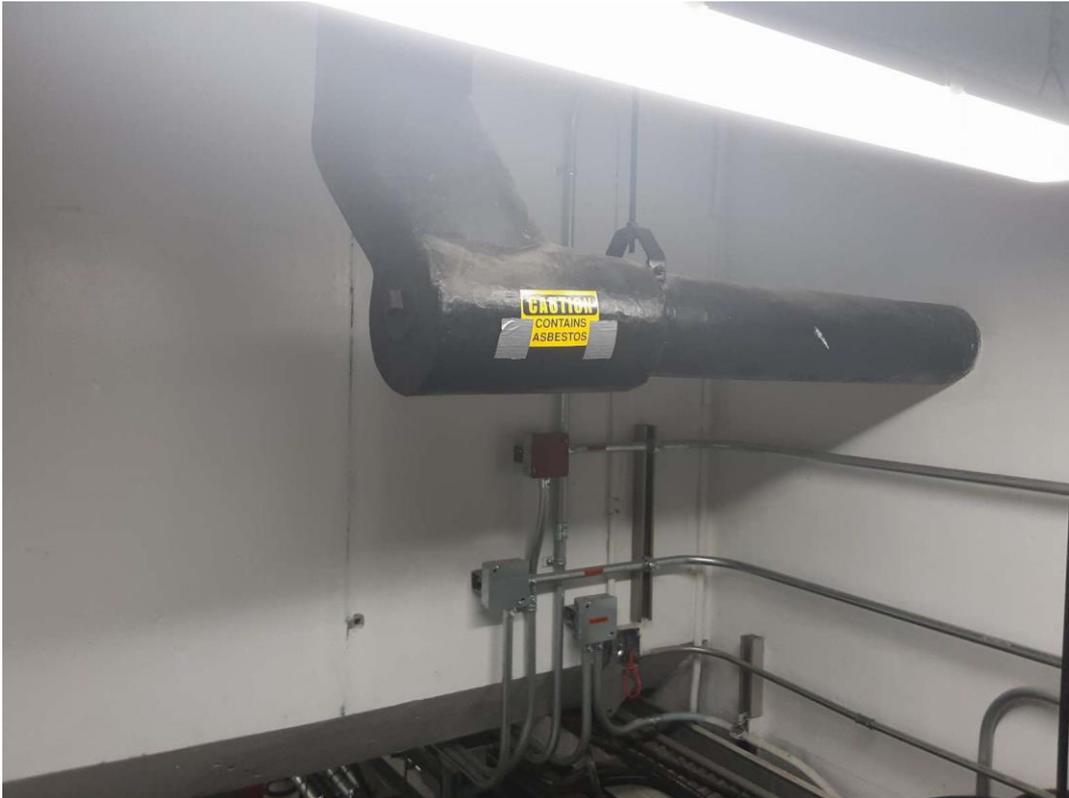
V0001 (Confirmed Asbestos), Piping, Rain Water Leader,
Chlorine Building - Stairwell (Location #: 11)

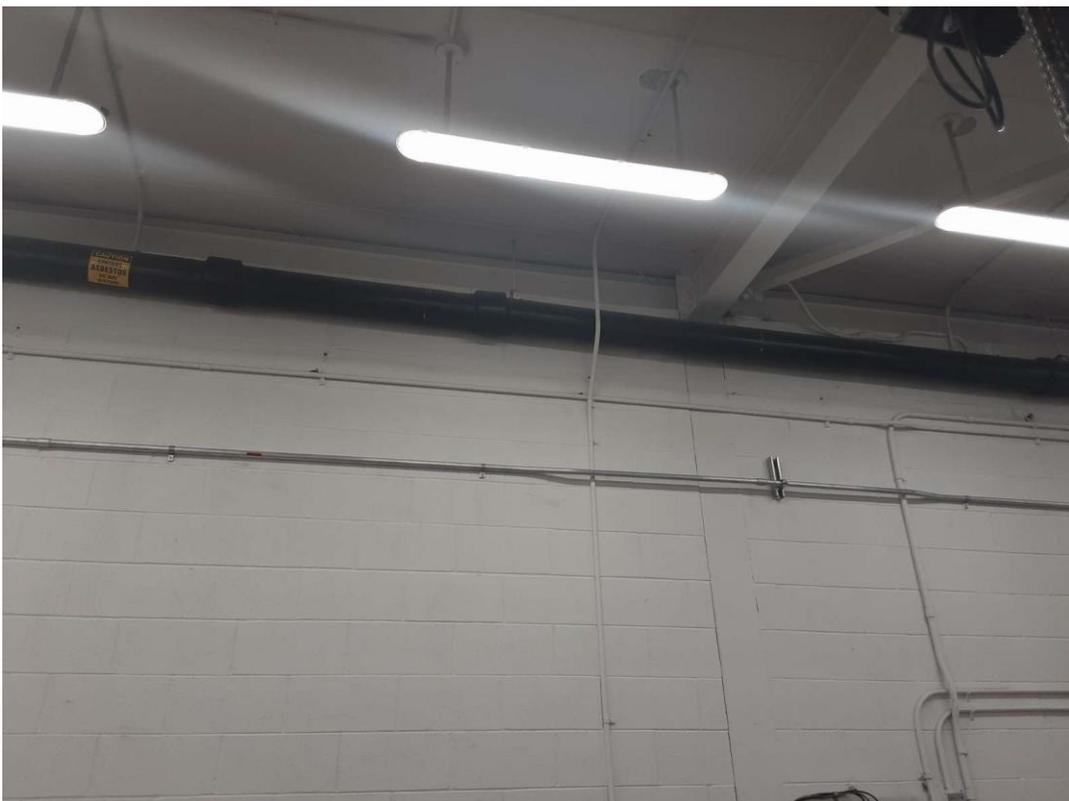
V0001 (Confirmed Asbestos), Piping, Rain Water Leader,
Chlorine Building - Chlorine Tonner Room (Location #: 8)

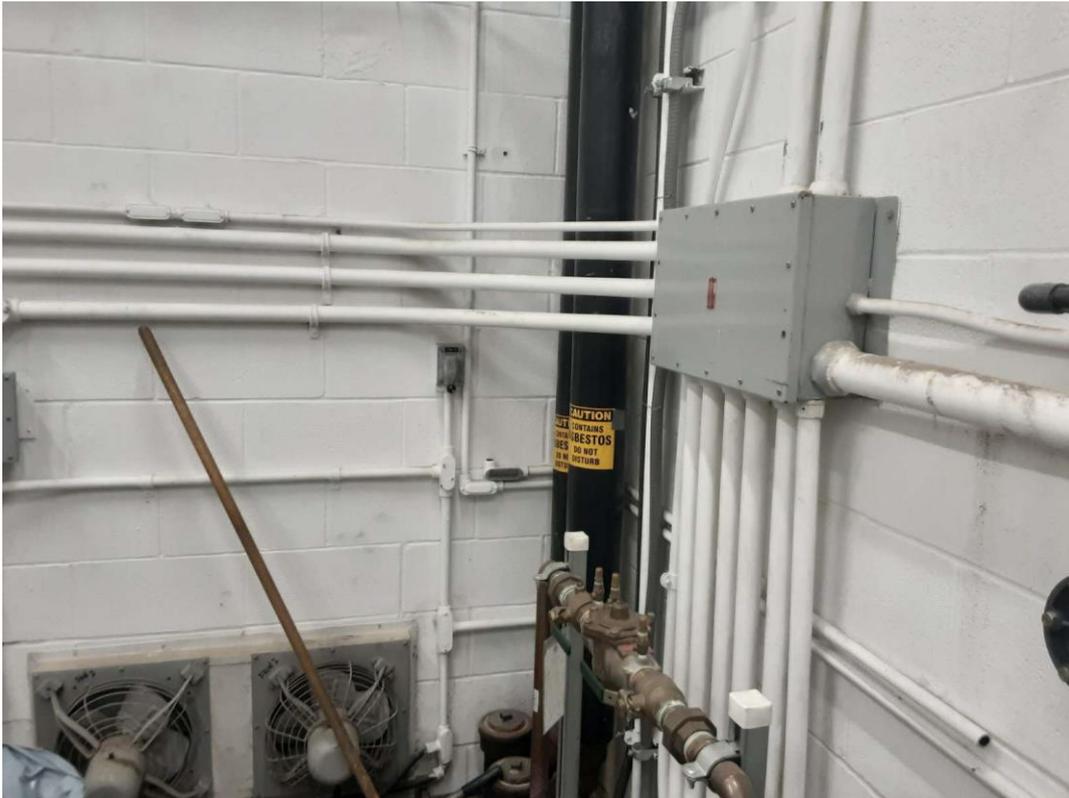
V0001 (Confirmed Asbestos), Piping, Rain Water Leader,
Chlorine Building - Chlorinator Room (Location #: 9)

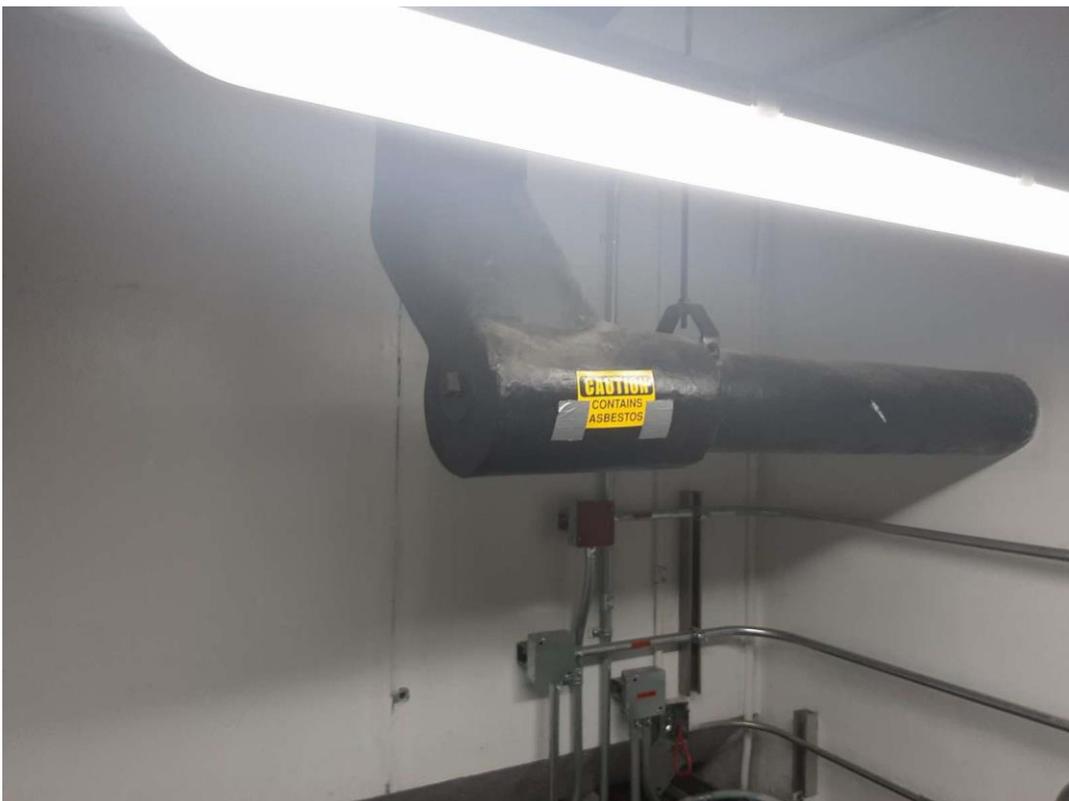
V0007 (Confirmed Asbestos), Piping, Rain Water Leader, Parging over Fibreglass,
Chlorine Building - Stairwell (Location #: 11)

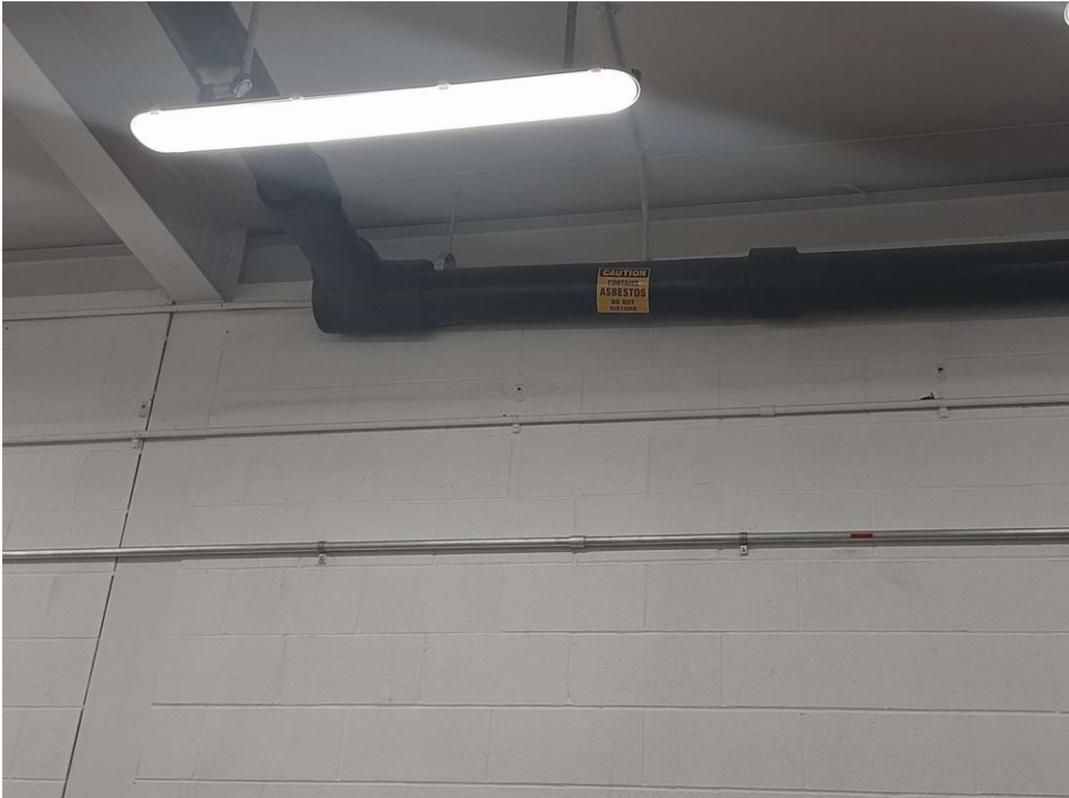
V0007 (Confirmed Asbestos), Piping, Rain Water Leader, Parging over Fibreglass,
Chlorine Building - Chlorine Tonner Room (Location #: 8)

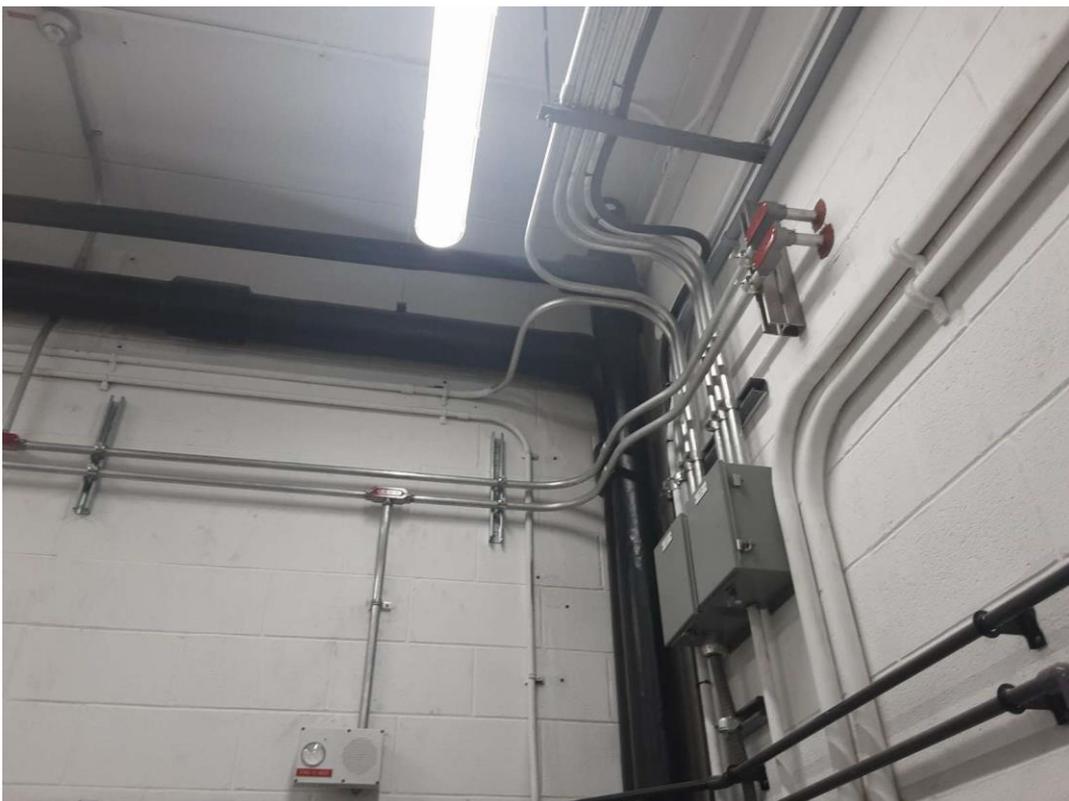
S0007 (Confirmed Asbestos), Piping, Rain Water Leader, Parging over Fibreglass,
Chlorine Building - Chlorinator Room (Location #: 9)

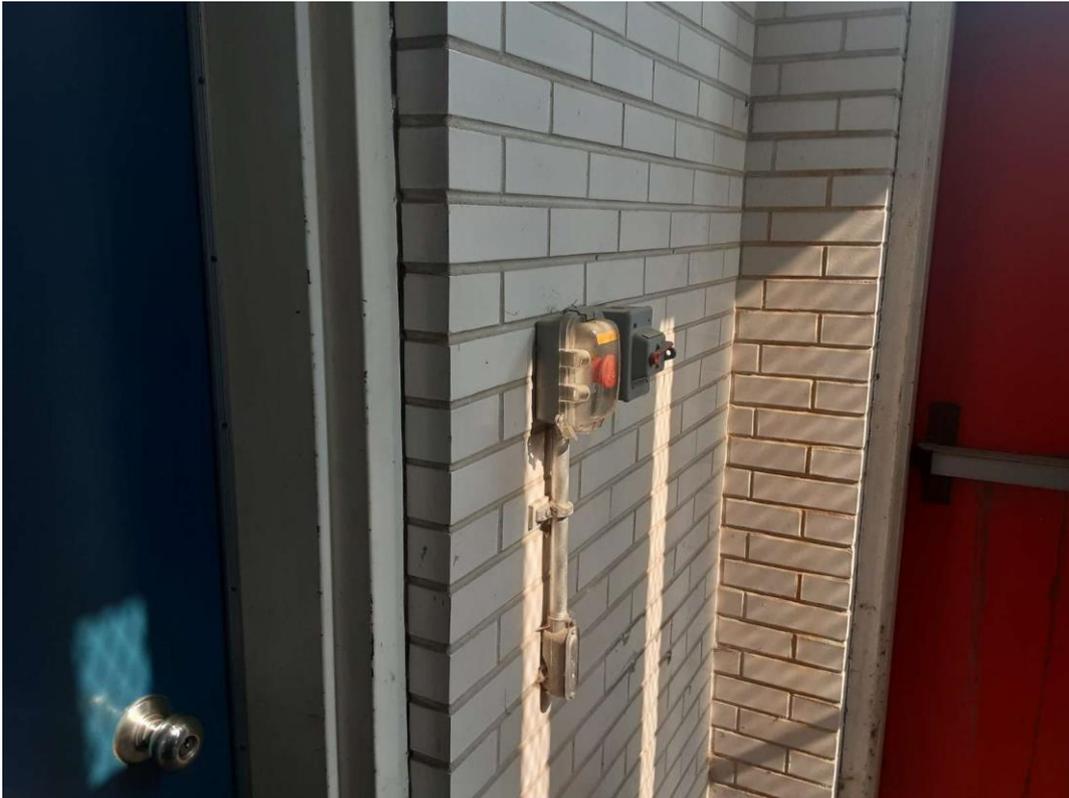
V9500 (Presumed Asbestos), Wall, Vermiculite,
Chlorine Building - Vestibule (Location #: 10)

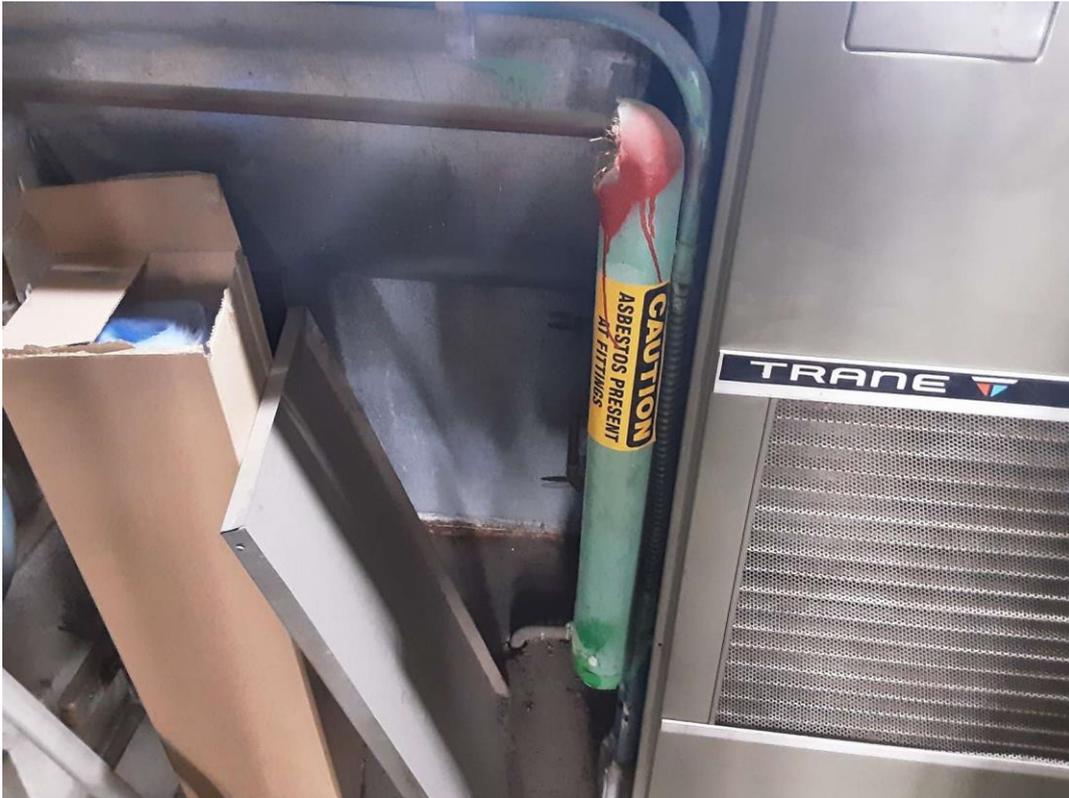
V0004 (Confirmed Asbestos), Damaged Piping, Domestic Water (Hot and Cold), Parging over Fibreglass, Old Pump Building
- Furnace Room (Location #: 21)
