City of Winnipeg
Chlorine Ventilation Upgrades
At Regional Pumping Stations
Tender Opportunity 415-2025

APPENDIX F
Asbestos Reports

2023 Asbestos Reassessment

G.C MacLean Pumping Station
and Reservoir
875 Lagimodiere Boulevard,
Winnipeg, Manitoba

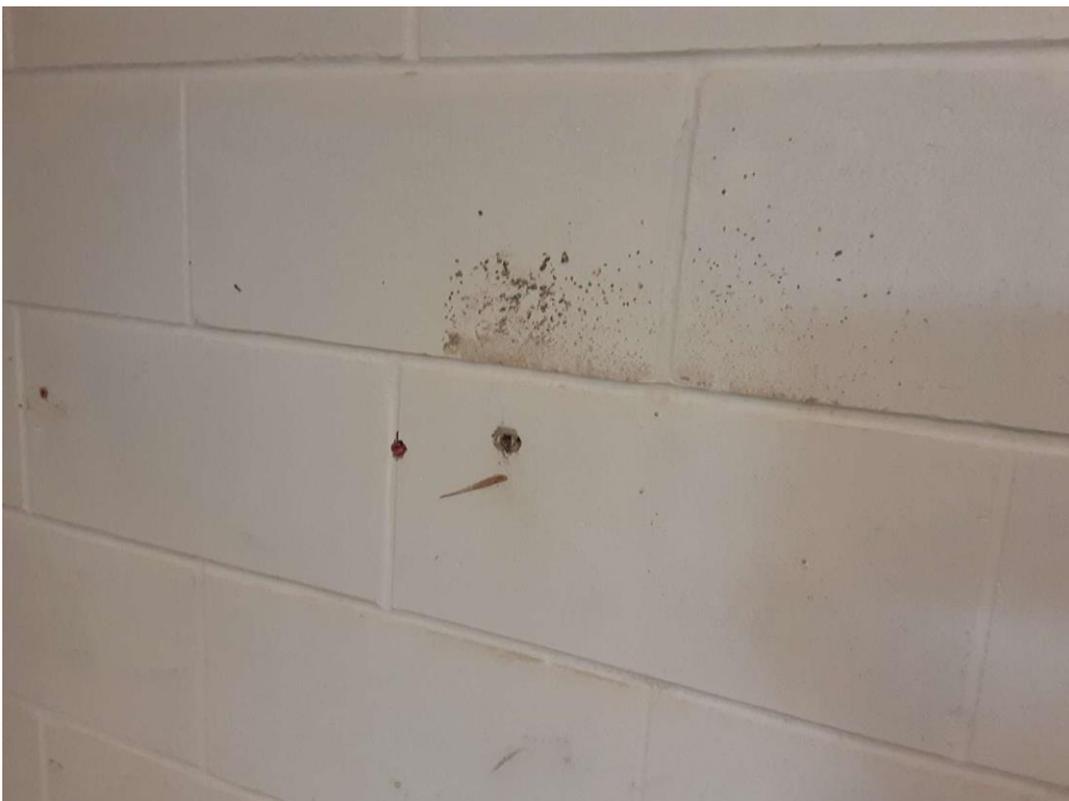
S0025 (Confirmed Asbestos), Wall, Vermiculite/concrete block walls,
Old Pump Building - Electrical Room (Location #: 30)

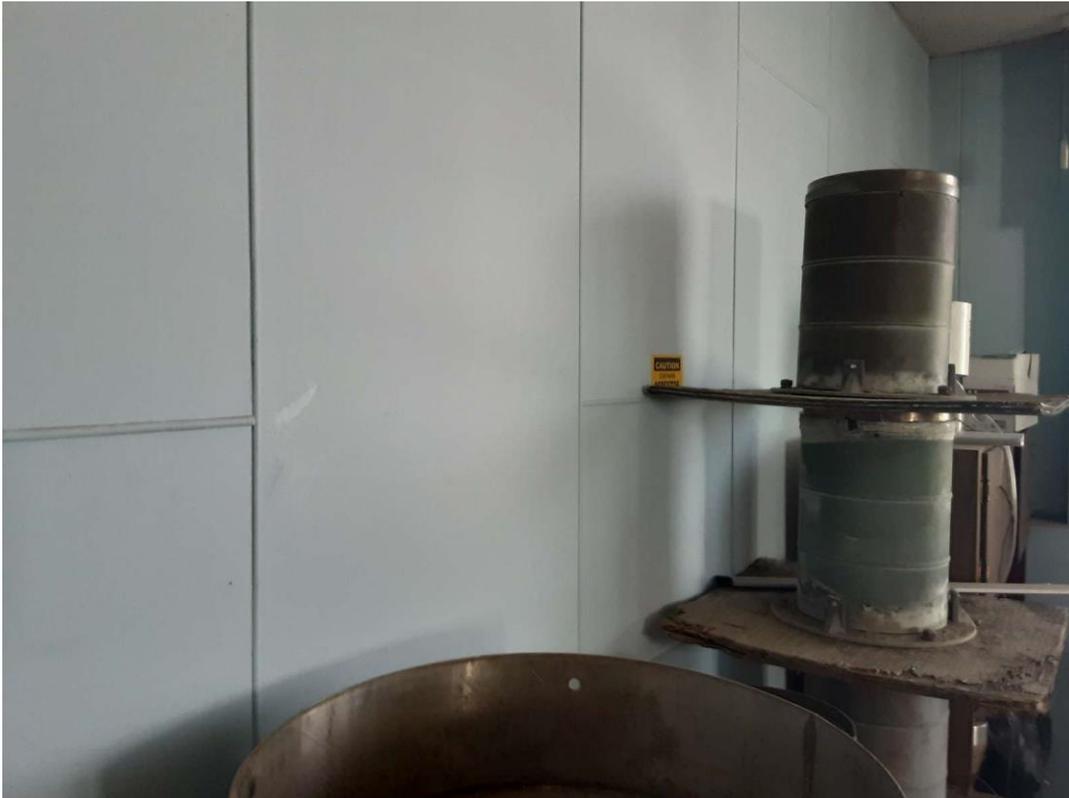
V9000 (Confirmed Asbestos), Wall, Cement Product,
Old Pump Building - Dispatch (Location #: 13)

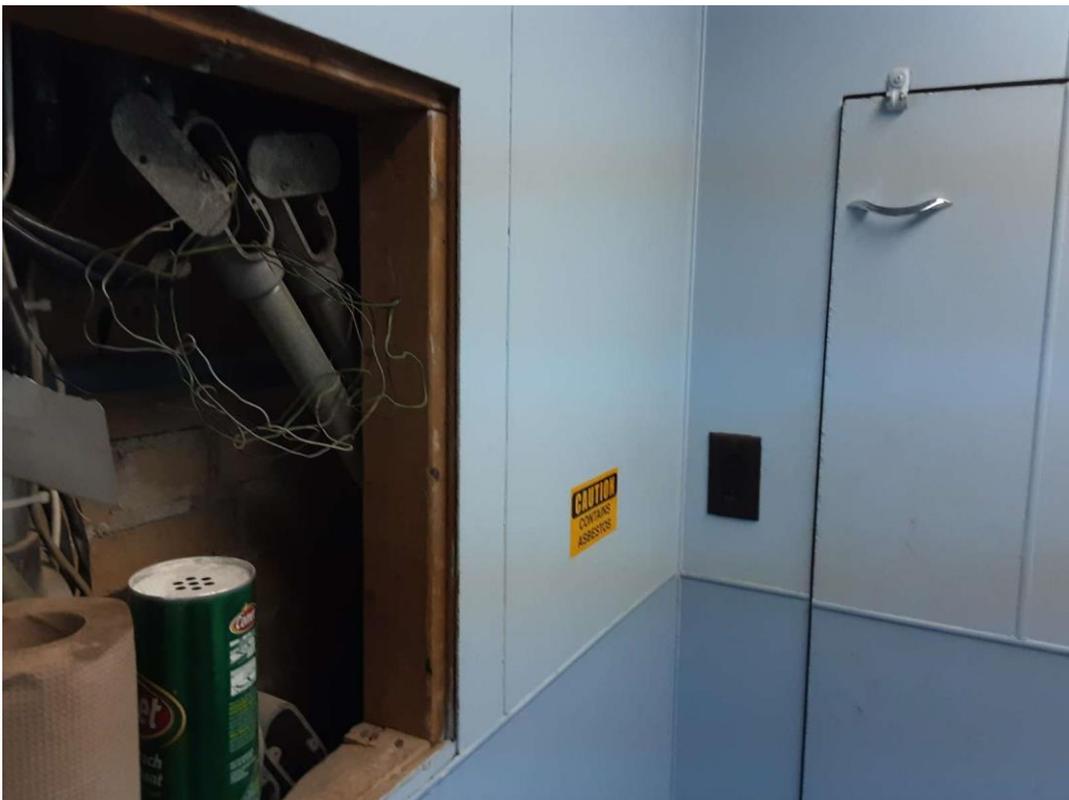
V9000 (Confirmed Asbestos), Wall, Cement Product,
Old Pump Building - Washroom (Location #: 16)

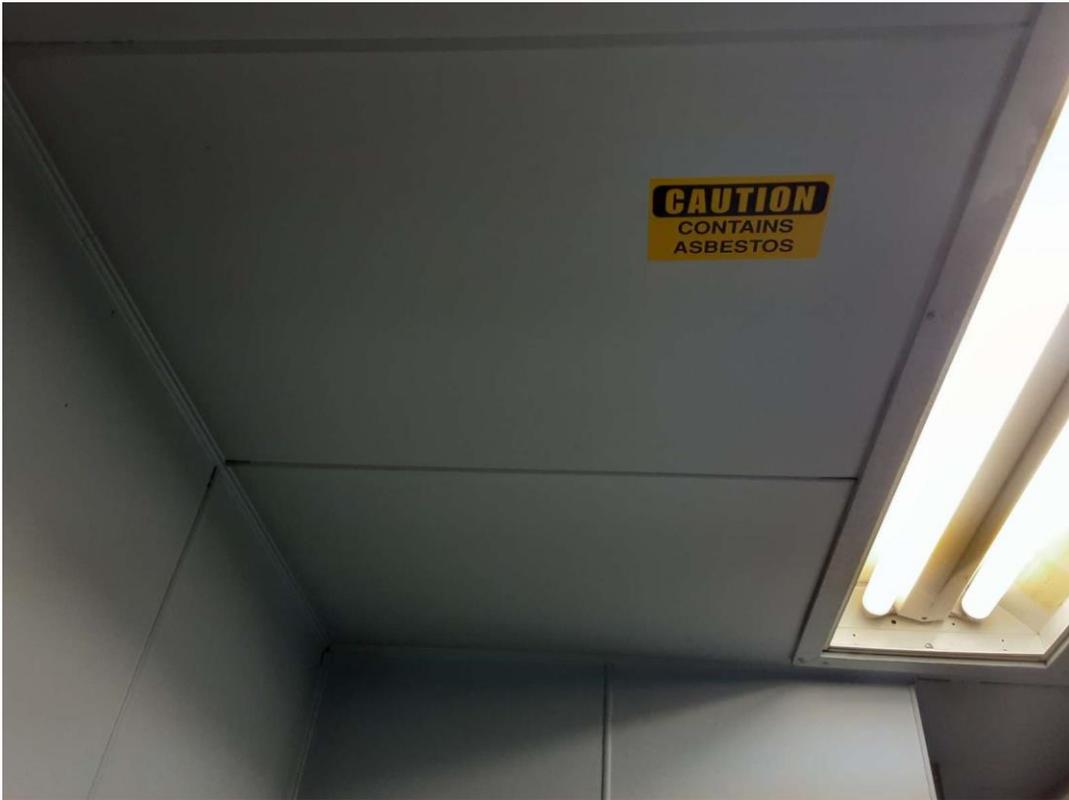
V9000 (Confirmed Asbestos), Ceiling, Cement Product,
Old Pump Building - Washroom (Location #: 16)

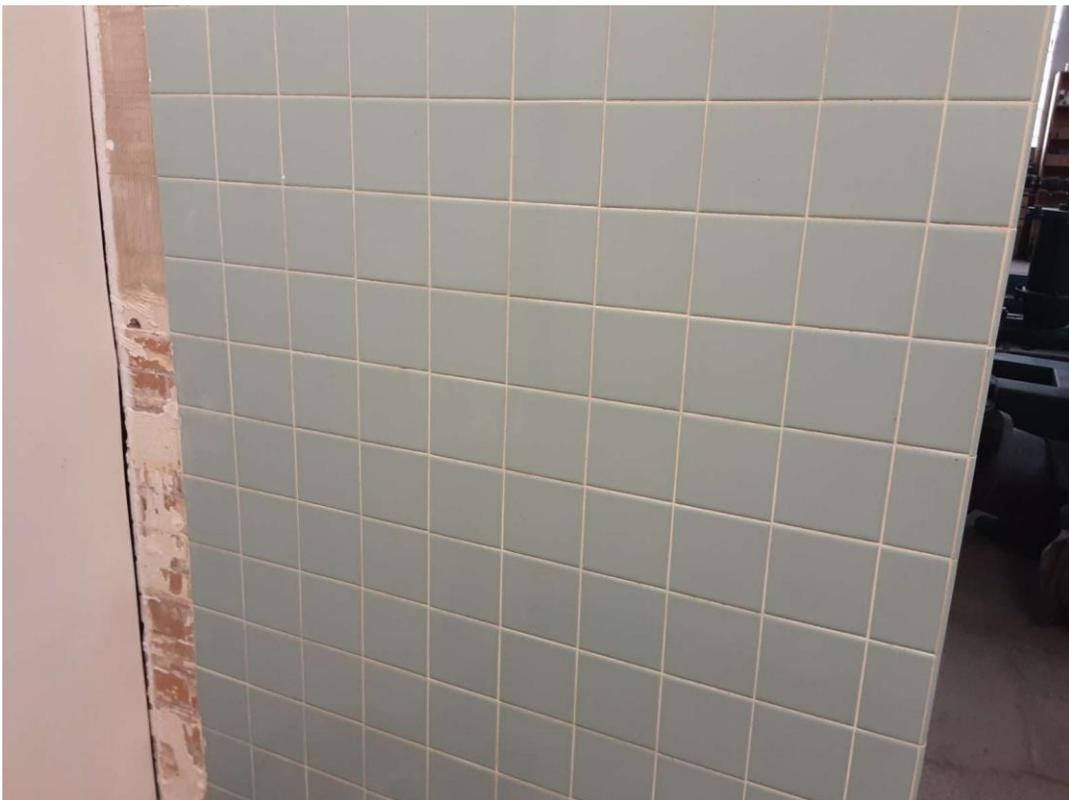
V9500 (Presumed Asbestos), Wall, All, Mortar,
Old Pump Building - Washroom (Location #: 28)

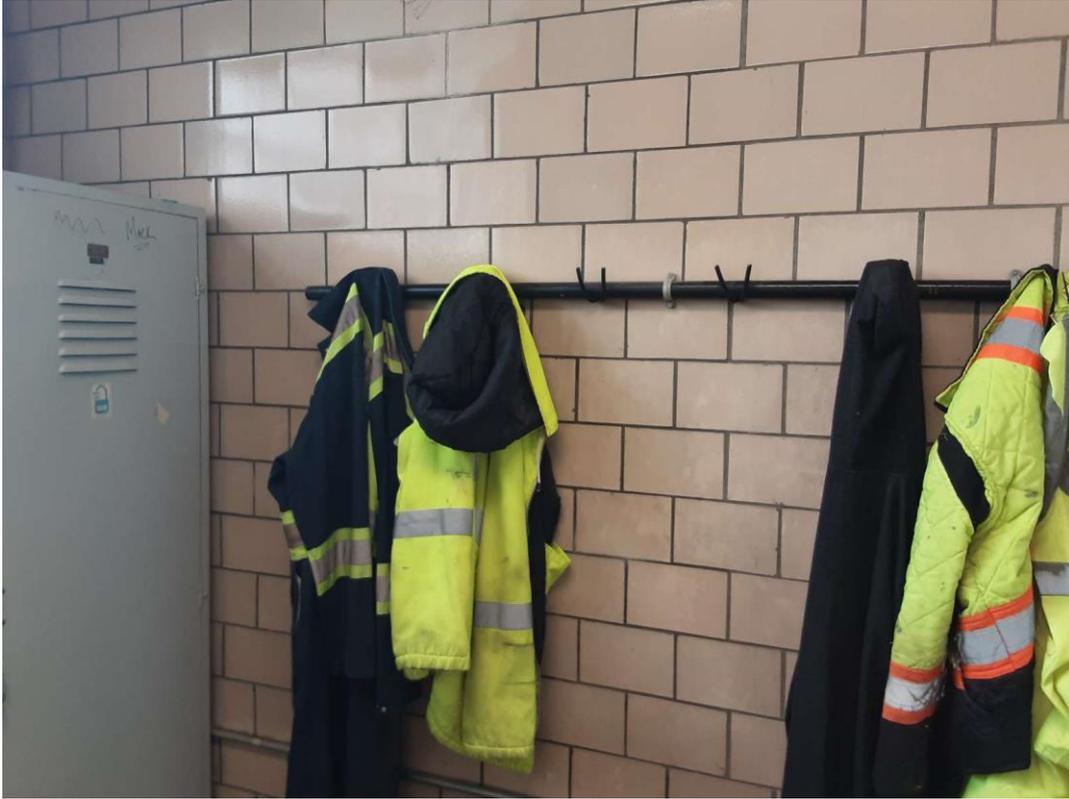
V9500 (Presumed Asbestos), Wall, All, Mortar,
Old Pump Building - Locker Room (Location #: 29) setting compound

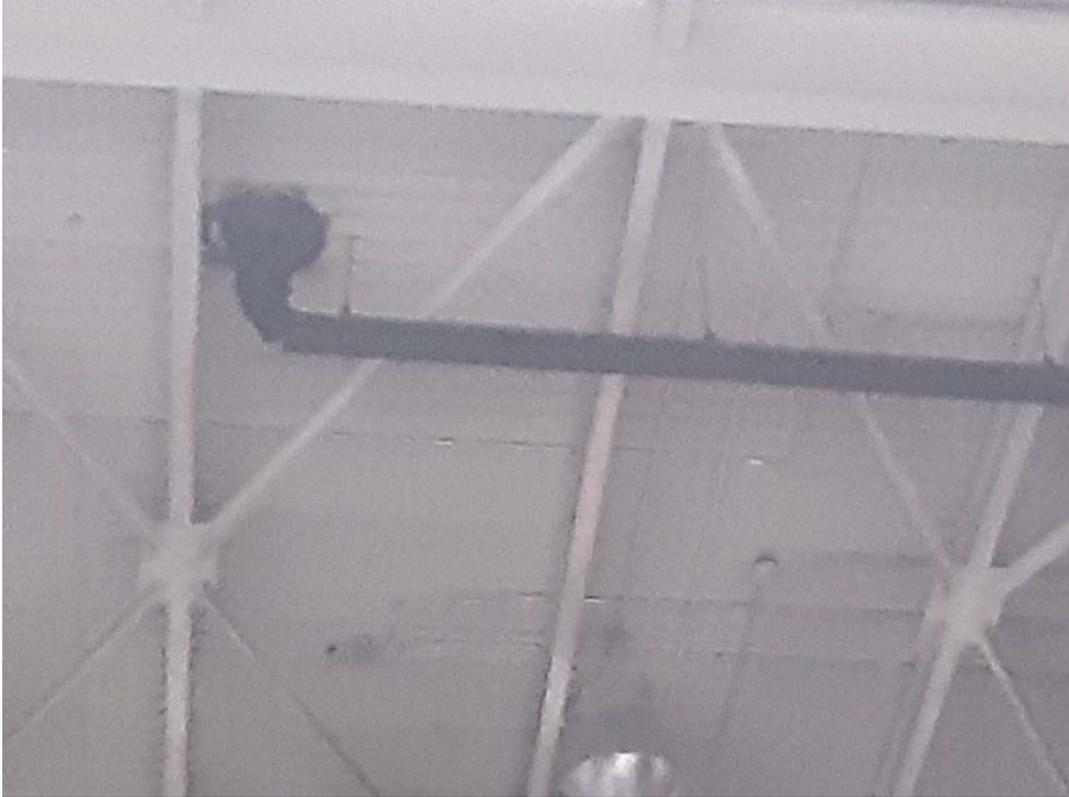
S0001 (Confirmed Asbestos), Piping, Rain Water Leader, Pump Building - Basement (Location #: 1)

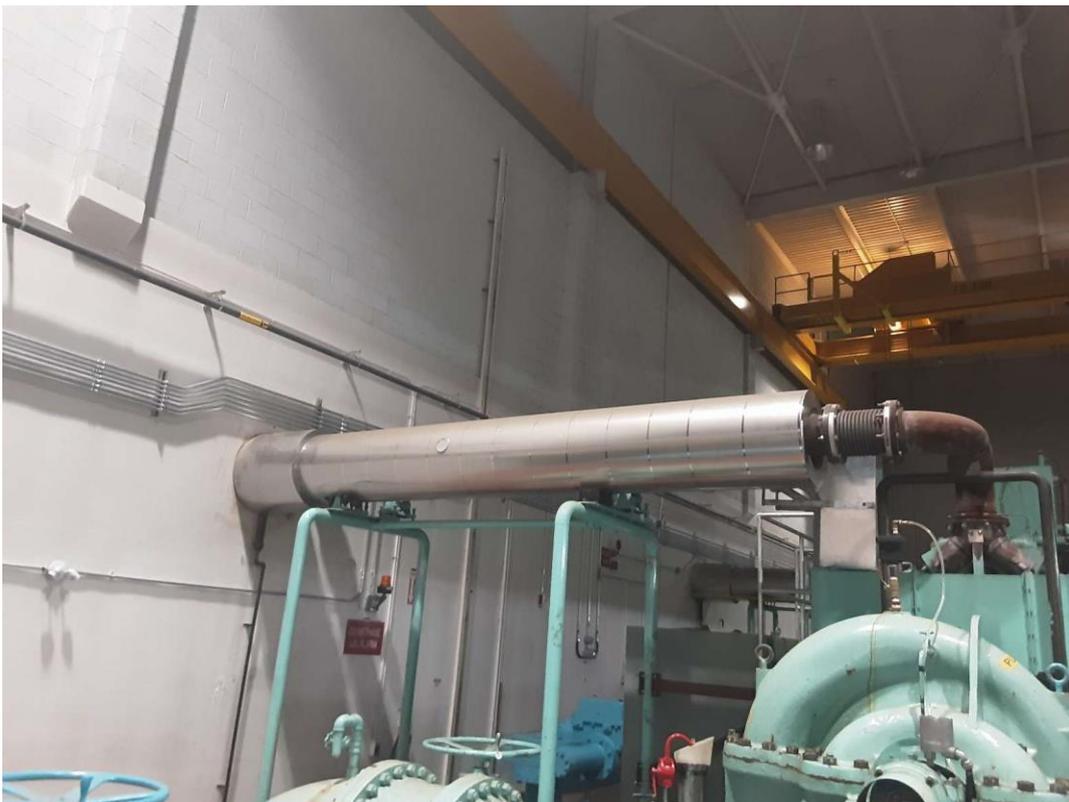
S0003 (Confirmed Asbestos), Duct, Generator Exhaust, Magnesia block, Pump Building - Basement (Location #: 1)

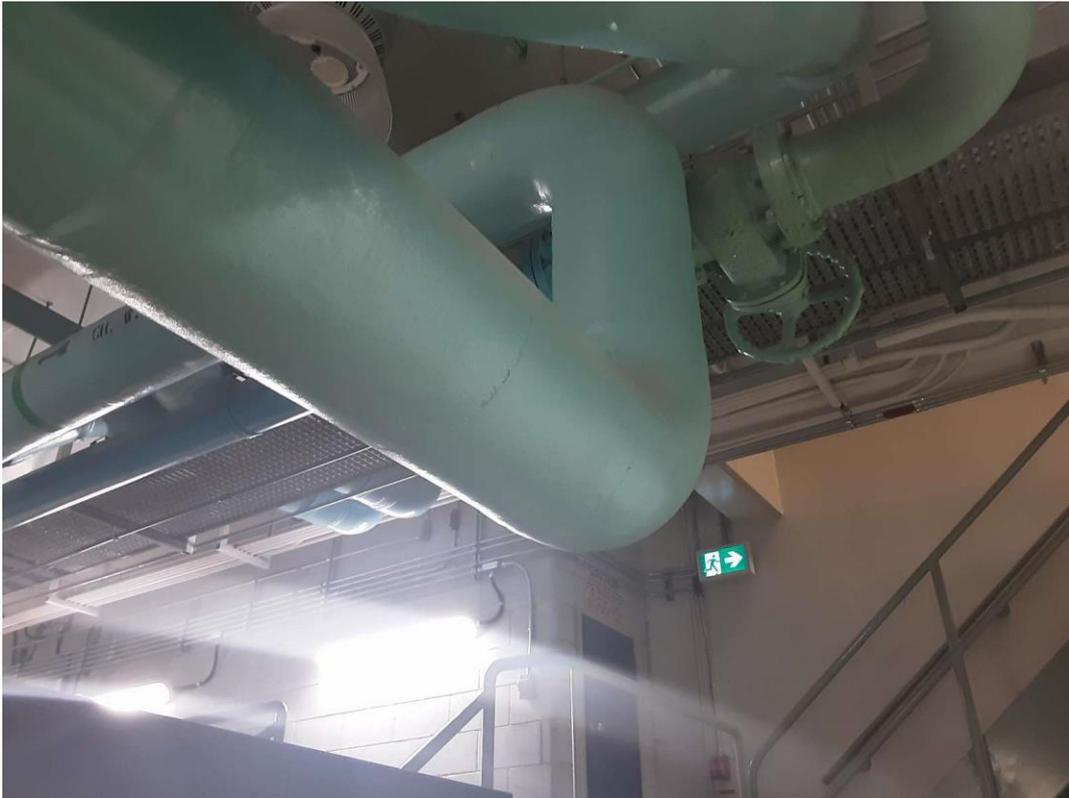
V0004 (Confirmed Asbestos), Piping, Chilled Water Return, Parging Cement, Pump Building - Basement (Location #: 1)

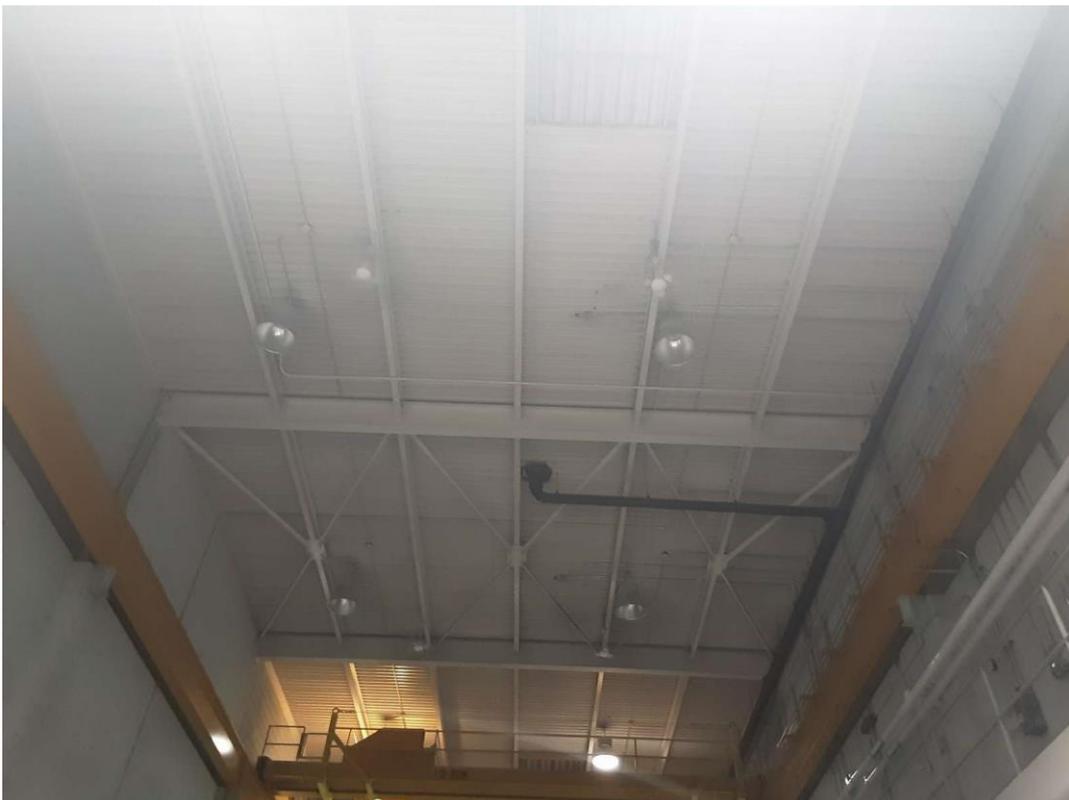
V0004 (Confirmed Asbestos), Piping, Rain Water Leader, Parging Cement, Pump Building - Basement (Location #: 1)

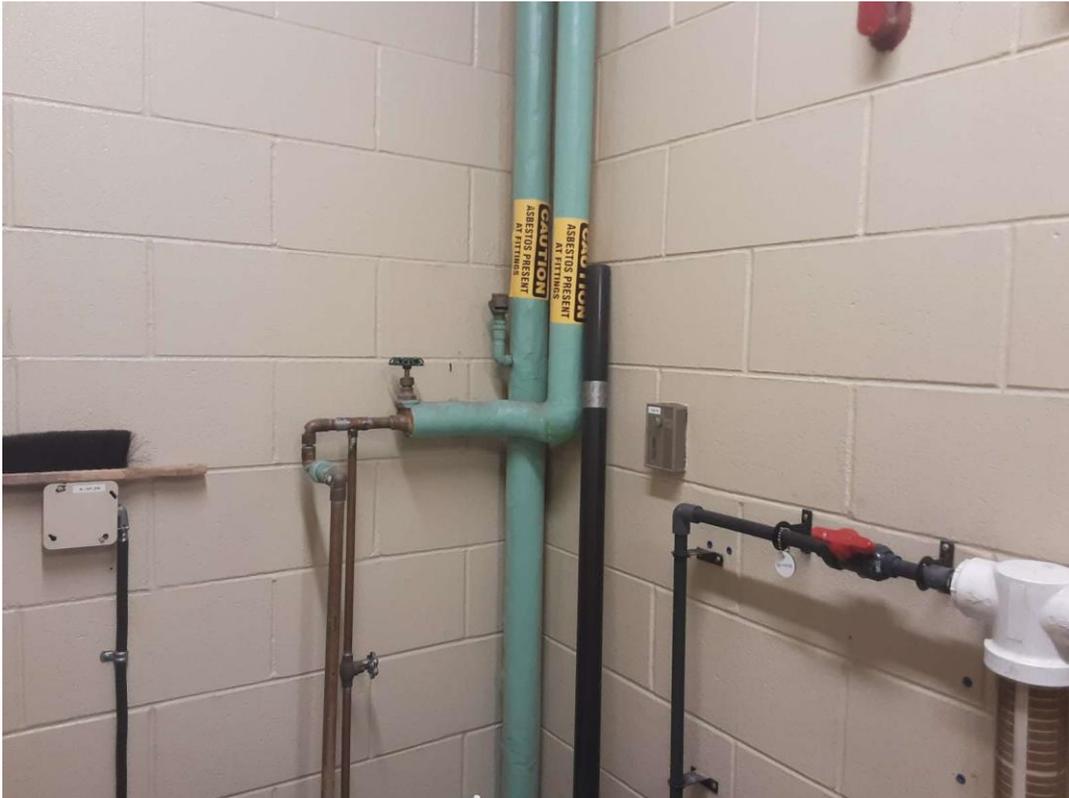
V0006 (Confirmed Asbestos), Piping, Heating Water Return, Parging over Fibreglass, Pump Building - Chlorine Analyzer Room (Location #: 2)

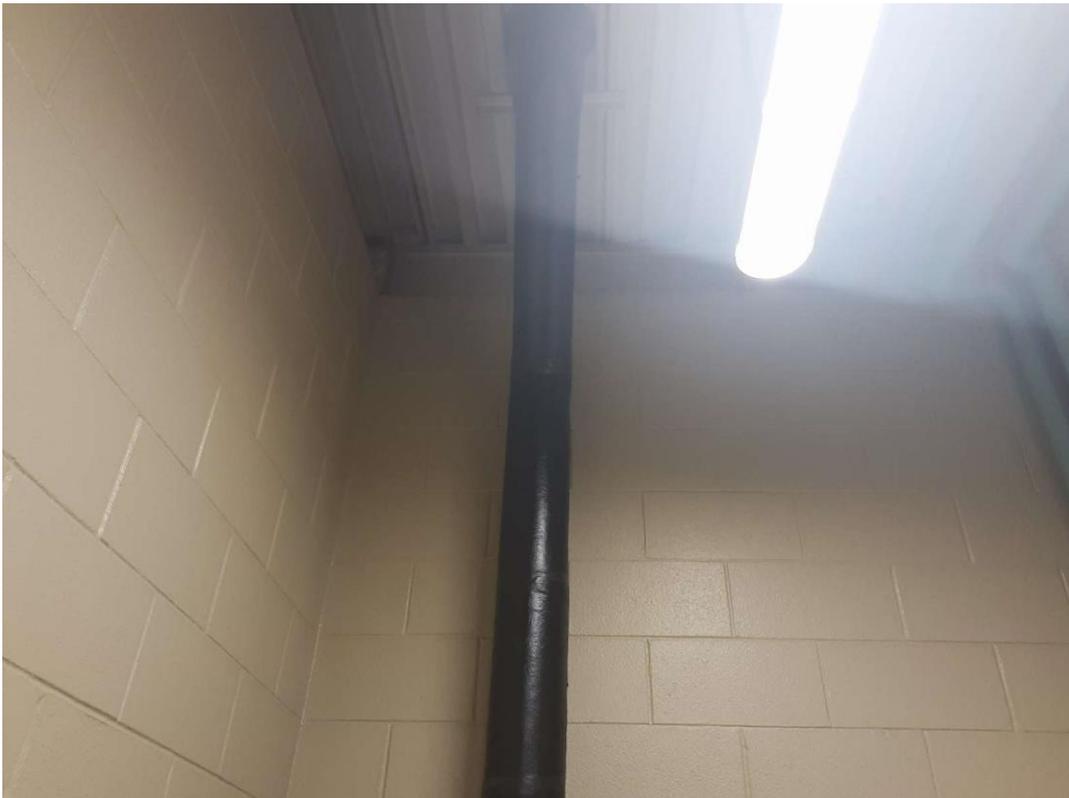
V0007 (Confirmed Asbestos), Piping, Rain Water Leader, Parging over Fibreglass, Pump Building - Chlorine Analyzer Room (Location #: 2)

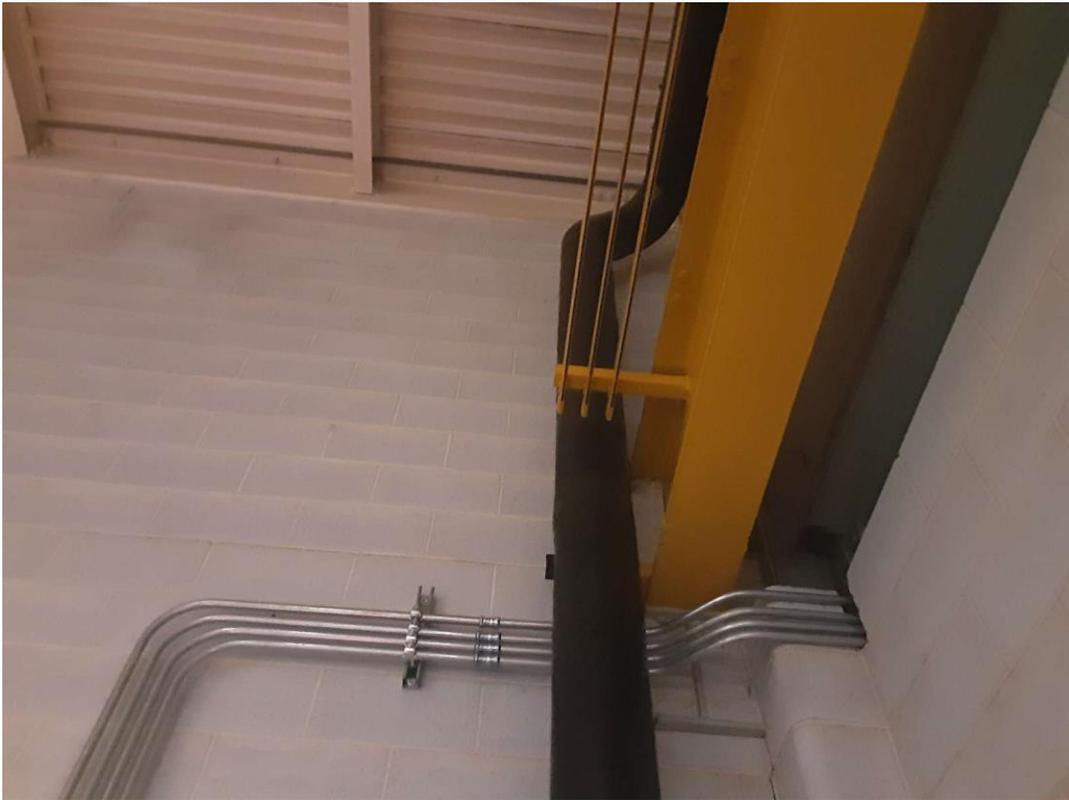
V0007 (Confirmed Asbestos), Piping, Rain Water Leader, Parging over Fibreglass, Pump Building - Vestibule/Stairwell (Location #: 4)

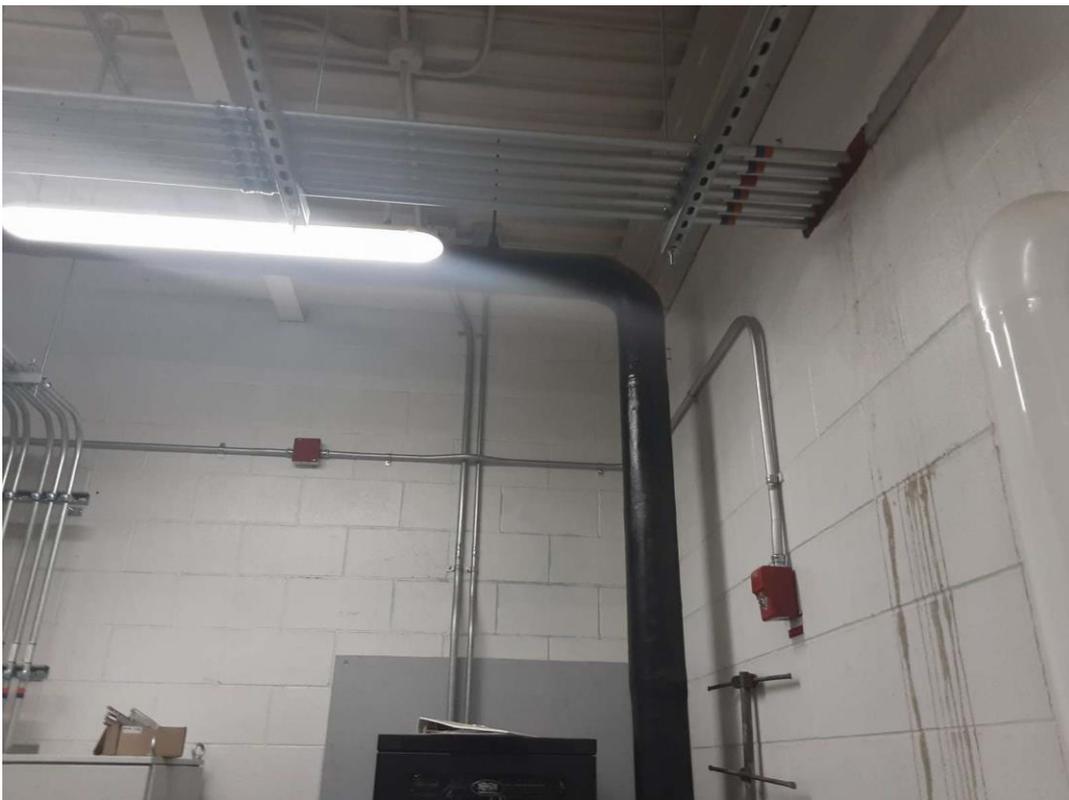
V0007 (Confirmed Asbestos), Piping, Rain Water Leader, Parging Cement, Pump Building - Filter Room (Location #: 7)

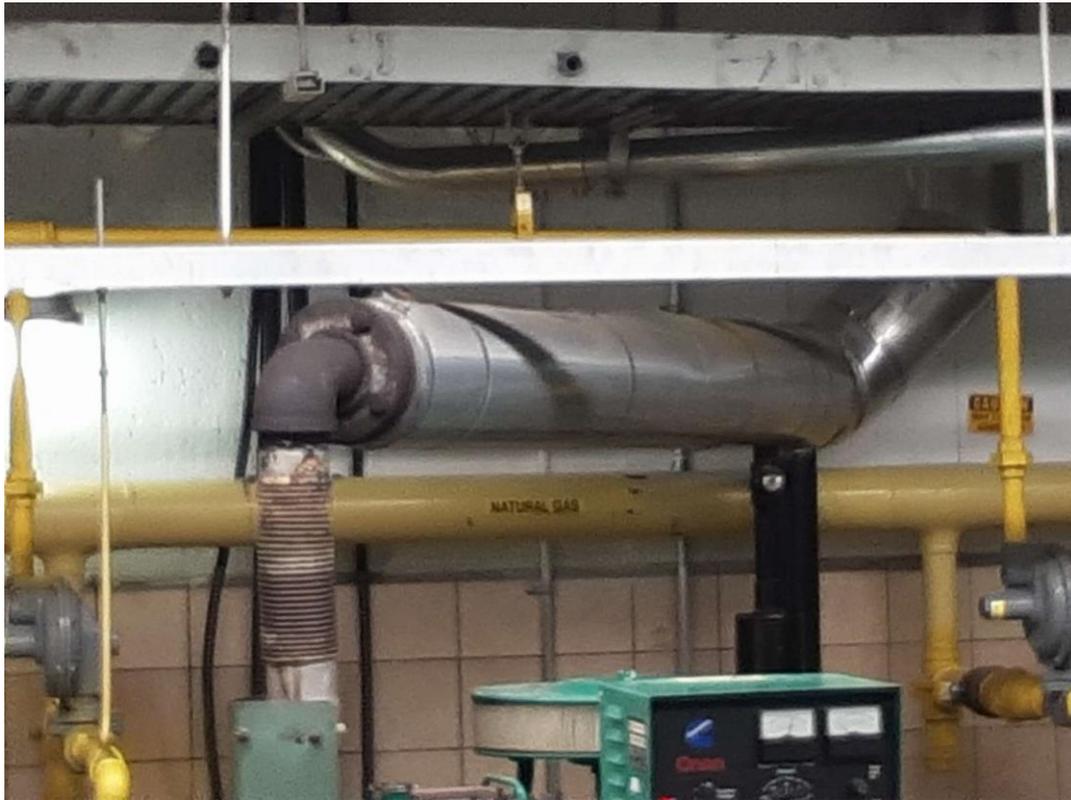
S0003 (Confirmed Asbestos), Mechanical Equipment, Generator Exhaust, Magnesia block, Main Building - Pump Room (Location #: 10)

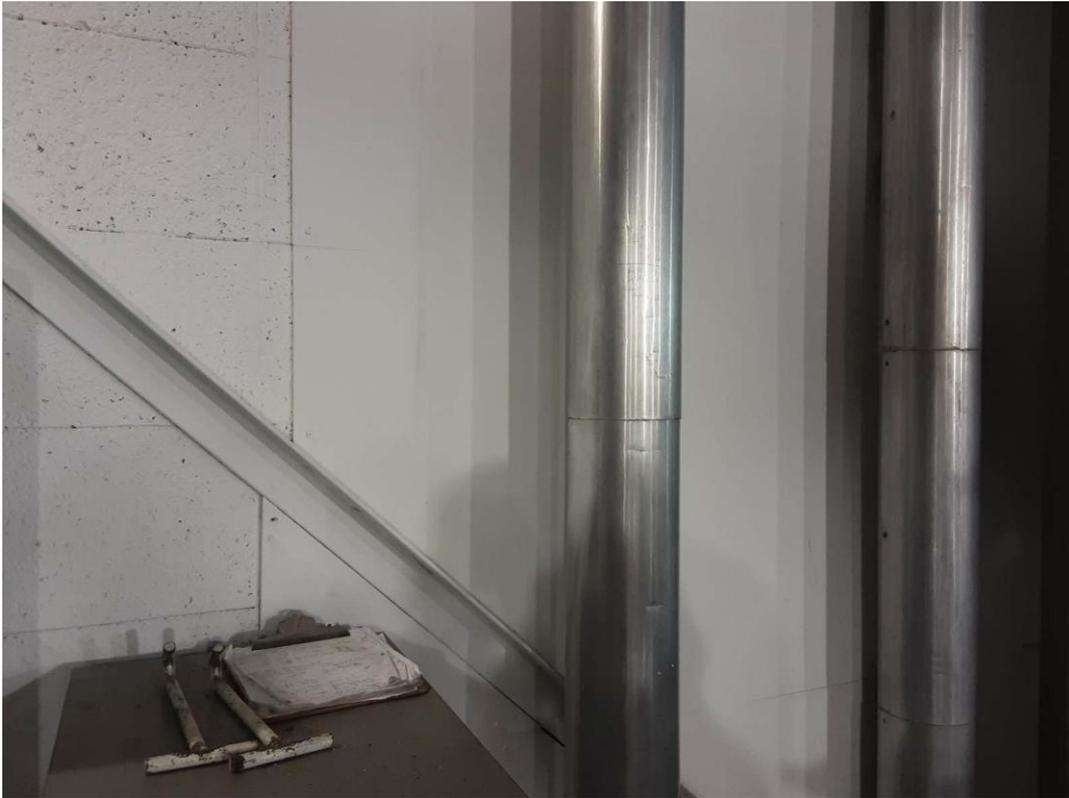
V0006 (Confirmed Asbestos), Wall, Cement Product, Main Building - Landing/Loading Area (Location #: 5)

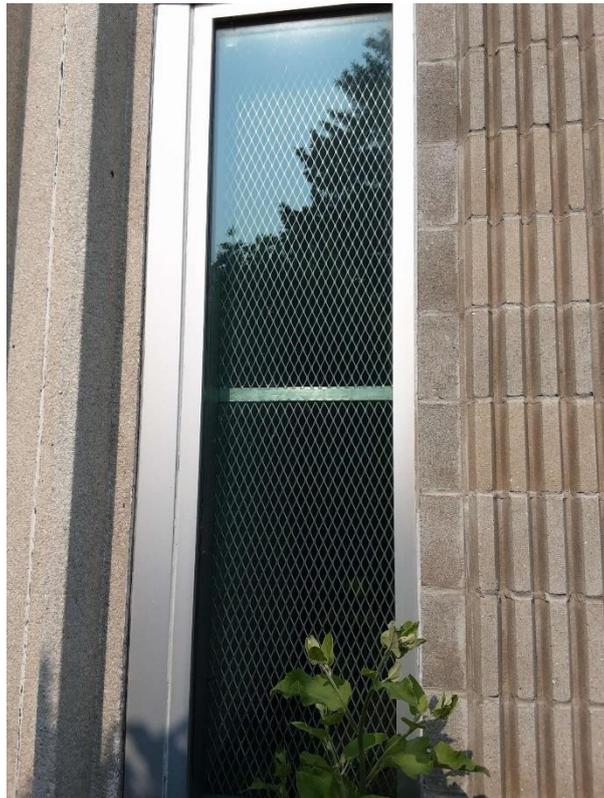
S0010 (Confirmed Asbestos), Wall, Window Liner, Caulking, Hurst Pump Station Main Building Exterior (Location #: 19)

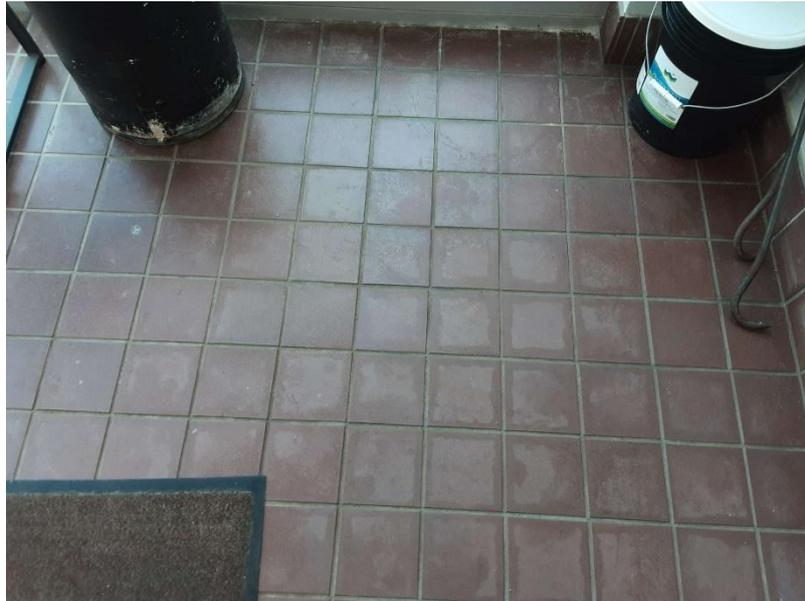
V9500 (Presumed Asbestos), Floor, All, Mortar, Main Building - Vestibule (Location #: 1)
Setting compound

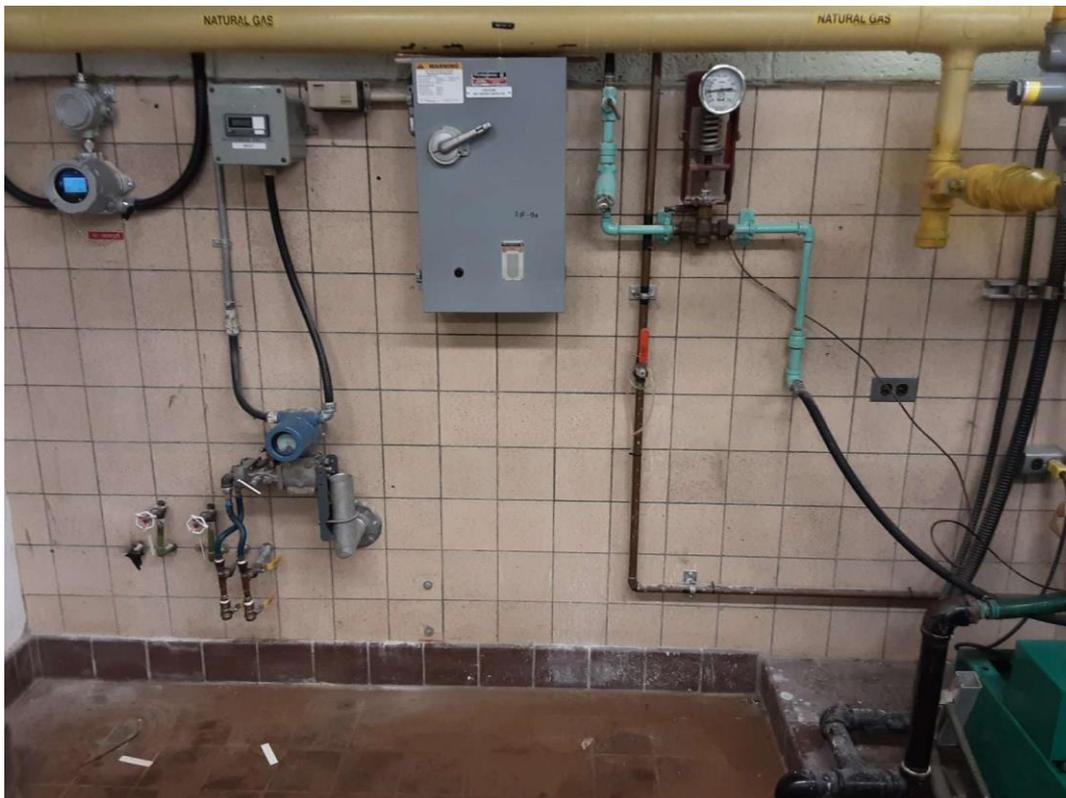
V9500 (Presumed Asbestos), Wall, Ceramic Tiles, Main Building - Pump Room (Location #: 10)

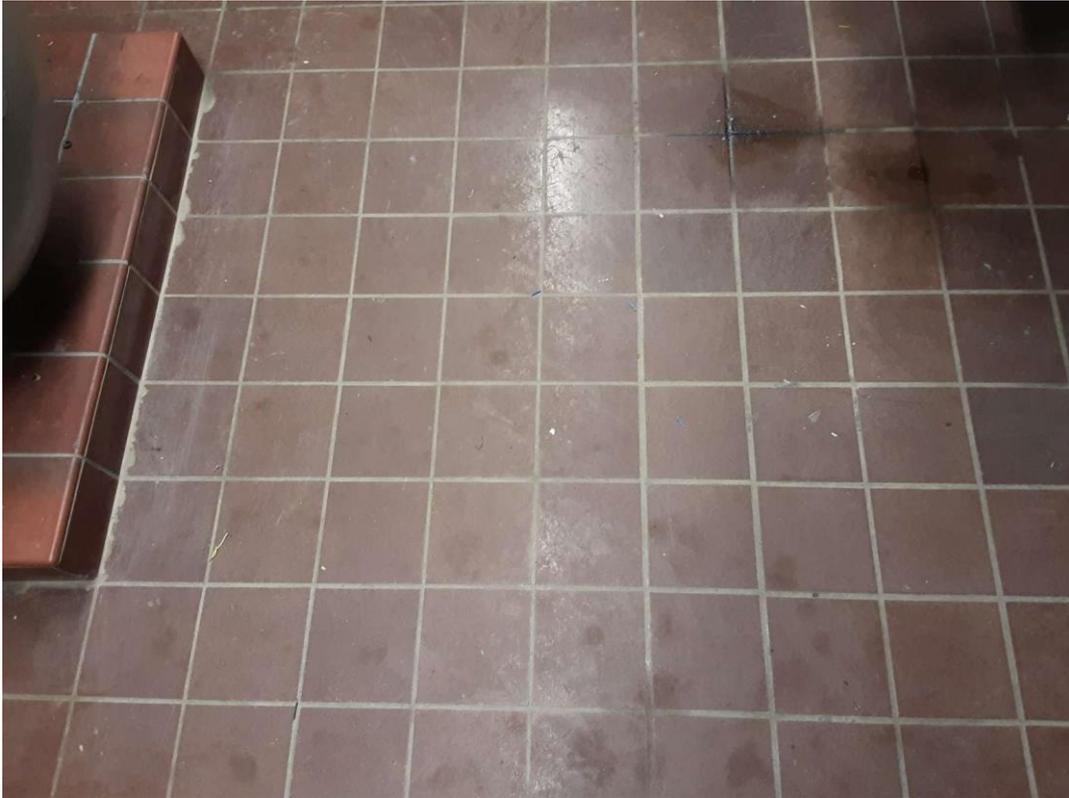
V9500 (Presumed Asbestos), Floor, All, Mortar, Main Building - Pump Room (Location #: 10)
Setting compound

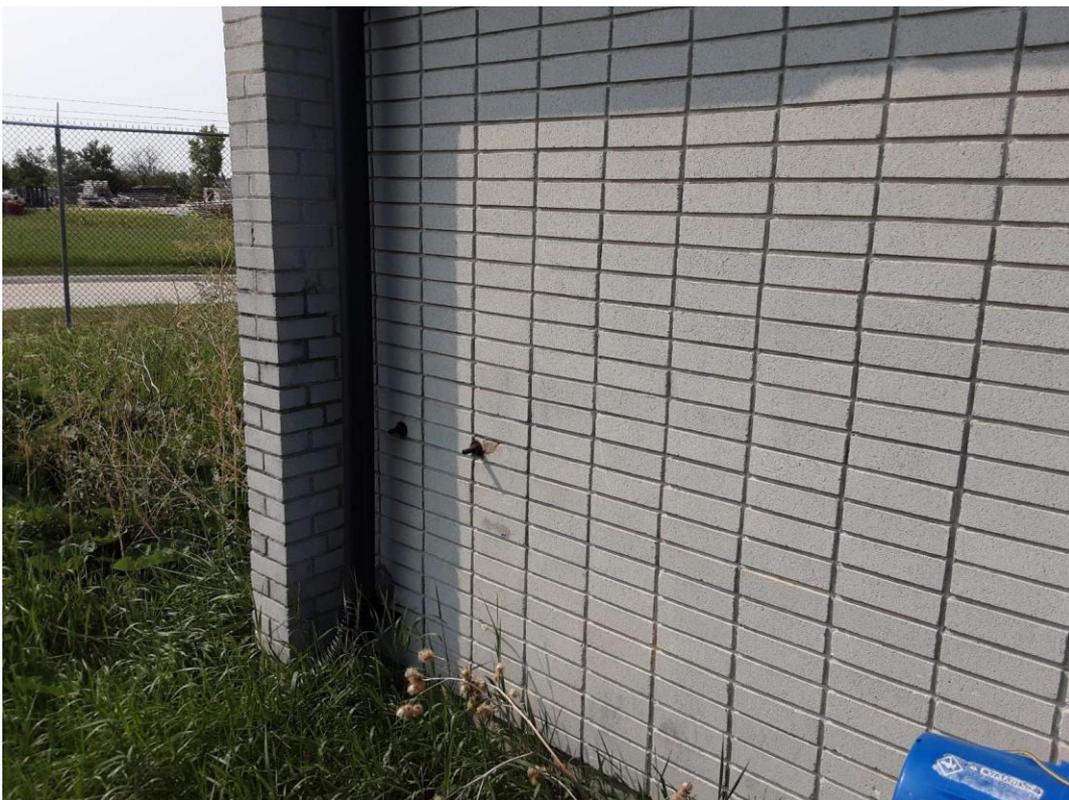
V9500 (Presumed Asbestos), Wall, Vermiculite, B Pit Building (Location #: 18)

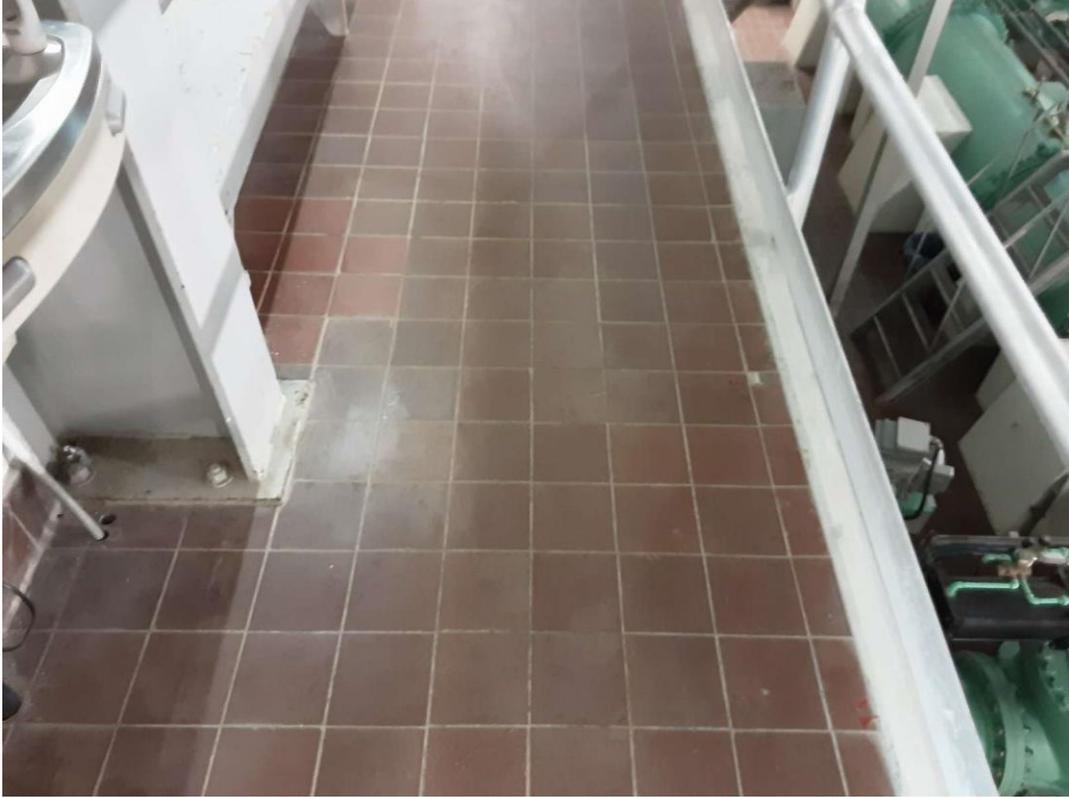
V9500 (Presumed Asbestos), Floor, All, Mortar, Main Building - Walkway (Location #: 4)
