**City of Winnipeg – Drinking Water Treatment Plant
PO# 611415**

Inspection Date:
16-March-2021

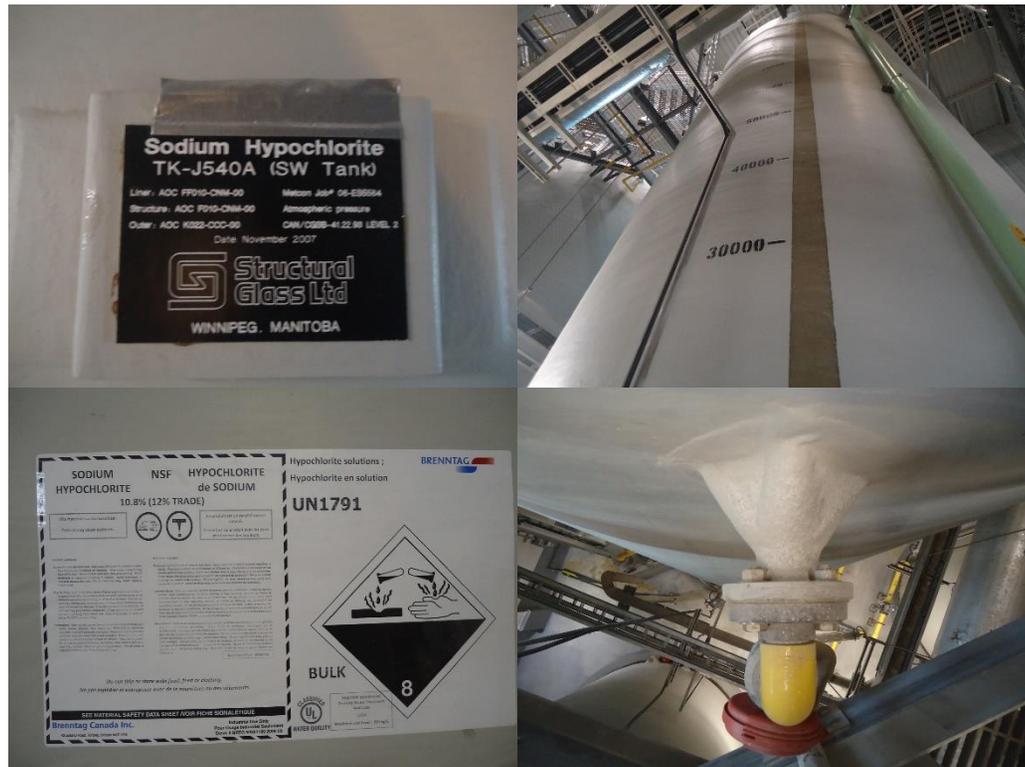
Inspector:
Bon Bacani, CCT-C, C.Tech.

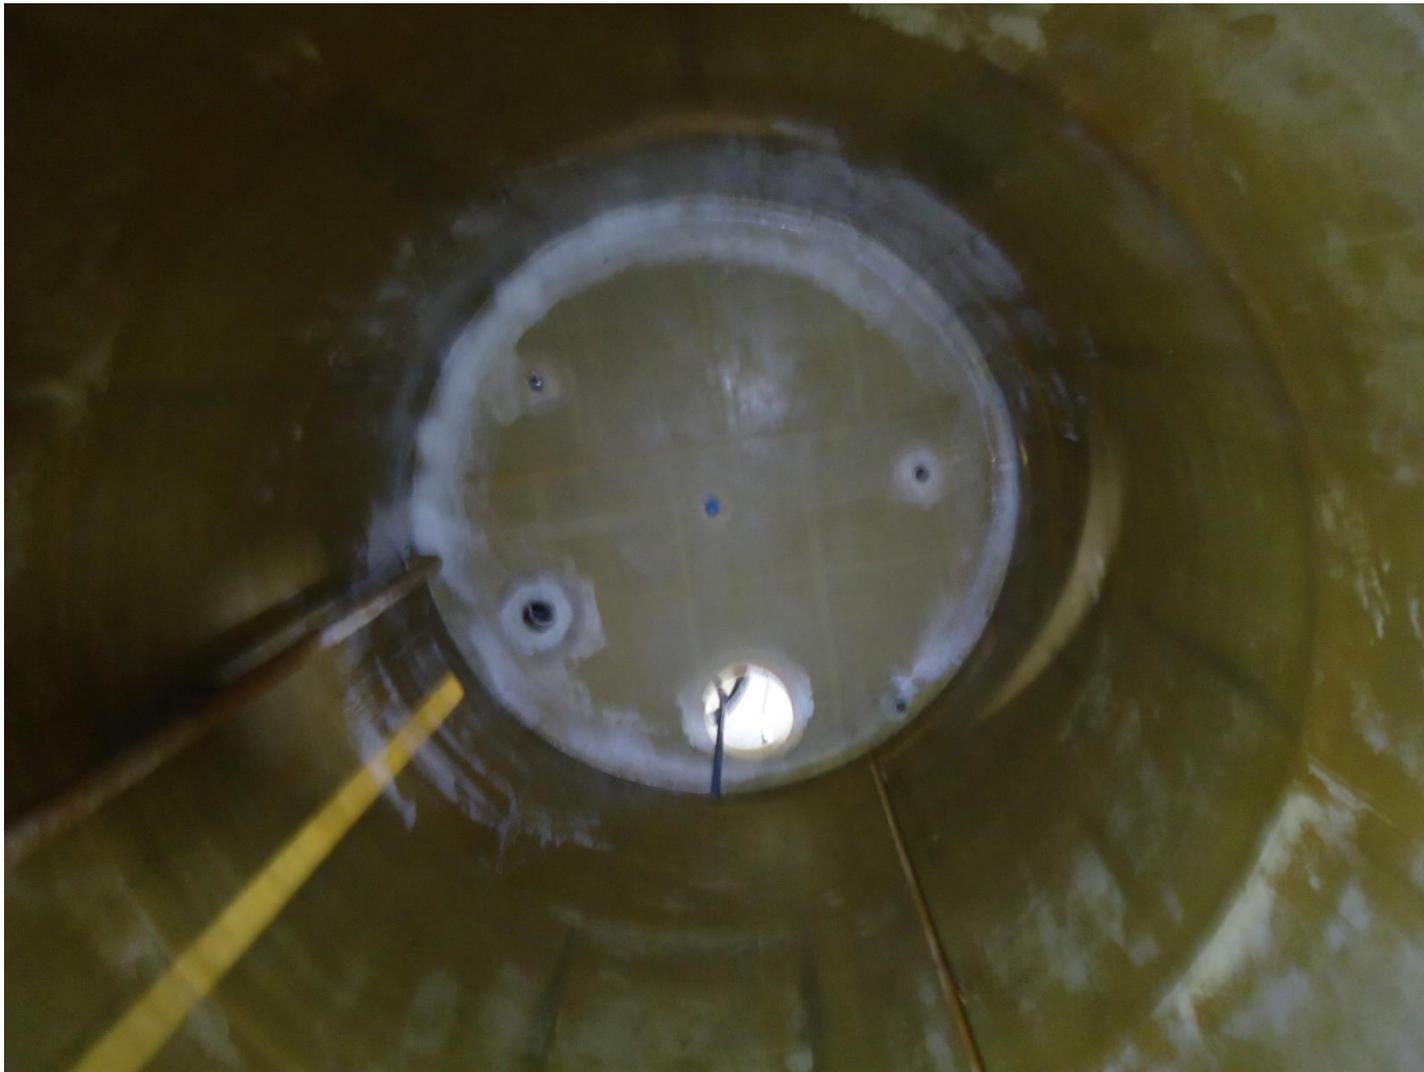
Inside View of the tank lid looking from the tank floor

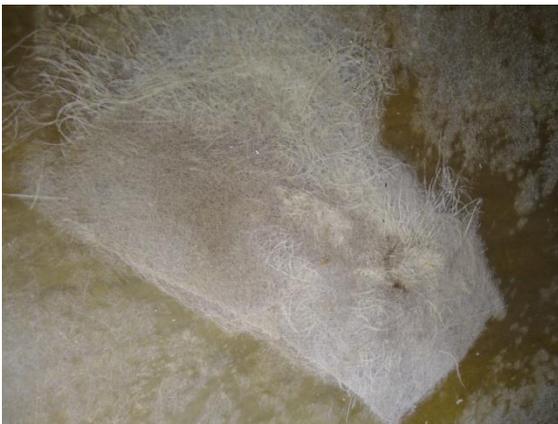
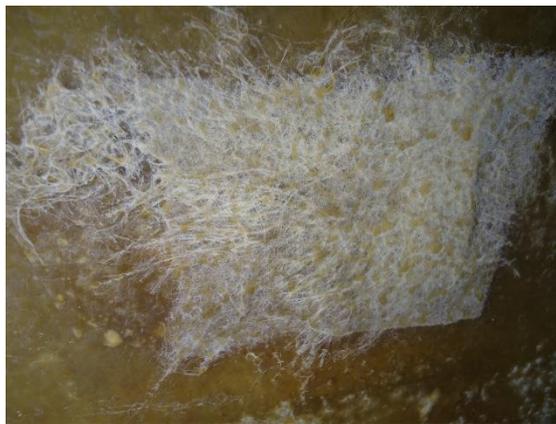
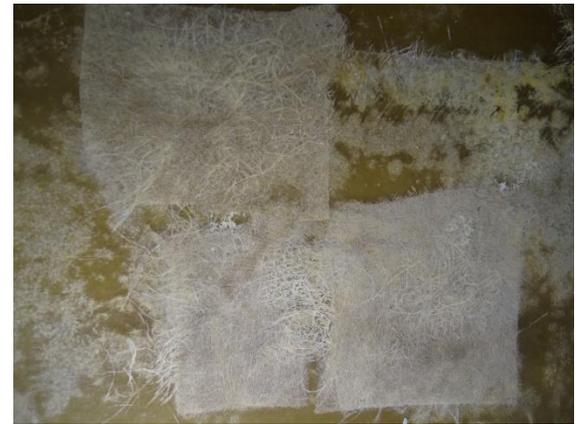
**Significant Number of
Small Patches | Patches
without Surfacing Veil |
Exposed Mat on Patches**

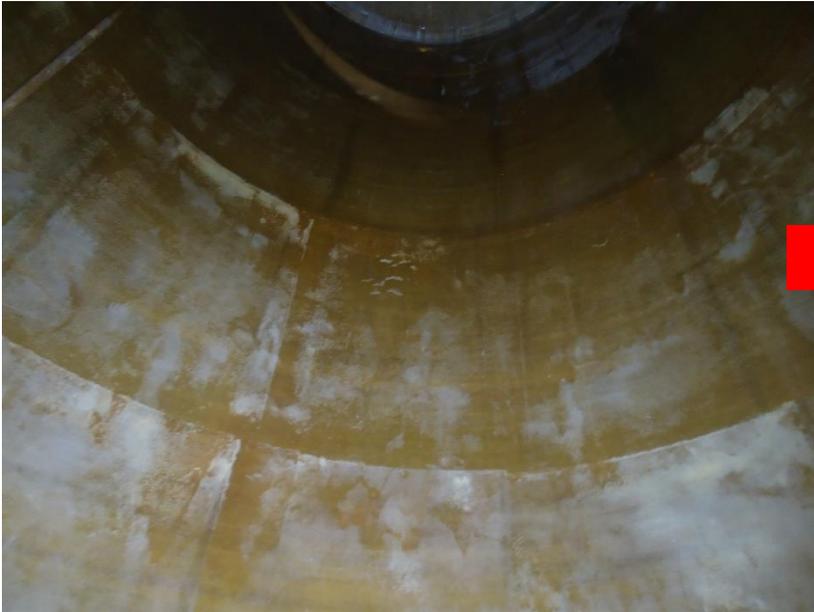
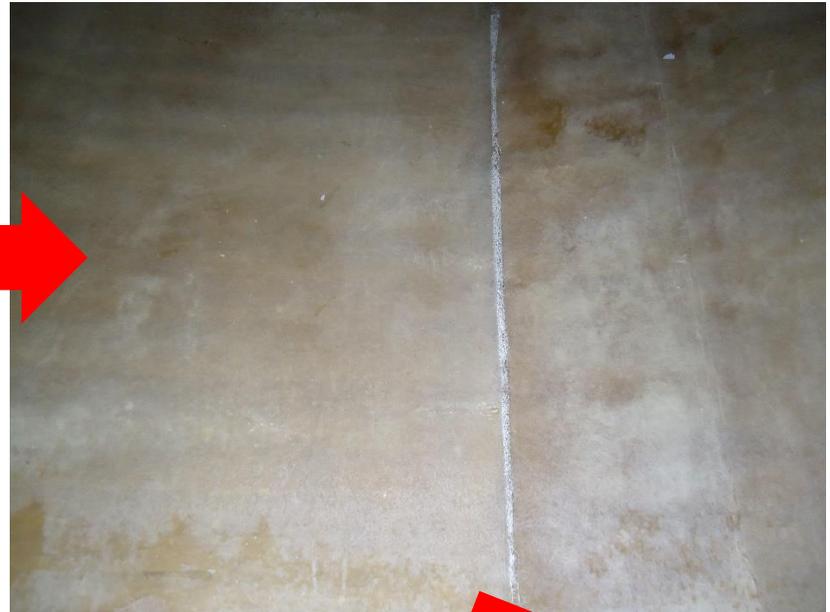
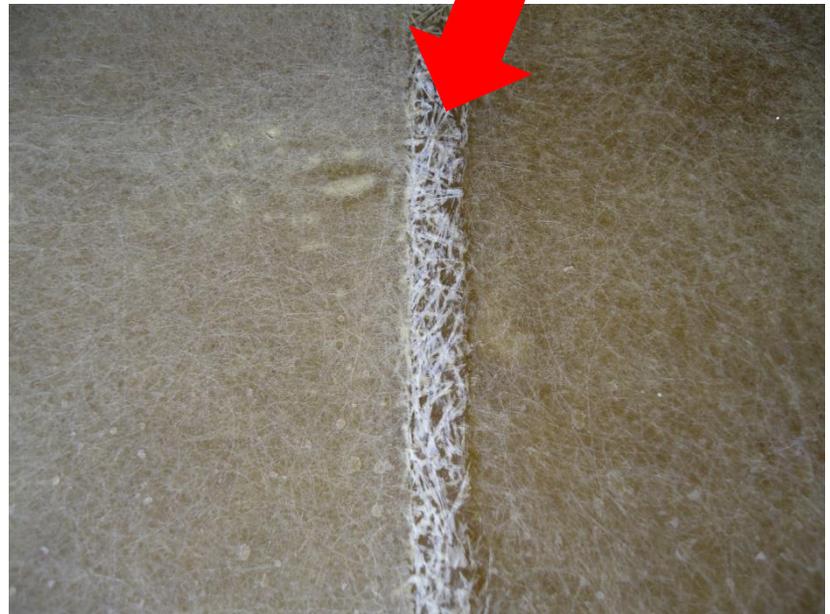
**Non-Overlapping Surfacing Veil on
Repair Patches**

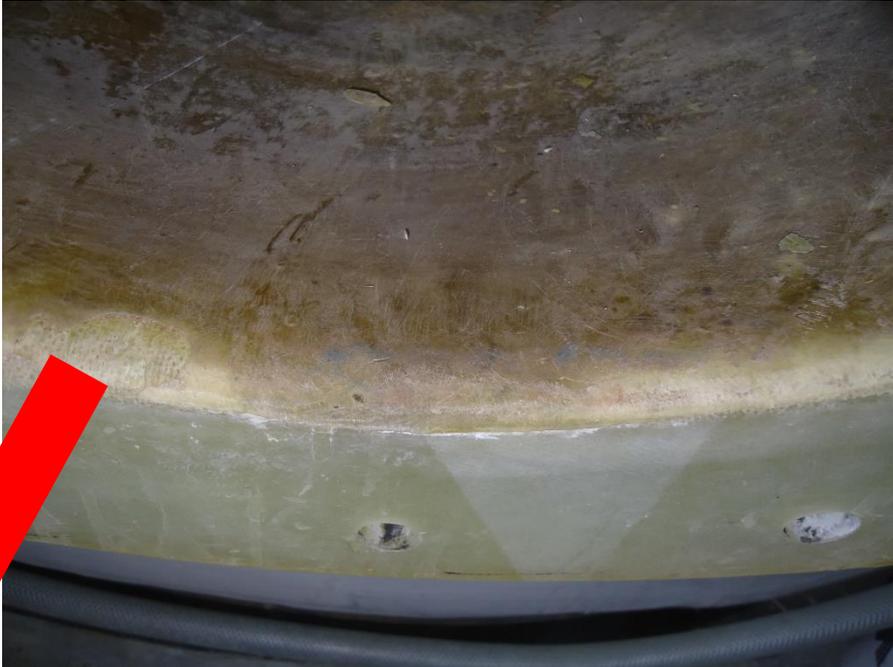
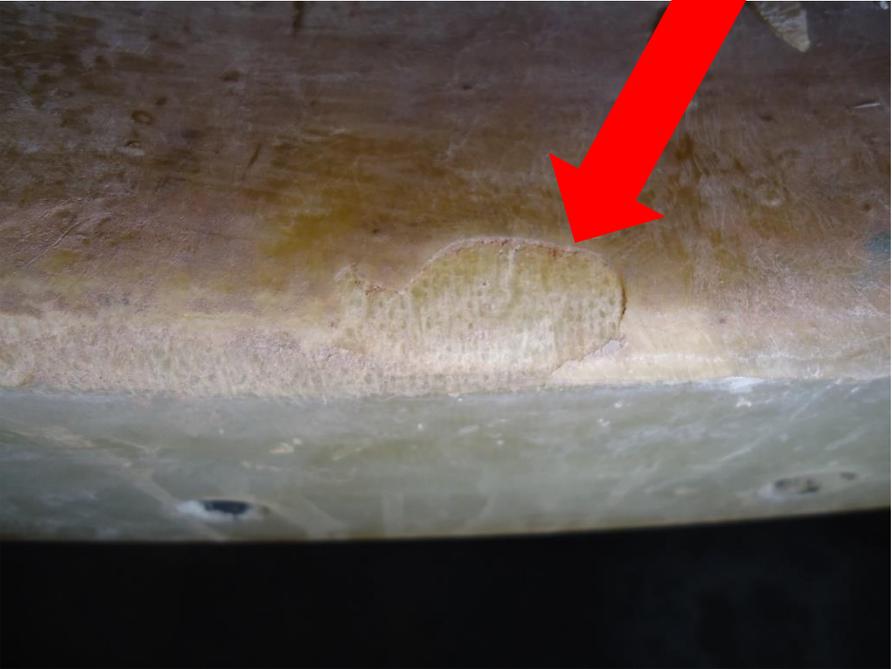
Inspection Photos – Tank Outside

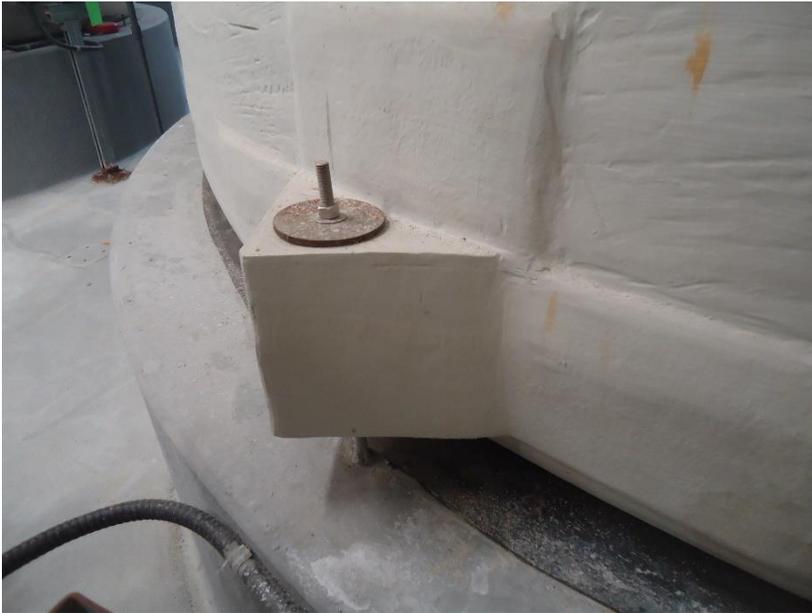
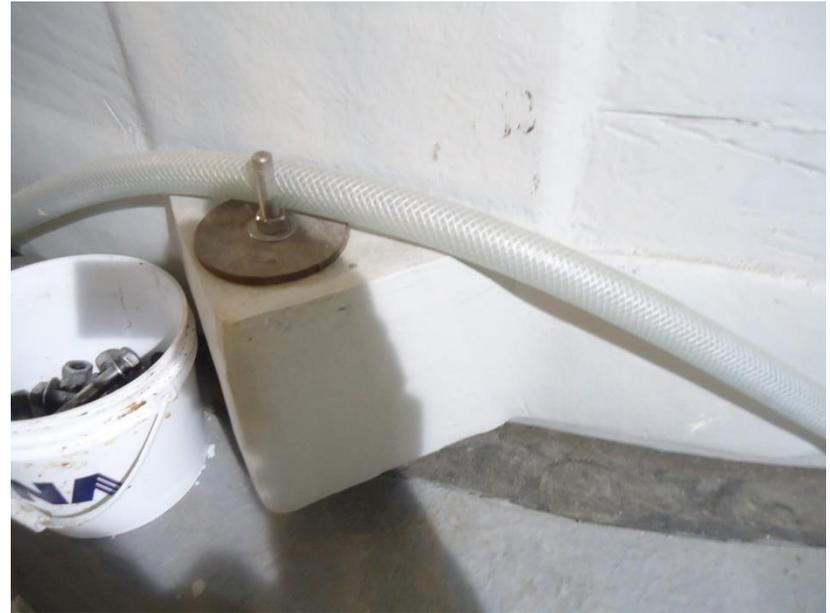
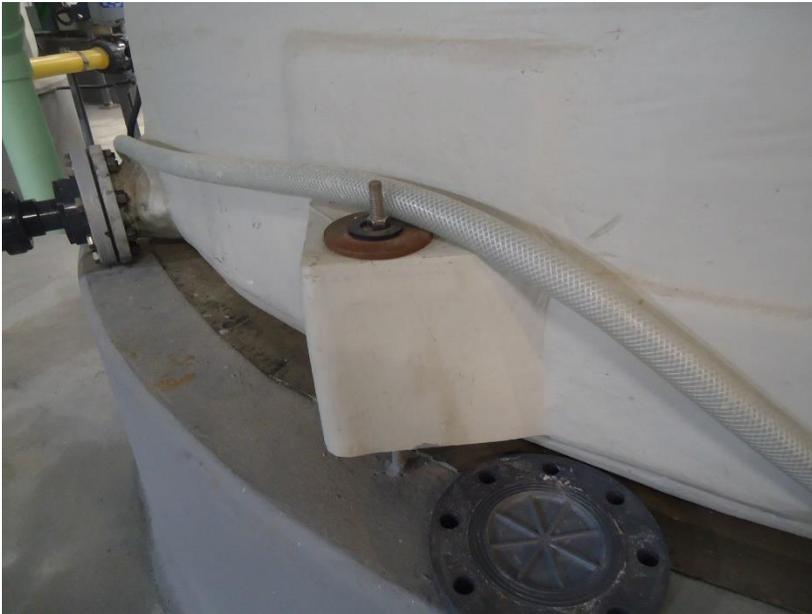
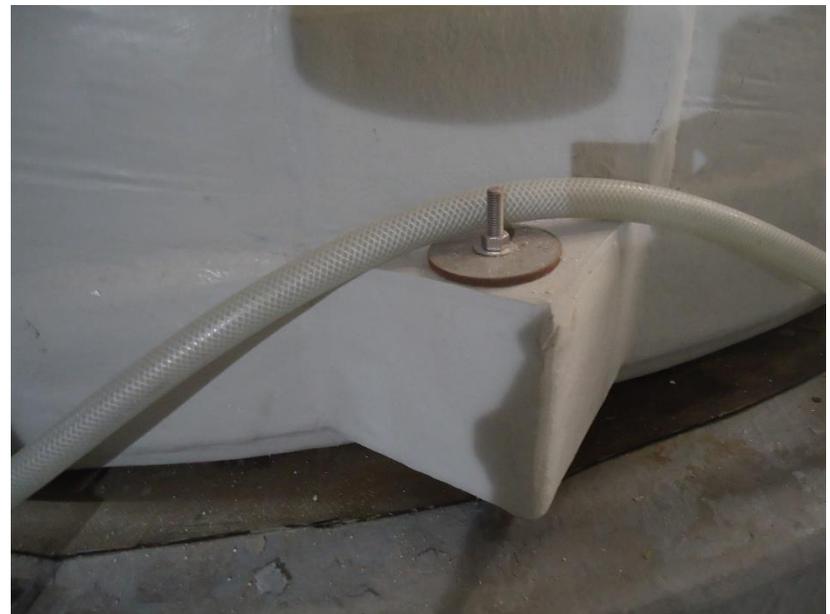
Integral Hold Down Lugs appear to be in good condition | No evidence of leaks seen on the tank knuckle

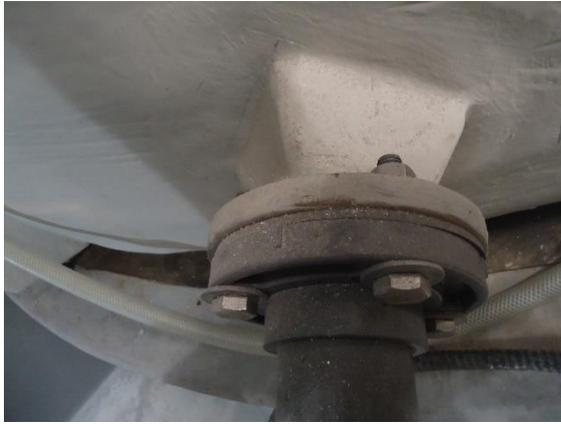
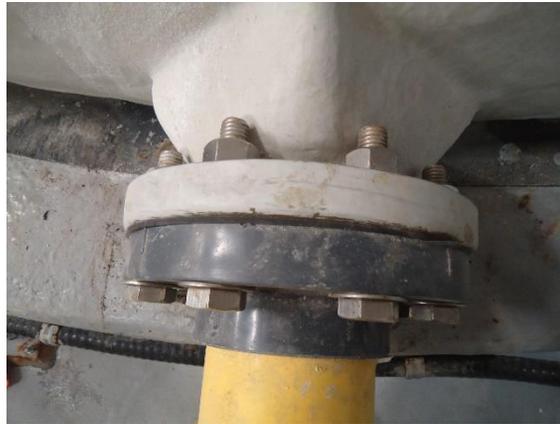
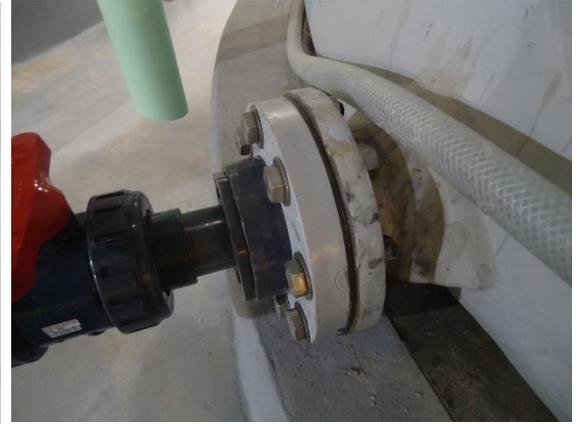
Flanges as seen from the outside of the tank

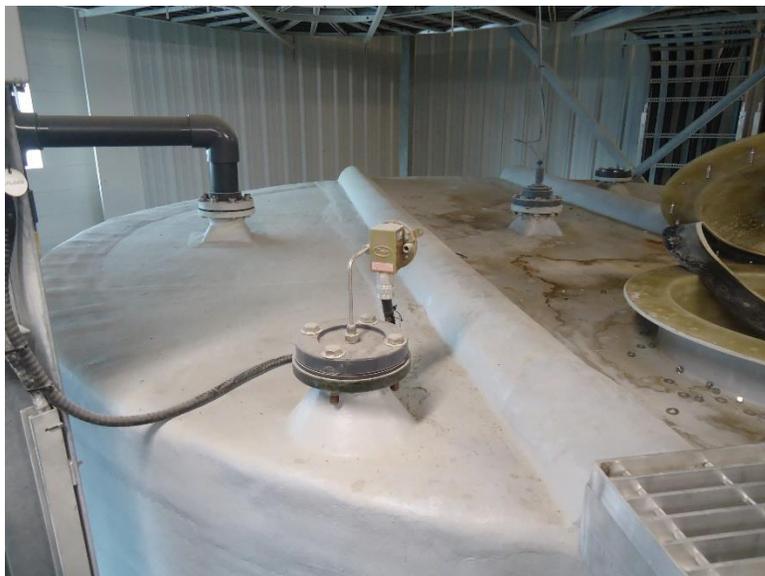
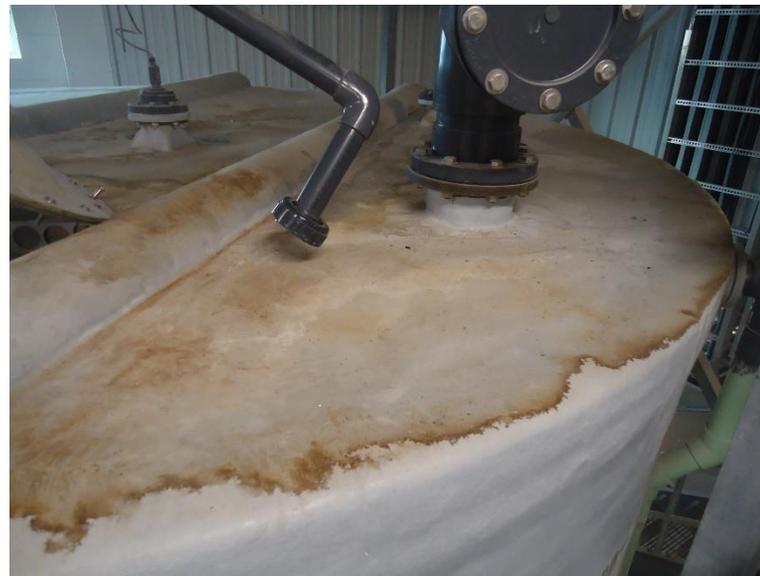
Section Views of Tank Lid
Evidence of a recent leak can be seen on the lid but there was no concern on its effect to the tank lid surface.
