Replacement of the FGSV Siphon

Geotechnical Data Report
FINAL – Rev. 1

City of Winnipeg

April 2025

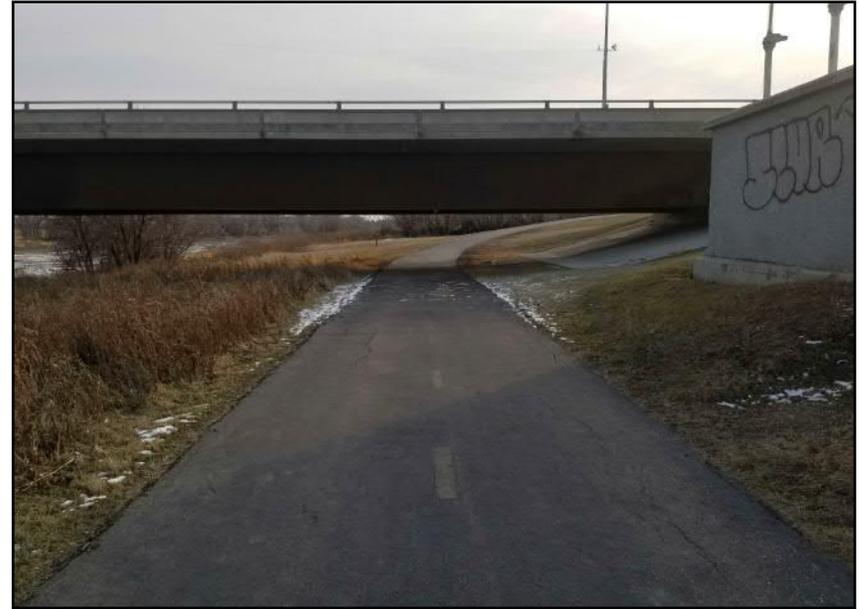
Site 4 - Western Riverbank	Asphalt paved pedestrian pathway. Minor cracking observed parallel to bank crest (facing S)
-----------------------------------	---

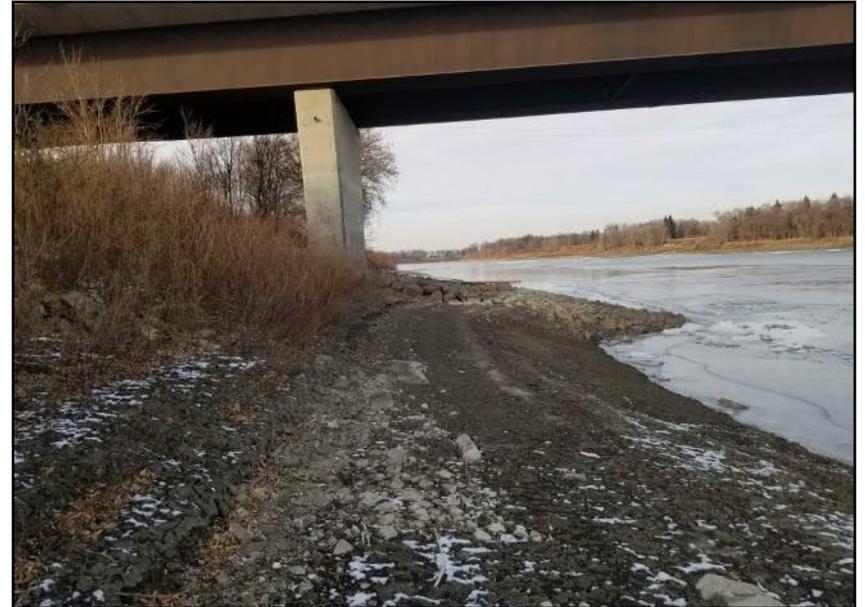
Site 4 - Western Riverbank | Short erosion scarps, localized rip-rap, gradual toe slope within crossing alignment (facing N)

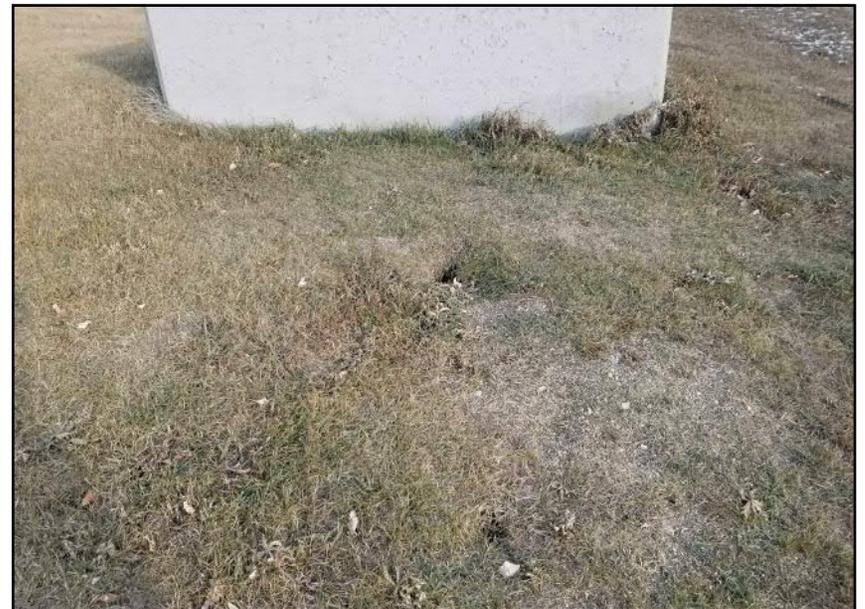
Site 4 - Eastern Riverbank	Animal burrows observed in front of siphons inlet chamber structure (facing W)
-----------------------------------	--

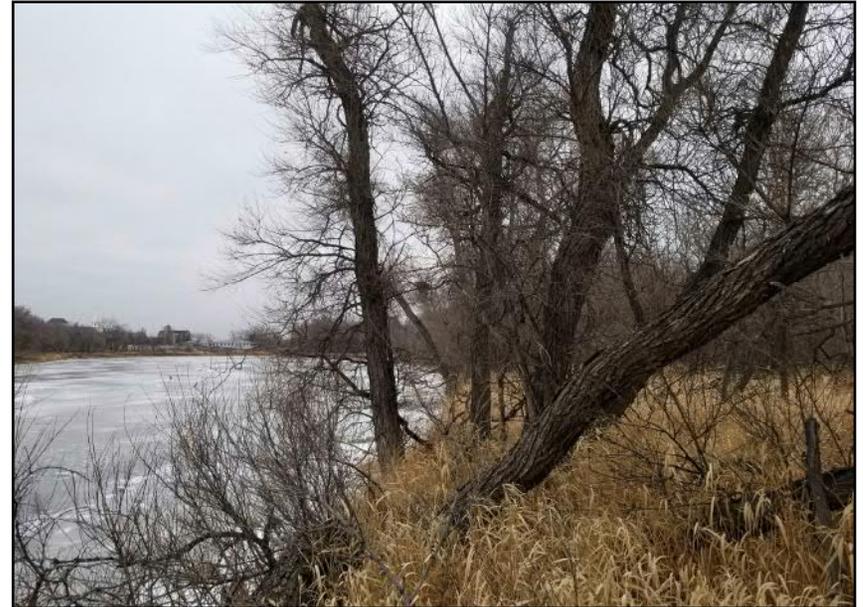
Site 5 - Southern Riverbank Fallen tree in close proximity to crossing alignment and erosion scarp at river edge (facing NE)

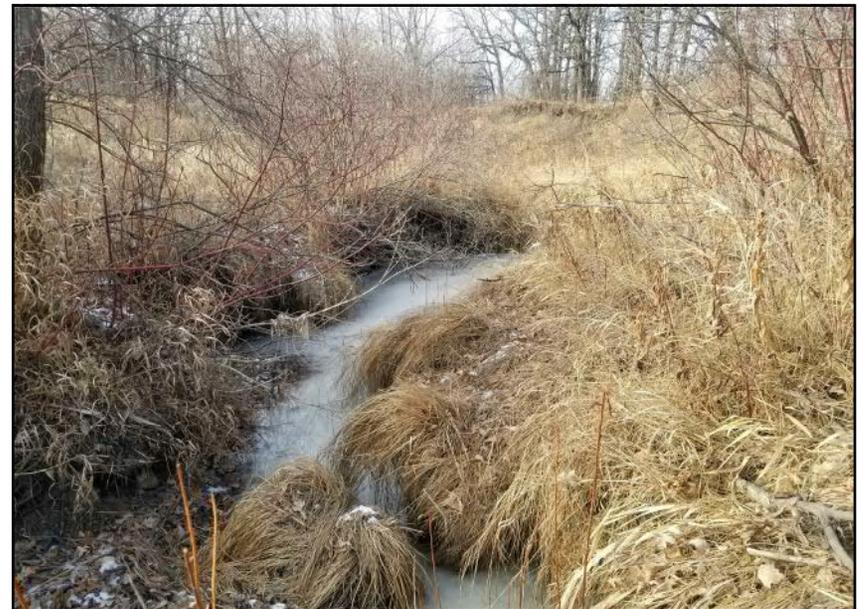
Site 6A - Northern Bank | Erosion scarp observed along drain edges, varying in height (facing W)

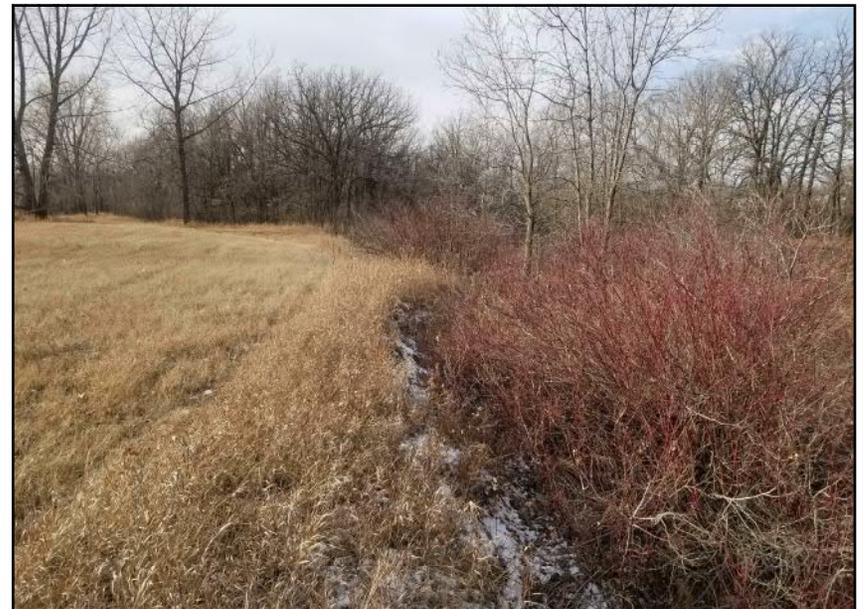
Site 6A - Southern Bank | Progressive slope instabilities have progressed towards the bank crest (facing W)

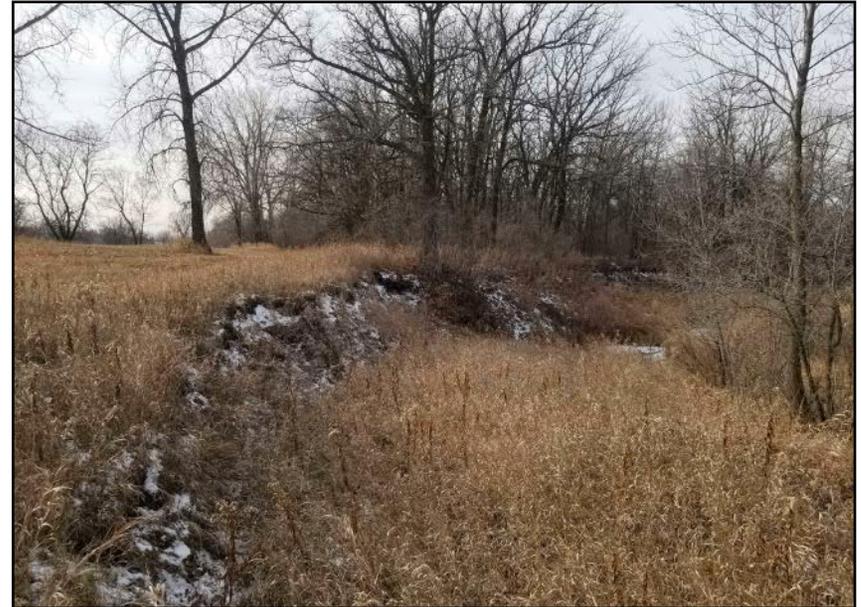
Site 6A - Southern Bank | Slope instability ridges observed near bank crest west of the crossing alignment (facing W)

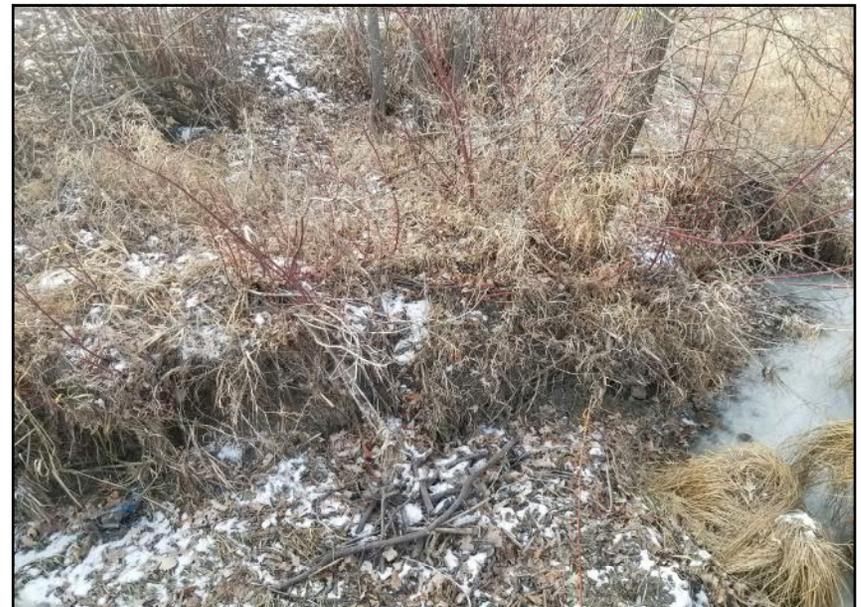
Site 6A - Southern Bank | Shallow slope instabilities observed at localized areas along bank toe (facing S)

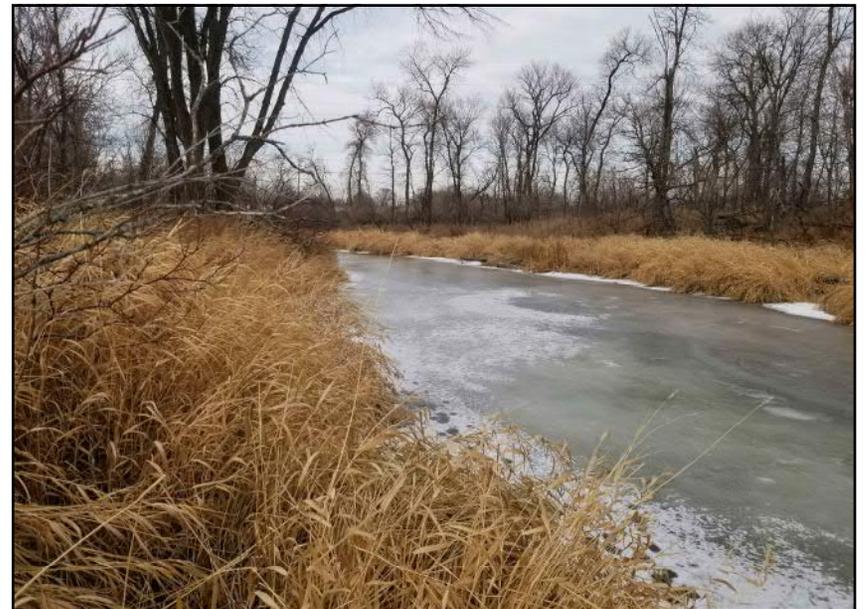
Site 6B - Western Bank	Minor erosion observed at localized areas along bank toe (facing N)
-----------------------------------	---

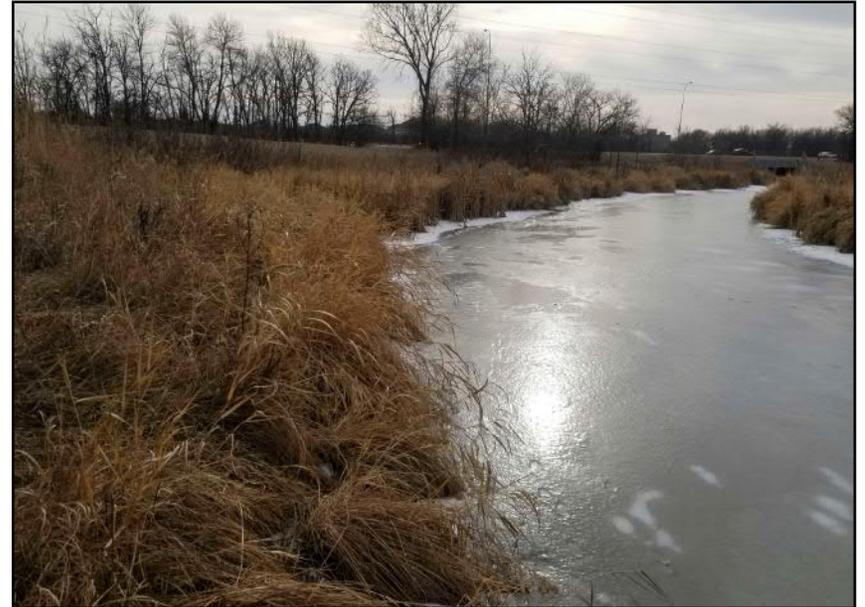
Site 6B - Eastern Bank	Minor erosion observed at localized areas along bank toe (facing S)
-------------------------------	---

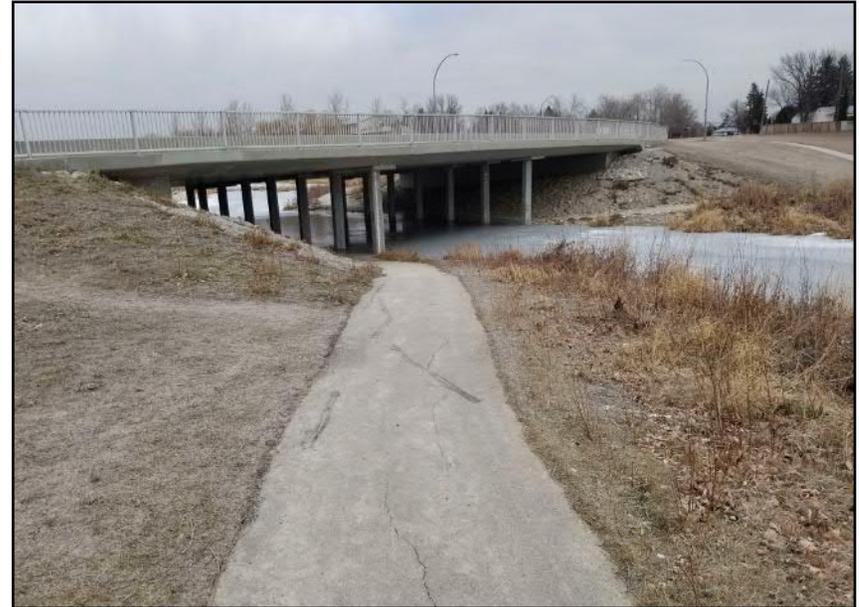
Site 7 - Western Bank Steeper slope around bridge abutment and minor cracking along pedestrian pathway (facing NE)

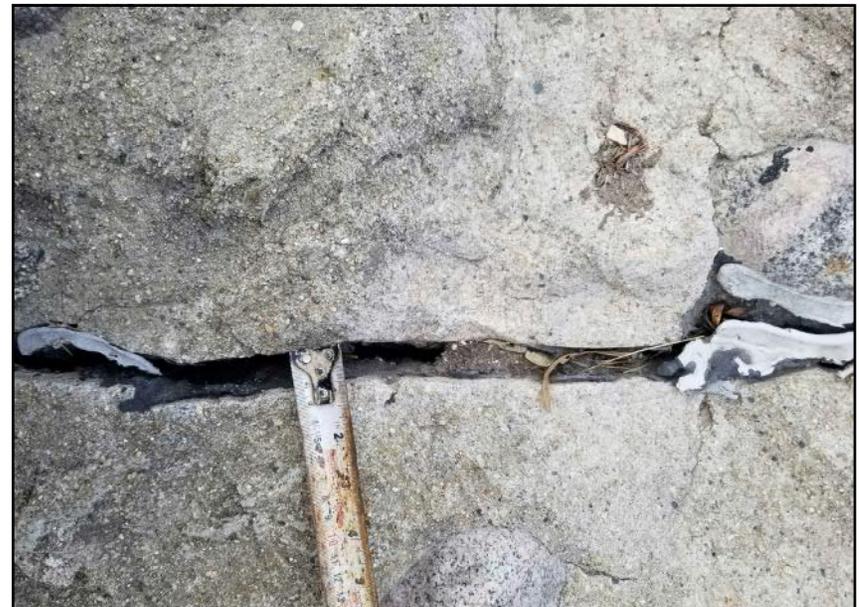
Site 7 - Western Bank Cracks observed within grouted rip-rap armorment at various orientations

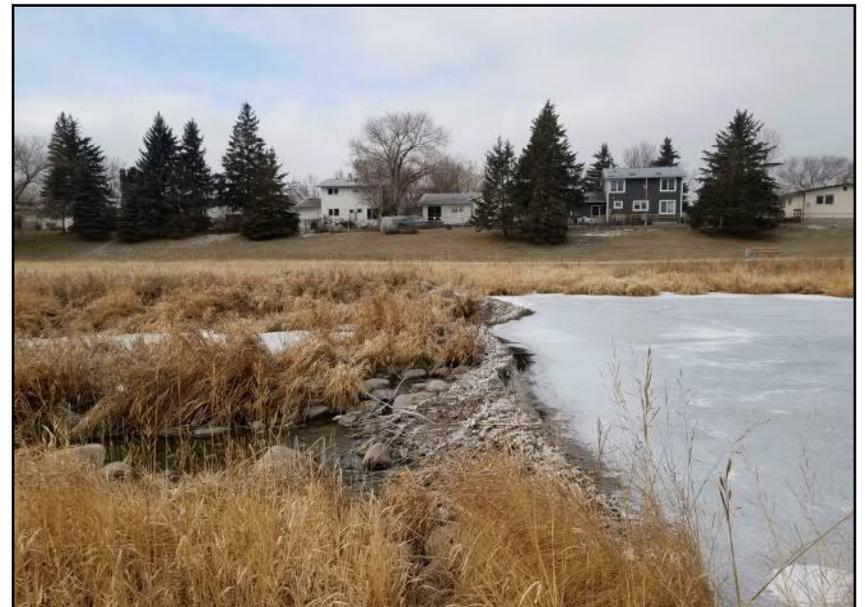
Site 7 - Eastern Bank	Beaver dam south of study area causing higher water levels within the study area (facing W)
------------------------------	---

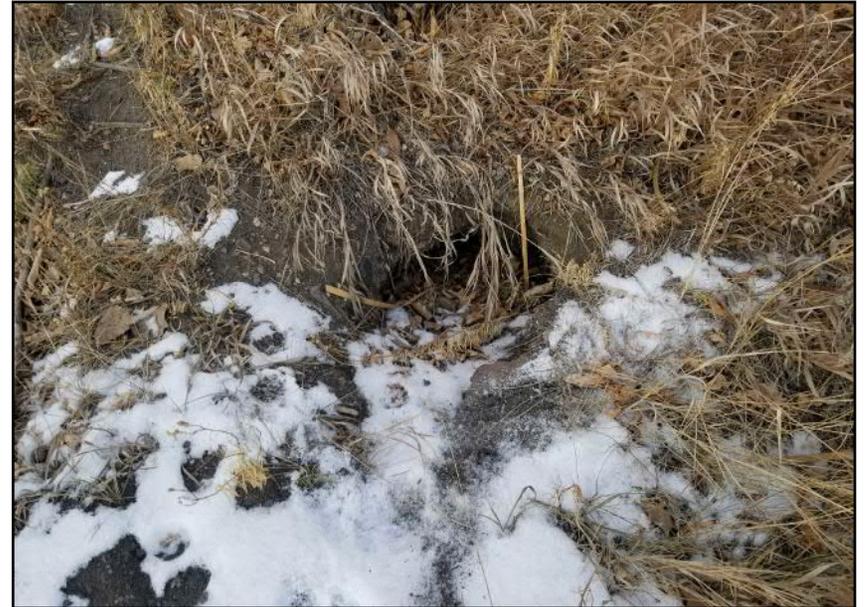
Site 8 - Eastern Bank	Animal burrows observed along bank slopes.
------------------------------	--

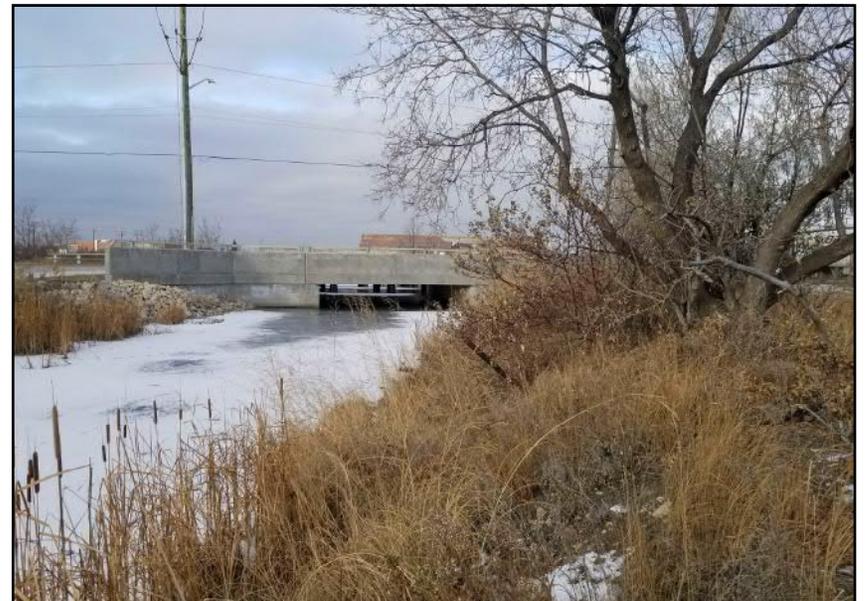
Site 8 - Eastern Bank	Oversteepened banks observed within southern portion of the study area (facing N)
------------------------------	---

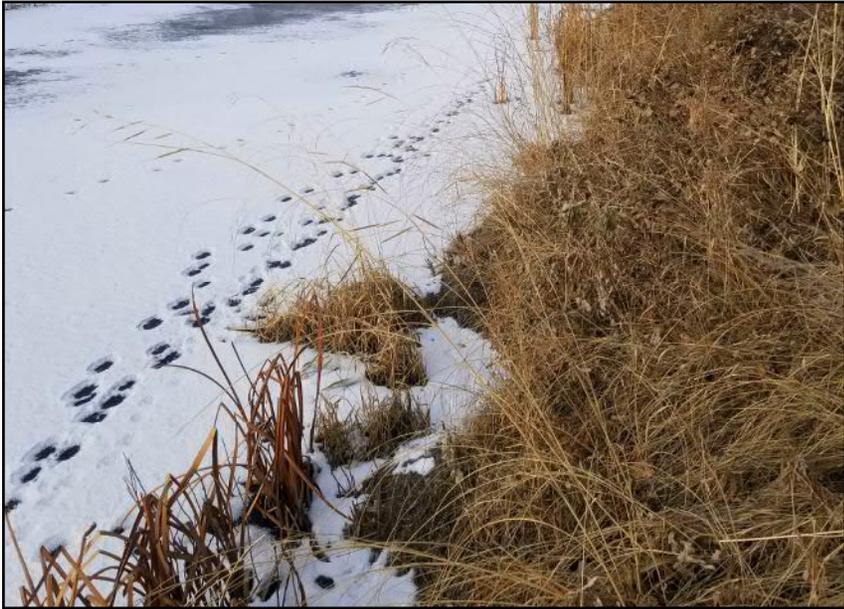
Site 8 - Eastern Bank	Minimal erosion observed along bank toe south of the rip-rap area (facing N)
------------------------------	--

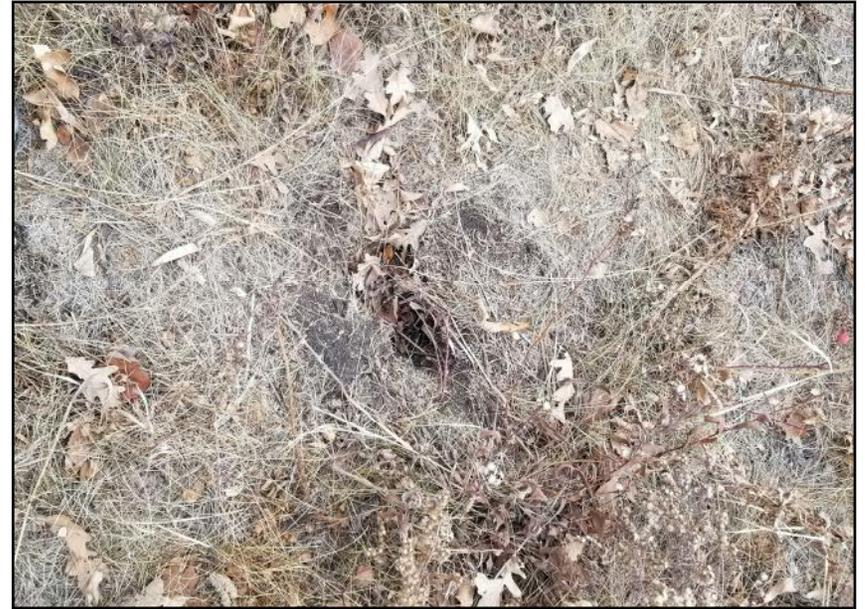
Site 9 - Western Bank	Animal burrows observed within bank slopes.
------------------------------	---

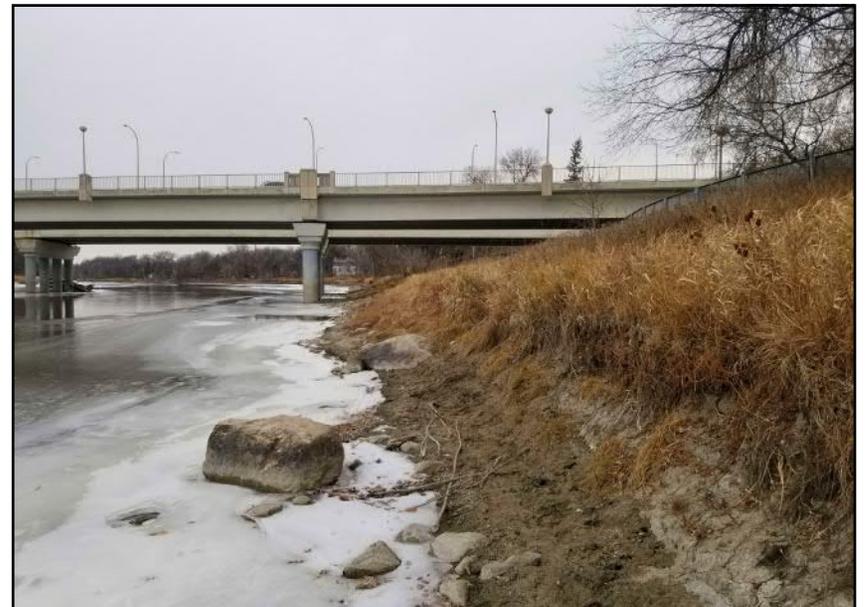
Site 10 - Northern Riverbank Scarp near river edge observed along full length of bank toe within study area (facing W)

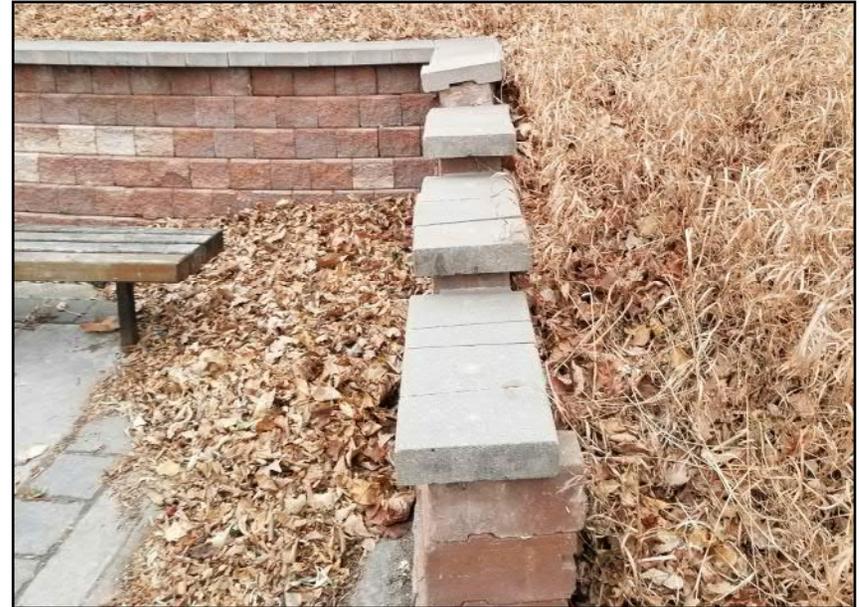
Site 10 - Northern Riverbank	Masonry retaining wall structure near pedestrian pathway shows small signs of movement (facing W)
-------------------------------------	---

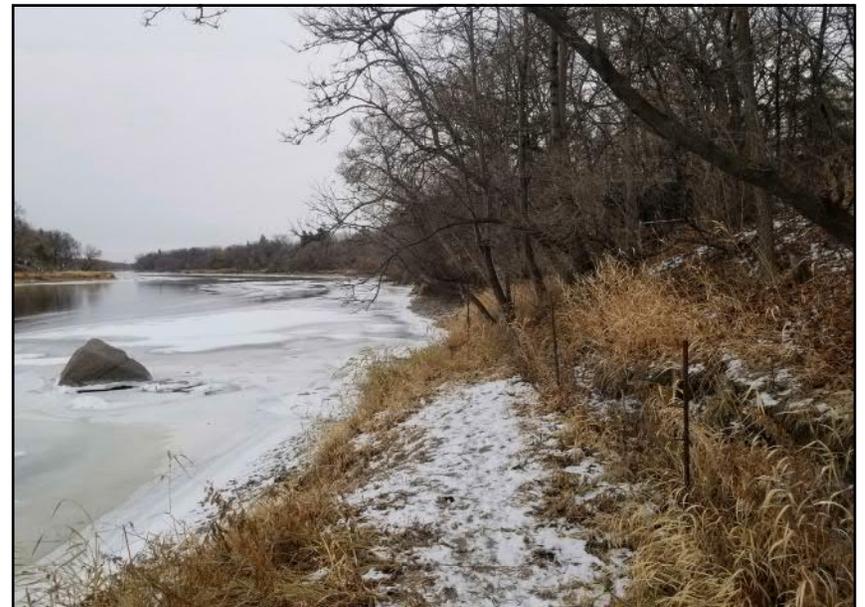
Site 10 - Southern Riverbank | Oversteepened banks and instabilities observed within eastern portion of study area (facing E)

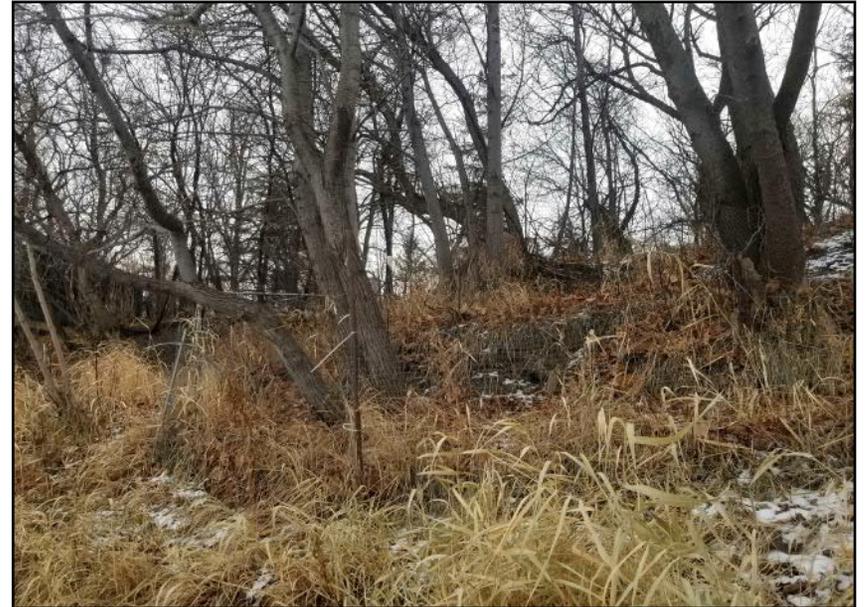
Site 10 - Southern Riverbank Larger scarps and leaning trees observed along banks in eastern portion of study area (facing SE)

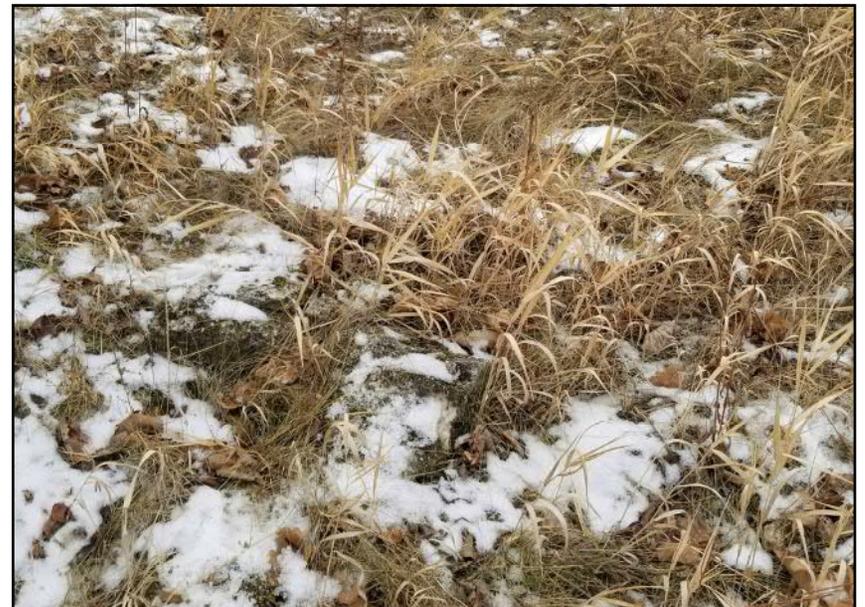
Site 10 - Southern Riverbank Small scarp and crack observed along flat portion of bank crest near crossing alignment (facing S)
