# **GEOTECHNICAL REPORT**

<b>GEOTECHNICAL REPORT FOR 2006 RESIDENTIAL STREET RENEWAL PROGRAM</b>	<b>2</b>
Test Hole Location Plan	1
Table 1 - Test Hole Summary Locations	1
Table 2 – Summary of Pavement Structure and Sub-grade Description	3
Test Hole Log for #: TH1	1
Test Hole Log for #: TH2	1
Test Hole Log for #: TH3	1
Test Hole Log for #: TH4	1
Test Hole Log for #: TH5	1
Test Hole Log for #: TH6	1
Test Hole Log for #: TH7	1
Particle Size Analysis Report	5
Pavement Core Photos	4

**RE:** Geotechnical Investigation – Simcoe Street Rehabilitation - Between Ellice Avenue and St. Matthews Avenue, Winnipeg, Manitoba

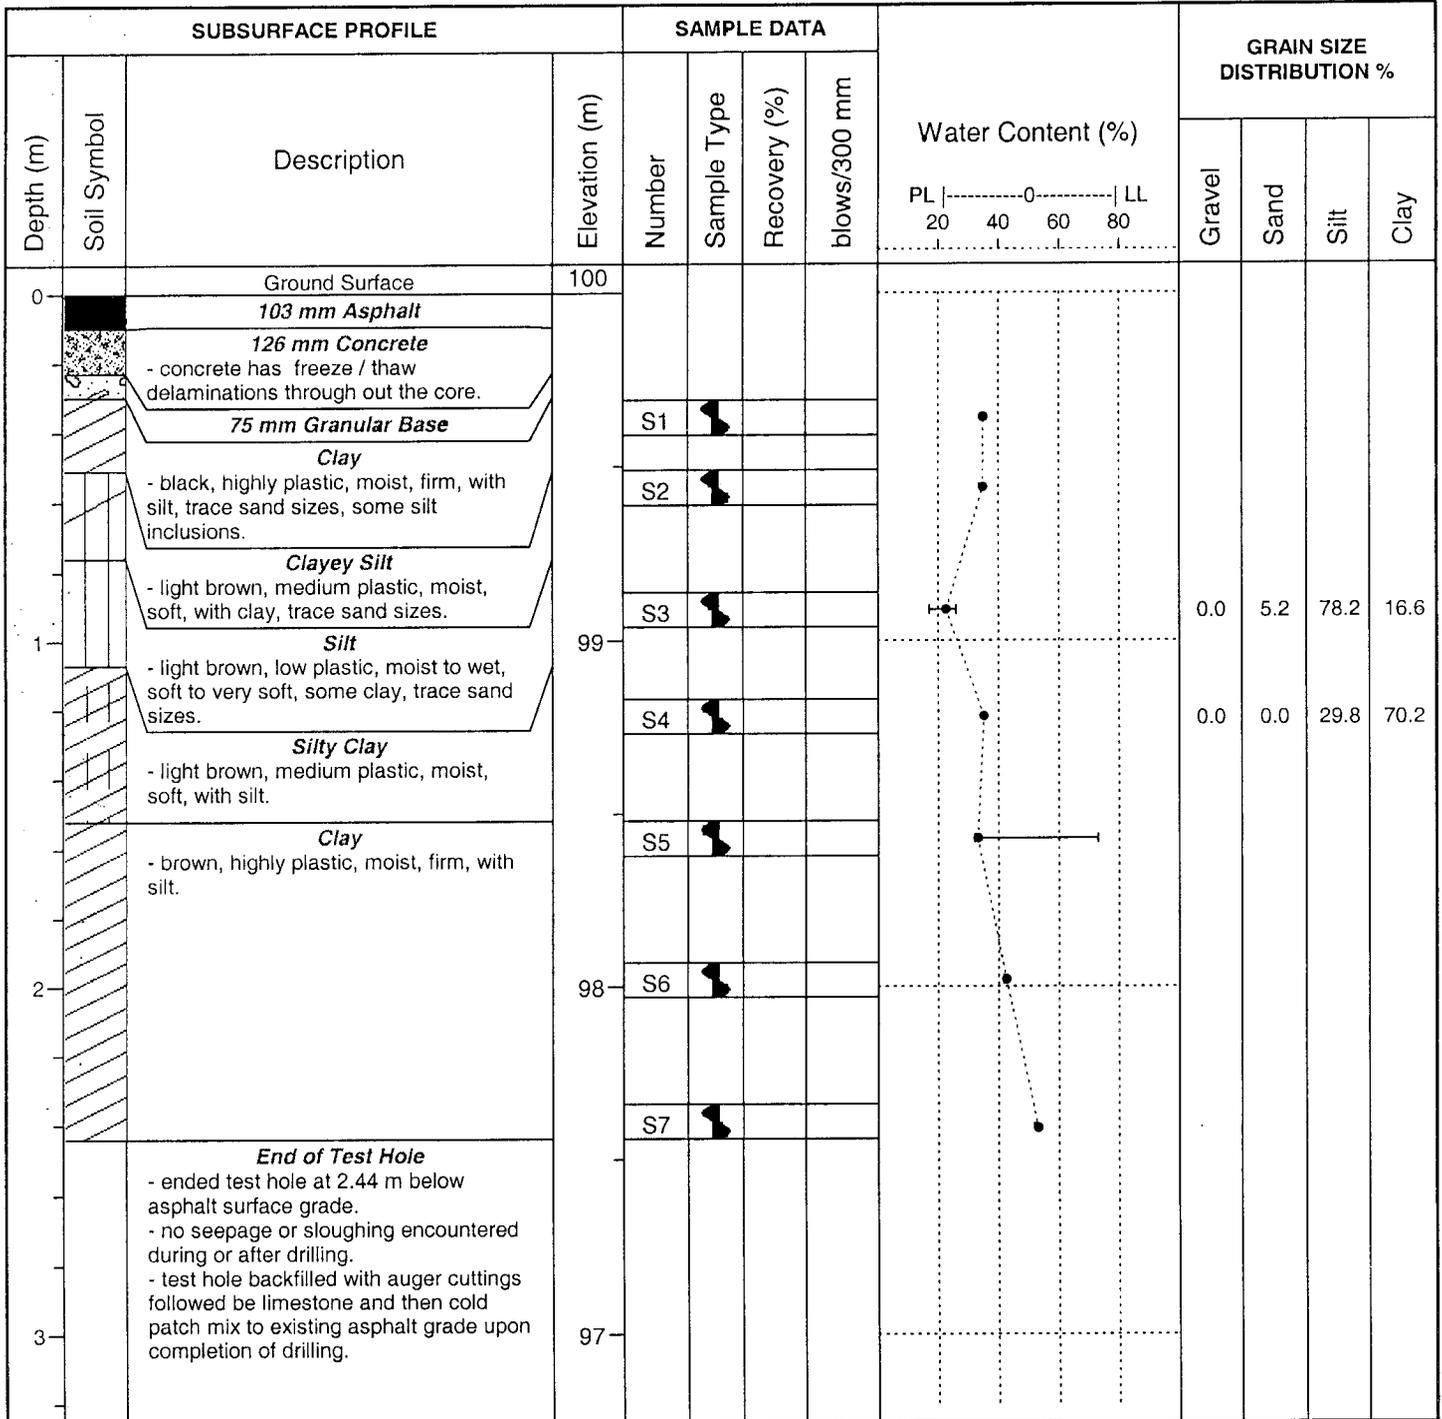
Test Hole #: TH4

Location: North Bound Lane / 178 m south of the center line of Ellice Ave.

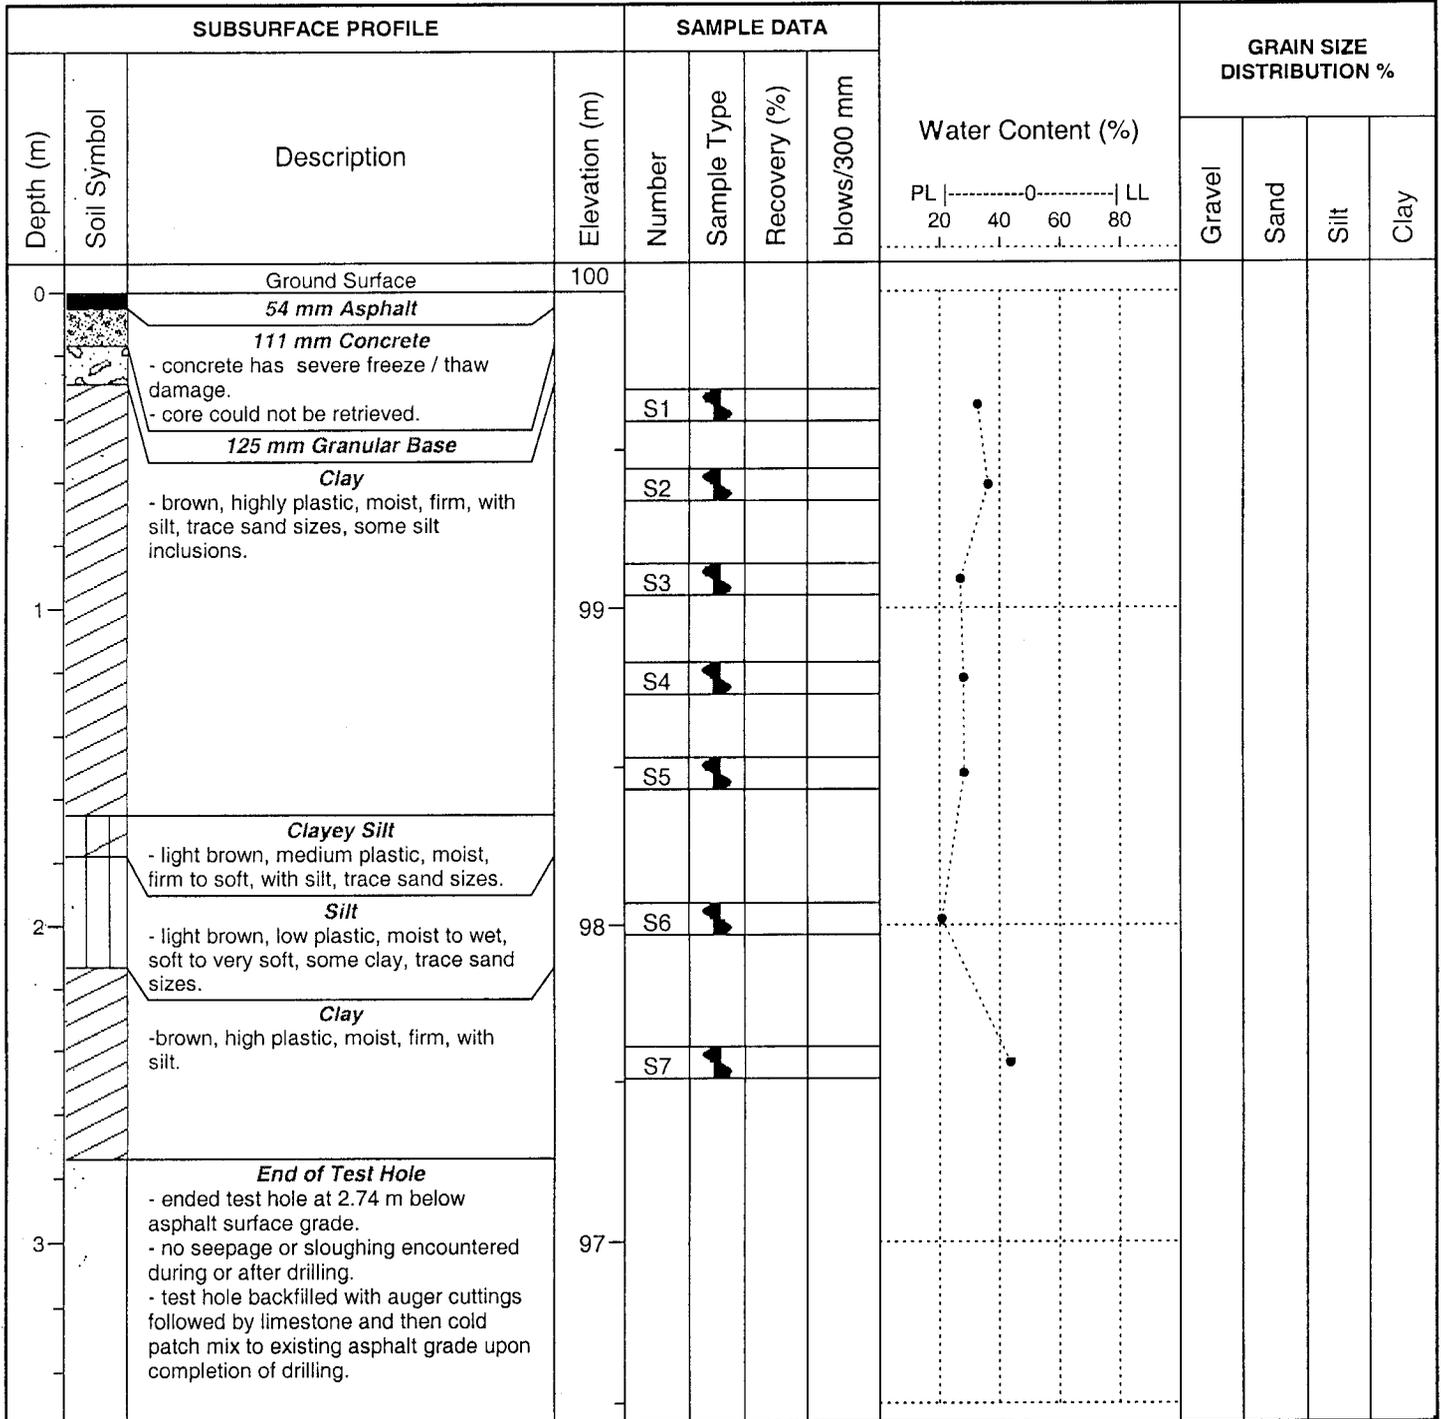
**Test Hole #: TH6**

Location: North Bound Lane / 61 m south of the center line of Ellice Ave.

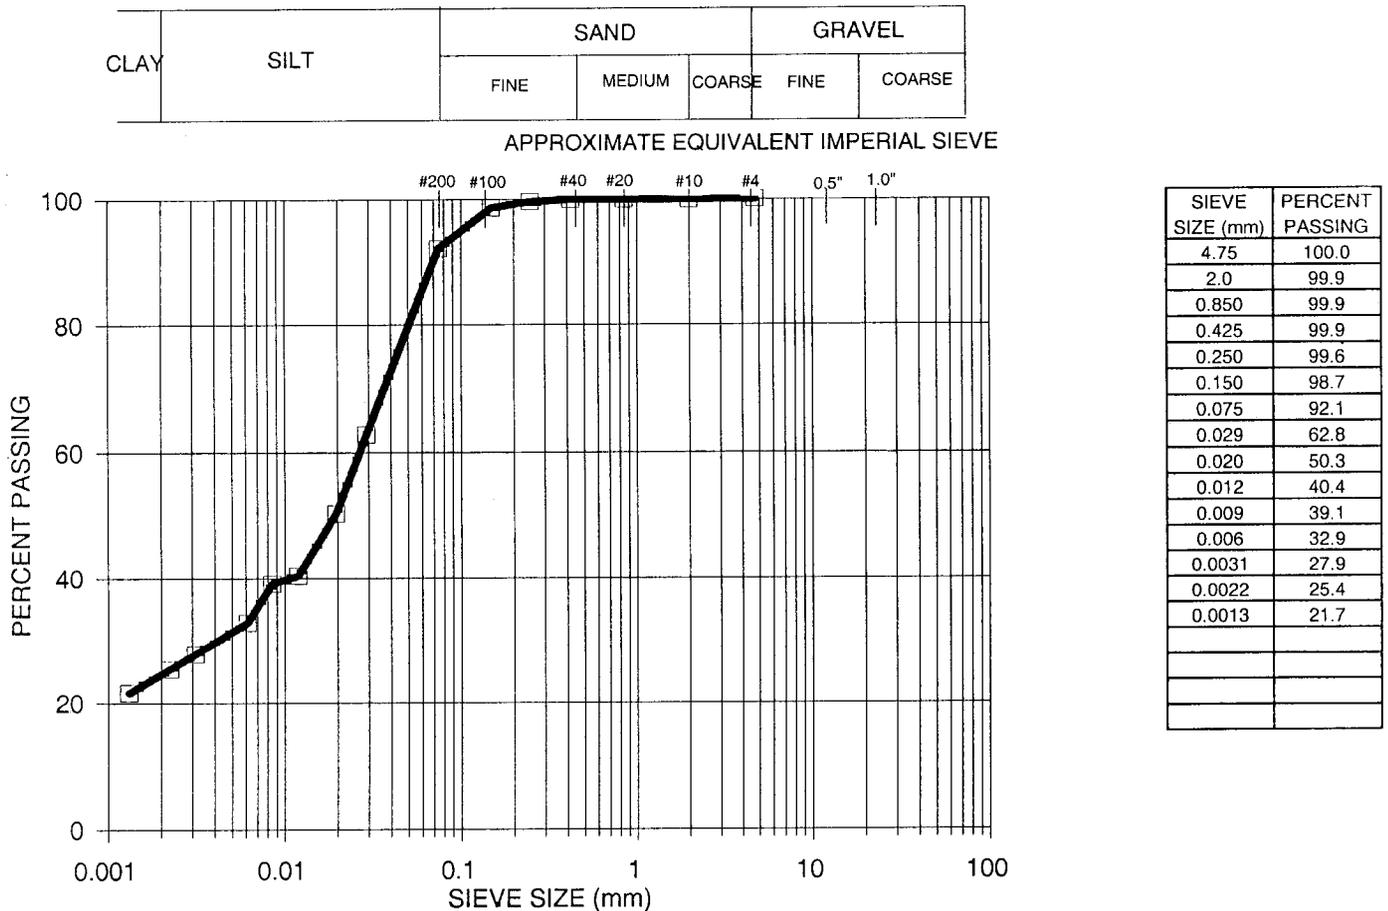
**PARTICLE SIZE  
 ANALYSIS REPORT**

<b>Test Hole No.</b> TH 1	<b>Sample No.</b> S4	<b>Depth:</b> 1.22 m
<b>Sampled By:</b> ENG-TECH	<b>Type of Sample:</b> Grab	<b>Source:</b> Simcoe Street
<b>Date Sampled:</b> March 9/06	<b>Date Received:</b> March 17/06	<b>Date Tested:</b> Mar 22/06

**Percent of:** GRAVEL (0.0%), SAND (7.9%), SILT (67.5%) and CLAY (24.6%)  
**Sample Description:** See Test Hole Logs

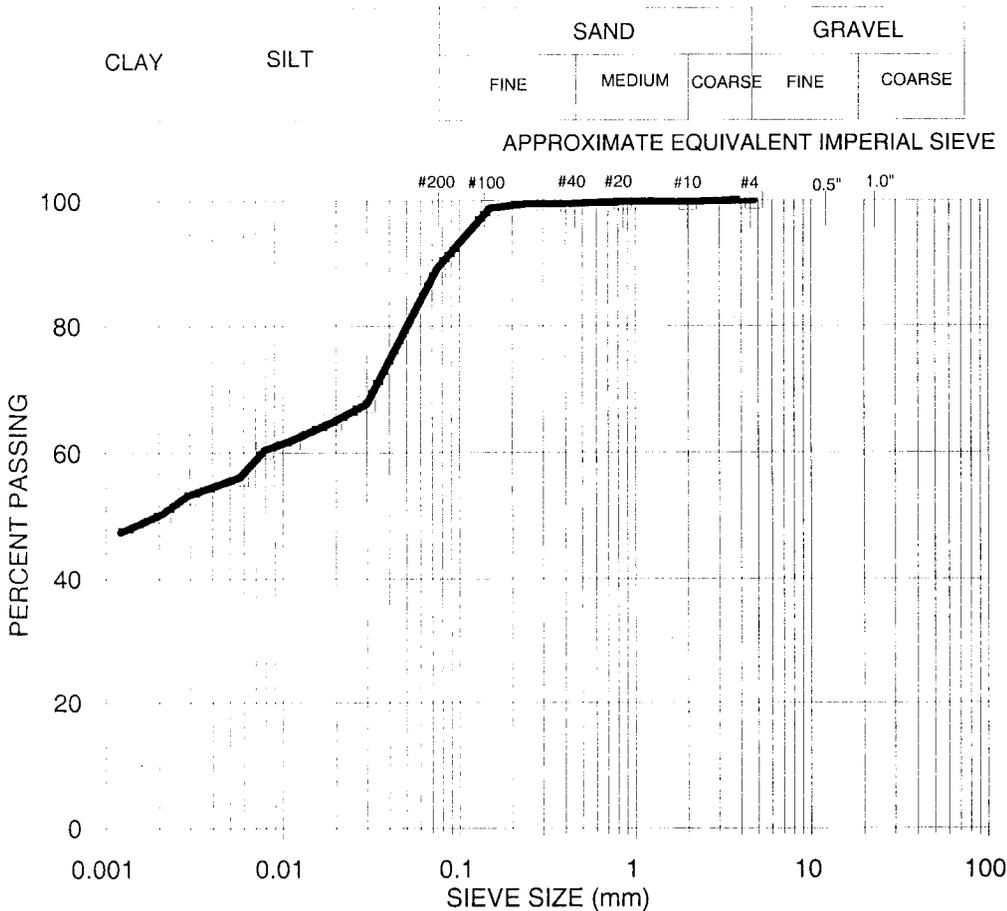
**PARTICLE SIZE  
 ANALYSIS REPORT**

<b>Test Hole No.</b>	TH 2	<b>Sample No.</b>	S2	<b>Depth:</b>	0.61m
<b>Sampled By:</b>	ENG-TECH	<b>Type of Sample:</b>	Grab	<b>Source:</b>	Simcoe Street
<b>Date Sampled:</b>	March 9/06	<b>Date Received:</b>	March 17/06	<b>Date Tested:</b>	Mar 22/06

SIEVE SIZE (mm)	PERCENT PASSING
4.75	100.0
2.0	99.9
0.850	99.9
0.425	99.6
0.250	99.6
0.150	98.8
0.075	89.1
0.030	67.6
0.019	64.7
0.011	61.9
0.008	60.4
0.006	56.2
0.0029	53.3
0.0021	50.5
0.0012	47.6

**Percent of:** GRAVEL (0.0%), SAND (10.9%), SILT (38.9%) and CLAY (50.2%)  
**Sample Description:** See Test Hole Logs

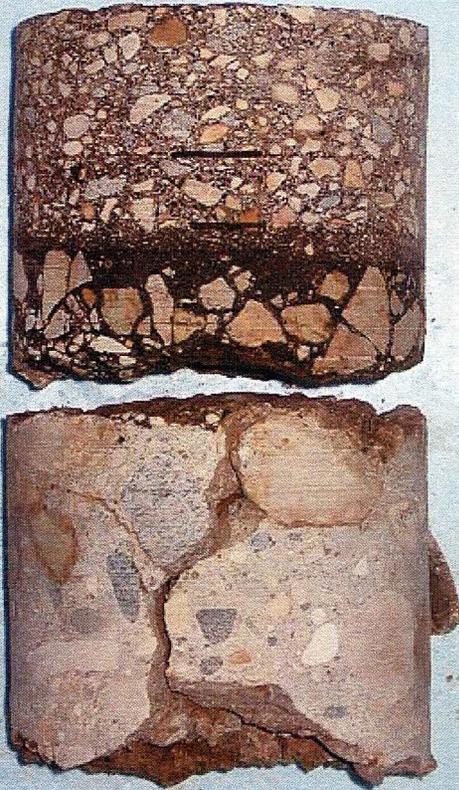
- freeze / thaw delaminations present throughout core.													
		65 mm Granular Base		S1	Shelby Tube										
		Silty Clay Fill													
		- dark brown, highly plastic, moist, firm, with silt, trace sand sizes.		S2	Shelby Tube										
		Clay

Simcoe Street – Btwn Ellice and  
St. Matthews Avenue  
TH # 1 – In front of House # 354  
South Bound Lane  
120 mm Asphalt  
121 mm Concrete

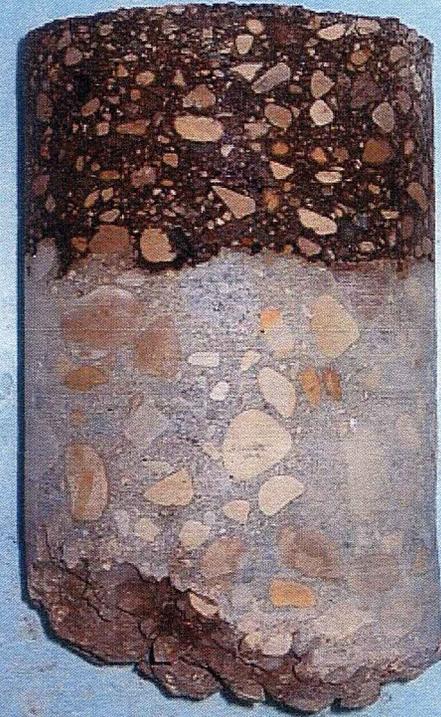
Simcoe Street – Btwn Ellice and  
St. Matthews Avenue  
TH # 2 – Btwn House # 361 and #363  
North Bound Lane  
80 mm Asphalt  
136 mm Concrete

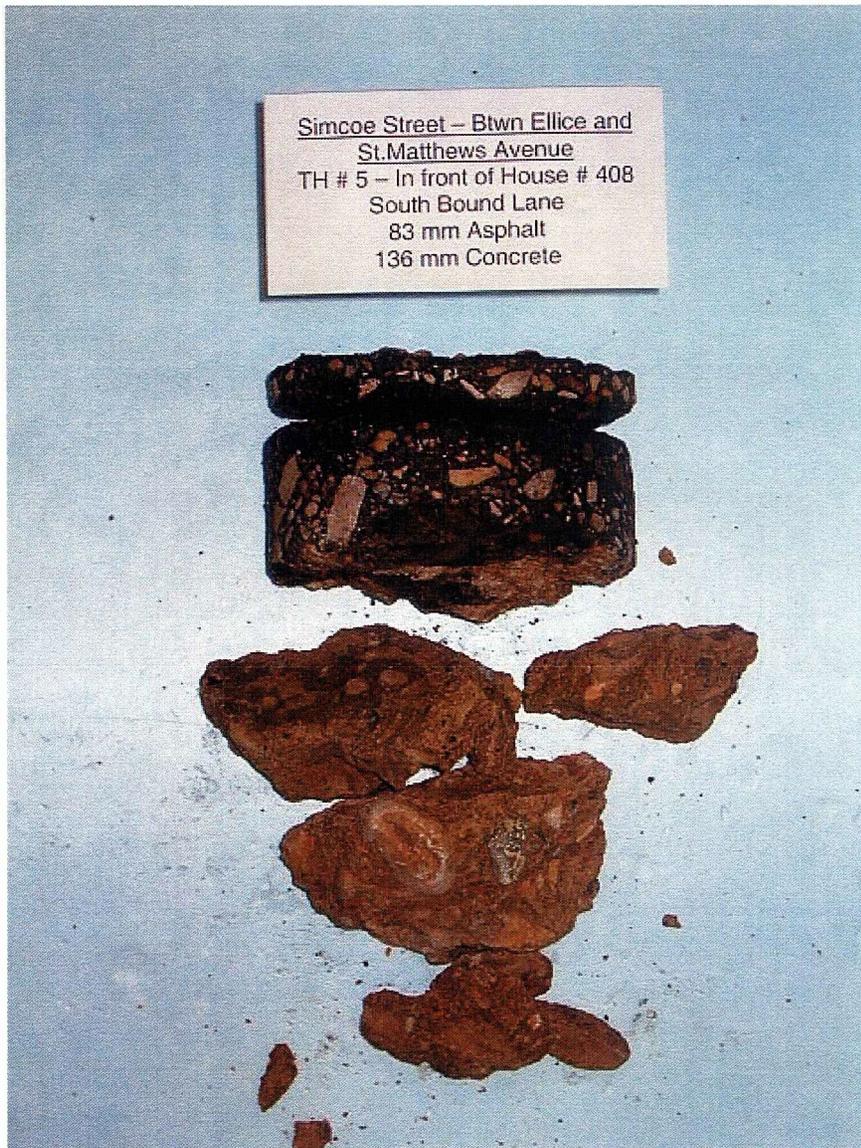
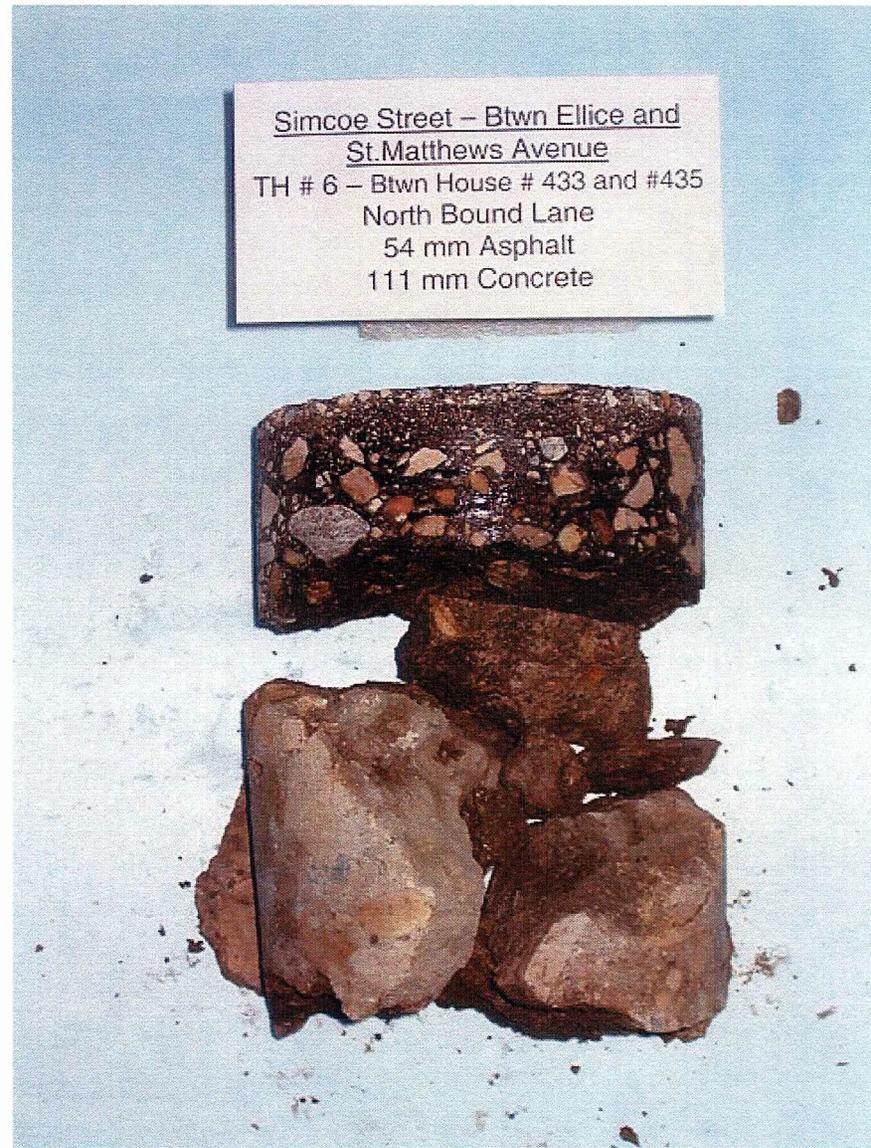
Simcoe Street – Test Holes TH3 and TH4

SUBSURFACE PROFILE			SAMPLE DATA				Water Content (%)	GRAIN SIZE DISTRIBUTION %			
Depth (m)	Soil Symbol	Description	Elevation (m)	Number	Sample Type	Recovery (%)		blows/300 mm	Gravel	Sand	Silt
0		Ground Surface	100								
		125 mm Asphalt									
		116 mm Concrete - concrete has severe freeze / thaw damage. - core could not be retrieved.		S1	Shelby Tube						
		65 mm Granular Base									
		Silty Clay Fill - dark brown, highly plastic, moist, stiff, with silt, trace sand sizes.		S2	Shelby Tube						
		Clay - black, highly plastic, moist, firm, some silt, trace sand sizes.		S3	Shelby Tube						
1		- below 0.91 m, turning brown	99

- concrete has severe freeze / thaw damage.													
		- core could not be retrieved.													
		75 mm Granular Base													
		Clay

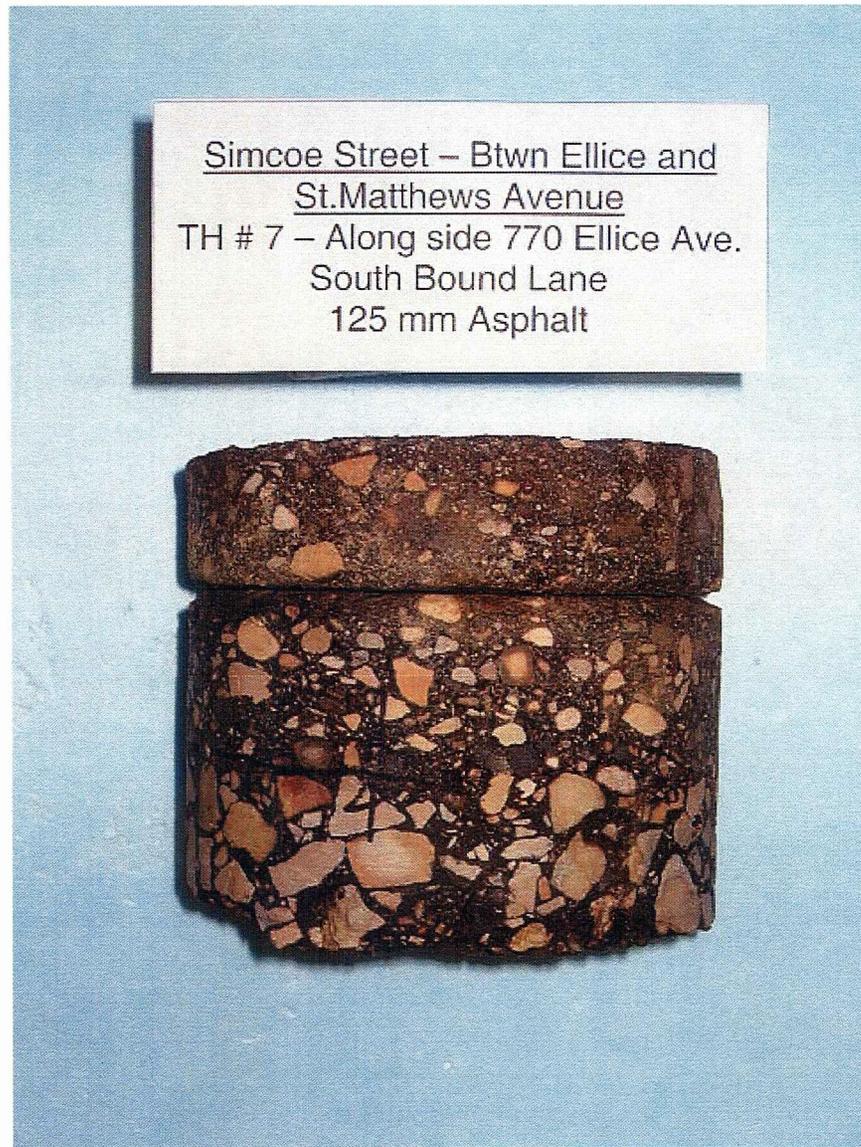
Simcoe Street – Test Hole TH7

Simcoe Street – Btwn Ellice and  
St. Matthews Avenue  
TH # 7 – Along side 770 Ellice Ave.  
South Bound Lane  
125 mm Asphalt
