ENGINEER'S SEAL  
CONSULTANT DRAWING NUMBER  
**14-1411-S-107**

**THE CITY OF WINNIPEG**  
WATER AND WASTE DEPARTMENT  
ENGINEERING DIVISION  
WILKES RESERVOIR NORTH CELL REHABILITATION  
FOOTING AND WALL JOINT REPLACEMENT  
SECTIONS AND DETAILS  
SHEET 15 OF 47  
CITY DRAWING NUMBER  
**1-0650R-S0007-001**

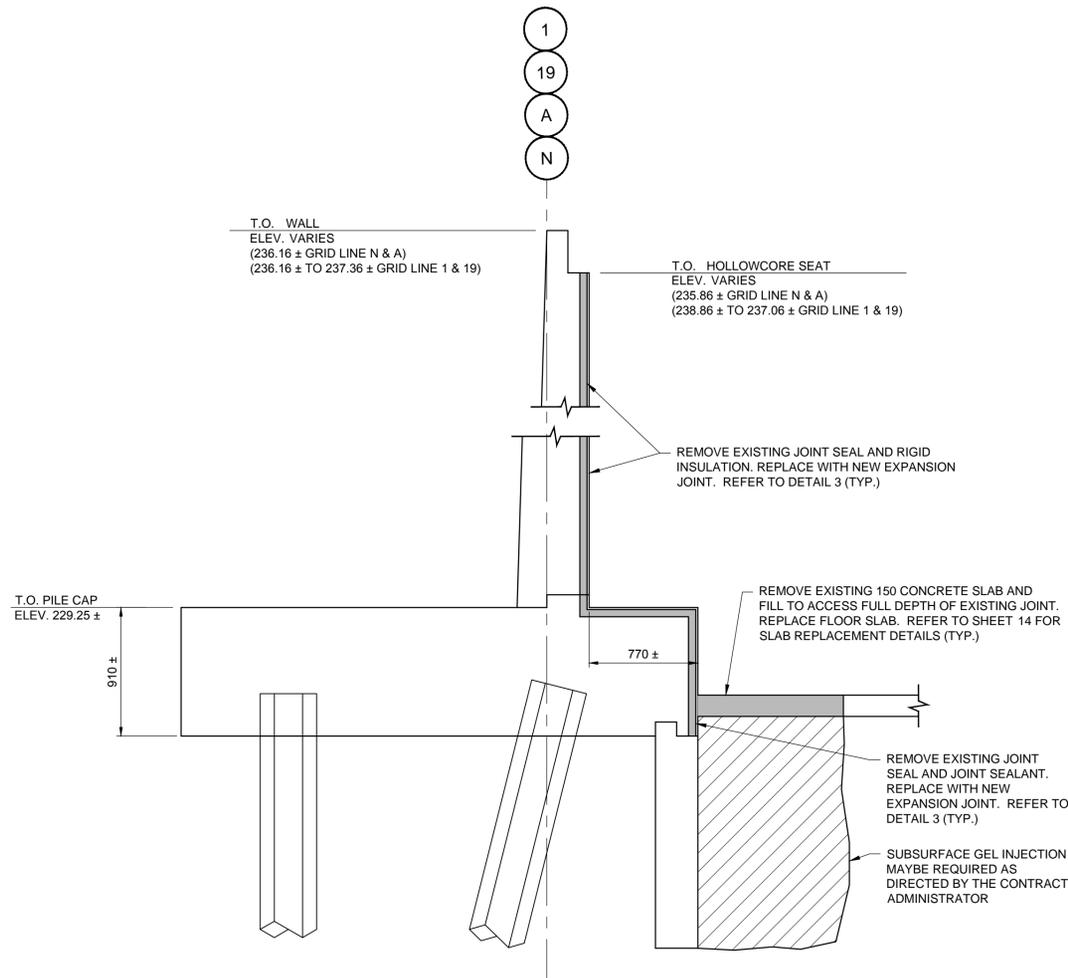
**1 SECTION**  
TYPICAL EXTERIOR WALL (8 THUS)

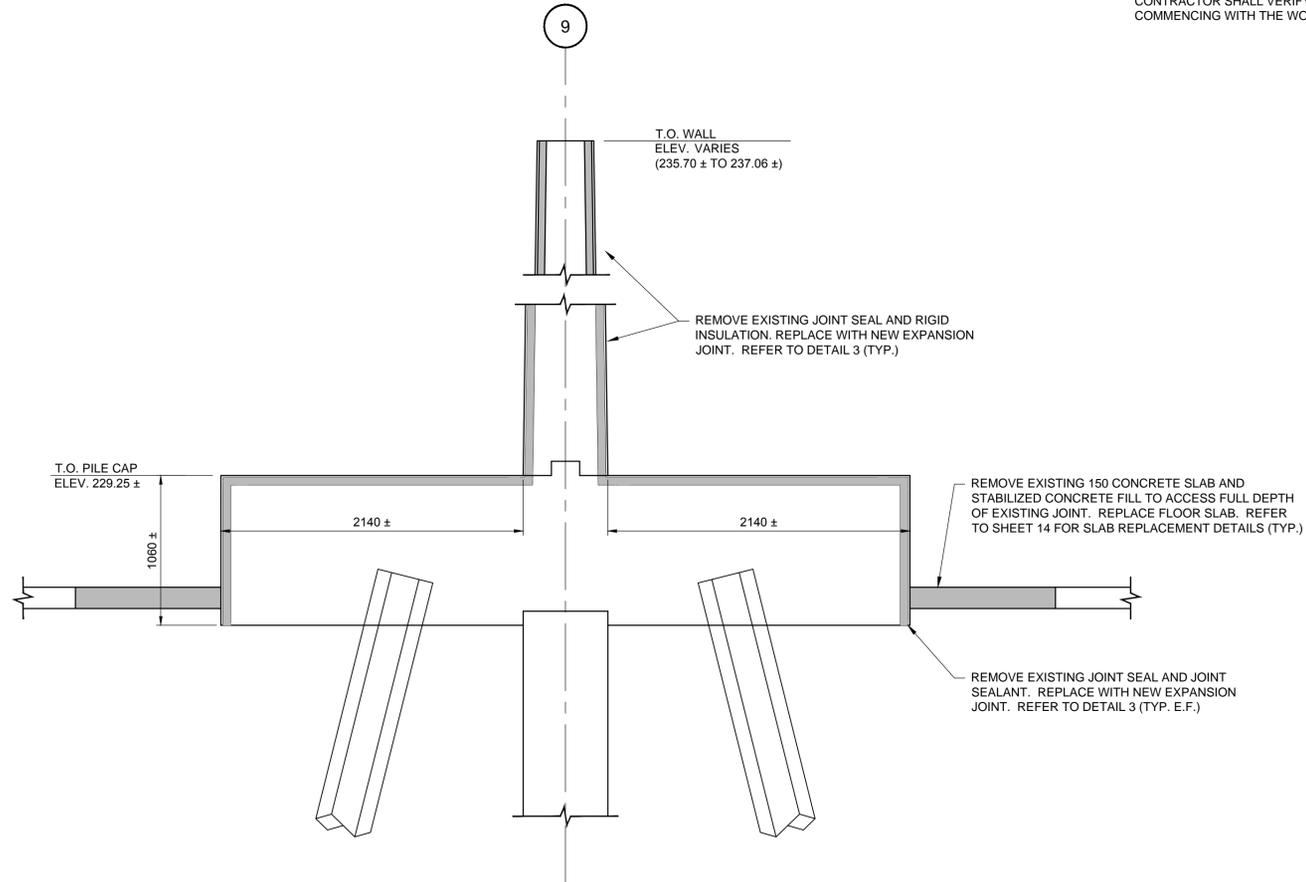
**2 SECTION**  
TYPICAL INTERIOR WALL

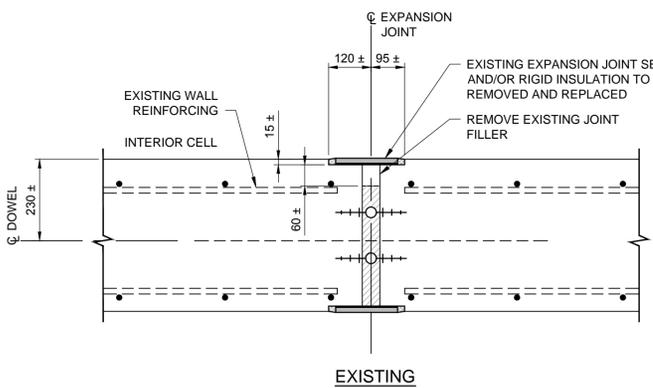
**3 DETAIL**  
EXISTING INTERIOR WALL AND FOOTING EXPANSION JOINT REPAIR

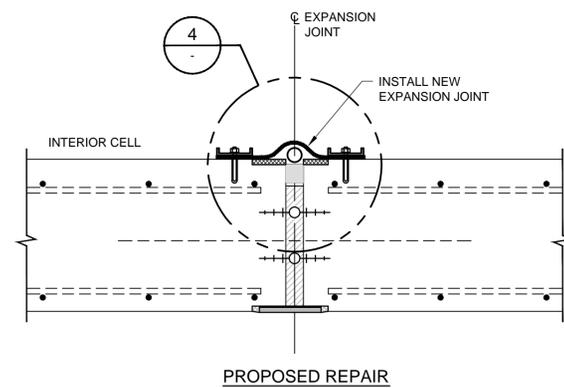
**4 DETAIL**  
PROPOSED REPAIR INTERIOR WALL AND FOOTING EXPANSION JOINT REPAIR

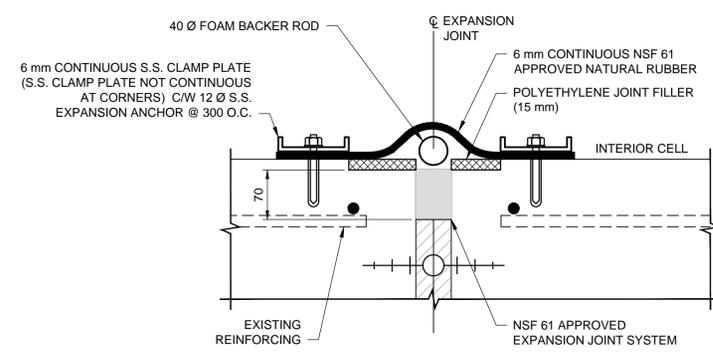
**4 DETAIL**  
TYPICAL EXPANSION JOINT REPLACEMENT

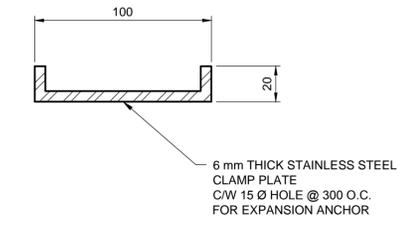
**5 DETAIL**  
STAINLESS STEEL CLAMP PLATE
