# **GEOTECHNICAL REPORT**

## **St. James Street Reconstruction – Portage Avenue to Maroons Road – Sub Surface Investigation**

**RE: Sub-Surface Investigation Report for  
St. James Reconstruction – Portage Avenue to Maroons Road**

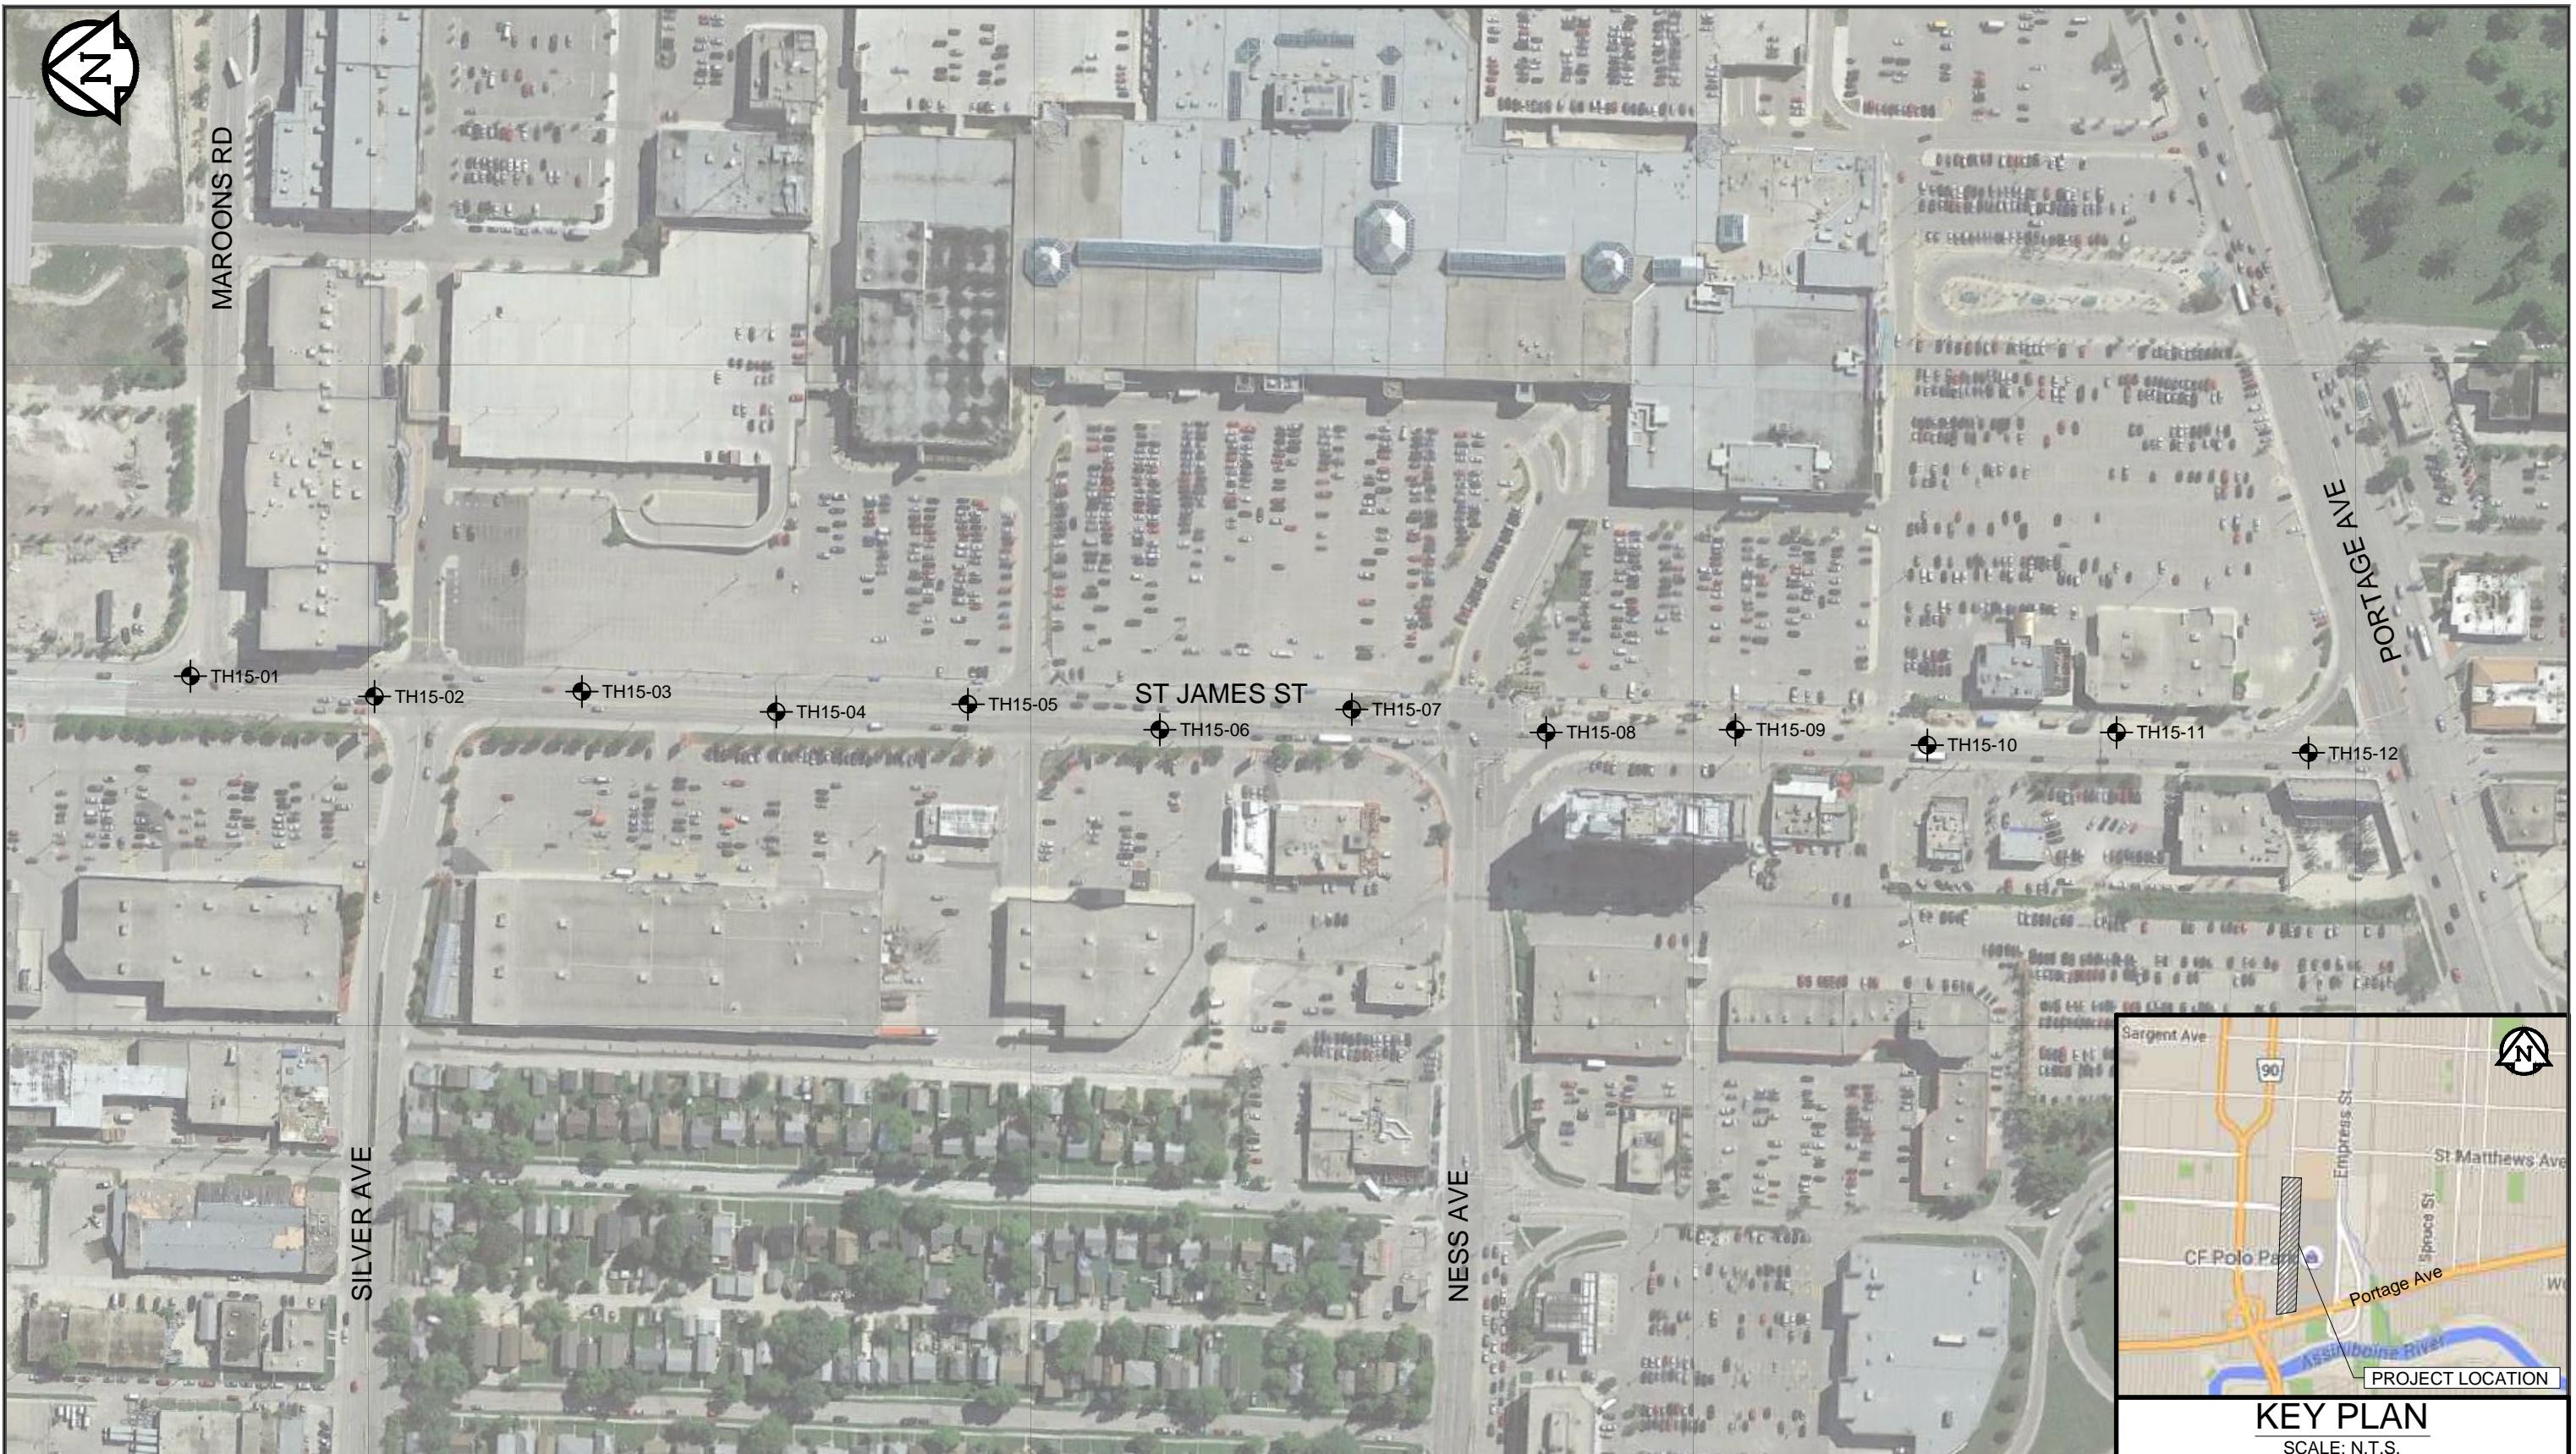
Figure 01 Test Hole Location Plan – St. James Street

A total of 12 test holes were drilled on St James Street from Maroons Road to Portage Avenue at the locations shown on Figure 01. The test holes were drilled in order to determine sub-surface conditions for design and reconstruction of the road segment.

Test hole locations noted on the test hole logs and shown on Figure 01 are based on measured distances from the nearest curb and from the intersection of Portage Avenue and St. James Street.

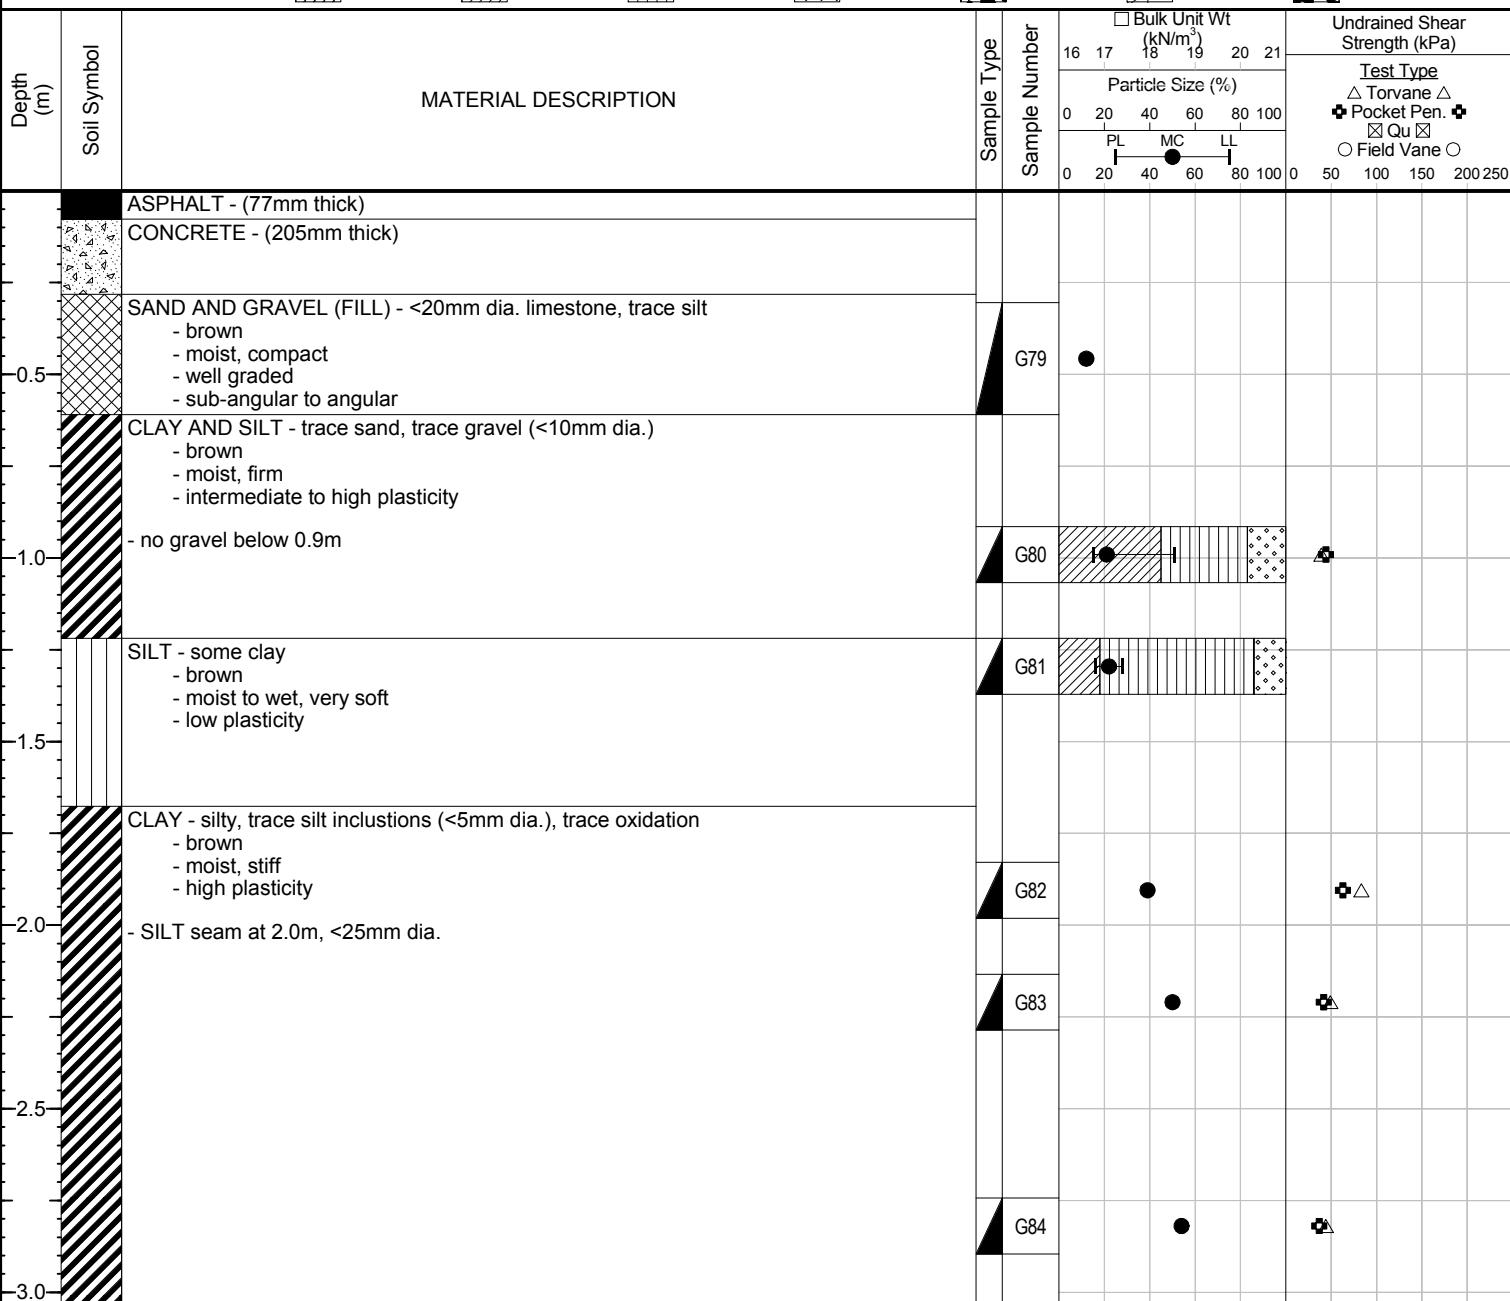
END OF TEST HOLE AT 3.0m IN CLAY

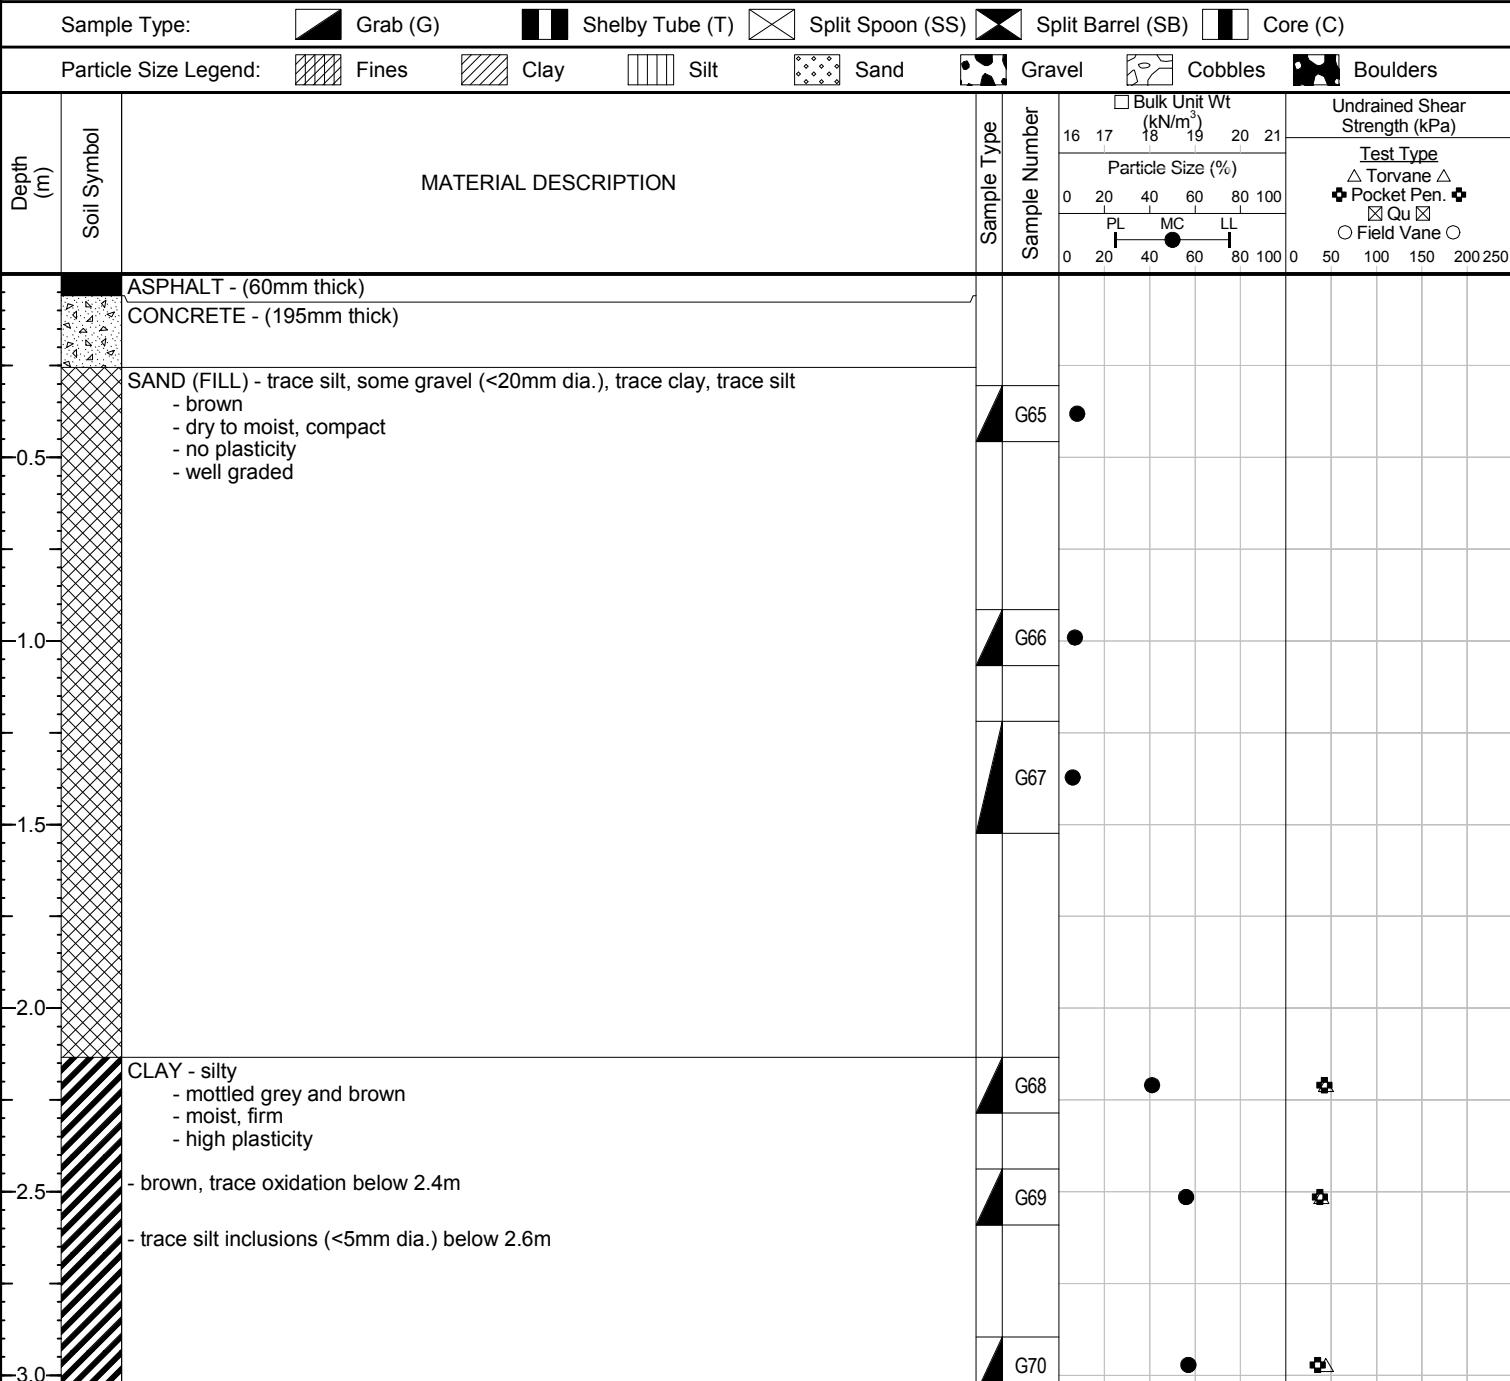
Notes:  
1) No sloughing or seepage.  
2) Test hole open to 2.9m at completion of drilling.  
3) Test hole backfilled with auger cuttings, bentonite and cold patch asphalt.  
4) Test hole located in median north bound lane 552m north of the intersection of Portage Ave. and St. James St., 5.6m west from east curb. U14 (5527431m N, 629211m E).

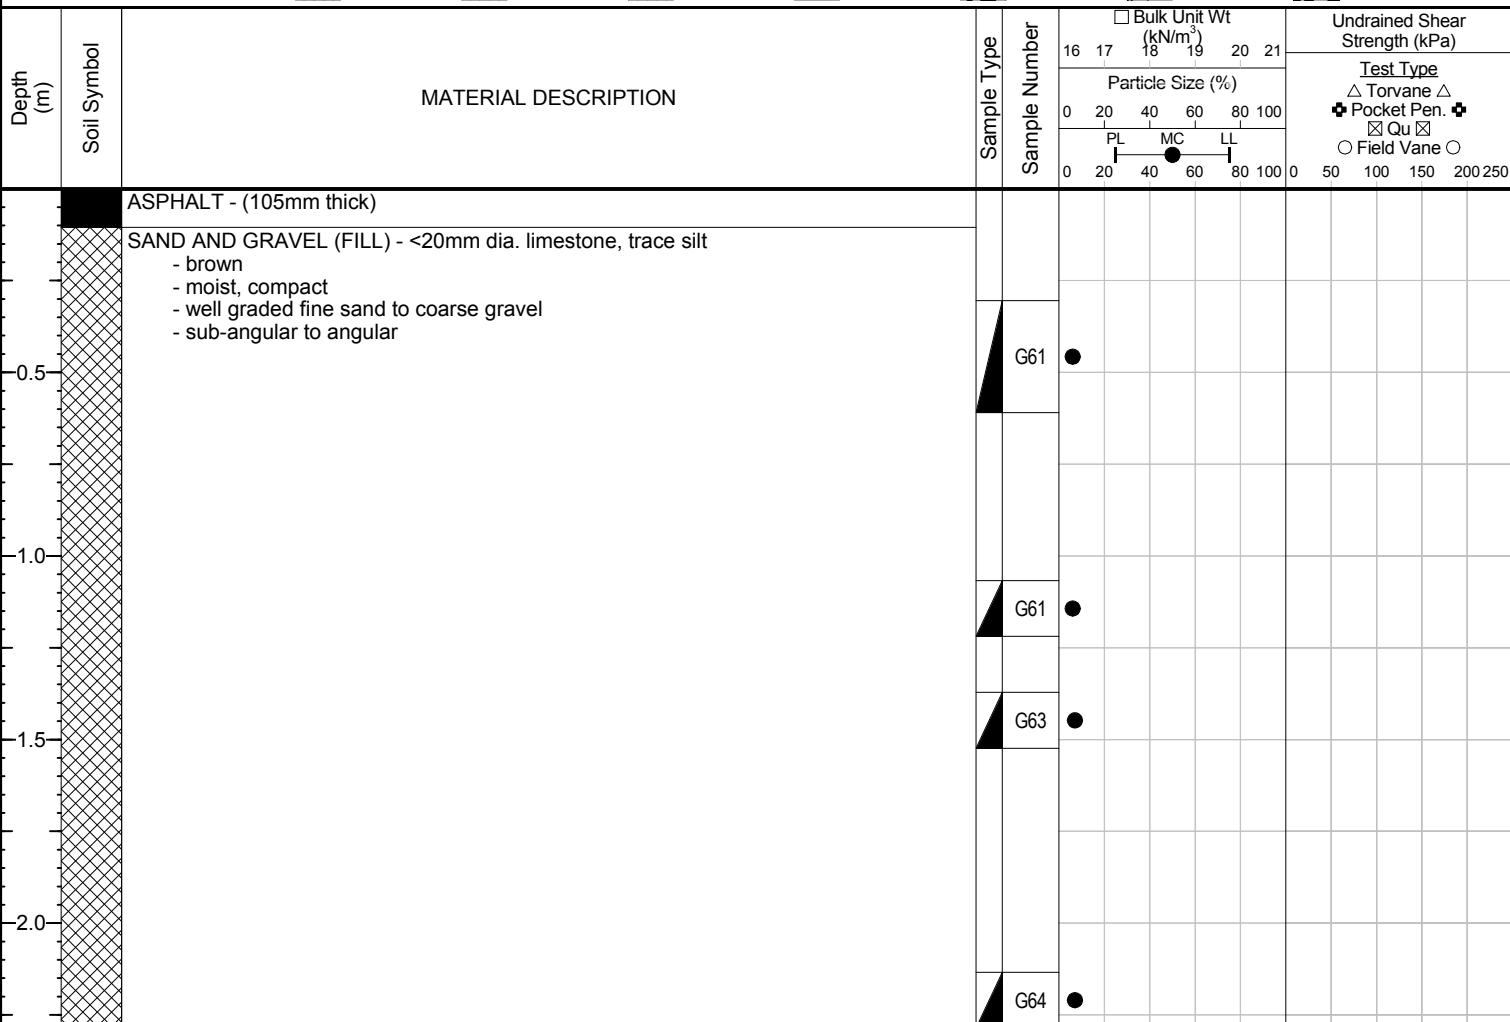
END OF TEST HOLE AT 2.3m IN SAND AND GRAVEL (FILL)

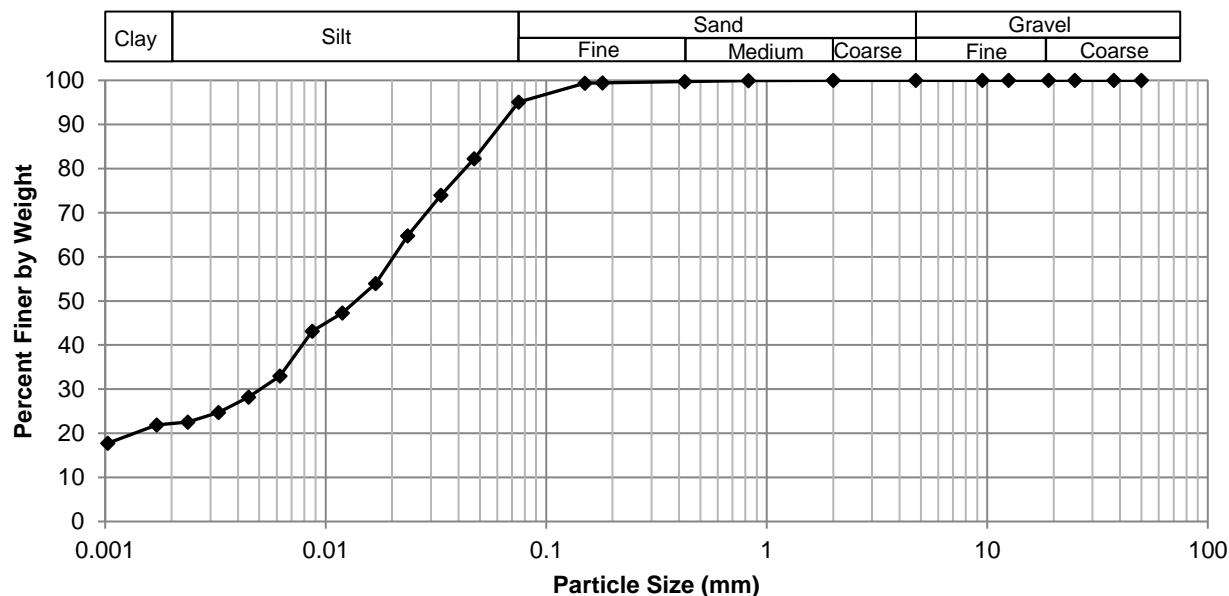
### Particle Size Distribution Curve

<b>Gravel</b>	0.0%
<b>Sand</b>	4.9%
<b>Silt</b>	73.0%
<b>Clay</b>	22.1%

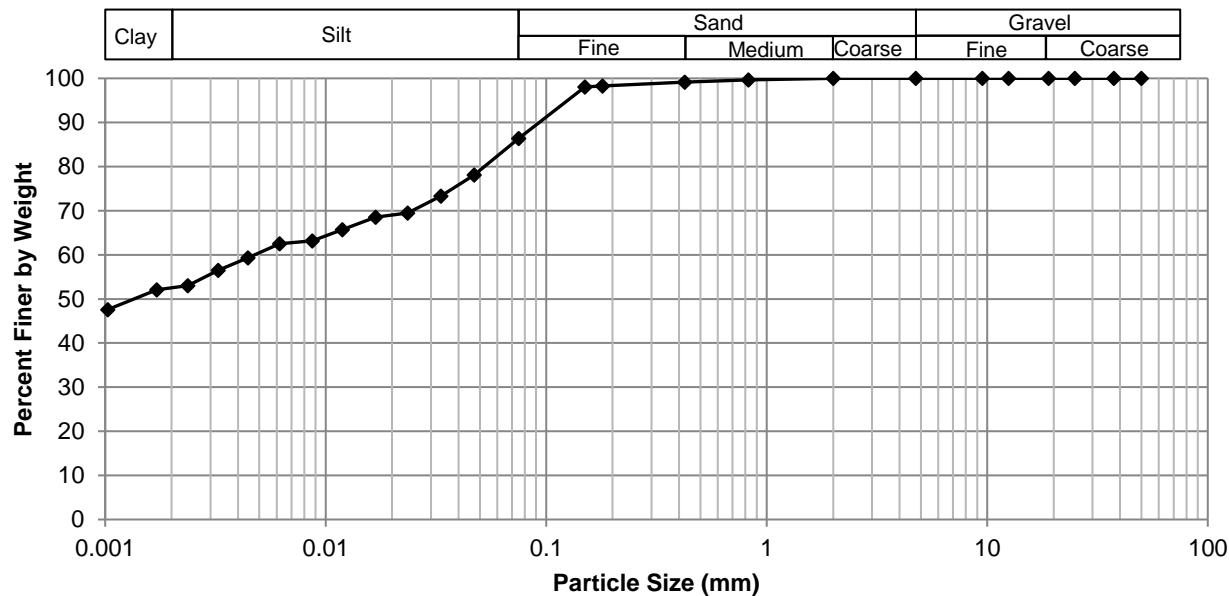
**Particle Size Distribution Curve**

<b>Gravel</b>	0.0%
<b>Sand</b>	13.6%
<b>Silt</b>	33.9%
<b>Clay</b>	52.5%

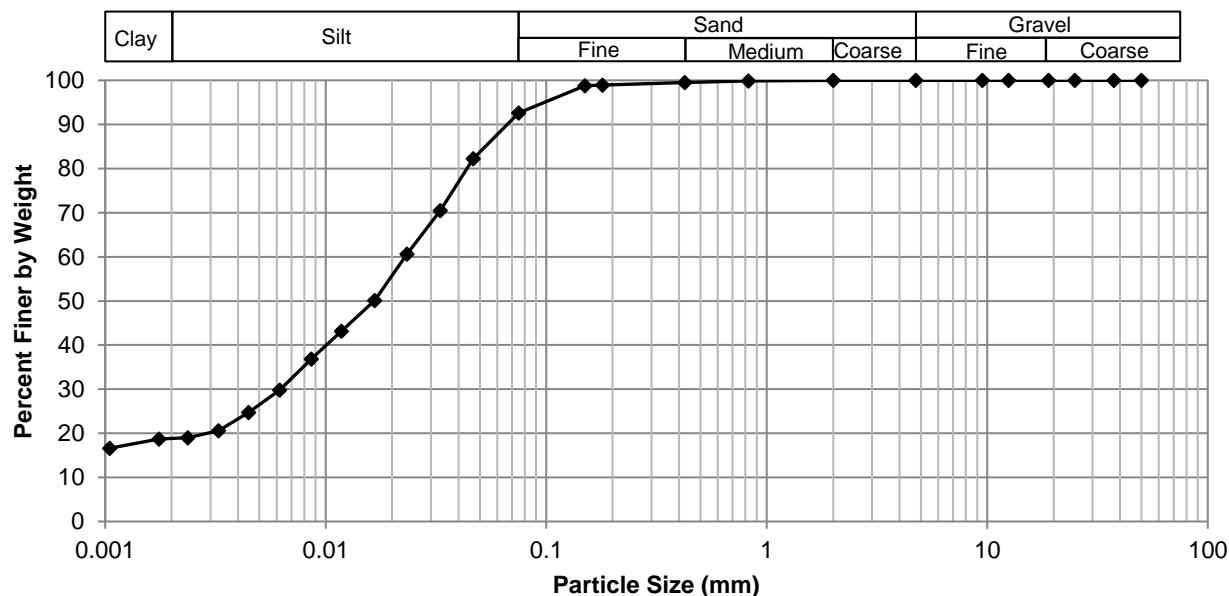
**Particle Size Distribution Curve**

<b>Gravel</b>	0.0%
<b>Sand</b>	7.4%
<b>Silt</b>	73.8%
<b>Clay</b>	18.8%

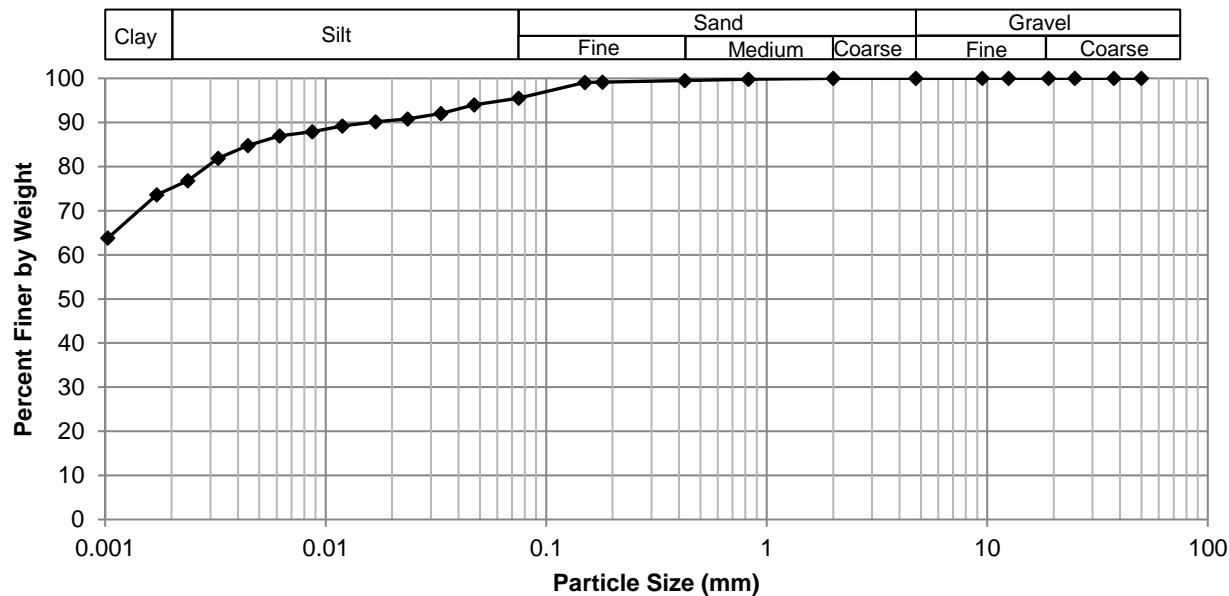
**Particle Size Distribution Curve**

<b>Gravel</b>	0.0%
<b>Sand</b>	4.5%
<b>Silt</b>	20.5%
<b>Clay</b>	75.0%

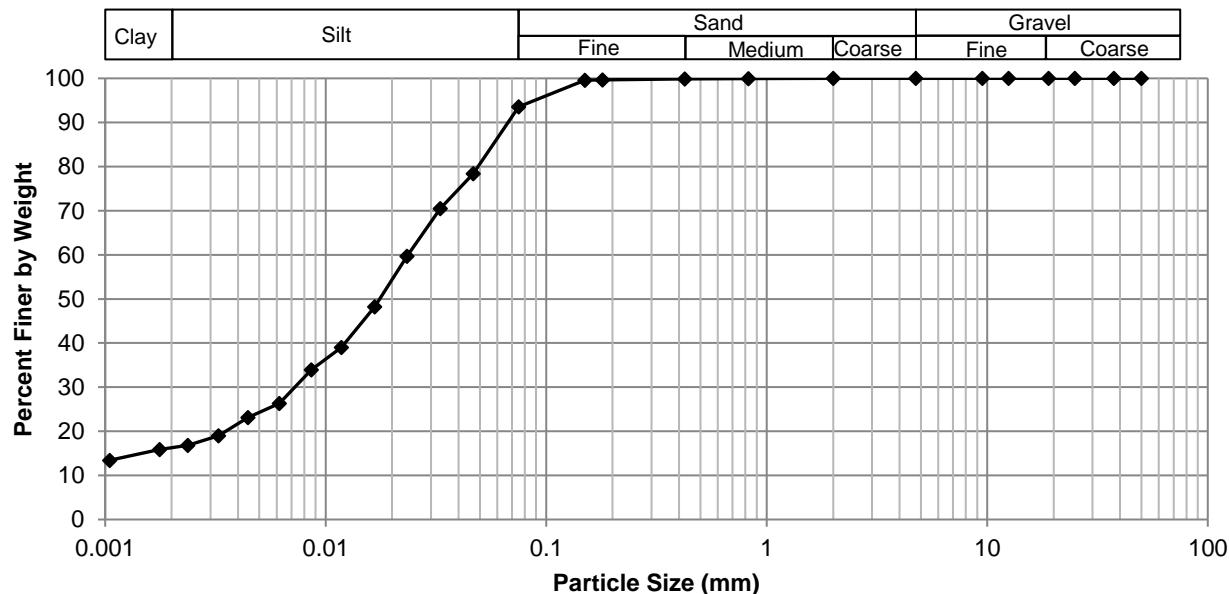
### Particle Size Distribution Curve

<b>Gravel</b>	0.0%
<b>Sand</b>	6.4%
<b>Silt</b>	77.4%
<b>Clay</b>	16.2%

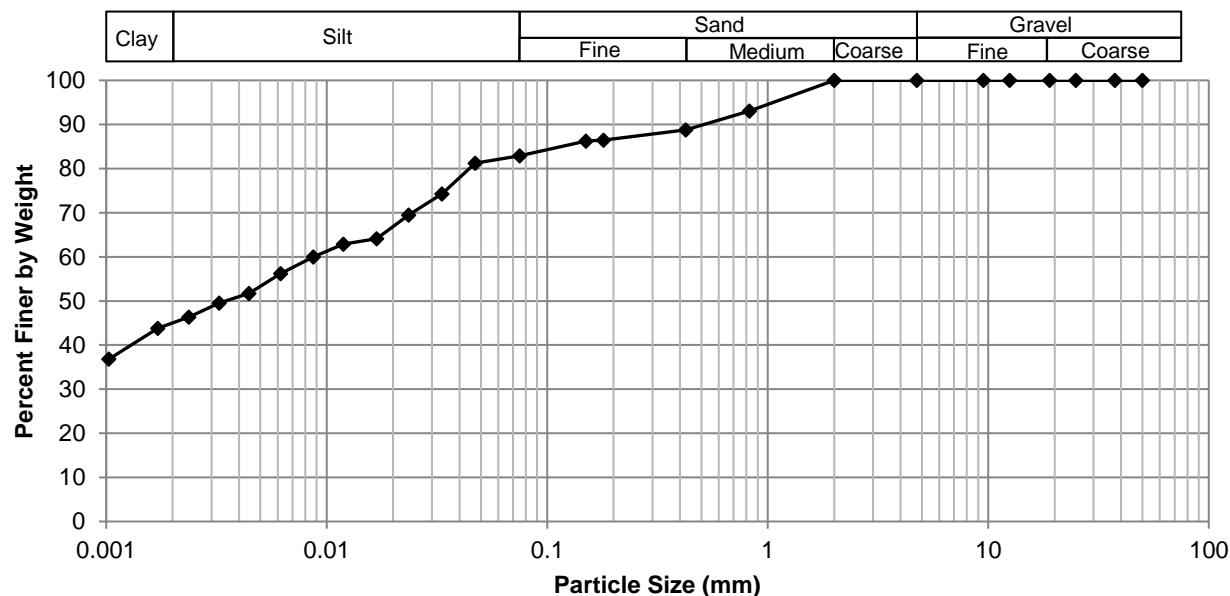
### Particle Size Distribution Curve

<b>Gravel</b>	0.0%
<b>Sand</b>	17.1%
<b>Silt</b>	38.0%
<b>Clay</b>	44.9%

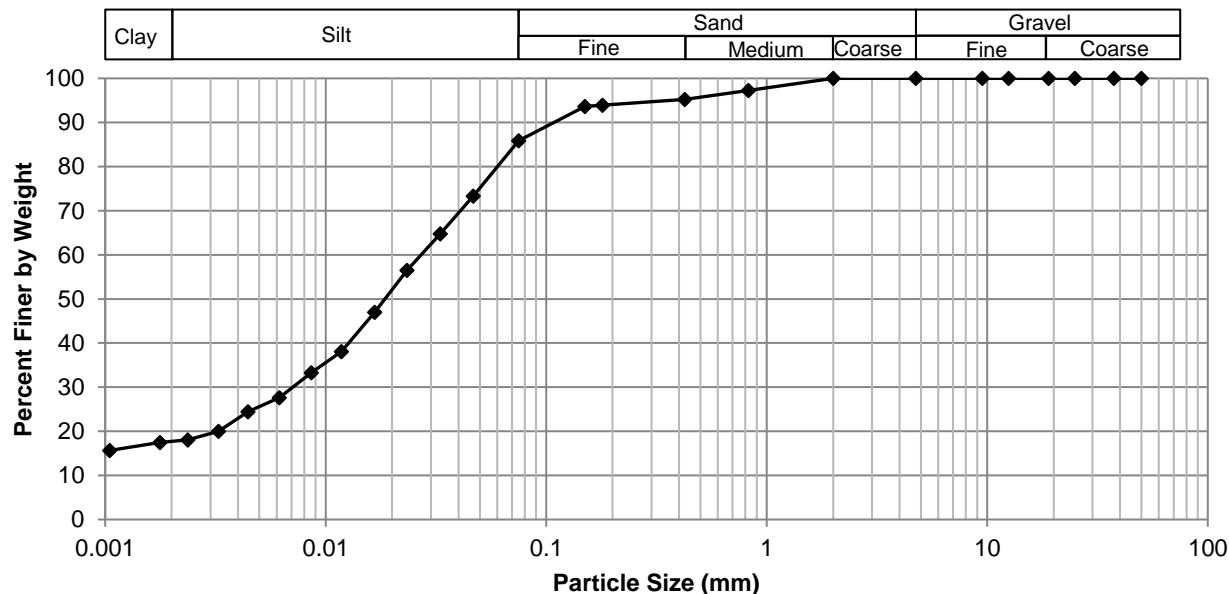
**Particle Size Distribution Curve**

<b>Gravel</b>	0.0%
<b>Sand</b>	14.1%
<b>Silt</b>	68.2%
<b>Clay</b>	17.7%

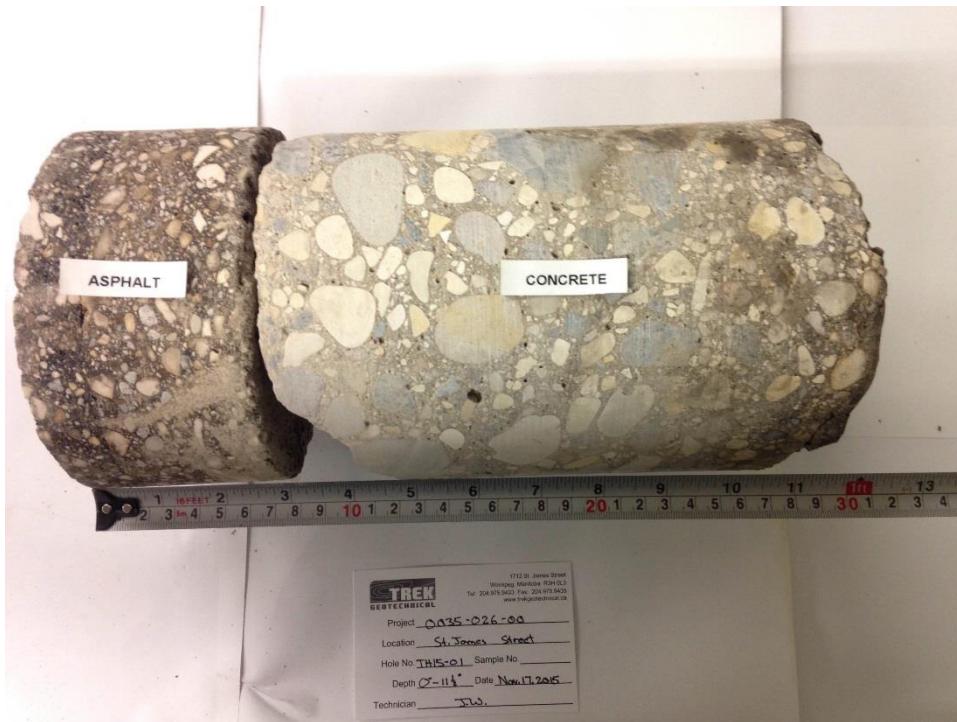
Photo 1: Concrete Core Sample From Test Hole TH15-01

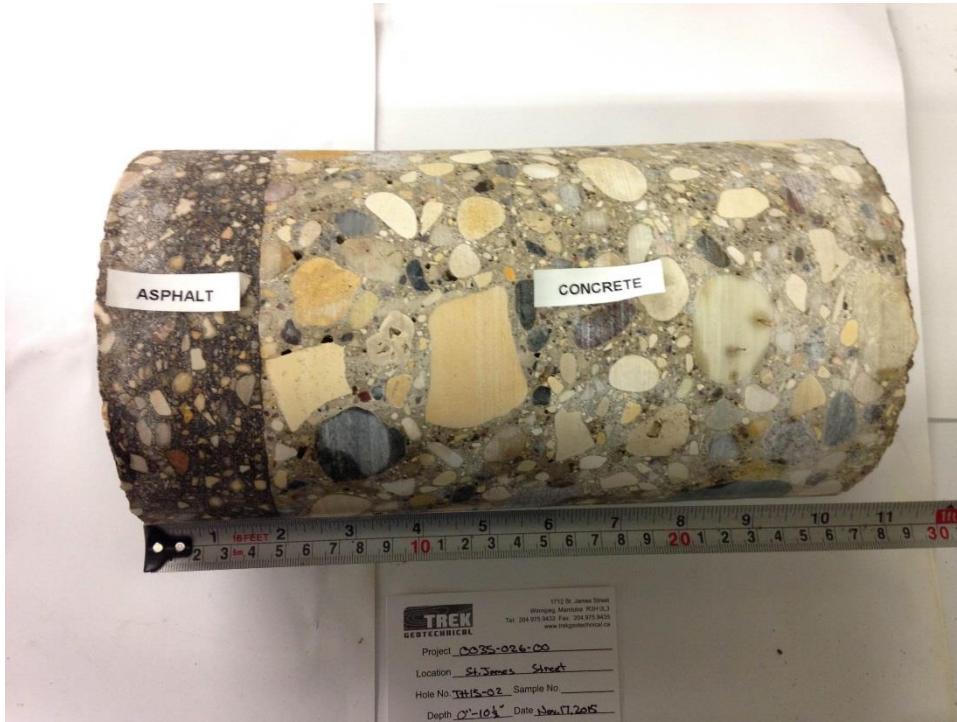
Photo 2: Concrete Core Sample From Test Hole TH15-02

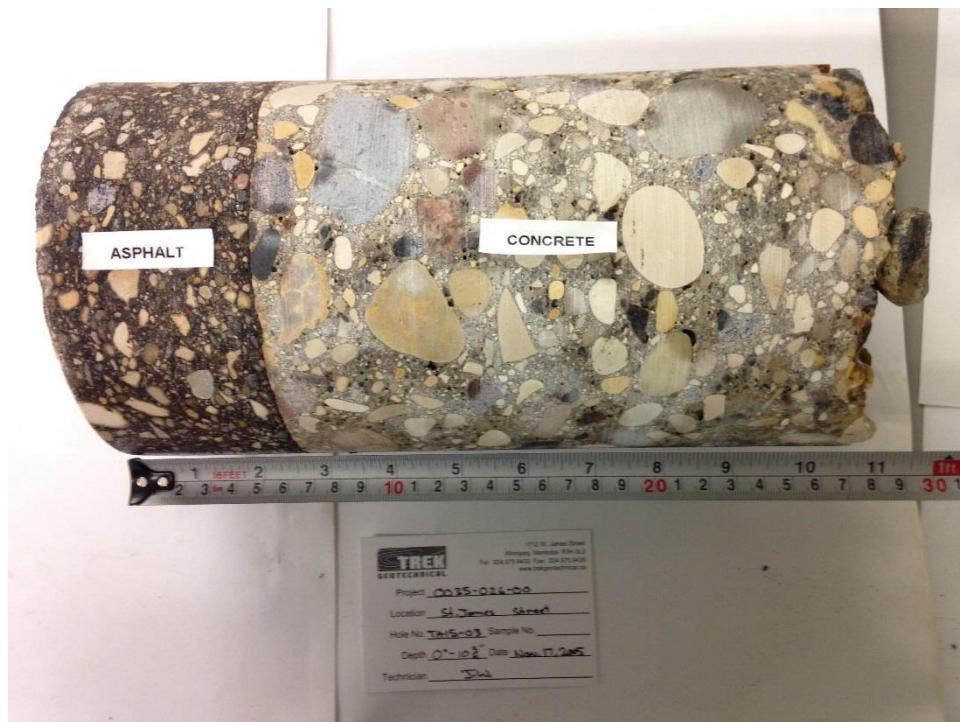
Photo 3: Concrete Core Sample From Test Hole TH15-03

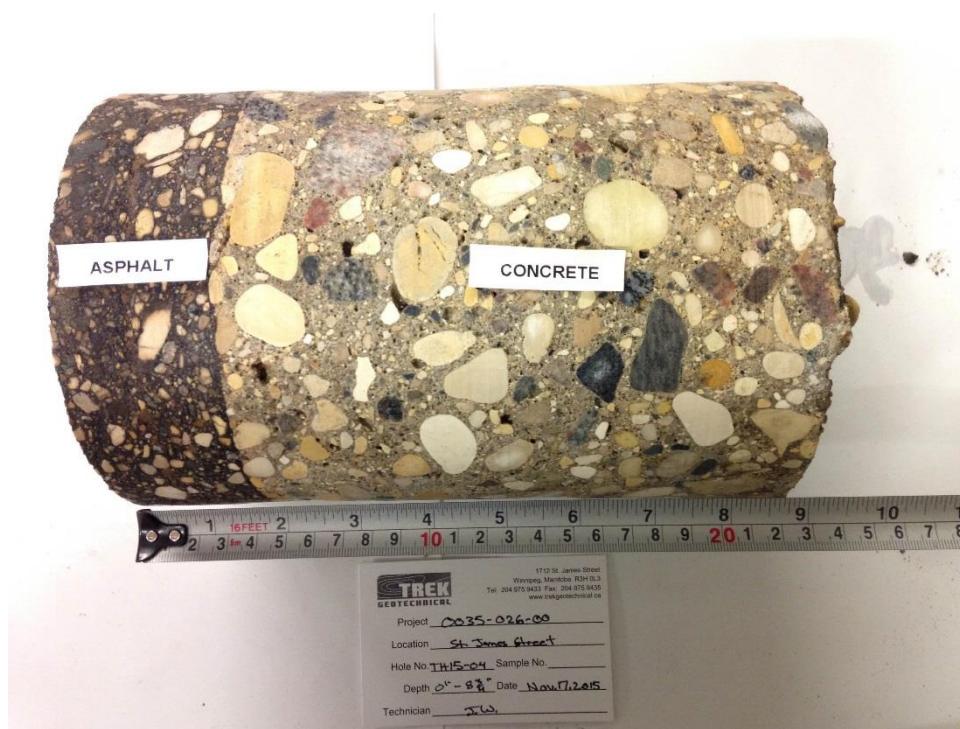
Photo 4: Concrete Core Sample From Test Hole TH15-04

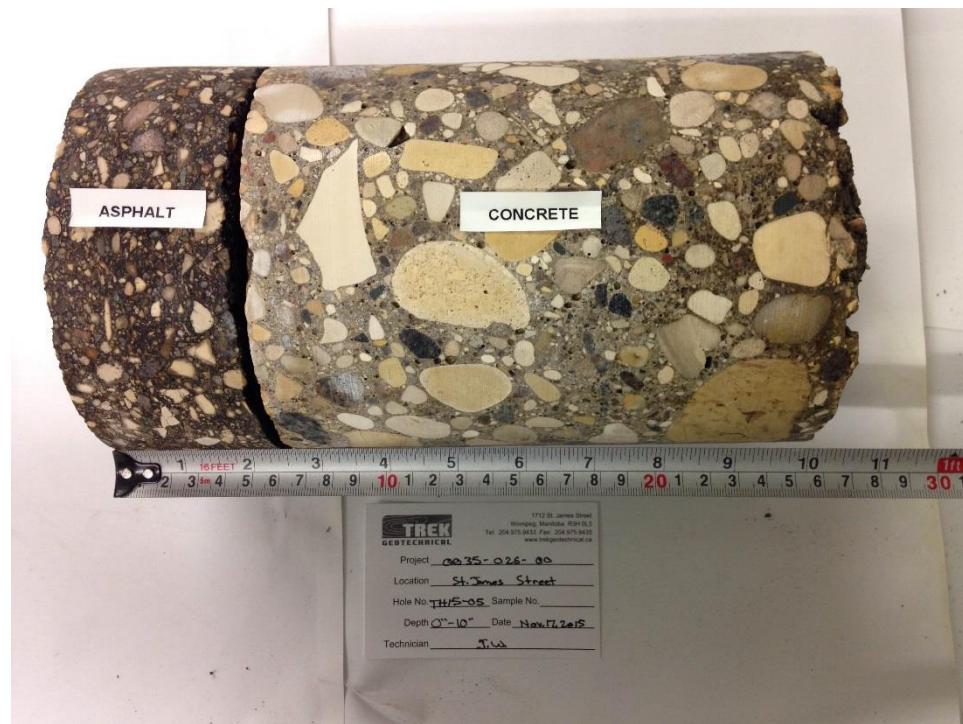
Photo 5: Concrete Core Sample From Test Hole TH15-05

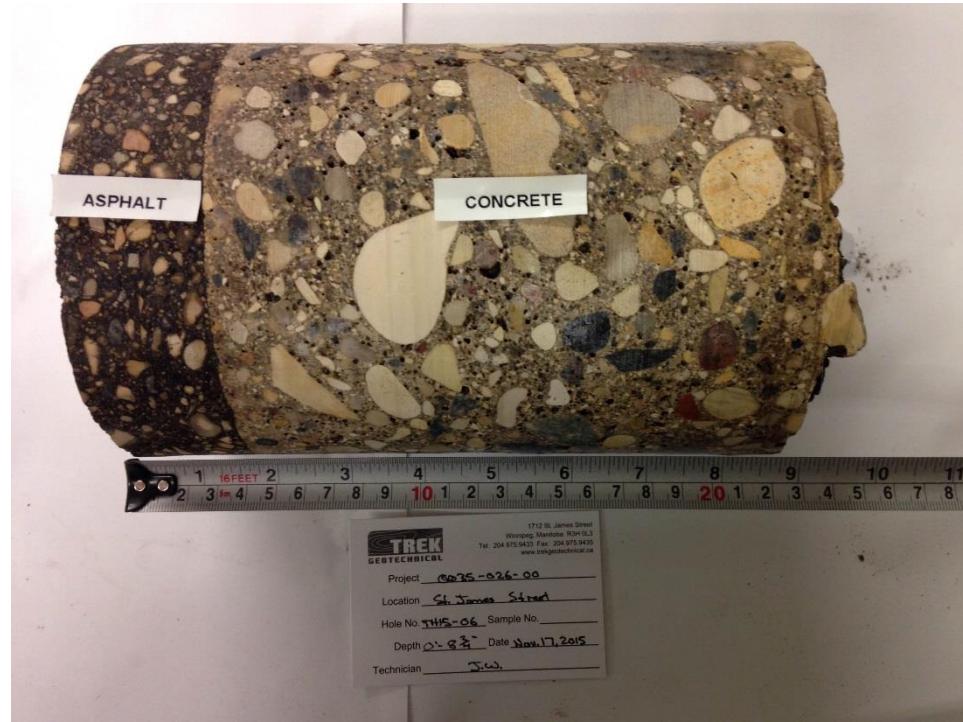
Photo 6: Concrete Core Sample From Test Hole TH15-06

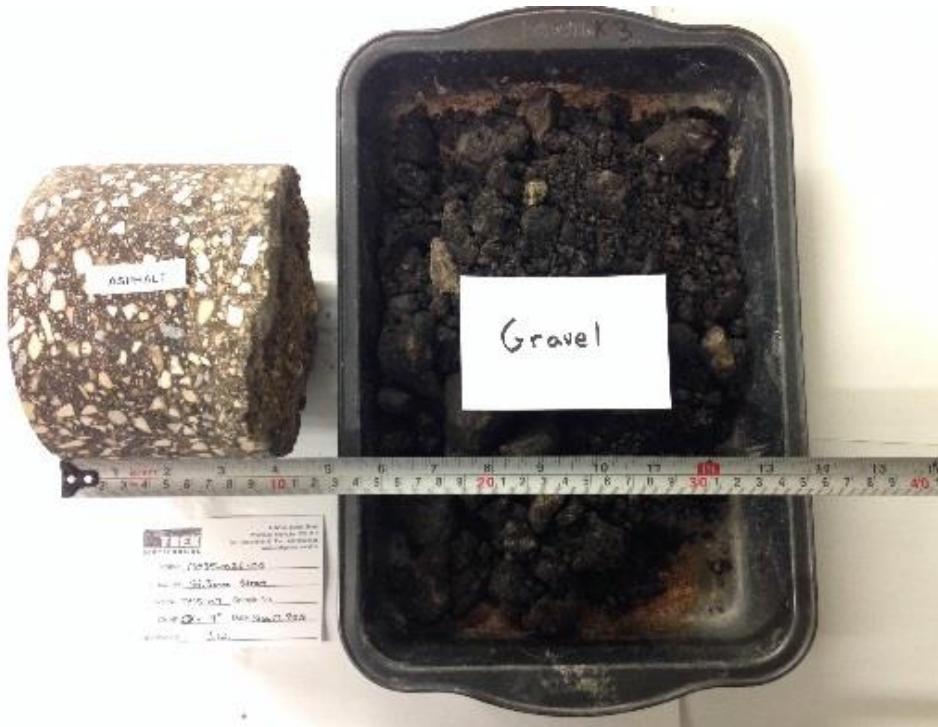
Photo 7: Concrete Core Sample From Test Hole TH15-07

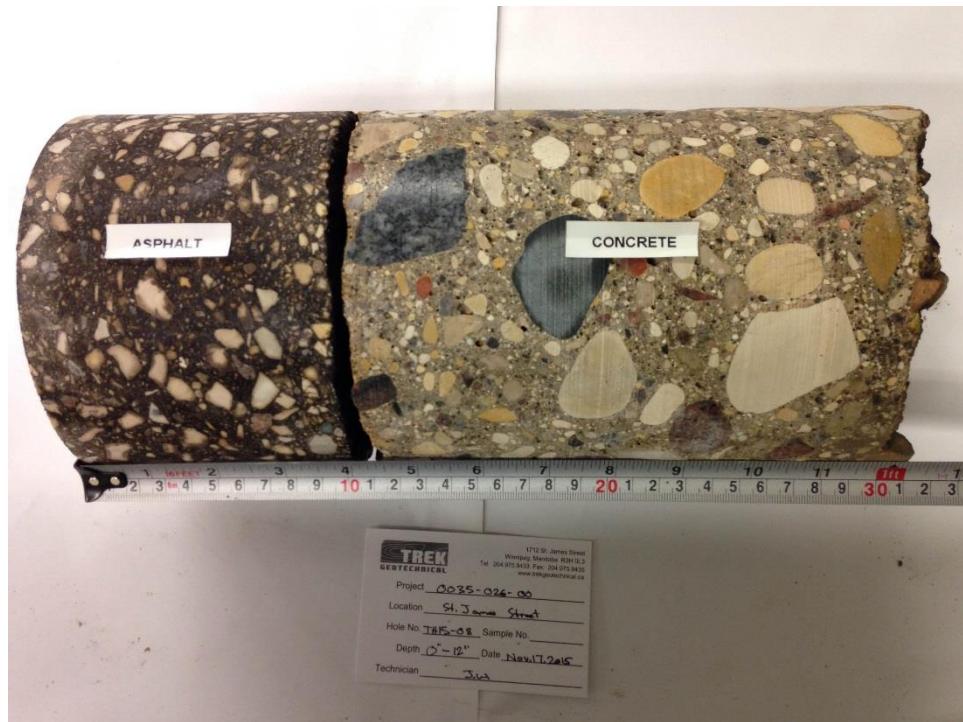
Photo 8: Concrete Core Sample From Test Hole TH15-08

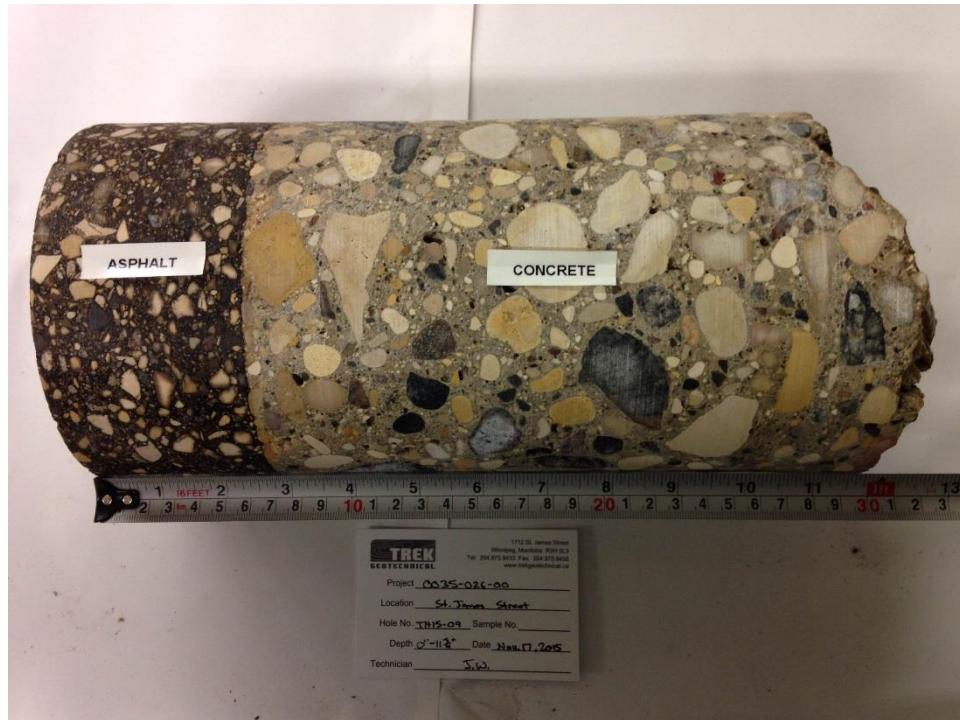
Photo 9: Concrete Core Sample From Test Hole TH15-09

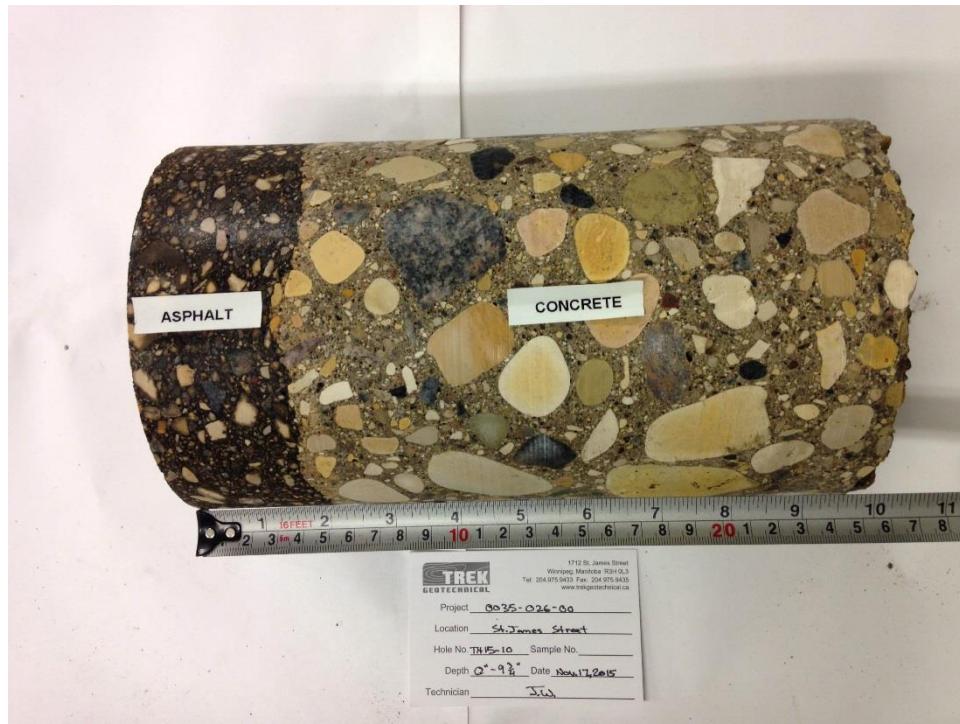
Photo 10: Concrete Core Sample From Test Hole TH15-10

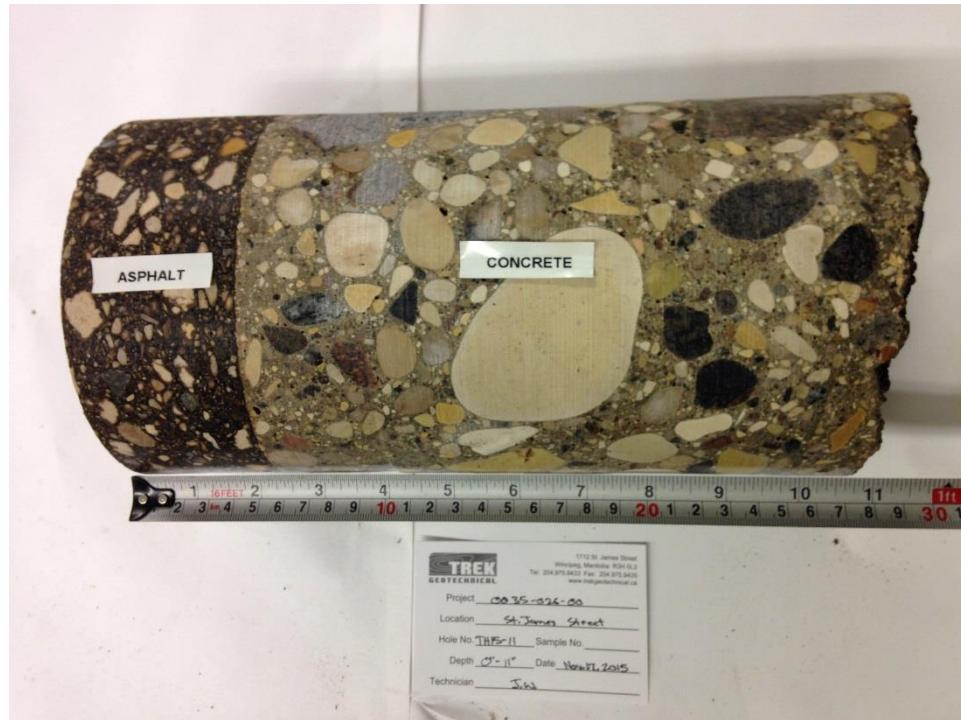
Photo 11: Concrete Core Sample From Test Hole TH15-11
